Your Ref: 8771463315SG
Our Ref :CC3/AIG17023077/D

18 December 2017

TECHNICAL INVESTIGATION REPORT OF FIRE INCIDENT INVOLVING THE INSURED VEHICLE SKB 3988P ON 01 DECEMBER 2017

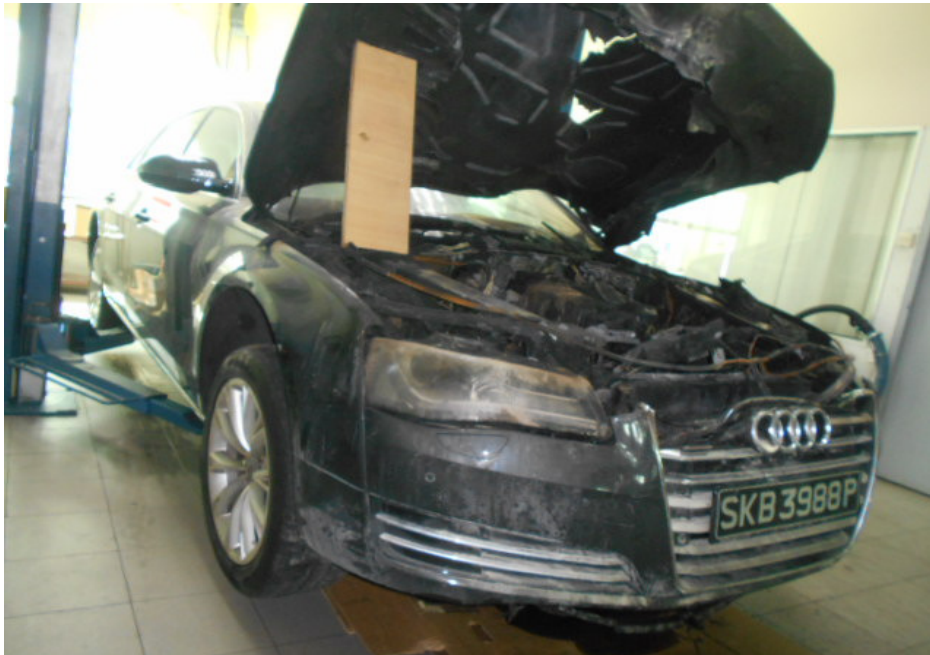
Photo 1 shows a general view of the front right body of the Insured Vehicle at the time of inspection. The Insured Vehicle was observed to be severely burnt at its front body. Its front bumper, front bonnet, front grille, front right headlamp and front right fender were amongst the body parts that were found to have been affected as a result of the fire.

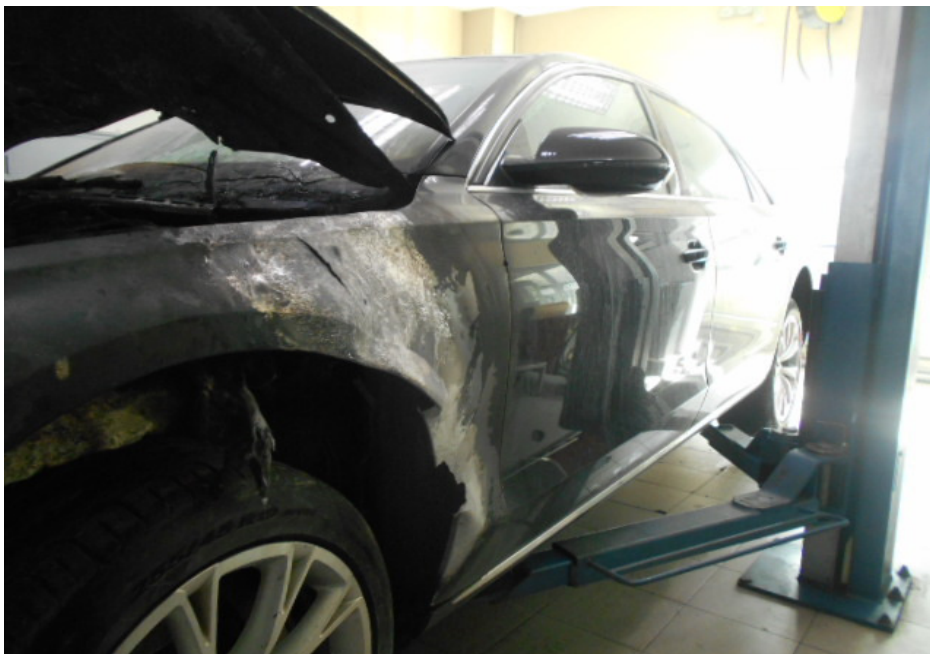
Photo 2 shows a general view of the front left body of the Insured Vehicle at the time of inspection. The Insured Vehicle was observed to be severely burnt at its front body. Its front left fender, front left wheel rim, front left tyre, front bonnet and front windscreen were amongst the body parts that were found to have been burnt and/or melted as a result of the fire.

19. For this case, the burnt pattern of the Insured Vehicle suggest that the fire had originated at the left rear area of its engine compartment. This can be established by the whitish burn marks found on the front left fender, at the area nearer to the front left door of the Insured Vehicle (refer to photograph 2 above). These whitish burn marks are a result of exposure to high heat intensity and can normally be used to indicate where a vehicle fire had originated. As can be seen from the photographs and videos, flames were correspondingly concentrated at the area towards the back of the front left wheel of the Insured Vehicle.

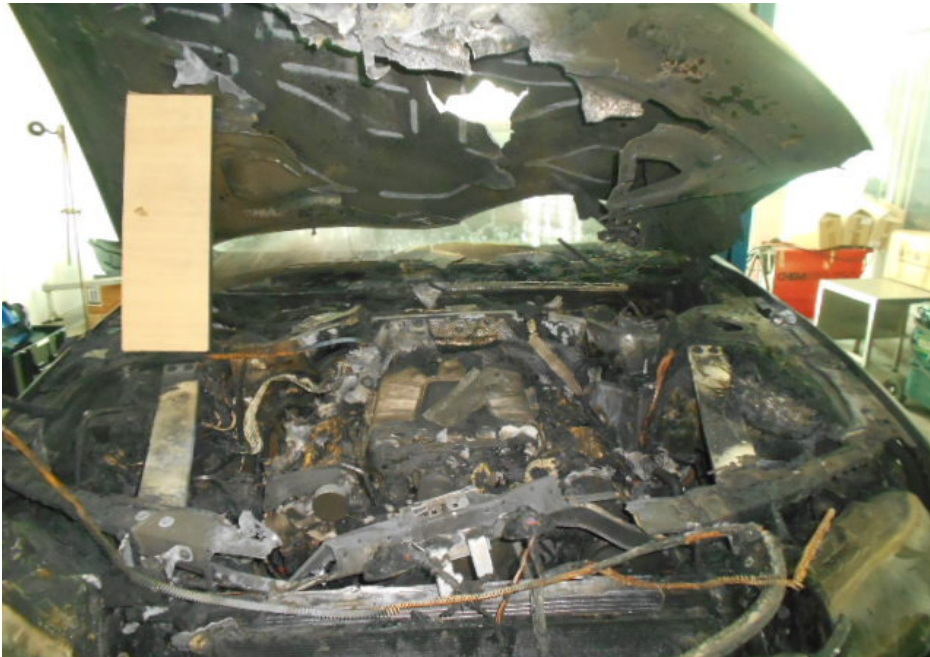
Photo 3 shows the engine compartment of the Insured Vehicle at the time of inspection. Almost all the parts inside the engine area were observed to be burnt and/or melted as a result of the fire. These parts had included its radiator, air condenser, cooling fan, intake manifold, front bonnet absorbers, air duct, hoses and pipes amongst others.

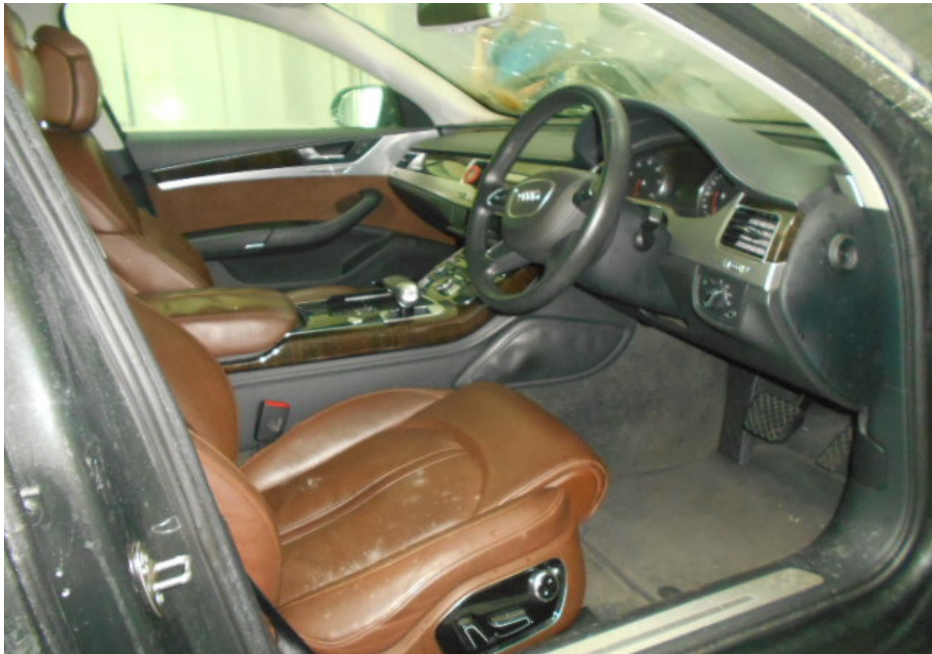
Photo 4 shows the interior compartment of the Insured Vehicle at the time of inspection. The interior compartment and rear body of the Insured Vehicle was unaffected by the fire.

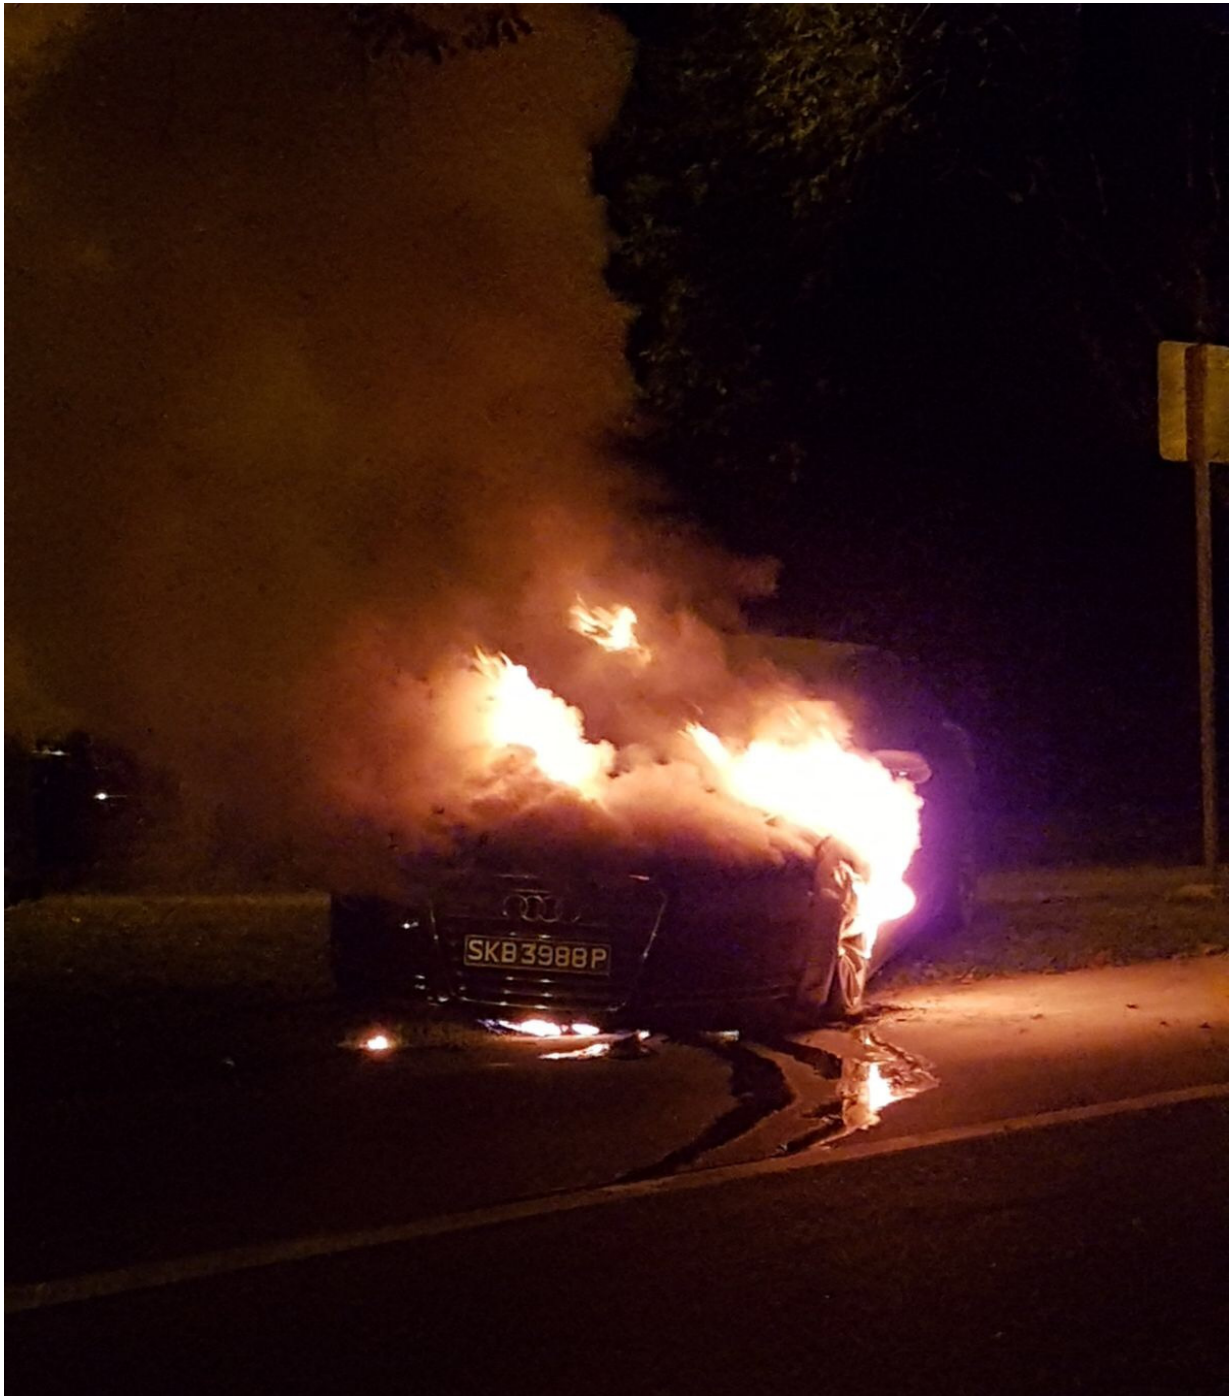
18. Upon further examination of the photographs and videos, I had also noted that there was no unusual foreign material(s) and/or object(s) on the ground in the immediate area of where the Insured Vehicle was parked. I did however observed fluid trails on the ground, beneath the front left side and in front of the Insured Vehicle. These fluids were likely leakage from the engine compartment of the Insured Vehicle but however were not the source of fire ignition given that the fluid was not combusted. See photo 5 & 6 below.

Photo 5 shows the Insured Vehicle at the incident scene with flames engulfing its left front body. Trails of fluid could be seen on the ground beneath the front left side, and in front of the Insured Vehicle. These leaked fluid were unlikely the source of fire as the fluid were not combusted. There was also no unusual foreign material(s) and/or object(s) on the ground in the immediate area of where the Insured Vehicle was parked.

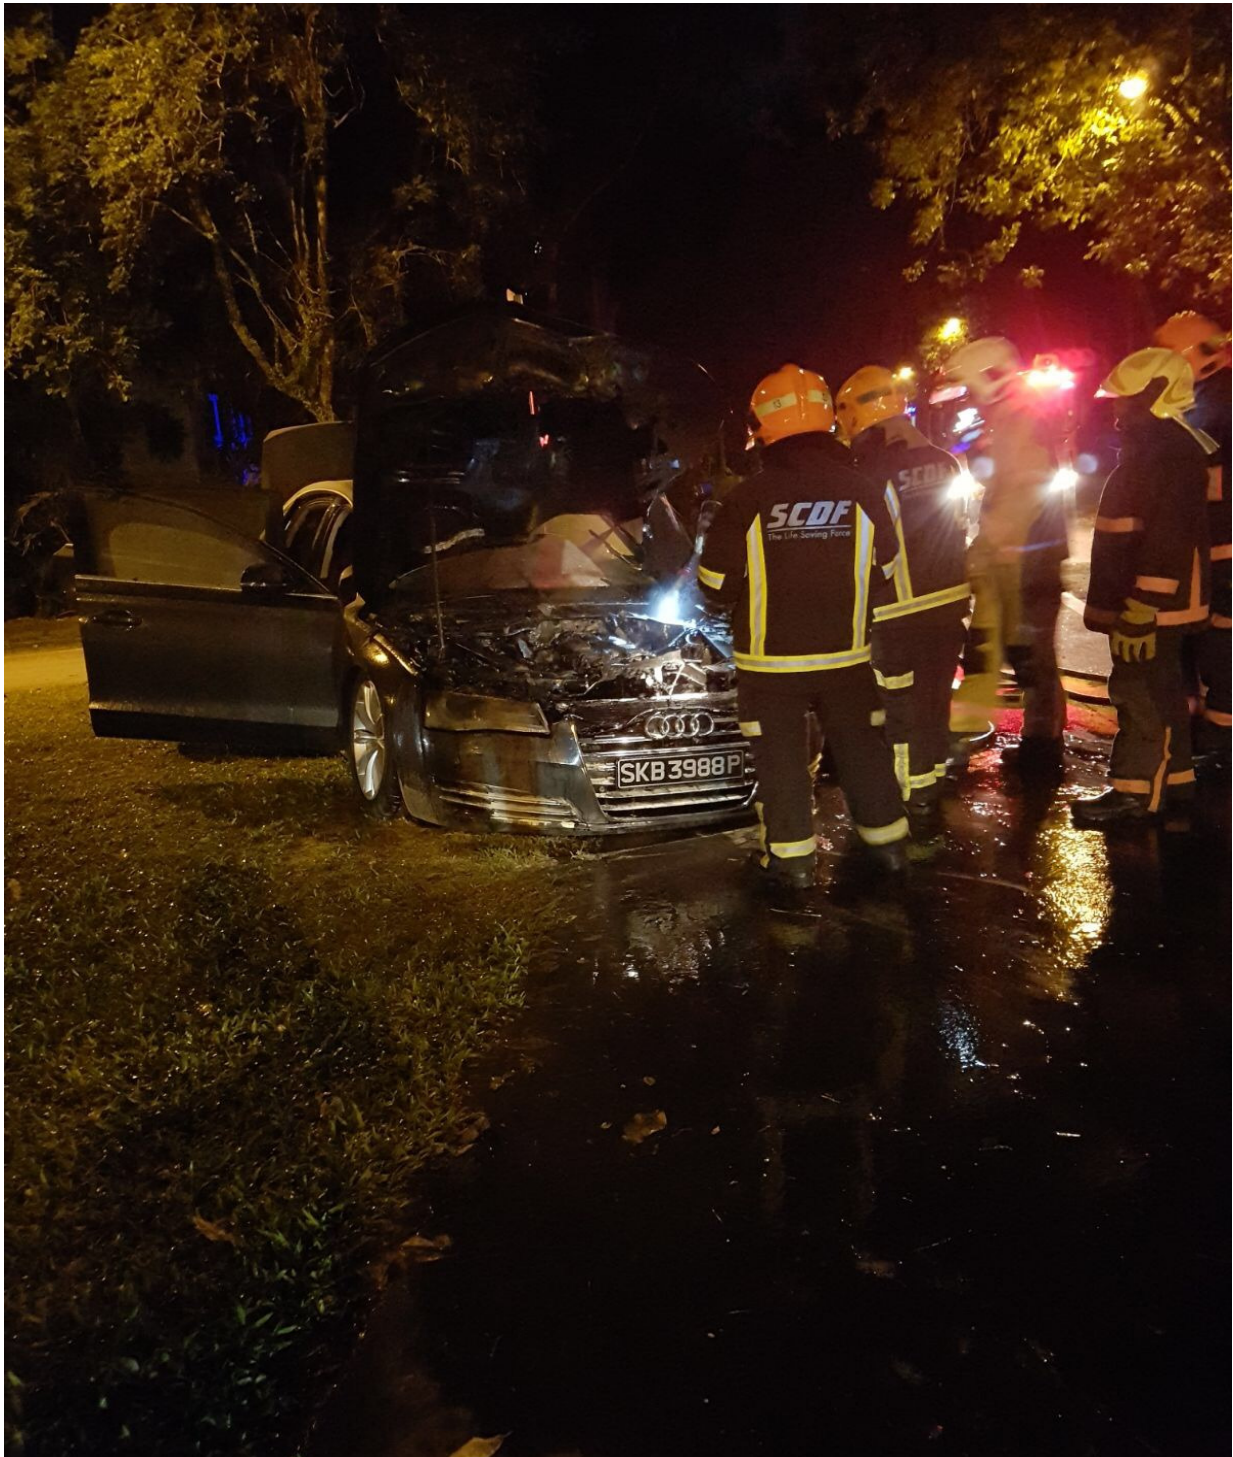
17. The photographs and videos provided to me had showed the Insured Vehicle with flames mainly engulfing its front left side. SCDF officers were seen examining the left side of the engine compartment after the fire was extinguished. This appears to correspond to the location (front left side of the Insured Vehicle) where smoke was first detected by the driver of the Insured Vehicle, and also where flames were first seen by another driver.

Photo 6 shows the Insured Vehicle at the incident scene after the fire was extinguished. SCDF officers could be seen examining the left side of the engine compartment. The left front side of the Insured Vehicle was where smoke was first detected by the driver of the Insured Vehicle and also where flames were first seen by another driver.

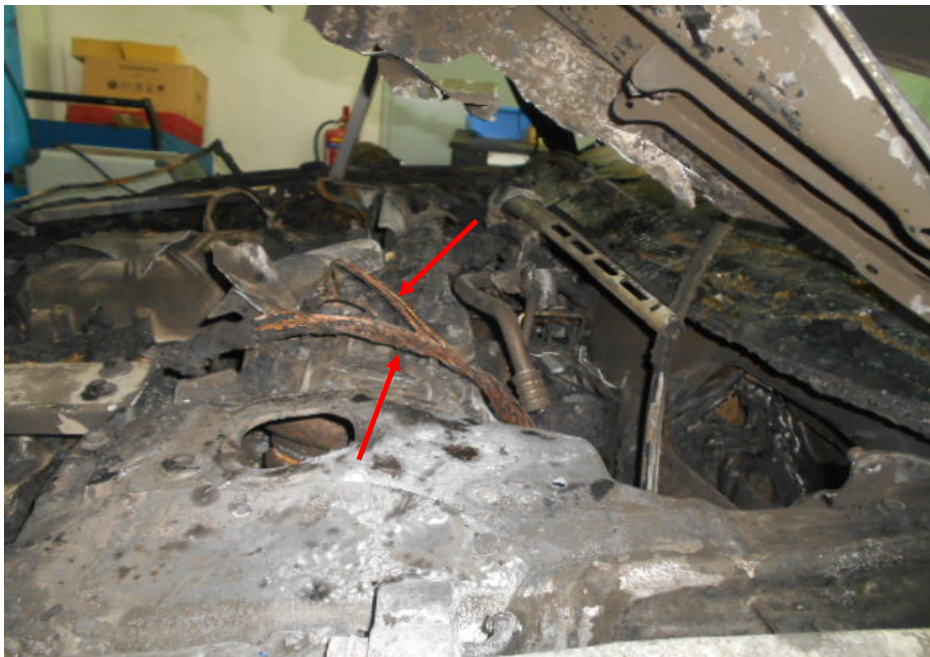
20. My examination of the left rear area of the engine compartment during my inspection of the Insured Vehicle revealed wirings that were completely burned to its copper state. The wirings were likely to be original wire harnesses of the Insured Vehicle. The bright reddish colour of the copper wires suggest that the wirings were exposed to high heat. Such condition normally indicate internal heating of copper wires which is a sign of an electrical short circuit occurring. This would then appear to suggest that the cause of fire to the Insured Vehicle could have possibly been due to electrical in nature. See photo 7 – 9 below.

Photo 7 shows the wirings at the left rear area of the Insured Vehicle's engine compartment. The wirings (arrowed) were found to be completely burned to its bare copper state. The bright reddish colour of the copper wires suggest that the wirings were exposed to high heat. Such condition normally indicate internal heating of copper wires which is a sign of an electrical short circuit occurring. The wires were likely to be original wire harnesses of the Insured Vehicle.

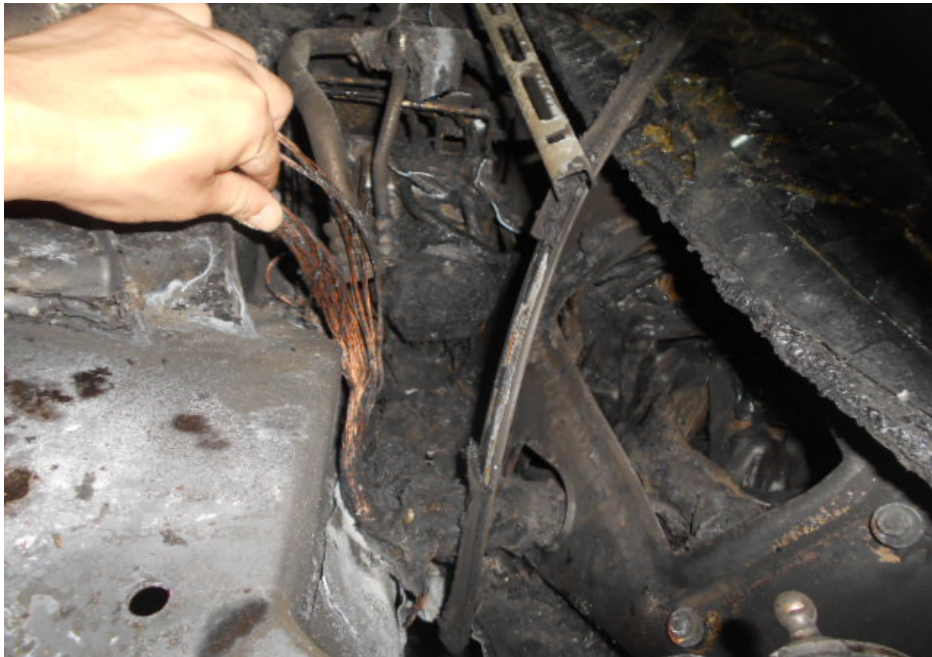
Photo 8 shows a closer view of the wirings at the left rear area of the Insured Vehicle's engine compartment. The wirings were found to be completely burned to its bare copper state. Such condition normally indicate internal heating of copper wires which is a sign of an electrical short circuit occurring.

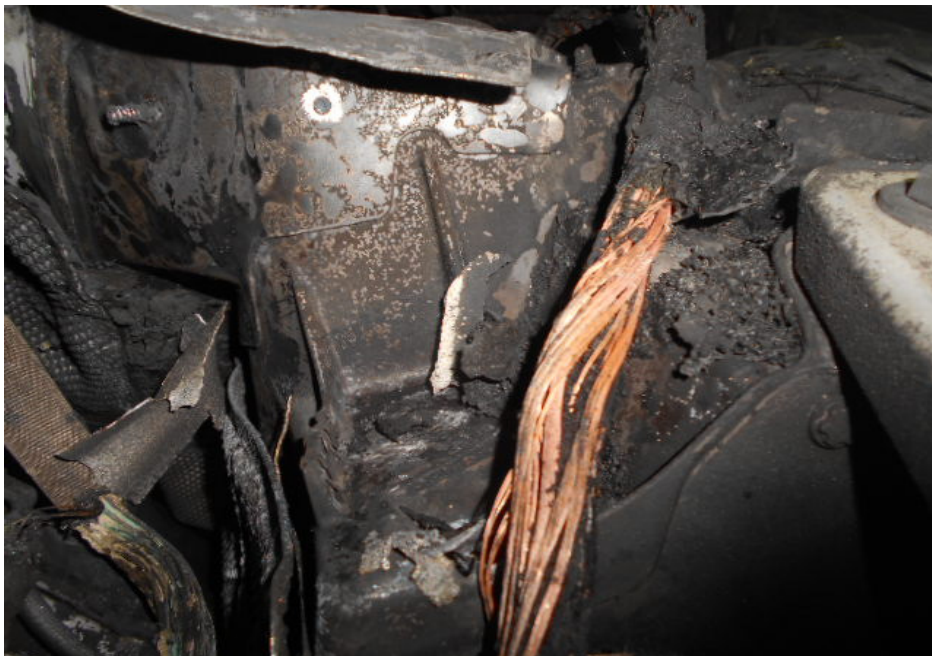
Photo 9 shows a closer view of another stretch of wirings at the left rear area of the Insured Vehicle's engine compartment. The bright reddish colour of the copper wires suggest that the wirings were exposed to high heat. Such condition normally indicate internal heating of copper wires which is a sign of an electrical short circuit occurring. This would then appear to suggest that the cause of fire to the Insured Vehicle could have possibly been due to electrical in nature.
