# LKK Auto Consultants Pte Ltd

| Affiliated to Federation Internationale Des Experts En Automobile | | | | |
|---|---|---|---|--|
| AUTOMOTIVE ENGINEERING & MGT DIVISION | | Ref : CS/SPF17023172/Gvb | | |
| Insured Veh. | Veh. Inspected | | QX 329A | |

# ACCIDENT/DAMAGE REPAIR AND AD HOC WORKS REQUEST FORM

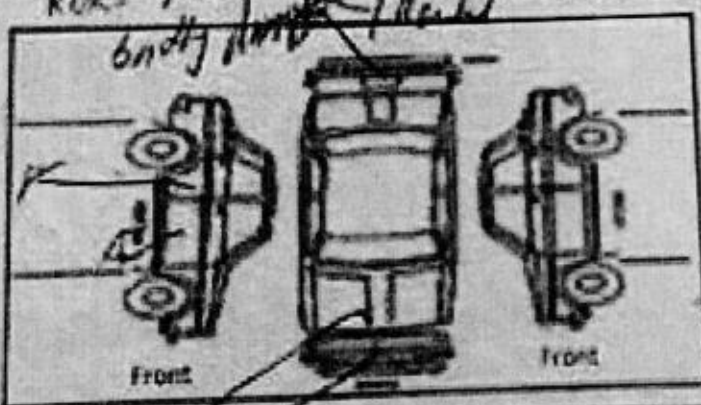
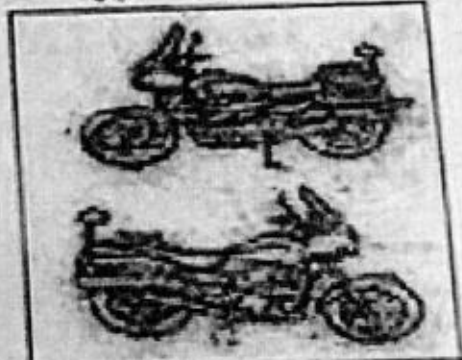
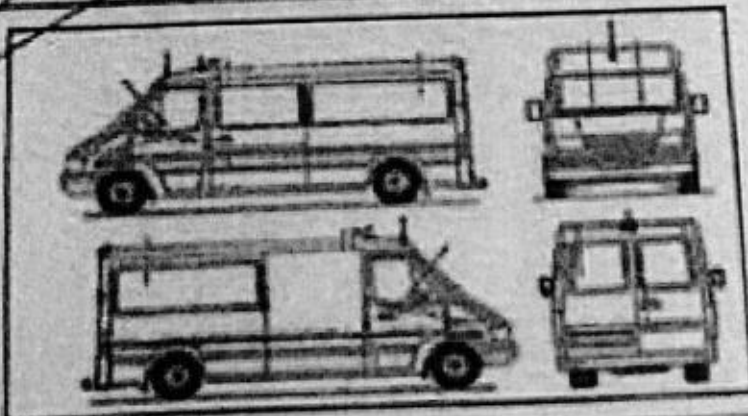
- ① Rear portion badly damaged and dented
- ② Right portion / front and rear door dented
- ③ front portion badly damaged / dented

④ to do alignment  
check  
req

Due to chassis member badly damaged.  
It's unsafe to repair the vehicle.

- (a) The vehicle sustained damages at the front and rear portion, o/s and n/s body. The undercarriage affected due to collision. (Details see photographs enclosed)

- (b) In view of this, we are of the opinion that it would be **unsafe** to proceed with the repairs due to extensive damages on the chassis under the category of **the section 2 of THE ROAD TRAFFIC ACT on THE MOTOR VEHICLES (CONSTRUCTION AND USE) (AMENDMENT NO.2) RULES 1989**, that:

*no vehicle shall be fitted with a replacement chassis or any body part where the chassis is an integral part of the vehicle.*  
and we therefore recommend it to be written off as **"Total Loss"**
