Your Ref: SHB 8971P
Our Ref :CI/TP17023247/D

06 December 2017

TECHNICAL INVESTIGATION REPORT OF FIRE INCIDENT INVOLVING A KIA OPTIMA MOTOR TAXI SHB 8971P ON 21 NOVEMBER 2017

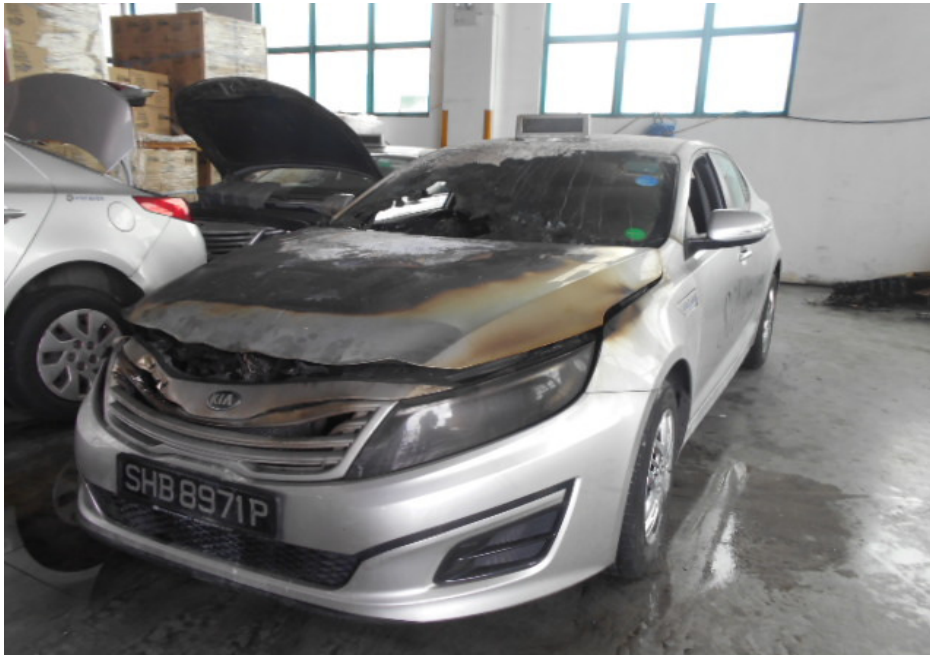
Photo 1 shows a general view of the front left body of the Motor Taxi at the time of inspection. The Motor Taxi was observed to have been severely burnt at its frontal portion. Its front bumper, front bonnet, front grille, front left headlamp, front left fender, roof panel and front windscreen were amongst the body parts that were found to have been affected as a result of the fire.

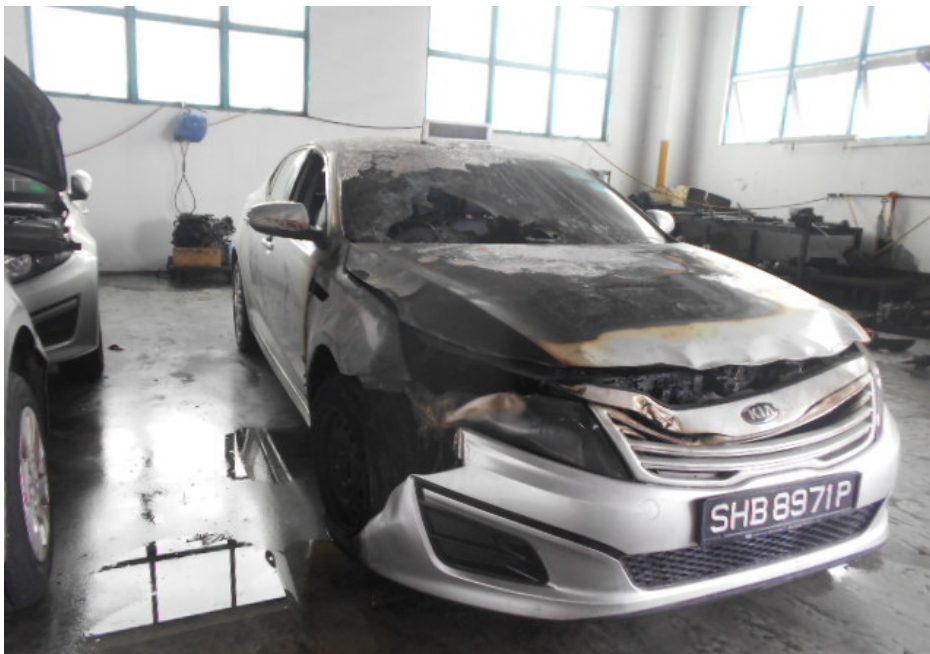
Photo 2 shows a general view of the front right body of the Motor Taxi at the time of inspection. The Motor Taxi was observed to be severely burnt at its frontal portion. Its front bumper, front bonnet, front right headlamp, front right fender, roof panel and right side wing mirror were amongst the body parts that were found to have been affected as a result of the fire.

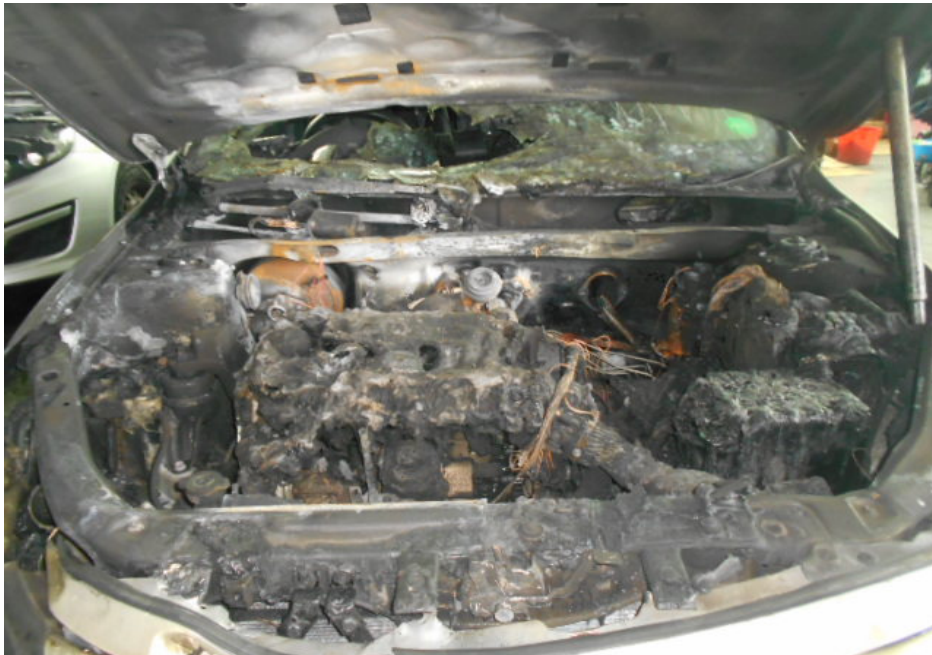
Photo 3 shows the engine area of the Motor Taxi at the time of inspection. Almost all the parts inside the engine compartment were observed to be completely burnt and/or melted as a result of the fire. This had included its radiator, cooling fan, engine housing, fuel rail, brake booster and fuse box amongst others.

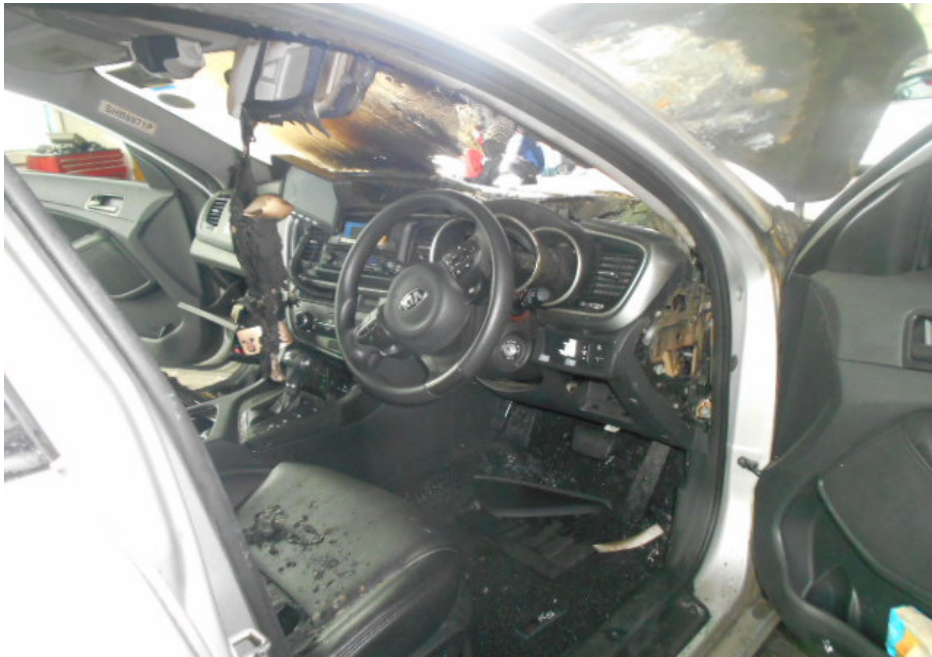
Photo 4 shows the interior compartment of the Motor Taxi at the time of inspection. Parts towards the front area of the interior compartment were found to be burnt and/or partially melted as a result of the fire. This had included the dashboard, upholstery and carpet amongst others.

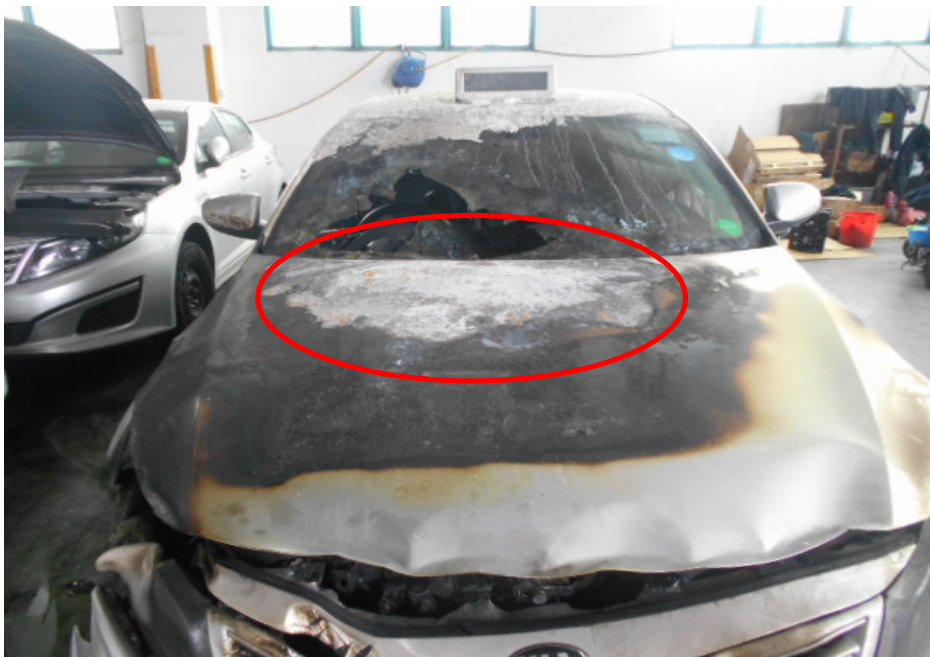
7. For this particular case, the fire appears to have originated within the engine compartment of the Motor Taxi, at the rear area, slightly towards the right from the centre of the engine compartment. This can be determined from the high heat intensity burn marks (whitish burn marks) that could be found on the top side of the front bonnet, at the rear right area, and the rust that had developed on the underside of the front bonnet, at the same area.

Photo 5 shows the whitish burn marks (circled) that were found on the top side of the Motor Taxi's front bonnet. Such whitish burn marks are a result of exposure to prolonged heat intensity, which may indicate where the fire had started. Rust would also begin to develop on these areas soon after the fire.

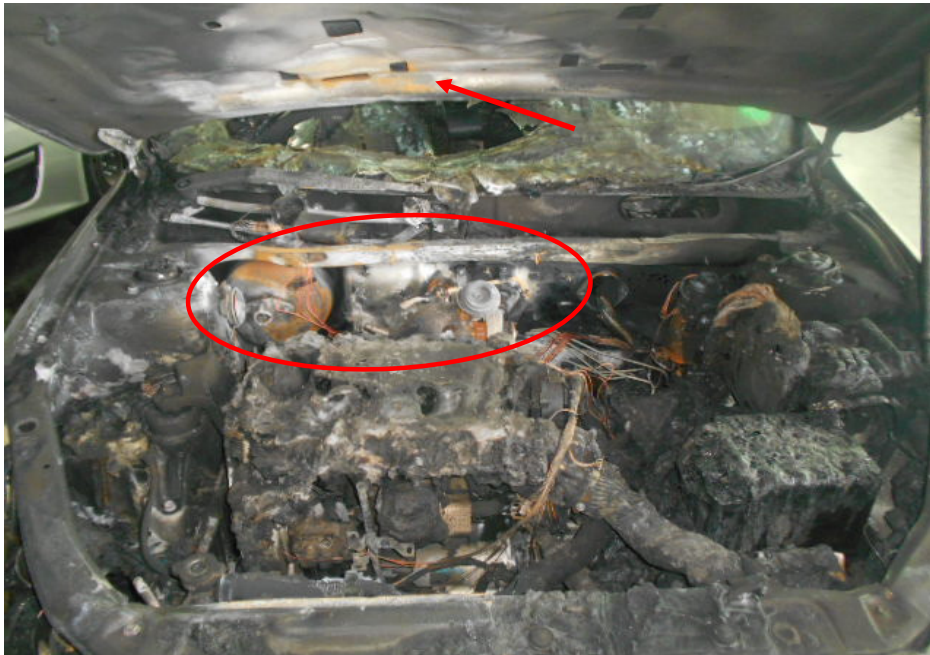
8. Rust would normally start to develop around areas that were exposed to prolonged heat intensity, soon after a fire, as such exposure usually causes the steel/metal material body parts to be exposed to natural environmental condition. For this case, the rust that had developed on the underside of the front bonnet, around the rear right area, is an indication that the rear right area of the engine compartment was exposed to prolonged high heat intensity. The fire to the Motor Taxi can hence be determined to have originated around the rear right area of its engine compartment. See photo 5 & 6 below.

Photo 6 shows the approximate location of where the fire had originated. This was around the rear right area of the engine compartment (circled), as determined from the rust that had developed on the underside of the Motor Taxi's front bonnet (arrowed). The development of rust is a consequence of that area being exposed to prolonged high heat intensity, where such exposure usually causes the steel/metal material body parts to be exposed to natural environmental condition.

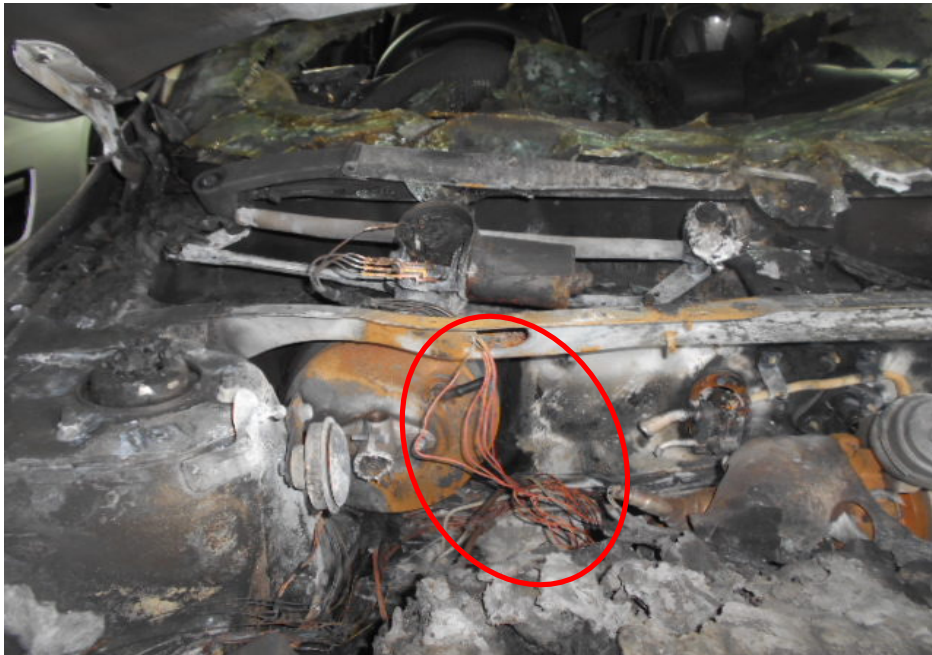
9. Upon closer examination of the area around the rear right of the engine compartment, which was directly below the area on the underside of the front bonnet where rust was seen, I had found several stretches of wiring burnt internally to its bare copper state. Such condition normally indicates internal heating of copper wires which is a sign of an electrical short circuit occurring. This would then appear to suggest that the cause of fire to the Motor Taxi could have possibly been due to electrical in nature. See photo 7 & 8 below.

Photo 7 shows the wirings around the rear right of the engine compartment, which was where the fire to the Motor Taxi had likely started. The wirings (circled) were found to have been burnt internally to its bare copper state, suggesting occurrence of an electrical short circuit.

23. Basing on my inspection of the Motor Taxi, I am of the view that the fire had originated around the rear right area of the Motor Taxi's engine compartment. The cause of fire was likely to be of electrical in nature, where deterioration of rubber wire insulators could have caused live wires to come into contact with each other and/or the metal body of the vehicle, creating sparks that had ignited the fire.

24. This deterioration of rubber wire insulators are difficult to be visually detected and tend to be unnoticed during the periodic maintenance of a vehicle. If detected, the entire wire harness of the vehicle would have to be replaced in order to eliminate any possible fire risk. This would involve costly rectification and long periods of downtime.

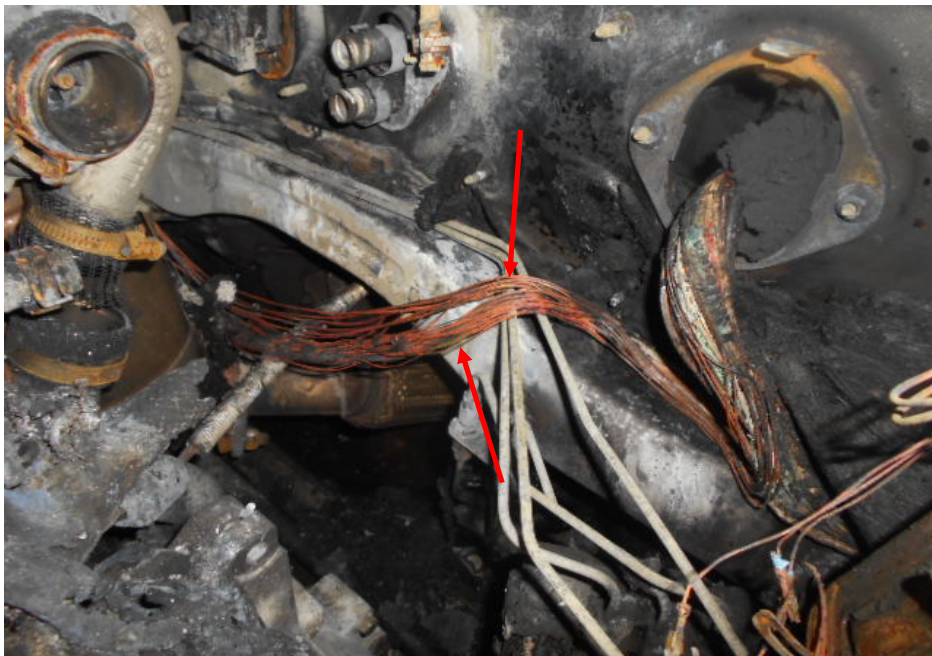
Photo 8 shows another stretch of wirings around the rear of the engine compartment, which was in the immediate vicinity where the fire to the Motor Taxi had likely started. The wirings were found to have been burnt internally to its bare copper state, suggesting occurrence of an electrical short circuit.

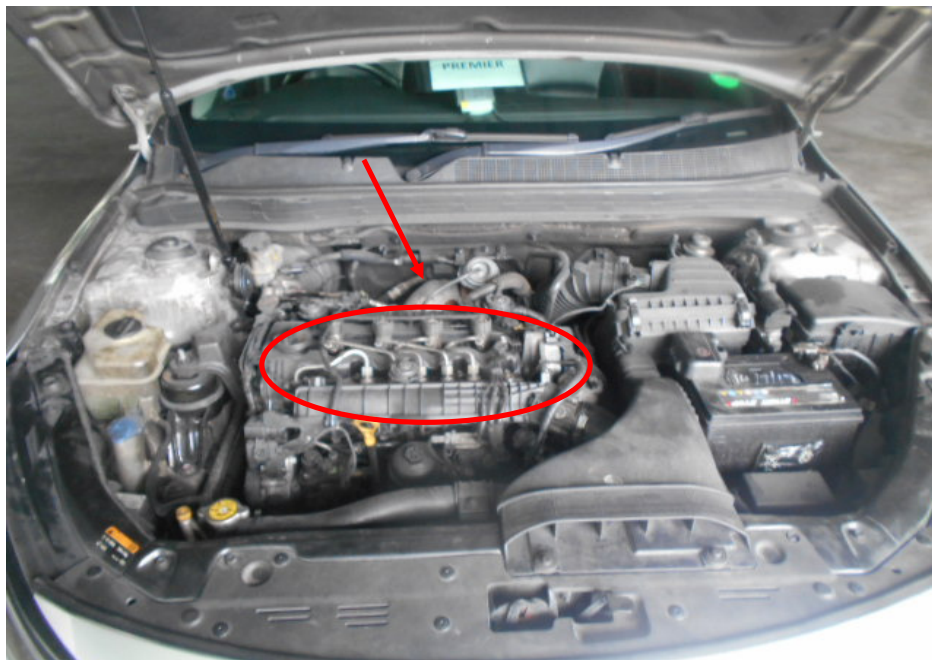
Photo 9 shows the engine layout of a similar make and model motor taxi as the Motor Taxi. The fuel rail and fuel injectors were located towards the front area of the engine compartment (circled), away from the hot surfaces of the exhaust manifold and the DPF, which are both located towards the rear of the engine compartment (arrowed).

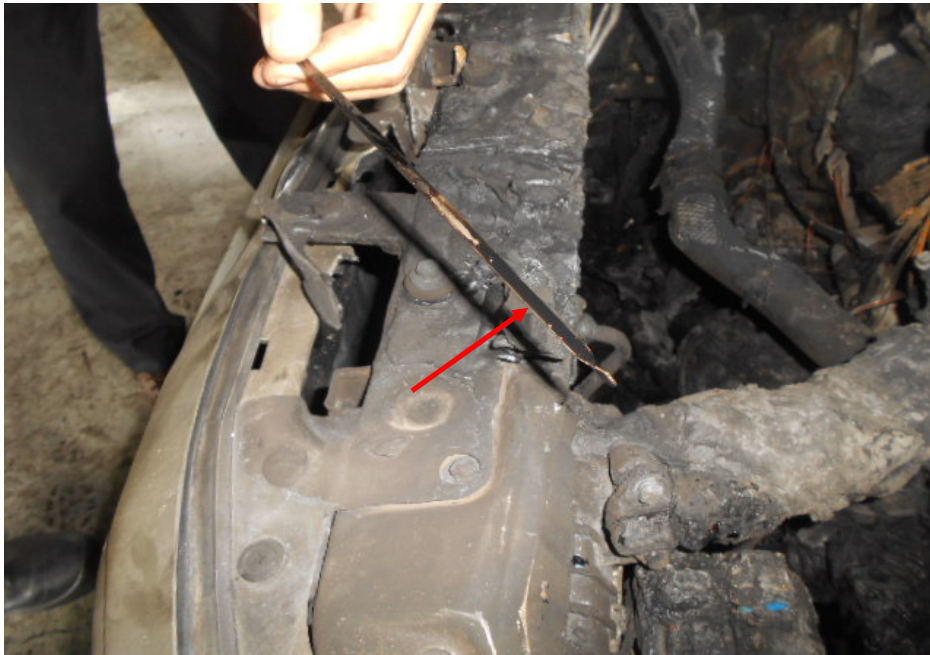
Photo 10 shows the engine oil dip stick of the Motor Taxi. The engine oil of the Motor Taxi was found to be of sufficient level (arrowed) for operating purposes, indicating no leakage of engine oil. In general, there appears to be no sign(s) or indication(s) to suggest that the Motor Taxi had experienced fluid leakage prior to the fire incident. Cause of fire being due to fluid leakage would then be unlikely.

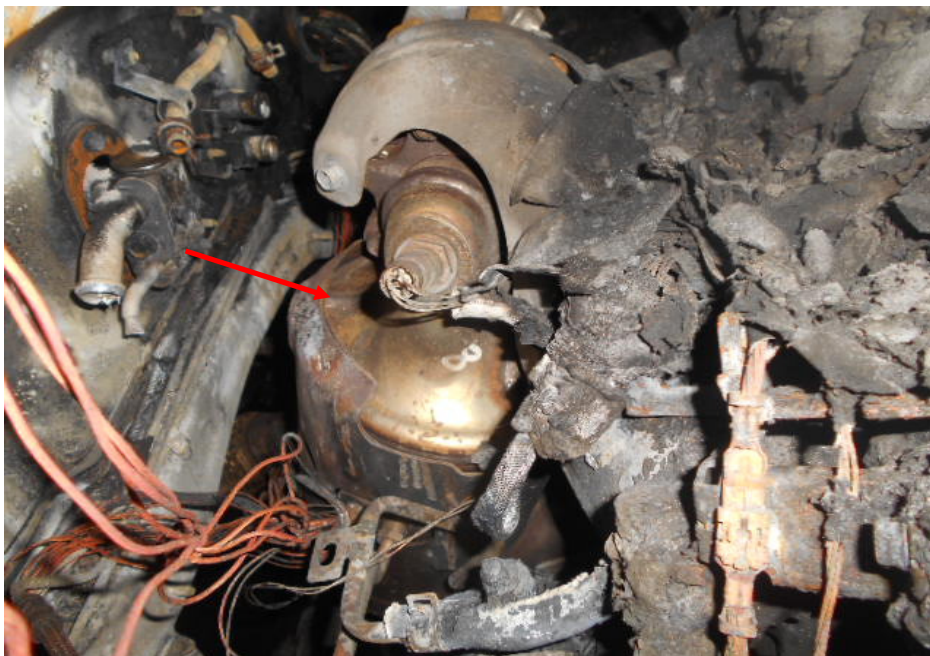
Photo 11 shows the DPF (Diesel Particulate Filter) of the Motor Taxi (arrowed). Although the DPF was located in the immediate vicinity of where the fire to the Motor Taxi had originated. The exterior surfaces of the exhaust manifold and the DPF both did not contain any sign(s) of being directly exposed to high heat intensity (whitish burn marks) that could have suggested that fluid had leaked onto the hot surfaces of the exhaust pipes to cause the fluid to self-ignite.

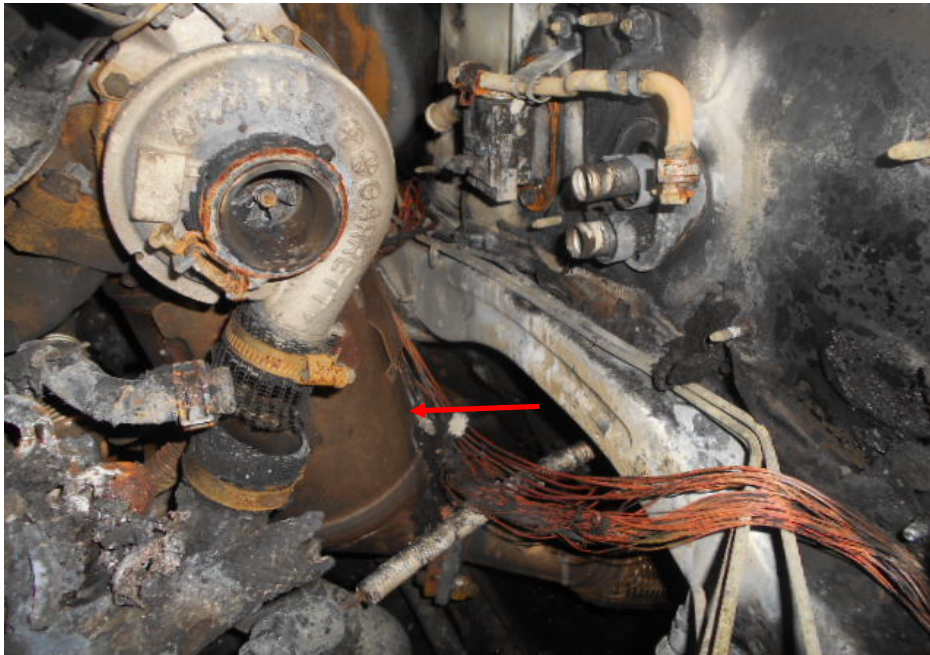
Photo 12 shows the DPF (Diesel Particulate Filter) of the Motor Taxi (arrowed). Although the DPF was located in the immediate vicinity of where the fire to the Motor Taxi had originated. The exterior surfaces of the exhaust manifold and the DPF both did not contain any sign(s) of being exposed to high heat intensity (whitish burn marks) that could have suggested that fluid had leaked onto the hot surfaces of the exhaust pipes to cause the fluid to self-ignite.

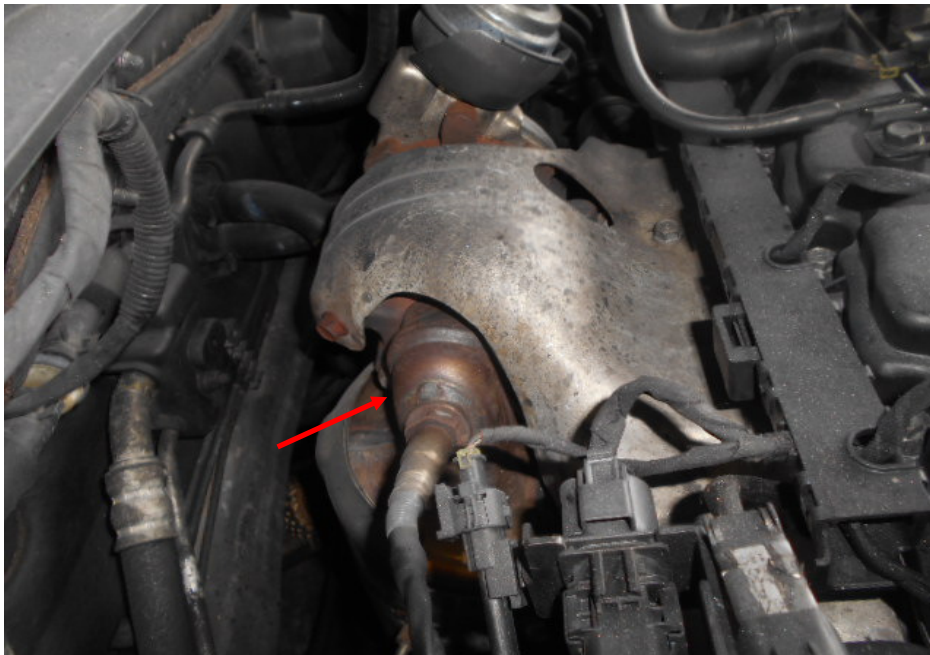
Photo 13 shows the DPF (Diesel Particulate Filter) of a similar make and model motor taxi as the Motor Taxi (arrowed) for comparison of its exterior surfaces. I also note that there was no fluid carrying pipe/hose directly above the area where the DPF is located.
