Your Ref: SHB 8971P  
Our Ref :CI/TP17023247/D

06 December 2017

**TECHNICAL INVESTIGATION REPORT OF FIRE INCIDENT INVOLVING A KIA OPTIMA MOTOR TAXI SHB 8971P ON 21 NOVEMBER 2017**

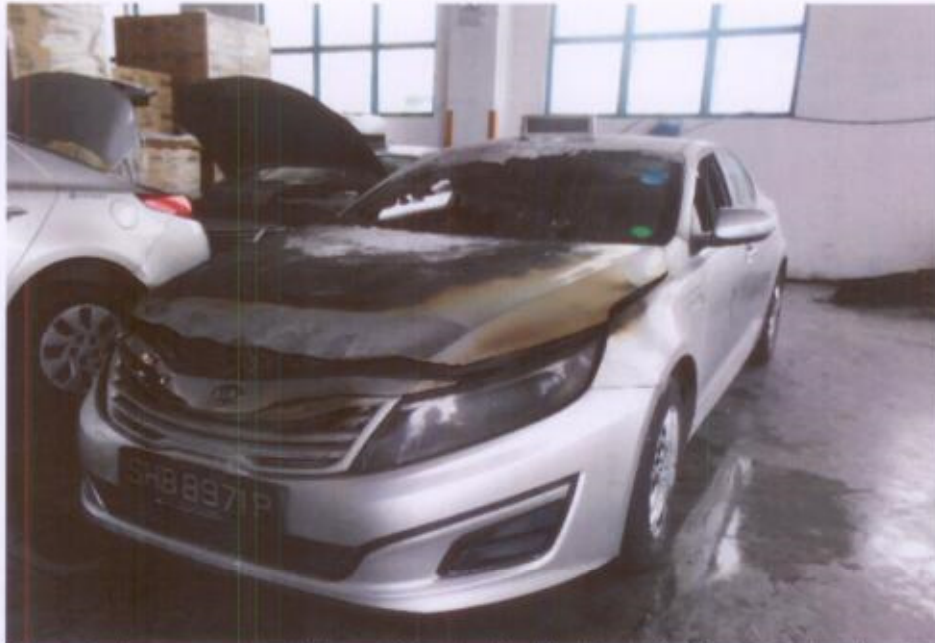
4. The Motor Taxi was noted to have sustained severe fire damage that was confined to its frontal portion. Its engine compartment was extensively burnt; its interior compartment was also burnt at its front area.
5. The body parts at the front portion of the Motor Taxi that were observed to have been burnt and/or melted had included its front bumper, front fenders, front bonnet, front headlamps, front grille, front right tyre, right side wing mirror, right side front door, roof panel and front windscreen amongst others. Almost all the parts and components inside the engine compartment were burnt and/or partially melted. Parts towards the front area of the interior compartment, like the dashboard, upholstery and carpet, were also burnt and/or partially melted. See photo 1 – 4 below.

**Photo 1** shows a general view of the front left body of the Motor Taxi at the time of inspection. The Motor Taxi was observed to have been severely burnt at its frontal portion. Its front bumper, front bonnet, front grille, front left headlamp, front left fender, roof panel and front windscreen were amongst the body parts that were found to have been affected as a result of the fire.

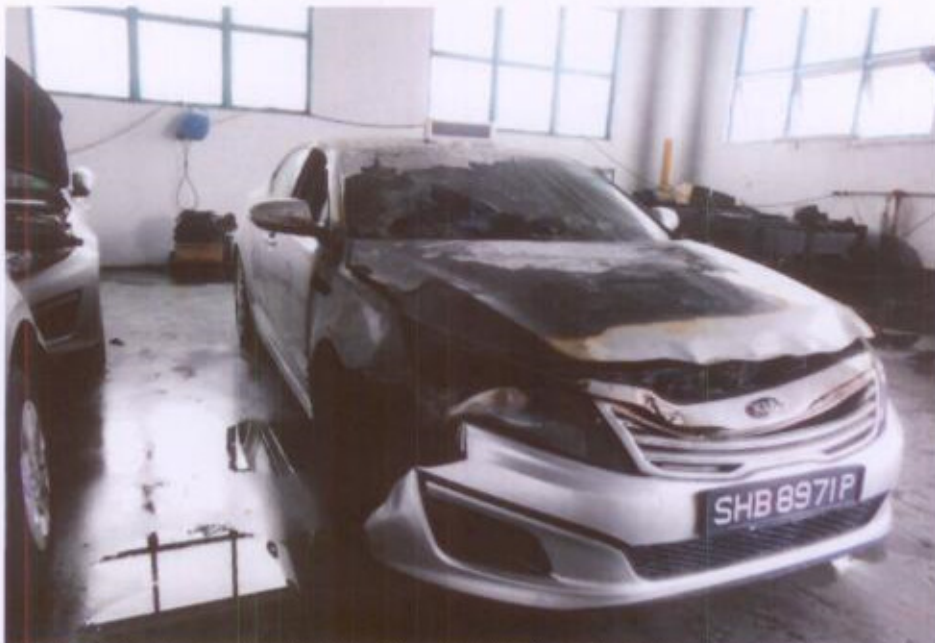
**Photo 2** shows a general view of the front right body of the Motor Taxi at the time of inspection. The Motor Taxi was observed to be severely burnt at its frontal portion. Its front bumper, front bonnet, front right headlamp, front right fender, roof panel and right side wing mirror were amongst the body parts that were found to have been affected as a result of the fire.

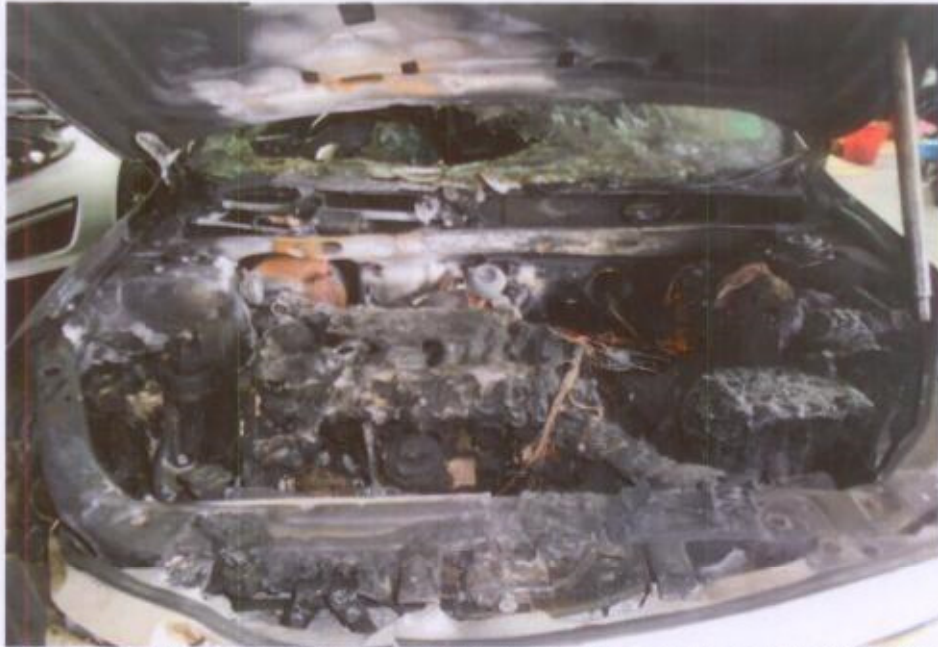
**Photo 3** shows the engine area of the Motor Taxi at the time of inspection. Almost all the parts inside the engine compartment were observed to be completely burnt and/or melted as a result of the fire. This had included its radiator, cooling fan, engine housing, fuel rail, brake booster and fuse box amongst others.

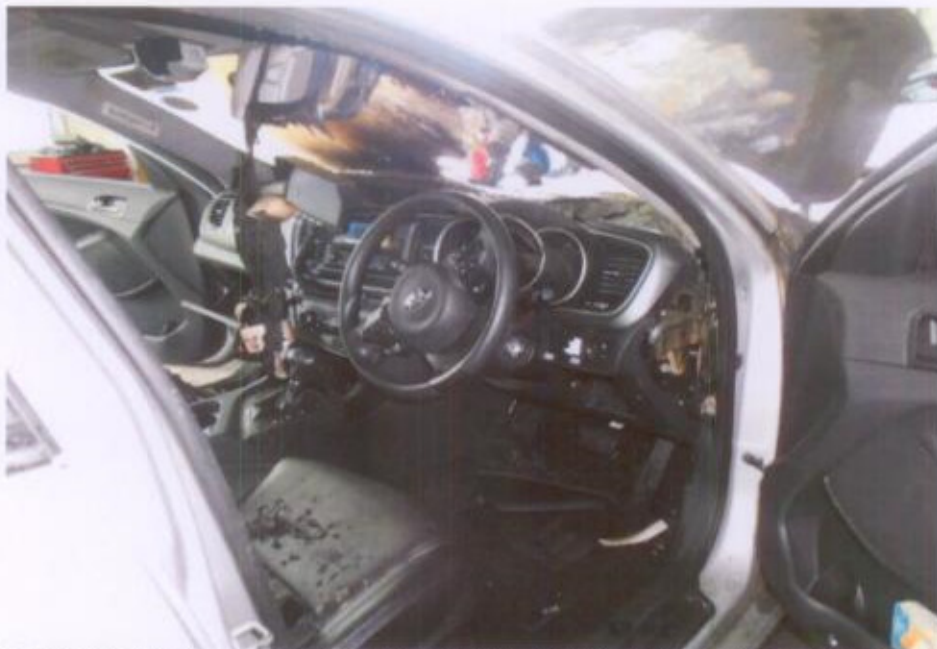
**Photo 4** shows the interior compartment of the Motor Taxi at the time of inspection. Parts towards the front area of the interior compartment were found to be burnt and/or partially melted as a result of the fire. This had included the dashboard, upholstery and carpet amongst others.

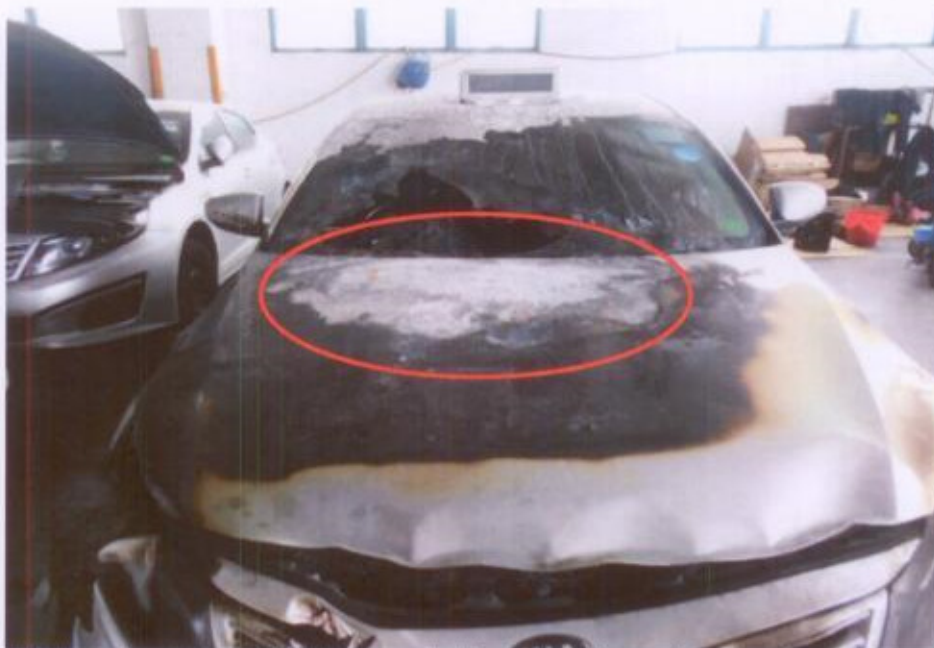
7. For this particular case, the fire appears to have originated within the engine compartment of the Motor Taxi, at the rear area, slightly towards the right from the centre of the engine compartment. This can be determined from the high heat intensity burn marks (whitish burn marks) that could be found on the top side of the front bonnet, at the rear right area, and the rust that had developed on the underside of the front bonnet, at the same area.

**Photo 5** shows the whitish burn marks (circled) that were found on the top side of the Motor Taxi's front bonnet. Such whitish burn marks are a result of exposure to prolonged heat intensity, which may indicate where the fire had started. Rust would also begin to develop on these areas soon after the fire.

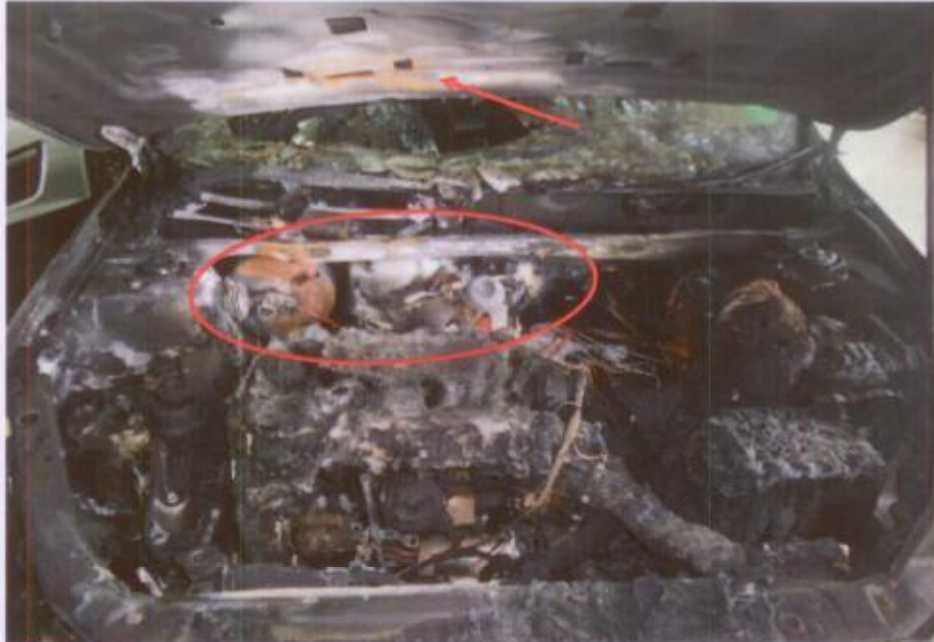
8. Rust would normally start to develop around areas that were exposed to prolonged heat intensity, soon after a fire, as such exposure usually causes the steel/metal material body parts to be exposed to natural environmental condition. For this case, the rust that had developed on the underside of the front bonnet, around the rear right area, is an indication that the rear right area of the engine compartment was exposed to prolonged high heat intensity. The fire to the Motor Taxi can hence be determined to have originated around the rear right area of its engine compartment. See photo 5 & 6 below.

Photo 6 shows the approximate location of where the fire had originated. This was around the rear right area of the engine compartment (circled), as determined from the rust that had developed on the underside of the Motor Taxi's front bonnet (arrowed). The development of rust is a consequence of that area being exposed to prolong high heat intensity, where such exposure usually causes the steel/metal material body parts to be exposed to natural environmental condition.

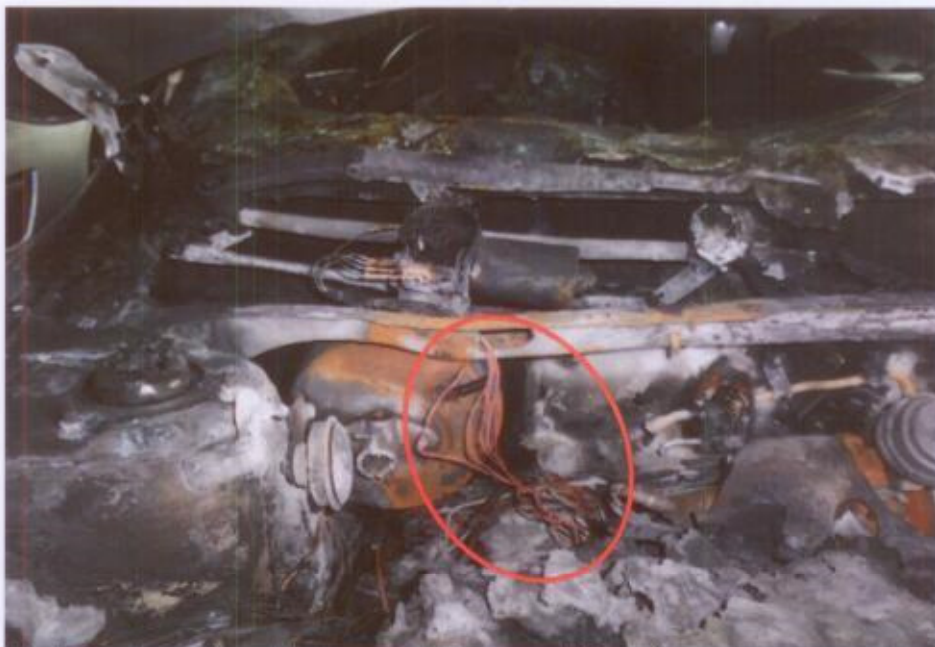
9. Upon closer examination of the area around the rear right of the engine compartment, which was directly below the area on the underside of the front bonnet where rust was seen, I had found several stretches of wiring burnt internally to its bare copper state. Such condition normally indicate internal heating of copper wires which is a sign of an electrical short circuit occurring. This would then appear to suggest that the cause of fire to the Motor Taxi could have possibly been due to electrical in nature. See photo 7 & 8 below.

**Photo 7** shows the wirings around the rear right of the engine compartment, which was where the fire to the Motor Taxi had likely started. The wirings (circled) were found to have been burnt internally to its bare copper state, suggesting occurrence of an electrical short circuit.

23. Basing on my inspection of the Motor Taxi, I am of the view that the fire had originated around the rear right area of the Motor Taxi's engine compartment. The cause of fire was likely to be of electrical in nature, where deterioration of rubber wire insulators could have caused live wires to come into contact with each other and/or the metal body of the vehicle, creating sparks that had ignited the fire.

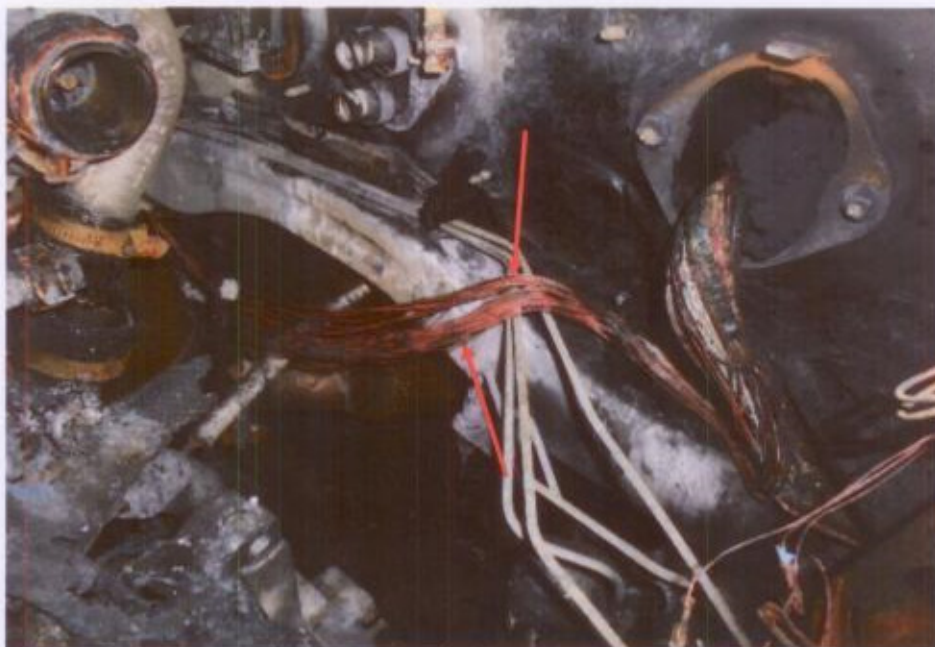
**Photo 8** shows another stretch of wirings around the rear of the engine compartment, which was in the immediate vicinity where the fire to the Motor Taxi had likely started. The wirings were found to have been burnt internally to its bare copper state, suggesting occurrence of an electrical short circuit.

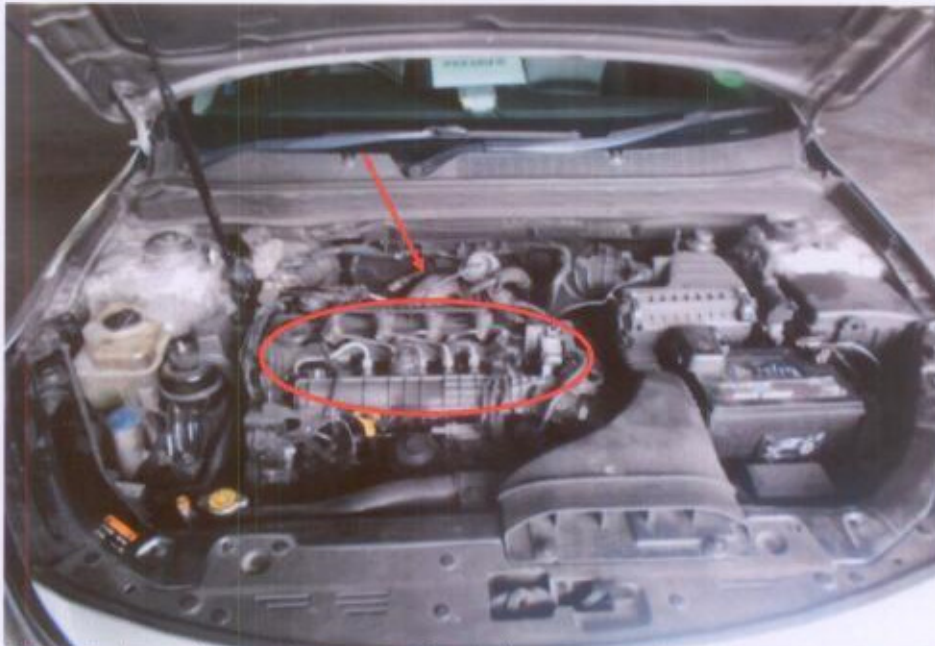
15. During my comparison of the engine layout of a similar make and model taxi, I had also observed that the fuel rail and fuel injectors were located towards the front area of the engine compartment, away from the hot surfaces of the exhaust manifold and the DPF. The engine oil level of the Motor Taxi was also checked and found to be of sufficient level, indicating no leakage of engine oil. Since the Motor Taxi was able to come to a complete stop after smoke was first seen, it is likely that there is no leak (vacuum or fluid) in the braking system of the Motor Taxi.
16. In general, there appears to be no sign(s) or indication(s) to suggest that the Motor Taxi had experienced fluid leakage prior to the fire incident. Following the discussion in paragraph 13 to paragraph 15, the cause of fire being due to fluid leakage would then be unlikely. See photo 9 - 13 below.

**Photo 9** shows the engine layout of a similar make and model motor taxi as the Motor Taxi. The fuel rail and fuel injectors were located towards the front area of the engine compartment (circled), away from the hot surfaces of the exhaust manifold and the DPF, which are both located towards the rear of the engine compartment (arrowed).

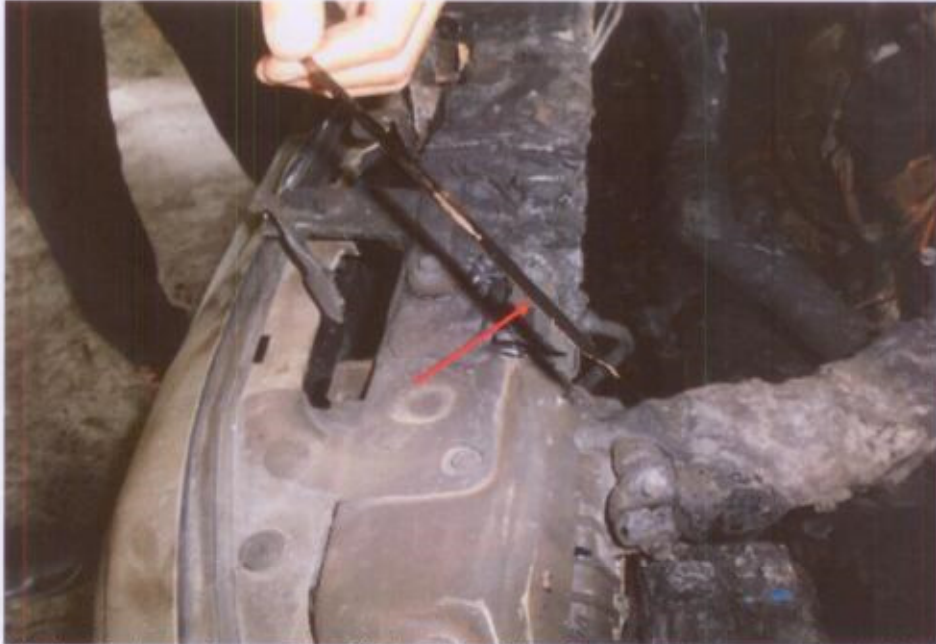
Photo 10 shows the engine oil dip stick of the Motor Taxi. The engine oil of the Motor Taxi was found to be of sufficient level (arrowed) for operating purposes, indicating no leakage of engine oil. In general, there appears to be no sign(s) or indication(s) to suggest that the Motor Taxi had experienced fluid leakage prior to the fire incident. Cause of fire being due to fluid leakage would then be unlikely.

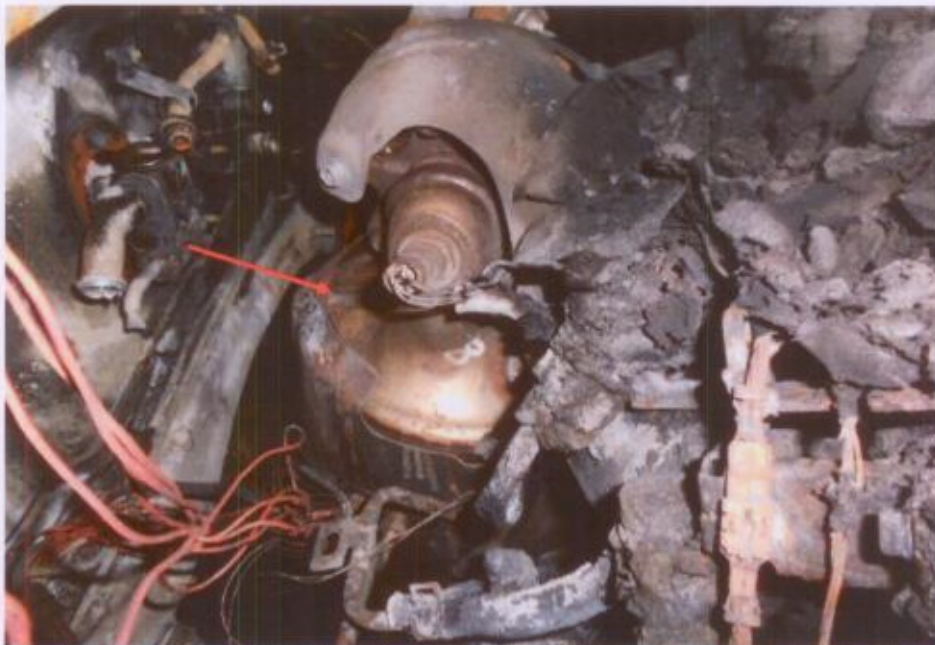
13. Leakage of fluid within the engine compartment may cause a fire to be ignited when the leaked fluid comes into contact with hot surfaces (usually exhaust pipes). The leaked fluid could possibly reach temperature sufficient for it to self-ignite. For the Motor Taxi, I note that the exhaust manifold and DPF (Diesel Particulate Filter) was located at the rear of the engine compartment, in the immediate vicinity of where the fire to the Motor Taxi had originated. The exterior surfaces of the exhaust manifold and the DPF both did not contain any sign(s) of being exposed to high heat intensity (whitish burn marks) that could have suggested that the DPF was being directly exposed to prolong heat from self-igniting fluid.

Photo 11 shows the DPF (Diesel Particulate Filter) of the Motor Taxi (arrowed). Although the DPF was located in the immediate vicinity of where the fire to the Motor Taxi had originated. The exterior surfaces of the exhaust manifold and the DPF both did not contain any sign(s) of being directly exposed to high heat intensity (whitish burn marks) that could have suggested that fluid had leaked onto the hot surfaces of the exhaust pipes to cause the fluid to self-ignite.

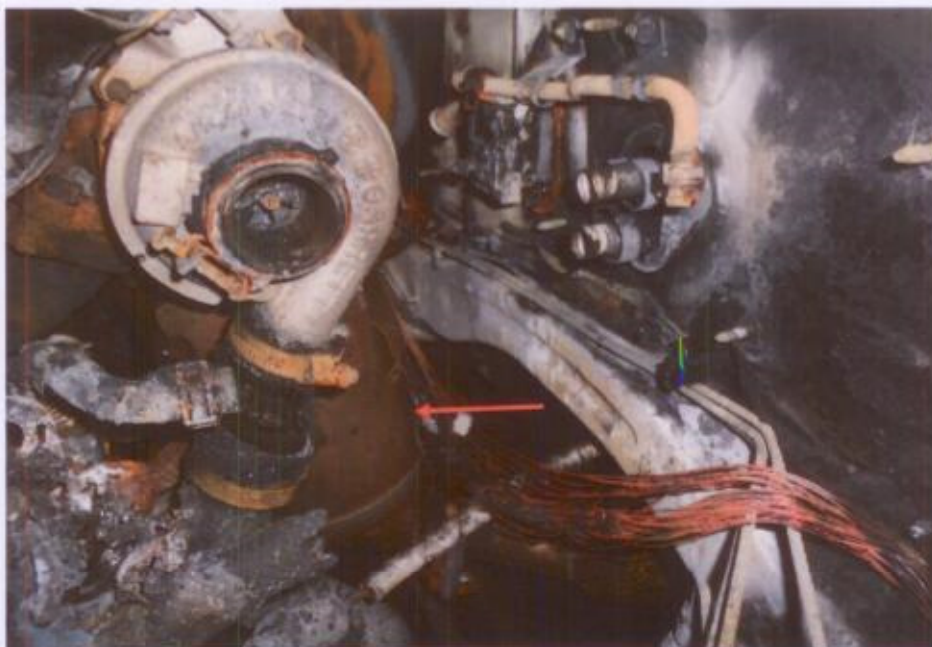
**Photo 12** shows the DPF (Diesel Particulate Filter) of the Motor Taxi (arrowed). Although the DPF was located in the immediate vicinity of where the fire to the Motor Taxi had originated. The exterior surfaces of the exhaust manifold and the DPF both did not contain any sign(s) of being exposed to high heat intensity (whitish burn marks) that could have suggested that fluid had leaked onto the hot surfaces of the exhaust pipes to cause the fluid to self-ignite.

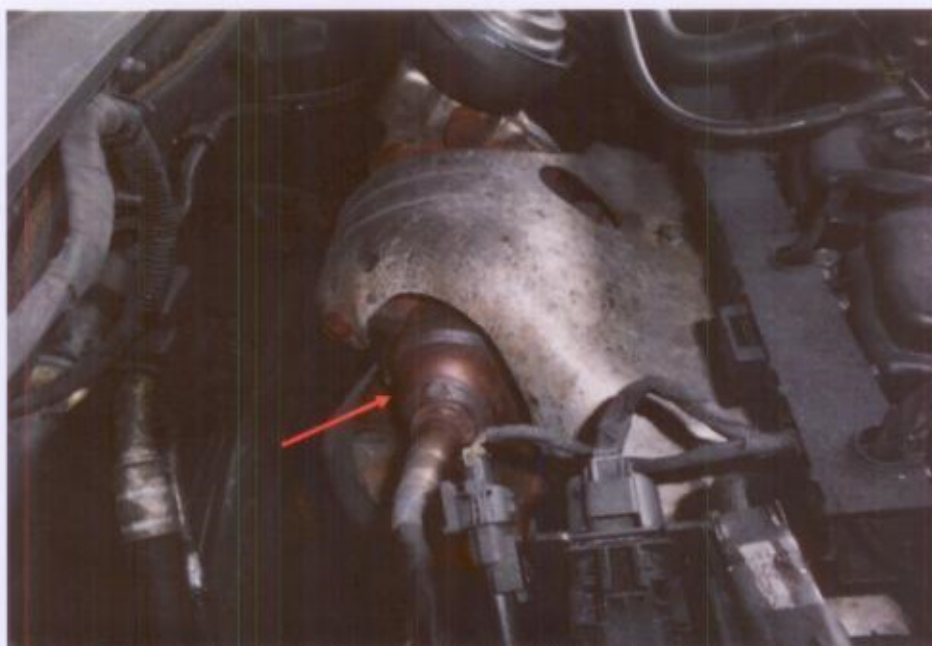
**Photo 13** shows the DPF (Diesel Particulate Filter) of a similar make and model motor taxi as the Motor Taxi (arrowed) for comparison of its exterior surfaces. I also note that there was no fluid carrying pipe/hose directly above the area where the DPF is located.
