Your Ref: TP/IP/62279/2017
Our Ref : CI/TPD17023254/Z

14th December 2017

Fatal Accident Investigation Team

MECHANICAL INSPECTION REPORT OF MOTOR LORRY GBB 4882K

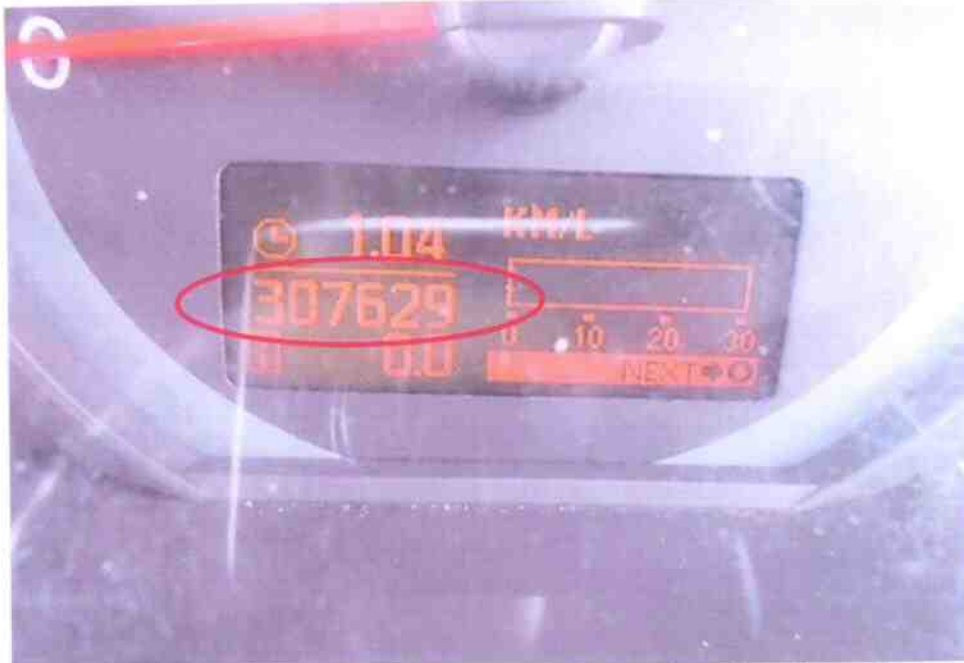
4. The mileage of the Motor Lorry at the time of our inspection was 307,629km.
5. The Motor Lorry was observed to have sustained relatively minor damages at its front right panel, front right wiper panel, front left lower bumper, front left side mirror (tilt inwards) and front left & right fender were amongst the body parts that were damaged as a result of the accident

Photo 1 shows the mileage of the Motor Lorry at the time of our inspection was 307,629km. (circled).

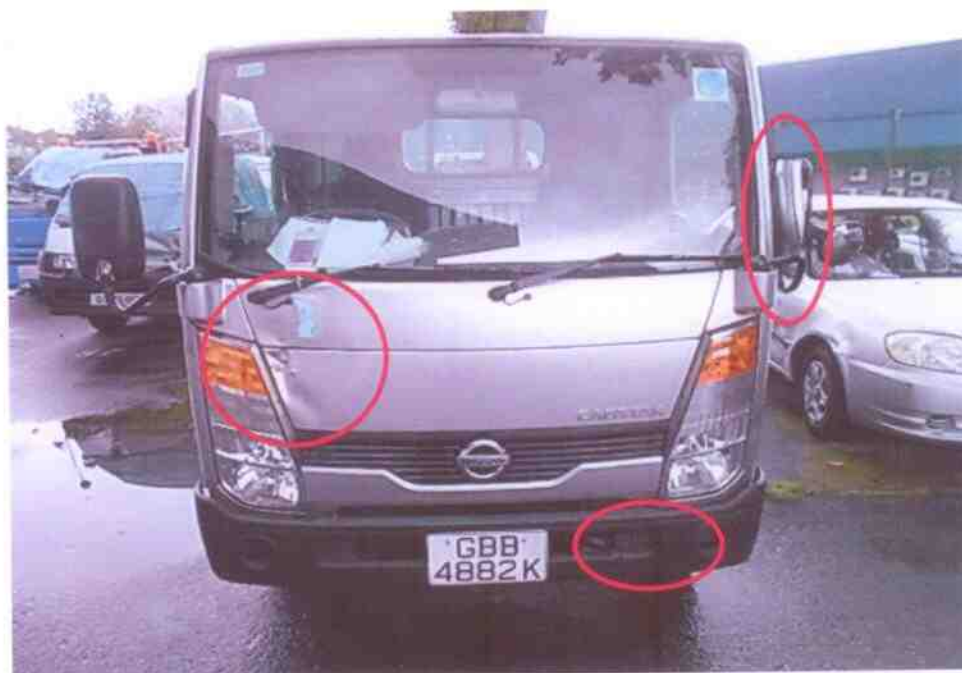
Photo 2 shows The Motor Lorry was observed to have sustained relatively minor damages at its front right panel, front right wiper panel, front left lower bumper, front left side mirror (tilt inwards) and front right fender were amongst the body parts that were damaged as a result of the accident (circled).

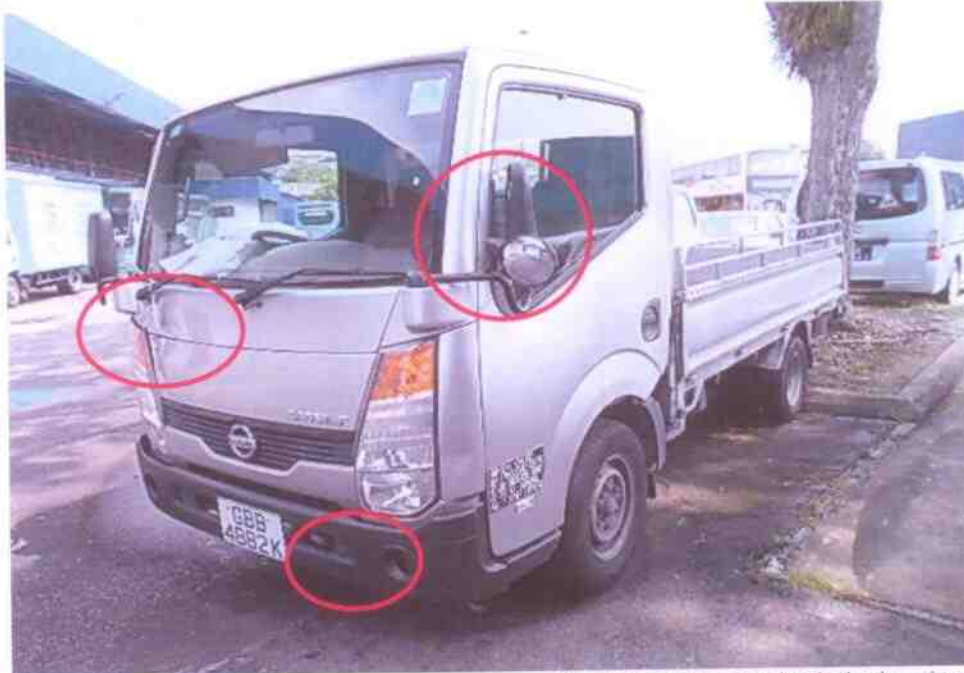
Photo 3 shows The Motor Lorry was observed to have sustained relatively minor damages at its front right panel, front right wiper panel, front left lower bumper, front left side mirror (tilt inwards) and front right fender were amongst the body parts that were damaged as a result of the accident (circled).

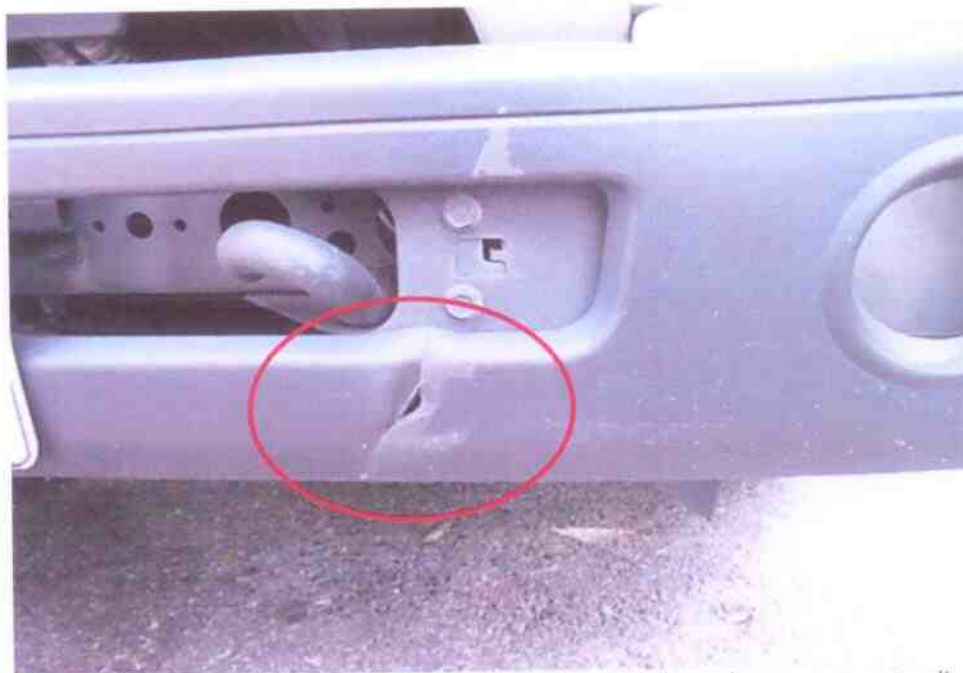
Photo 4 shows the damage sustained on the front left lower bumper as a result of the accident.

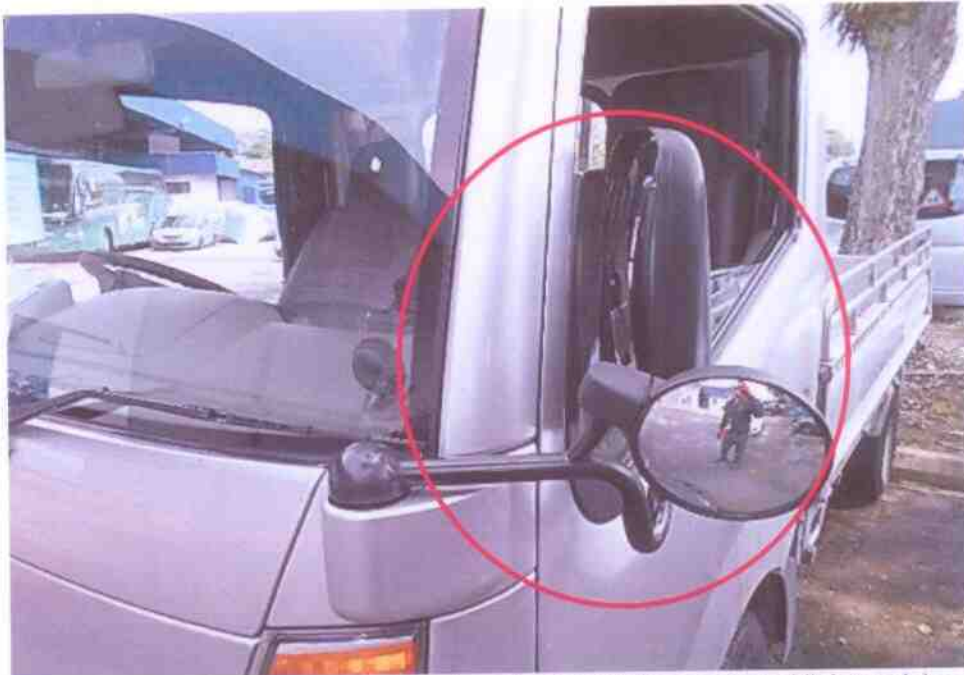
Photo 5 shows the damage sustained on the front left wing mirror (tilt inwards) as a result of the accident.

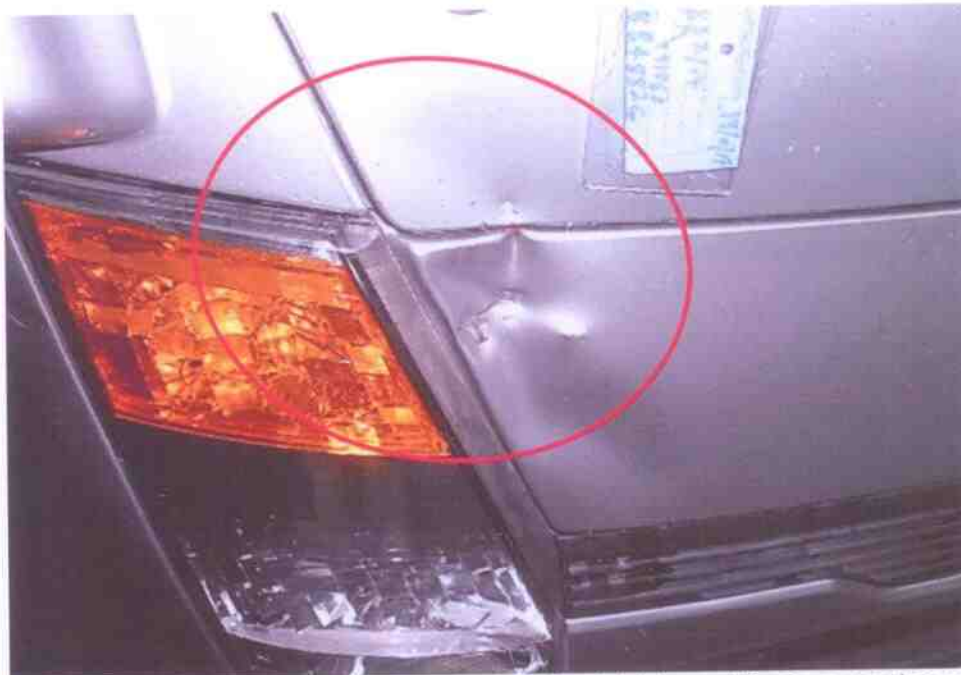
Photo 6 shows the damage sustained on the front right panel & wiper panel as a result of the accident.

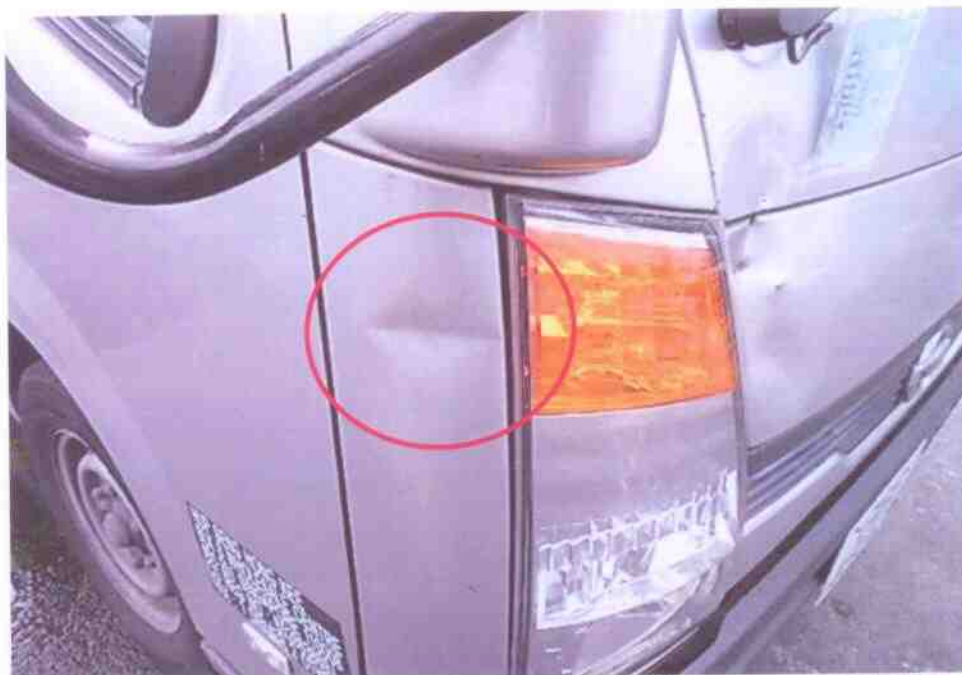
Photo 7 shows the damage sustained on the front right fender as a result of the accident.

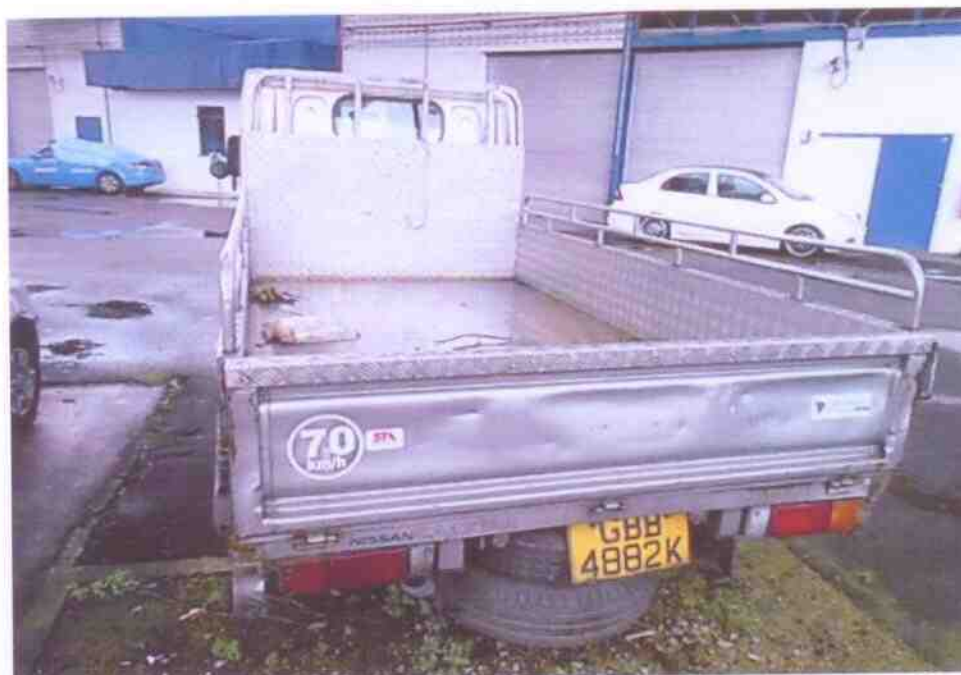
Photo 8 shows a general view of the Motor Lorry's rear body at the time of our inspection. There was no damage found to the rear portion of the Motor Lorry.

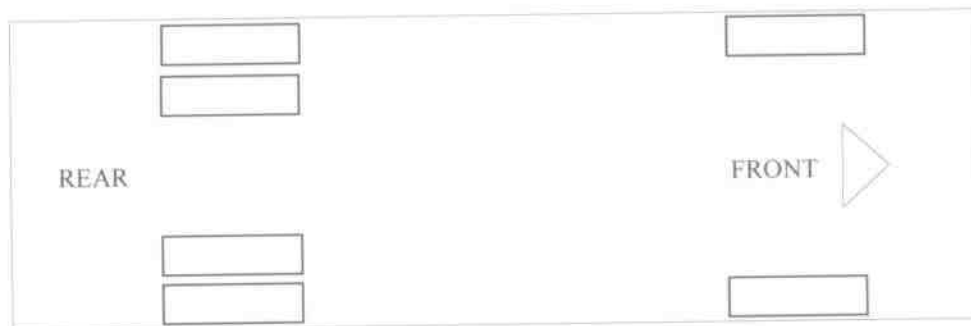
6. The 2 front tyres and 4 rear tyres of the Motor Lorry were observed to be in serviceable condition and sufficiently inflated for vehicular operation. We did not find any tear, cut or burst mark(s) on the outer and the inner sidewalls as well as across the tread of the 6 tyres. The tyre brand, tyre size and remaining tread depth of the 6 tyres of the Motor Lorry were recorded as follows:-

Yokohama Delivery Star 818
165R13 8PR(1mm)

Michelin Agilis 195R15C (4mm)

Yokohama Delivery Star 818
165R13 8PR(1.6mm)

Michelin Agilis 195R15C (5mm)

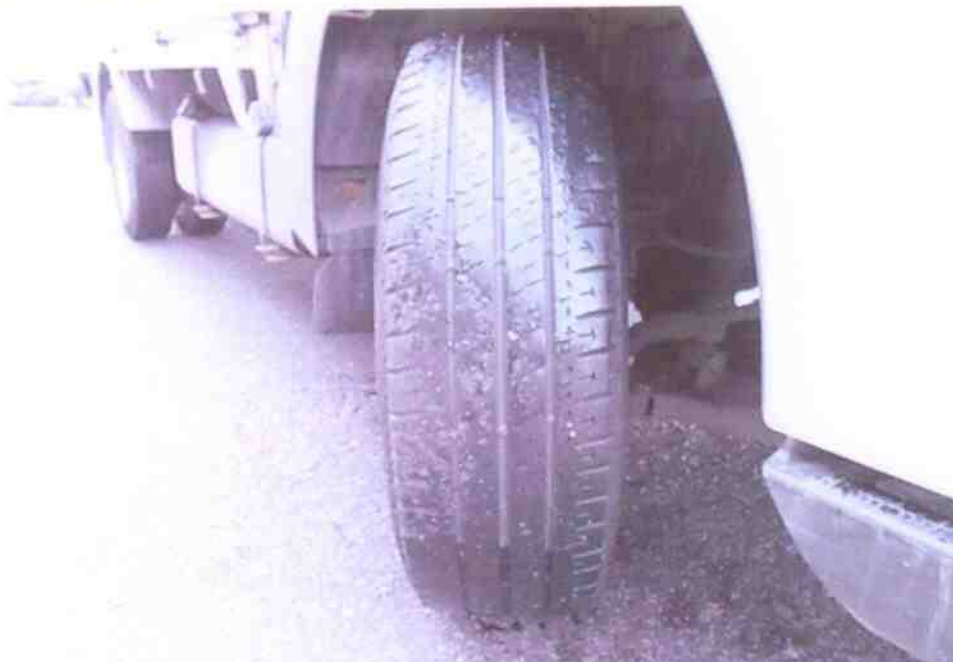
Photo 9 shows the condition of the front left tyre of the Motor Lorry, which was observed to be in serviceable condition with remaining tread depth of approximately 4mm. The tyre, which was wrapped around standard alloy wheel rim, was also observed to be sufficiently inflated for vehicular operation. There was no tear, cut or burst mark(s) on the outer and the inner sidewalls.

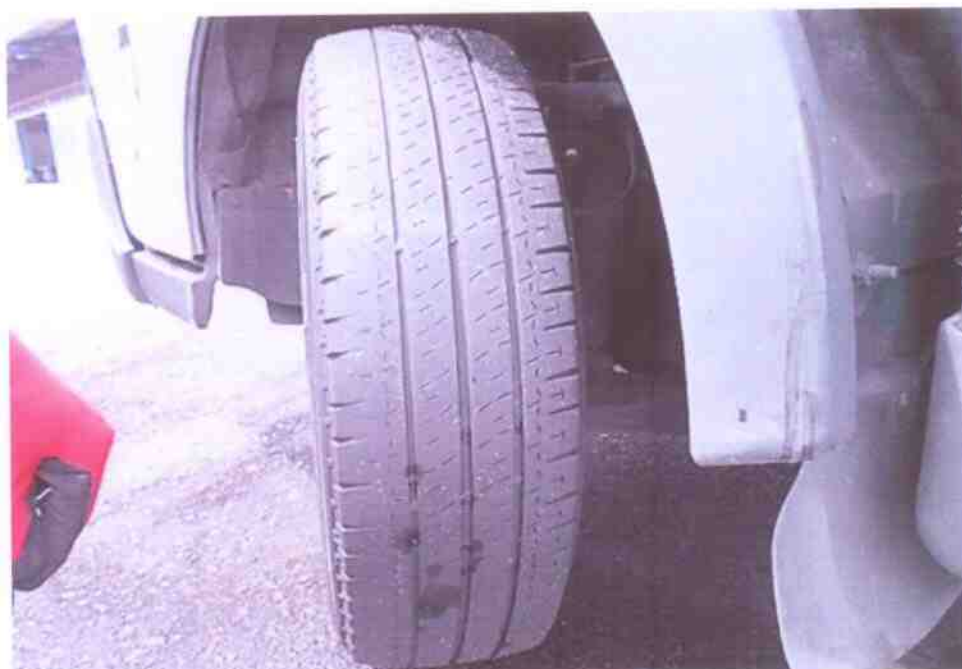
Photo 10 shows the condition of the front right tyre of the Motor Lorry, which was observed to be in serviceable condition with remaining tread depth of approximately 5mm. The tyre, which was wrapped around standard alloy wheel rim, was also observed to be sufficiently inflated for vehicular operation.

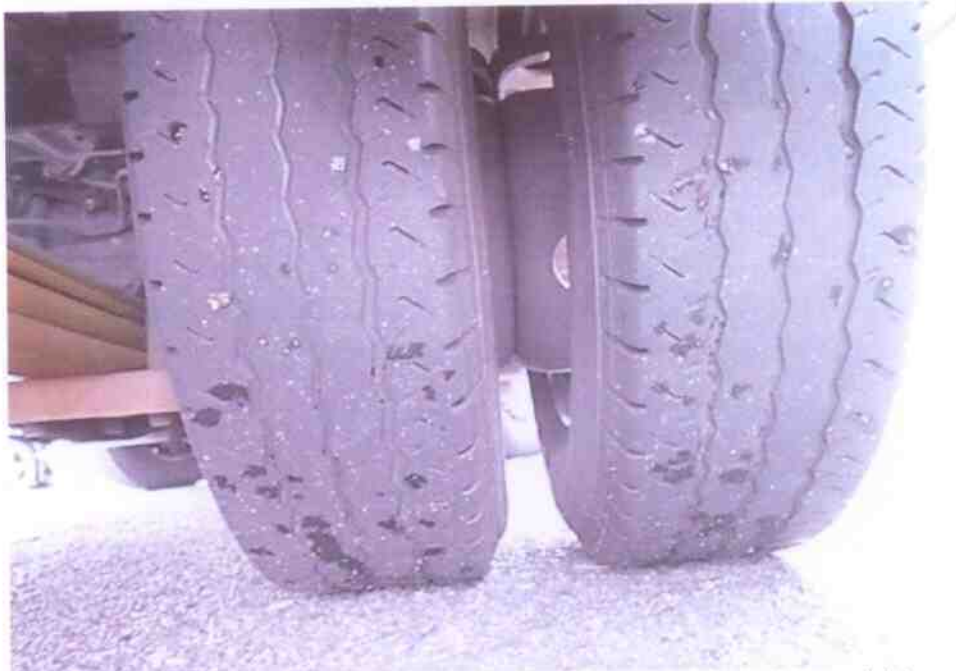
Photo 11 shows the condition of the rear left tyres of the Motor Lorry, which was observed to be in serviceable condition with remaining tread depth of approximately 1mm. The tyres, which were wrapped around standard alloy wheel rim, were also observed to be sufficiently inflated for vehicular operation.

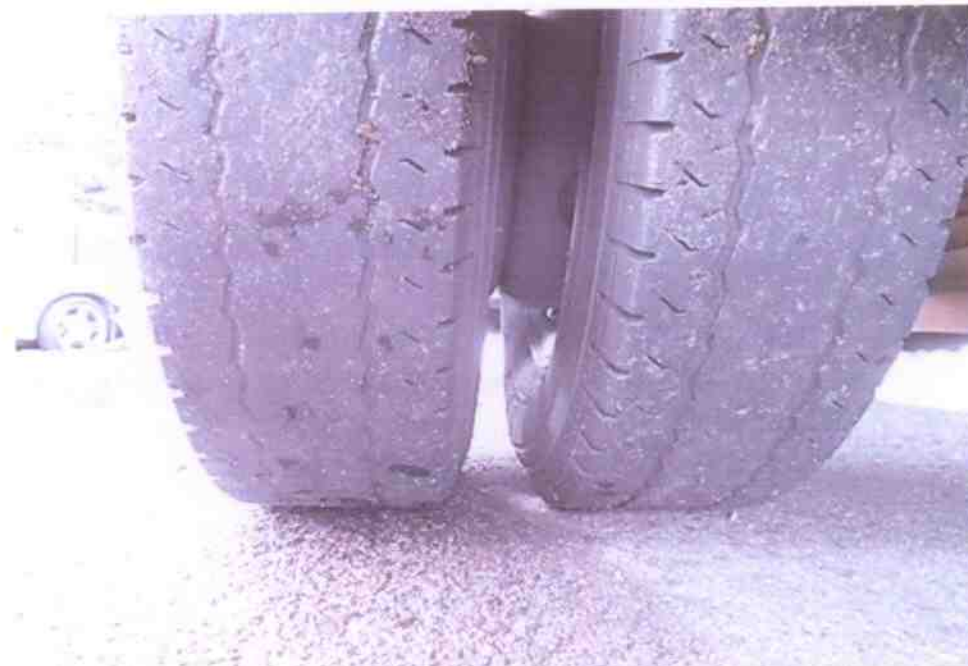
Photo 12 shows the condition of the rear right tyres of the Motor Lorry, which were observed to be in serviceable condition with remaining tread depth of approximately 1.6mm. There was also no tear, cut or burst mark(s) on the outer and the inner sidewalls.

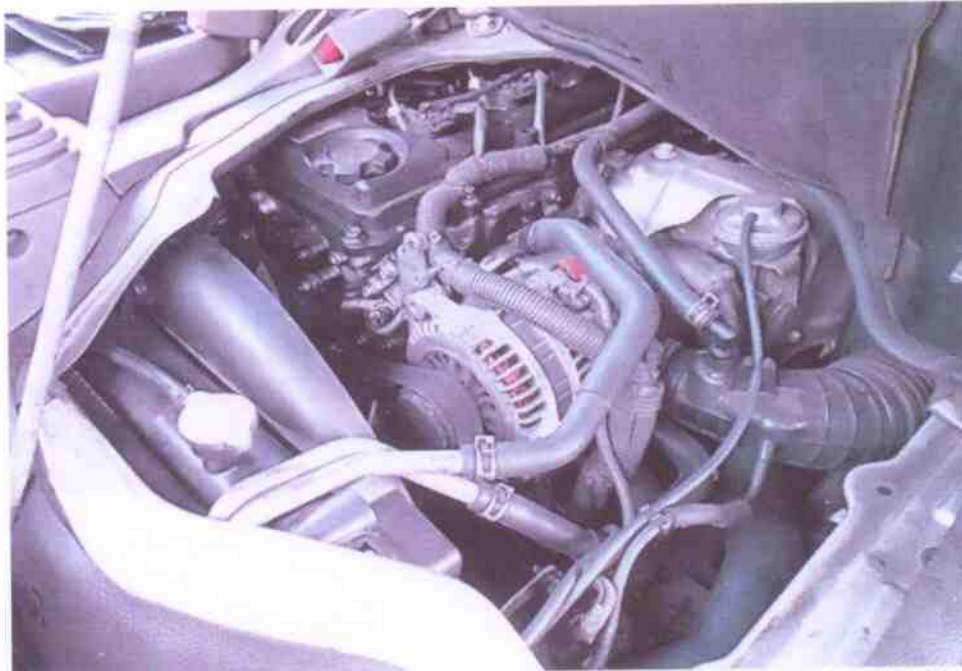
Photo 13 shows a general view of the Motor Lorry's engine compartment, which was accessed by lifting the front passenger seat of the Motor Lorry. The various parts and components inside the engine compartment were unaffected by the accident. There was also no sign(s) or indication(s) of fresh fluid leakage and/or fluid stain within the engine compartment (photograph shows the engine compartment as viewed from the left front side of the Motor Lorry).

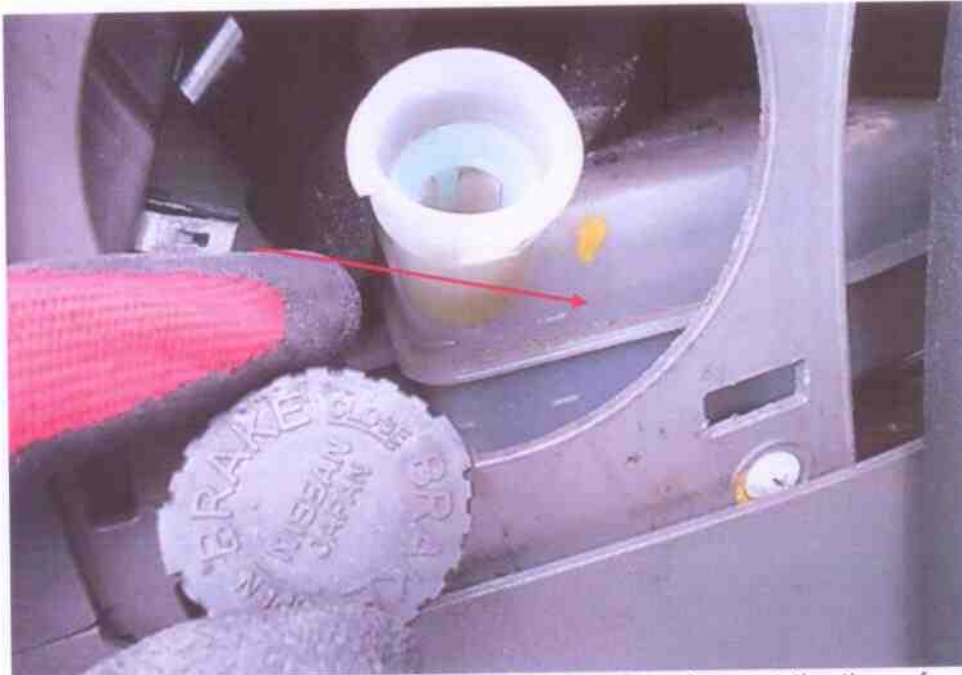
Photo 14 shows the brake fluid reservoir of the Motor Lorry at the time of our inspection. The brake fluid was observed to be of sufficient level and without any visible contamination.

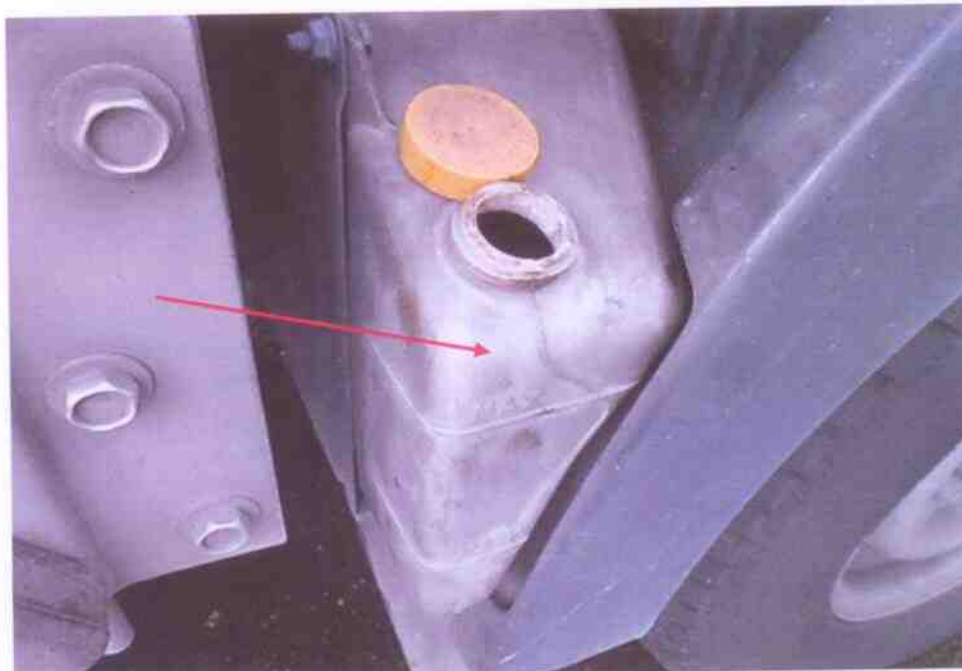
Photo 15 shows the engine coolant reservoir of the Motor Lorry at the time of our inspection. The engine coolant was observed to be of sufficient level and without any visible contamination.

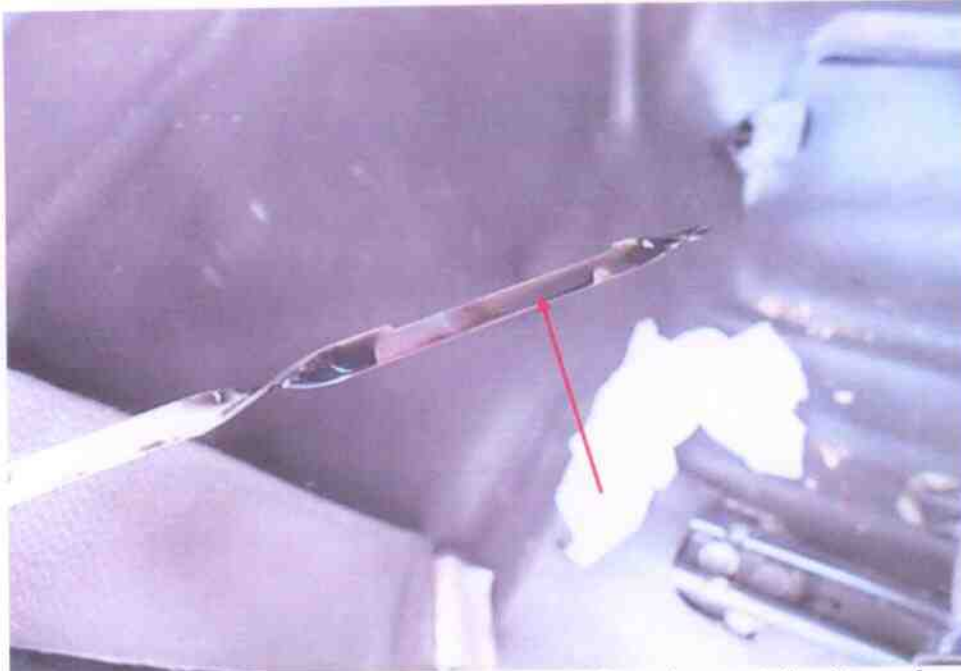
Photo 16 shows the engine dip stick of the Motor Lorry at the time of our inspection. The engine oil was observed to be of sufficient level and without any visible contamination (arrowed).

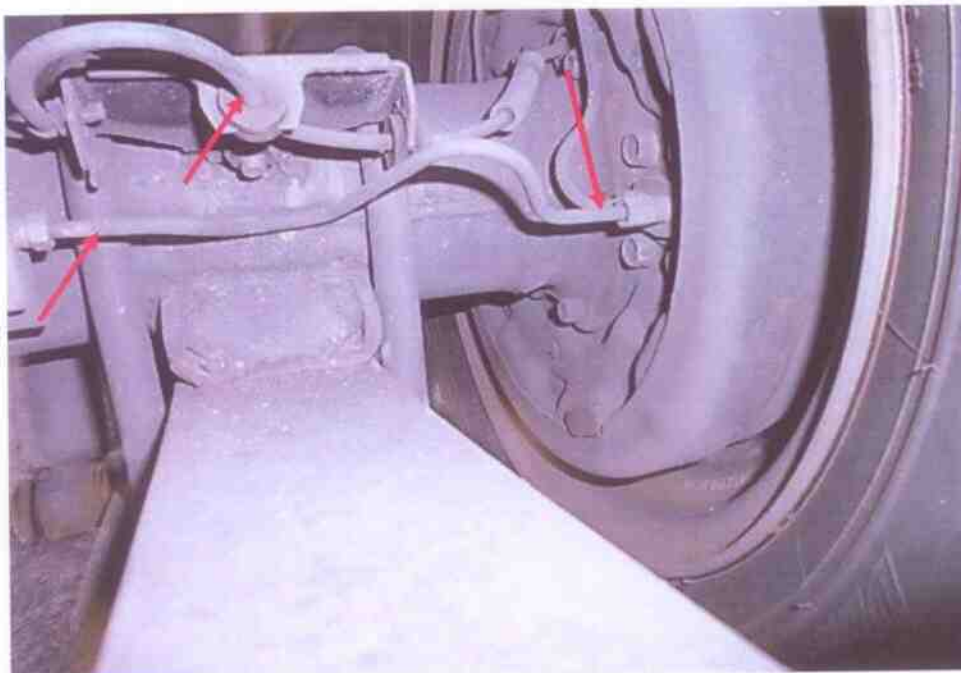
Photo 17 shows the brake pipe (arrowed) at the left rear wheel of the Motor Lorry. We did not observe any leakage of brake fluid at the time of our inspection of the Motor Lorry. Our static tests had indicated that there was no internal leakage of pressure/vacuum. Hence the braking system of the Motor Lorry was likely to be in serviceable condition at the material time of accident.

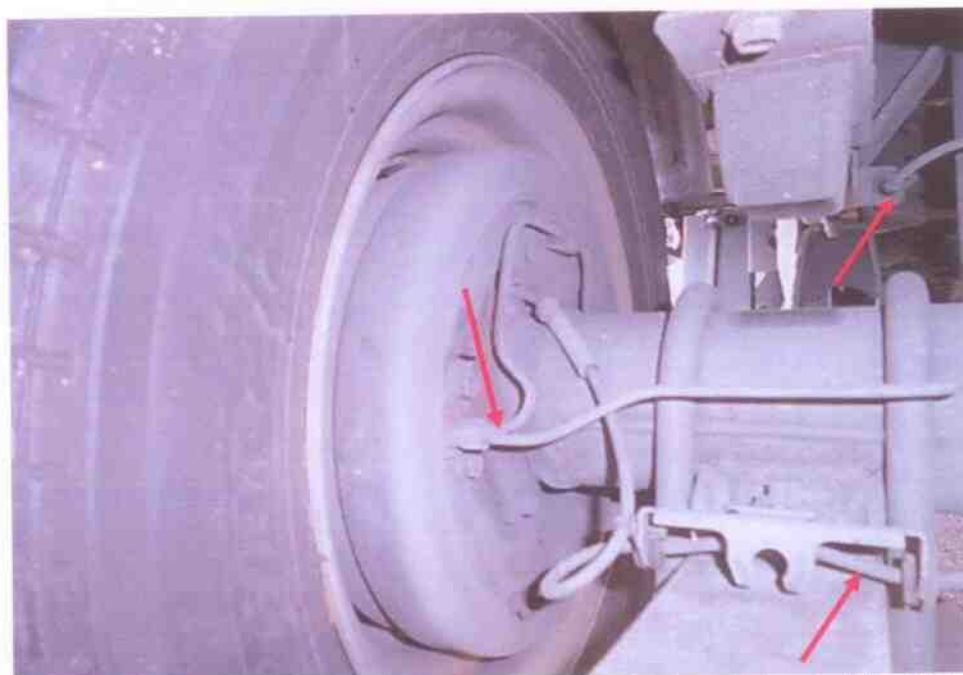
Photo 18 shows the brake pipe (arrowed) at the right rear wheel of the Motor Lorry. We did not observe any leakage of brake fluid at the time of our inspection of the Motor Lorry. Our static tests had indicated that there was no internal leakage of pressure/vacuum. Hence the braking system of the Motor Lorry was likely to be in serviceable condition at the material time of accident.

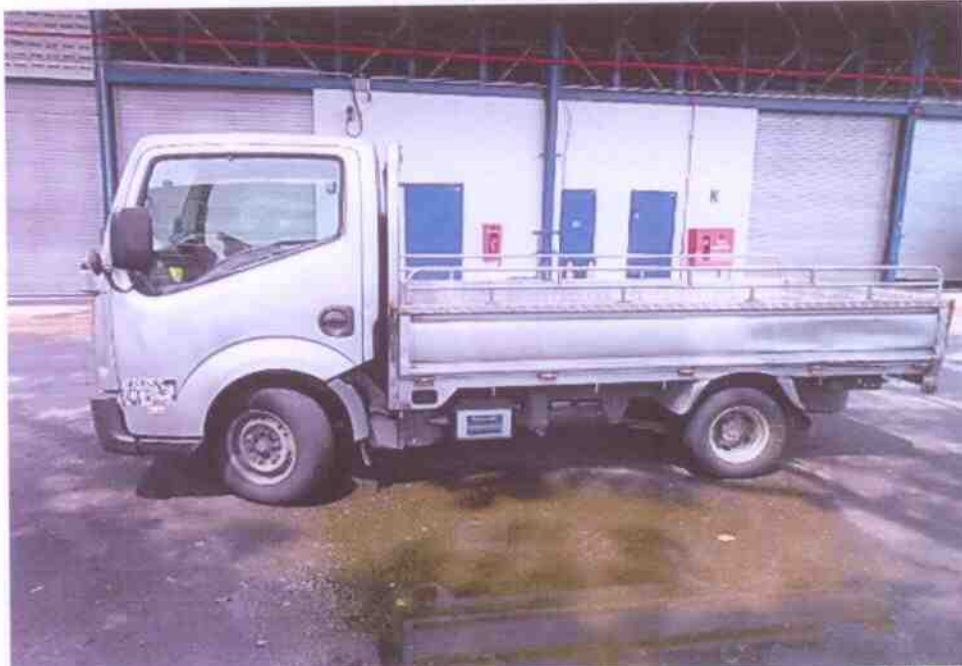
Photo 19 shows the front left wheel of the Motor Lorry turned to its full left. During our steering system test, we did not experience any abnormal free play and/or resistance when we had turned the steering wheel towards full left and full right.

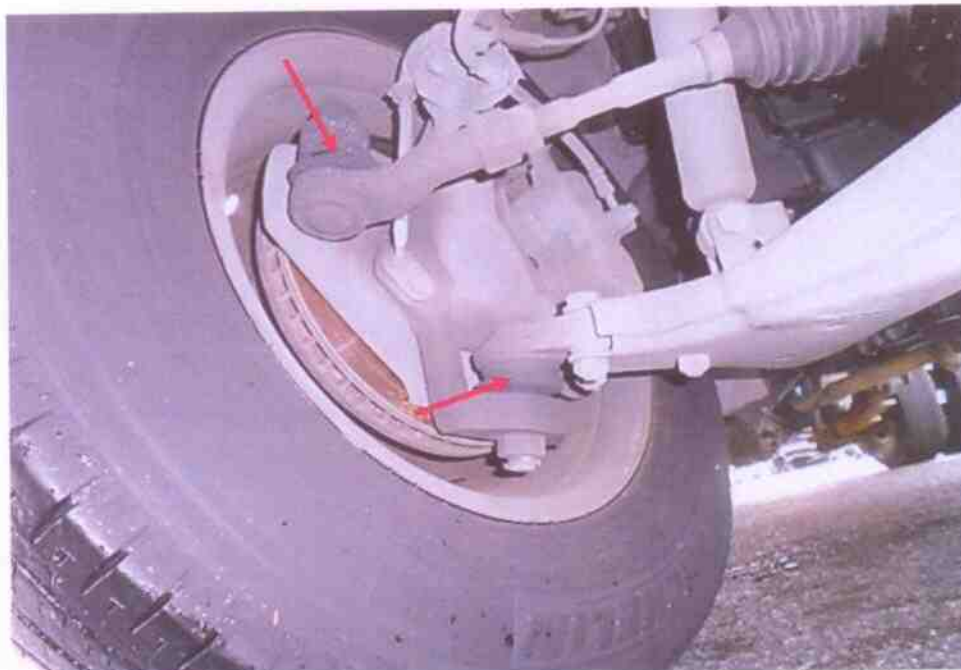
Photo 20 shows the various undercarriage components at the front right wheel of the Motor Lorry, in particular the steering tie rod end (arrowed). The various steering components were all found to be intact. There was also no sign of fluid stain(s) observed on the various undercarriage components.

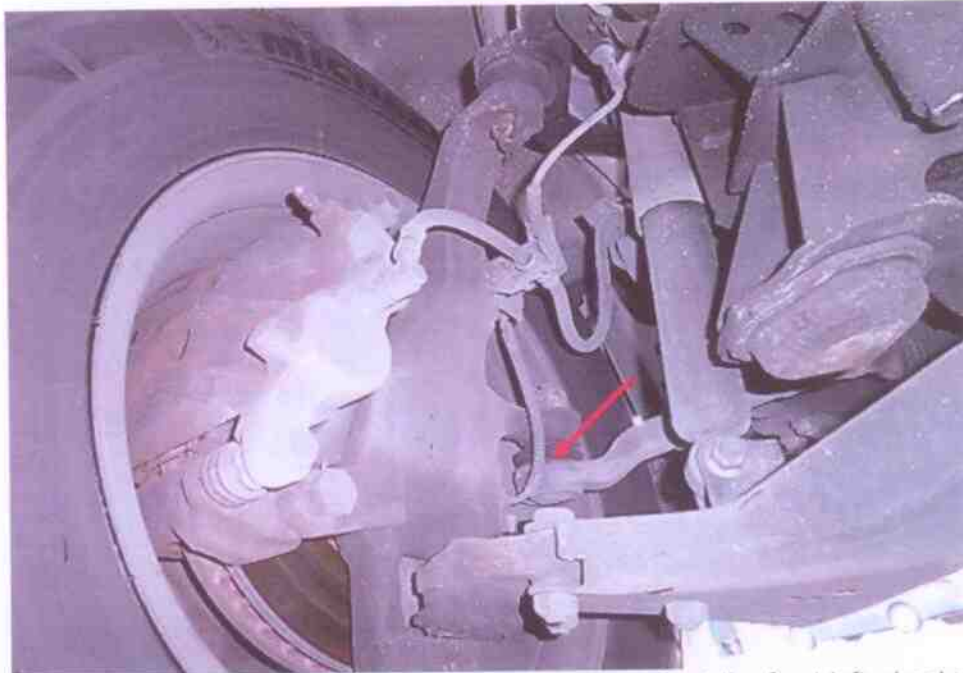
Photo 21 shows the various undercarriage components at the front left wheel of the Motor Lorry, in particular the steering tie rod end (arrowed). The various undercarriage components of the Motor Lorry were all found to be intact without any visible damage. There was also no sign of fluid stain(s) observed on the various undercarriage components.
