Your Ref: TP/IP/59521/2017
Our Ref: CI/TPD17023255/Z

Fatal Accident Investigation Team

MECHANICAL INSPECTION REPORT OF MOTORCYCLE FBL 7393H

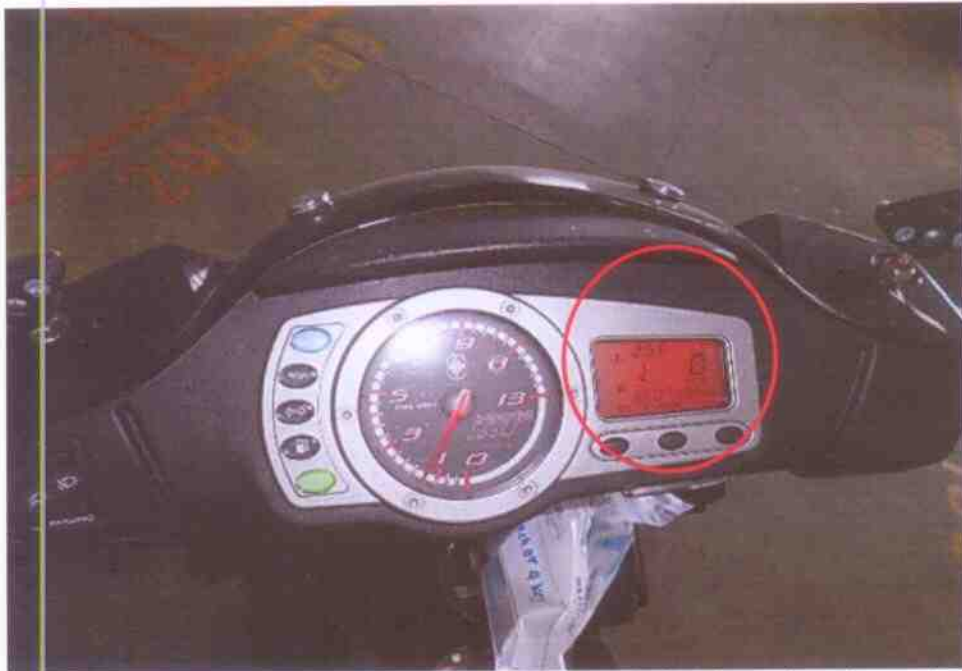
Photo 1 shows the mileage of the Motorcycle recorded at time of our inspection was 7,356km. (Circled)

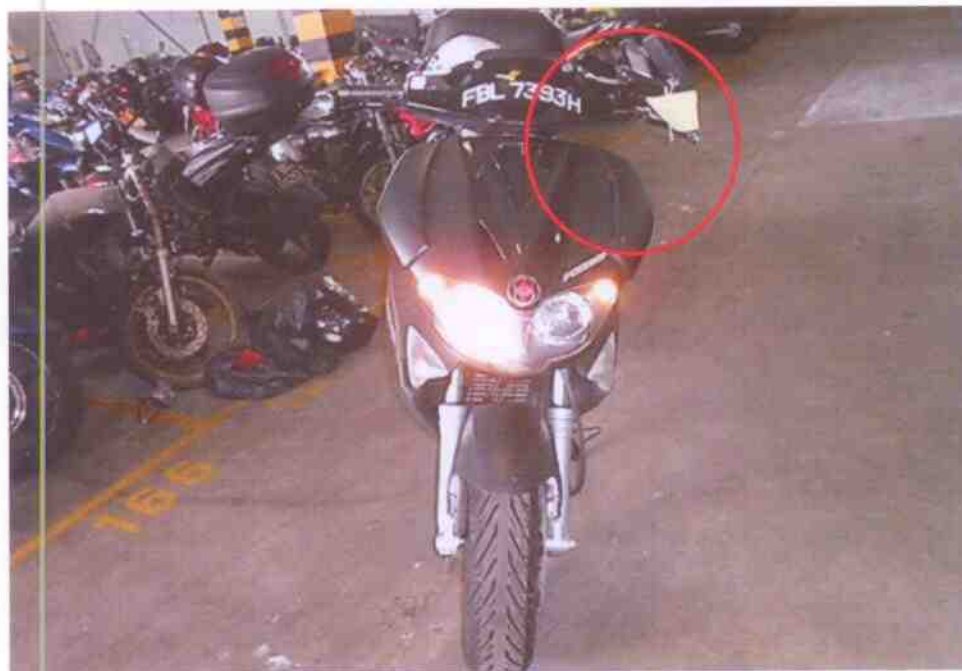
4. The mileage of the Motorcycle recorded at time of our inspection was 7,356km.
5. The Motorcycle was observed to have sustained relatively minor damages at the left portion. The body parts that were found to have been damaged include its left hand rear brake lever, left hand wing mirror, left top fairing, left lower fairing & main stand amongst others as a result of the accident.

Photo 2 shows a general view of the front body of the Motorcycle at the time of our inspection. The Motorcycle was observed to have sustained with relatively minor damages at the left handle due to the accident collision. (Circled)

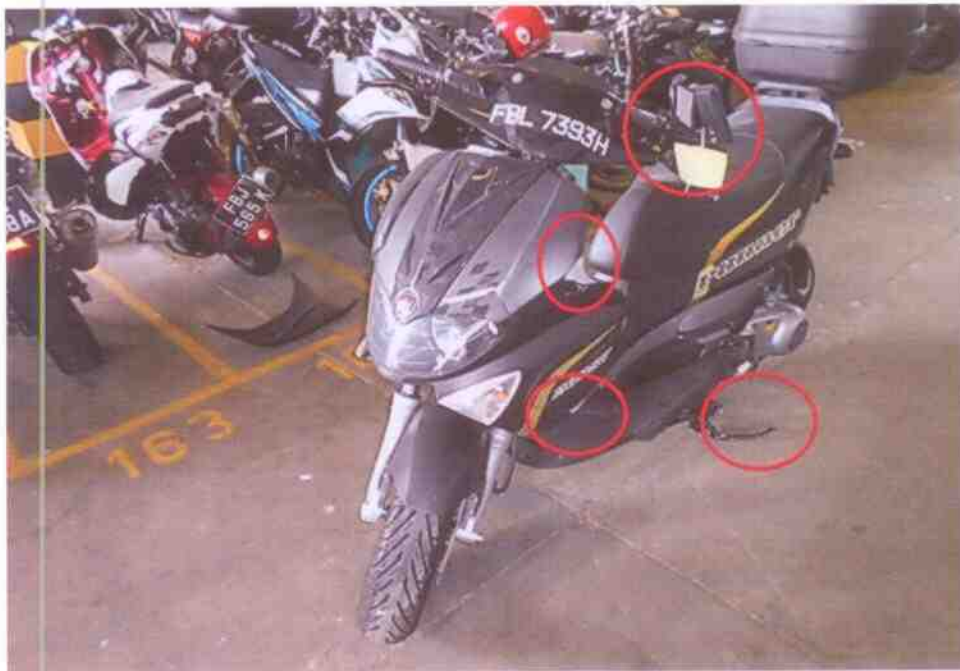
Photo 3 shows a general view of the front left body of the Motorcycle at the time of our inspection. The Motorcycle was observed to have sustained minor damages at the frontal portion & along its left side. (Circled)

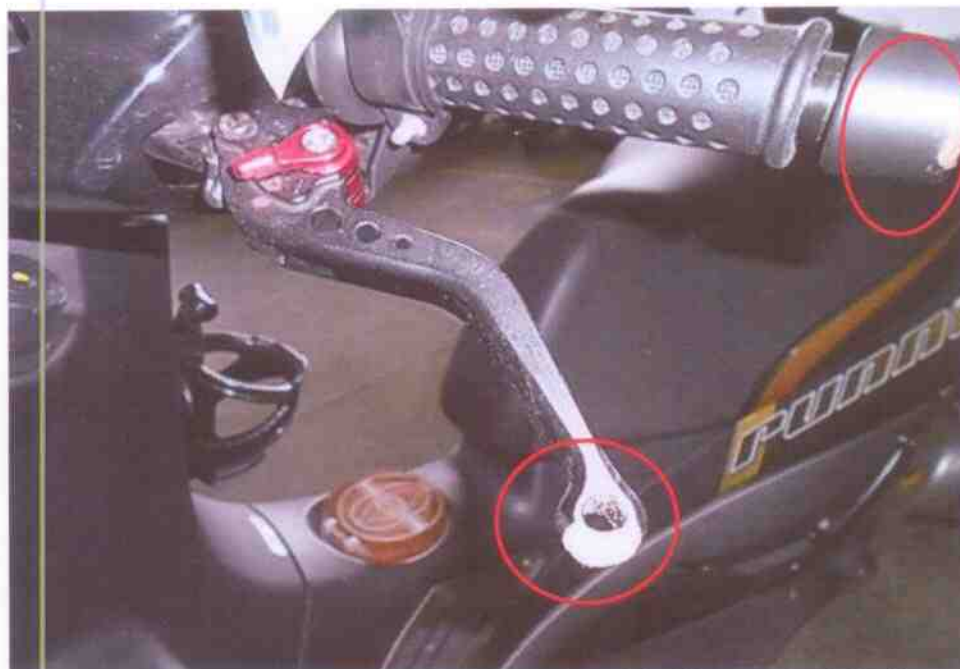
Photo 4 shows a closer view of the frontal portion of the Motorcycle at the time of our inspection. The Motorcycle was observed to be sustained relatively minor impact due to the accident collision. (Circled)

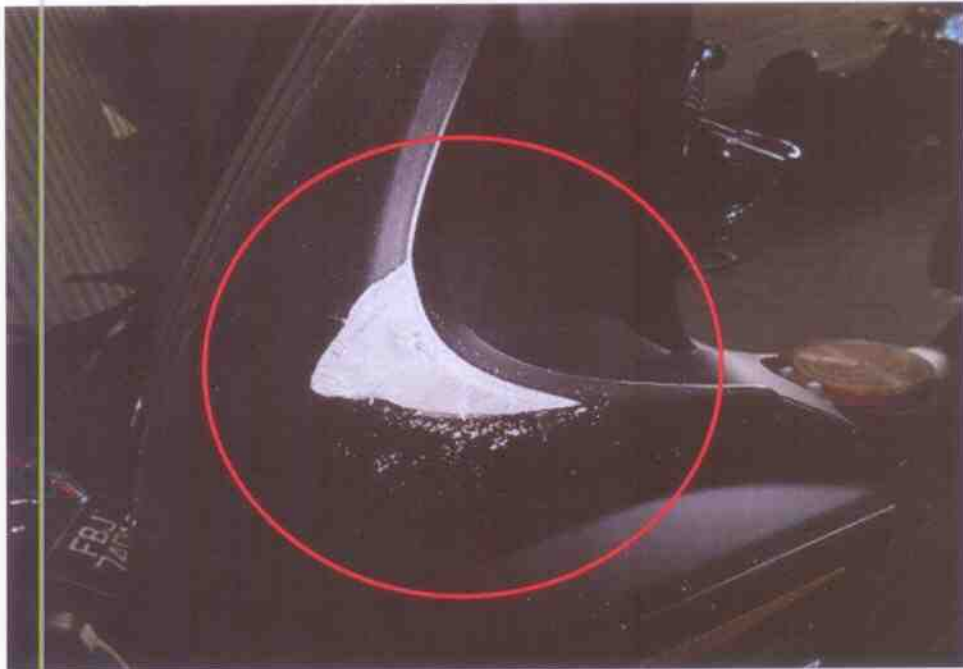
Photo 5 shows a closer view of the left portion fairing of the Motorcycle at the time of our inspection. It was observed to have sustained deep grazing mark due to the accident collision. (Circled)

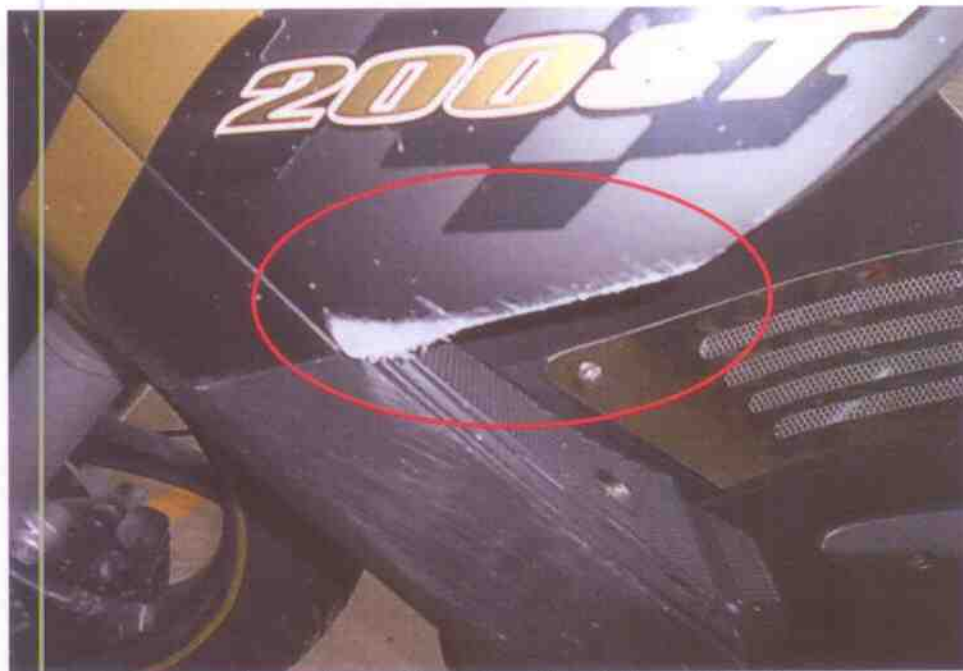
Photo 6 shows a closer view of the left portion fairing of the Motorcycle at the time of our inspection. It was observed to have sustained deep grazing mark due to the accident collision. (Circled)

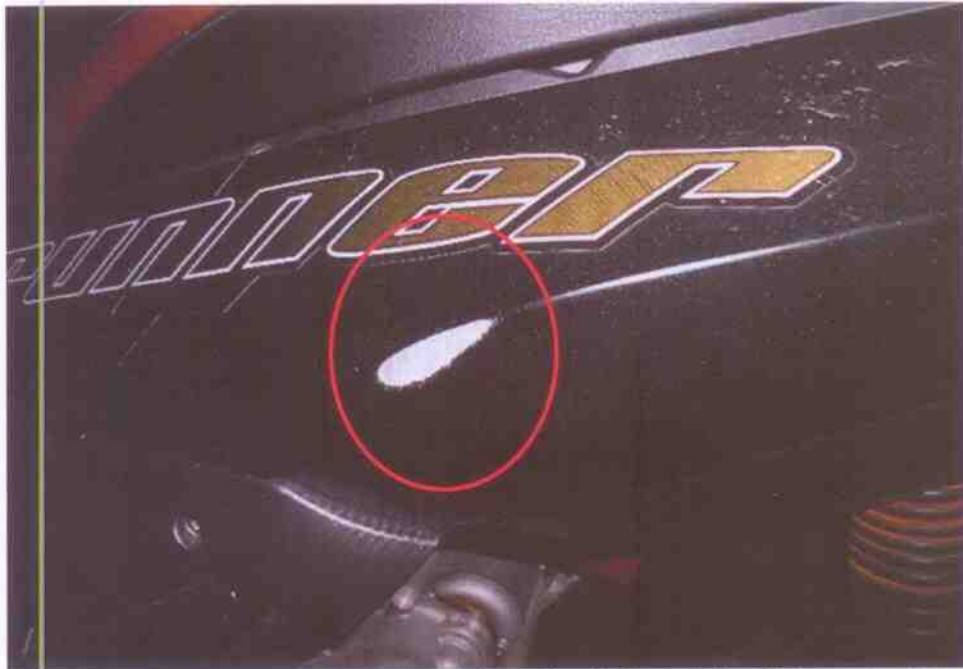
Photo 7 shows a closer view of the left portion fairing of the Motorcycle at the time of our inspection. It was observed to have sustained deep grazing mark due to the accident collision. (Circled)

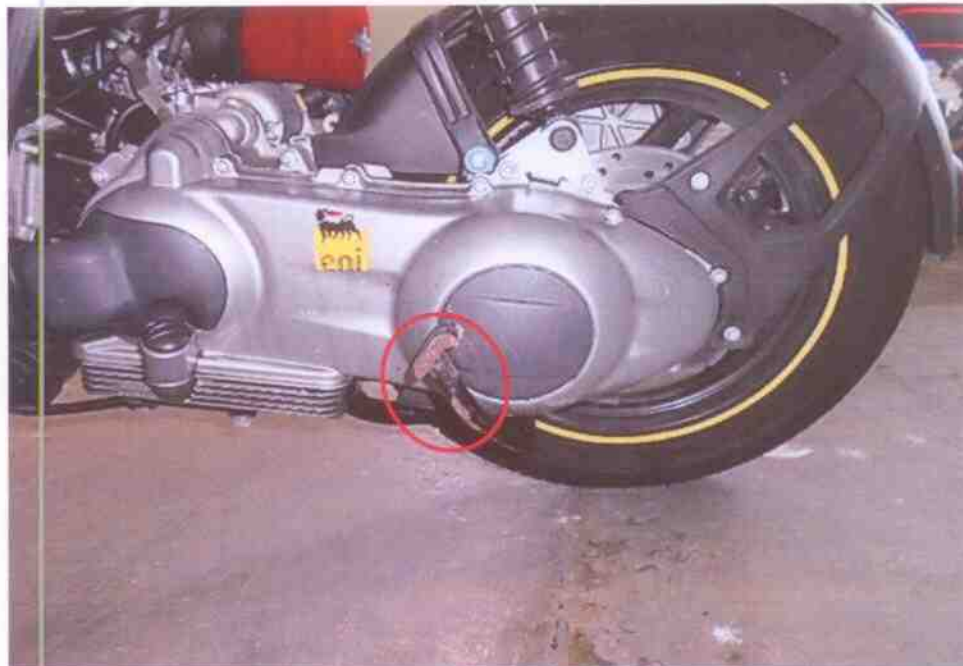
Photo 8 shows a closer view of the left side main stand of the Motorcycle at the time of our inspection. It was observed to have sustained grazing mark due to the accident collision. (Circled)

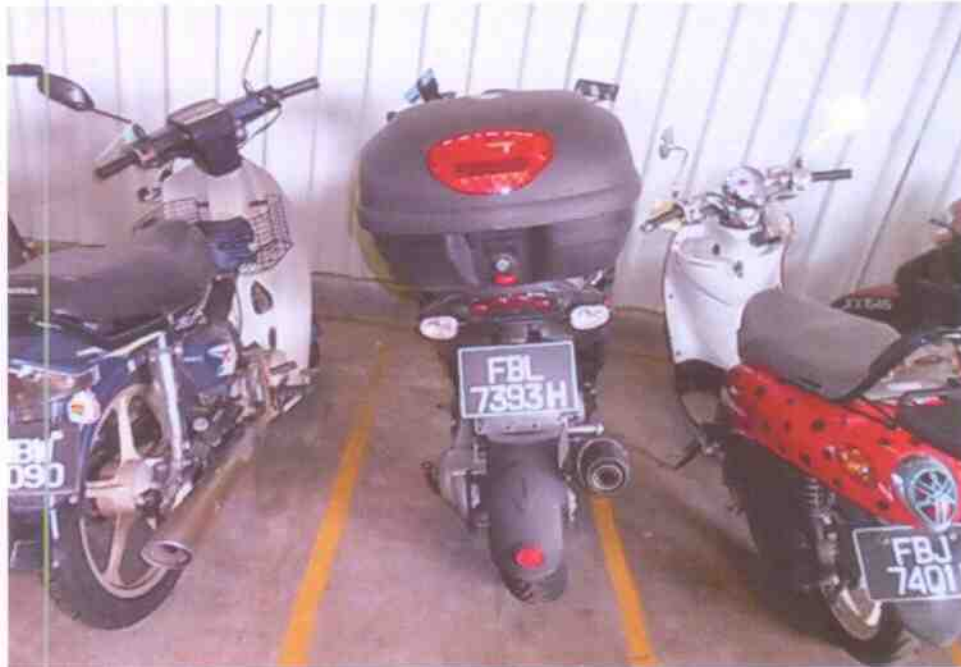
Photo 9 shows a view of the rear of the Motorcycle at the time of our inspection. It was observed to be in good general condition without any damages.

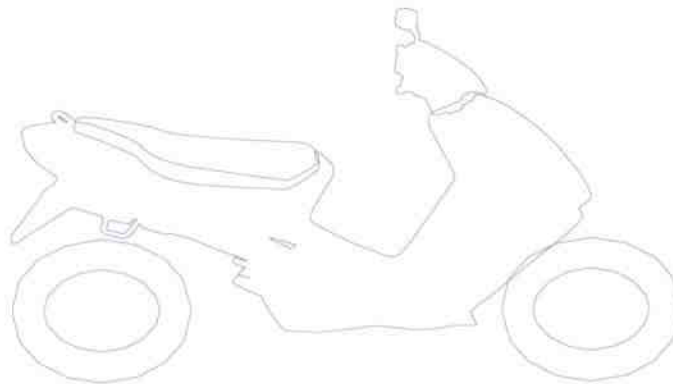
6. The condition of the Motorcycle's 2 tyres was observed to be in serviceable condition. The tread pattern of the 2 tyres was clearly visible. We did not observe any tear, burst mark(s) and/or punctured hole(s) on the sidewalls as well as across the tread of the 2 tyres. The 2 tyres were both observed to be sufficiently inflated for vehicular operation. The tyre brand, tyre size and remaining tread depth of the 2 tyres were recorded as follows:-

Michelin City Grip 140/60 -R15
(4mm)

Michelin City Grip 120/70 -R14
(4mm)

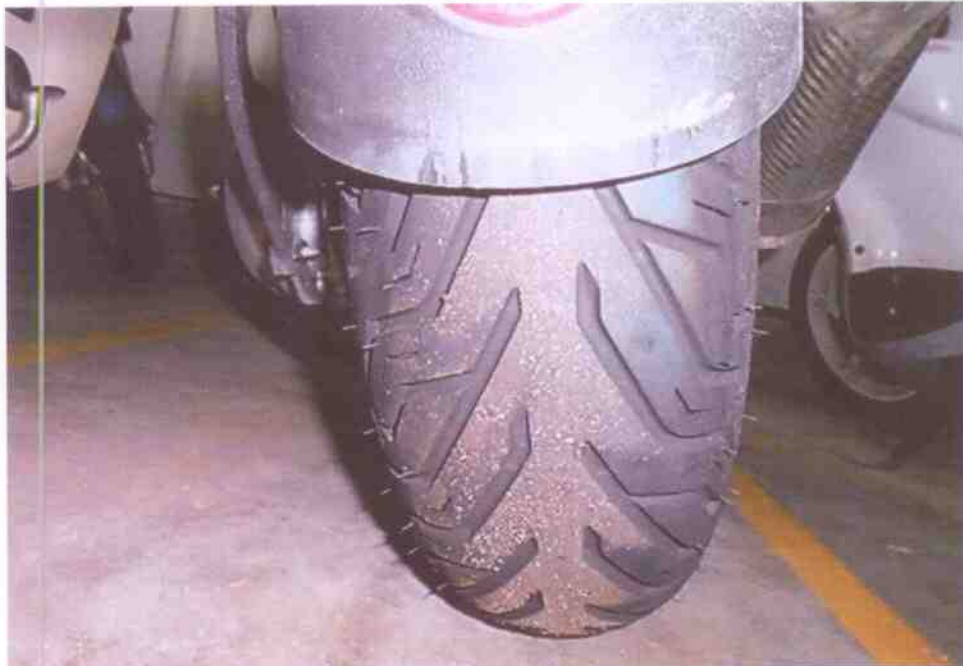
7. The rear tyre was wrapped around alloy wheel rims that were found to be without any significant damage. See photo 10 – 11 below

Photo 10 shows the rear tyre of the Motorcycle. The rear tyre was observed to be in serviceable condition with remaining tread depth of approximately 4mm. The tyre was also observed to be sufficiently inflated for vehicular operation.

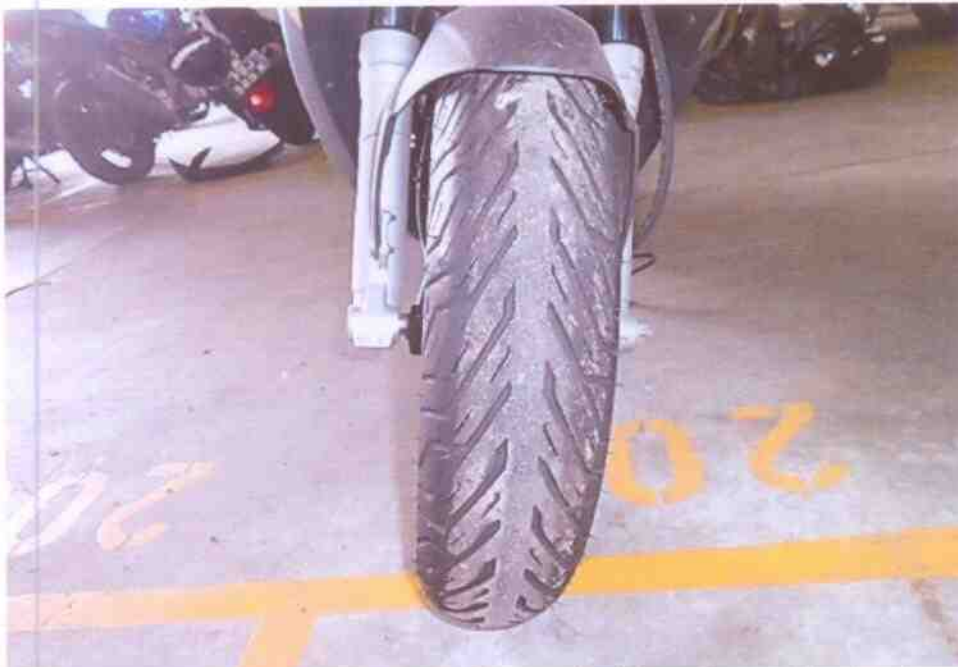
Photo 11 shows the front tyre of the Motorcycle. The pattern of the tread was clearly visible. There was no tear, burst mark(s) and/or punctured hole(s) on the sidewalls as well as across the tread of the front tyre.

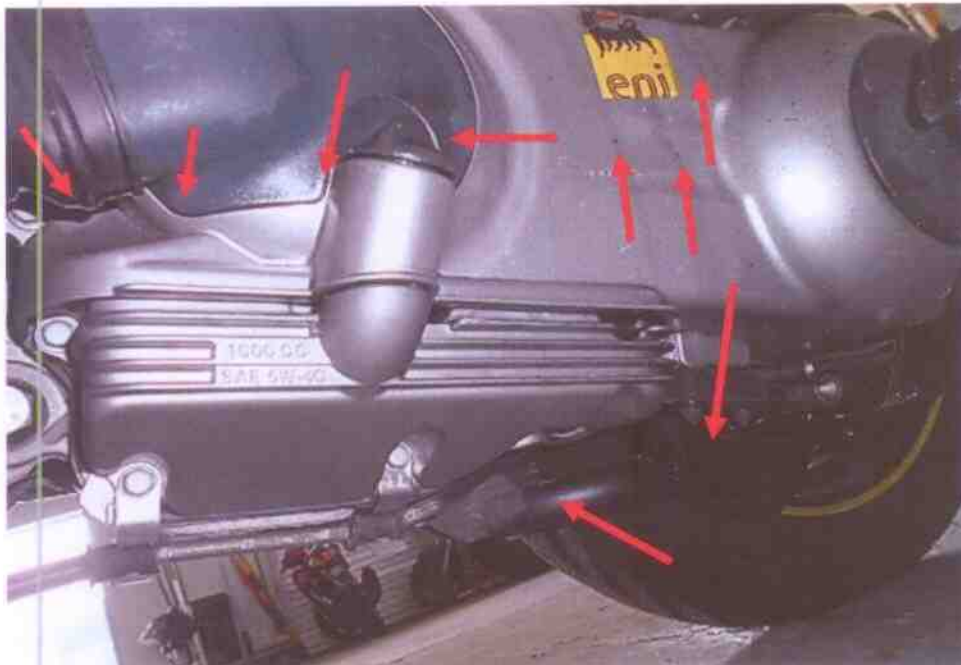
8. Upon examination of the Motorcycle's engine area, we had observed that the various engine related parts and components were intact with no visible damage. Except for there was sign(s) or indication(s) of fresh fluid leak observed around the engine area of the Motorcycle likely due to the accidents impact.
9. The drive train of the motorcycle was found to be intact without any misalignment. There was also no visible tear or cut observed on the connecting hoses and cables. See photo 12 – 15 below.

Photo 12 shows was sign(s) or indication(s) of fresh fluid leakage observed around the engine area of the Motorcycle.

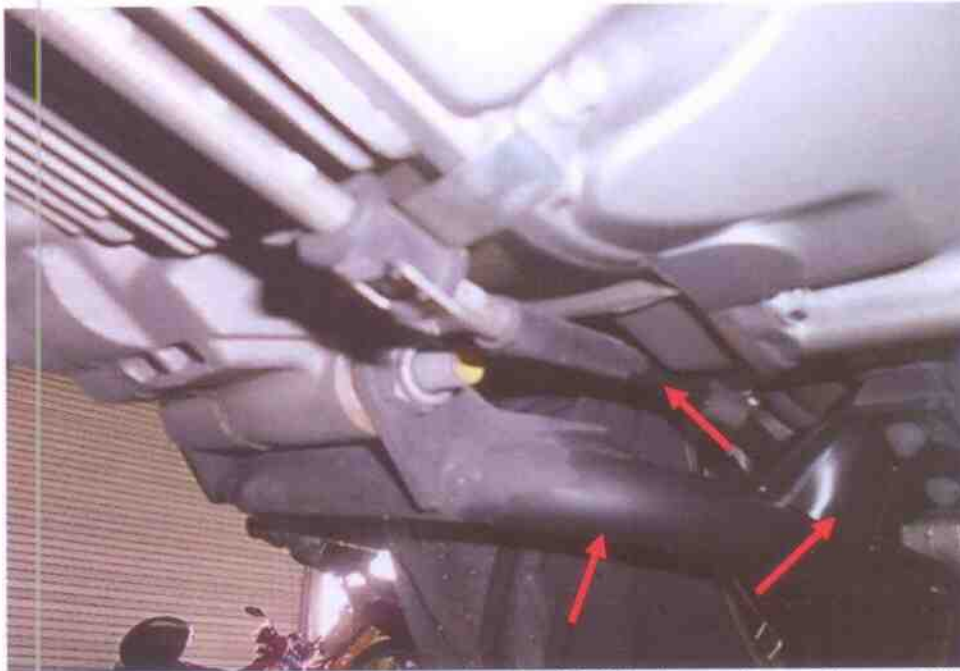
Photo 13 shows was sign(s) or indication(s) of fluid leakage observed around the engine undercarriage area of the Motorcycle.

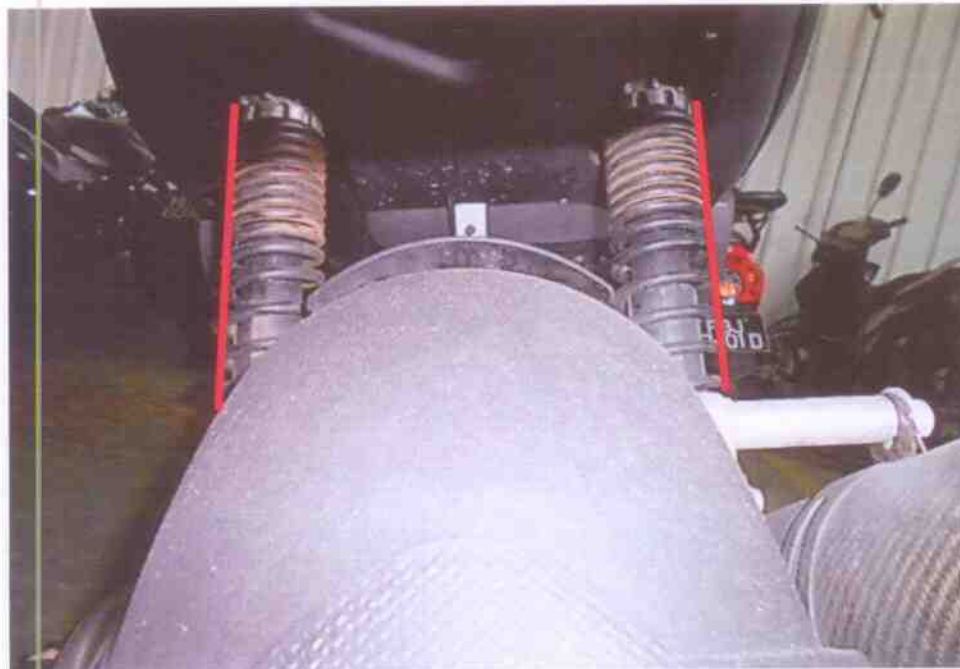
Photo 14 shows the rear shock absorber of the motorcycle was found to be intact without any misalignment.

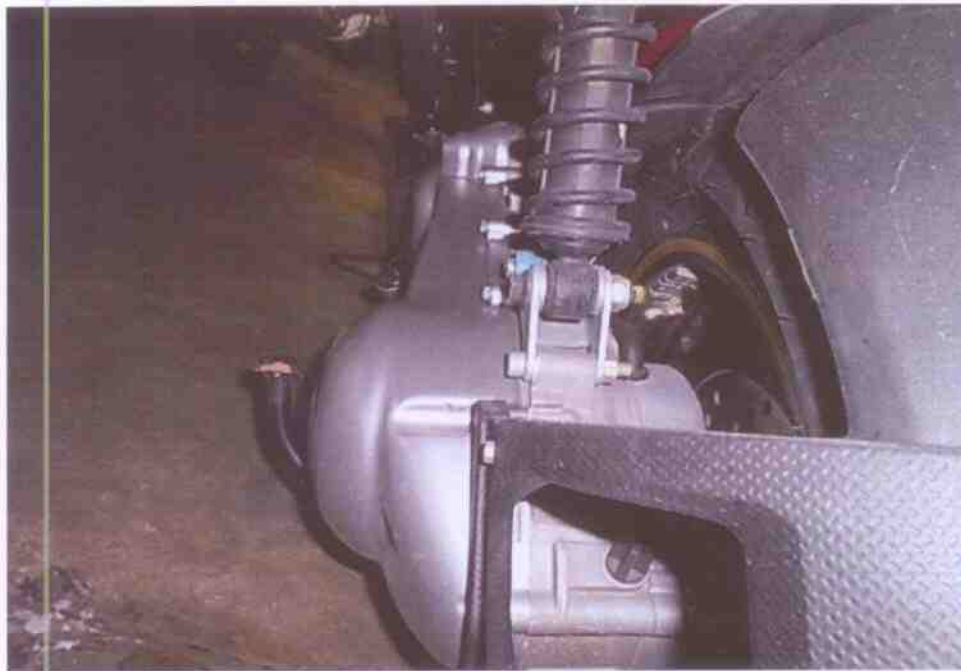
Photo 15 shows the drive train of the motorcycle was found to be intact without any misalignment.

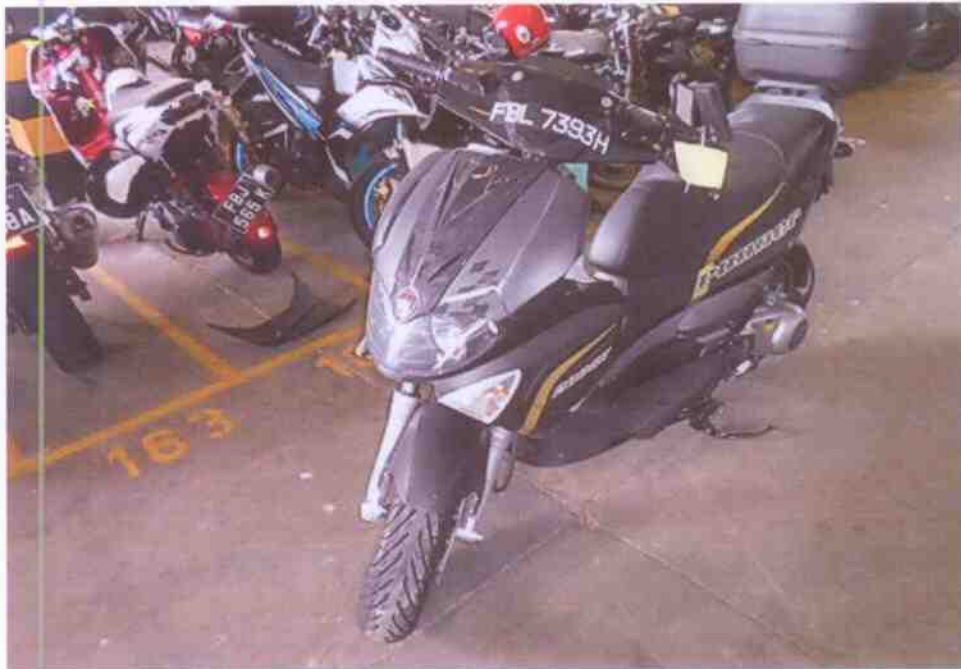
10. My checks on the various steering components of the Motorcycle had revealed that its steering system was in serviceable condition. Its front fork was found to be intact and undamaged. Turning the handle bar towards the left and right also did not produce any abnormal free play and/or resistance.
11. The braking system of the Motorcycle was observed to be of a full hydraulic type, where hydraulic (brake fluid) pressure controls the brake for the front wheel and rear wheel. The brake for the front wheel is engaged by pulling the brake lever at the right side of the Motorcycle's handle bar while the brake for the rear wheel is engaged by pulling the brake lever at the left side of the Motorcycle's handle bar.

Photo 16 shows the steering system was observed to be in a serviceable condition. It was able to be steered to the full left & right at time of our inspection.

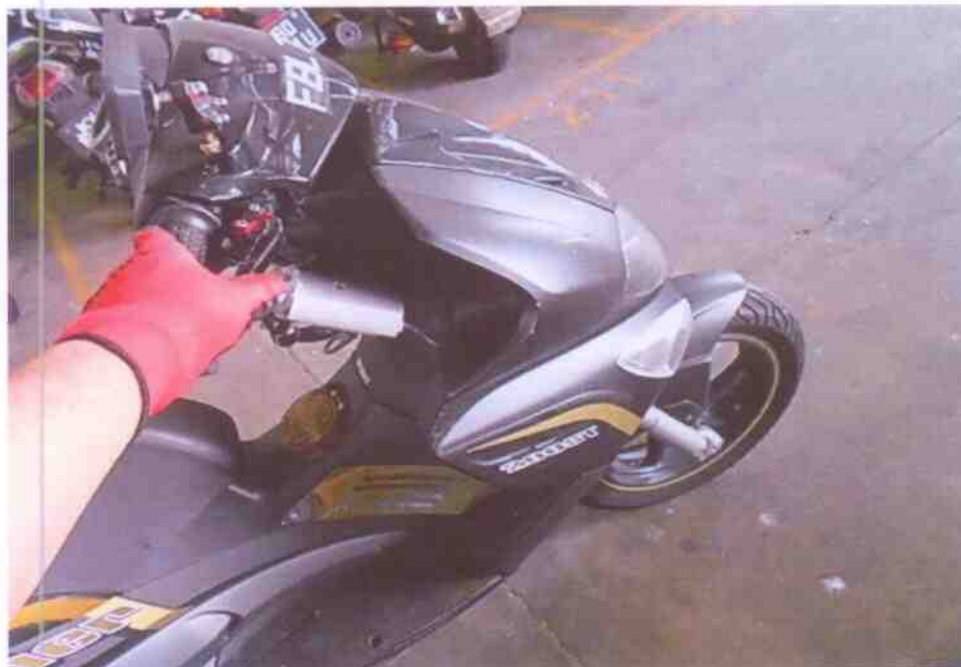
12. Static brake tests conducted on the Motorcycle front brake had appeared to indicate that the brake system of the Motorcycle was in serviceable condition. There was some resistance felt (spongy like feel) upon pressing the brake lever at the right side of the handle bar. This would indicate that there's no leakage of pressure/vacuum in the brake system. The rear brake on the other hand, although due to the accident's impact that loosen the brake lever from the original installation, the braking system of the Motorcycle was also likely to be in serviceable condition. There was some resistance felt (spongy like feel) upon pressing the brake lever at the right side of the handle bar. This would indicate that there's no leakage of pressure/vacuum in the brake system. This is taking into consideration that the various mechanical parts of the braking system were all intact & undamaged.

Photo 17 shows the static brake tests conducted on the Motorcycle front brake had appeared to indicate that the brake system of the Motorcycle was in serviceable condition. There was some resistance felt (spongy like feel) upon pressing the brake lever at the right side of the handle bar.

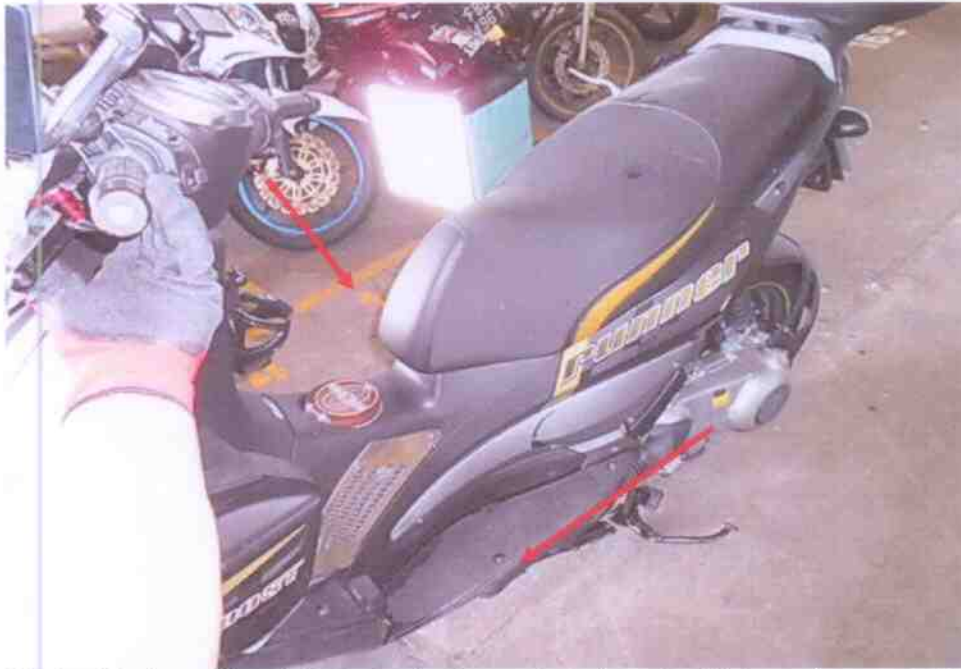
Photo 18 shows the static brake tests conducted on the Motorcycle rear brake had appeared to indicate that the brake system of the Motorcycle was in serviceable condition. There was some resistance felt (spongy like feel) upon pressing the brake lever at the right side of the handle bar.

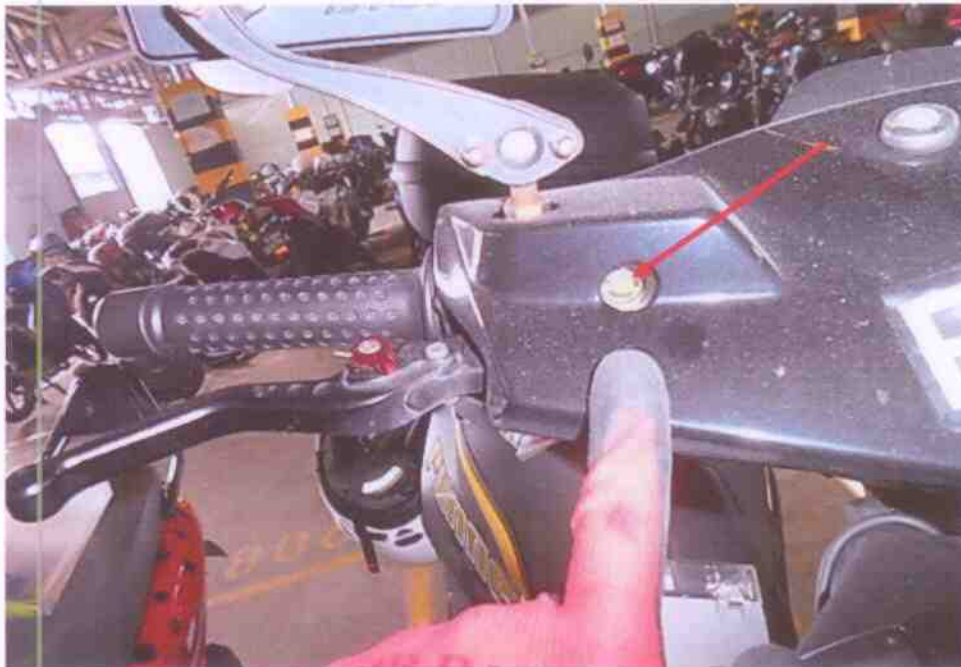
Photo 19 shows the right hand brake fluid reservoir on the Motorcycle that indicates that it was sufficient at time of inspection.

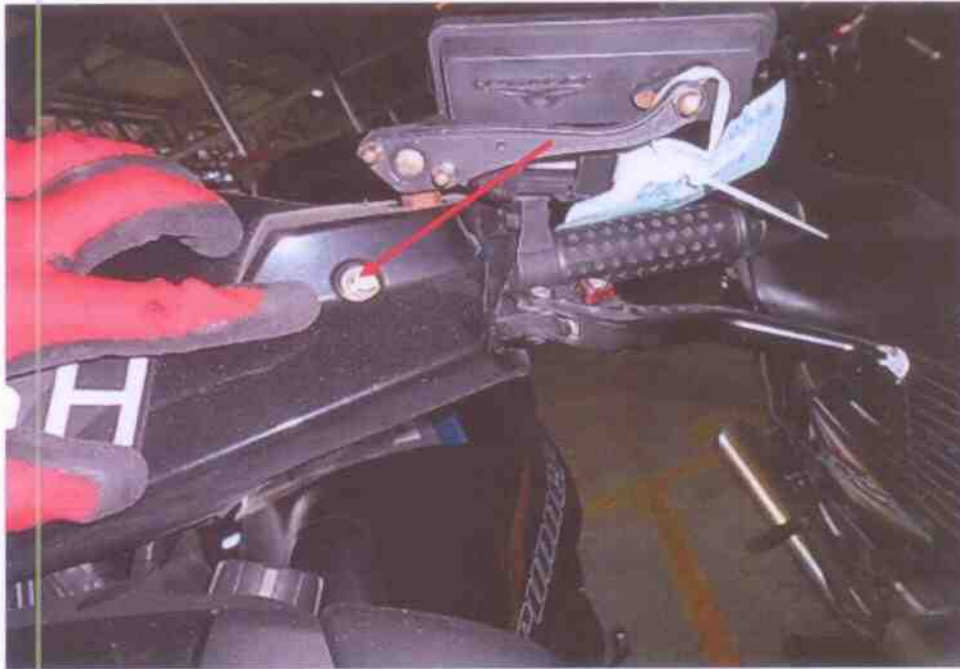
Photo 20 shows the left hand brake fluid reservoir on the Motorcycle that indicates that it was sufficient at time of inspection.
