Your Ref: TP/IP/51353/2017  
Our Ref :CI/TPD17023257/Z

**Fatal Accident Investigation Team**

**INSPECTION REPORT OF BICYCLE (GREEN) - TRAFFIC POLICE POUND  
REPORT NO. PR3995/17**

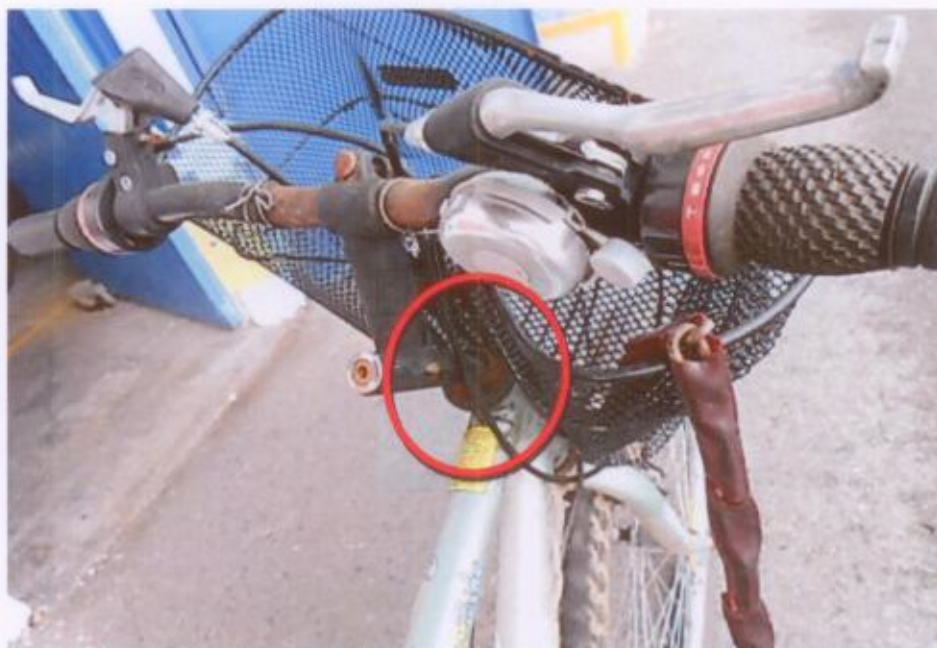
4. The Bicycle was observed to have sustained damages at the frontal portion, rear portion & along both its left side and right side. The body parts that were found to have been damaged include its handle & fork connecting bar, front & rear braking components & gear train amongst others as a result of the accident.

Photo 2 shows the frontal portion of the Bicycle at time of inspection. Damage on the handle & fork connecting bar was observed likely due to the accident.

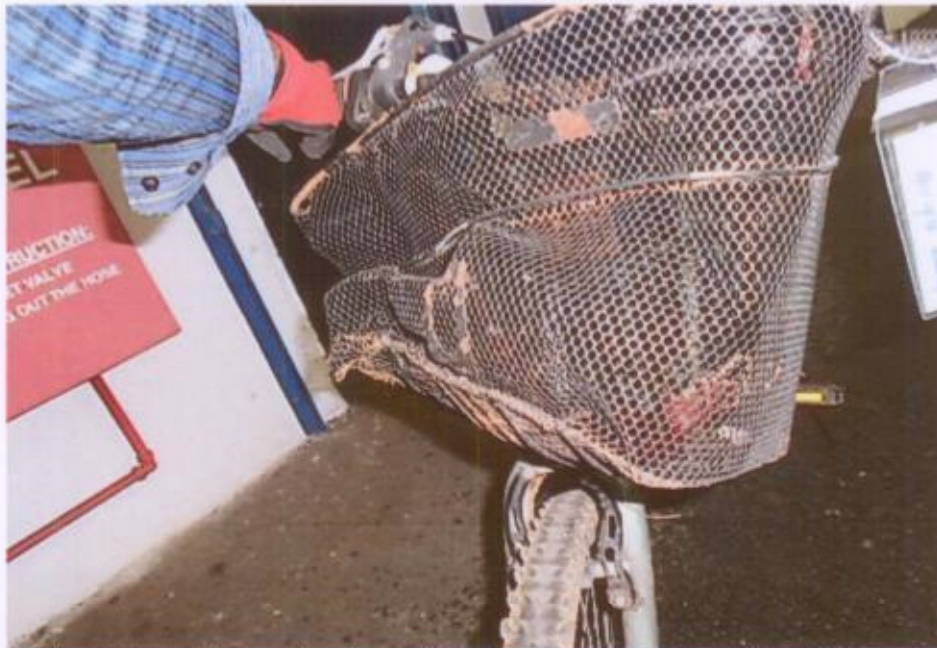
Photo 3 shows the front basket of the Bicycle at time of inspection. Damage on the front basket was observed likely due to the accident.

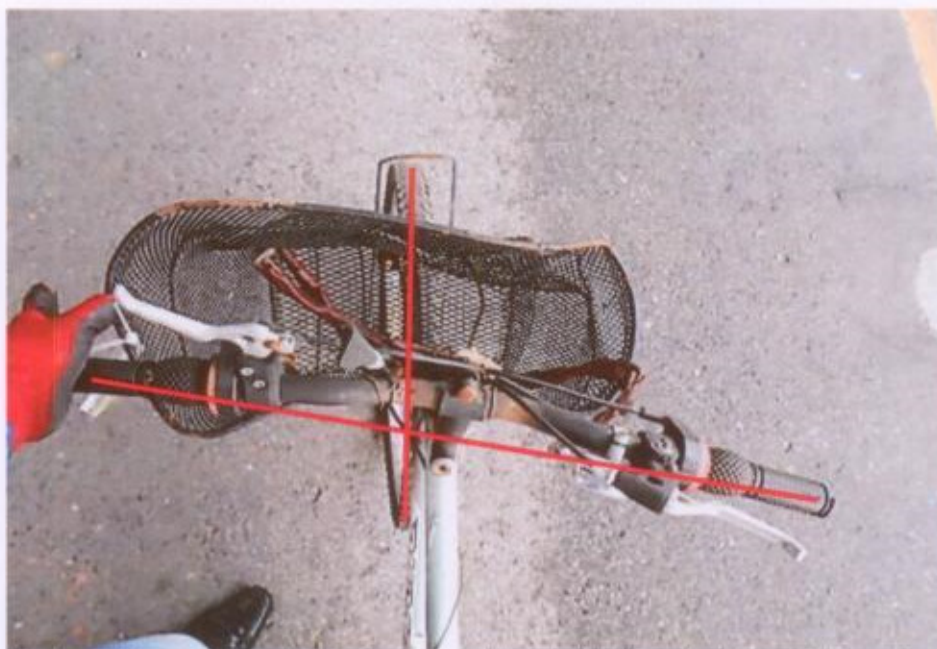
Photo 4 shows the frontal portion of the Bicycle (top view) at time of inspection. Misalignment of the handle bar & front tyre was observed.

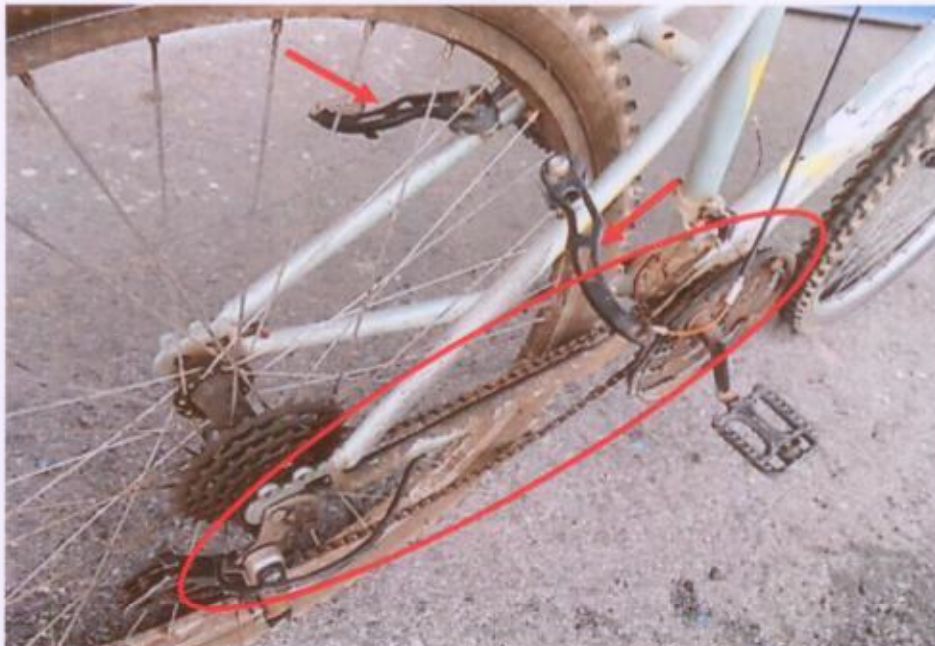
**Photo 5** shows a close-up view of the chain gear of the Bicycle at the time of our inspection. It was observed to be out of tension at time of our inspection (circled). The rear brake clamp was also found to be dislodging from the original assembly.

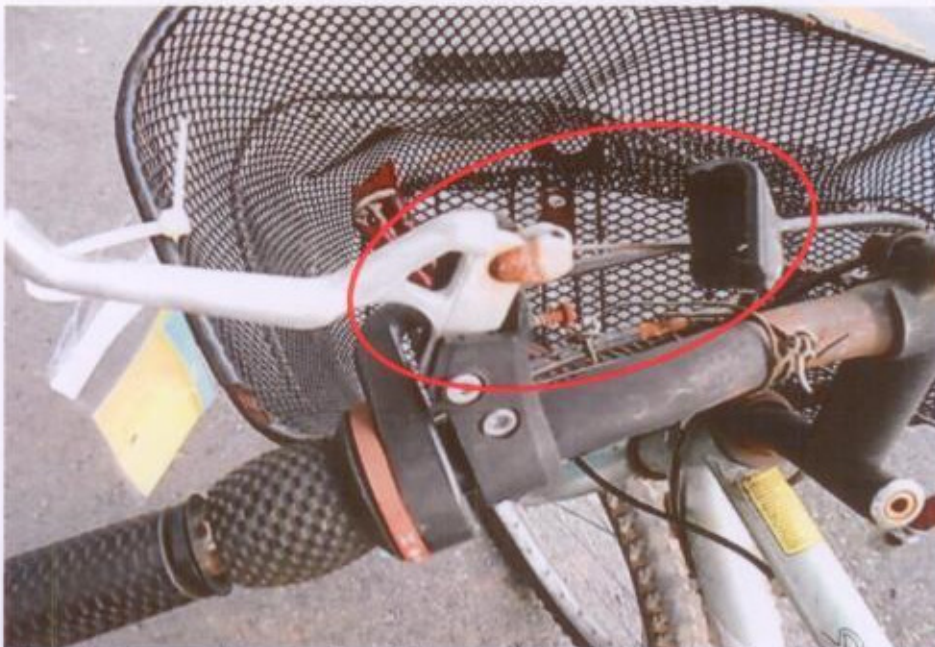
**Photo 6** shows a close-up view of the rear brake lever of the Bicycle at the time of our inspection. It was observed to be damage at the rear brake lever of the Bicycle likely due to the accident.

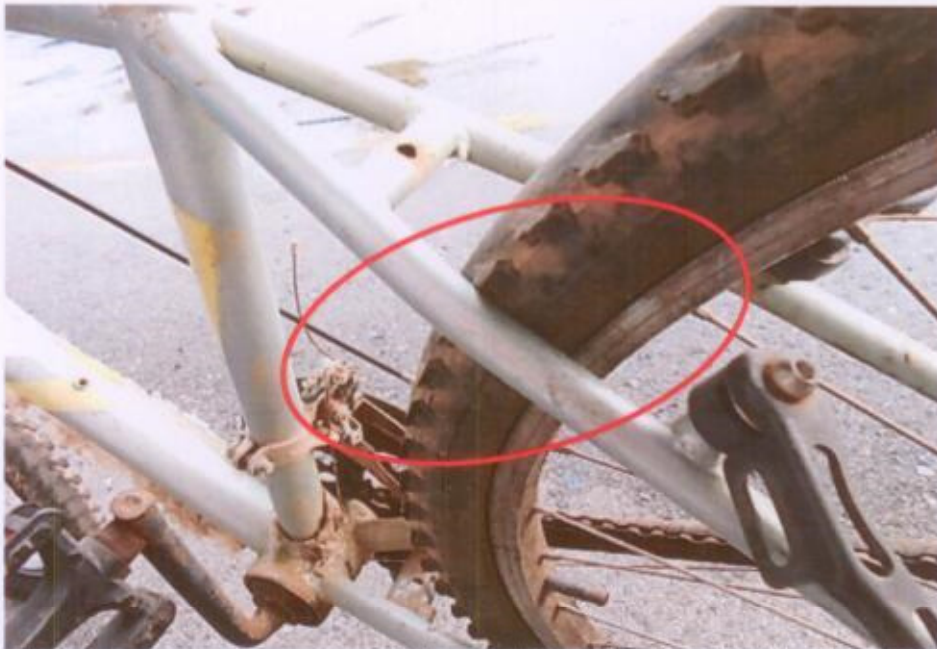
Photo 7 shows a close-up view of the rear tyre of the Bicycle at the time of our inspection. It was observed to be pushed against the rear fork of the Bicycle likely due to the accident.

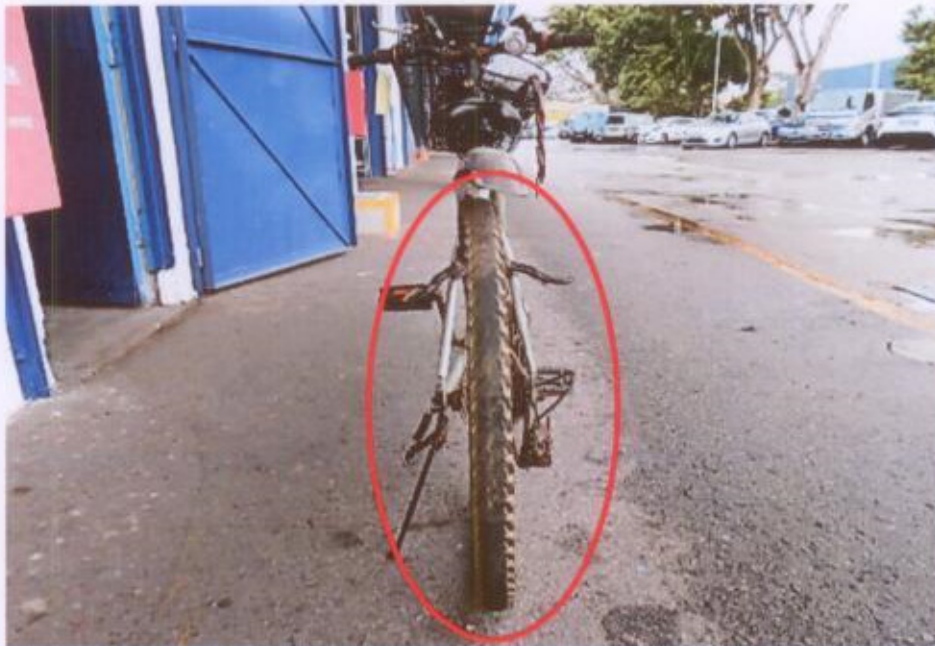
5. The condition of the Bicycle's front & rear tyres was observed not to be in serviceable condition. The tread pattern of the 2 tyres was observed only visible on the sides of both tyres, the middle section of the 2 tyres was observed to be bald.
6. Further examination on the rear tyre revealed that the inner core of the tyre was found to be exposed at the middle section of the tyre. Having said that, we did not observe any tear, burst mark(s) and/or punctured hole(s) on the sidewalls as well as across the tread of the 2 tyres.
7. The front tyre was observed to be deflated at time of our inspection whereas the rear tyre was sufficiently inflated for vehicular operation. The tyre brand, tyre size and remaining tread depth of the 2 tyres were recorded as follows:-

8. The tyres were wrapped around alloy spork wheel rim that was found to be without any significant damage. See photo 8 & 11 below

**Photo 8** shows the rear tyre of the Bicycle at the time of our inspection. The tread pattern of the rear tyre was observed only visible on the sides of the tyre, the middle section of the tyre was observed to be bald.

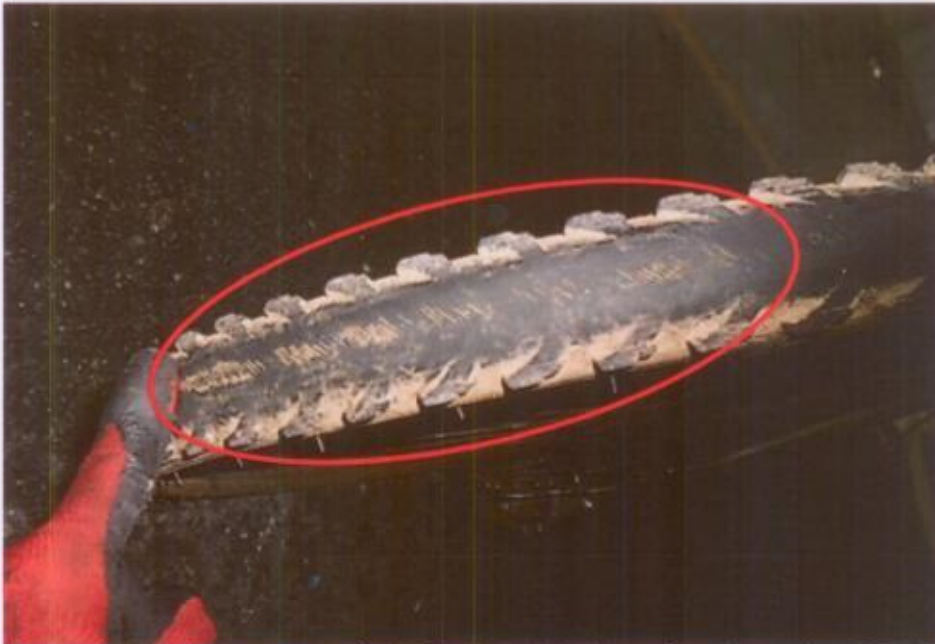
**Photo 9** shows the rear tyre of the Bicycle at the time of our inspection. Further examination on the rear tyre revealed that the inner core of the tyre was found to be exposed at the middle section of the tyre.

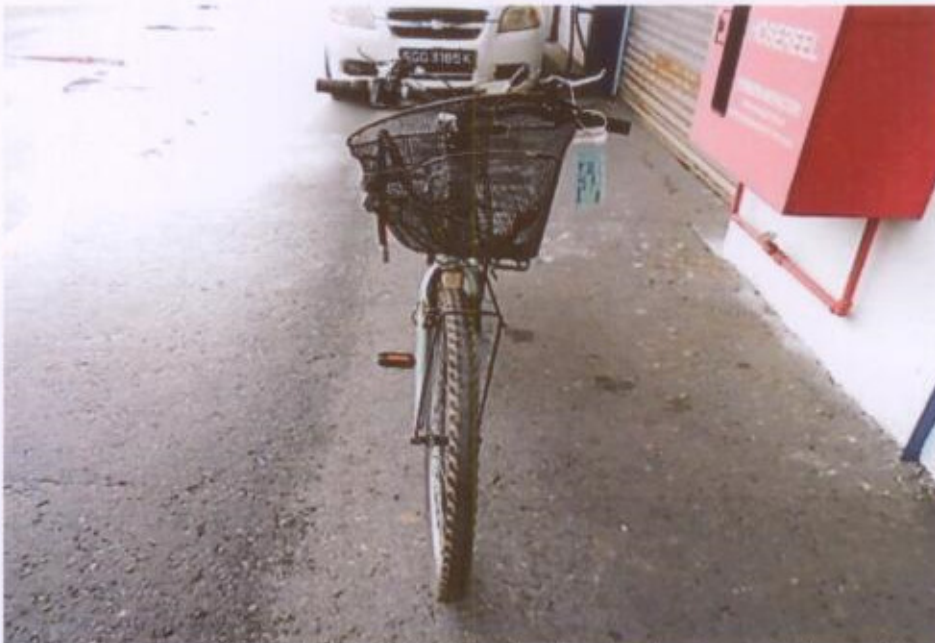
**Photo 10** shows the front tyre of the bicycle. The tread pattern of the front tyre was observed only visible on the sides of the tyre, the middle section of the tyre was observed to be bald.

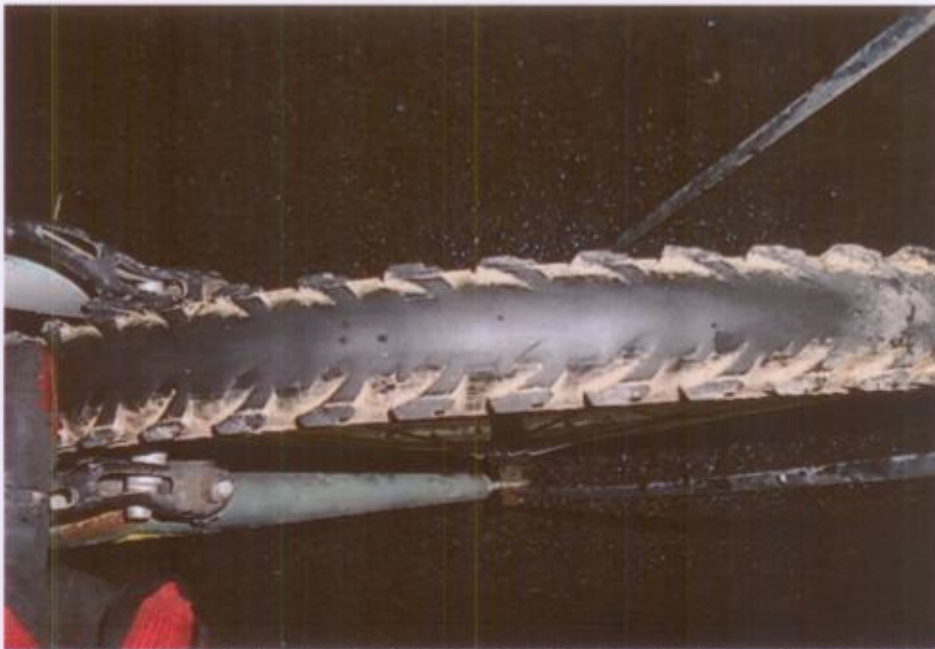
Photo 11 shows the front tyre of the bicycle. The tread pattern of the front tyre was observed only visible on the sides of the tyre, the middle section of the tyre was observed to be bald.

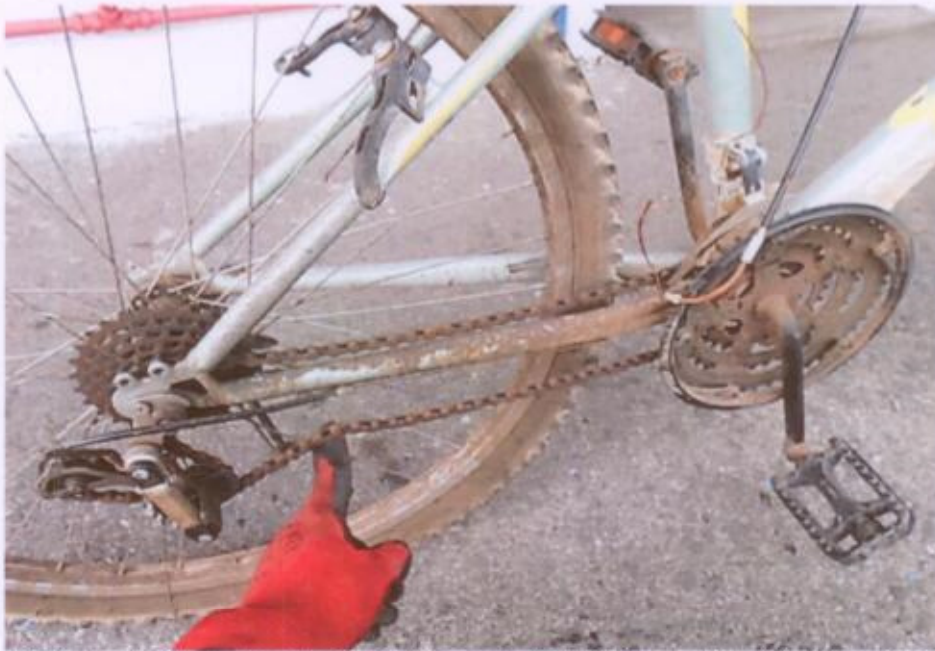
9. The gear chain of the Bicycle was found to be out of tension likely due to the accident. Free play tension test was found to be unacceptable (too loose to be in an operational condition). See photo 12 below.

**Photo 12** shows a close-up view of the rear chain of the Bicycle at the time of our inspection. It was observed to be out of tension at time of our inspection.

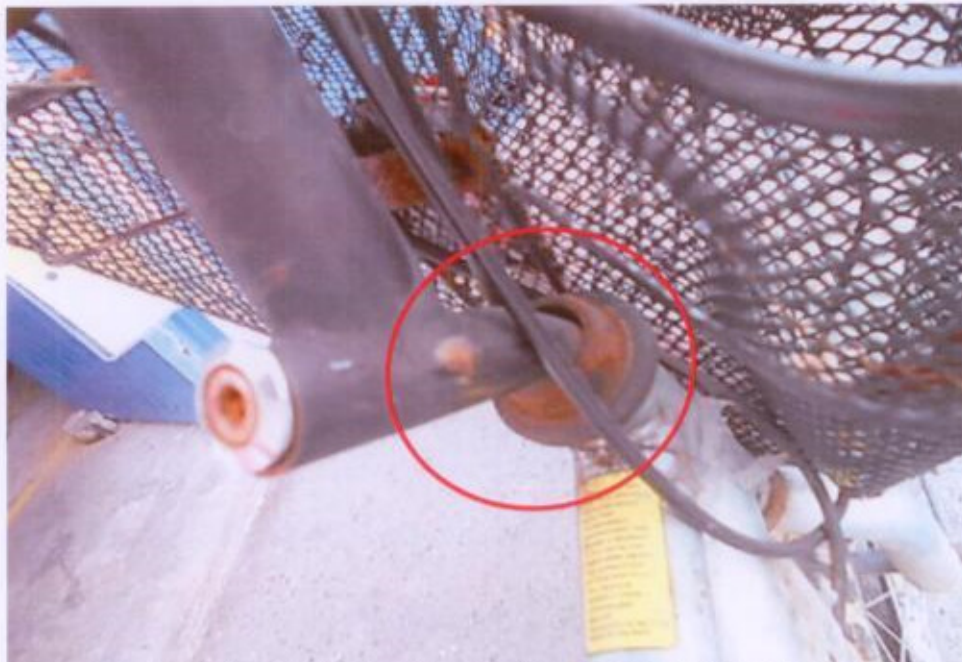
10. For this case, we were not able to conduct any test(s) on the steering system of the Bicycle due to the damages on its front fork. The front fork was found to be misaligned as a result of the accident, hence causing the whole steering system to be out of alignment.
11. The brake system of the Bicycle was controlled by mechanical means (cables and springs). Our visual examination of the various components in the brake system, like the hand brake lever (left & right), brake clamps (front & rear), revealed some of the components sustained damages.
12. Further examination revealed that the hand brake lever for rear brake was observed to be broken; the cable at the end of the rear brake clamp was dislodged from its original assembly. The rear brake clamp assembly was seen to be broken likely due to the accidents impact.

**Photo 13** shows the front fork that was observed to have sustained damages likely due to the accidents impact.

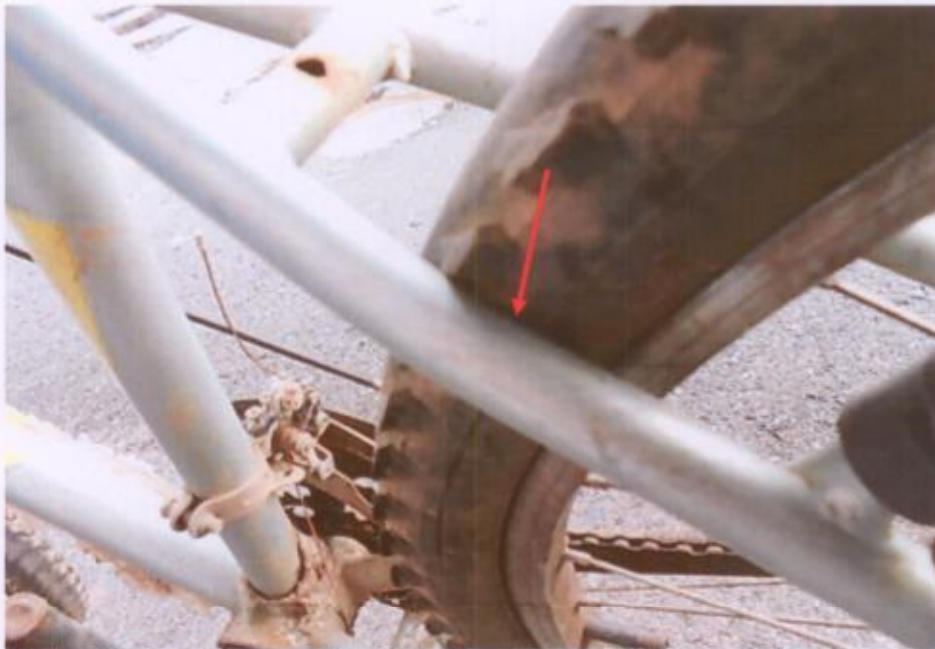
Photo 14 shows the rear fork that was observed to have sustained damages likely due to the accidents impact.

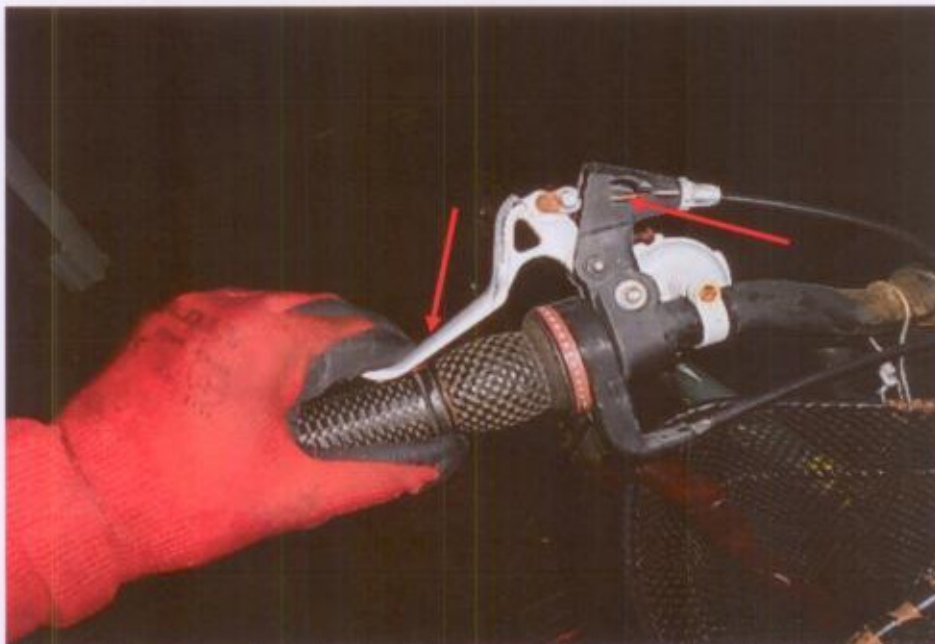
13. The front brake clamp on the other hand, was observed to have worn out rubber brake pad. However, the hand brake lever & connecting cables was in undamaged condition.
14. A static brake test was conducted only on the Bicycle's front brake. The test was conducted by lifting the front tyre above ground & applies a little spinning action to it. The hand brake lever was then gripped in order to stop the spinning front tyre. The result was unsatisfactory. It didn't stop after gripping the hand brake to the fullest. It shows that the front brake clamps was not responding to the gripping action. Further to this, a close examination on the rubber brake pad revealed that a thin gap was noted when even a full grip to the brake lever was performed. This had appeared to indicate that the brake system was not in a serviceable condition.

Photo 15 shows a static brake test was conducted only on the Bicycle's front brake. The test was conducted by lifting the front tyre in the air & applies a little spinning action to it. The hand brake lever was then gripped in order to the stop the spinning front tyre. The result was unsatisfactory. It didn't stop after gripping the hand brake to the fullest.

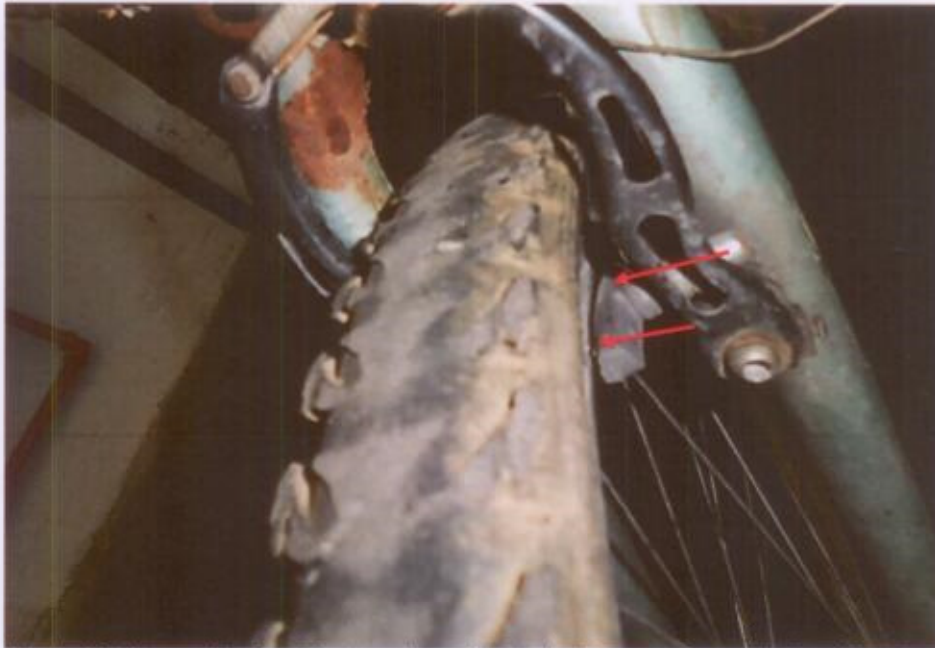
**Photo 16** shows the front brake clamp that failed to stop the spinning front tyre. The result was unsatisfactory. It didn't stop after gripping the hand brake to the fullest. Likely due to the worn out rubber pad. A thin gap was noted when gripping the brake lever to the fullest.

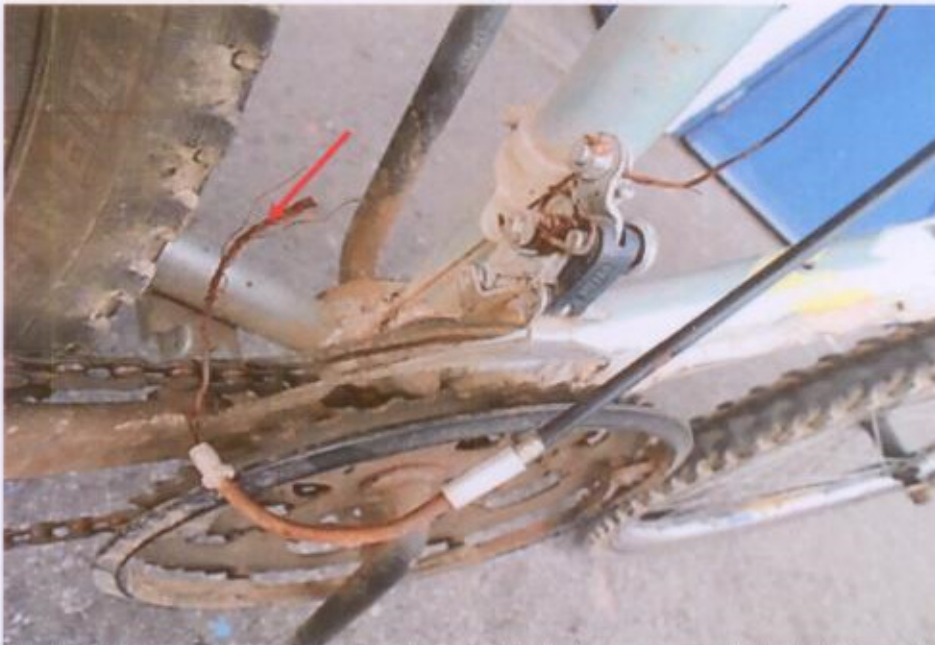
**Photo 17** shows the rear brake clamp cable that was seen dislodged from the original assembly.

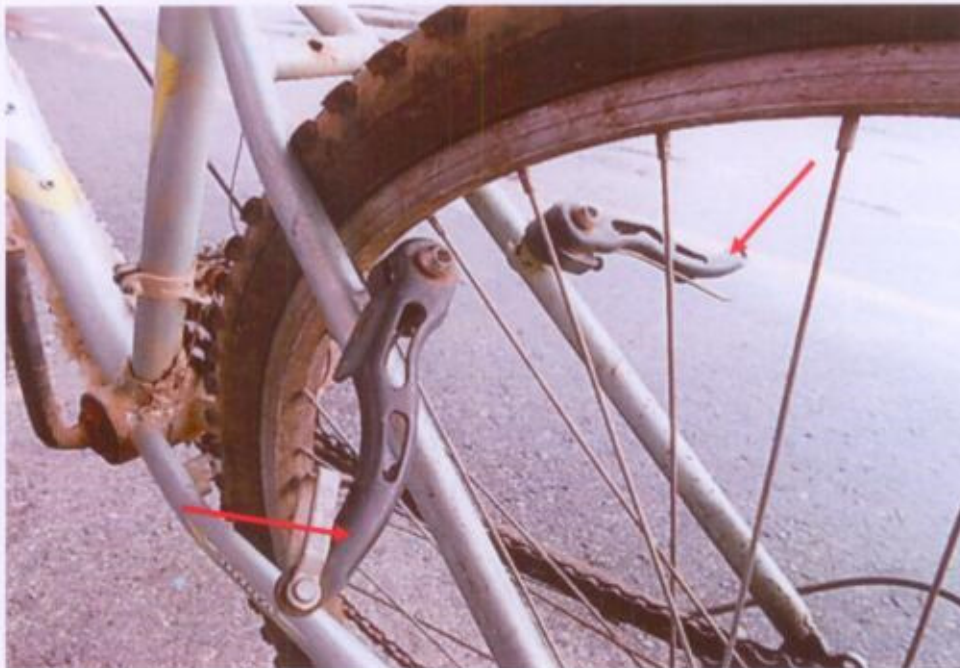
**Photo 18** shows the rear brake clamp that was seen dislodged from the original assembly.
