INSPECTION REPORT OF MOTORCYCLE FBE 3545A

1. We refer to your request dated 24th November 2017 to conduct a physical inspection of a motorcycle bearing registration number FBE 3545A (herein referred to as "**Motorcycle**"), which was involved in a fatal road traffic accident.
2. The purpose of this inspection is to primarily determine if there was any possible mechanical failure to the Motorcycle that may have contributed to the accident.
3. Following the request, we had carried out a physical inspection of the Motorcycle on 07th December 2017 at the premises of Traffic Police vehicle pound, 517 Airport Road Singapore 539942. We now set out below our observations and comments with respect to this inspection.

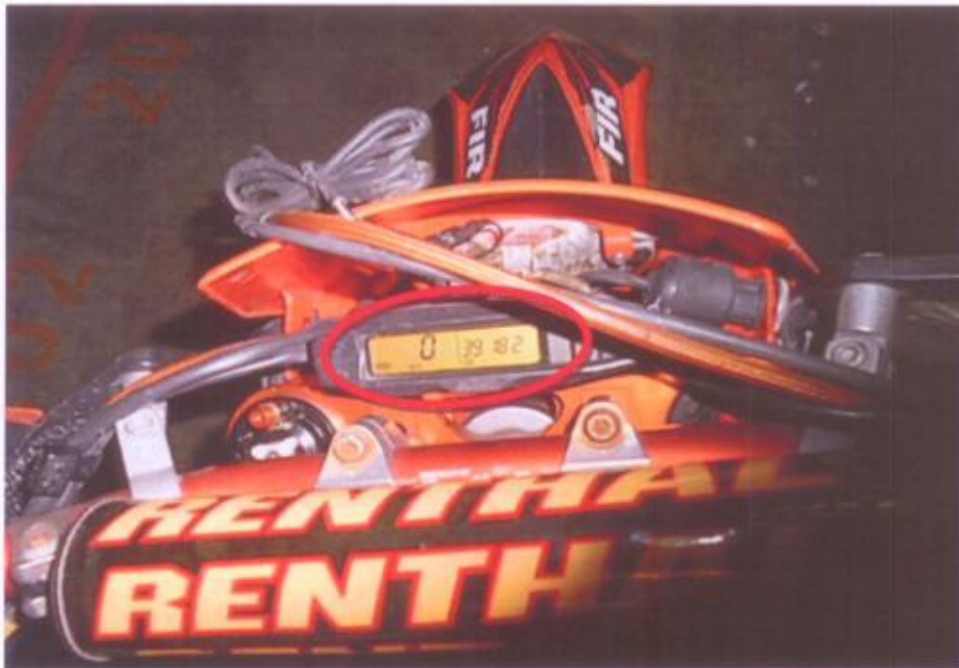
4. The mileage of the Motorcycle recorded at time of our inspection was 39,182km.
5. The Motorcycle was observed to have sustained minor damages at the frontal portion & at its left side. The body parts that were found to have been damaged include its left handle bar (throttle area), left front wheel protector, left rear wheel protector & left signal lamp amongst others as a result of the accident.

Photo 1 shows the mileage of the Motorcycle recorded at time of our inspection was 39,182km.

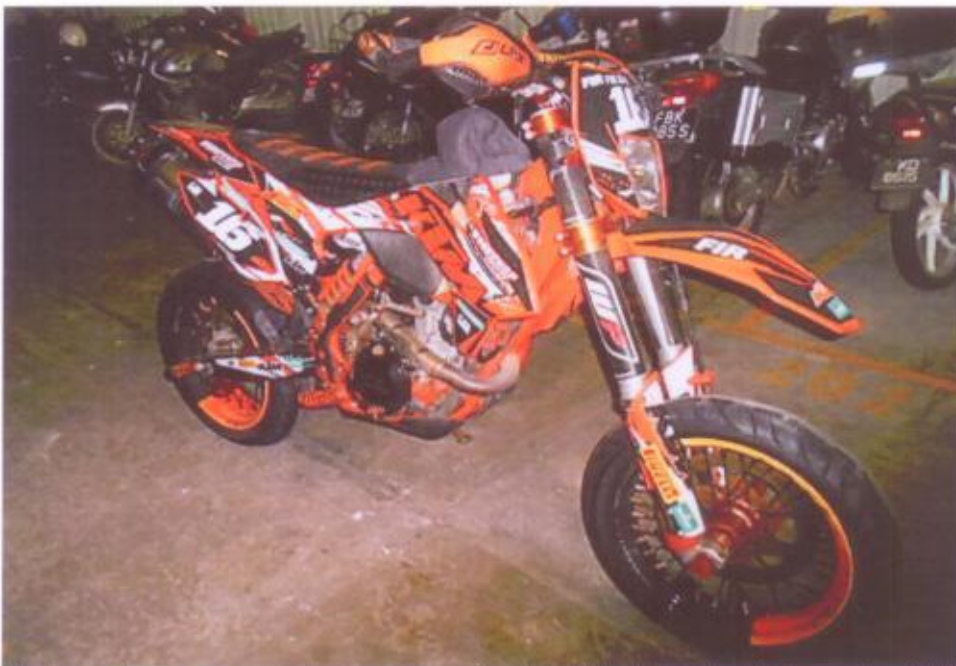
Photo 2 shows a general view of the front right body of the Motorcycle at the time of our inspection. The Motorcycle was observed to be in good general condition at time of inspection.

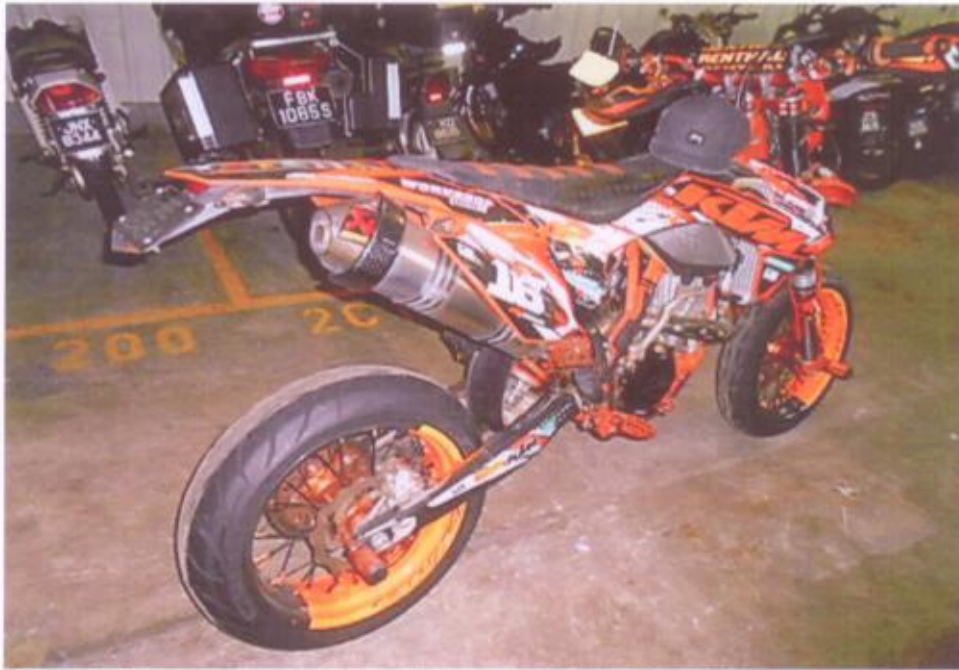
Photo 3 shows a general view of the rear right body of the Motorcycle at the time of our inspection. The Motorcycle was observed to be in good general condition at time of inspection.

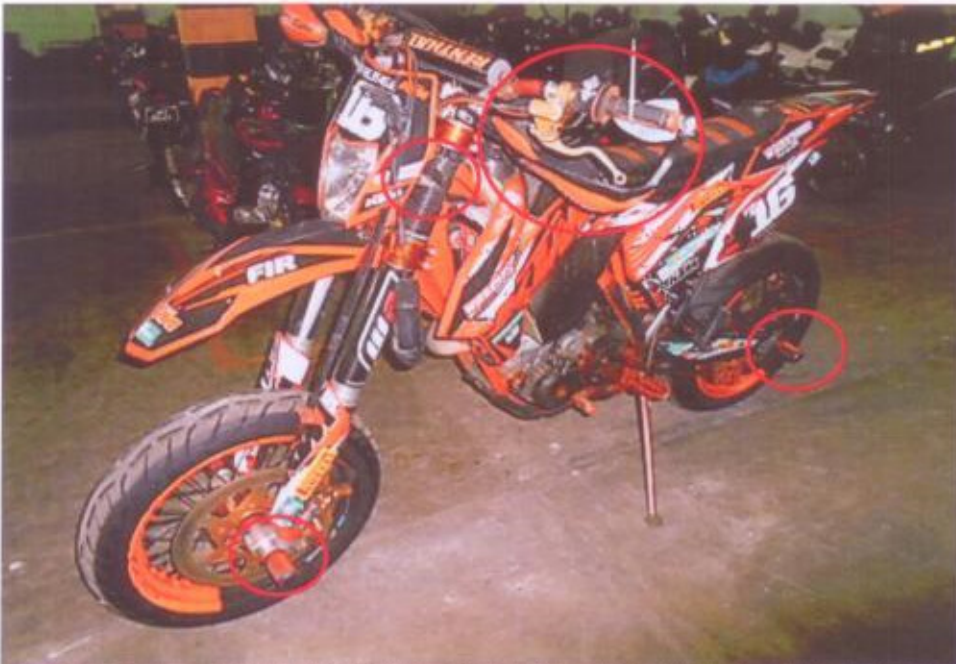
Photo 4 shows a general view of the front left body of the Motorcycle at the time of our inspection. The Motorcycle was observed to have sustained minor damages at time of inspection.

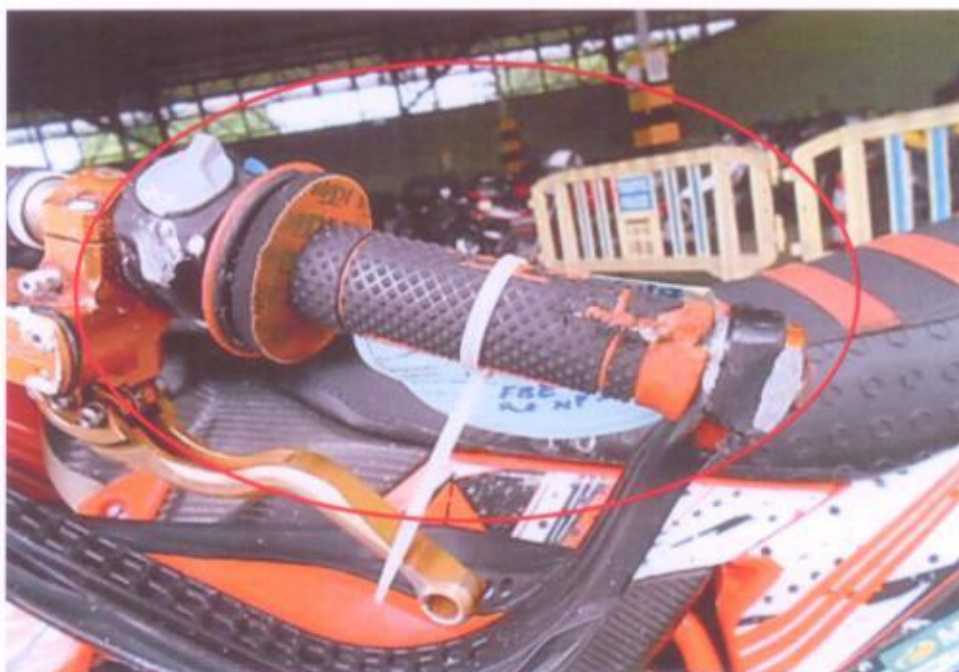
Photo 5 shows a closer view of the left handle of the Motorcycle at the time of our inspection. The Motorcycle was observed to have sustained with relatively minor damages due to the accident collision. (Circled)

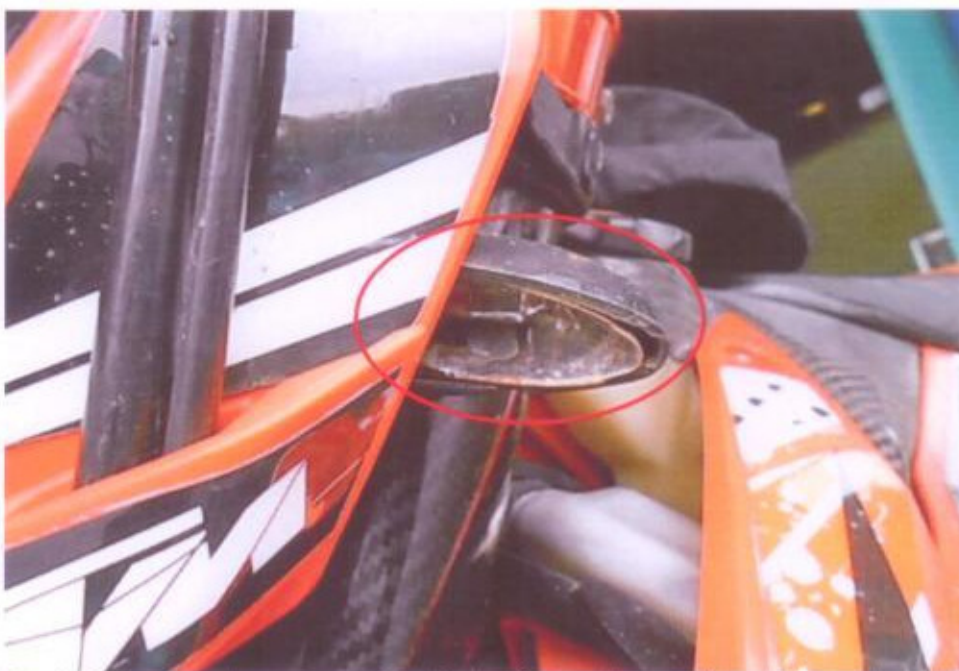
Photo 6 shows a closer view of the front left signal lamp of the Motorcycle at the time of our inspection. It was observed to be damage likely due to the accident. (Circled)

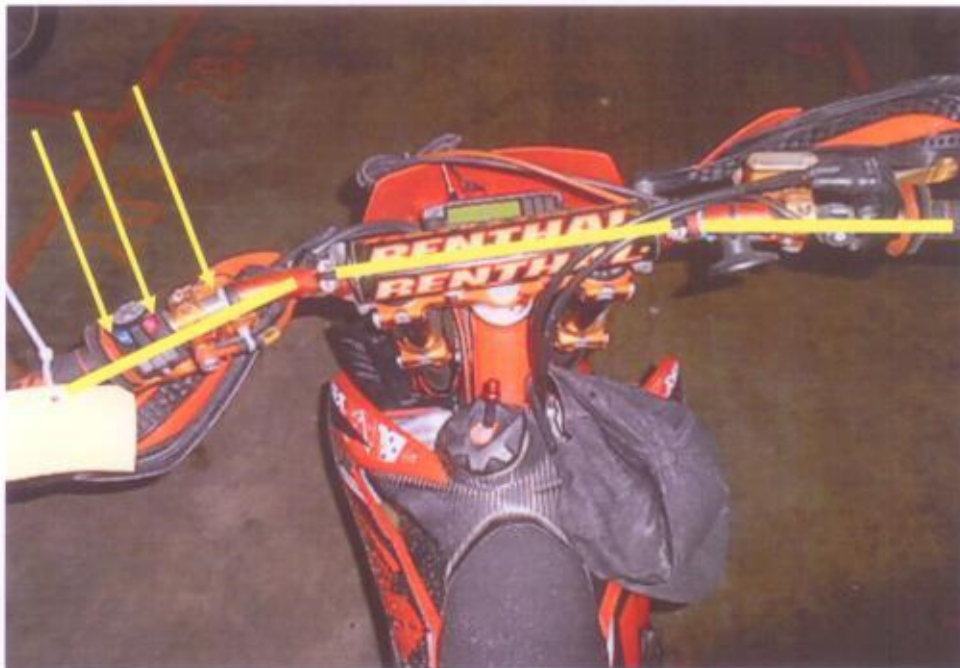
Photo 7 shows a close-up view of the front handle of the Motorcycle at the time of our inspection. It was observed to have sustained slight misalignment due to the accident collision. (Arrowed)

10. Our checks on the various steering components of the Motorcycle had revealed that its steering system was in serviceable condition. Its front fork was found to be intact and undamaged. Despite a slight bend to the handle bar (due to the accident) an operational test towards the left and right also did not produce any abnormal free play and/or resistance.

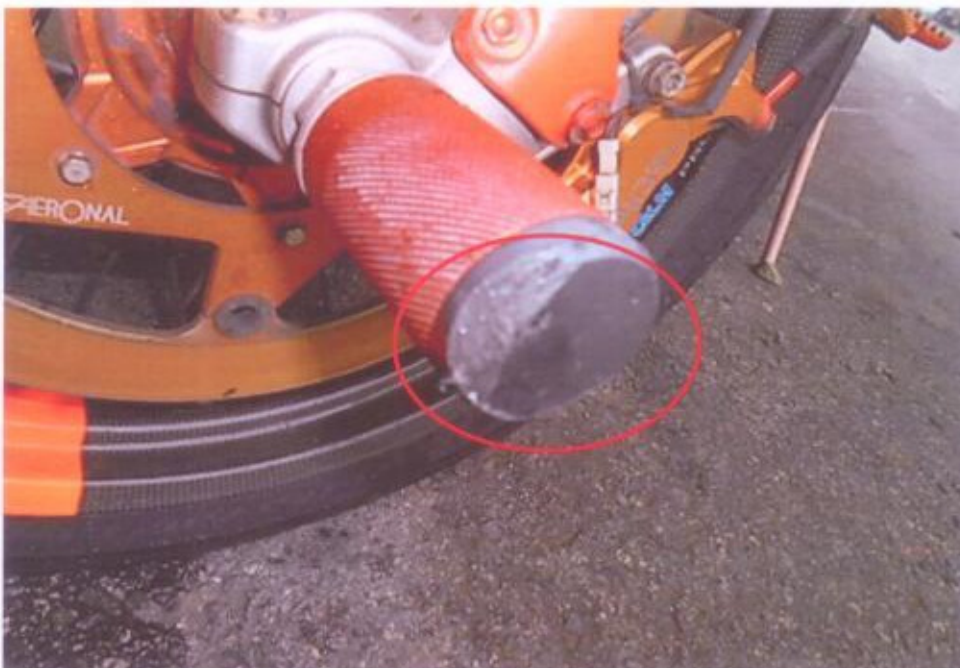
Photo 8 shows a closer view of the left front wheel protector of the Motorcycle at the time of our inspection. It was observed to be damage due to the accident impact. (Circled)

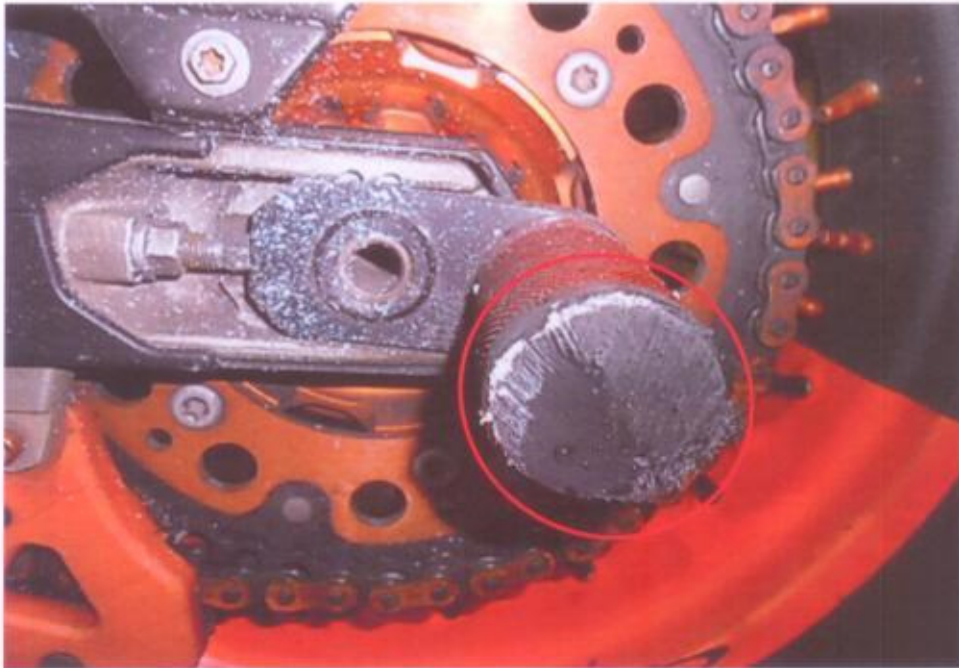
Photo 9 shows a closer view of the left rear wheel protector of the Motorcycle at the time of our inspection. It was observed to be damage due to the accident impact. (Circled)

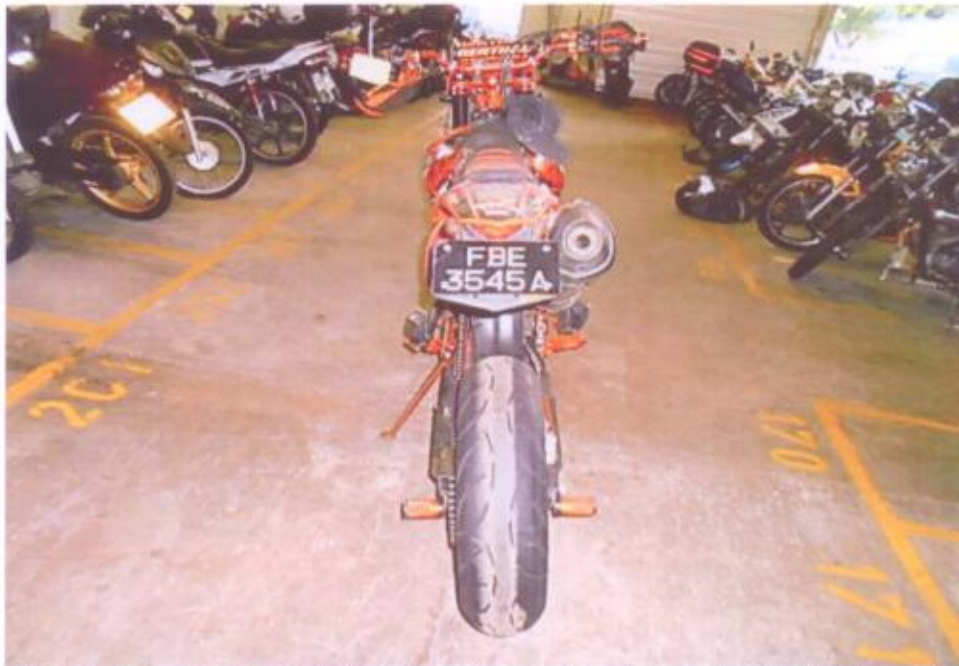
Photo 10 shows a general view of the rear portion of the Motorcycle. The Motorcycle was observed to be in good general condition at time of inspection.

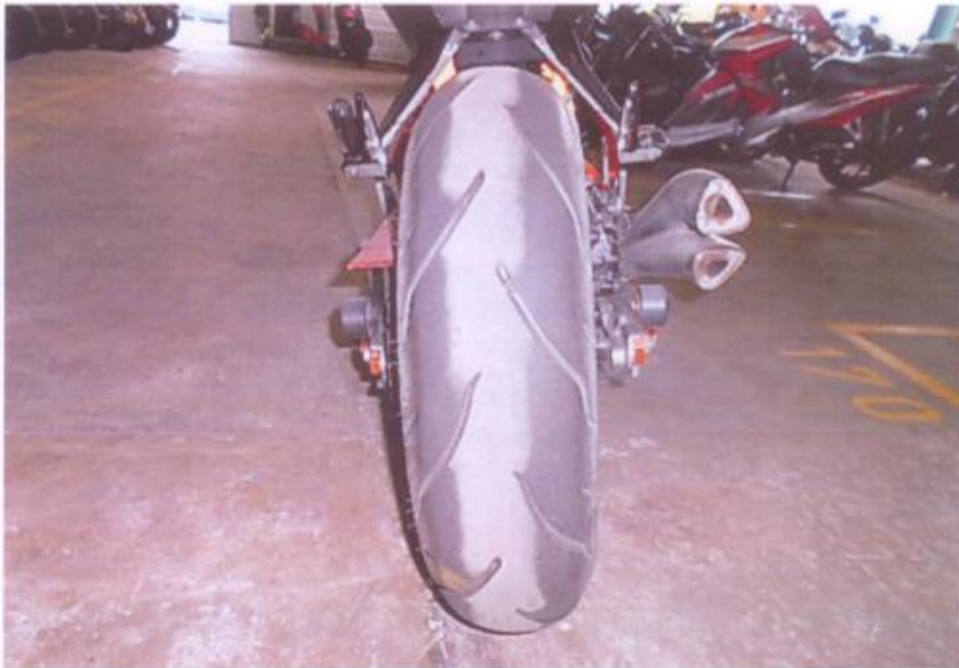
7. The rear tyre was wrapped around alloy wheel rims that were found to be without any significant damage. See photo 11 & 12 below

Photo 11 shows the rear tyre of the Motorcycle. The rear tyre was observed to be in serviceable condition with remaining tread depth of approximately 3mm. The tyre was also observed to be sufficiently inflated for vehicular operation.

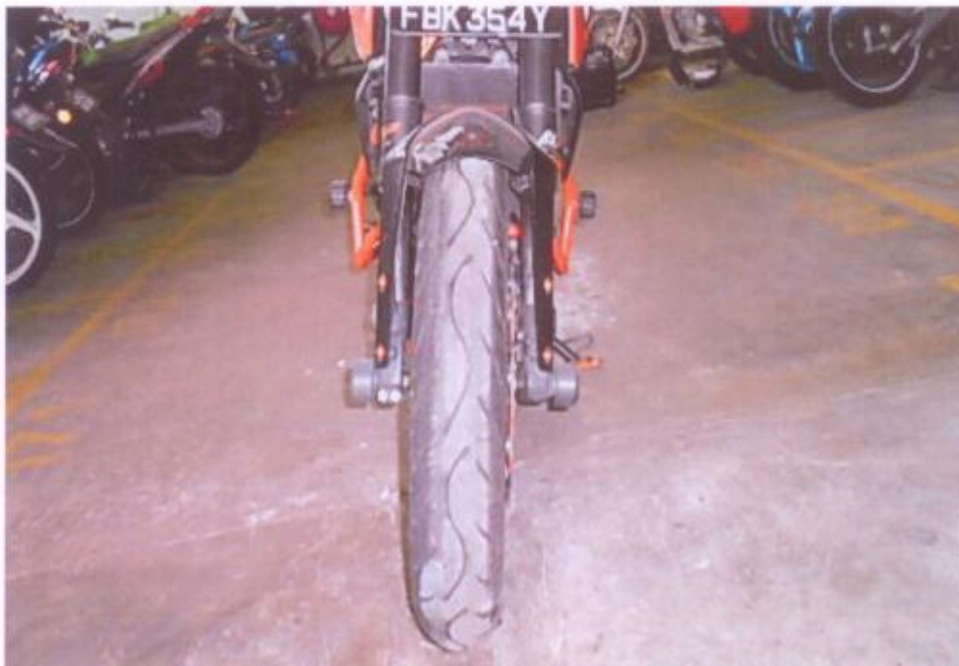
Photo 12 shows the front tyre of the Motorcycle. The front tyre was observed to be in serviceable condition with remaining tread depth of approximately 2mm. The tyre was also observed to be sufficiently inflated for vehicular operation.

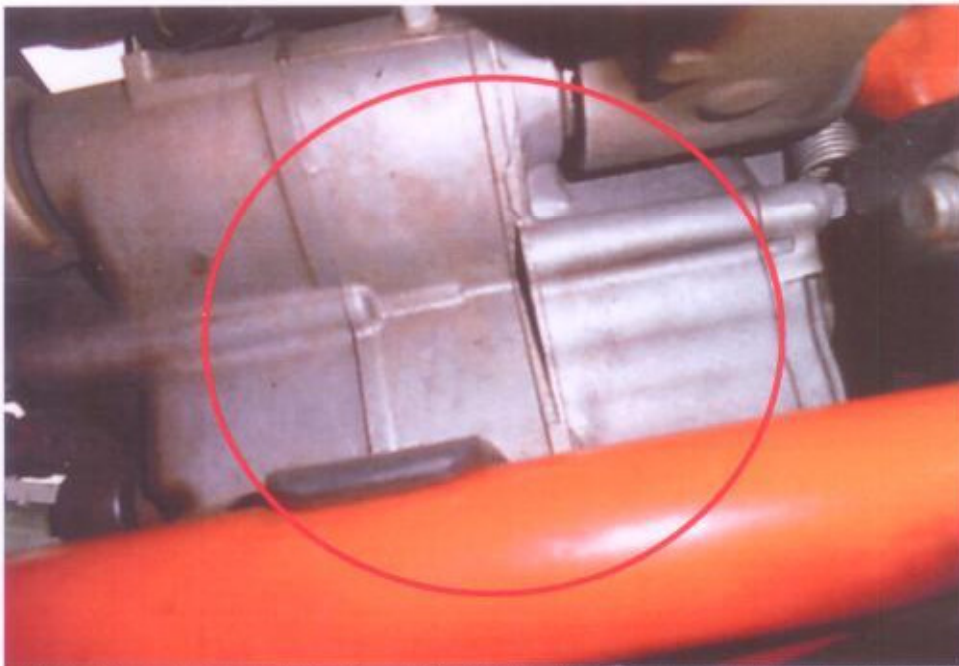
Photo 13 shows no sign(s) or indication(s) of fluid leak observed around the underside of the engine area of the Motorcycle.

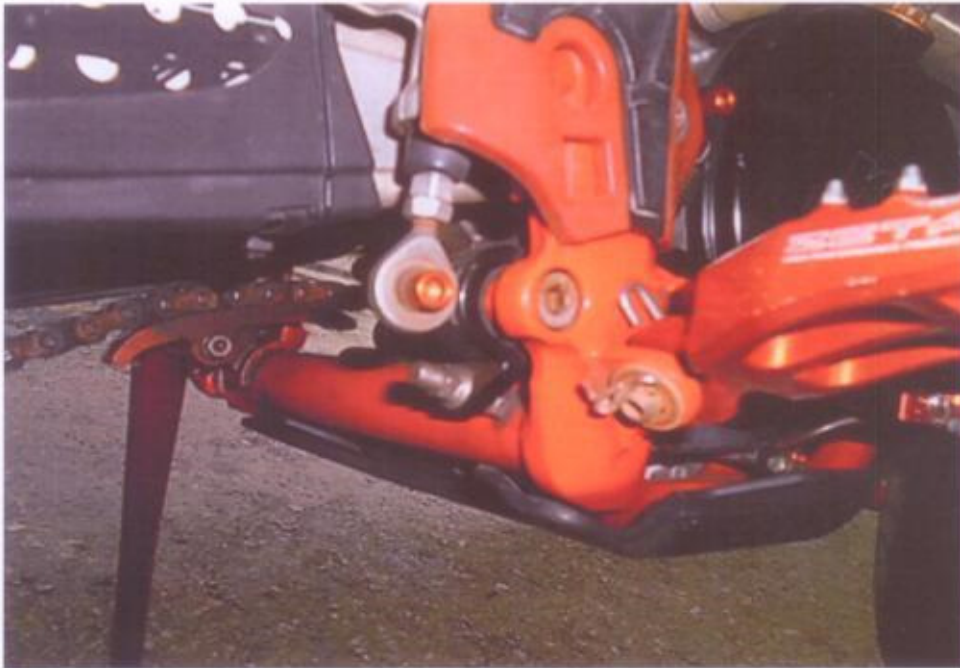
Photo 14 shows no sign(s) or indication(s) of fluid leakage stain observed around the right side of the engine area of the Motorcycle.

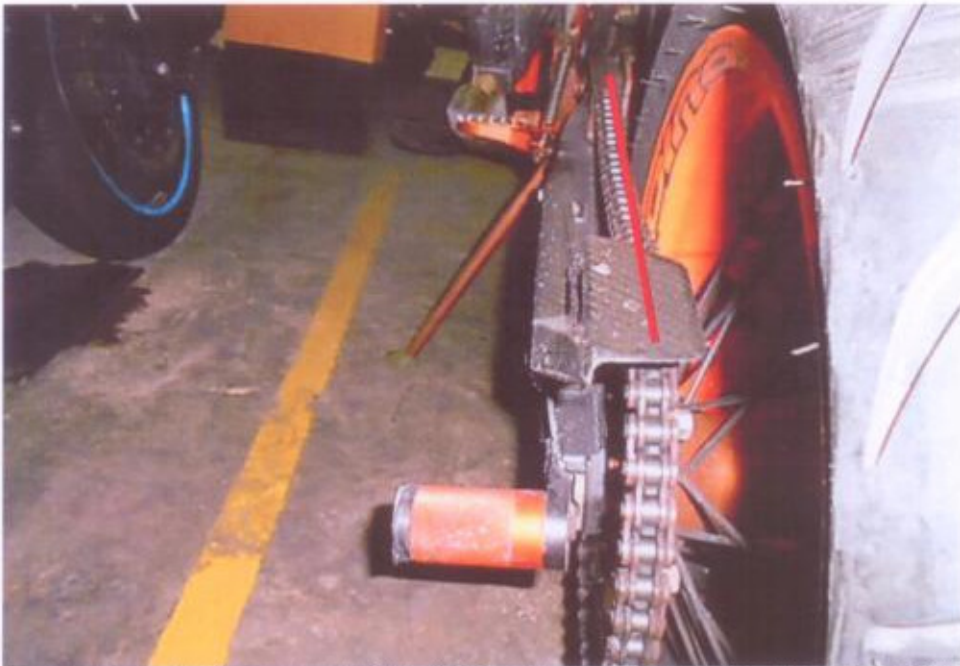
Photo 15 shows the general view of the gear train (arrowed) of the Motorcycle, which was observed to be intact with no misalignment. It was also adequately lubricated for operating purposes.

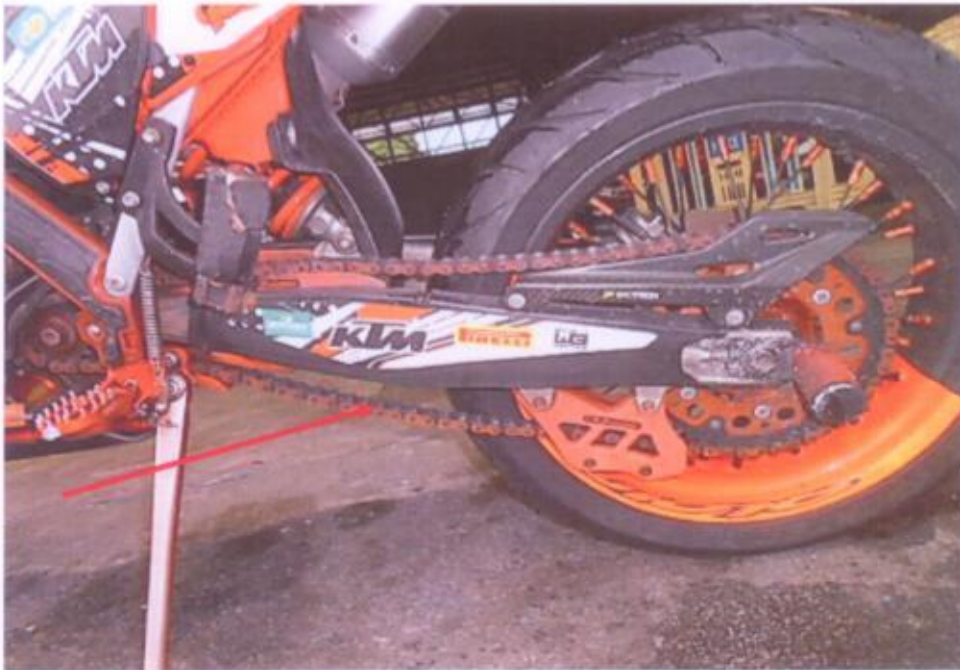
Photo 16 shows the general view of the gear train (arrowed) of the Motorcycle, which was observed to be intact with no misalignment. It was also adequately lubricated for operating purposes.

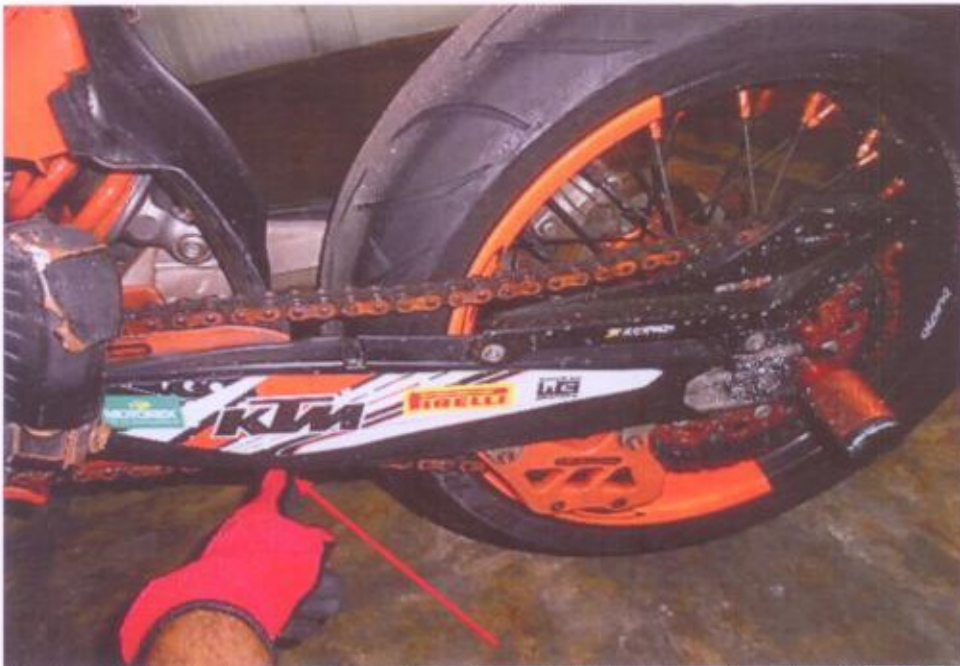
Photo 17 shows the general view of the gear train (arrowed) of the Motorcycle, which was observed to be intact with no misalignment. It was also adequately lubricated for operating purposes. Free play tension was also observed & found adequately acceptable.

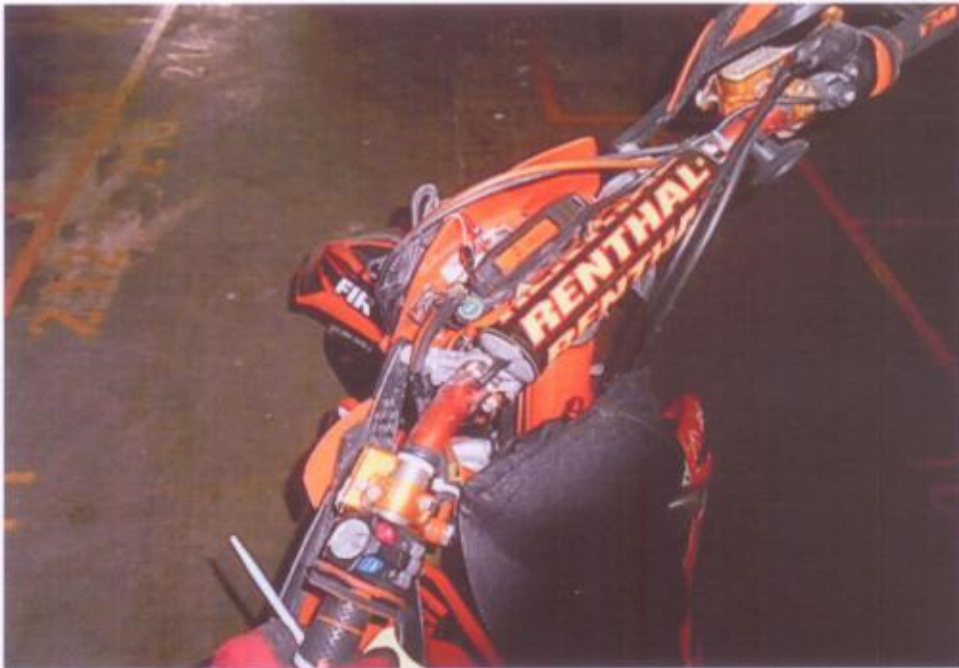
Photo 18 shows the steering system was observed to be in a serviceable condition. It was able to be steered to the full left & right at time of our inspection.

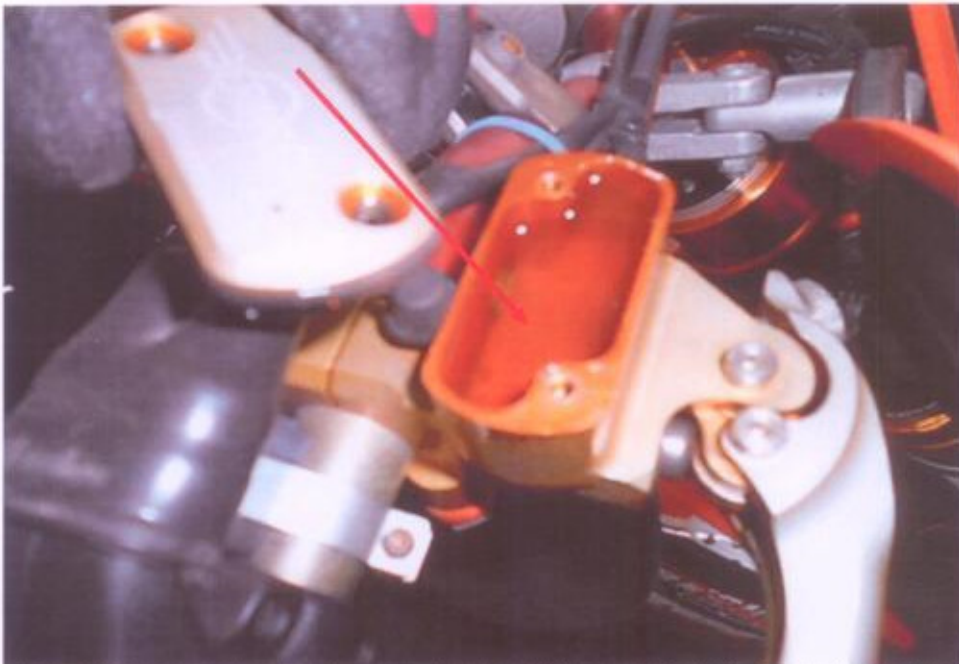
Photo 19 shows our checks on the brake fluid reservoir had also indicated that the brake fluid was of sufficient level for operational purposes, and without contamination.

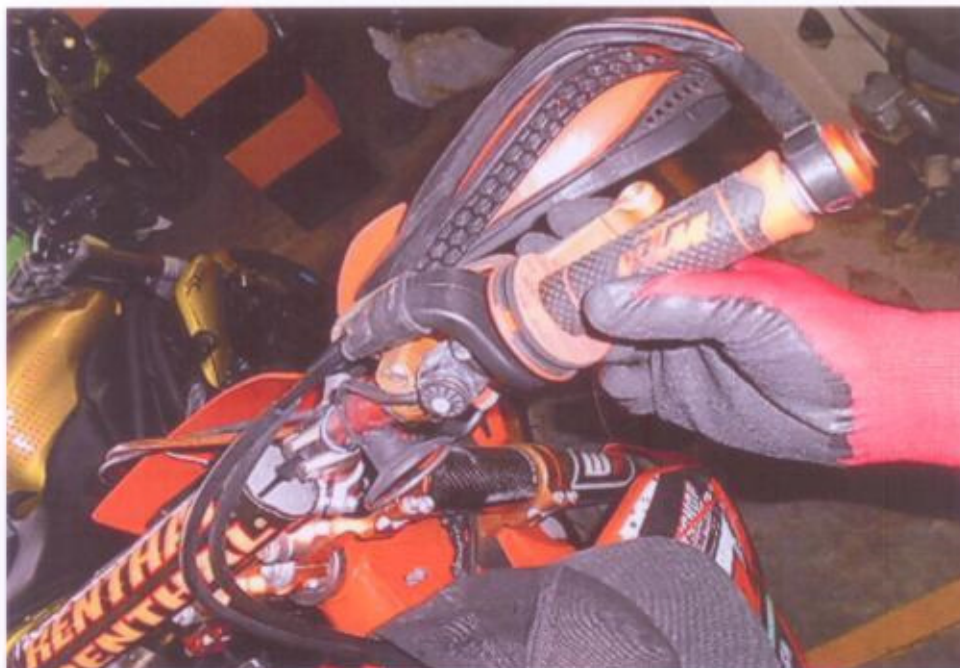
Photo 20 shows testing of the braking of the front brake in progress. There was some resistance felt (spongy like feel) upon pressing the brake lever.

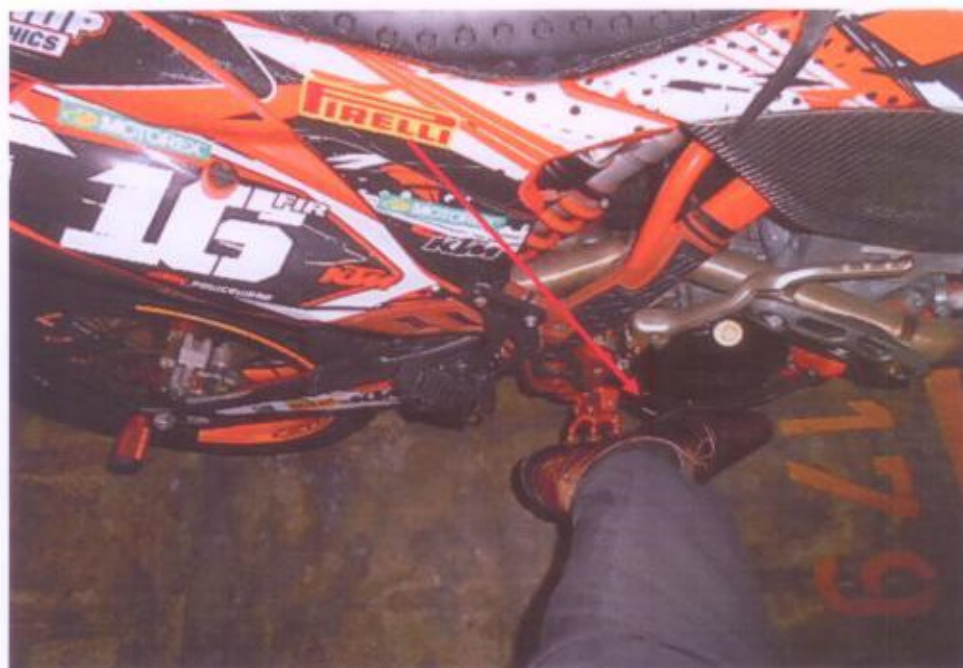
Photo 21 shows testing of the braking of the rear brake in progress. There was some resistance felt (spongy like feel) upon stepping on the brake pedal.
