| Affiliated to Federation Internationale Des Experts En Automobile | | | | |
|---|---|---|---|---|
| FIRST CAPITAL INSURANCE LTD | | | Ref : CS/FCI17023341/Kvb | |
| Insured Veh. | SHC 7493D | | Veh. Inspected | SKR 515G |

**INITIAL INSPECTION REPORT OF VEHICLE NO. SKR 515G**

### ADJUSTMENT ON REPAIR COST FOR VEHICLE NO. SKR 515G

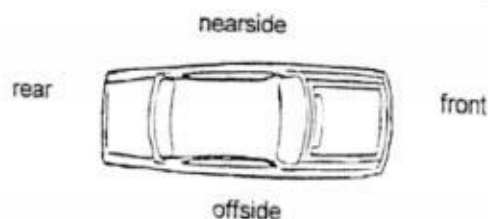
**Description of Damage:**

The vehicle sustained damages at the rear and front portion

**Comments/Present Status:**  
Damages Consistent
