Your Ref: E/20171109/0020  
Our Ref : CI/SPF17023355/D

11 December 2017

**DAMAGE CONSISTENCY REPORT OF PERIMETER WALLS OF 2  
RESIDENTIAL UNITS ALONG JALAN BAHAGIA**

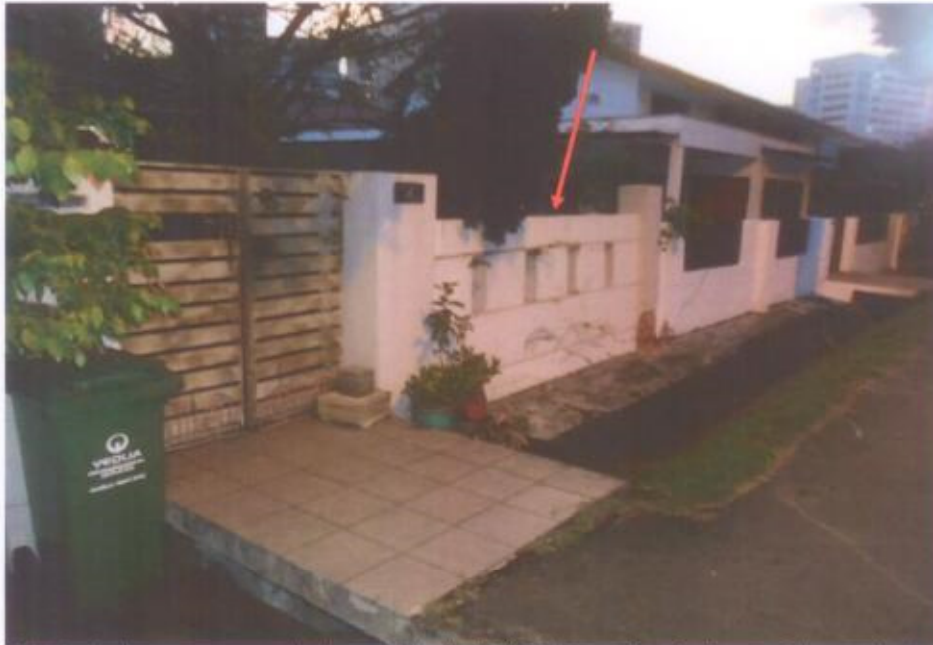
**Photo 1** shows a general view of Block 45 #01-192 Jalan Bahagia. The perimeter wall (arrowed) towards the left of the unit (from the perspective when standing inside the unit) was observed to have been damaged. The 2 pillars at the right side and left side of the wall, together with the access gate of the unit were also affected.

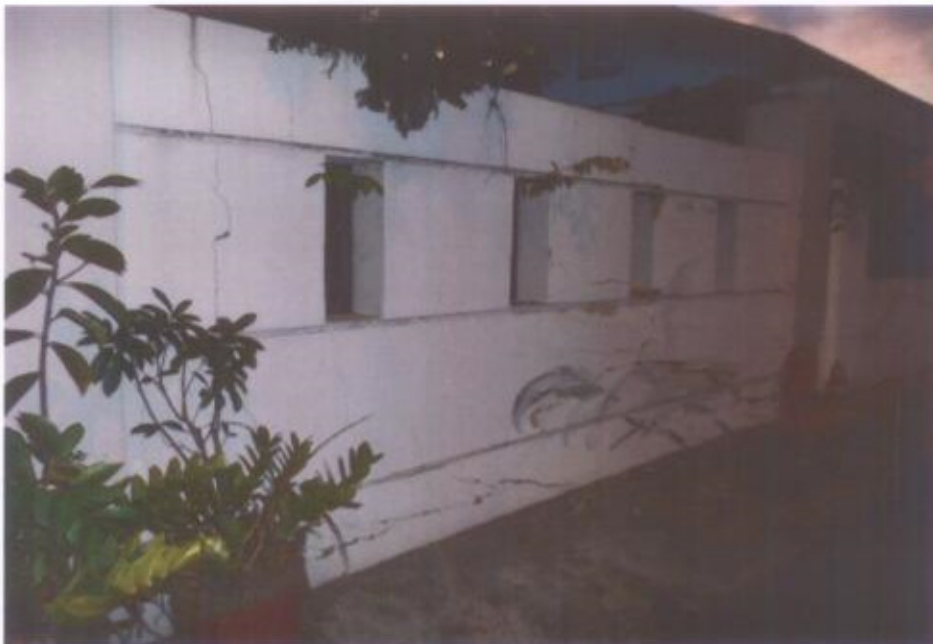
**Photo 2** shows a general view of the damaged perimeter wall of Block 45 #01-192 Jalan Bahagia.

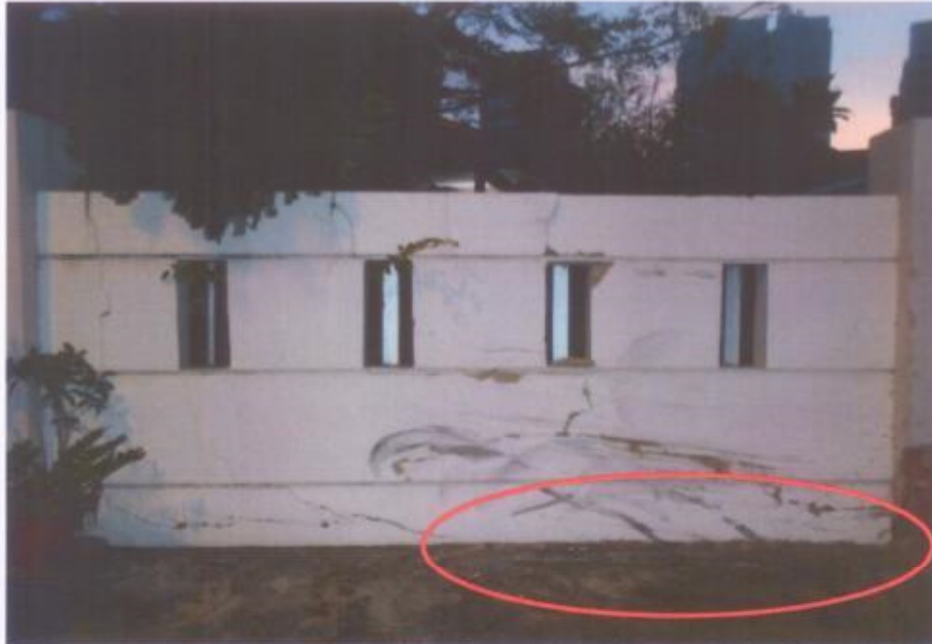
4. The perimeter wall towards the left side of the unit (from the perspective when standing inside the unit) was found to be with multiple crack lines. The crack lines could be found on both the interior side and exterior side of the wall. The base of this wall was observed to be shifted inwards. A section of the wall at the upper part was also separated into 2.

**Photo 3** shows a general view of the damaged perimeter wall of Block 45 #01-192 Jalan Bahagia. The wall was found to be with multiple crack lines. The crack lines could be found on both the interior side and exterior side of the wall. The base of the wall (circled) was also observed to be shifted inwards.

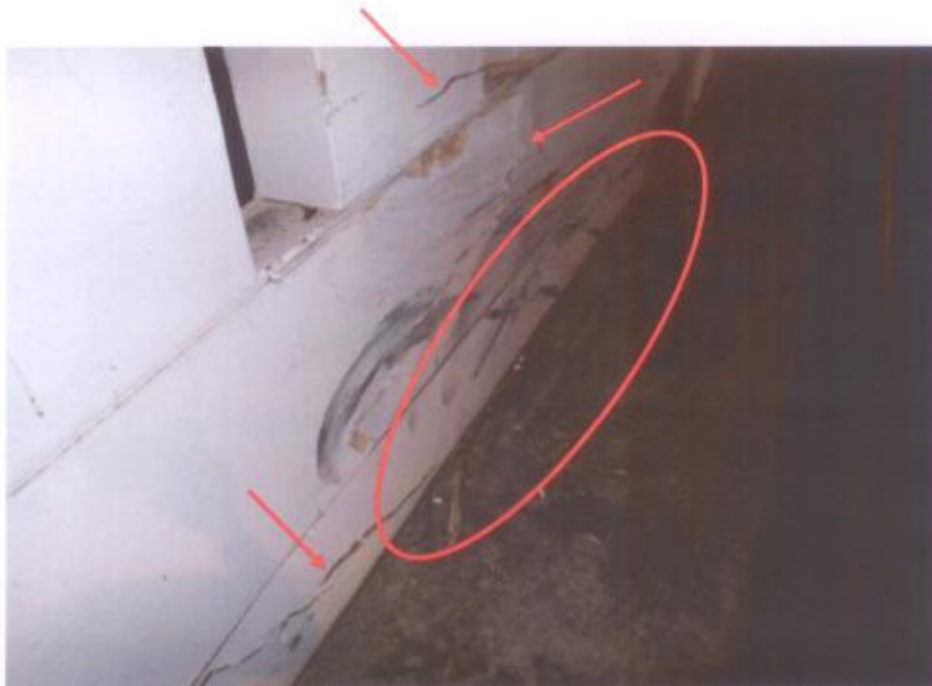
**Photo 4** shows a closer view of the damage to the exterior side of the perimeter wall. Multiple crack marks (arrowed) were seen on the wall. The base of the wall (circled) was also observed to have been shifted inwards.

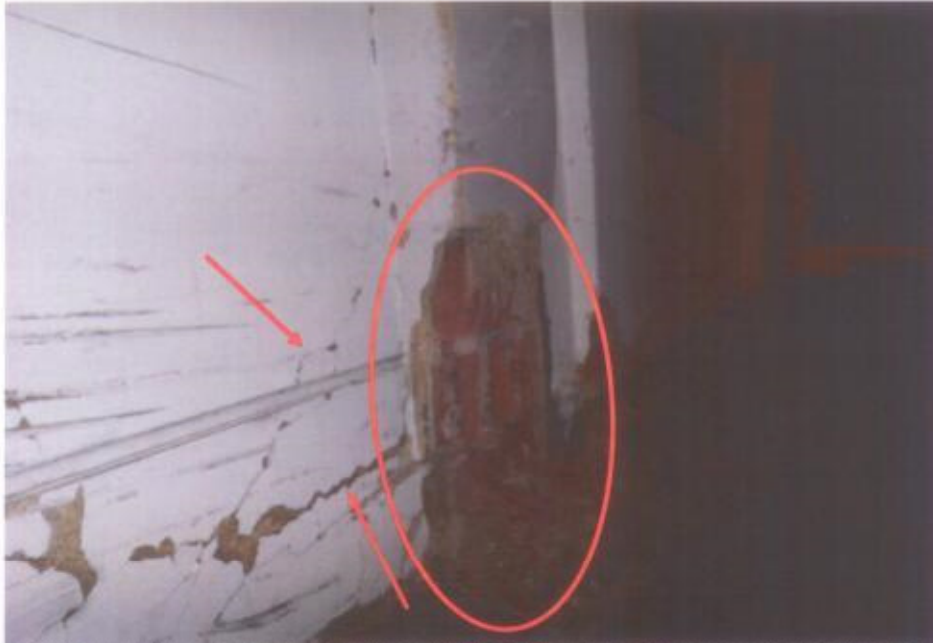
5. The crack lines of the wall, at both the interior side and exterior side, had extended towards the pillars at the end of the left side and right side of the wall. The cement at the base, on the exterior side of the pillar towards the left of the wall, was also observed to be broken, exposing the bricks used to construct the pillar.

**Photo 5** shows the crack lines (arrowed) of the wall extending towards the pillar at the left side of the wall. The cement at the base (circled), on the exterior side of the pillar, was also observed to be broken, exposing the bricks used to construct the pillar.

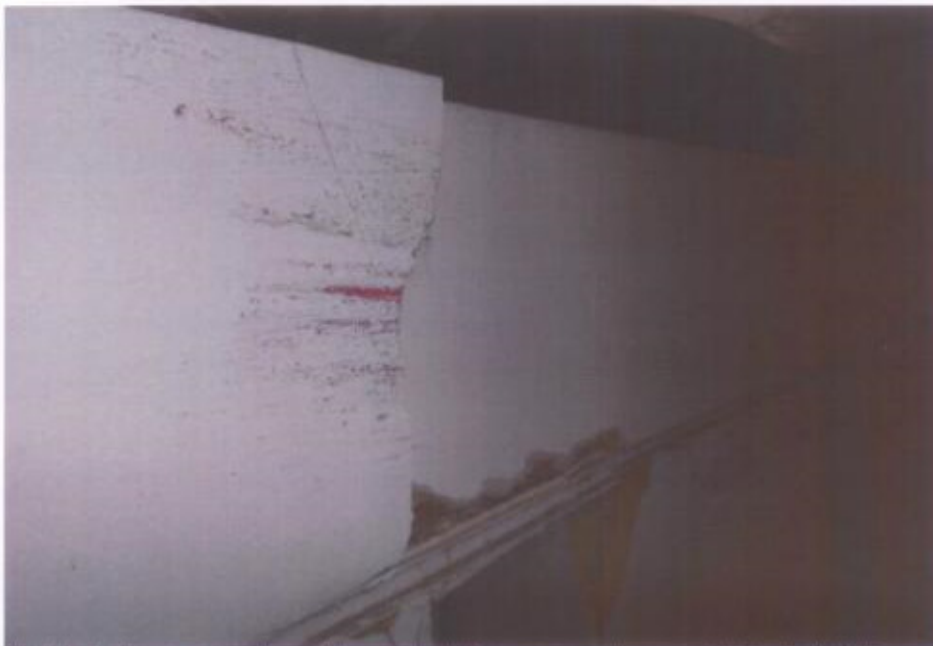
**Photo 6** shows a section of the wall at the upper part separated into 2. This was on the exterior side of the wall.

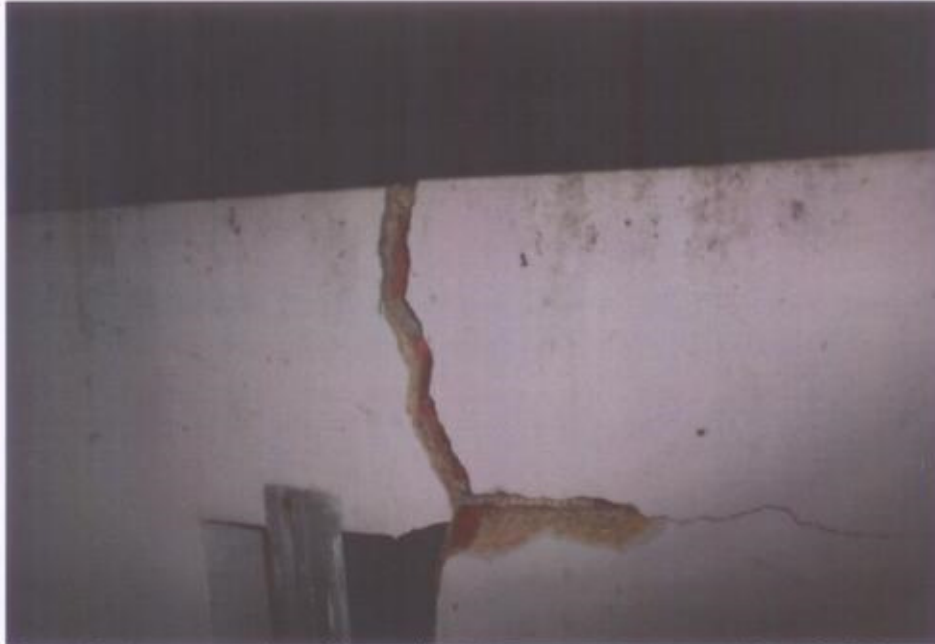
**Photo 7** shows a section of the wall at the upper part separated into 2. This was on the interior side of the wall.

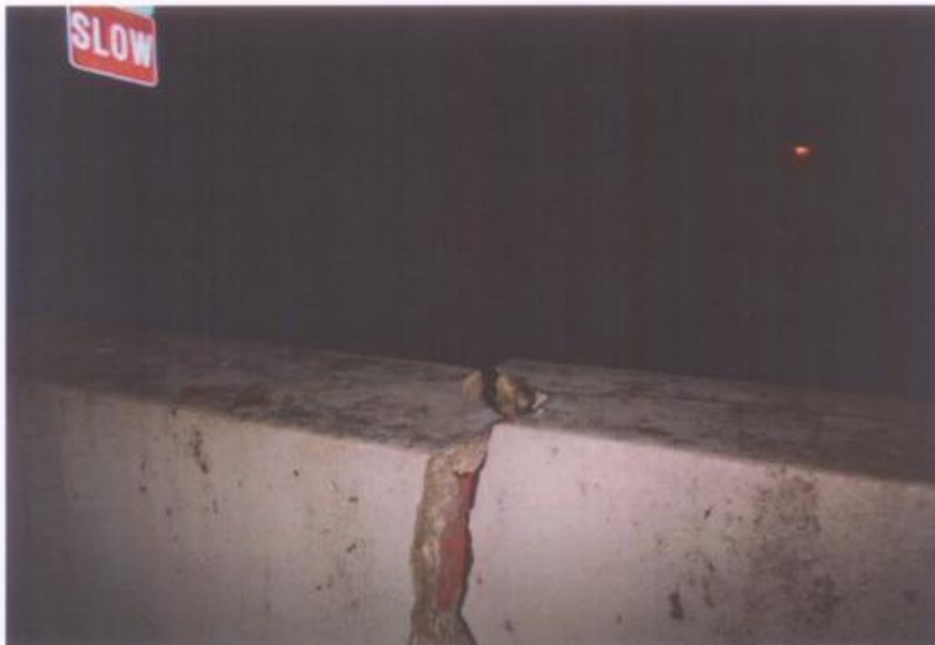
**Photo 8** shows a section of the wall at the upper part separated into 2. This was at the top surface of the wall.

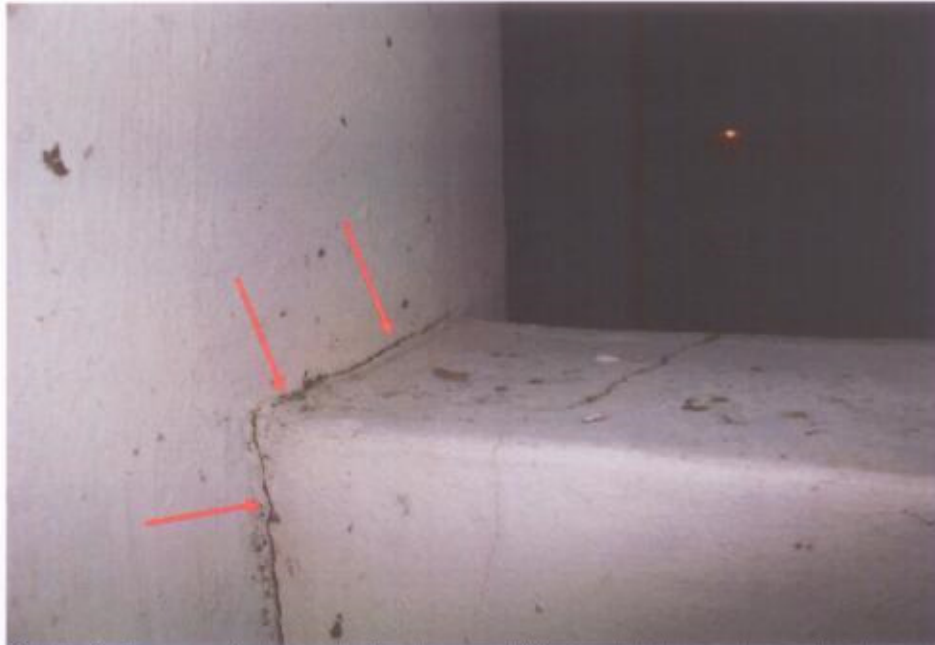
**Photo 9** shows a single crack line (arrowed) formed between the perimeter wall and the pillar that was on the left side of the wall.

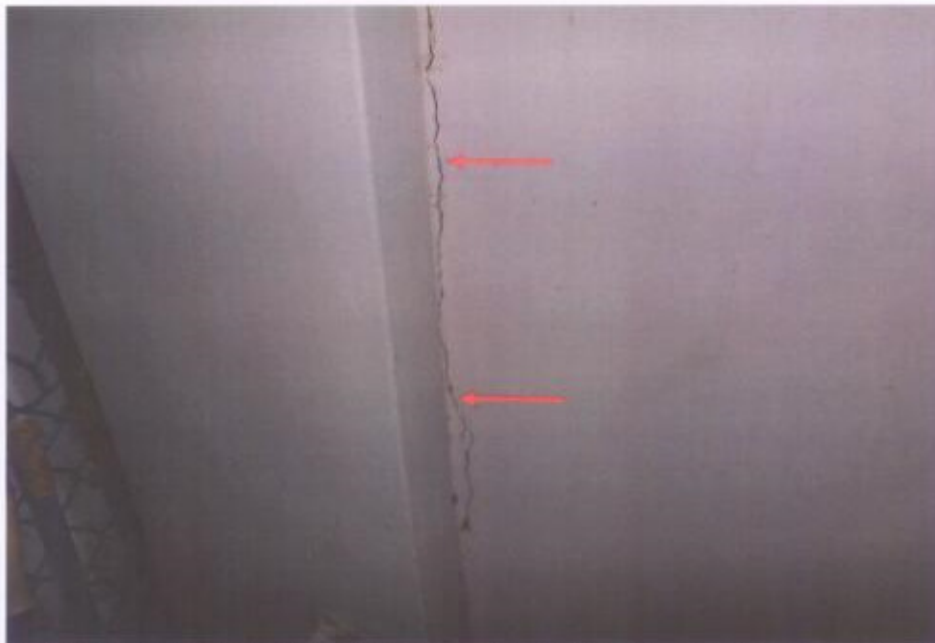
**Photo 10** shows the single crack line (arrowed) formed between the perimeter wall and the pillar at the left side of the wall. The crack line was from the top surface extending downwards on the interior side of the wall.

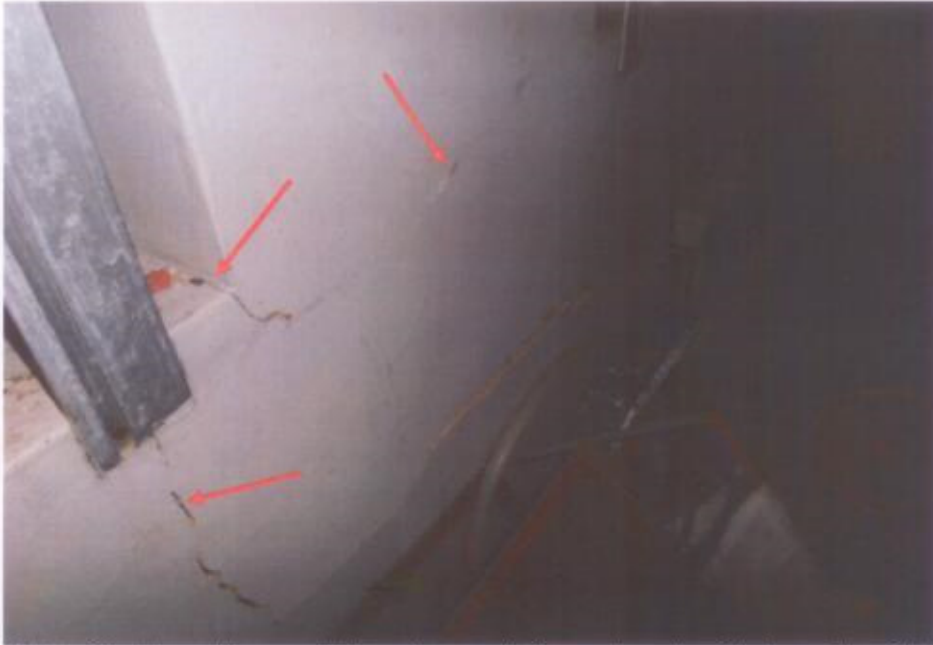
**Photo 11** shows the crack lines (arrowed) formed on the interior side of the perimeter wall. The crack lines were largely traced from the exterior side of the wall extending into the interior side.

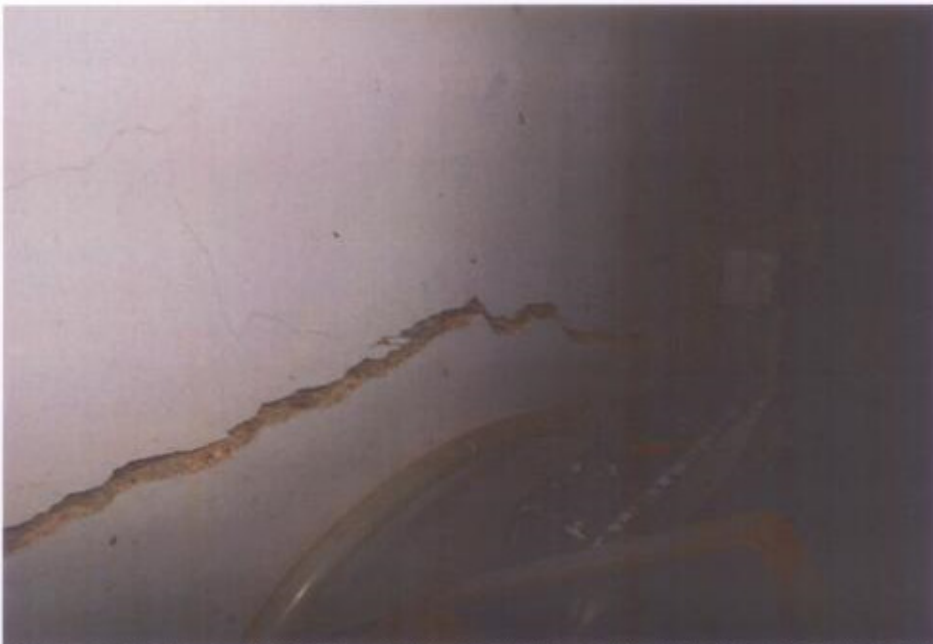
**Photo 12** shows a closer view of the crack line on the interior side of the wall, leading towards the pillar on the right side of the wall.

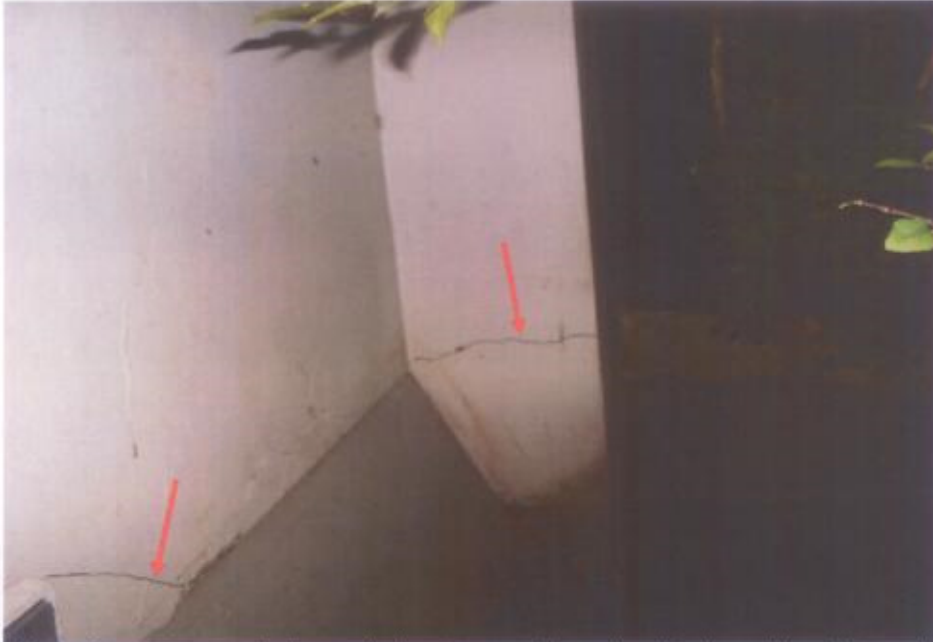
**Photo 13** shows a single crack line (arrowed) on the interior side of the wall, leading towards the pillar on the right side of the wall.

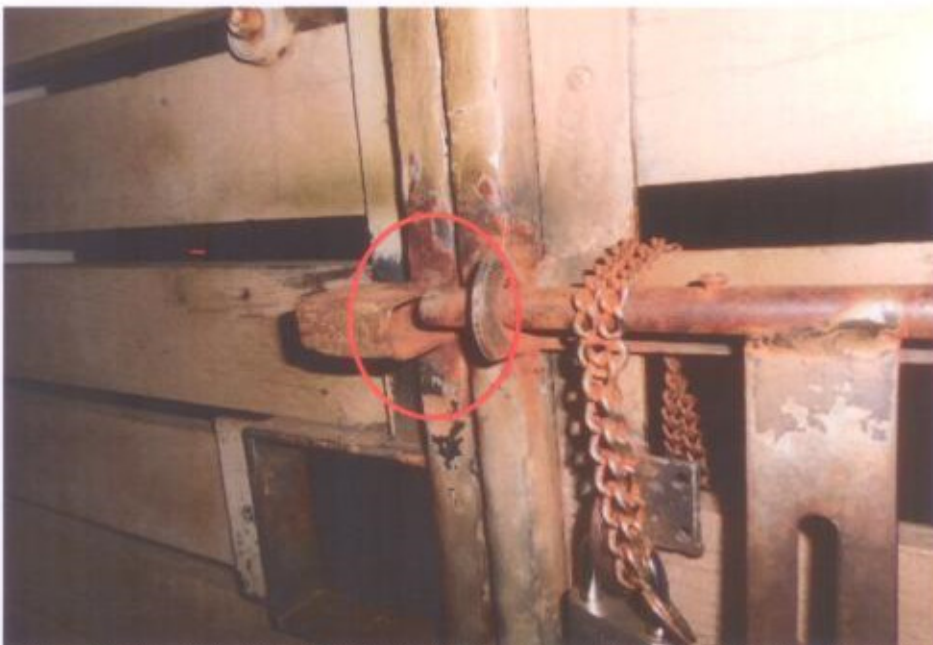
6. The access gate of the unit was unable to be locked as the horizontal holding arm of the gate, which was mounted on the pillar towards the right of the wall, was slightly shifted. The horizontal bolt of the gate could not slide into its lock chamber due to slight misalignment. See photo 1 – 15 below.

**Photo 14** shows the horizontal bolt of the access gate could not slide into its lock chamber (circled) due to slight misalignment. This was a result of the horizontal holding arm of the gate, which was mounted on the pillar towards the right of the wall, being slightly shifted.

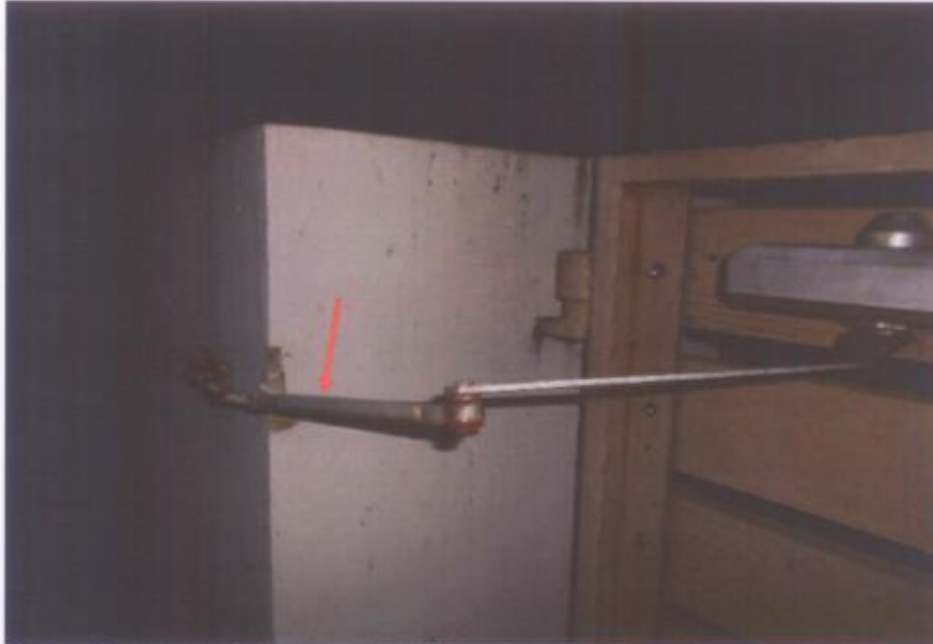
**Photo 15** shows the horizontal holding arm (arrowed) of the gate, which was mounted on the pillar towards the right of the wall. Due to slight shifting of this arm, the horizontal bolt of the access gate could not slide into its lock chamber.

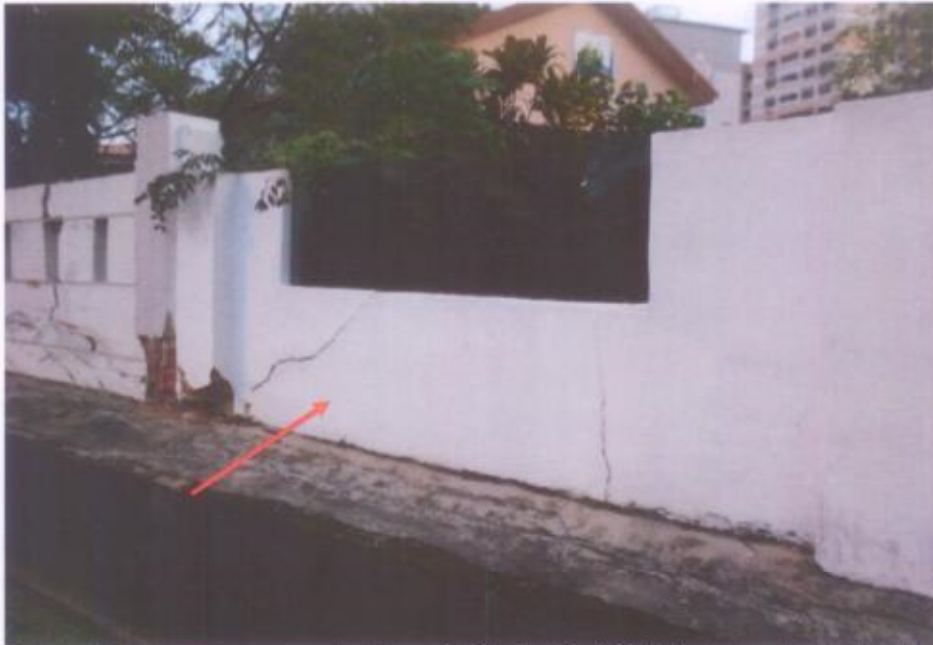
7. The damaged perimeter wall and pillar of this unit was adjacent to the damaged perimeter wall and pillar of Block 45 #01-192. The extent of damage to this wall was however less severe as compared to the wall of Block 45 #01-192.
8. The perimeter wall towards the right side of this unit (from the perspective when standing inside the unit) was found to be with a single crack line on the exterior side, extending over the top surface towards the interior side of the wall. A section of the wall at the upper part towards the top surface was also separated into 2. The glass partition erected at the centre section of this wall was however unaffected.
9. The cement at the base of the pillar towards the right side of the wall was also found to have been broken, exposing the bricks used to construct the pillar. See photo 16 – 23 below.

**Photo 16** shows a general view of Block 46 #01-190 Jalan Bahagia. The perimeter wall (arrowed) towards the right of the unit (from the perspective when standing inside the unit) was observed to have been damaged on its exterior side and interior side. The pillar at the right side of the wall was also affected. The glass partition erected at the centre section of this wall was however unaffected.

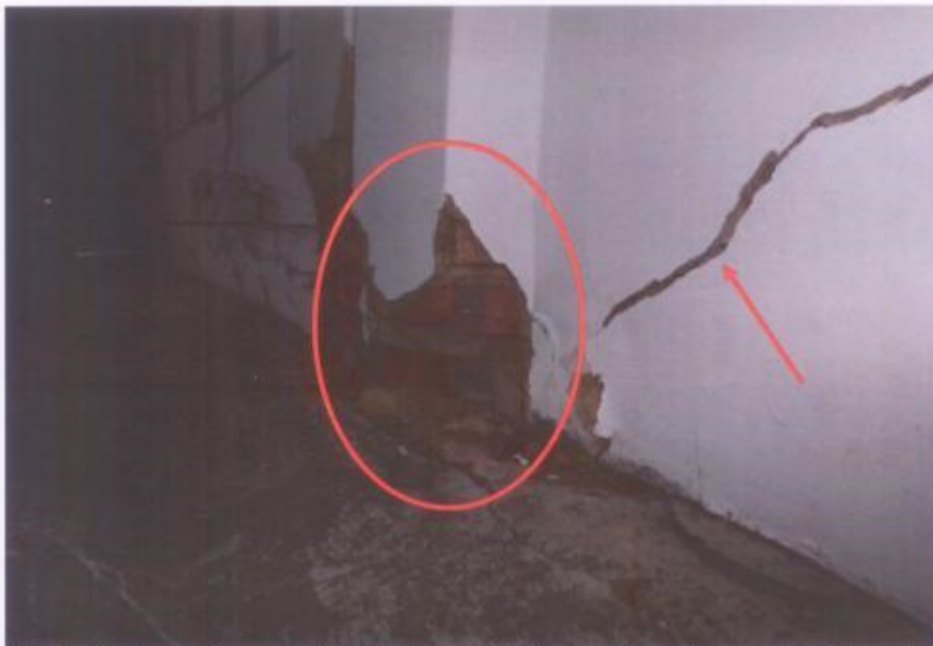
**Photo 17** shows the cement at the base (circled) on the exterior side of the pillar broken, exposing the bricks used to construct the pillar. A single crack line (arrowed) was formed from the pillar extending towards the upper section of the wall.

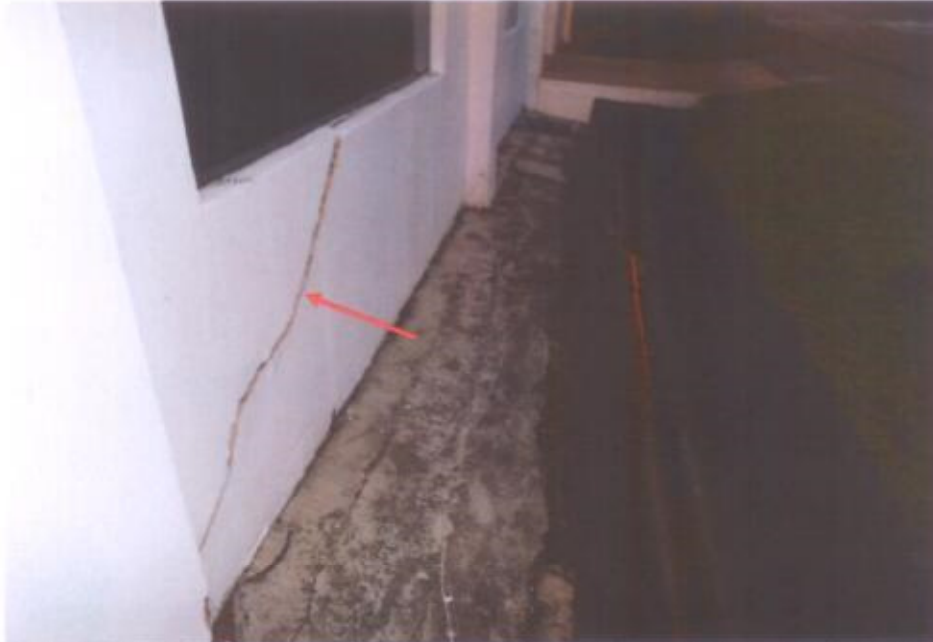
**Photo 18** shows the single crack line (arrowed) on the exterior side of the wall, from the pillar extending towards the upper section of the wall.

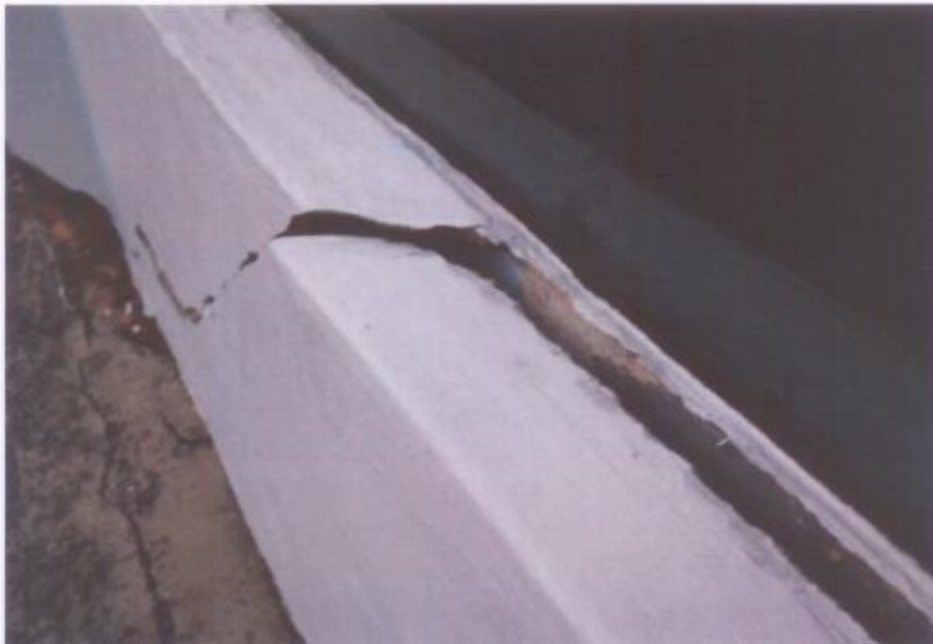
**Photo 19** shows a section of the wall at the upper part and at the top surface, was separated into 2. The glass partition erected at the top surface of this wall was however unaffected.

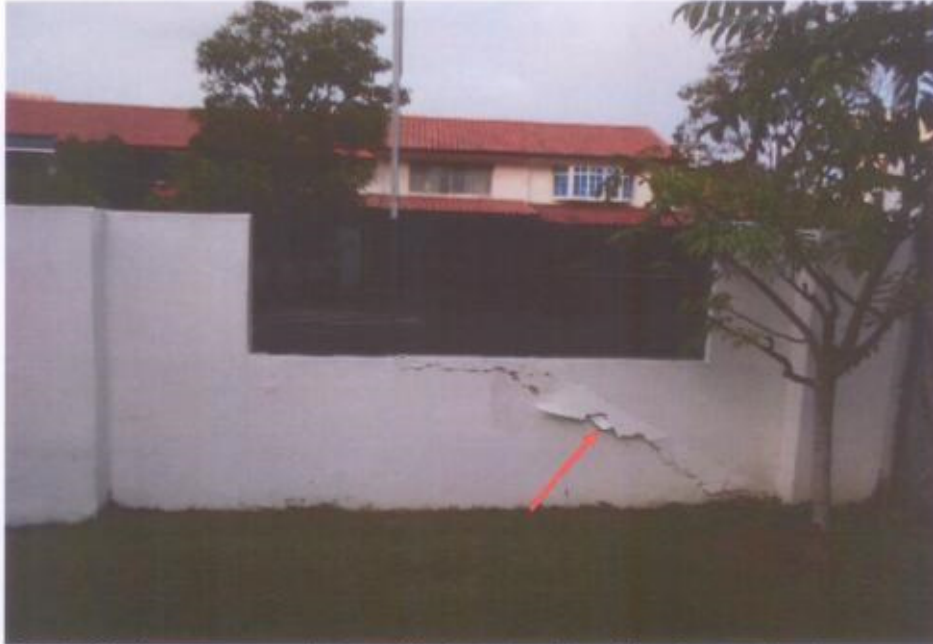
**Photo 20** shows a general view of the interior side of the damaged perimeter wall of Block 46 #01-190 Jalan Bahagia. A single crack line (arrowed) was observed on the interior side from the top surface stretching towards the bottom of the pillar at the right side of the wall.

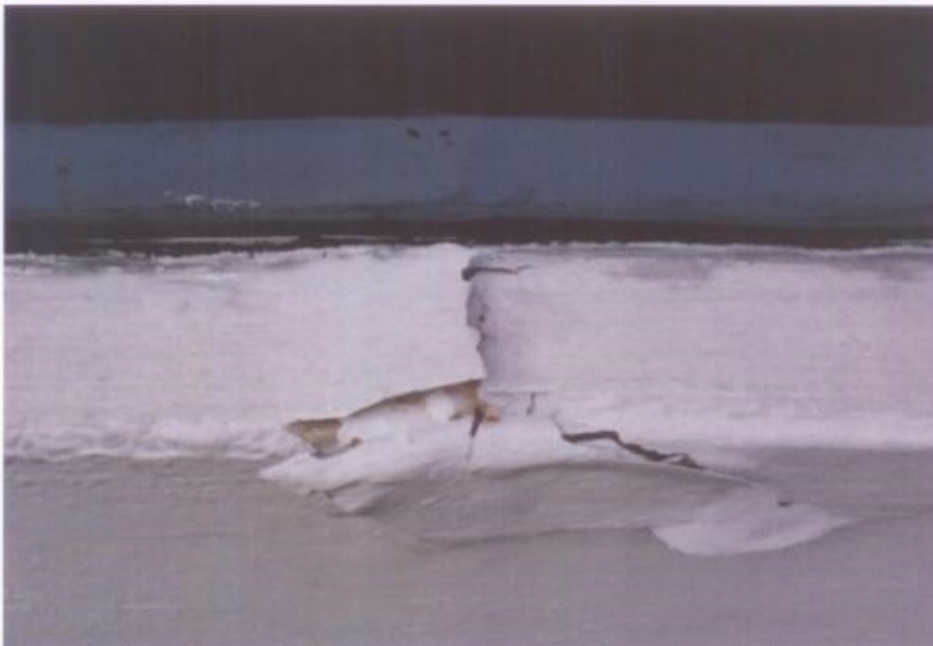
**Photo 21** shows a close up view of the single crack line on the top surface, at the interior side of the wall, stretching towards the bottom of the wall.

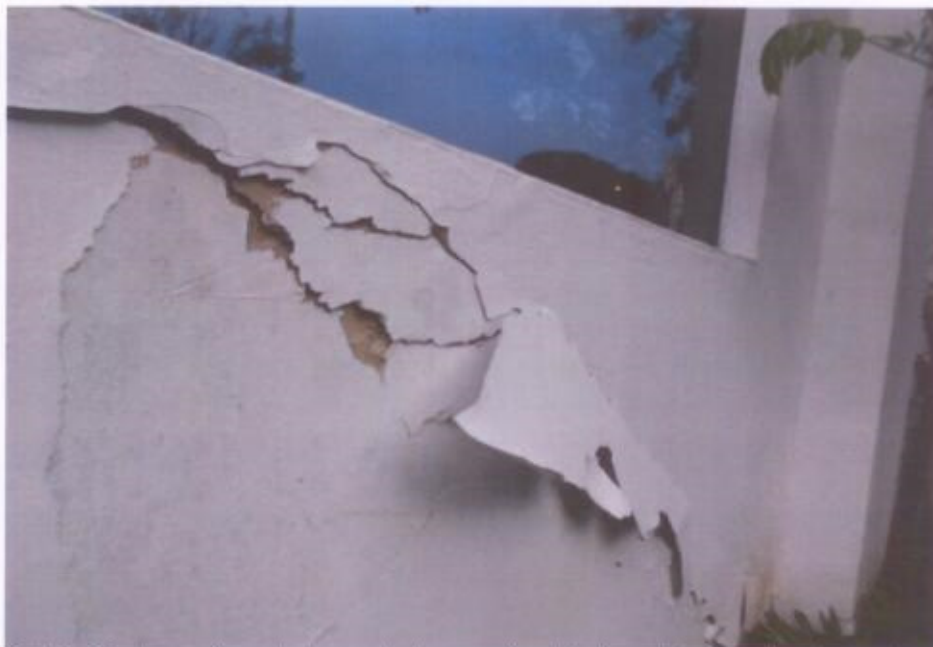
**Photo 22** shows the single crack line on the interior side from the top surface stretching towards the bottom of the pillar at the right side of the wall.

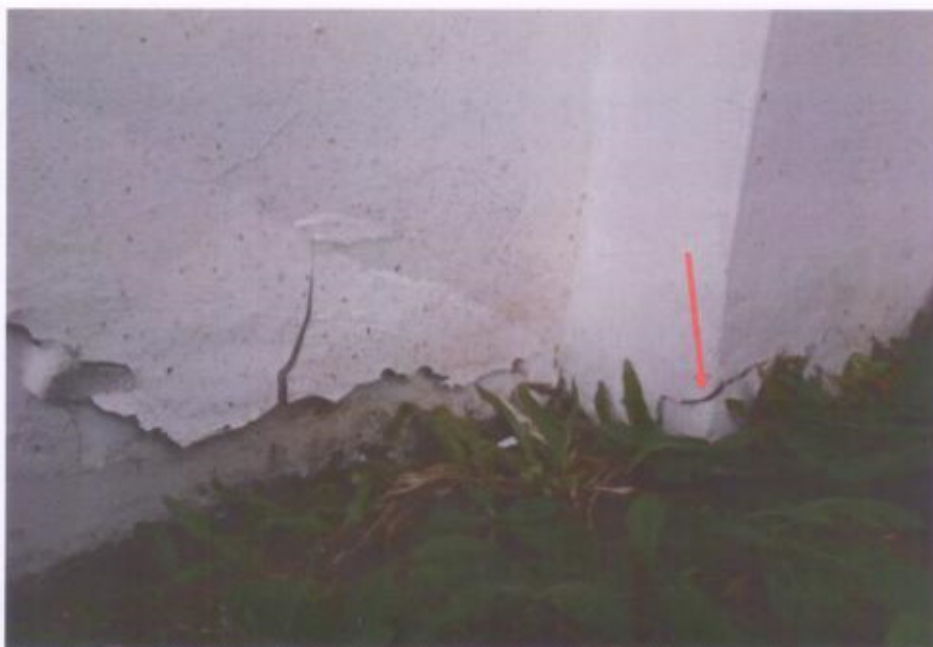
**Photo 23** shows the single crack line on the interior side from the top surface stretching towards the bottom of the pillar (arrowed) at the right side of the wall.
