Your Ref: 9434846195SG-001  
Our Ref : CI/AIG17023412/N

1 December 2017

**TECHNICAL INVESTIGATION REPORT OF FIRE INCIDENT INVOLVING THE  
INSURED VEHICLE SGG 6916Z ON 25 NOVEMBER 2017**

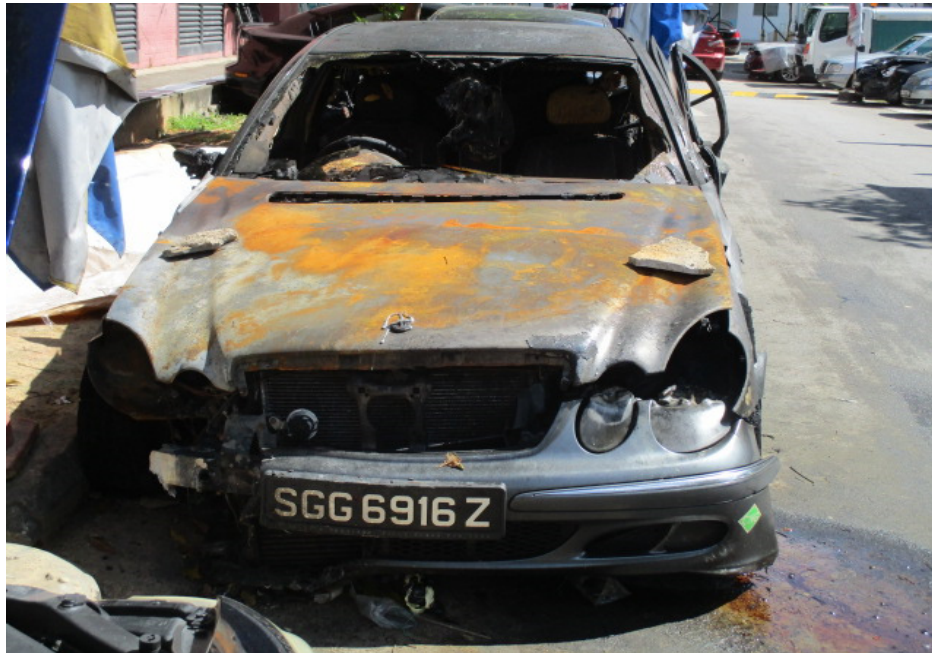
**Photo 1** shows the general view of the front portion of the Insured Vehicle at the time of our inspection. The exterior body of the Insured Vehicle had sustained visible fire damage. This included its front windscreen, front bonnet, headlights, front bumper, front bumper reinforcement panel, side panels, front rims and front tyres.

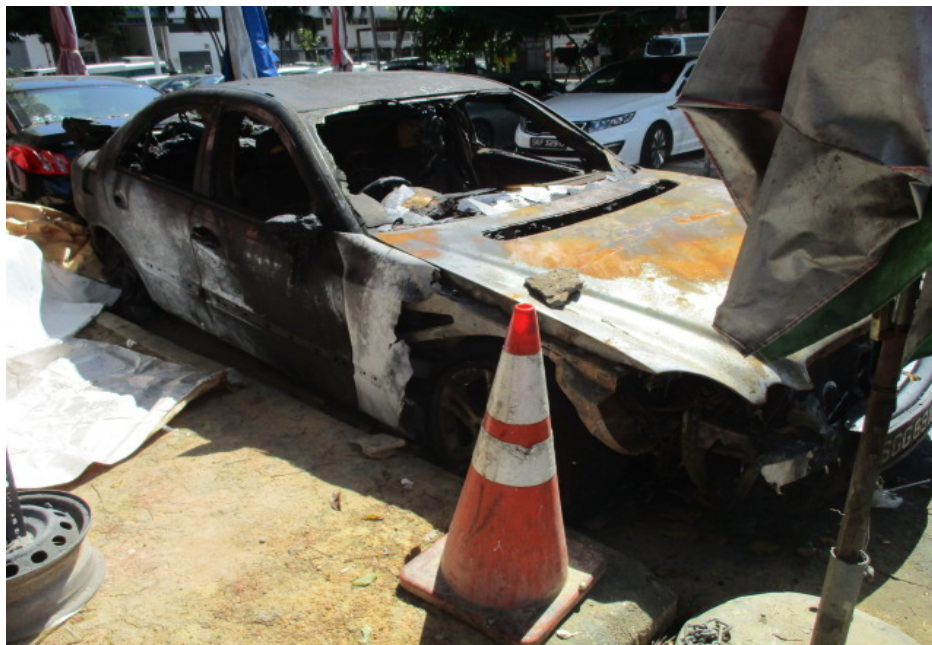
**Photo 2** shows the general view of the right front portion of the Insured Vehicle at the time of our inspection. The exterior body of the Insured Vehicle had sustained visible fire damage. This included its front windscreen, front bonnet, headlights, front bumper, front bumper reinforcement panel, right side panel, front right rim and front right tyre.

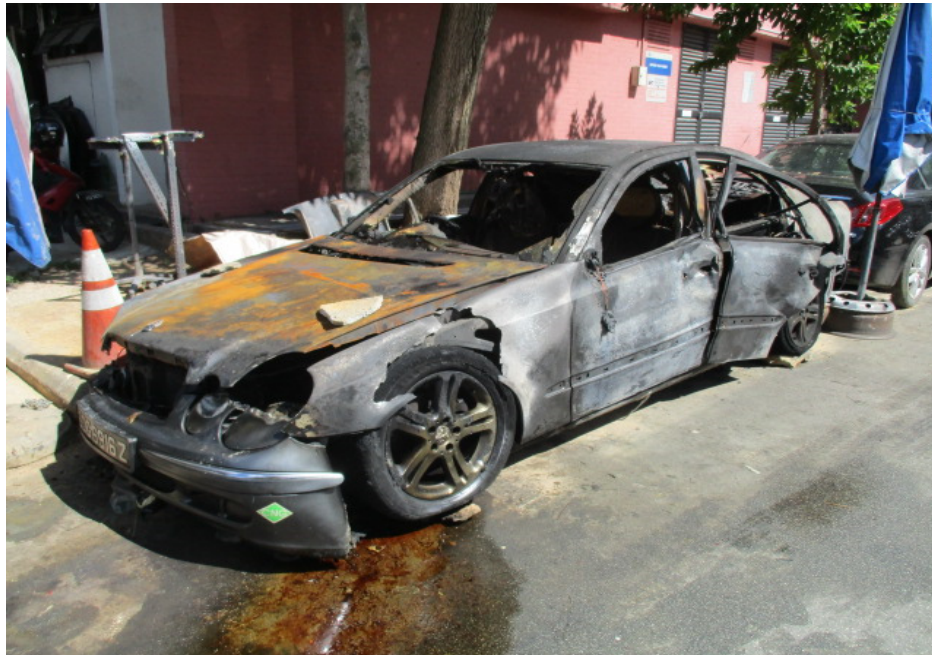
**Photo 3** shows the general view of the left front portion of the Insured Vehicle at the time of our inspection. The exterior body of the Insured Vehicle had sustained visible fire damage. This included its front windscreen, front bonnet, headlights, front bumper, front bumper reinforcement panel, left side panel, front left rim and front left tyre.

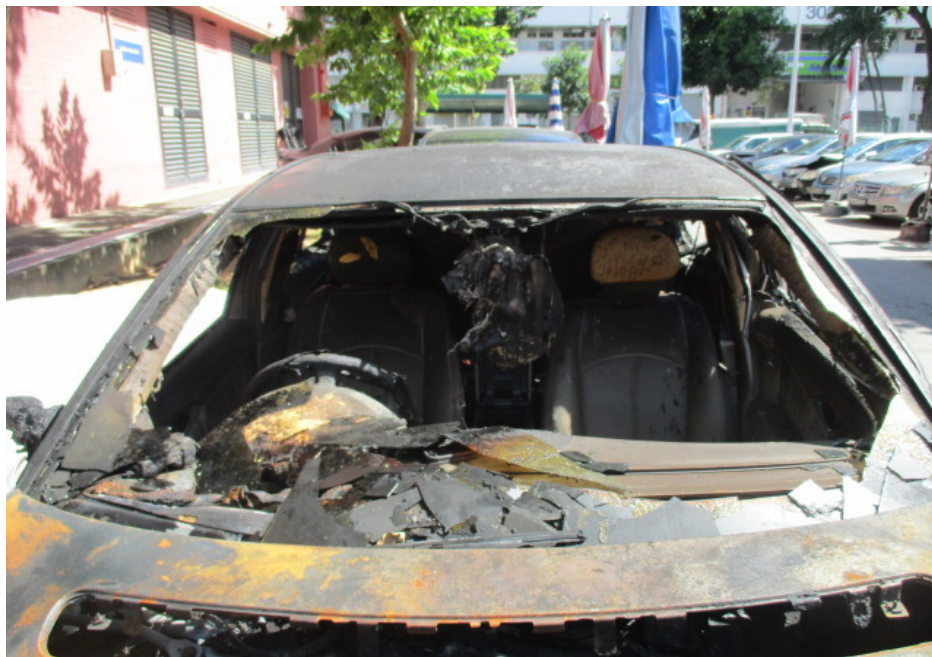
**Photo 4** shows a closer view of the front windscreen of the Insured Vehicle at the time of our inspection. The front windscreen had sustained serious fire damage.

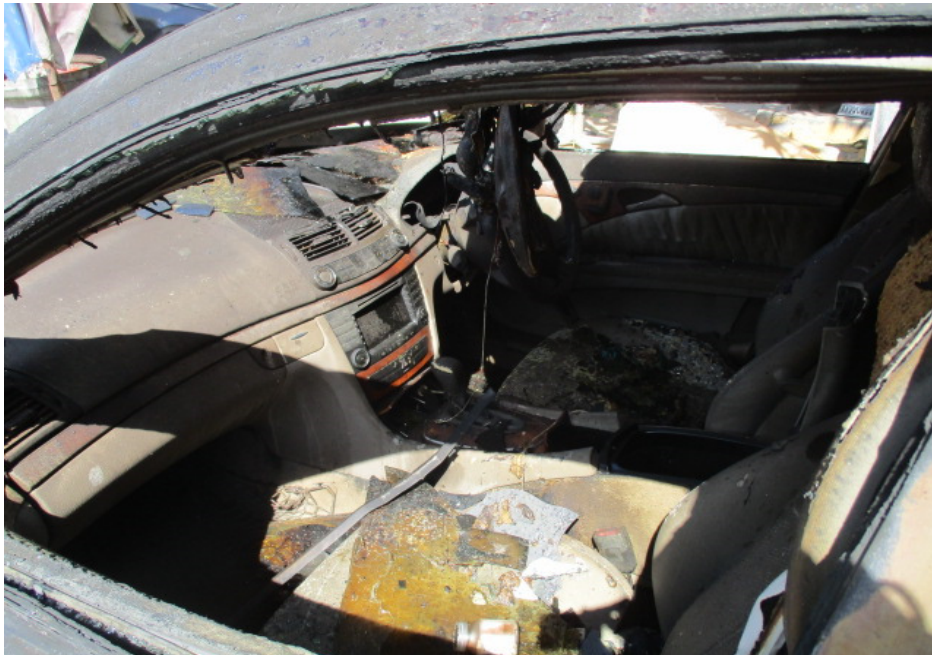
**Photo 5** shows the interior compartment of the Insured Vehicle at the time of our inspection. The interior compartment of the Insured Vehicle was observed to be significantly affected by the fire which included the dashboard, steering wheel, front seats and roof upholstery amongst others.

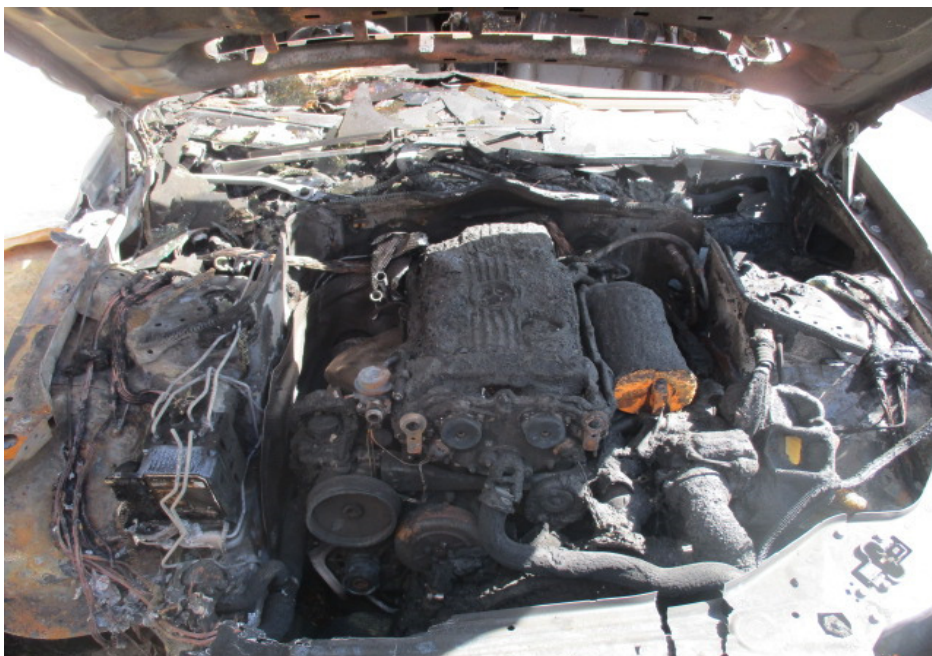
**Photo 6** shows a general view of the engine compartment of the Insured Vehicle at the time of our inspection. Most of the components inside the engine compartment were severely burnt and/or melted as a result of the fire.

8. For this particular case, the fire appears to have originated within the engine compartment of the Insured Vehicle as this was the area where the damage of fire nature was most severe.
9. Upon closer examination of the engine compartment, which was where the fire to the Insured Vehicle had likely started, we had found traces of greenish residue on several stretches of burnt wirings at the rear centre portion. The presence of greenish residue indicates internal heating of copper wires, a sign of an electrical short circuit occurring. The greenish residue is normally left behind from oxidation as a result of chemical reaction involving the copper wires. This physical evidence would then appear to suggest that the cause of fire to the Insured Vehicle could have possibly been due to electrical in nature. See photos 7 - 9 below.

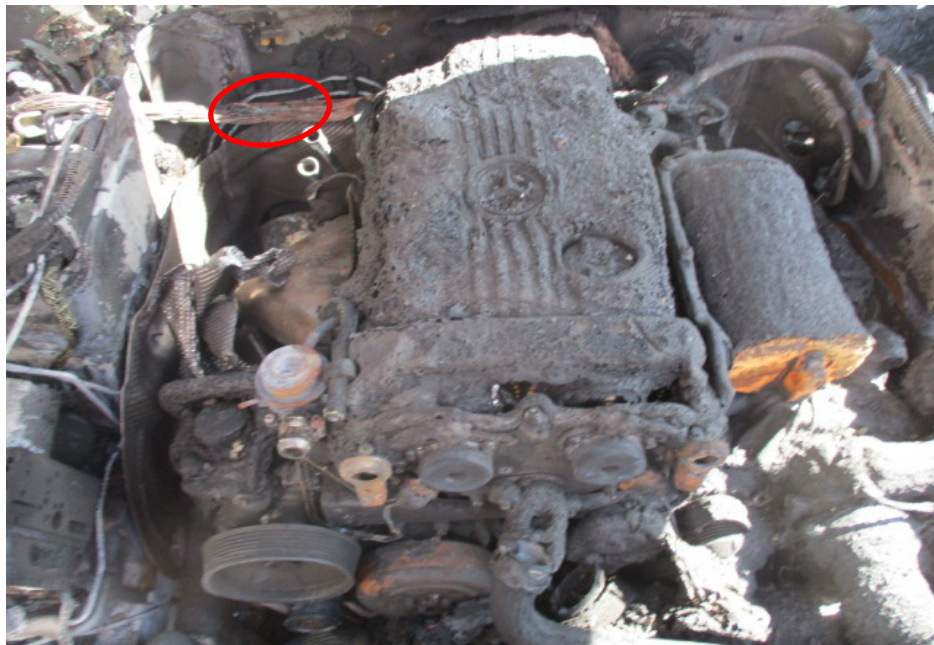
**Photo 7** shows the wirings around the rear centre portion of the engine compartment which is near to the vicinity where the fire to the Insured Vehicle had likely started. We observed greenish residue on some of the wirings (circled). The presence of greenish residue indicates internal heating of copper wires, a sign of an electrical short circuit occurring.

28. The possibility of the fire being due to electrical in nature would then seem more likely given that engine overheating and external factors would both seem unlikely. The fire being due to electrical nature is also supported by the condition of the wirings that were found in the engine compartment of the Insured Vehicle, which was earlier discussed in paragraph 9 above.

30. Having investigated and technically analysed the damages of burnt nature to the Insured Vehicle, we are of the view that the cause of fire to the Insured Vehicle was of electrical in nature. For this particular case, the fire had originated along the wirings inside the engine compartment, somewhere around the rear centre portion. The wirings were original factory wirings of the Insured Vehicle.

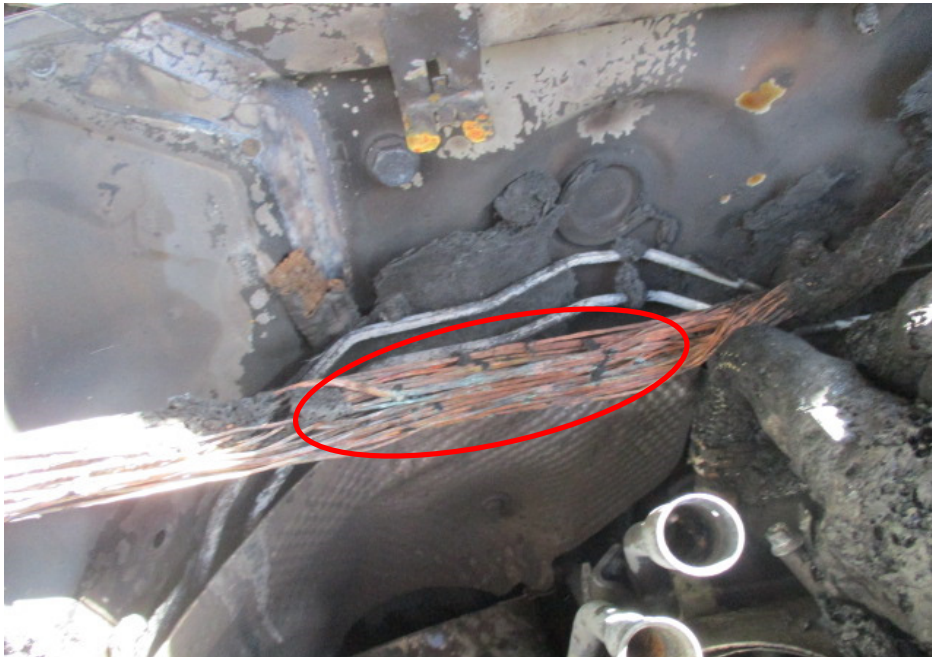
**Photo 8** shows a closer view of the greenish residue found on the wirings (circled) at the rear centre portion of the engine compartment. The presence of such greenish residue suggests occurrence of an electrical short circuit.

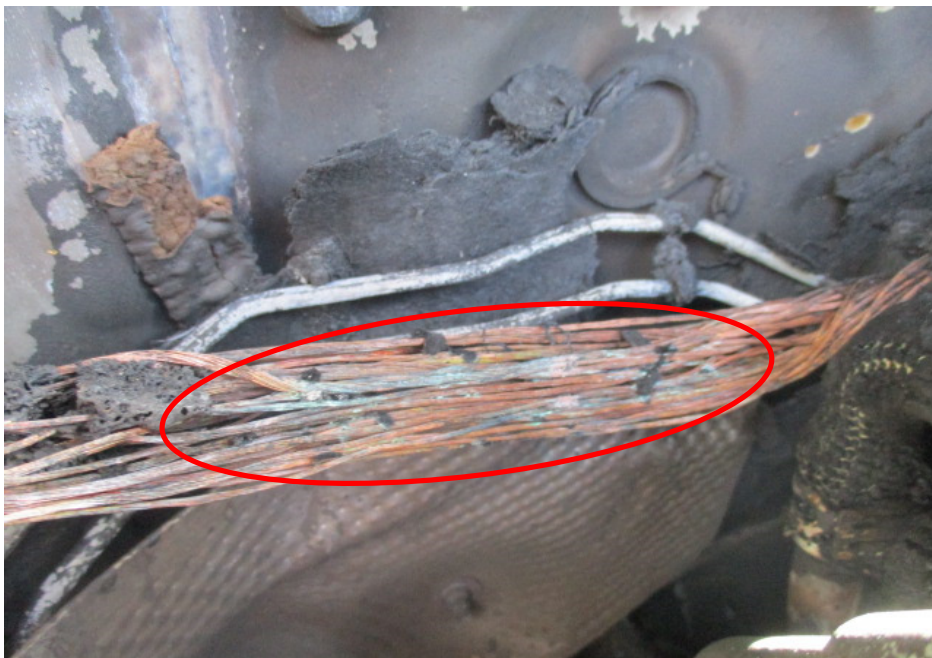
**Photo 9** shows a close up view of the greenish residue found on the wirings (circled) at the rear centre portion of the engine compartment. The presence of such greenish residue suggests occurrence of an electrical short circuit.

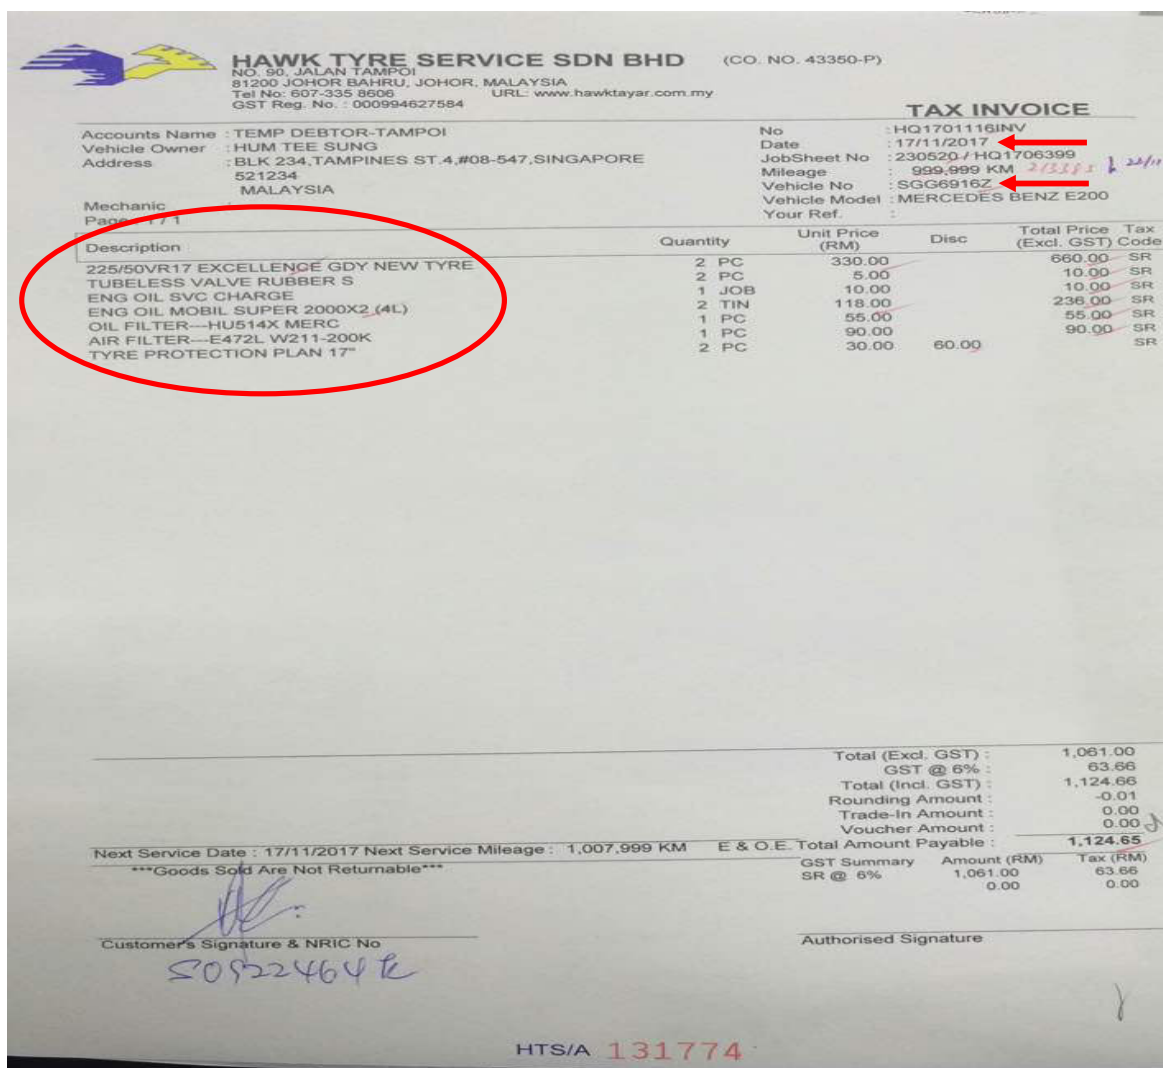
**Invoice 1** shows the latest servicing done on the Insured Vehicle on 17 November 2017 at Hawk Tyre (red arrows). The servicing package included the changing of engine oil, oil filter and air filter. Mr Hum also had the front tyres and the front tyre tube valve rubbers replaced (circled).

25. Based on the vehicle service record invoice provided, we are of the opinion that it is unlikely that the fire could have been caused by poor maintenance of the Insured Vehicle.
26. Given the circumstances of the incident as reported, the possibility of the cause of fire to the Insured Vehicle being due to engine overheating would seem unlikely as Mr Hum had mentioned to us there were no indications of abnormally high temperatures on the Insured Vehicle when he was driving on the day of the incident.

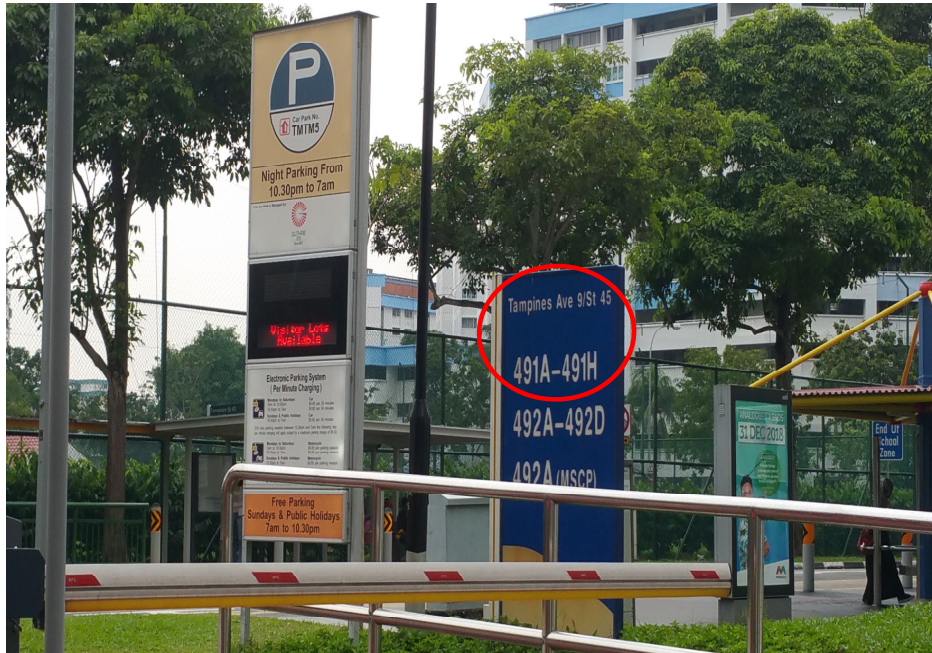
**Photo 10** shows the entrance of Block 491H located at Tampines Street 45 (circled).

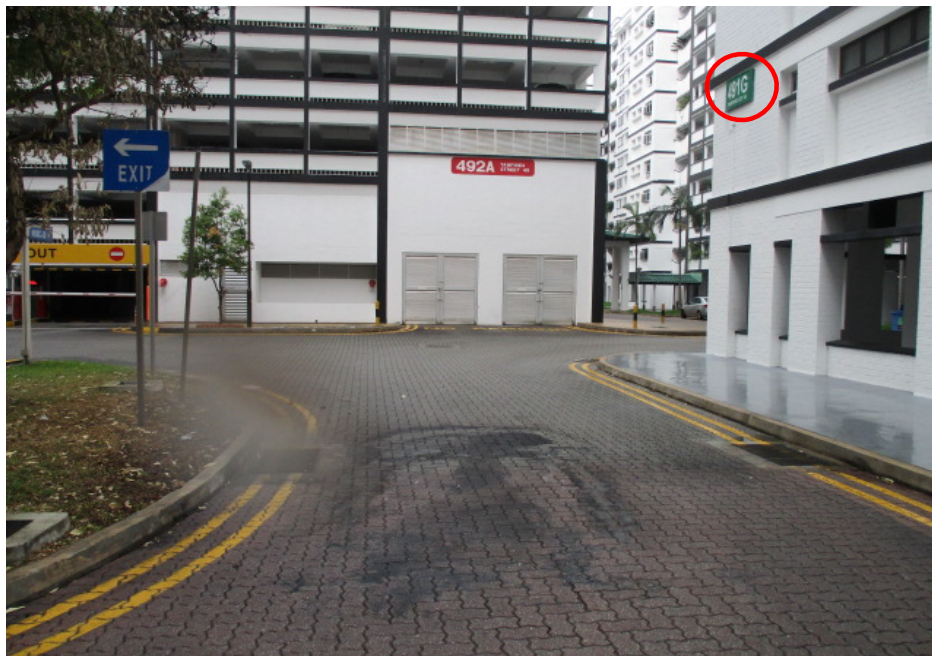
**Photo 11** shows the service road in between blocks 491G (circled) and 491H where the Insured Vehicle was positioned when the incident occurred.

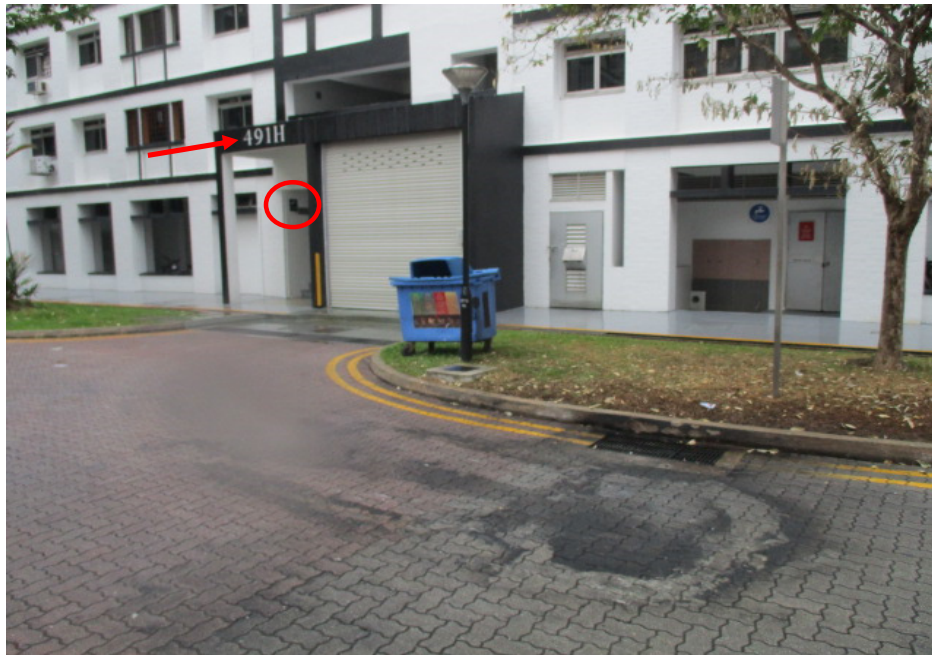
**Photo 12** shows the service road in between blocks 491G and 491H (arrowed) where the Insured Vehicle was positioned when the incident occurred. There is a police camera affixed at the lift lobby of Block 491H (circled).

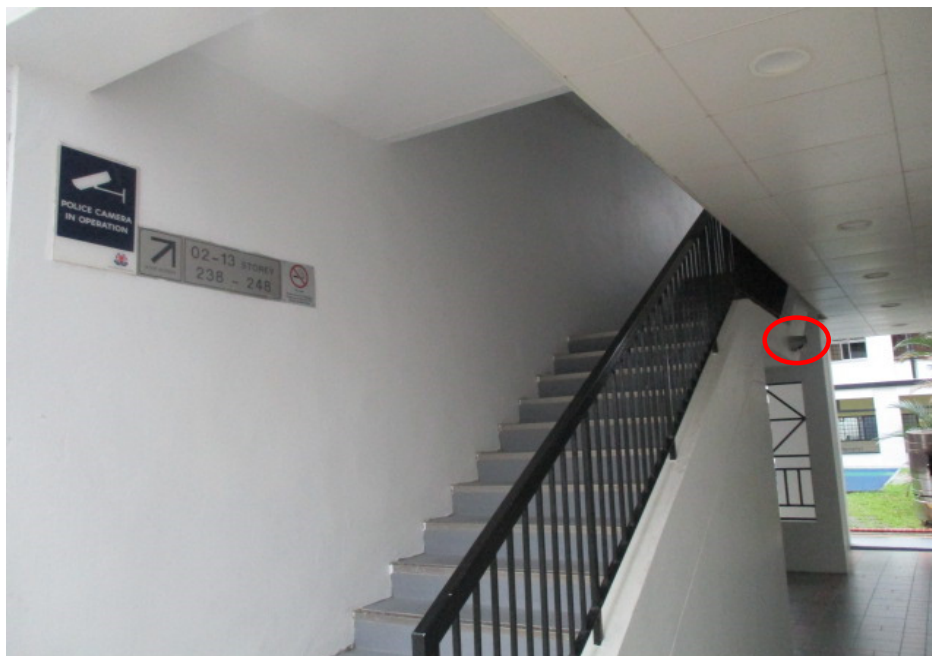
**Photo 13** shows a closer view of the police camera affixed at the lift lobby of Block 491H (circled). However the view of the camera is blocked by a wall. The Insured Vehicle was positioned behind the wall at the time of the incident. Hence the camera would have been unable to record any footage of the incident from that angle.

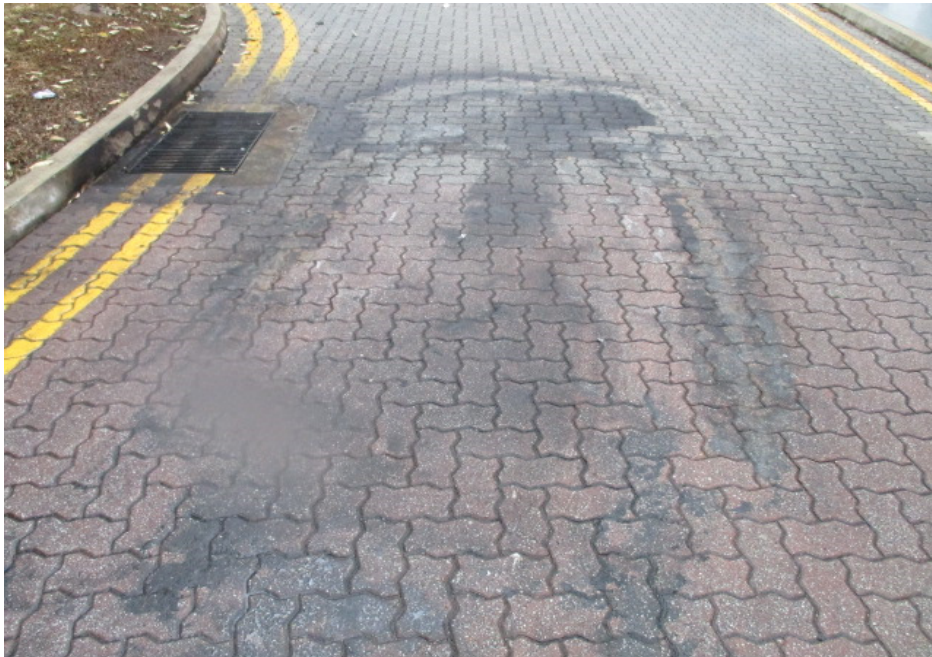
**Photo 14** shows a close up view of the burnt marks and/or burnt residual remains on the ground where the Insured Vehicle was positioned at the time of incident (circled).

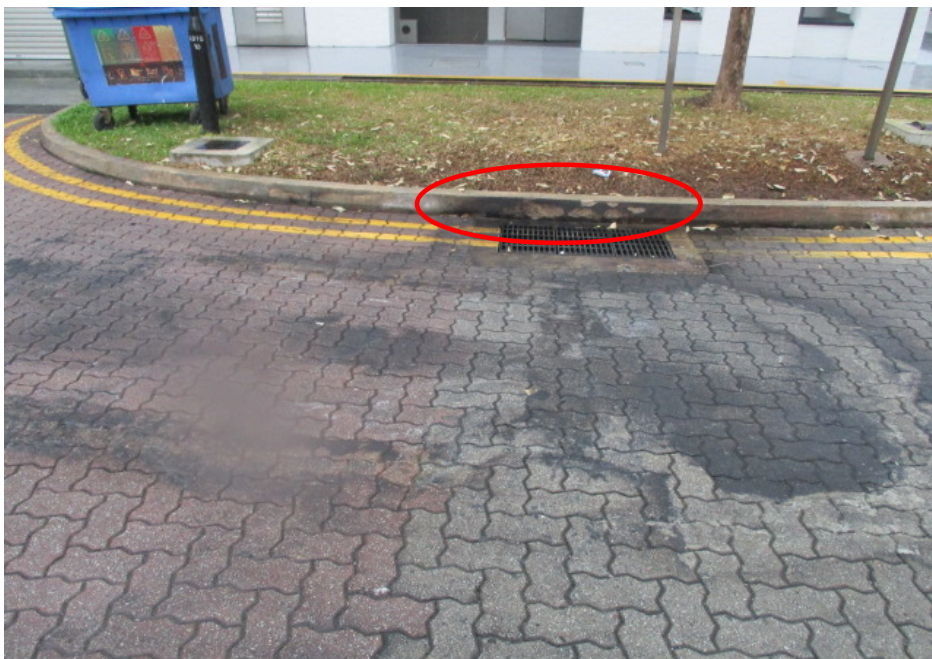
**Photo 15** shows the burnt marks on the kerb nearest to where the Insured Vehicle was positioned when the fire occurred (circled). Apart from the burnt marks on the kerb, we did not observe any other damaged or newly replaced government property at the time of our visit to the incident location.

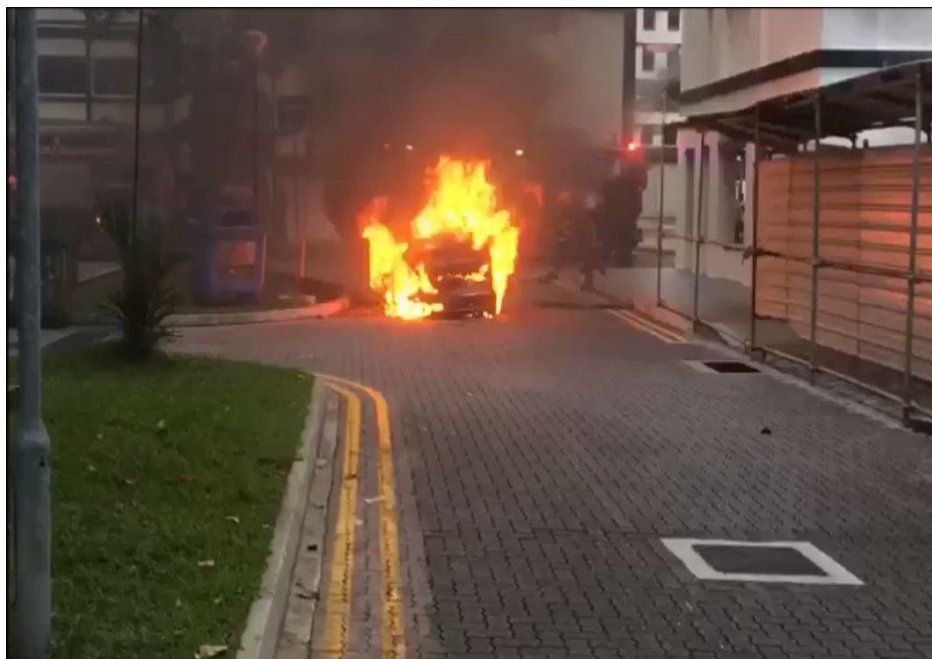
**Photo 16** shows the arrival of the SCDF to the incident location. In general, the information that could be gathered from this photograph had corresponded to the events that were related to us by Mr Hum in which the fire had engulfed the Insured Vehicle by the time the SCDF arrived.

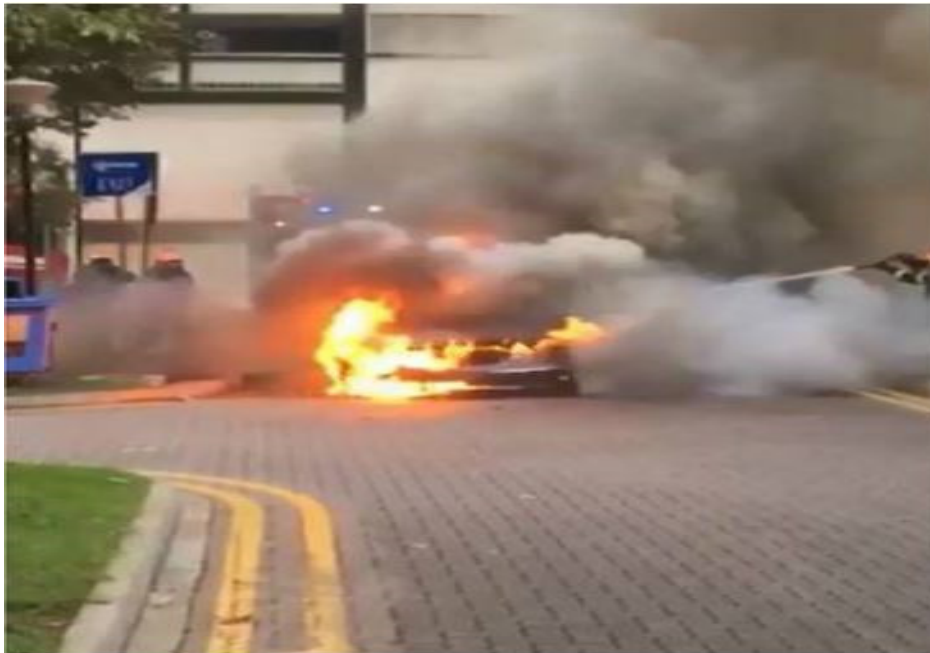
**Photo 17** shows firefighters beginning to put out the fire.

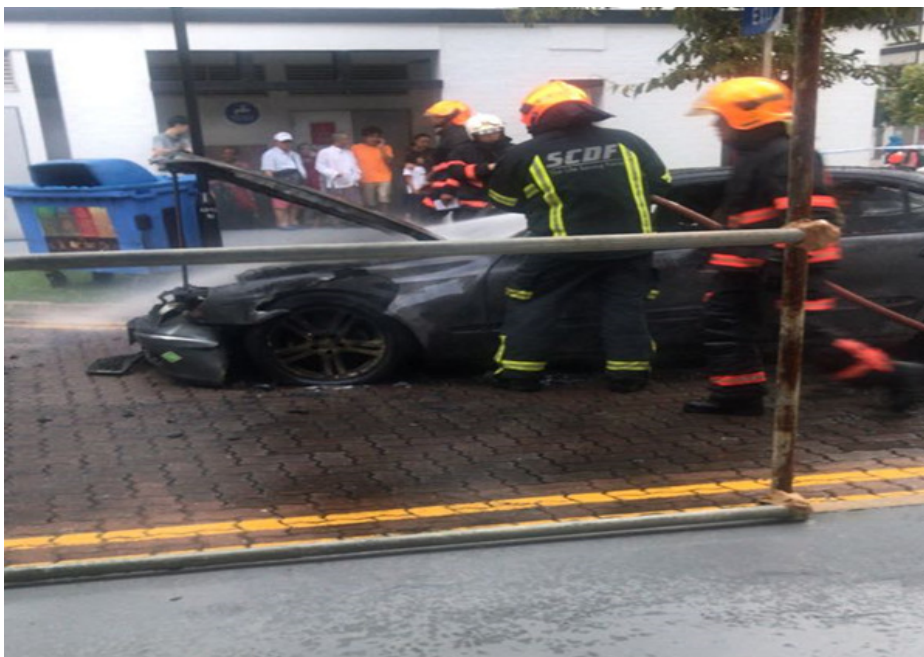
**Photo 18** shows firefighters extinguishing the last remnants of the fire.

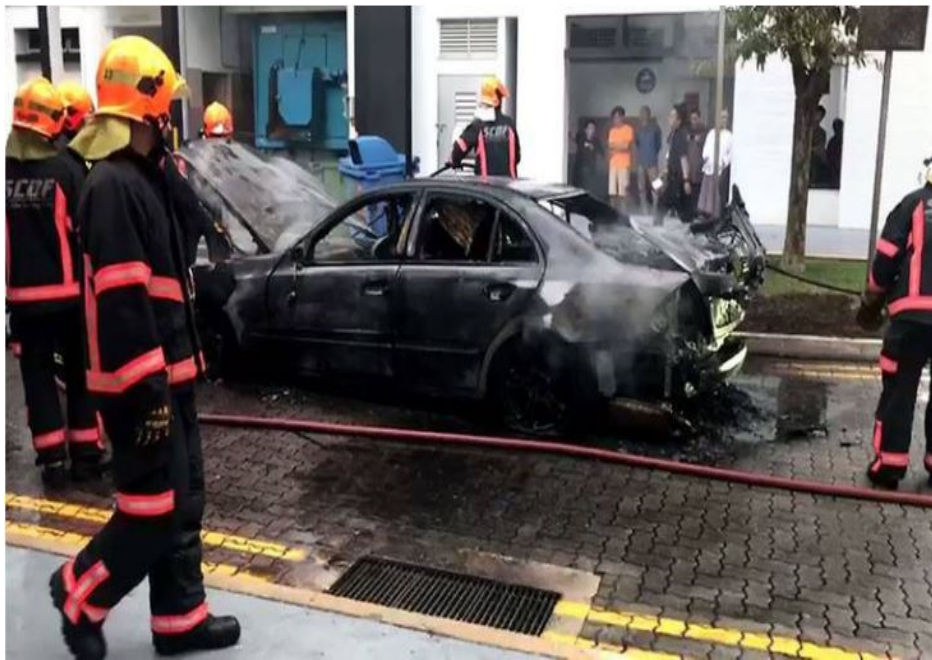
**Photo 19** shows the SCDF making sure that the fire had been completely extinguished.

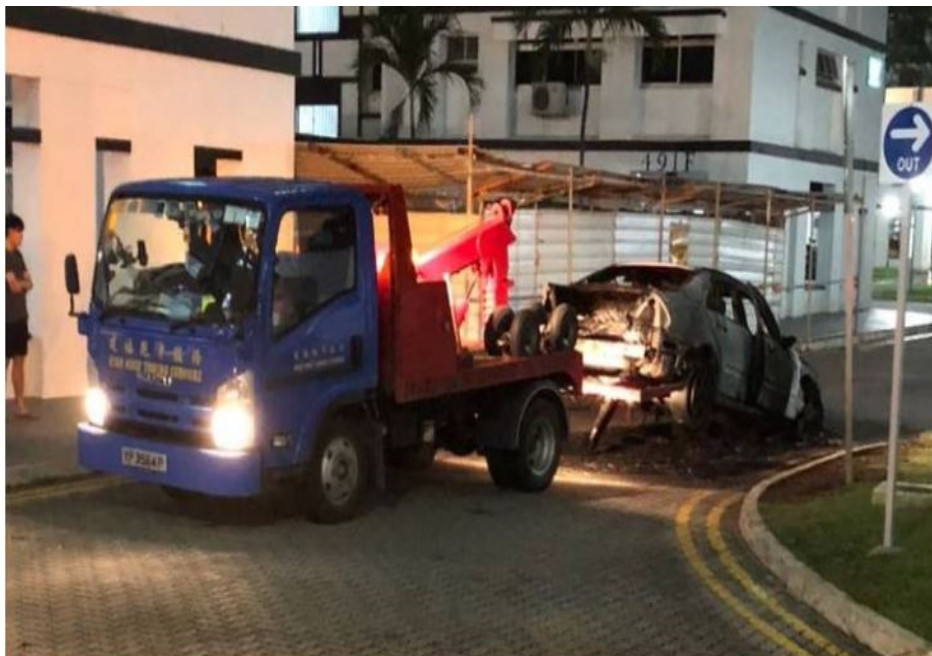
**Photo 20** shows the Insured Vehicle being towed away.

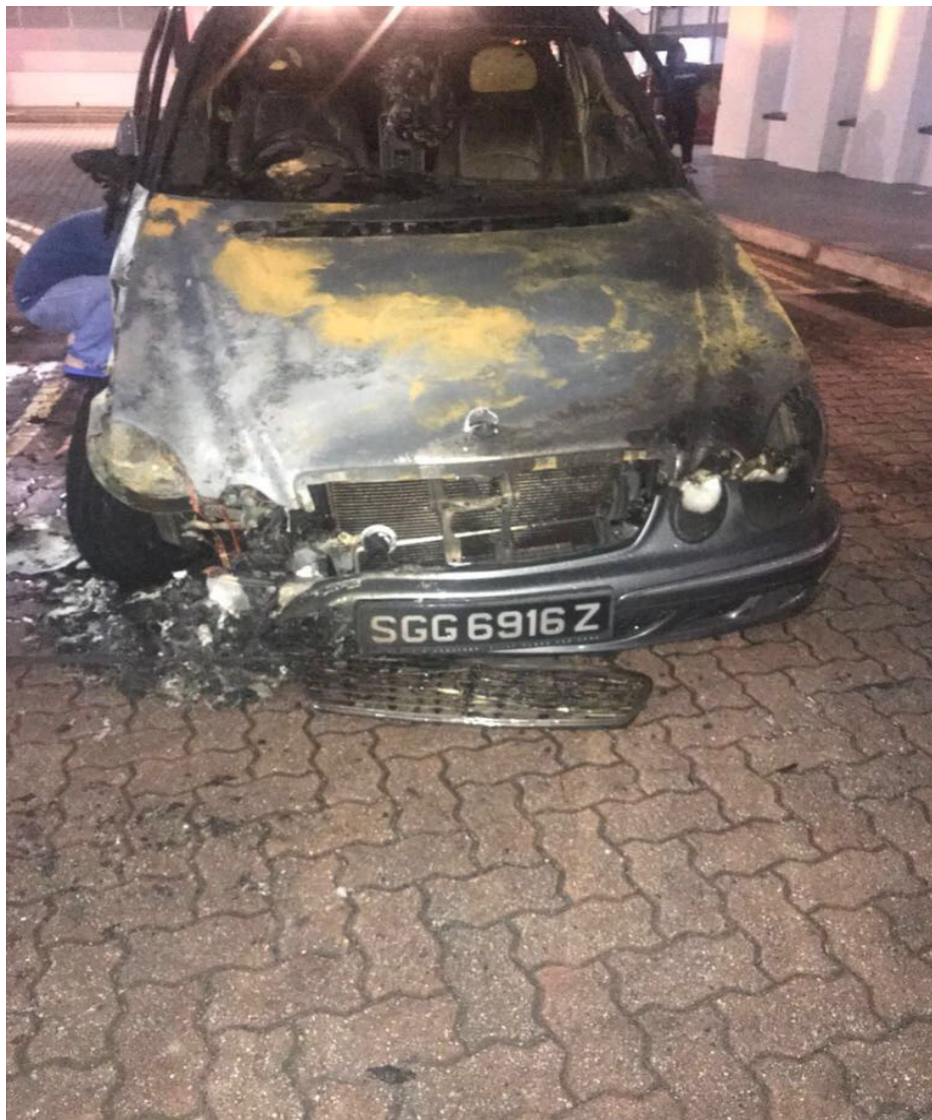
**Photo 21** shows a front view of the Insured Vehicle as it was being prepped to be towed away. In general, the extensive damages sustained to the front portion had corresponded to the events that were related to us by Mr Hum, which is the fire started from the front bonnet.
