Your Ref: 9434846195SG-001
Our Ref : CI/AIG17023412/N

1 December 2017

**TECHNICAL INVESTIGATION REPORT OF FIRE INCIDENT INVOLVING THE
INSURED VEHICLE SGG 6916Z ON 25 NOVEMBER 2017**

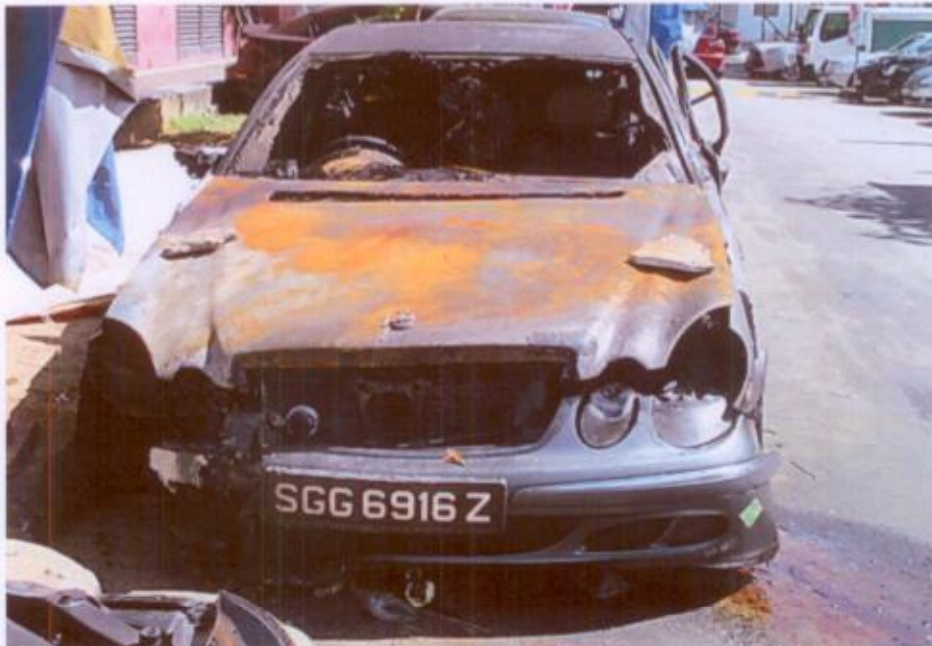
Photo 1 shows the general view of the front portion of the Insured Vehicle at the time of our inspection. The exterior body of the Insured Vehicle had sustained visible fire damage. This included its front windscreen, front bonnet, headlights, front bumper, front bumper reinforcement panel, side panels, front rims and front tyres.

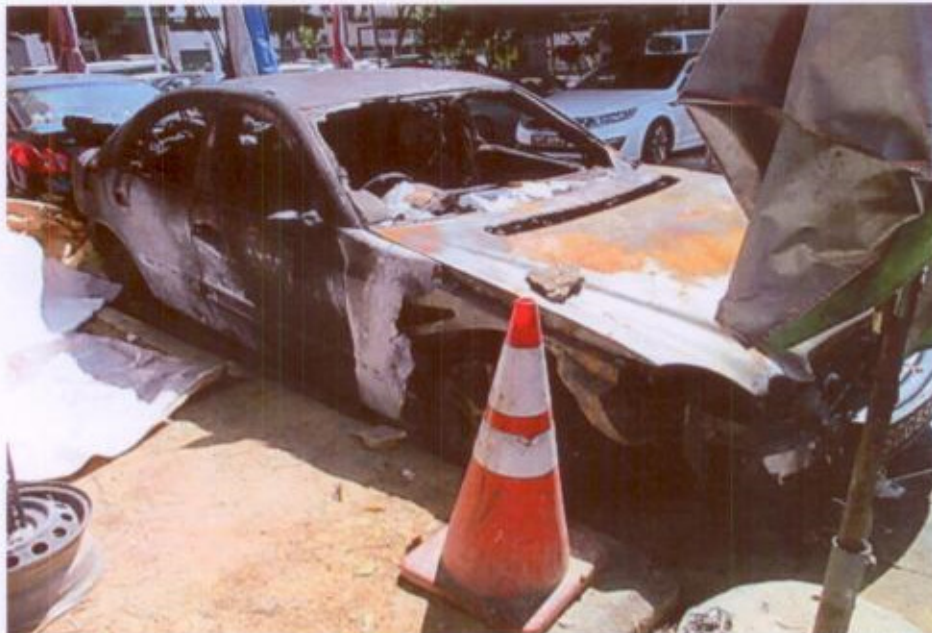
Photo 2 shows the general view of the right front portion of the Insured Vehicle at the time of our inspection. The exterior body of the Insured Vehicle had sustained visible fire damage. This included its front windscreen, front bonnet, headlights, front bumper, front bumper reinforcement panel, right side panel, front right rim and front right tyre.

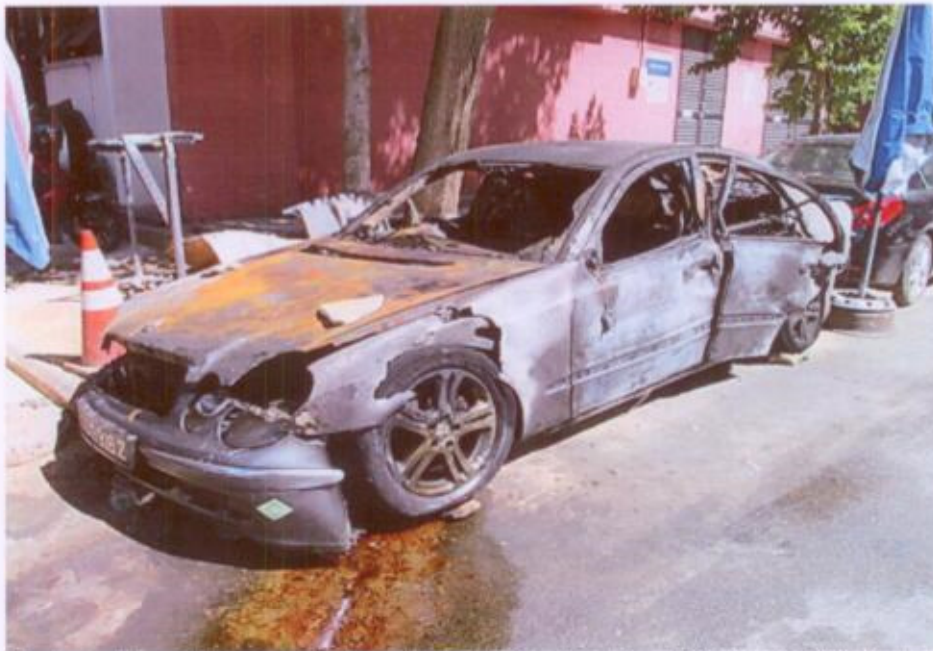
Photo 3 shows the general view of the left front portion of the Insured Vehicle at the time of our inspection. The exterior body of the Insured Vehicle had sustained visible fire damage. This included its front windscreen, front bonnet, headlights, front bumper, front bumper reinforcement panel, left side panel, front left rim and front left tyre.

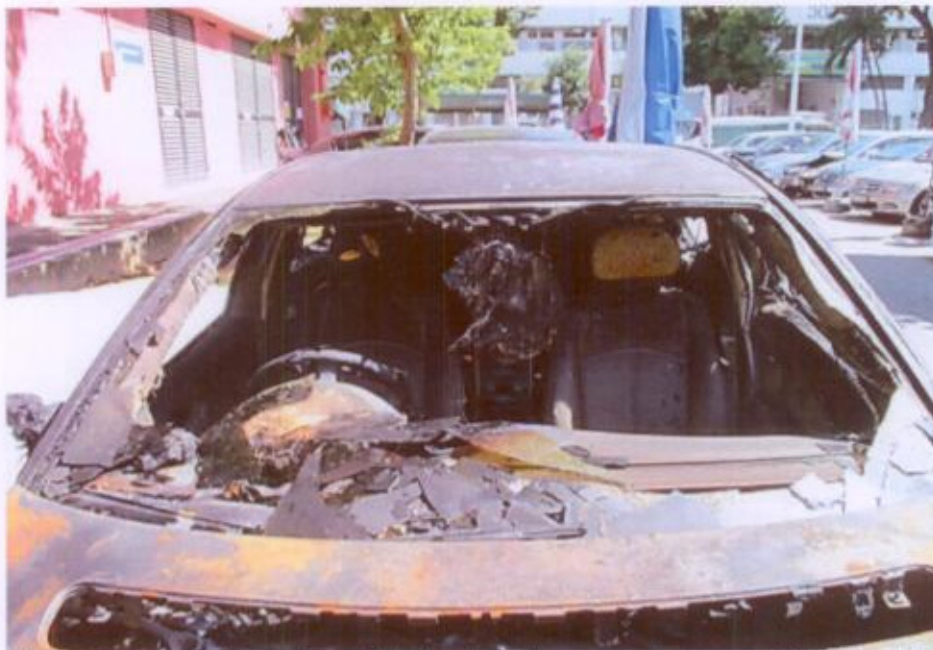
Photo 4 shows a closer view of the front windscreen of the Insured Vehicle at the time of our inspection. The front windscreen had sustained serious fire damage.

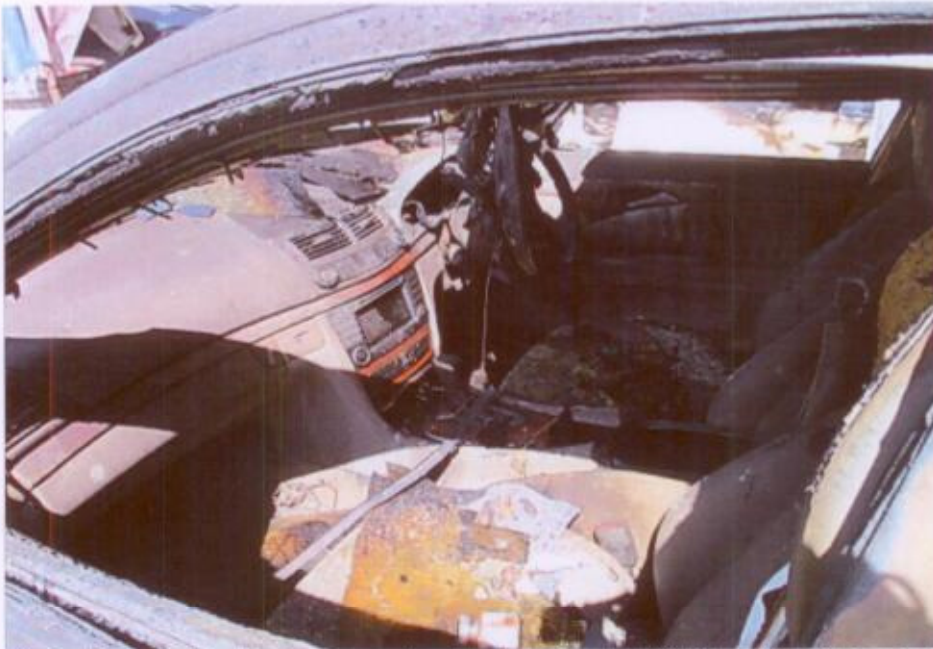
Photo 5 shows the interior compartment of the Insured Vehicle at the time of our inspection. The interior compartment of the Insured Vehicle was observed to be significantly affected by the fire which included the dashboard, steering wheel, front seats and roof upholstery amongst others.

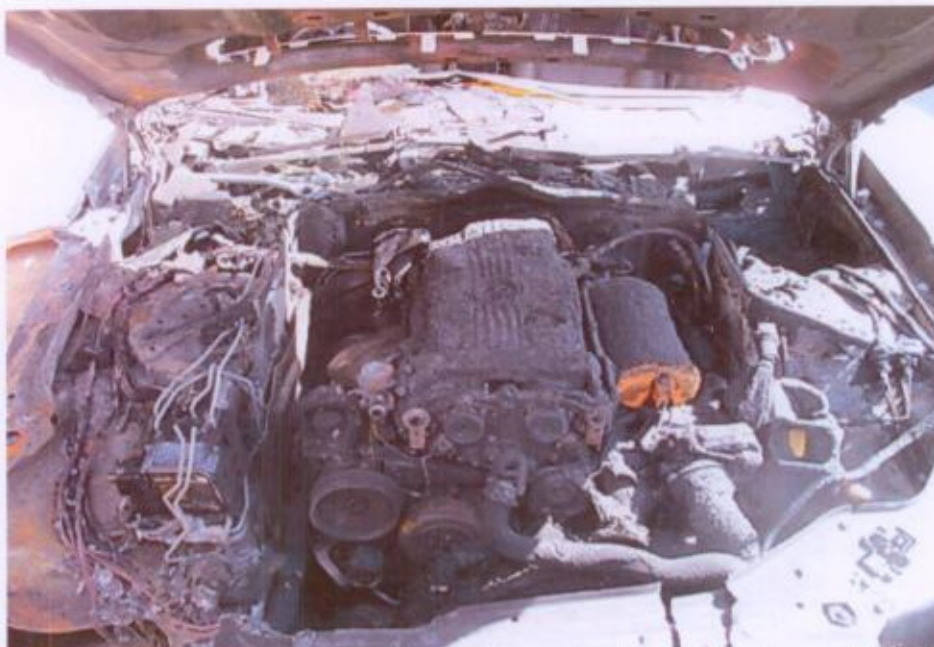
Photo 6 shows a general view of the engine compartment of the Insured Vehicle at the time of our inspection. Most of the components inside the engine compartment were severely burnt and/or melted as a result of the fire.

8. For this particular case, the fire appears to have originated within the engine compartment of the Insured Vehicle as this was the area where the damage of fire nature was most severe.
9. Upon closer examination of the engine compartment, which was where the fire to the Insured Vehicle had likely started, we had found traces of greenish residue on several stretches of burnt wirings at the rear centre portion. The presence of greenish residue indicates internal heating of copper wires, a sign of an electrical short circuit occurring. The greenish residue is normally left behind from oxidation as a result of chemical reaction involving the copper wires. This physical evidence would then appear to suggest that the cause of fire to the Insured Vehicle could have possibly been due to electrical in nature. See photos 7 - 9 below.

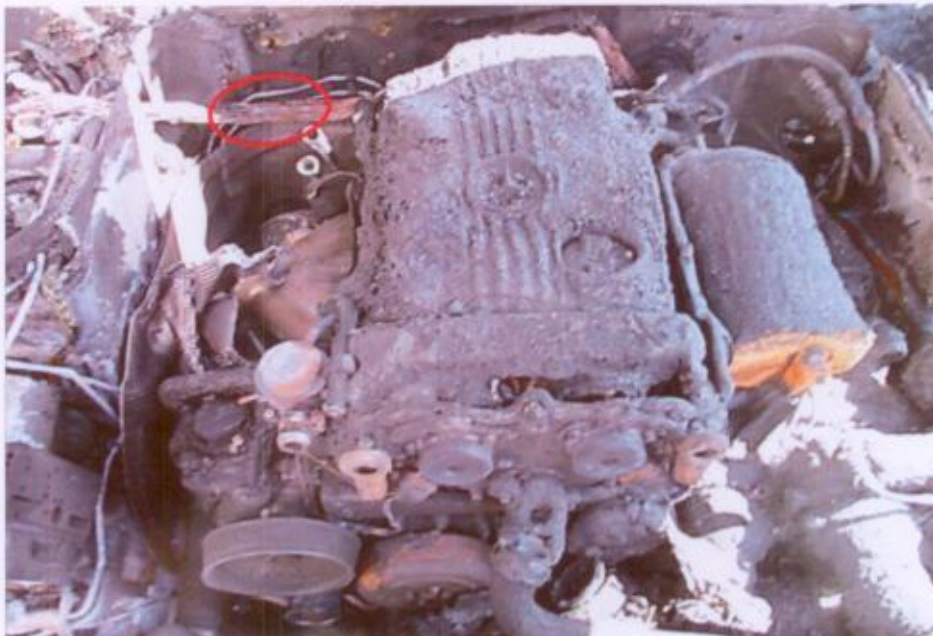
Photo 7 shows the wirings around the rear centre portion of the engine compartment which is near to the vicinity where the fire to the Insured Vehicle had likely started. We observed greenish residue on some of the wirings (circled). The presence of greenish residue indicates internal heating of copper wires, a sign of an electrical short circuit occurring.

28. The possibility of the fire being due to electrical in nature would then seem more likely given that engine overheating and external factors would both seem unlikely. The fire being due to electrical nature is also supported by the condition of the wirings that were found in the engine compartment of the Insured Vehicle, which was earlier discussed in paragraph 9 above.

30. Having investigated and technically analysed the damages of burnt nature to the Insured Vehicle, we are of the view that the cause of fire to the Insured Vehicle was of electrical in nature. For this particular case, the fire had originated along the wirings inside the engine compartment, somewhere around the rear centre portion. The wirings were original factory wirings of the Insured Vehicle.

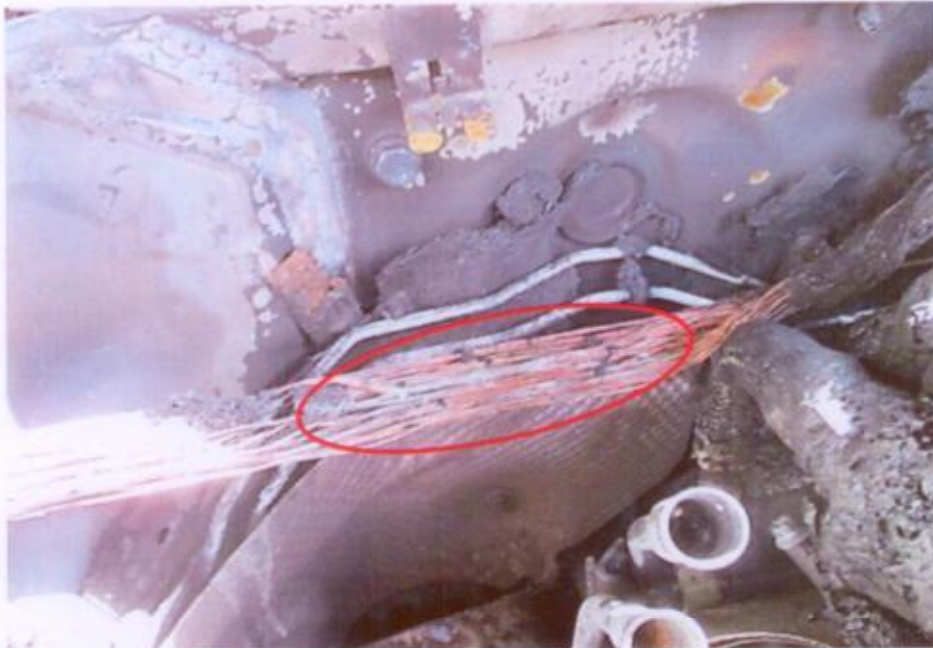
Photo 8 shows a closer view of the greenish residue found on the wirings (circled) at the rear centre portion of the engine compartment. The presence of such greenish residue suggests occurrence of an electrical short circuit.

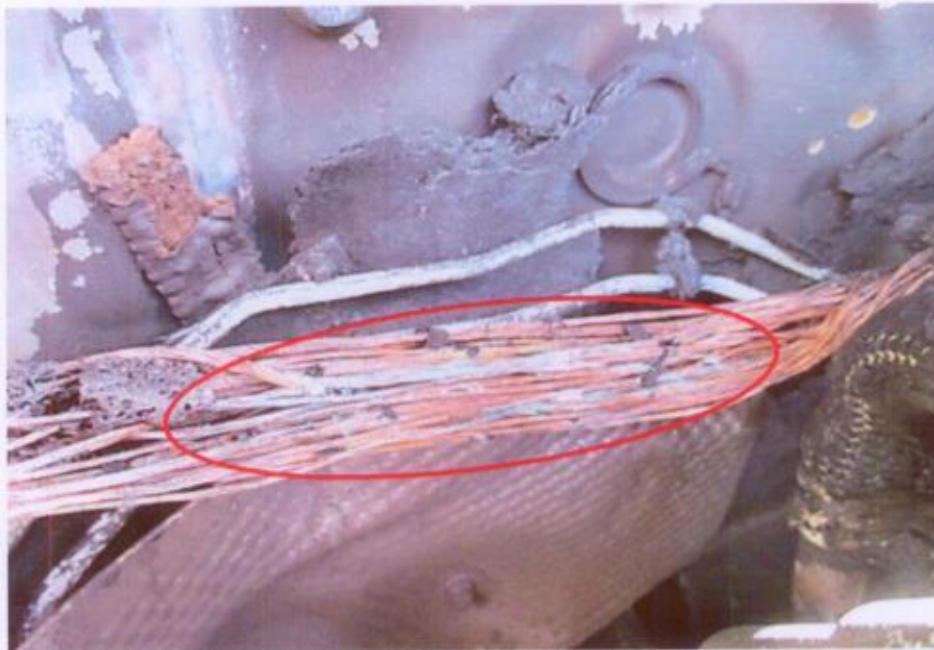
Photo 9 shows a close up view of the greenish residue found on the wirings (circled) at the rear centre portion of the engine compartment. The presence of such greenish residue suggests occurrence of an electrical short circuit.

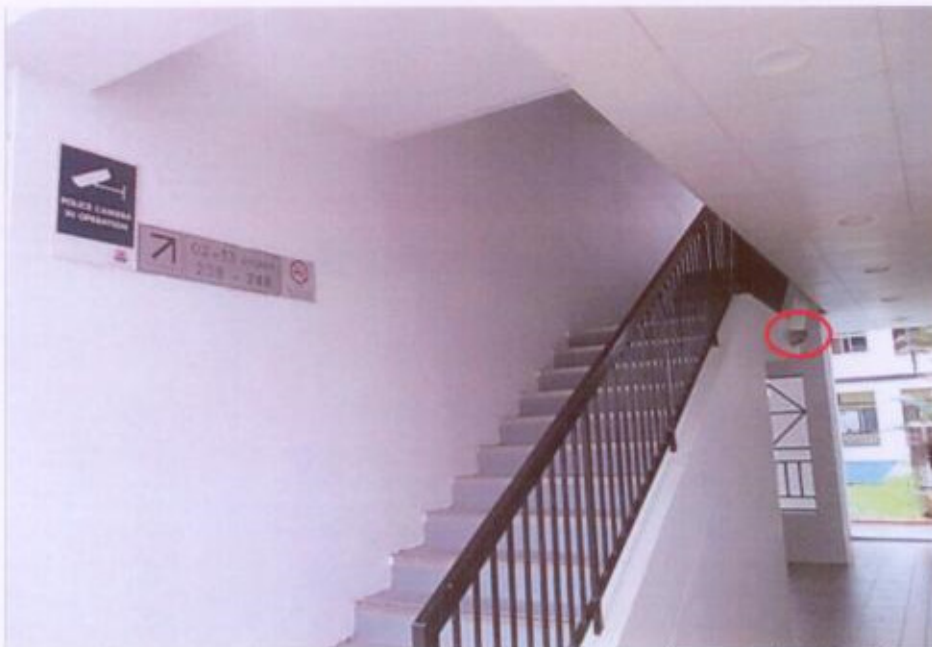
Photo 13 shows a closer view of the police camera affixed at the lift lobby of Block 491H (circled). However the view of the camera is blocked by a wall. The Insured Vehicle was positioned behind the wall at the time of the incident. Hence the camera would have been unable to record any footage of the incident from that angle.

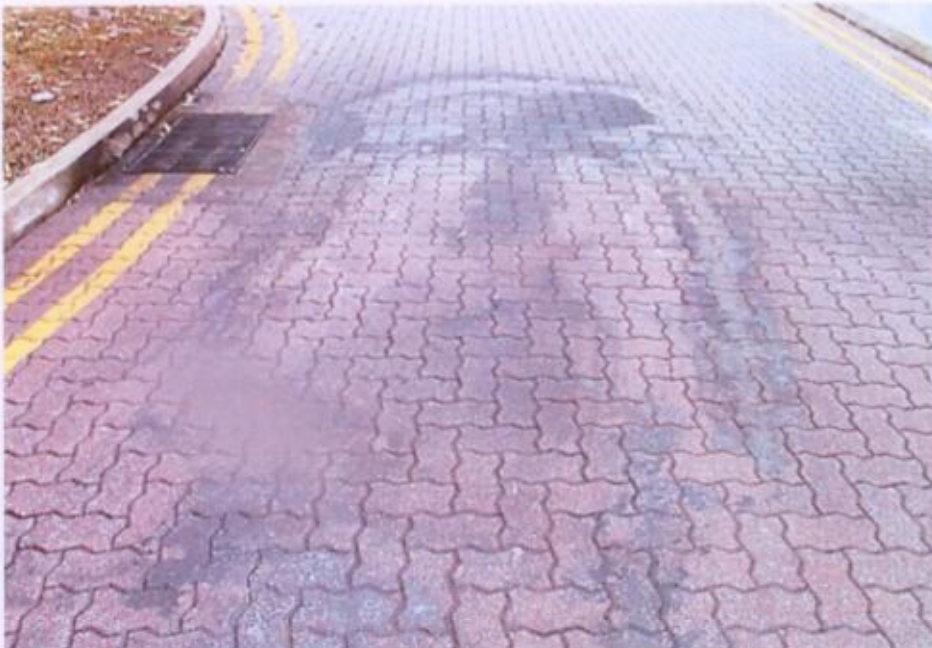
Photo 14 shows a close up view of the burnt marks and/or burnt residual remains on the ground where the Insured Vehicle was positioned at the time of incident (circled).

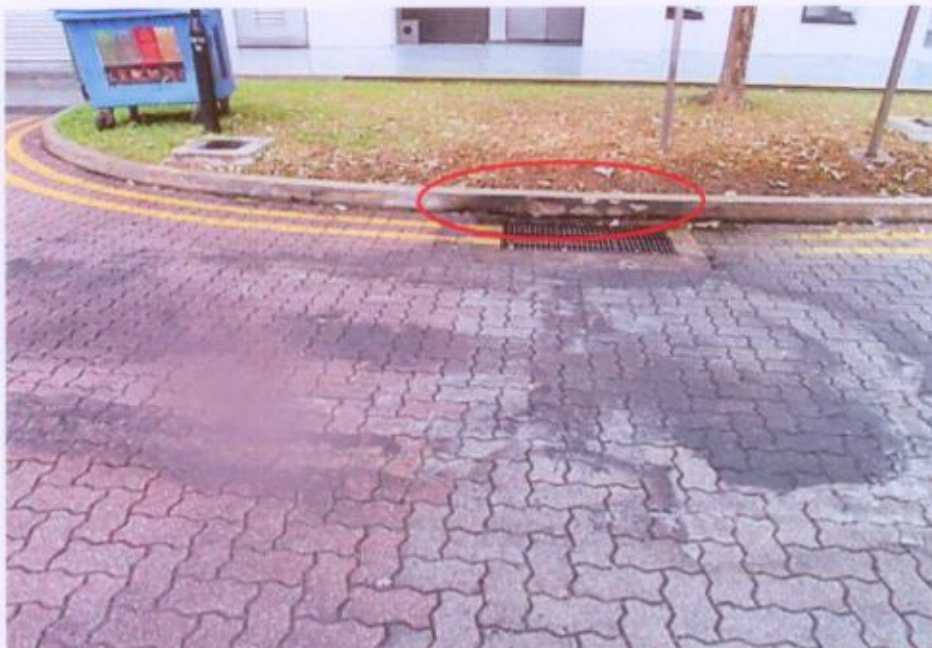
Photo 15 shows the burnt marks on the kerb nearest to where the Insured Vehicle was positioned when the fire occurred (circled). Apart from the burnt marks on the kerb, we did not observe any other damaged or newly replaced government property at the time of our visit to the incident location.

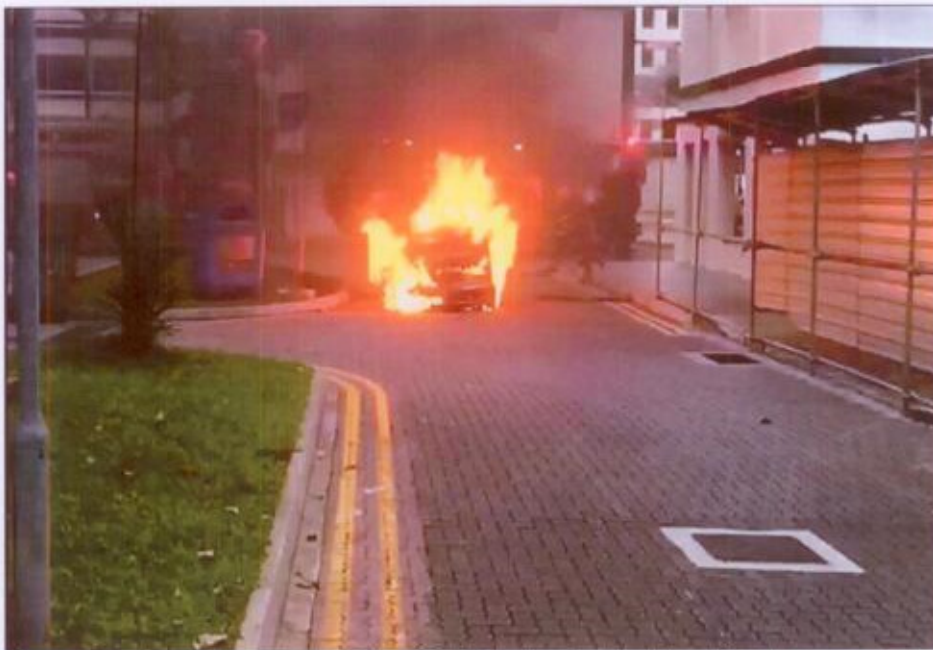
Photo 16 shows the arrival of the SCDF to the incident location. In general, the information that could be gathered from this photograph had corresponded to the events that were related to us by Mr Hum in which the fire had engulfed the Insured Vehicle by the time the SCDF arrived.

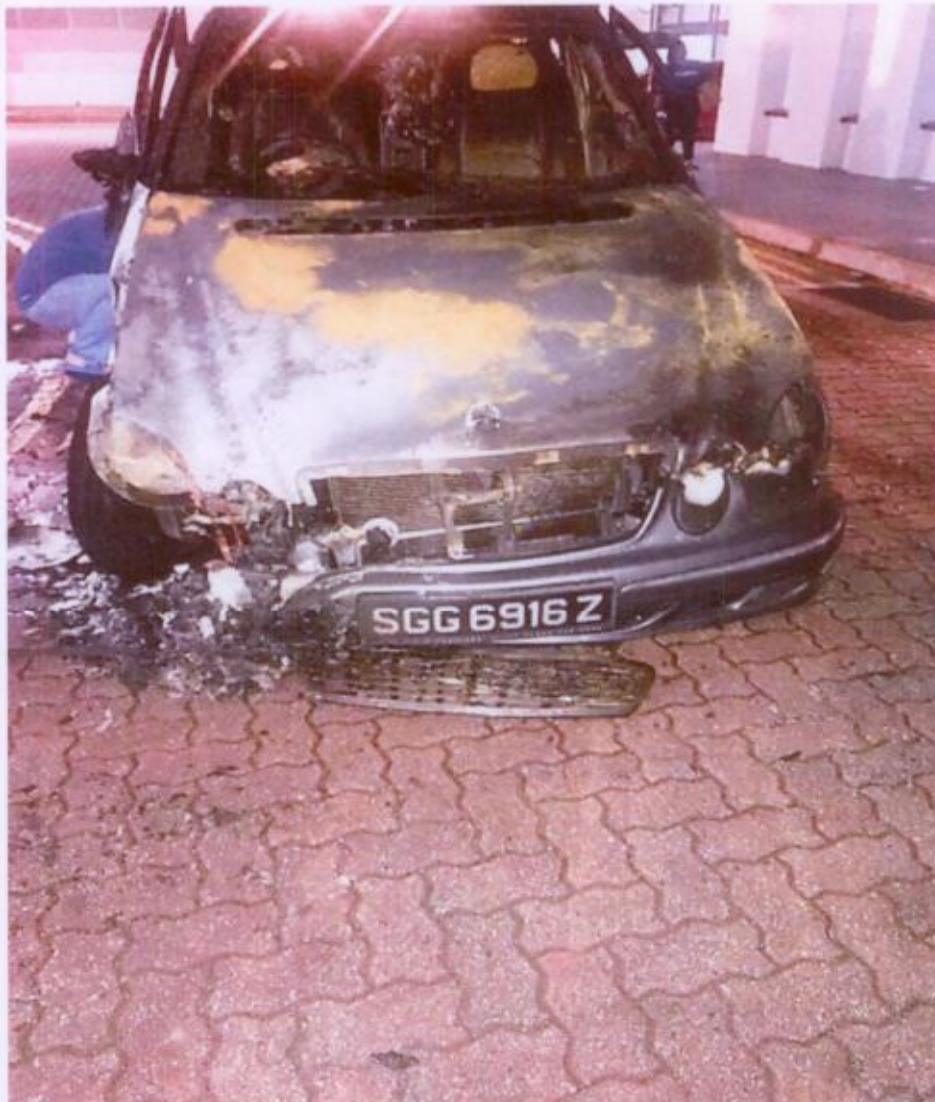
Photo 21 shows a front view of the Insured Vehicle as it was being prepped to be towed away. In general, the extensive damages sustained to the front portion had corresponded to the events that were related to us by Mr Hum, which is the fire started from the front bonnet.
