Your Ref : M1703953/FG
Our Ref : CI/TMI17014634/N-1

**AUTOMOBILE TECHNICAL INVESTIGATION REPORT OF ACCIDENT
INVOLVING SHA 4501U AND GBB 2494K ON 26 JULY 2017**

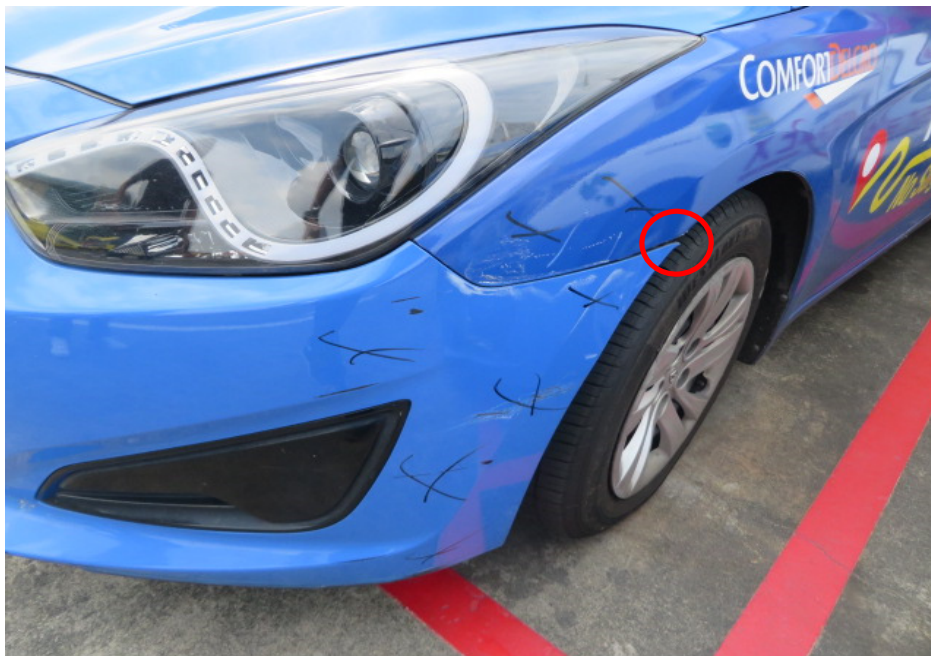
7. From our examination of the photographs taken during the Pre- Repair Survey conducted by LKK Auto Consultants Pte. Ltd. about 2 days after the accident, we observed paint graze marks on the top portion of the left side panel as well as around the left corner of the front bumper. We also noted that the front bumper was slightly misaligned at its left corner edge. See photos 1 - 5 below.

Photo 2 shows a closer view of the left front portion of the Taxi. We observed paint graze marks on the top portion of the left side panel as well as around the left corner of the front bumper (as marked by the X's). We also noted that the front bumper was slightly misaligned at its left corner edge (circled).

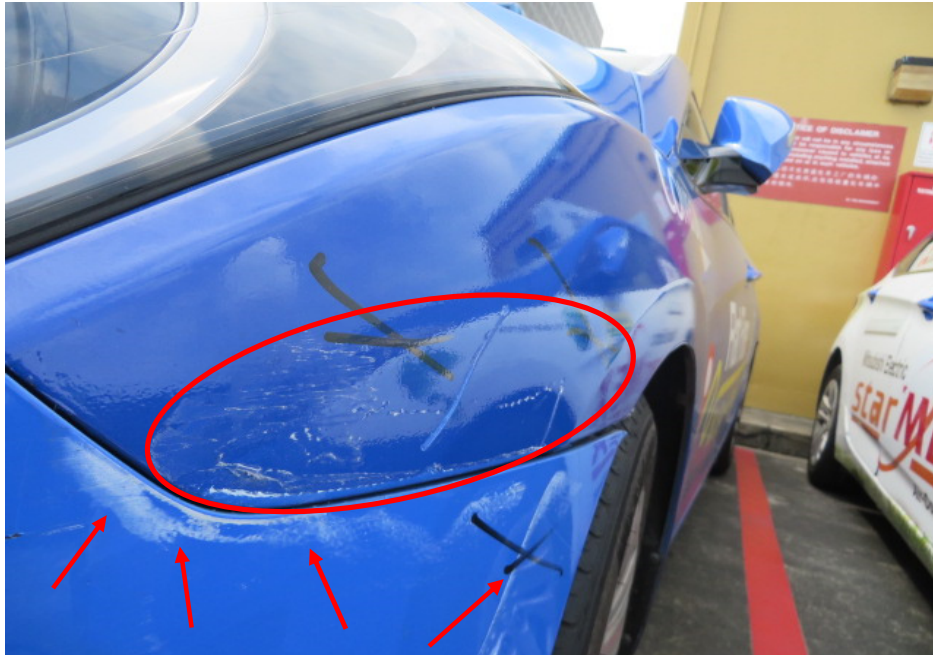
Photo 3 shows a close up view of the paint graze marks found on the top portion of the left side panel as well as around the left corner of the front bumper of the Taxi (red arrows).

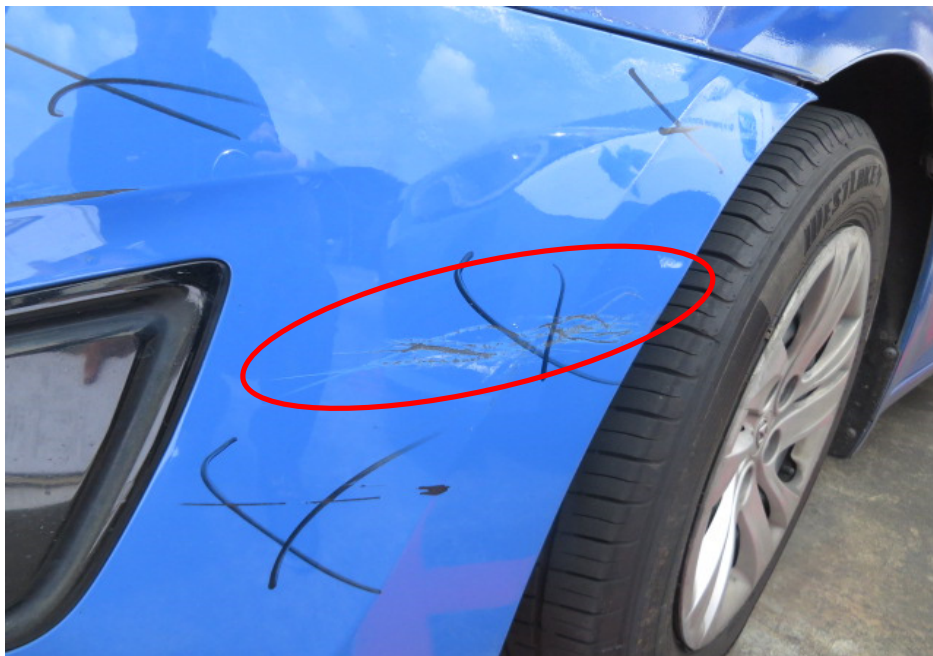
Photo 4 shows a close up view of the paint graze marks found around the left corner of the front bumper of the Taxi (circled).

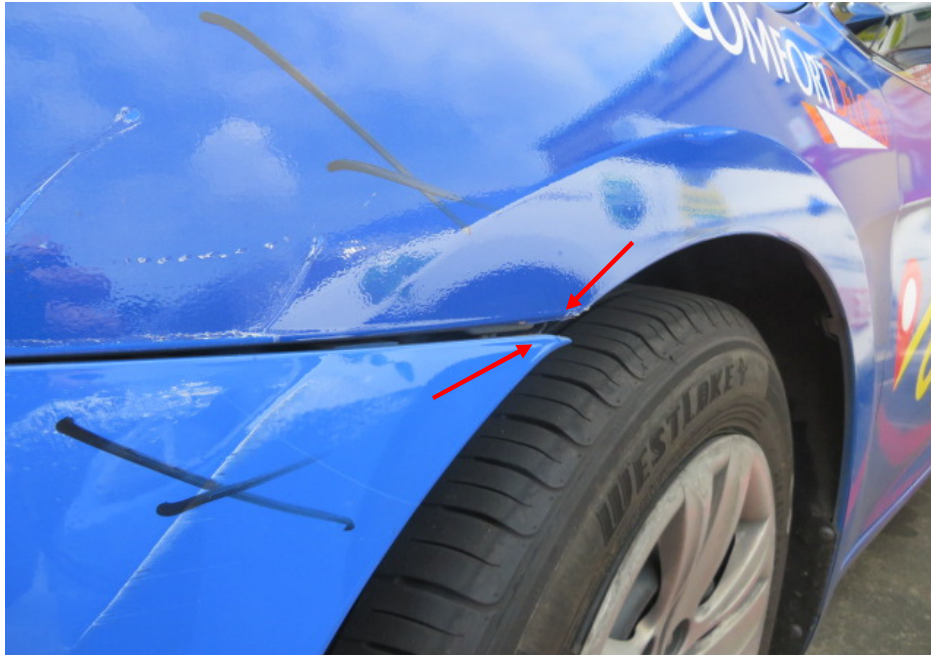
Photo 5 shows a close up view of the left side of the front bumper of the Taxi. We noted that the front bumper was slightly misaligned at its left corner edge (red arrows).

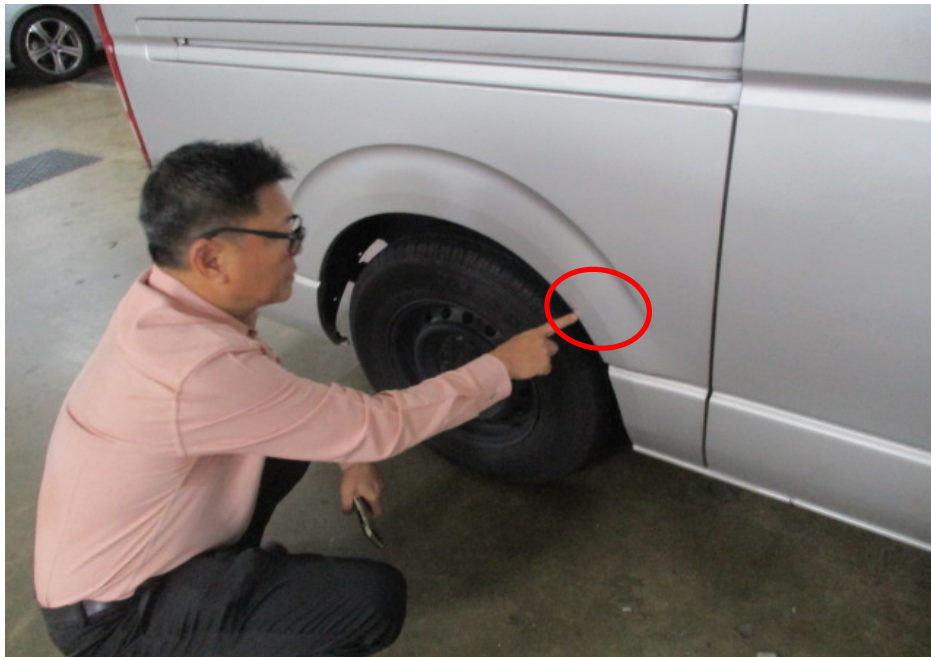
Photo 8 shows a closer examination of the rear right portion of the Van together with Principal Consultant, Mr K K Lau. We found paint graze marks and several paint scratch marks on the front portion of the rear right wheel fender (as pointed by Mr K K Lau) (circled).

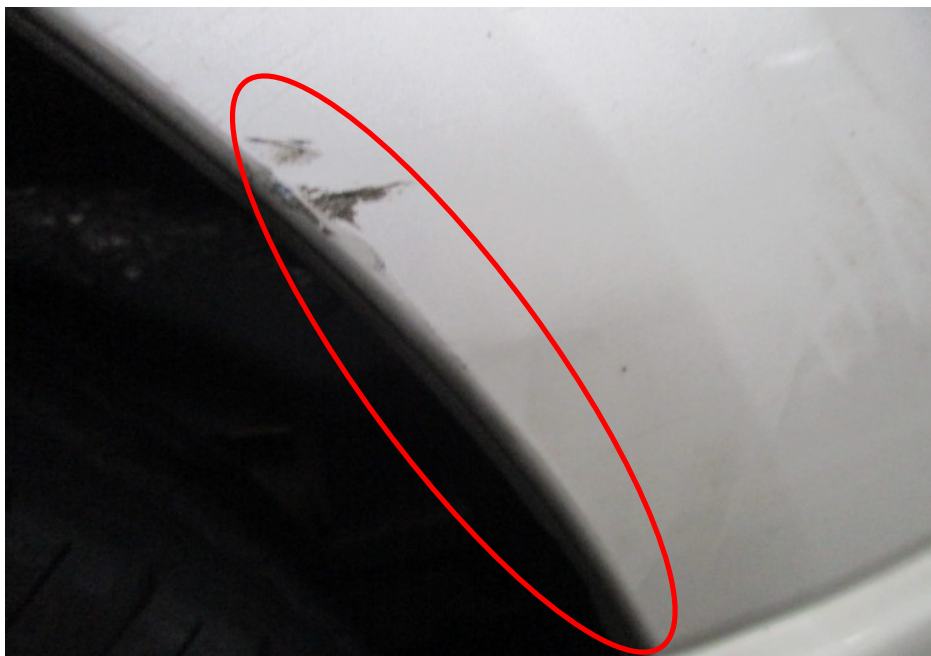
Photo 9 shows a closer view of the paint graze marks found on the front portion of the rear right wheel fender (circled).

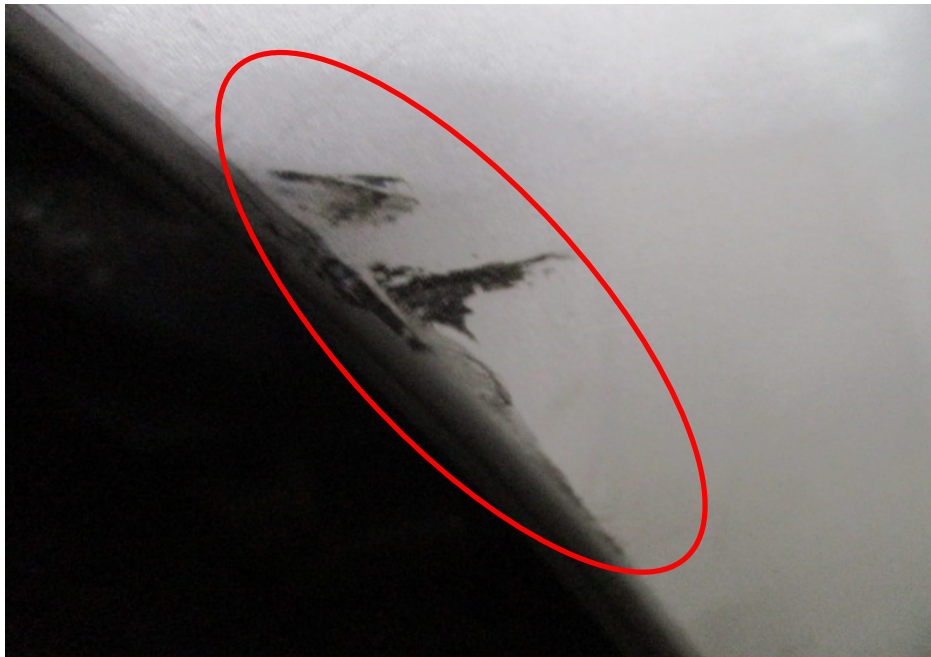
Photo 10 shows a close up view of the paint graze marks found on the front portion of the rear right wheel fender (circled).

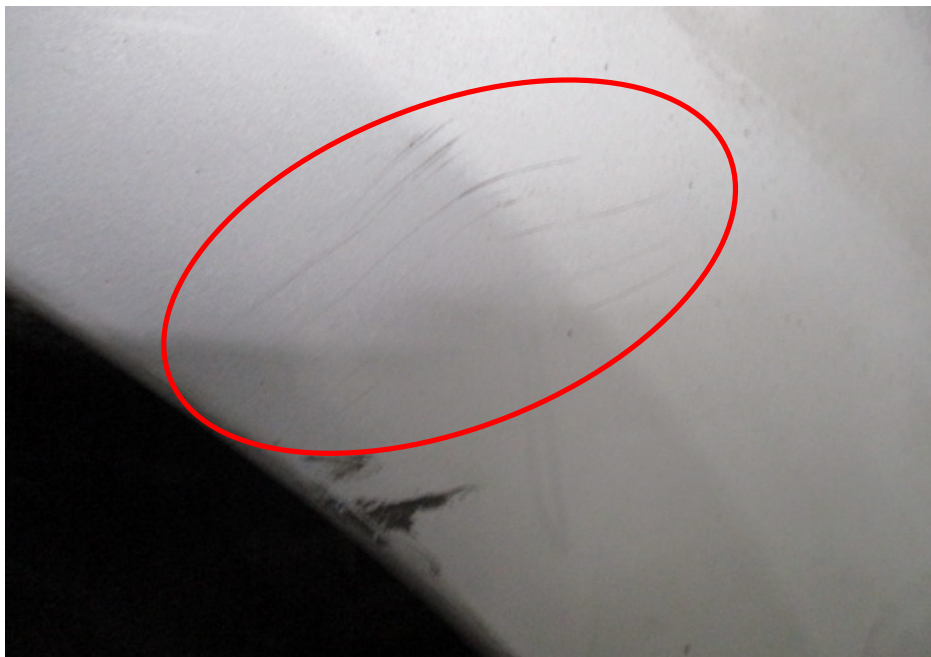
Photo 11 shows a close up view of the several paint scratch marks found on the front portion of the rear right wheel fender (circled).

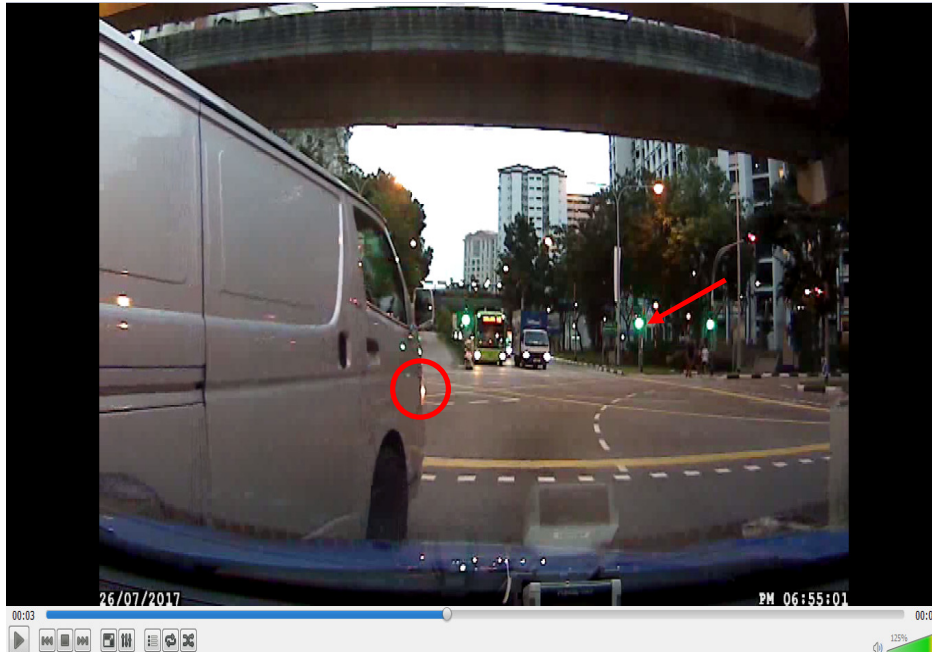
14. From the 2nd video recording, the Van can be seen trying to overtake the Taxi to turn right with the right turn signal indicator turned on as soon as the traffic light turned green at the 3 second mark. The Taxi can be seen inching forward. At the 7 second mark of the video recording, we had noted a slight movement (jerk like movement) of the Taxi as well as the Van. This was as the Involved Motor Vehicles were moving forward to turn right at the junction. The capturing of this slight movement by the video recording device that was mounted onto the front windscreen of the Taxi is a sign that there was a jerk like movement to the Taxi itself. Ultimately, indicating that there was contact between the left front portion of the Taxi and the right rear portion of the Van. However one would have to view the recording to see this slight movement. See screenshots 3 and 4 below.

Screenshot 3 of the 2nd video recording from the video recording device that was mounted onto the front windscreen of the Taxi shows the Van trying to overtake the Taxi to turn right with the right turn signal indicator turned on (circled) once the traffic light turned green at the 3 second mark (arrowed).

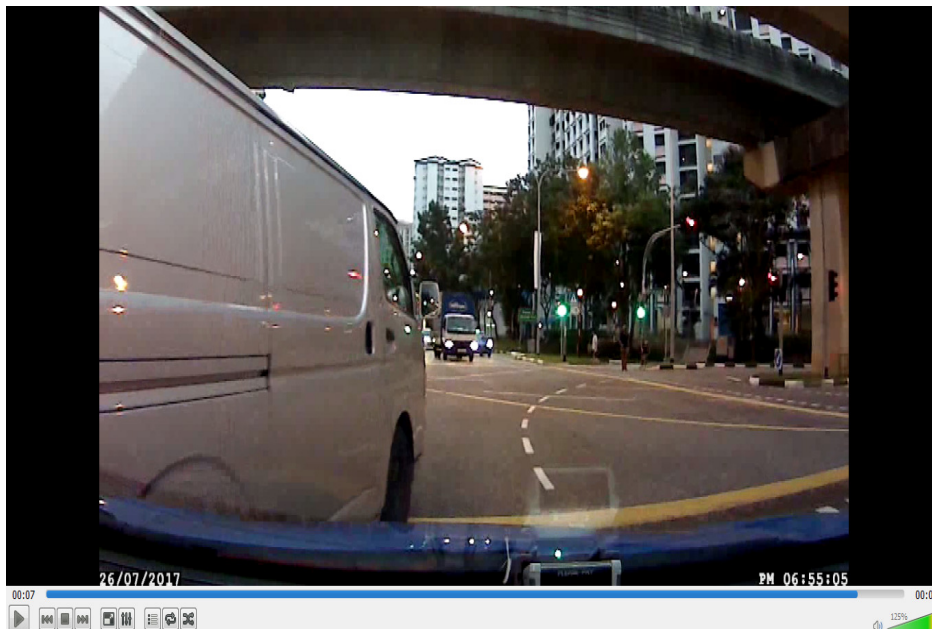
Screenshot 4 of the 2nd video recording from the video recording device that was mounted onto the front windscreen of the Taxi shows a slight movement (jerk like movement) of the Taxi as well as the Van at the 7 second mark. This was as the Involved Motor Vehicles were moving forward to turn right at the junction.

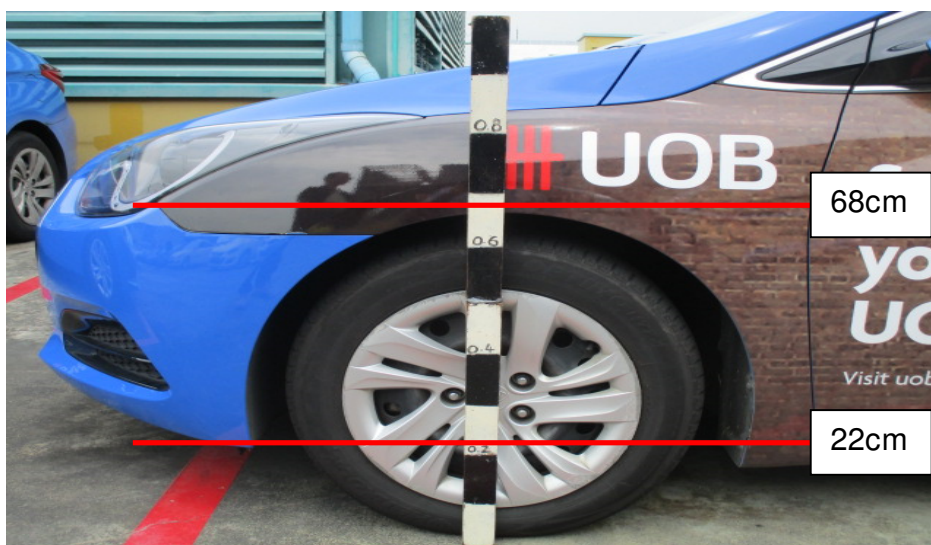
Photo 12 shows the height measurement being conducted on the left front portion of the Taxi (using a similar make and model). The height above ground level of the paint graze marks was between the ranges of 22cm to 68cm.

- a) the height above ground level of the paint graze marks on the front left portion of the Taxi was measured to be approximately between 22cm to 68cm;
- b) the height above ground level of the paint graze marks and several paint scratch marks on the front portion of the rear right wheel fender of the Van was measured to be approximately between 52cm to 68cm;
- c) the height measurements appear to support the findings of possible contact between the left front portion of the Taxi and the rear right portion of the Van. The damage observed on the left front portion of the Taxi was a result of this contact and corresponds to the damage observed on the rear right portion of the Van.

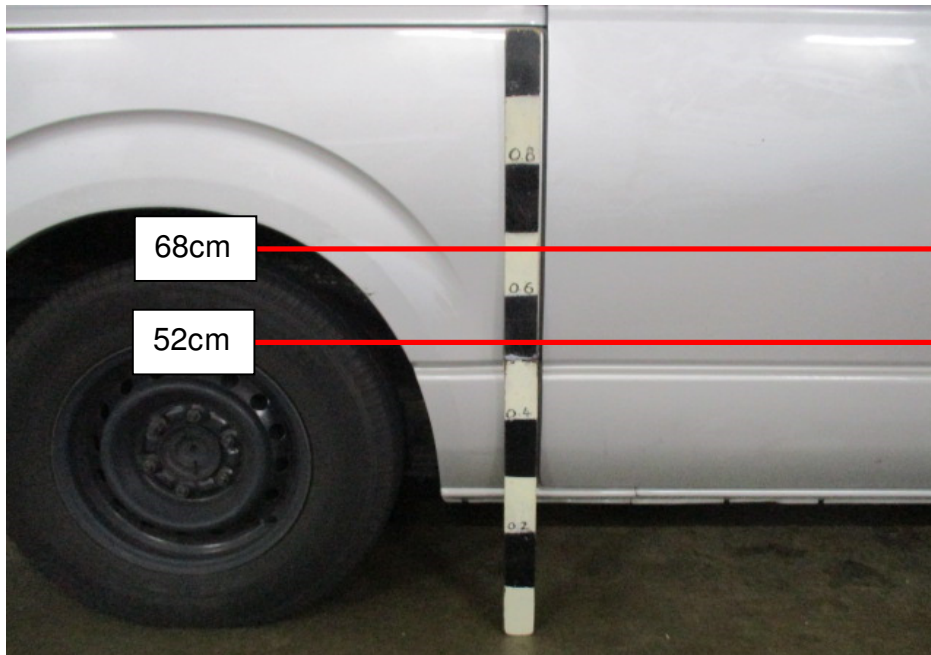
Photo 13 shows the height measurement being conducted on the rear right portion of the Van. The paint graze marks and several paint scratch marks found on the front portion of the rear right wheel fender are between 52cm and 68cm above ground level.
