Your Ref : M1703953/FG
Our Ref : CI/TMI17014634/N-1

20 November 2017

**AUTOMOBILE TECHNICAL INVESTIGATION REPORT OF ACCIDENT
INVOLVING SHA 4501U AND GBB 2494K ON 26 JULY 2017**

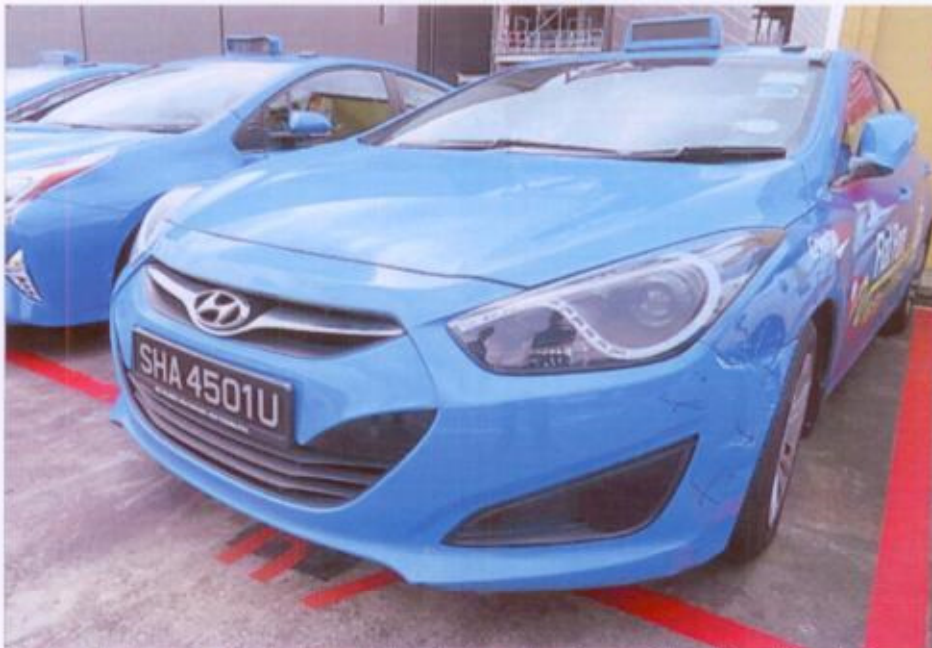
Photo 1 shows a front view of the Taxi at the time of the Pre- Repair Survey conducted by LKK Auto Consultants Pte. Ltd. which was taken about 2 days after the accident.

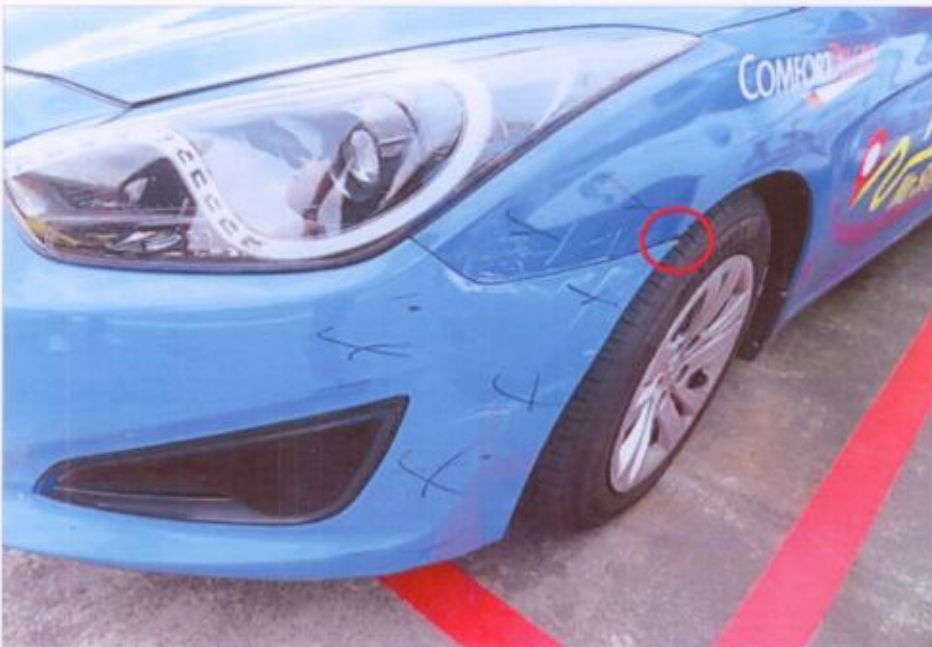
7. From our examination of the photographs taken during the Pre- Repair Survey conducted by LKK Auto Consultants Pte. Ltd. about 2 days after the accident, we observed paint graze marks on the top portion of the left side panel as well as around the left corner of the front bumper. We also noted that the front bumper was slightly misaligned at its left corner edge. See photos 1 - 5 below.

Photo 2 shows a closer view of the left front portion of the Taxi. We observed paint graze marks on the top portion of the left side panel as well as around the left corner of the front bumper (as marked by the X's). We also noted that the front bumper was slightly misaligned at its left corner edge (circled).

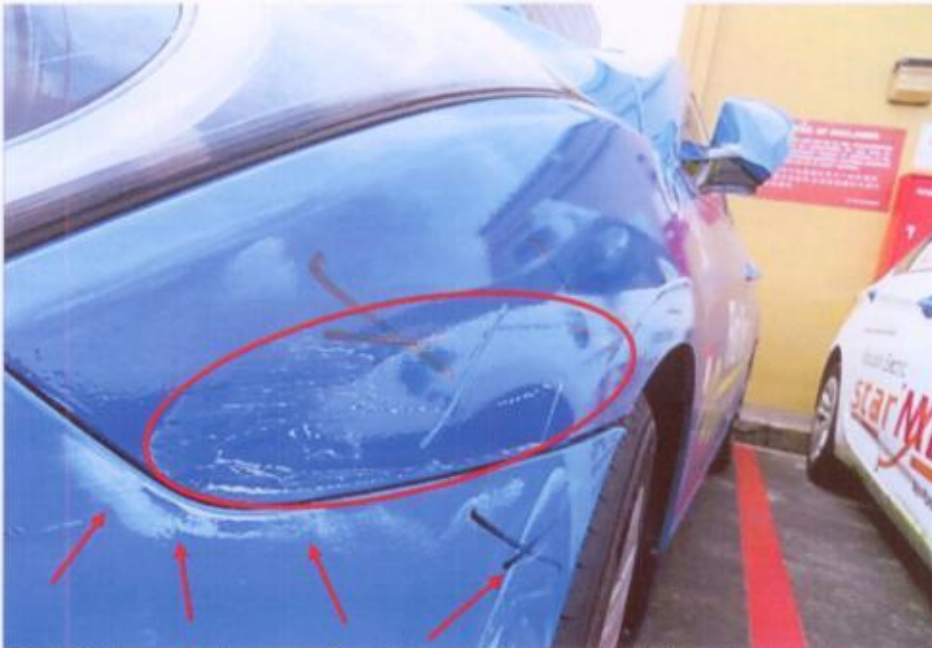
Photo 3 shows a close up view of the paint graze marks found on the top portion of the left side panel as well as around the left corner of the front bumper of the Taxi (red arrows).

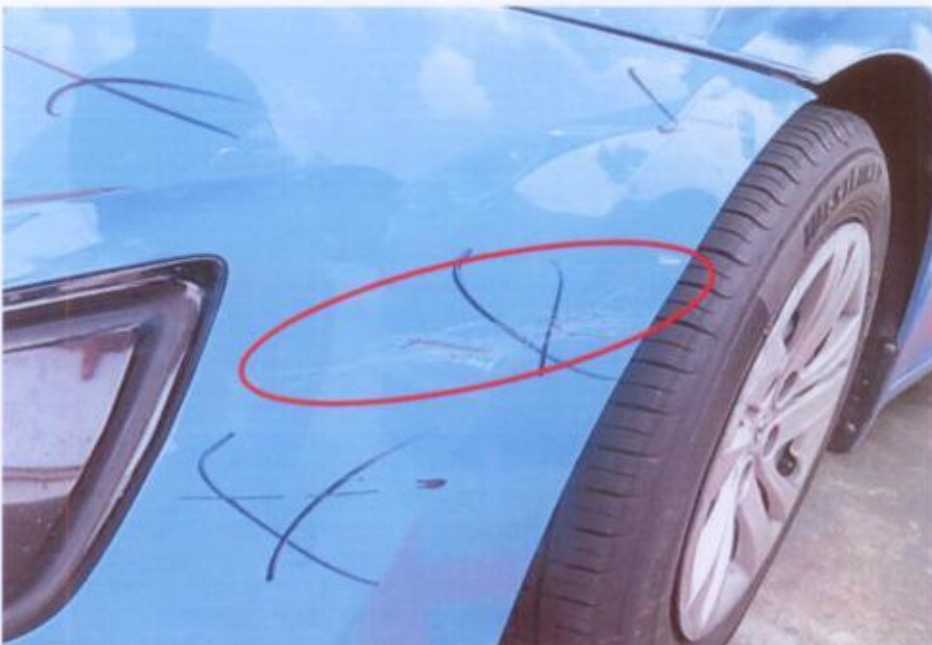
Photo 4 shows a close up view of the paint graze marks found around the left corner of the front bumper of the Taxi (circled).

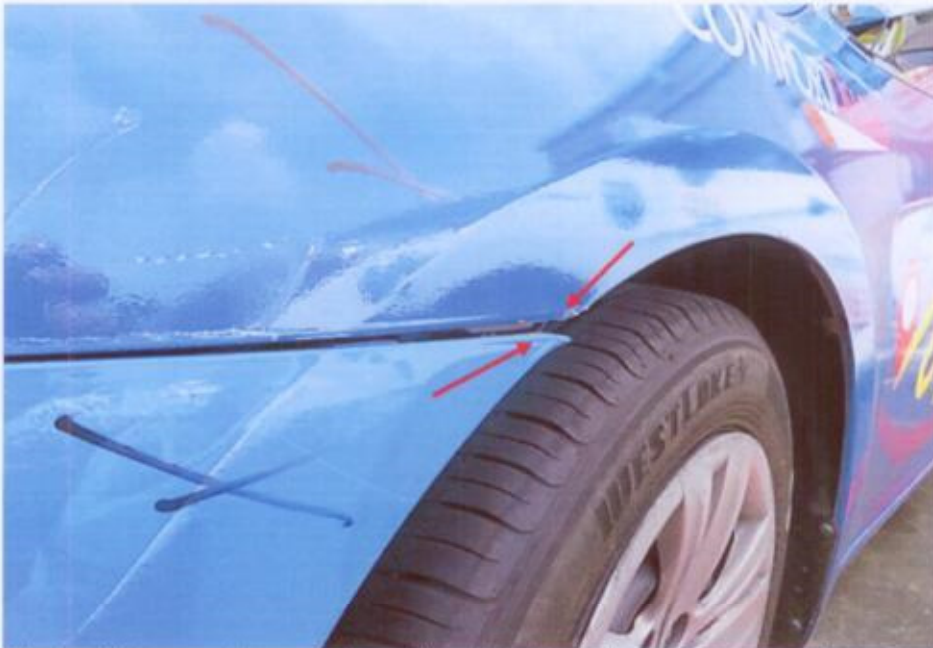
Photo 5 shows a close up view of the left side of the front bumper of the Taxi. We noted that the front bumper was slightly misaligned at its left corner edge (red arrows).

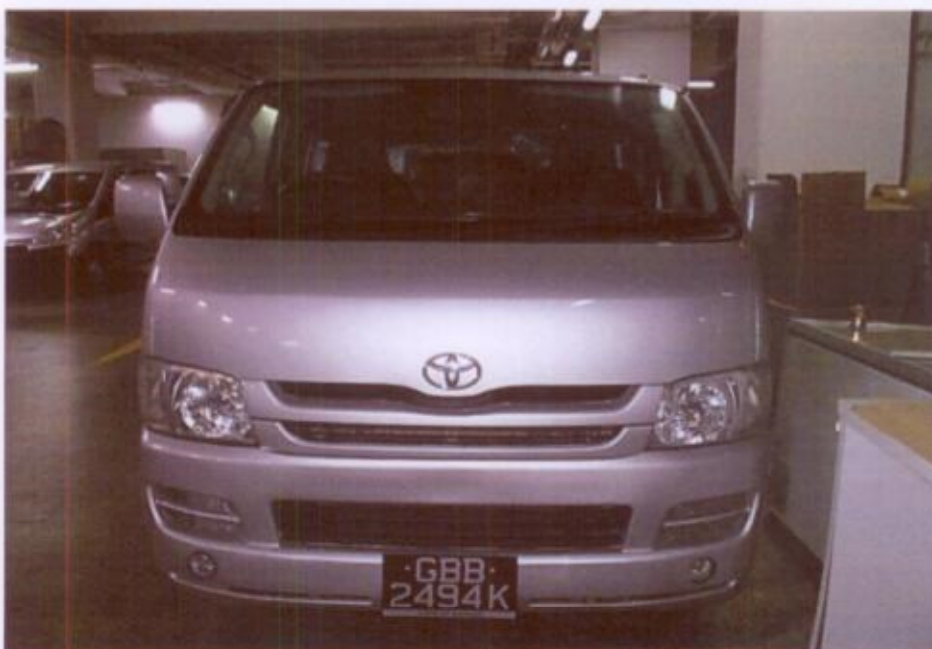
Photo 6 shows the general view of the front portion of the Van at the time of our inspection.

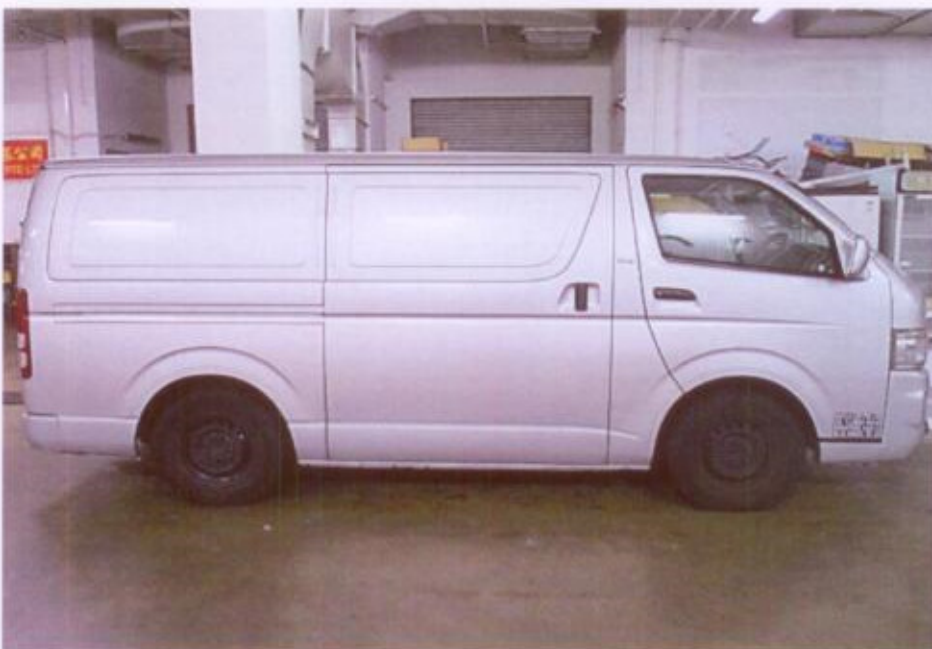
Photo 7 shows the general view of the right side of the Van at the time of our inspection.

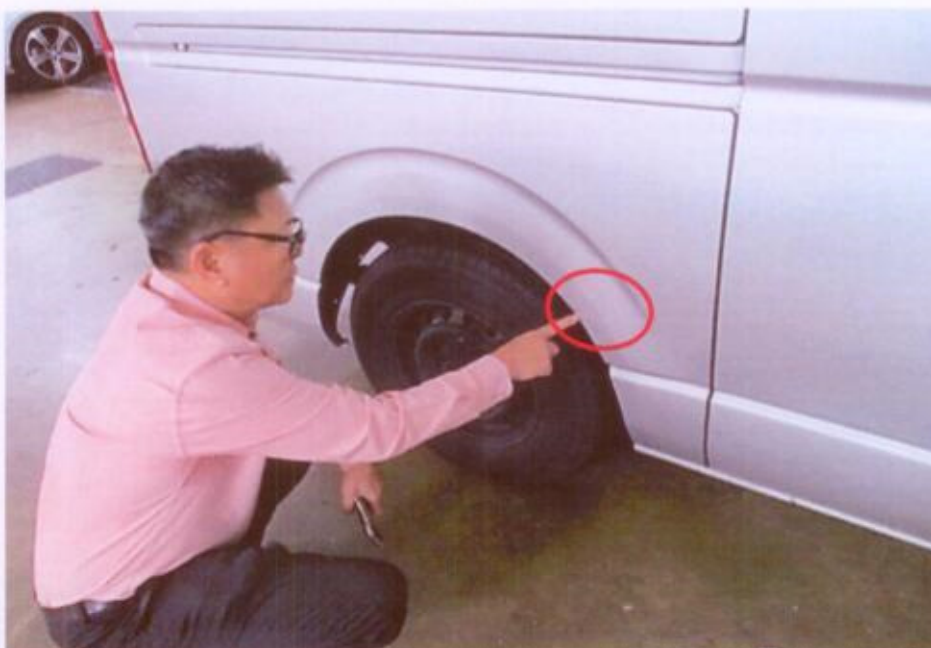
8. The Van was physically inspected on 15 November 2017 at the premises of Each-A-Cup Pte. Ltd. located at 9 Kaki Bukit Road 1, Eunos Technolink, #B1-05, Singapore 415938. Principal Consultant, Mr K K Lau was also present during this physical inspection.
9. The mileage recorded was 205,062km.
10. The physical inspection carried out had primarily focused on the right side of the Van as the accident was reported to be of a 'side swipe' nature where the Van was turning right from the 2nd lane beside the Taxi at the material time.
11. At the time of our inspection, we did not observe any damages on the driver door of the Van. Upon closer examination of the rear right portion of the Van, we found paint graze marks and several paint scratch marks on the front portion of the rear right wheel fender. See photos 6 - 11 below.

Photo 8 shows a closer examination of the rear right portion of the Van together with Principal Consultant, Mr K K Lau. We found paint graze marks and several paint scratch marks on the front portion of the rear right wheel fender (as pointed by Mr K K Lau) (circled).

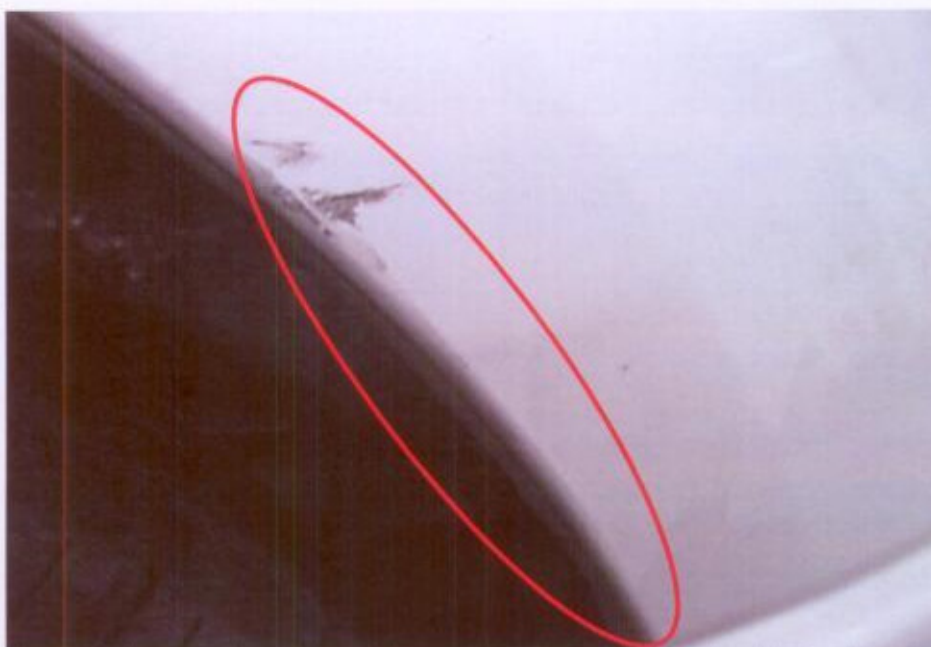
Photo 9 shows a closer view of the paint graze marks found on the front portion of the rear right wheel fender (circled).

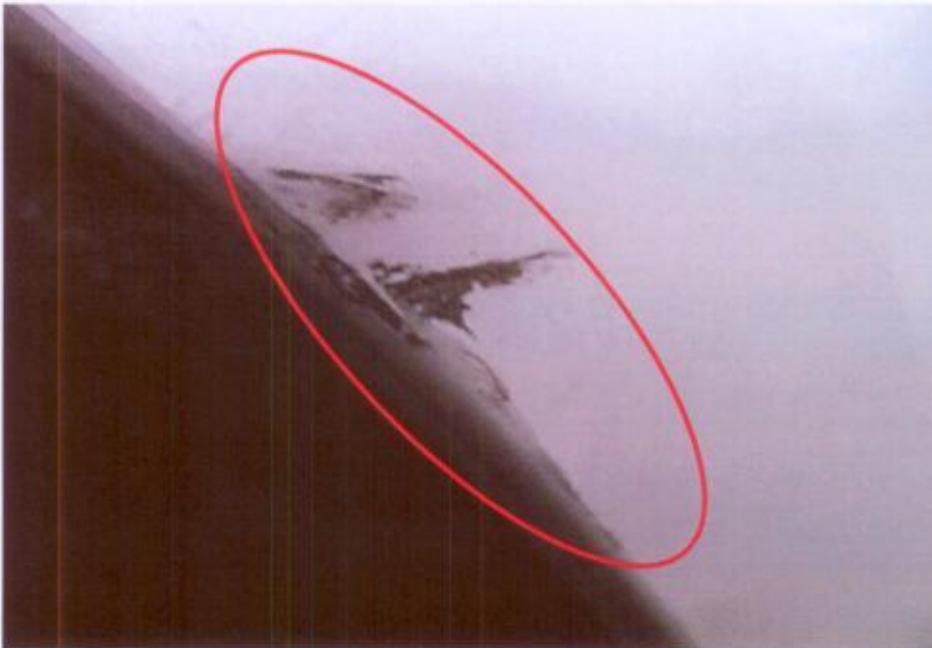
Photo 10 shows a close up view of the paint graze marks found on the front portion of the rear right wheel fender (circled).

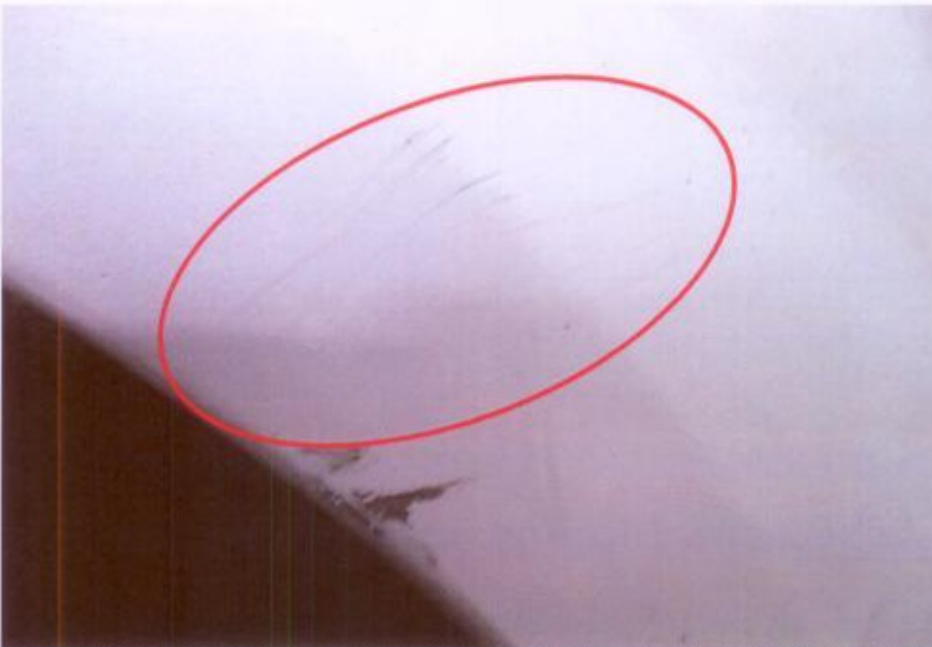
Photo 11 shows a close up view of the several paint scratch marks found on the front portion of the rear right wheel fender (circled).

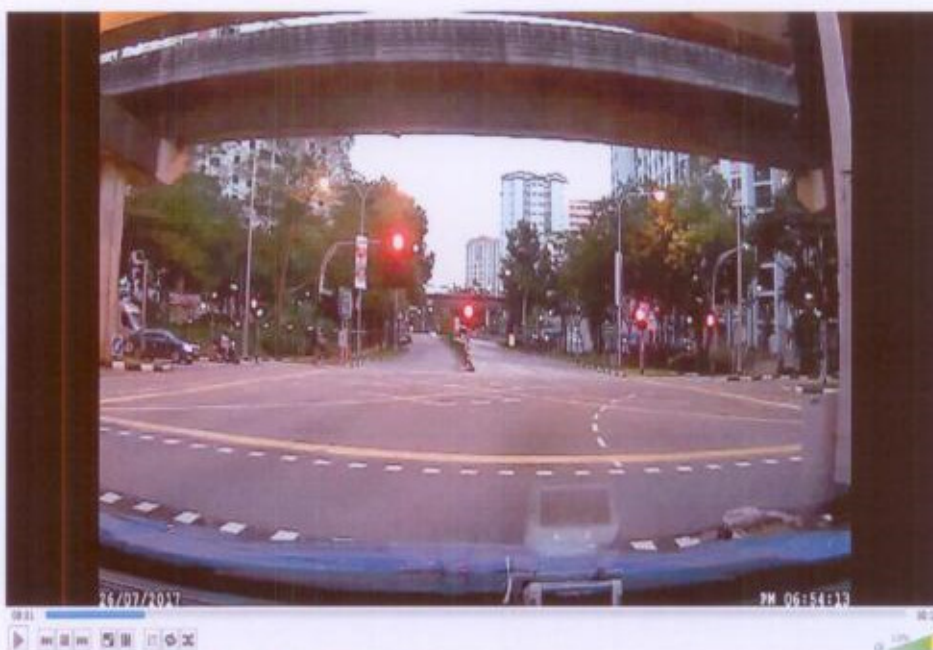
Screenshot 1 of the 1st video recording from the video recording device that was mounted onto the front windscreen of the Taxi shows the Taxi waiting to turn right into Rivervale Drive at the traffic junction of Sengkang East Way on the 1st lane at the 1 second mark.

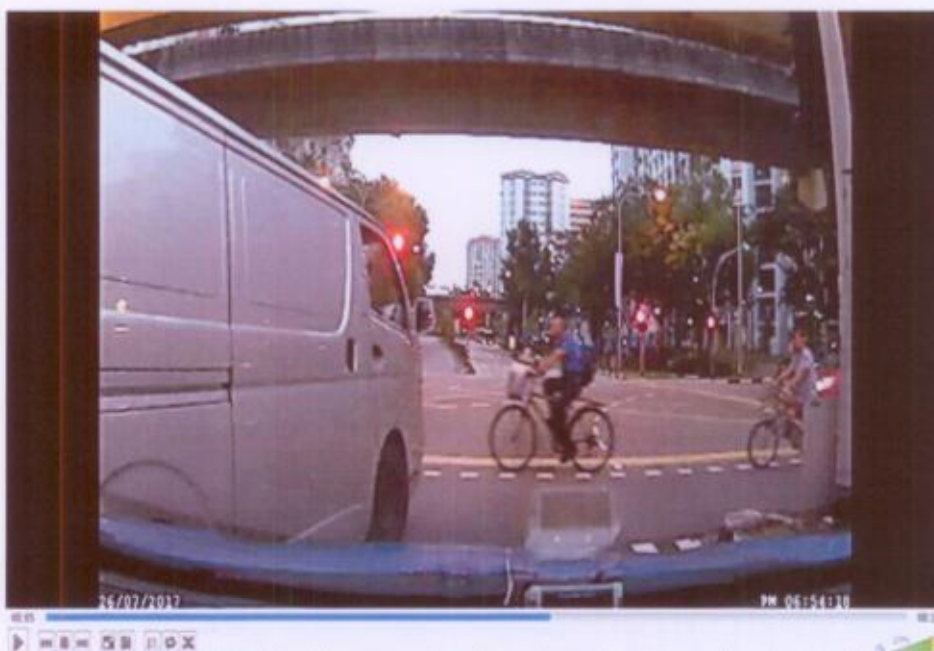
12. The video recordings that were provided to us in preparation of this report were taken from a video recording device that was mounted onto the front windscreen of the Taxi. The recordings showed the events before the accident and the accident itself. The length (duration) indicated in the 1st video recording was 10 seconds. The length (duration) indicated in the 2nd video recording was 8 seconds.
13. From the 1st video recording, the Taxi can be seen waiting to turn right into Rivervale Drive at the traffic junction of Sengkang East Way on the 1st lane at the 1 second mark. The rest of the duration of the video shows the Van approaching the traffic junction and the driver positioning the Van towards the right, close to the Taxi. See screenshots 1 & 2 below.

Screenshot 2 of the 1st video recording from the video recording device that was mounted onto the front windscreen of the Taxi shows the Van approaching the traffic junction and the driver positioning the Van towards the right, close to the Taxi from the 2 second mark till the end of the duration of the video.

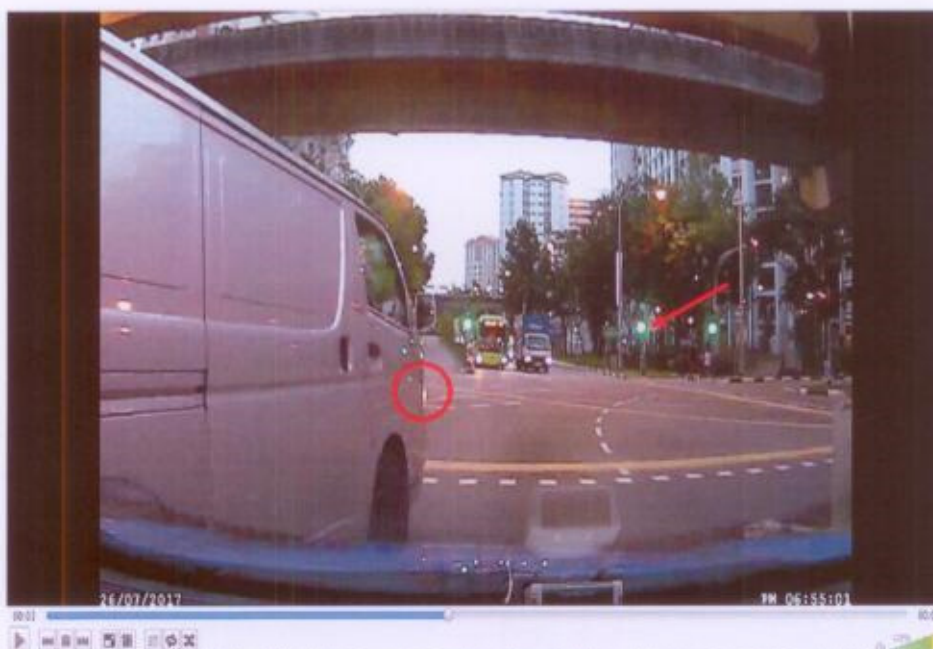
Screenshot 3 of the 2nd video recording from the video recording device that was mounted onto the front windscreen of the Taxi shows the Van trying to overtake the Taxi to turn right with the right turn signal indicator turned on (circled) once the traffic light turned green at the 3 second mark (arrowed).

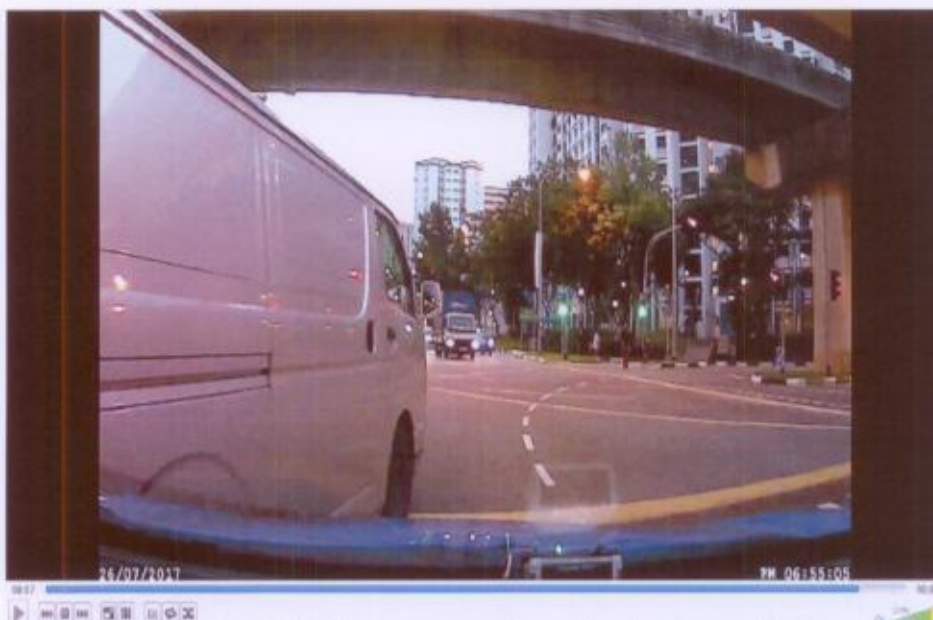
14. From the 2nd video recording, the Van can be seen trying to overtake the Taxi to turn right with the right turn signal indicator turned on as soon as the traffic light turned green at the 3 second mark. The Taxi can be seen inching forward. At the 7 second mark of the video recording, we had noted a slight movement (jerk like movement) of the Taxi as well as the Van. This was as the Involved Motor Vehicles were moving forward to turn right at the junction. The capturing of this slight movement by the video recording device that was mounted onto the front windscreen of the Taxi is a sign that there was a jerk like movement to the Taxi itself. Ultimately, indicating that there was contact between the left front portion of the Taxi and the right rear portion of the Van. However one would have to view the recording to see this slight movement. See screenshots 3 and 4 below.

Screenshot 4 of the 2nd video recording from the video recording device that was mounted onto the front windscreen of the Taxi shows a slight movement (jerk like movement) of the Taxi as well as the Van at the 7 second mark. This was as the Involved Motor Vehicles were moving forward to turn right at the junction.

15. For this case, based on the nature of damages of grazing nature to the left front portion of the Taxi and the rear right portion of the Van as well as close examination of the video recordings provided to us, it would appear that the point of contact between the Involved Motor Vehicles would be the left front portion of the Taxi and the rear right portion of the Van as the Van was trying to overtake the Taxi which was on the 1st lane, to turn right at the traffic junction.

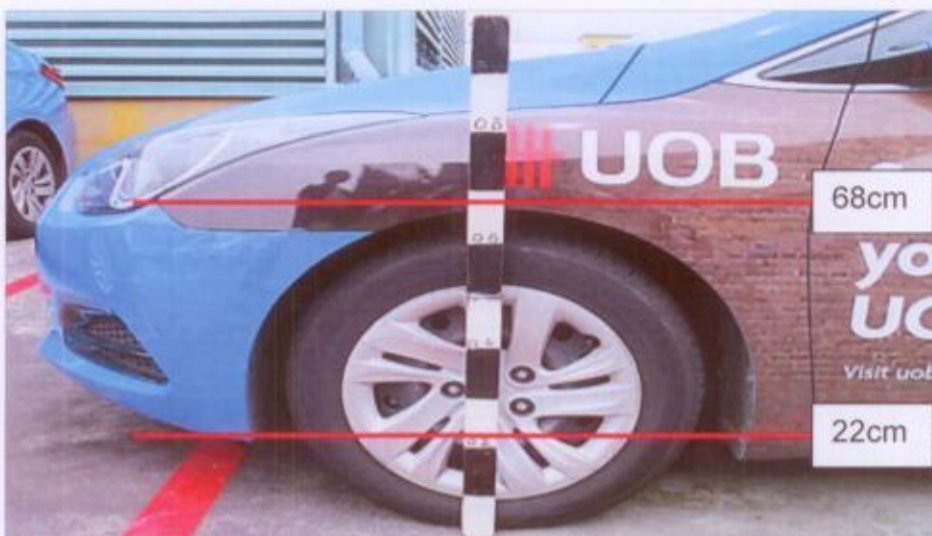
Photo 12 shows the height measurement being conducted on the left front portion of the Taxi (using a similar make and model). The height above ground level of the paint graze marks was between the ranges of 22cm to 68cm.

- a) the height above ground level of the paint graze marks on the front left portion of the Taxi was measured to be approximately between 22cm to 68cm;
- b) the height above ground level of the paint graze marks and several paint scratch marks on the front portion of the rear right wheel fender of the Van was measured to be approximately between 52cm to 68cm;
- c) the height measurements appear to support the findings of possible contact between the left front portion of the Taxi and the rear right portion of the Van. The damage observed on the left front portion of the Taxi was a result of this contact and corresponds to the damage observed on the rear right portion of the Van.

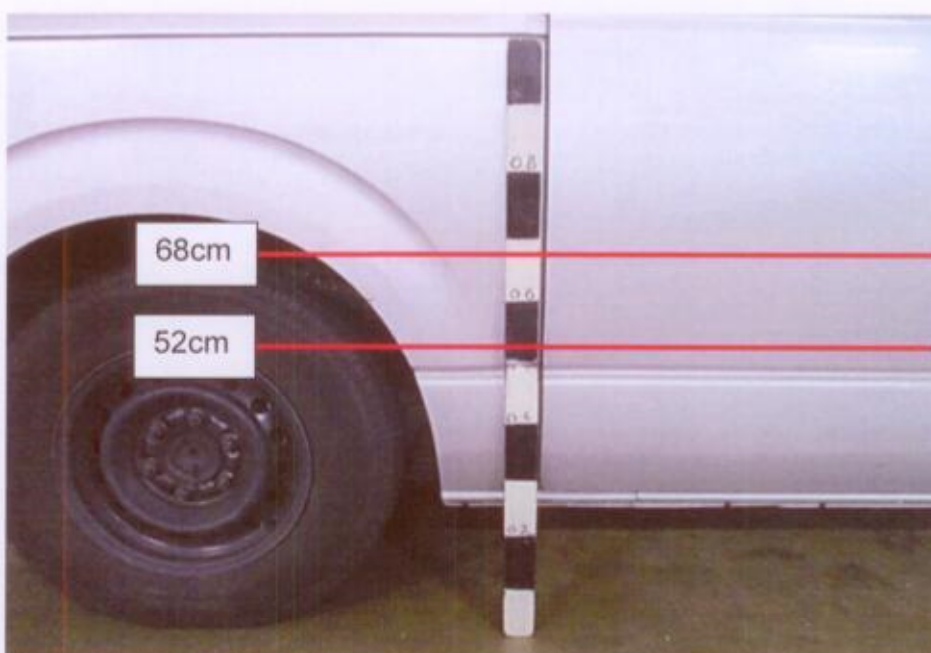
Photo 13 shows the height measurement being conducted on the rear right portion of the Van. The paint graze marks and several paint scratch marks found on the front portion of the rear right wheel fender are between 52cm and 68cm above ground level.
