Your Ref: 539536
Our Ref : CS/MSG17023436/N

15 December 2017

**TECHNICAL INVESTIGATION REPORT OF FIRE INCIDENT INVOLVING THE
INSURED VEHICLE SJH 5370M ON 1 DECEMBER 2017**

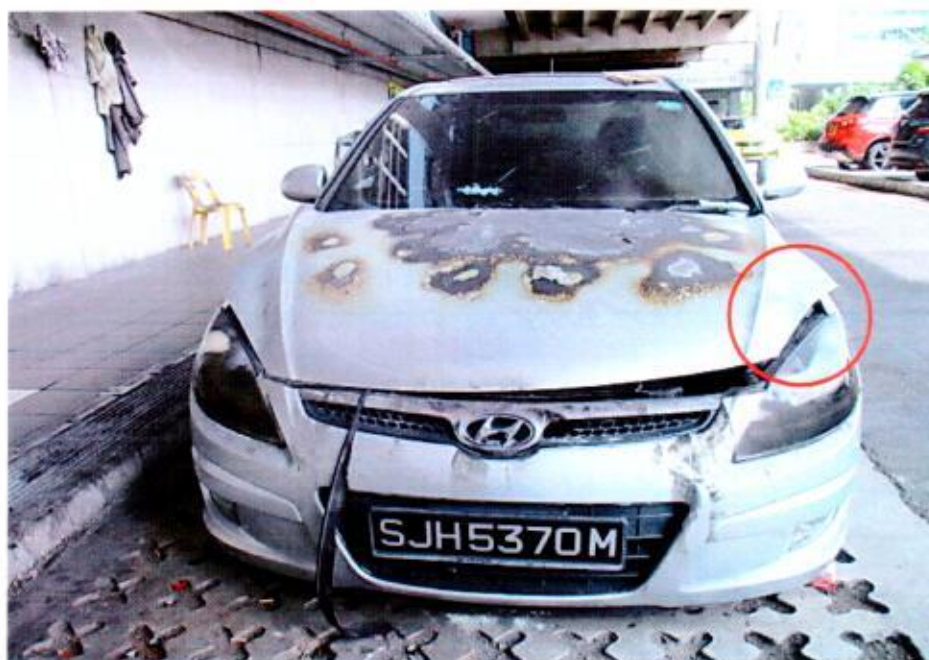
Photo 1 shows the general view of the front portion of the Insured Vehicle at the time of our inspection. The fire damage to the Insured Vehicle was confined to its front portion. Its front bonnet, front grille, front windscreen, front windscreen wipers, front left tyre, front left wheel rim, right side panel, left side panel and dashboard were amongst the body parts that were found to have been affected as a result of the fire. The left side of the front bonnet of the Insured Vehicle was slightly buckled (circled), likely due to rescue damage.

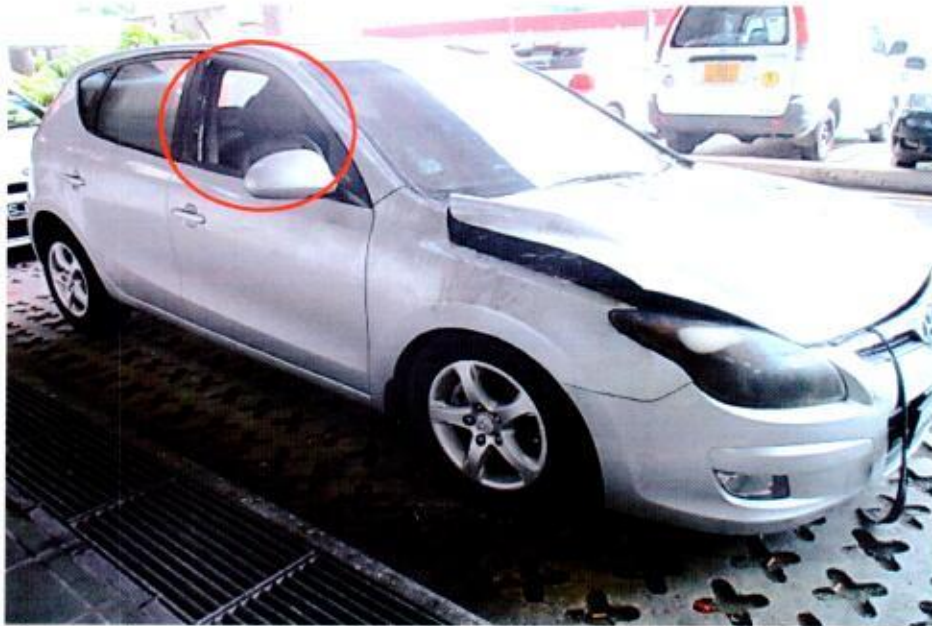
Photo 2 shows the general view of the right side of the Insured Vehicle at the time of our inspection. The fire damage to the Insured Vehicle was confined to its front portion. Its front bonnet, right side panel and right headlight were amongst the body parts that were found to have been affected as a result of the fire. The driver window glass was observed to be smashed (circled).

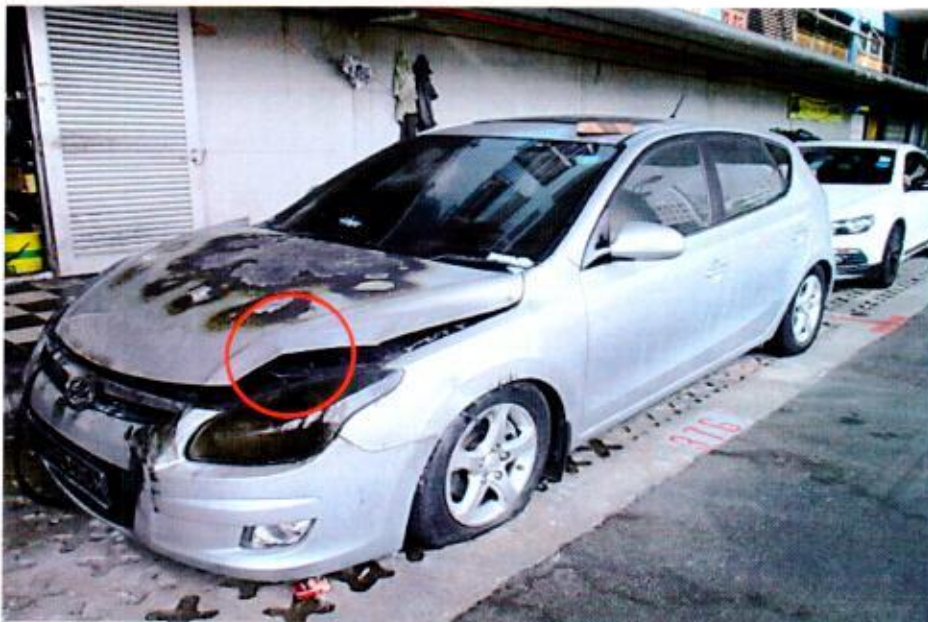
Photo 3 shows the general view of the left side of the Insured Vehicle at the time of our inspection. The fire damage to the Insured Vehicle was confined to its front portion. Its front bonnet, left side panel, left headlight, front left tyre and front left wheel rim were amongst the body parts that were found to have been affected as a result of the fire. The left side of the front bonnet of the Insured Vehicle was slightly buckled (circled), likely due to rescue damage.

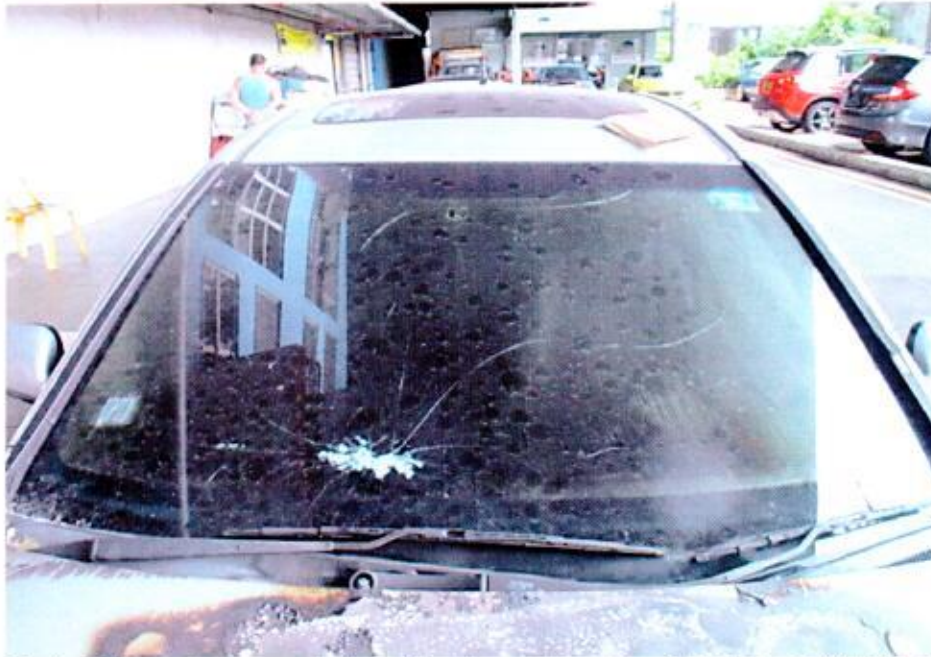
Photo 4 shows the general view of the front windscreen of the Insured Vehicle at the time of our inspection. The fire damage to the Insured Vehicle was confined to its front portion. Its front windscreen, front windscreen wipers, front wiper panel garnish and front windscreen water nozzles were amongst the body parts that were found to have been affected as a result of the fire.

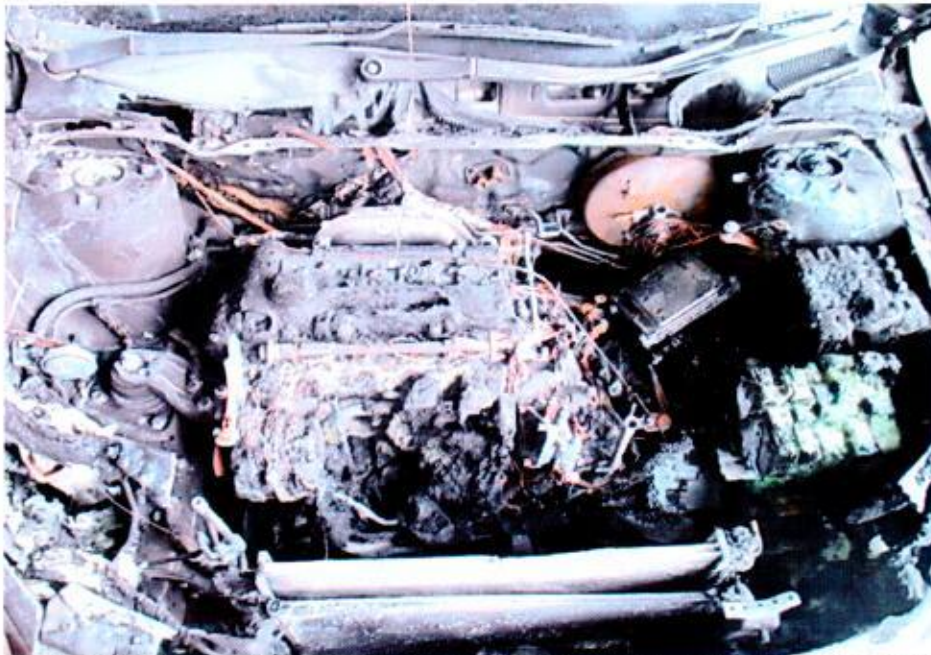
Photo 5 shows the engine compartment of the Insured Vehicle at the time of our inspection. The entire engine compartment of the Insured Vehicle was observed to be severely burnt. Most of the parts inside the engine compartment were found to be burnt and/or melted as a result of the fire.

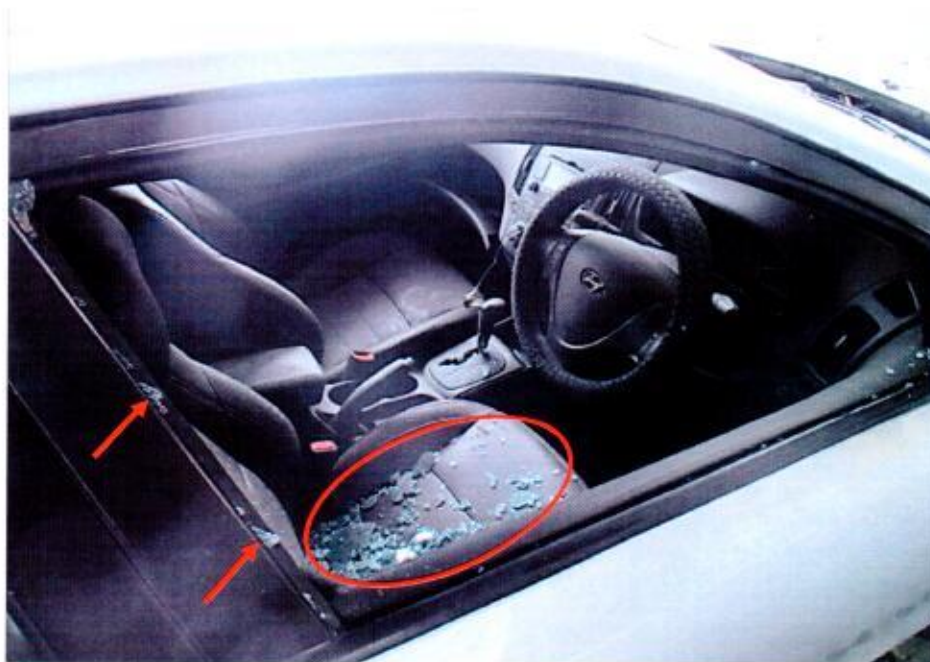
Photo 6 shows the interior compartment of the Insured Vehicle, which was observed to be partially burnt and/or melted. The dashboard and front windscreen were amongst the parts that were found to have been partially burnt and/or melted as a result of the fire. The driver window glass was observed to be smashed. Upon closer inspection, we found glass shards on the edges of the driver window (red arrows) as well as on the driver seat (circled).

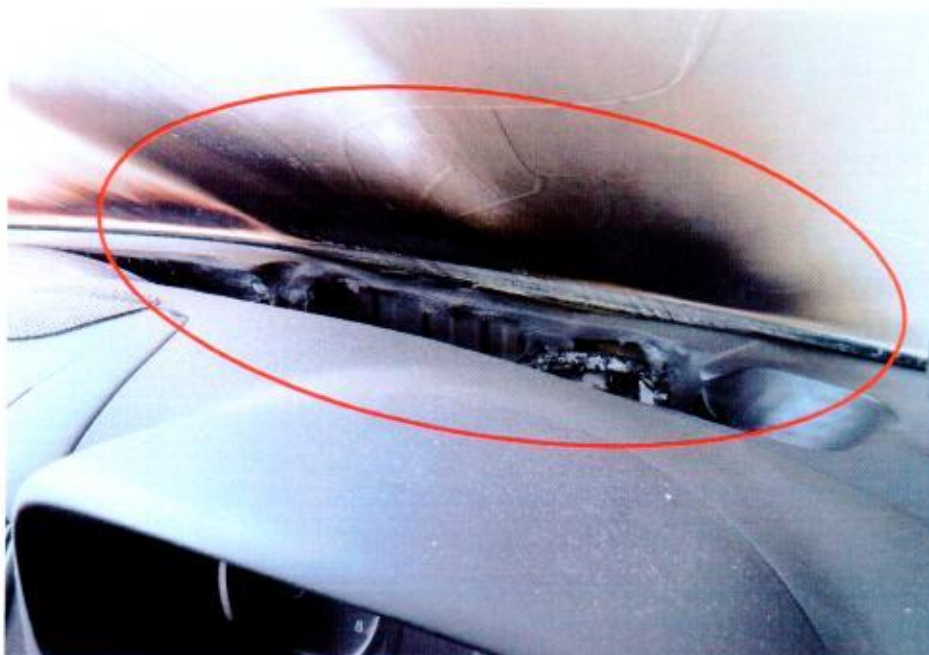
Photo 7 shows a closer view of the damaged front windscreen and dashboard (circled) of the Insured Vehicle (as viewed from the interior compartment).

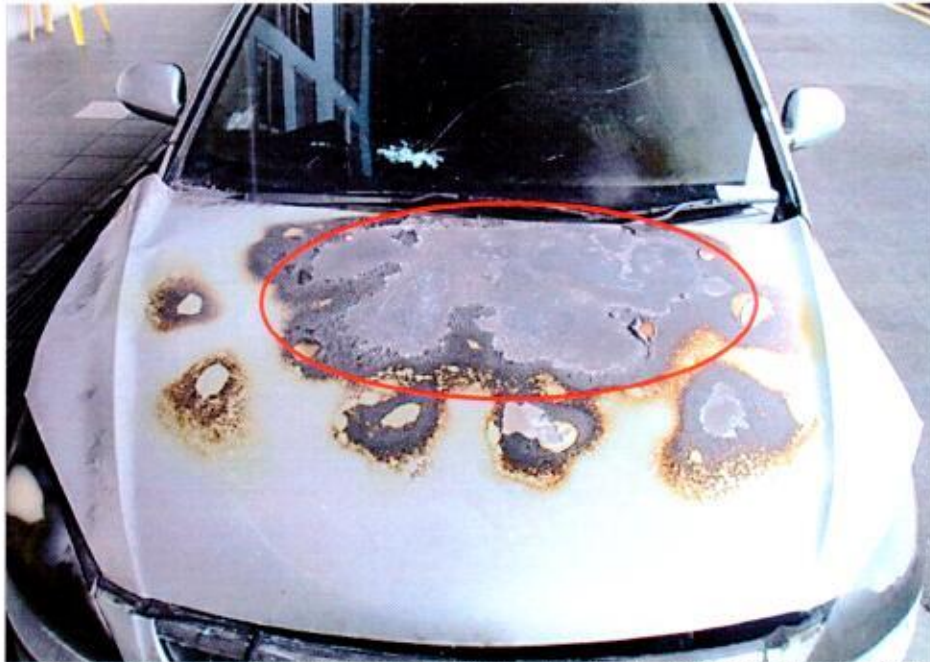
8. For this particular case, the fire appears to have originated within the engine compartment of the Insured Vehicle, somewhere around the centre portion of the engine compartment. This can be determined from the burn pattern and the high heat intensity burn marks (whitish burn marks) found on the centre portion of the front bonnet of the Insured Vehicle and also the rust that had developed on the underside of the front bonnet, at the centre area.

9. The whitish burn marks are a result of exposure to prolonged heat intensity. Rust would normally start to develop around these areas soon after a fire as prolonged exposure to high heat intensity usually causes steel/metal material body parts to be exposed to natural environmental condition. The rust that had developed on the underside of the front bonnet, around the centre area, is an indication that the centre portion of the engine compartment had sustained exposure to prolonged high heat intensity.

Photo 8 shows the burn pattern and whitish burn marks (circled) that were found on the centre portion of the front bonnet of the Insured Vehicle. Such whitish burn marks are a result of exposure to prolonged heat intensity, which may indicate where the fire had started. Rust would also begin to develop on these areas soon after the fire.

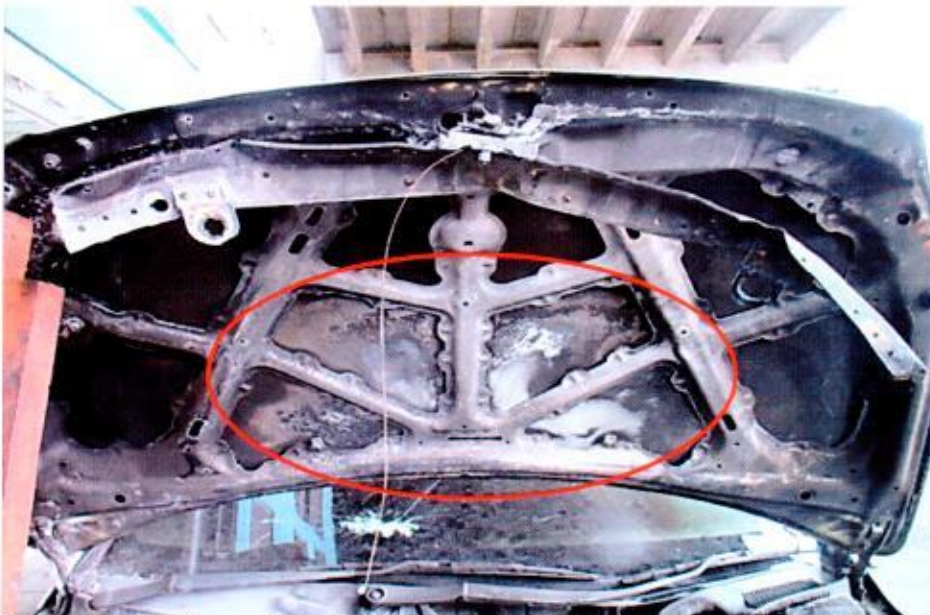
Photo 9 shows the rust (circled) that had developed on the underside of the front bonnet, around the centre area. The development of rust is an indication that the area was exposed to prolonged exposure to high heat intensity, which had caused the steel/metal material of the front bonnet to be exposed to natural environmental condition. Hence the fire to the Insured Vehicle can be determined to have originated towards the centre portion of the engine compartment.

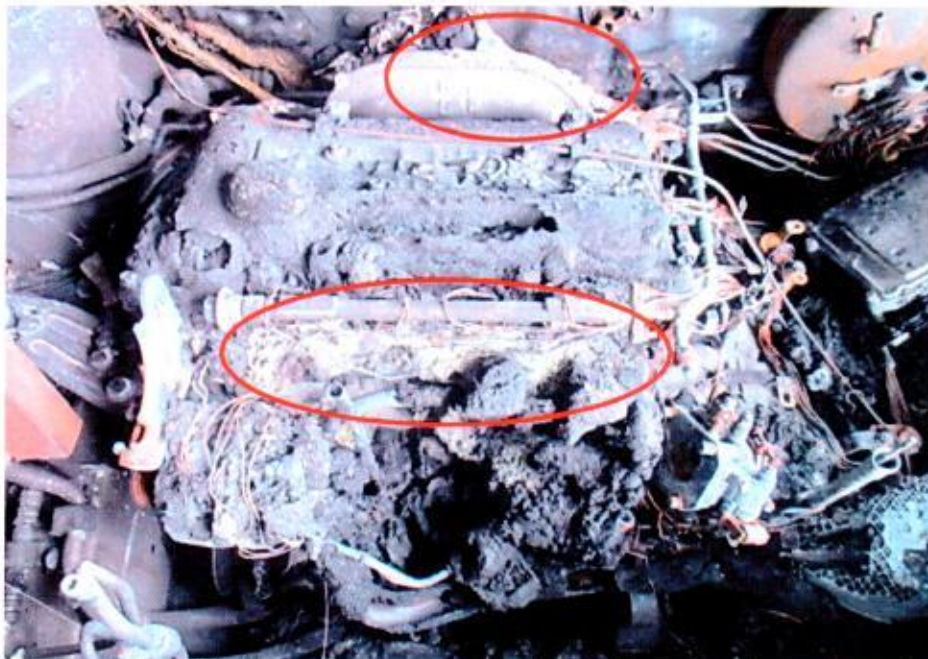
10. Furthermore, we found fire extinguisher residue around these areas. In general the location of the fires' origin was determined given that the damage of fire nature was confined to these particular areas on the Insured Vehicle. See photos 8 - 10 below.

Photo 10 shows the fire extinguisher residue (circled) found on the centre portion of the engine compartment of the Insured Vehicle. The nature of fire damage is an indication as to where the fire started.

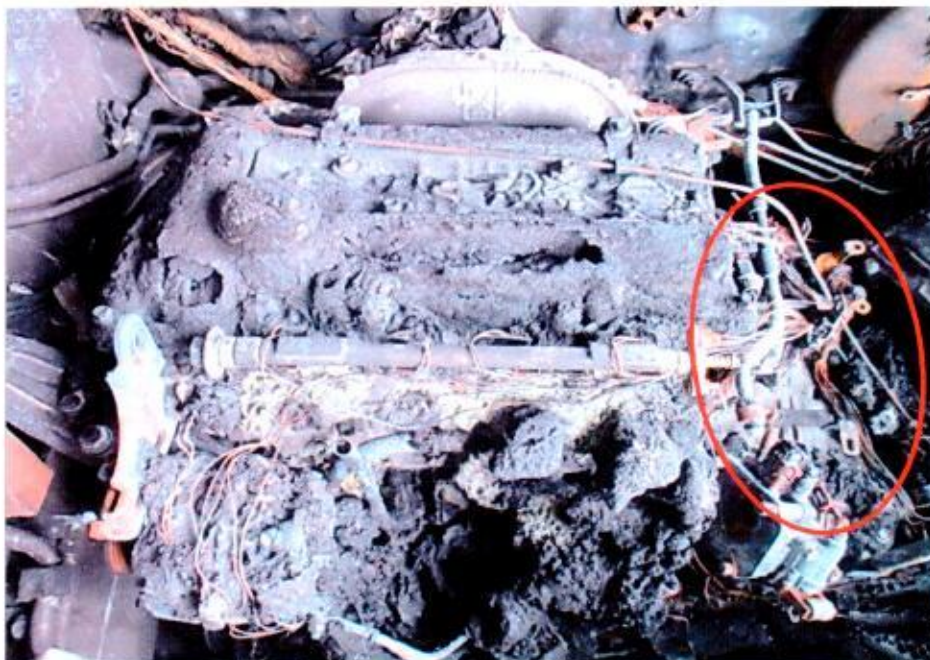
11. Upon closer examination of the centre portion of the engine compartment, which was where the fire to the Insured Vehicle had likely started, we had found traces of greenish residue on several stretches of burnt wirings. The presence of greenish residue indicates internal heating of copper wires, a sign of an electrical short circuit occurring. The greenish residue is normally left behind from oxidation as a result of chemical reaction involving the copper wires. This physical evidence would then appear to suggest that the cause of fire to the Insured Vehicle could have possibly been due to electrical in nature. See photos 11 - 14 below.

Photo 11 shows a view of the centre portion of the engine compartment which is where the fire to the Insured Vehicle had likely started. We observed greenish residue on some of the wirings (circled) at the centre portion of the engine compartment.

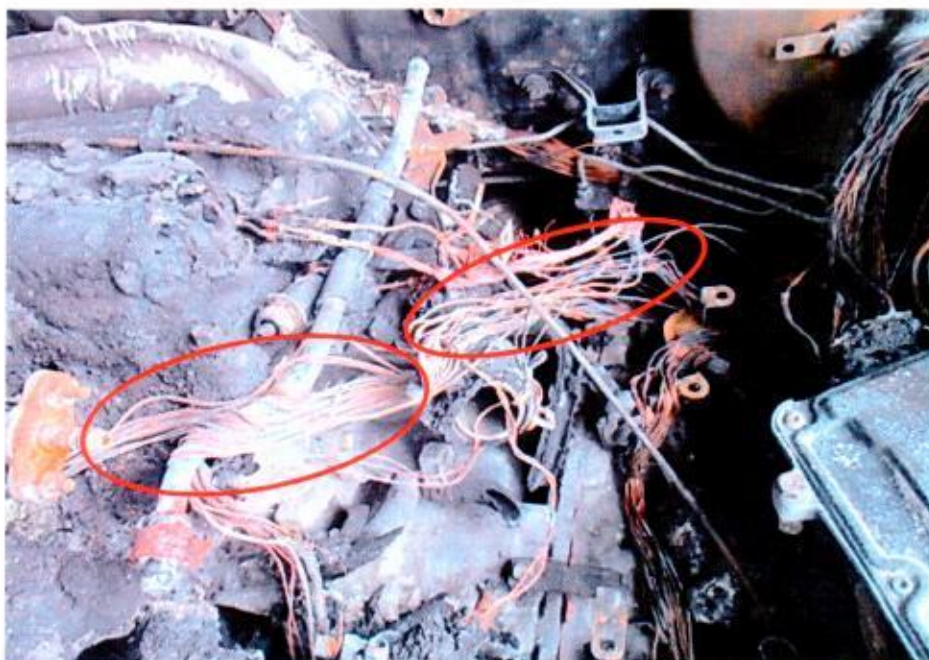
Photo 12 shows a closer view of the greenish residue found on some of the wirings (circled) at the centre portion of the engine compartment. The presence of such greenish residue suggests occurrence of an electrical short circuit.

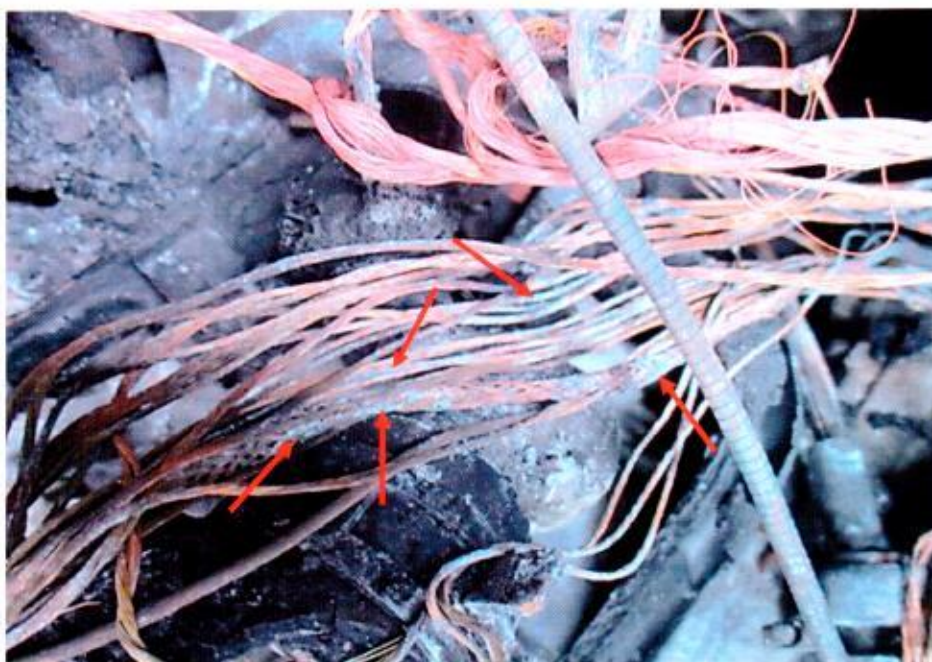
Photo 13 shows a close up view of the greenish residue found on some of the wirings (red arrows) at the centre portion of the engine compartment. The presence of such greenish residue suggests occurrence of an electrical short circuit.

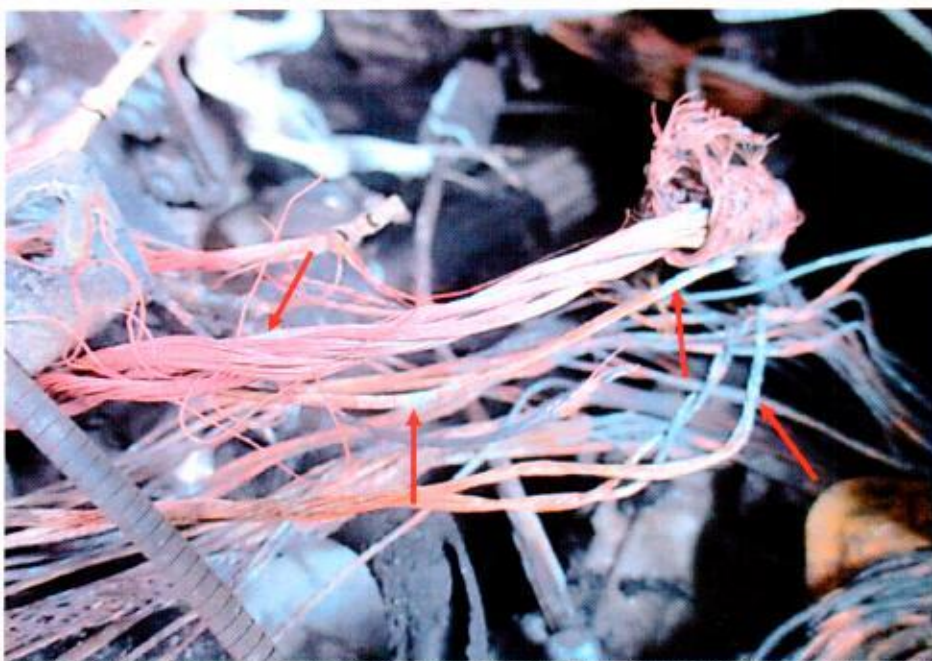
Photo 14 shows a close up view of the greenish residue found on some of the wirings (circled) at the centre portion of the engine compartment. The presence of such greenish residue suggests occurrence of an electrical short circuit.

37. Having investigated and technically analysed the damages to the Insured Vehicle, we are of the view that the cause of fire to the Insured Vehicle was of electrical in nature. For this particular case, the fire had originated along the wirings inside the engine compartment, somewhere around the centre portion. The wirings were original factory wirings of the Insured Vehicle.

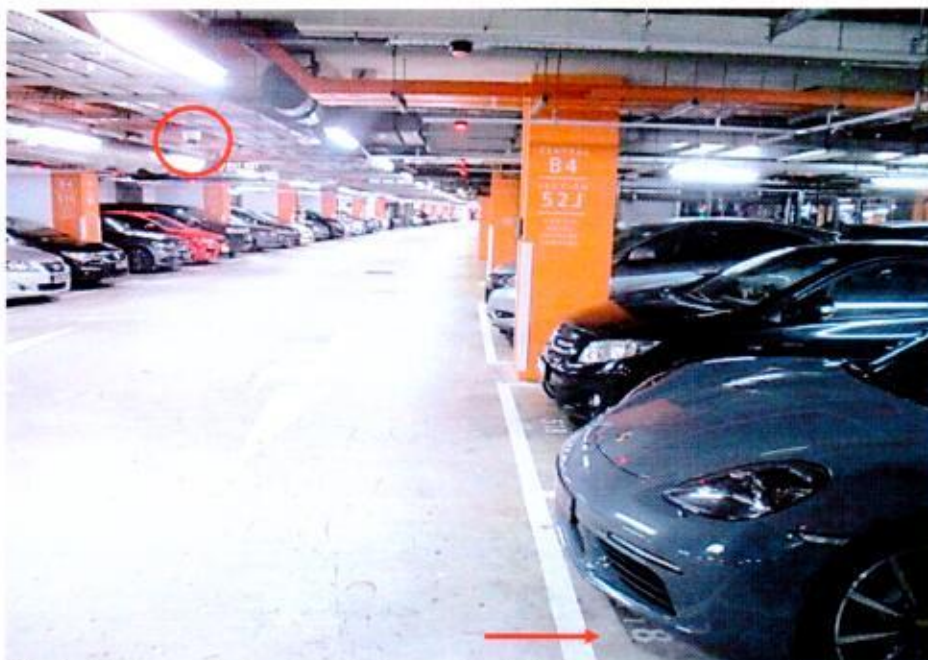
Photo 15 shows the basement 4 carpark which spans over an area that connects the Convention Centre to the Mastercard Theatre. Mr Chia had parked the Insured Vehicle at lot 518 which is nearer to the Mastercard Theatre. Lot 518 was observed to be the middle lot (arrowed). We noticed the incident location was monitored by CCTV camera(s) (circled) however we were unable to view the footage without a written request to the Marina Bay Sands management.

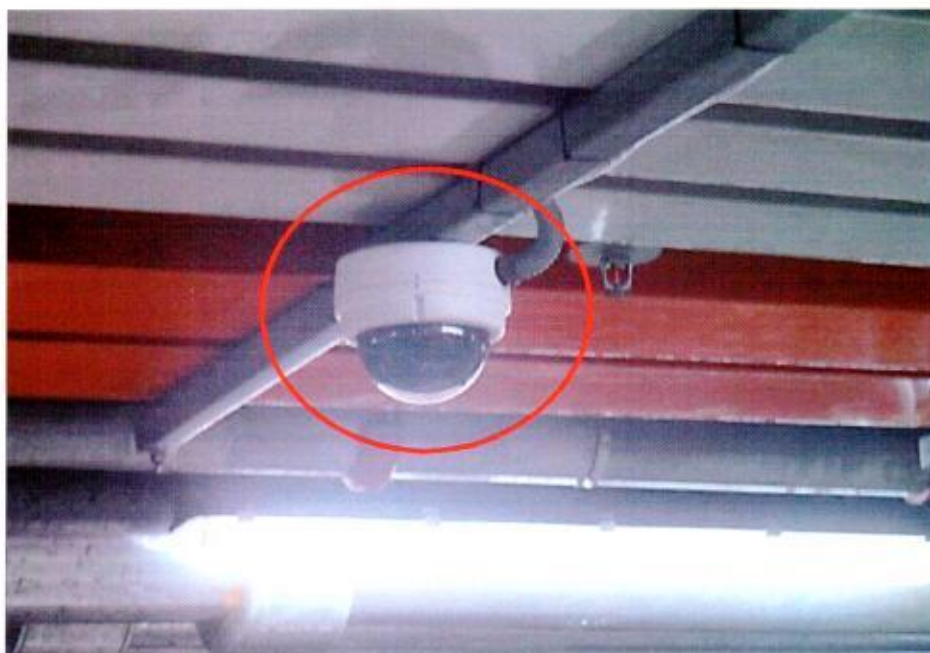
Photo 16 shows a closer view of the CCTV camera(s) (circled) at the incident location however we were unable to view the footage without a written request to the Marina Bay Sands management.

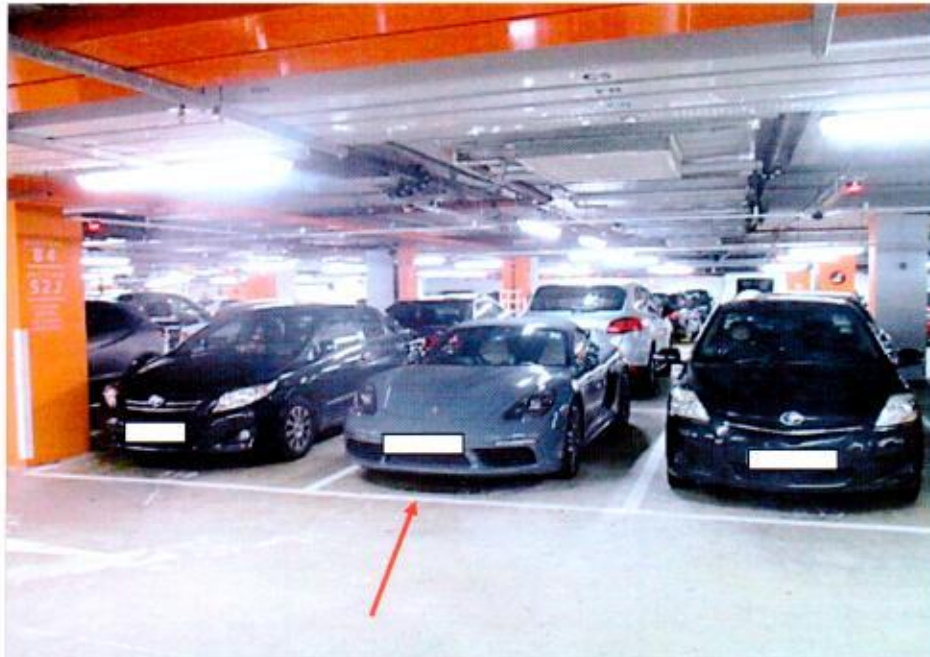
Photo 17 shows Mr Chia had parked the Insured Vehicle at lot 518 which is nearer to the Mastercard Theatre. Lot 518 was observed to be the middle lot (arrowed).

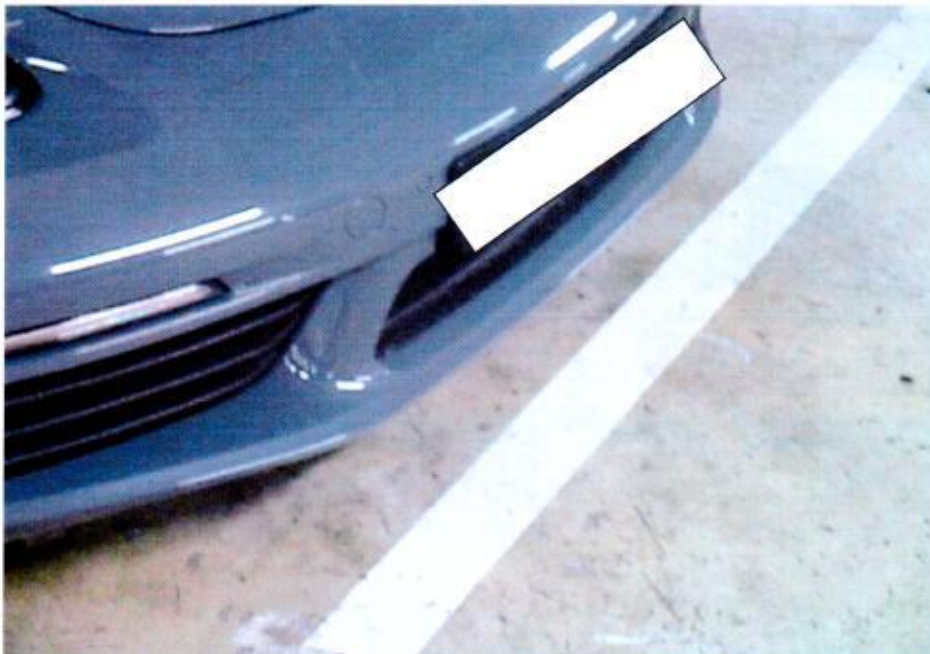
Photo 18 shows a close up view of lot 518 where the Insured Vehicle was parked on the day of incident. At the time of our visit, we did not find any burnt marks and/or burnt residual remains on the ground as there was a parked vehicle at the aforementioned lot.

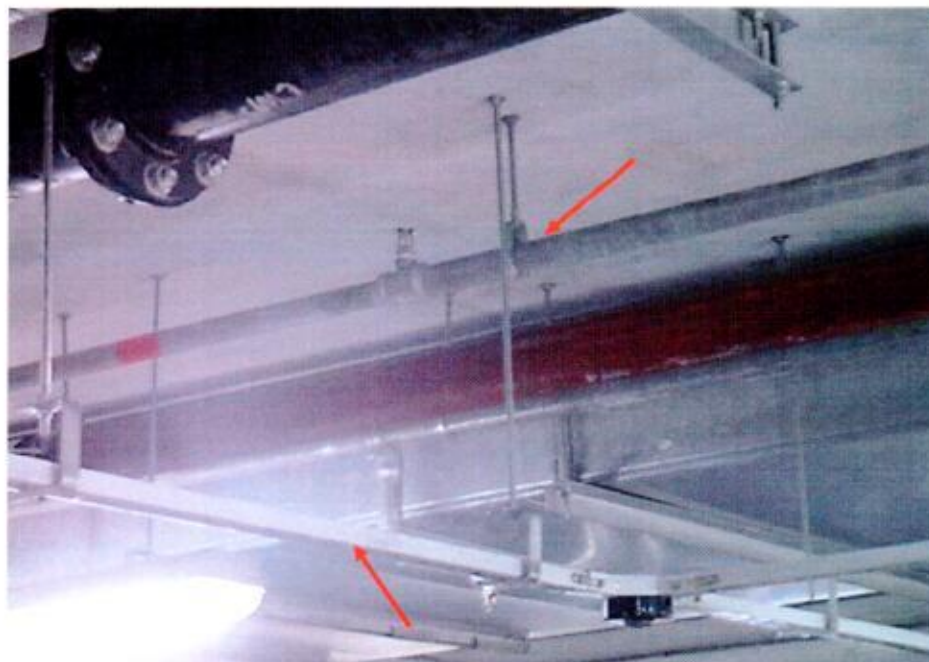
Photo 19 shows although we did not find any burnt marks and/or burnt residual remains on the ground where the Insured Vehicle was parked as there was a parked vehicle at the aforementioned lot at the time of our visit, we observed that the piping and metal railings above the lot where the Insured Vehicle was parked were blackened by soot (red arrows).

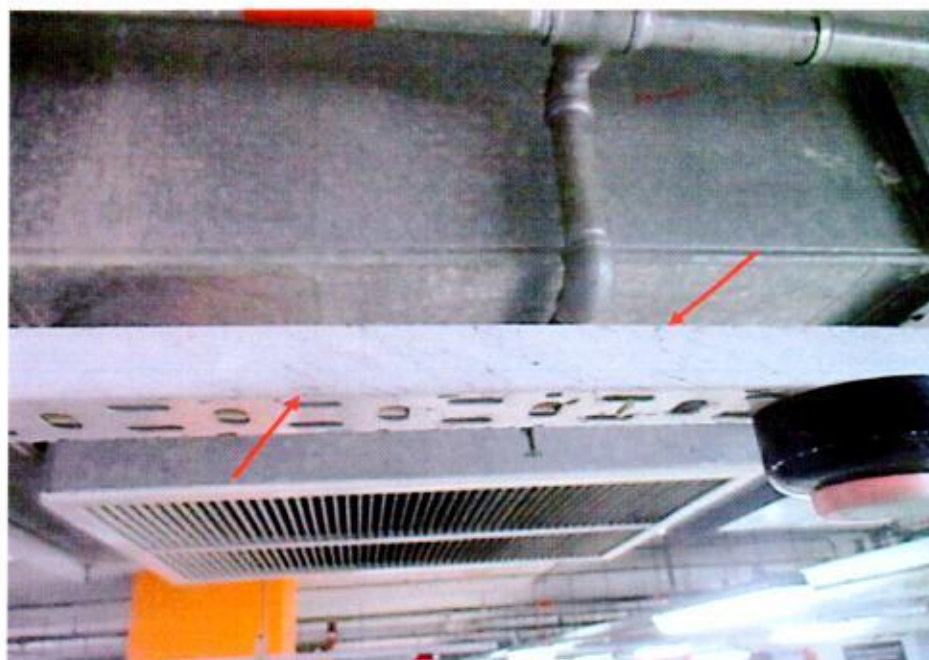
Photo 20 shows a close up view of a metal railing above the lot where the Insured Vehicle was parked blackened by soot (red arrows).

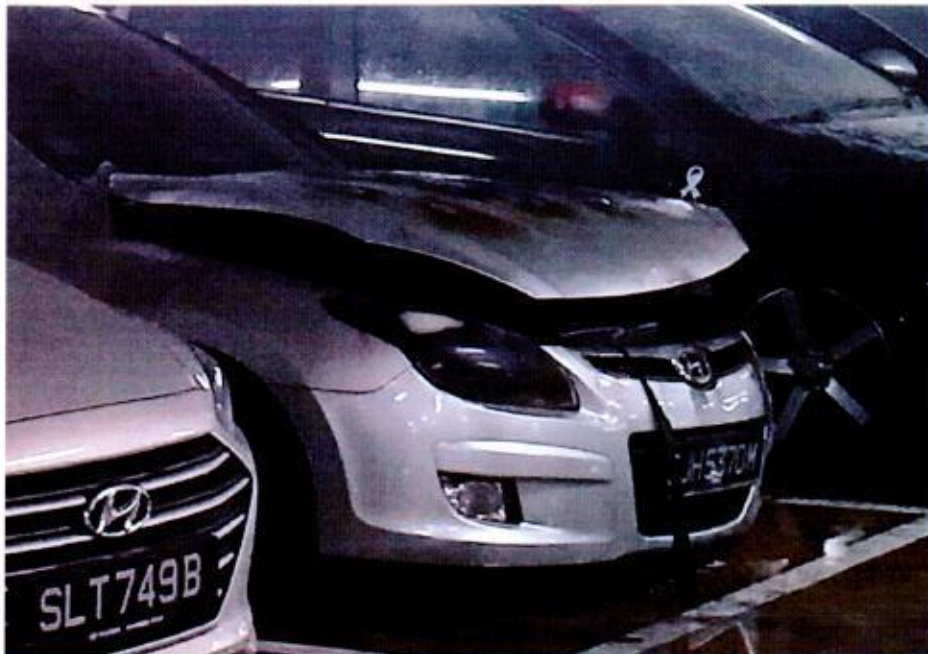
Photo 21 shows the Insured Vehicle after the fire was extinguished. In general, the information that could be gathered from this photograph had corresponded to the events that were related to us by Mr Chia, which is the Insured Vehicle was parked in the middle lot when the fire occurred.

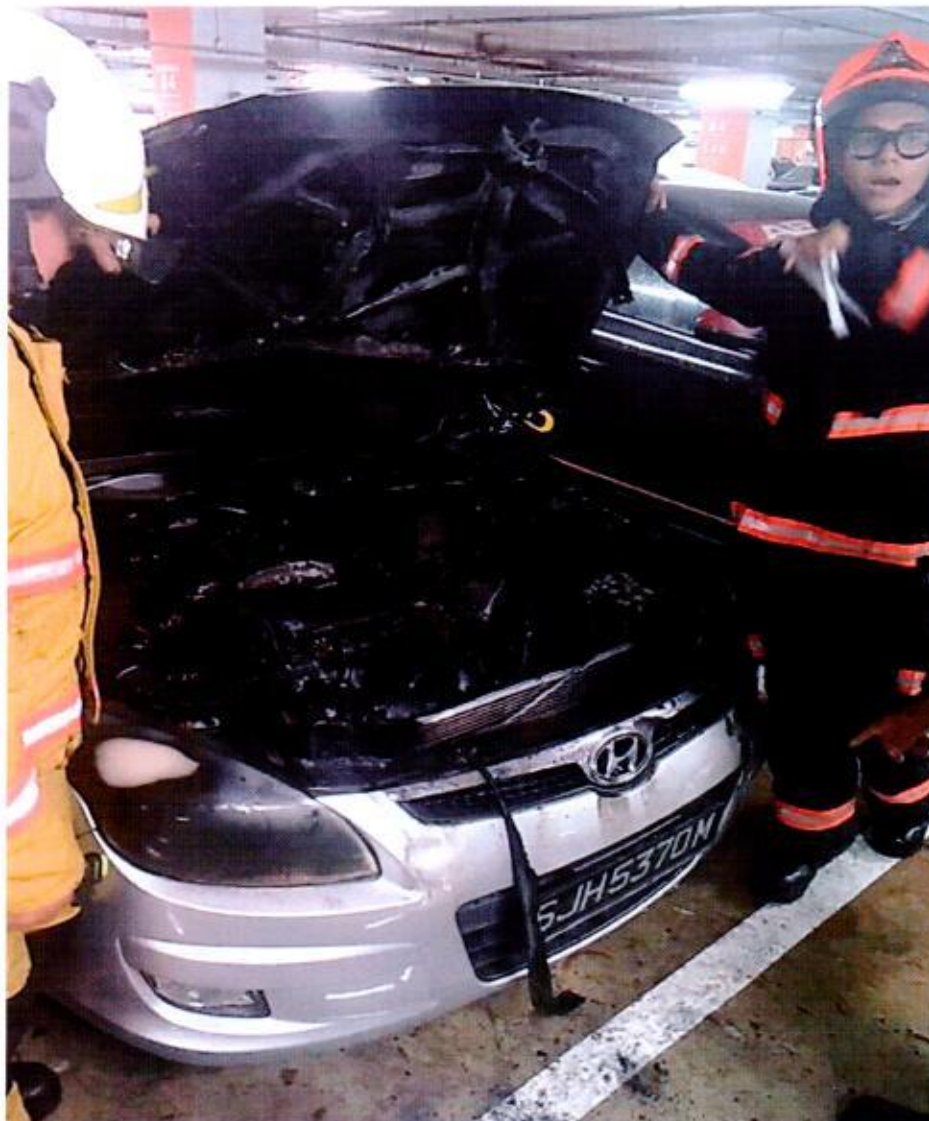
Photo 22 shows the front portion of the Insured Vehicle after the fire was extinguished. The extensive damages observed had corresponded to the events that were related to us by Mr Chia, which is the fire had started from the engine compartment and that the front bonnet was pried open by the SCDF to gain access to the engine bay.

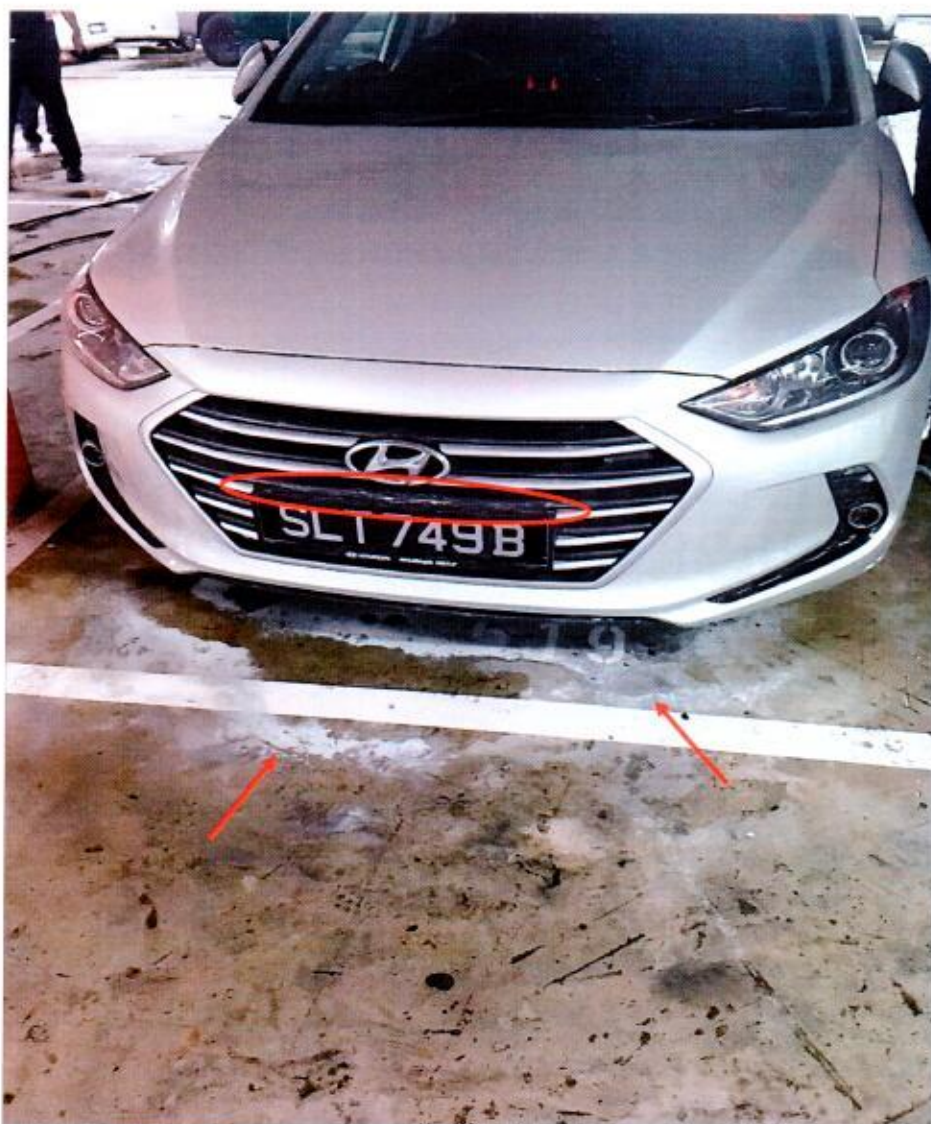
Photo 23 shows the vehicle parked at lot 519 which was to the right of the Insured Vehicle at the time of incident. We observed fire extinguisher residue on the top portion of its front number plate frame (circled) and ash on the ground (red arrows). In general, the information that could be gathered from this photograph had corresponded to the events that were related to us by Mr Chia, which is the vehicles parked within closest proximity to the Insured Vehicle at the time of incident were covered in fire extinguisher residue, ash and soot. However there was no obvious consequential damage sustained.

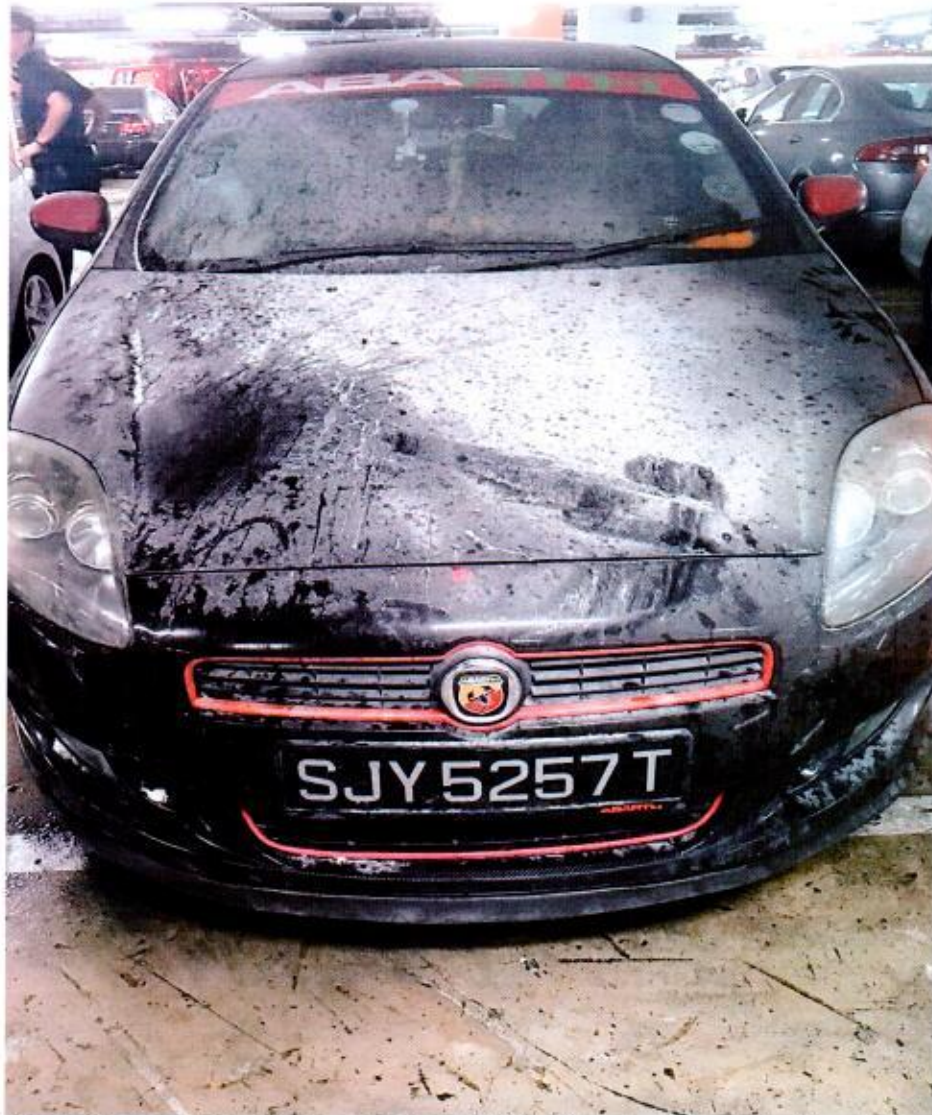
Photo 24 shows the vehicle parked at lot 517 which was to the left of the Insured Vehicle at the time of incident. The front portion was covered with fire extinguisher residue, ash and soot. In general, the information that could be gathered from this photograph had corresponded to the events that were related to us by Mr Chia, which is the vehicles parked within closest proximity to the Insured Vehicle at the time of incident were covered in fire extinguisher residue, ash and soot. However there was no obvious consequential damage sustained.
