NTUC INCOME INSURANCE CO-OPERATIVE LTD Ref: NS/INC17023612/K1rbn2

1. Policy Particulars :- THIRD PARTY CLAIM

Insured Veh.	GBD 4397J	Veh. Inspected	SH 7284J
Policy No.	5074898191-02	Coverage (\$)	0.00
Claim No.	MT/0973067-002	Excess (\$)	0.00
Assign From		Assign Date	12/12/2017

ADJUSTMENT ON REPAIR COST FOR VEHICLE NO. SH 7284J

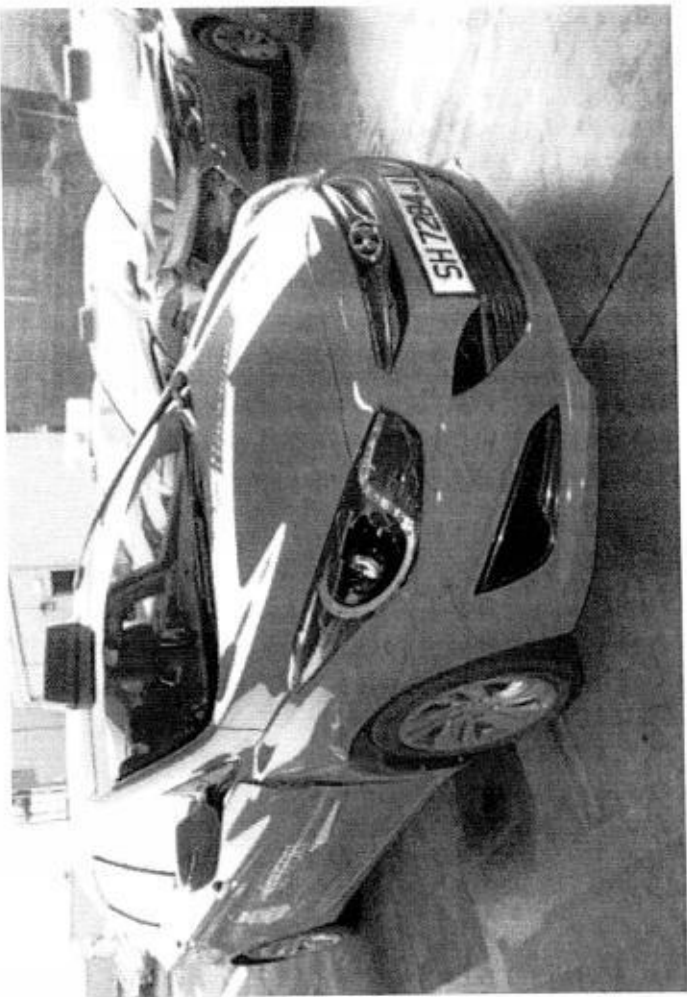
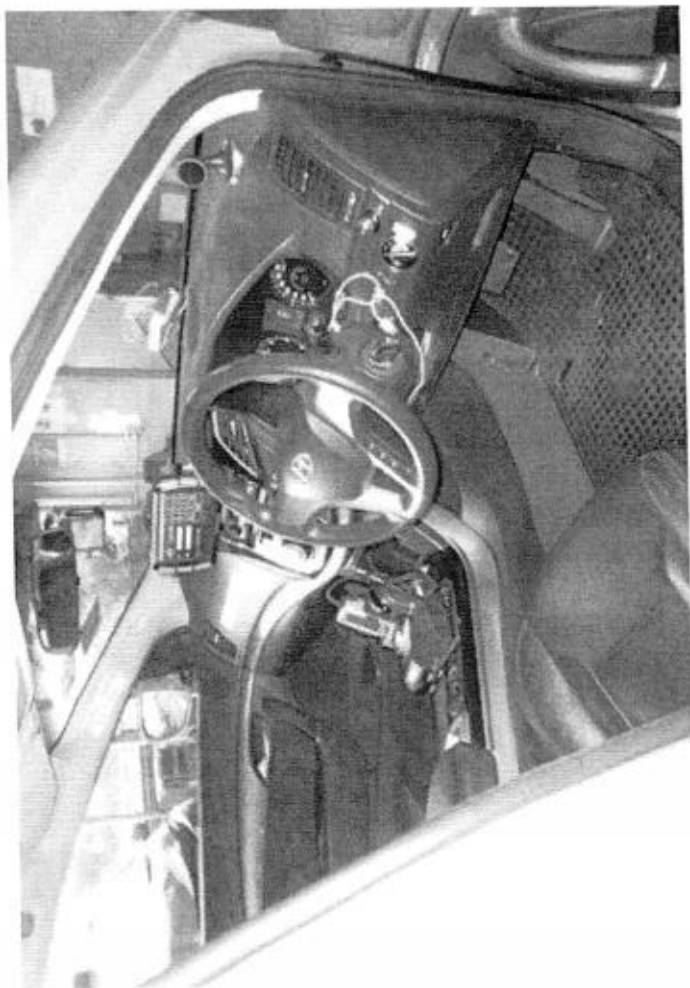
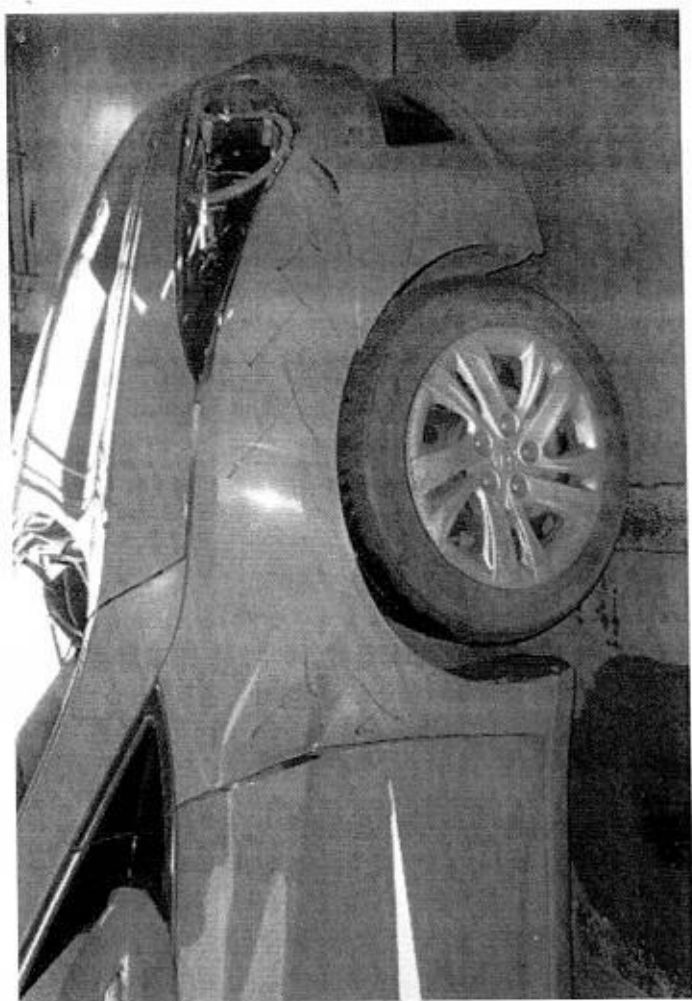
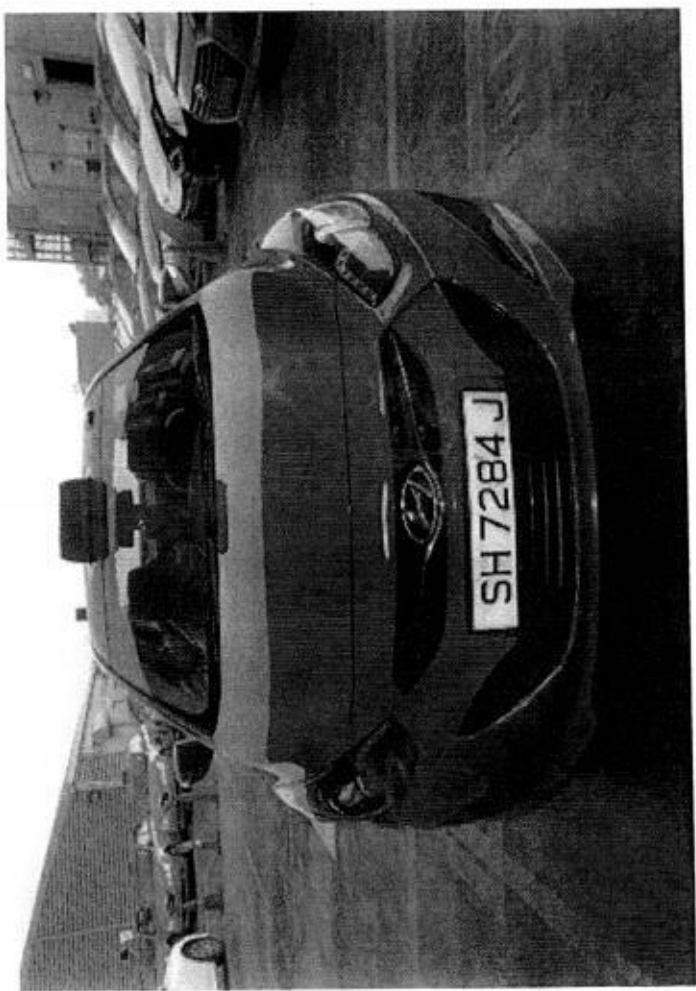
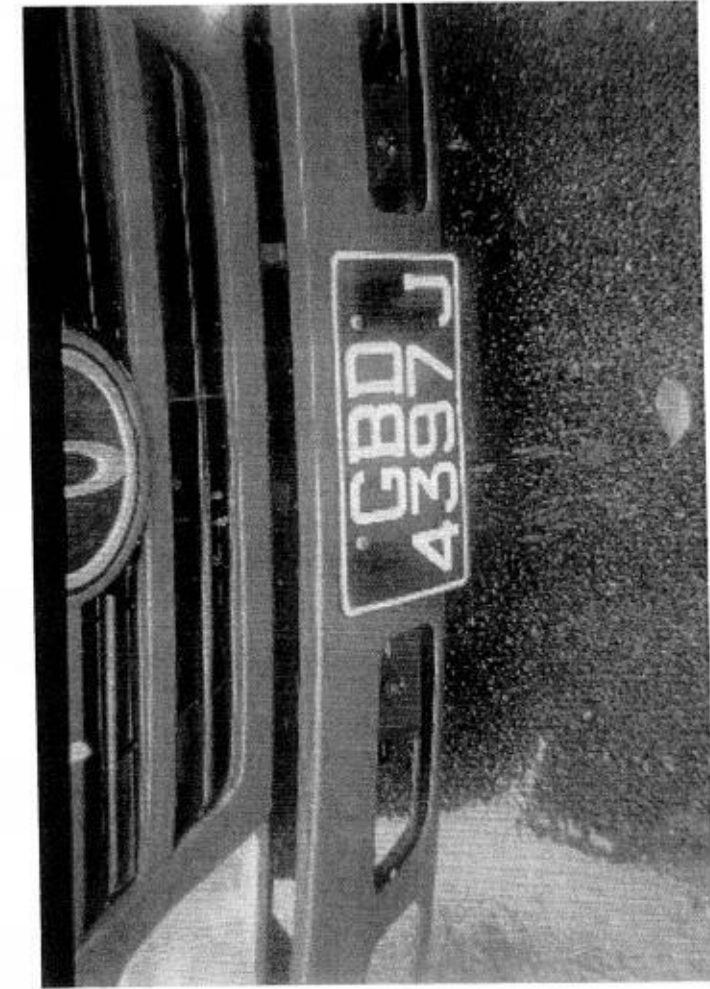
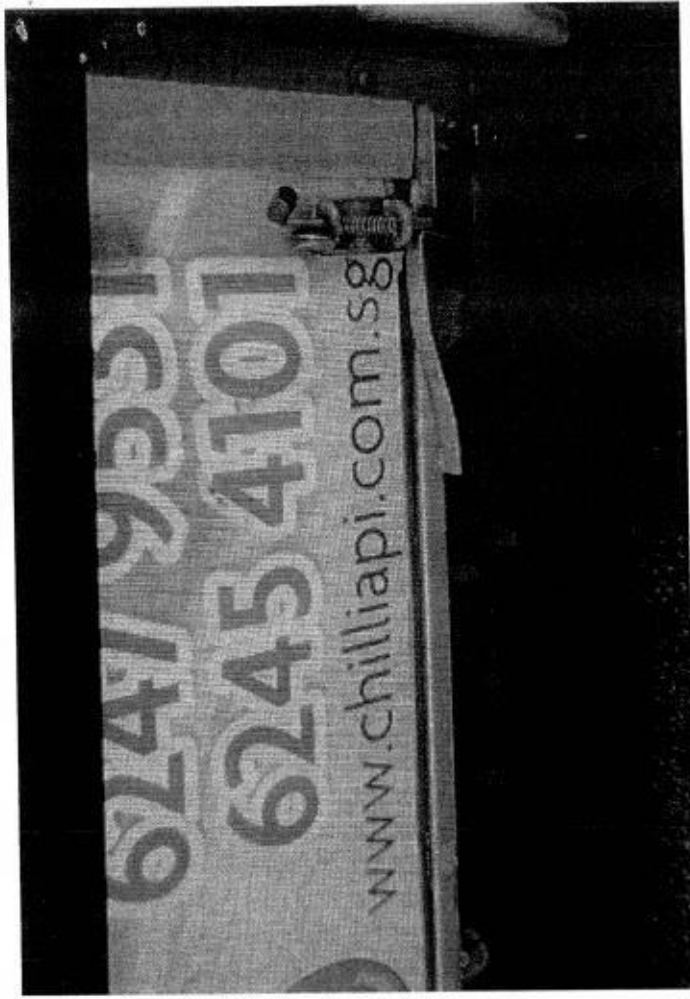
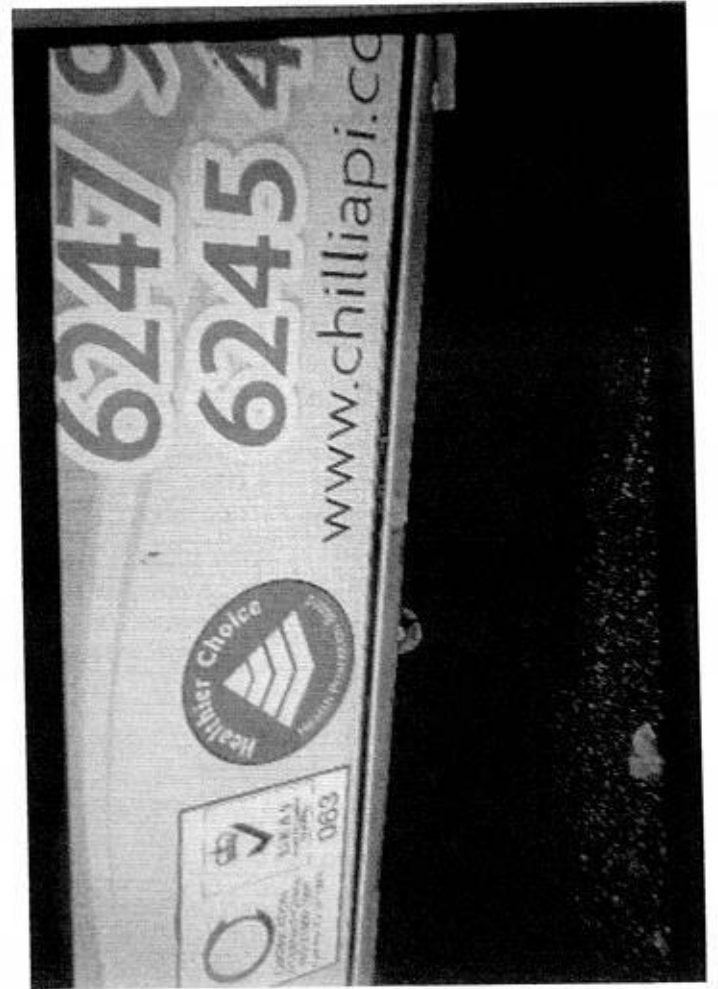
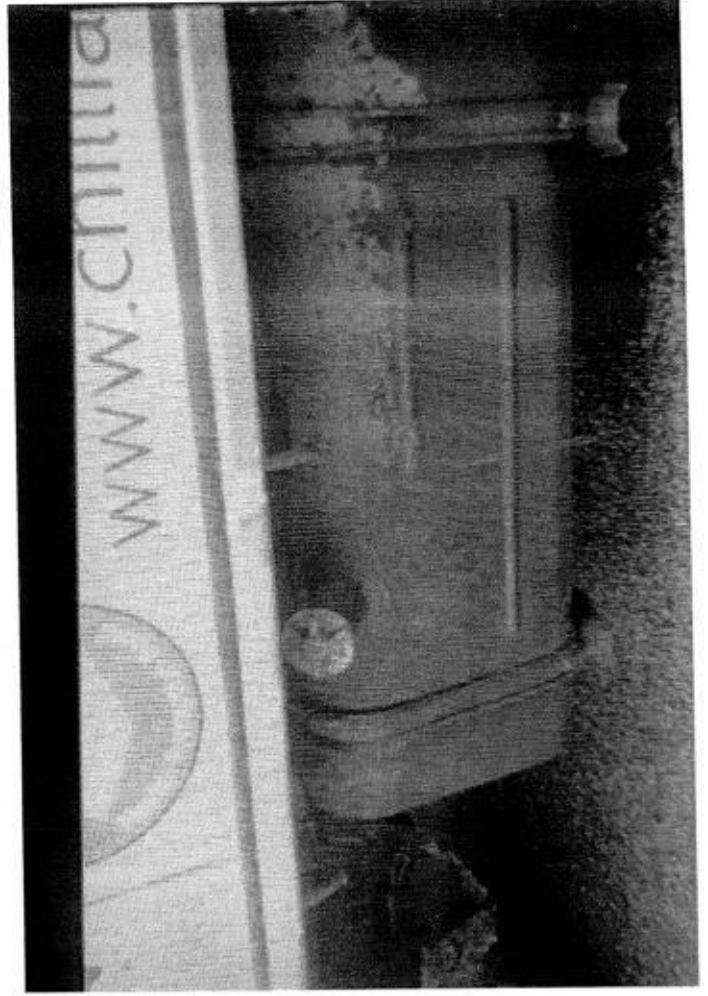
THE VEHICLE SUSTAINED DAMAGES AT THE O/S FRONT PORTION. DAMAGES SEE DETAILS.

Qty	Description of Parts	Condition	Estimate By Workshop (\$)	Our Adjusted (\$)
	<u>REPLACEMENT OF PARTS</u>			
1	FRONT BUMPER COVER	DEFORMED	562.30	562.30
1	FRONT BUMPER SPONGE	SERVICEABLE	142.20	-
1	FRONT BUMPER REINFORCEMENT	SERVICEABLE	526.10	-
1	FRONT BUMPER GRILLE (RH)	GRAZED	40.30	40.30
1	FRONT BUMPER BRACKET TOP (RH)	SERVICEABLE	22.40	-
1	FRONT BUMPER BRACKET (RH)	SERVICEABLE	24.60	-
1	FRONT BUMPER RETAINER MOUNTING	SERVICEABLE	9.20	-
1	HEADLAMP SUPPORT PANEL ASSY	SERVICEABLE	1,067.50	-
1	HEADLAMP (RH)	CRACKED	1,388.00	1,388.00
1	FRONT FENDER (RH)	DENTED	619.00	619.00
1	FRONT FENDER SHIELD (RH)	SERVICEABLE	169.80	-
1	FRONT FENDER RETAINER	SERVICEABLE	9.20	-
1	FRT WHEEL HUB CAP	SERVICEABLE	150.70	-
	LESS 20% DISCOUNT		-946.26	-521.92
			3,785.04	2,087.68
	<u>LABOUR</u>			
	THATCHAM STANDARD REPAIR TIME ON BODY WORKS.		1,130.00	420.00
	THATCHAM TTS STANDARD SPRAY PAINTING COST AND LABOUR.		650.00	560.00

1,780.00	980.00
	GRAND TOTAL		5,565.04	3,067.68
	RECOMMENDED COST OF LUMP SUM REPAIRS (TO ITS PRE-ACCIDENT CONDITION) (CONFIRMED)			2,450.00
