Your Ref : 3196258336SG
Our Ref : CI/AIG17023655/N

27 November 2017

**AUTOMOBILE TECHNICAL INVESTIGATION REPORT OF ACCIDENT
INVOLVING SLK 3182M AND SLF 7636X ON 16 NOVEMBER 2017**

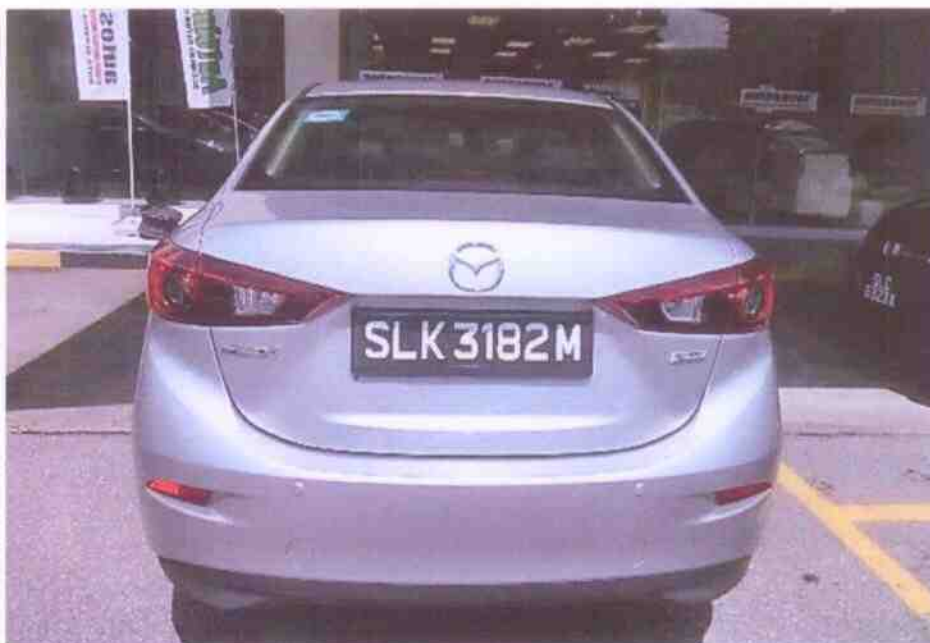
8. From the photographs contained in the Singapore Accident Statement of the Mazda, which was taken 4 days after the accident, we note that the Mazda had sustained an impact onto its rear portion. The damages were mainly observed to be at or around its rear bumper.

Photo 1 shows the general view of the rear of the Mazda at the time of reporting, which was 4 days after the accident. The damage to the Mazda was observed to be confined to its rear portion, at the rear bumper.

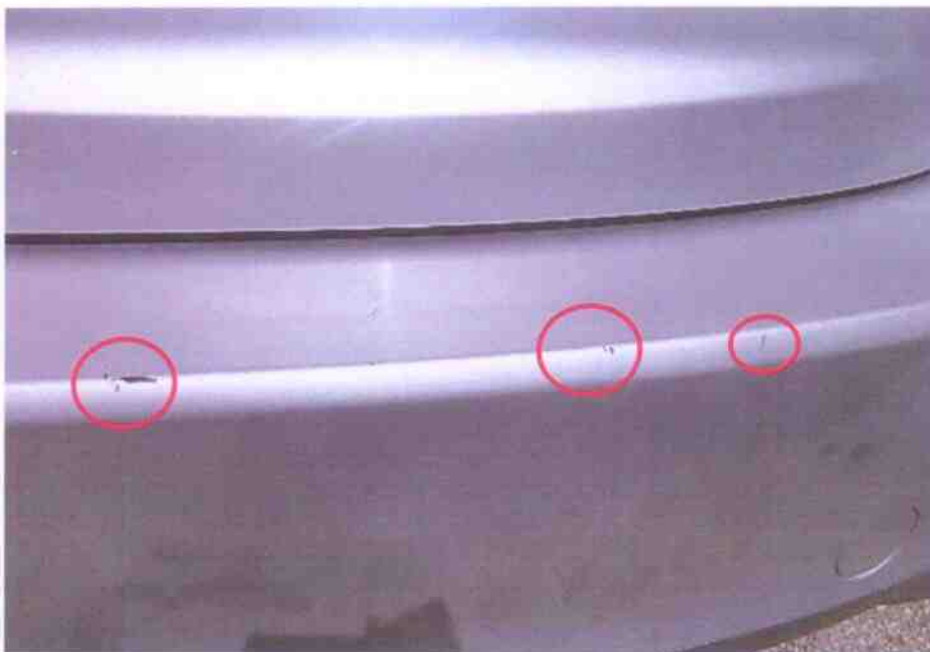
9. Upon reviewing the photographs showing the Mazda at the time of reporting, we had observed paint chip marks on the top centre portion of the rear bumper.

Photo 2 shows a closer view of the rear portion of the Mazda at the time of reporting, which was 4 days after the accident. Paint chip marks were found on the top centre portion of the rear bumper (circled).

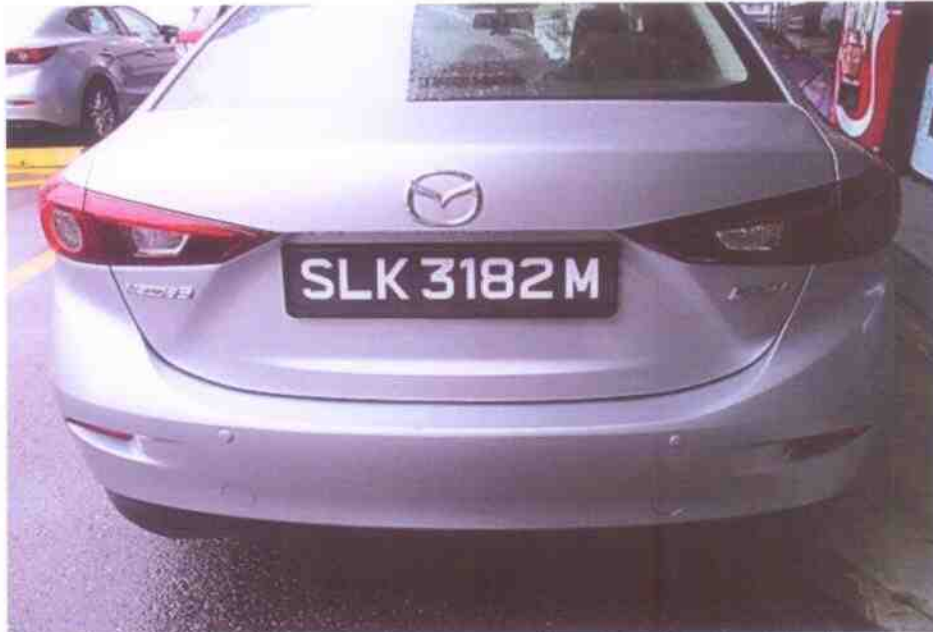
Photo 3 shows a general view of the rear portion of the Mazda at the time of our physical inspection.

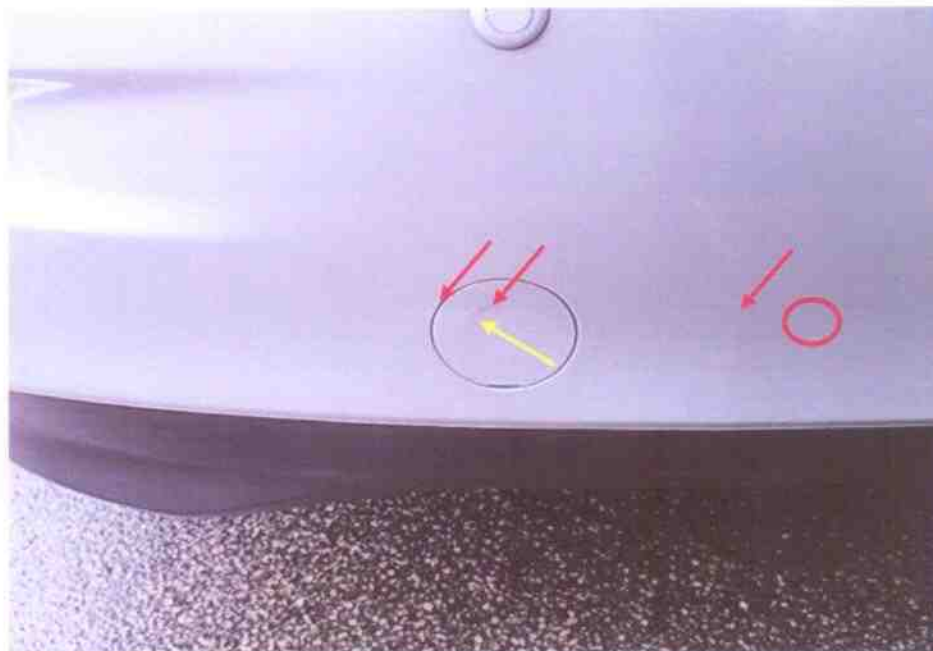
10. At the time of our physical inspection, we had observed a left-facing curved black mark on the lower centre portion of its rear bumper followed by faint broken black marks which had stretched horizontally downwards towards the lower left portion of its rear bumper. Below the black marks there was a right-facing crescent-shaped slight indentation. The right-facing crescent-shaped slight indentation was noted to be slightly towards the left from the lower centre portion of the Mazda's rear bumper.

Photo 4 shows upon closer examination, we observed a left-facing curved black mark on the lower centre portion of its rear bumper (circled) followed by faint broken black marks which had stretched horizontally downwards towards the lower left portion of its rear bumper (red arrows). Below the black marks there was a right-facing crescent- shaped slight indentation (yellow arrow). The right-facing crescent- shaped slight indentation was noted to be slightly towards the left from the lower centre portion of the Mazda's rear bumper.

18. Firstly, the damages on the lower centre portion of the Mazda's rear bumper which had stretched onto the lower left portion of its rear bumper was caused by an object that is of a similar shape, pressing onto the rear portion of the Mazda. If one was to consider the shape of the top portion and corners of the Toyota's front number plate frame, it would then appear that these damages were caused by the top portion and corners of the Toyota's front number plate frame.

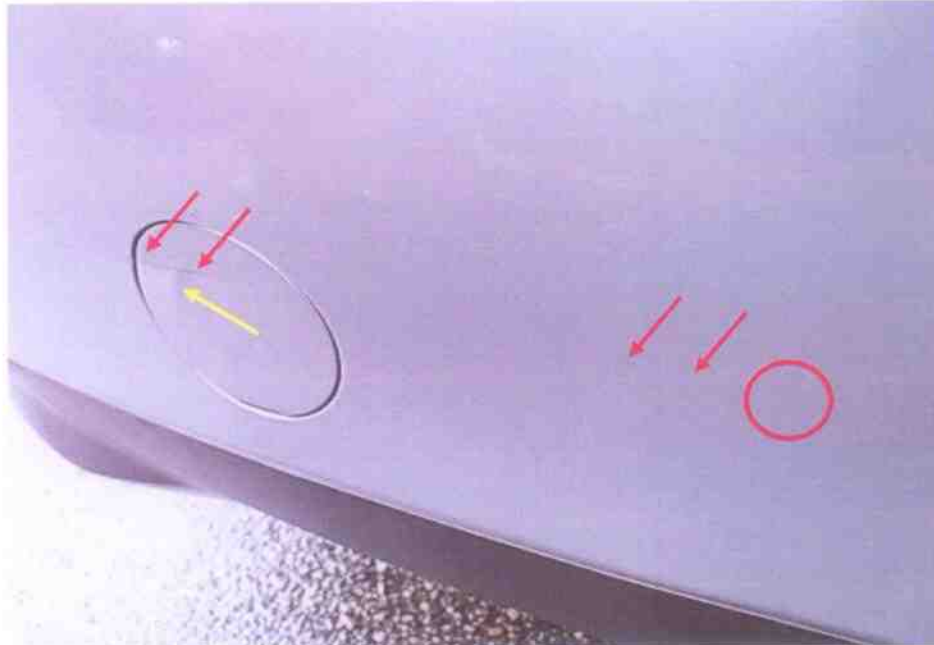
Photo 5 shows a closer view of the left-facing curved black mark on the lower centre portion of the Mazda's rear bumper (circled) followed by faint broken black marks which had stretched horizontally downwards towards the lower left portion of its rear bumper (red arrows). Below the black marks there was a right-facing crescent-shaped slight indentation (yellow arrow). The right-facing crescent-shaped slight indentation was noted to be slightly towards the left from the lower centre portion of the Mazda's rear bumper.

20. Thirdly, the left-facing curved black mark found on the lower center portion of the Mazda's rear bumper seems to correspond to the top right corner of the front number plate frame of the Toyota. Additionally, the right-facing crescent-shaped slight indentation found on the lower left portion of the Mazda's rear bumper seems to correspond to the top left corner of the front number plate frame of the Toyota which appeared to be pressed inwards when compared to the top right corner of the front number plate frame of the Toyota. Furthermore, the faint broken black marks found on the lower centre portion of the Mazda's rear bumper which had stretched horizontally downwards towards the lower left portion of its rear bumper also seem to correspond to the top portion of the front number plate frame of the Toyota which was also observed to be at a slight downward angle.

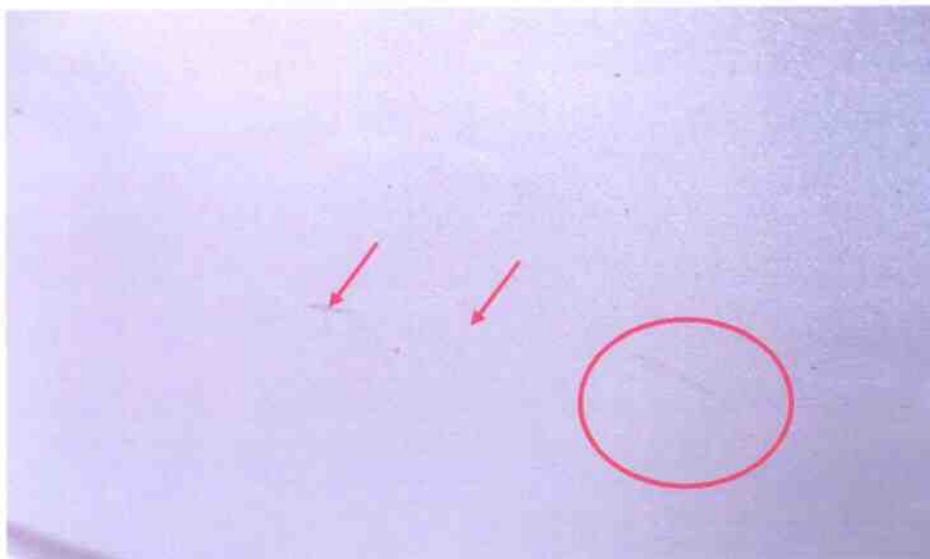
Photo 6 shows a close up view of the left-facing curved black mark on the lower centre portion of its rear bumper (circled) followed by faint broken black marks which had stretched horizontally downwards towards the lower left portion of its rear bumper (red arrows).

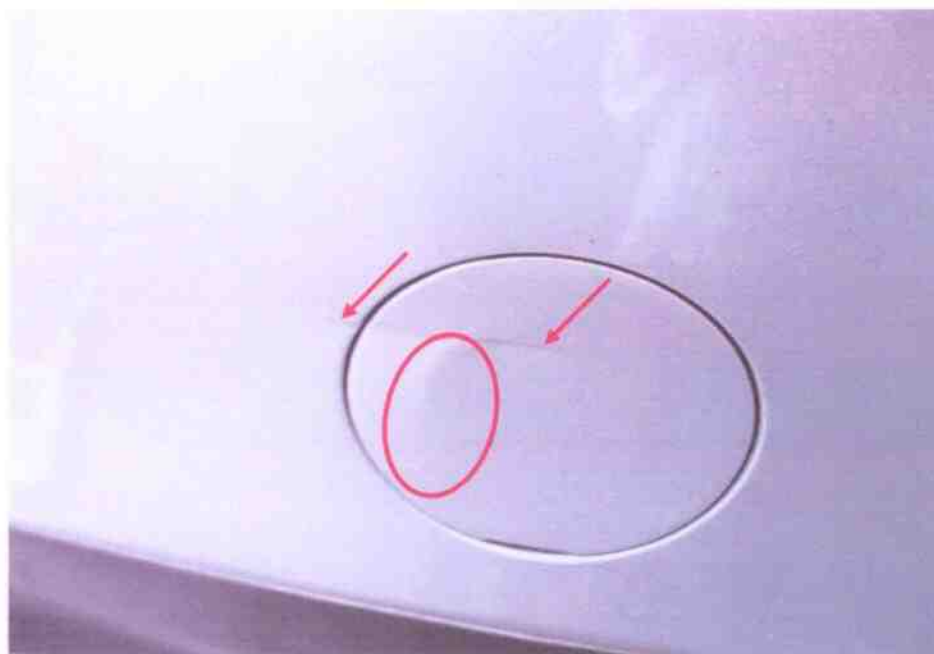
Photo 7 shows a close up view of the faint broken black marks which had stretched horizontally downwards towards the lower left portion of the Mazda's rear bumper (red arrows). Below the black marks there was a right-facing crescent- shaped slight indentation (circled). The right-facing crescent- shaped slight indentation was noted to be slightly towards the left from the lower centre portion of the Mazda's rear bumper.

26. Upon contact, the front number plate frame of the Toyota had compressed against the rear bumper of the Mazda, creating the permanent right- facing crescent- shaped slight indentation, horizontal faint black marks and the left-facing curved black mark on the lower portion of its rear bumper. As the impact force arising from the contact was not significant (slight contact), there was hence no obvious damage sustained by the front number plate frame of the Toyota, which is constructed from hard plastic material.

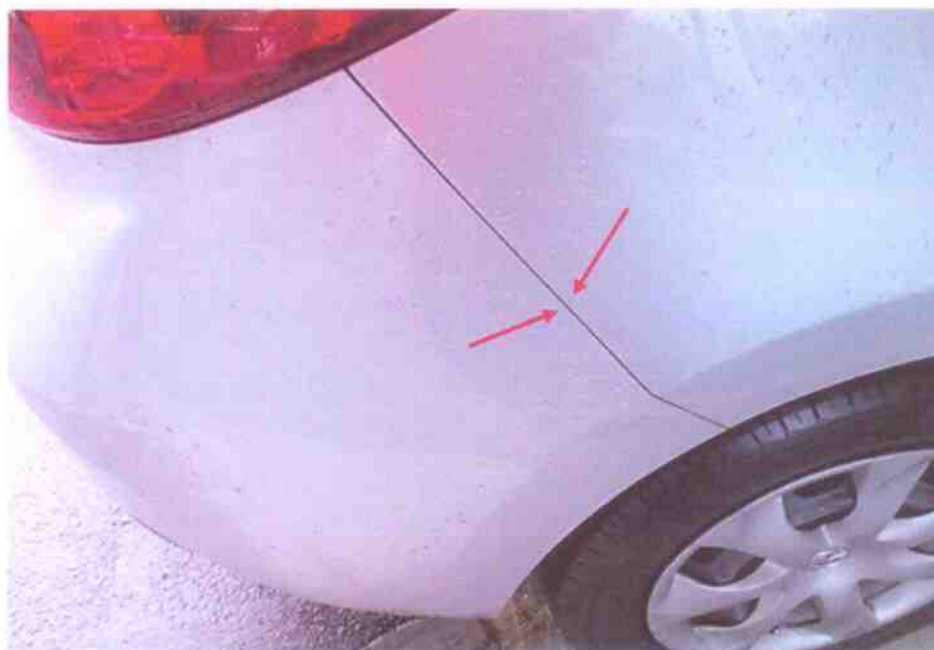
11. In general, these physical damages observed on the rear bumper of the Mazda indicate that it had sustained an impact directly onto its rear portion. This impact was relatively light as we did not observe any obvious misalignment at the corner edges of the rear bumper, adjacent to its rear fenders. See photos 1 - 9 below.

Photo 8 shows a close up view of the right corner edge of the rear bumper of the Mazda. We observed that there was no misalignment at the corner edges (red arrows).

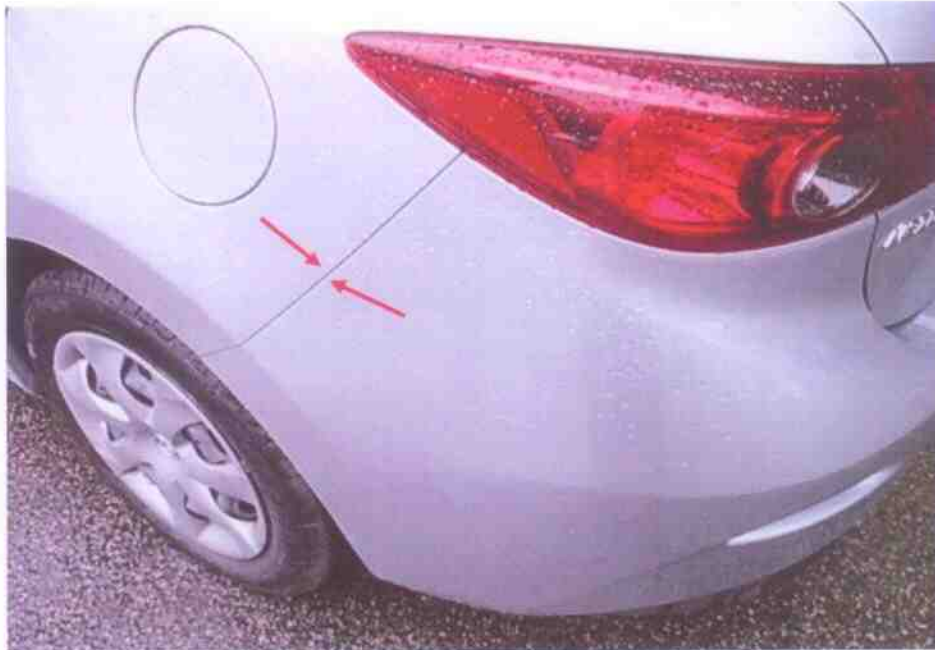
Photo 9 shows a close up view of the left corner edge of the rear bumper of the Mazda. We observed that there was no misalignment at the corner edges (red arrows).

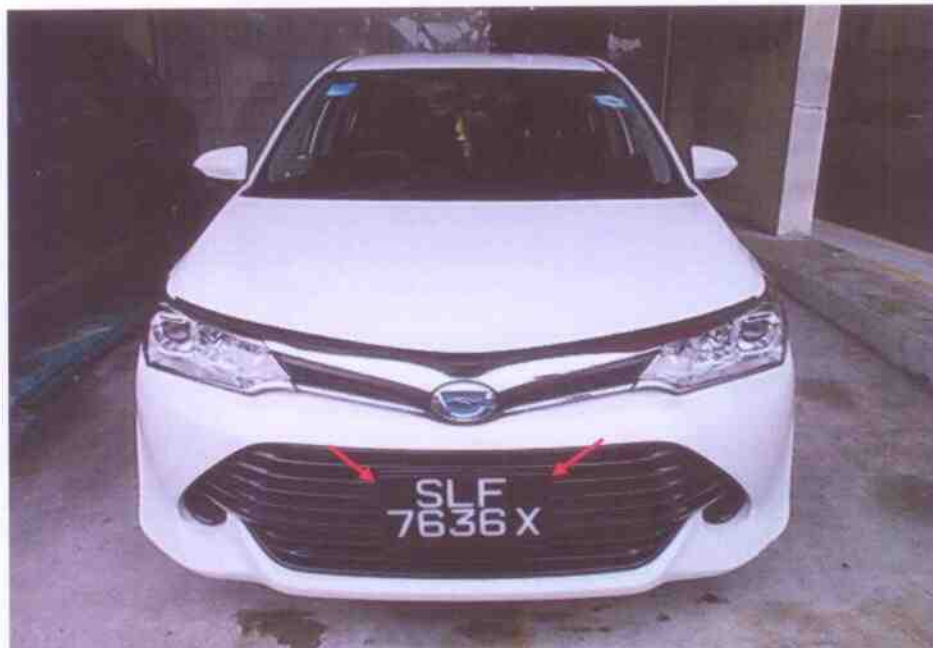
Photo 10 shows the general view of the front portion of the Toyota at the time of our physical inspection. The only body part shape on the front of the Toyota that could possibly correspond to the damages found on the lower portion of the rear bumper of the Mazda was the top portion as well as top corners of its rectangular- shaped front number plate frame. (red arrows).

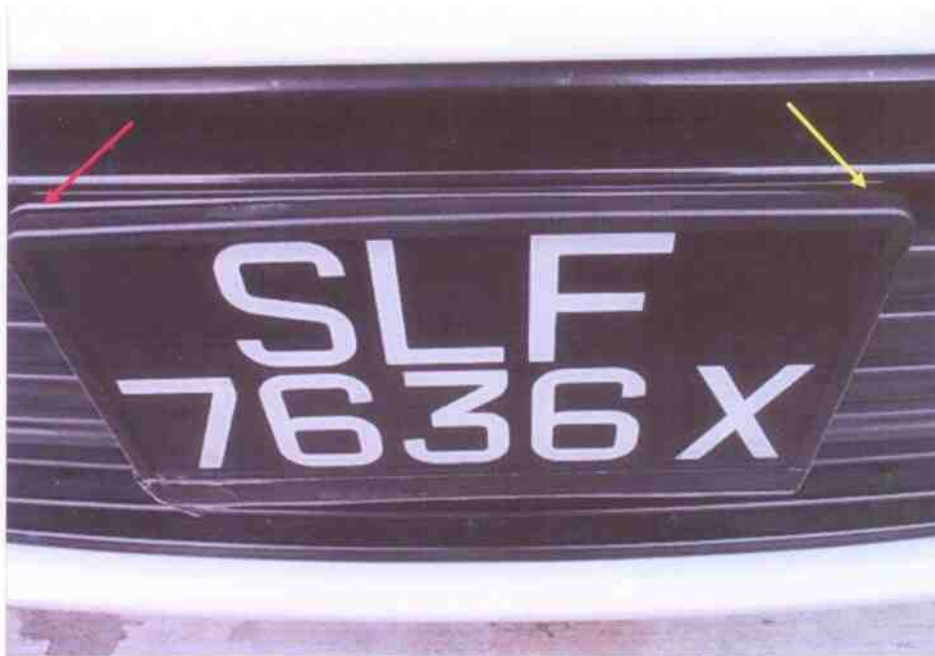
16. Our visual examination of the sides of the Toyota's front number plate frame revealed that both its left side and right side were slightly distorted and bent with the top left corner of the frame appearing to be pressed inwards when compared to the right top corner. The front number plate frame was also observed to be at a slight downward angle. However the frame was not broken and/or cracked. It would then appear that the front number plate frame of the Toyota had sustained an impact that was relatively light as there was no obvious crack or break on the front number plate frame. It was also noted that the front bumper was not misaligned at its corner edges. See photos 10 - 14 below.

Photo 11 shows a top view of the Toyota's front number plate. The frame was observed to be distorted and bent with the top left corner of the frame appearing to be pressed inwards (yellow arrow) as compared to the right top corner (red arrow). However there was no obvious crack or break on the front number plate frame.

19. Secondly, although there was no obvious crack or break on the front number plate frame of the Toyota at the time of our inspection, it could be due to the impact force arising from the contact being not significant enough to have stretched pass the material strength of the front number plate frame. In this aspect, one would have to consider the material stiffness of the number plate frame, which is constructed of hard plastic, against the thermoplastic (soft plastic) material of the rear bumper.

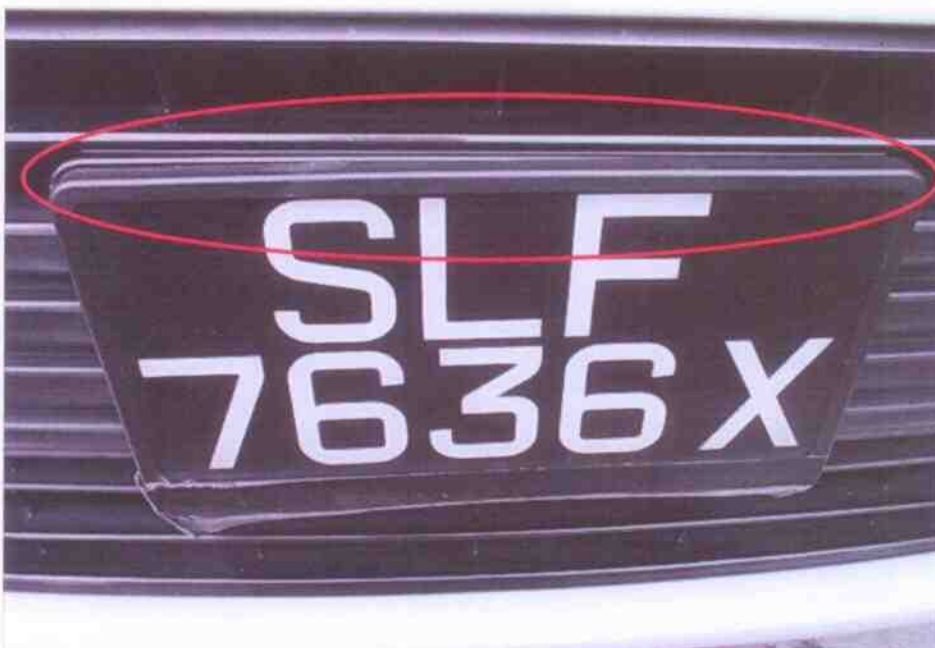
Photo 12 shows a closer view of the front number plate of the Toyota. The front number plate frame was also observed to be at a slight downward angle (circled).

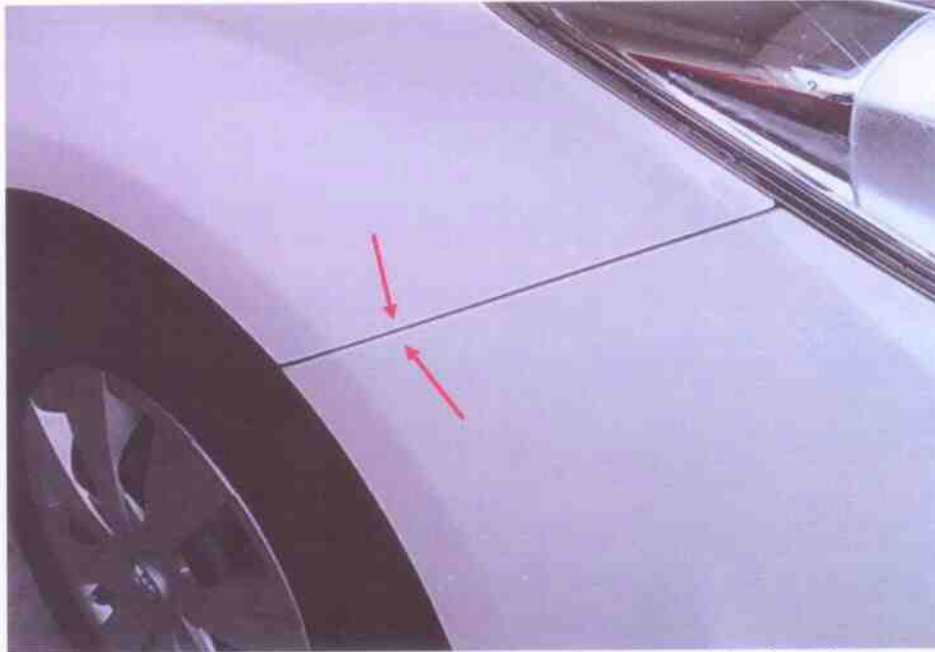
Photo 13 shows a close up view of the right corner edge of the front bumper of the Toyota. We observed that there was no misalignment at the corner edges (red arrows).

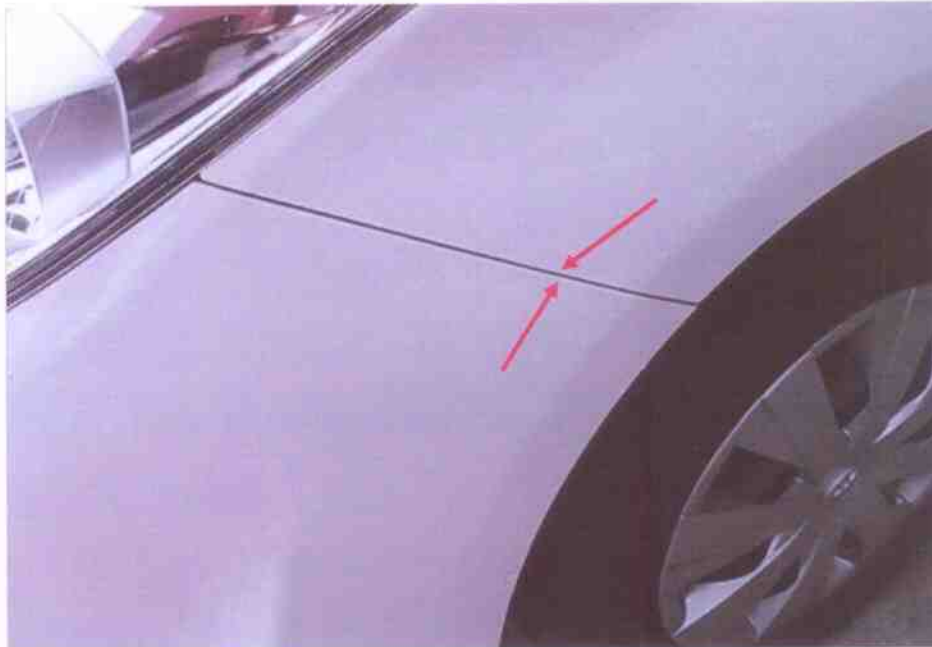
Photo 14 shows a close up view of the left corner edge of the front bumper of the Toyota. We observed that there was no misalignment at the corner edges (red arrows).

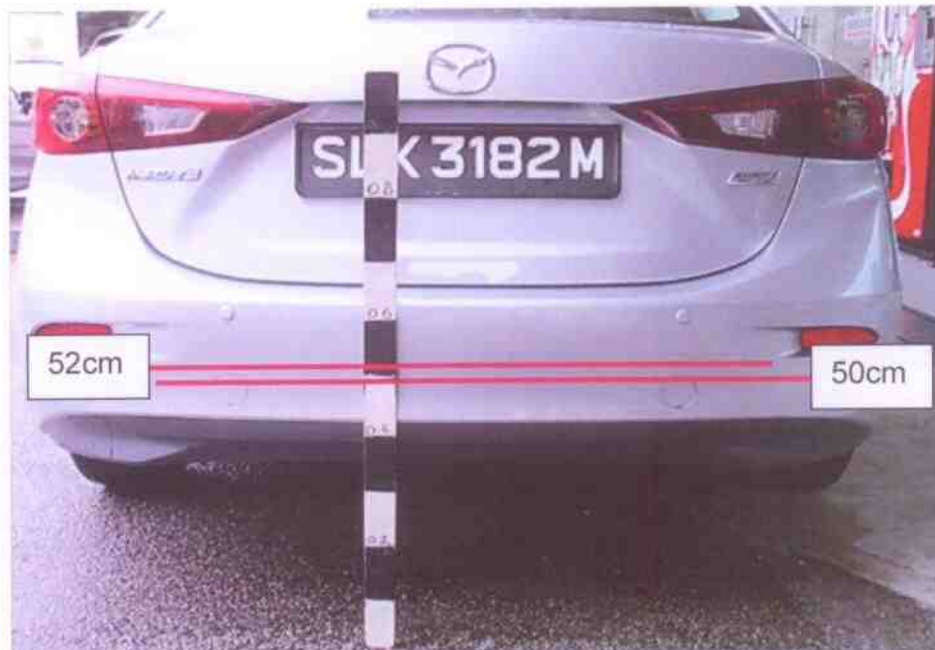
Photo 15 shows the height measurement being conducted on the rear portion of the Mazda. The height above ground level of the top end and lower end of the damages that were found on the lower portion of the rear bumper of the Mazda were measured to be approximately between 50cm and 52cm above ground level respectively.

- a) The height above ground level of the top end and lower end of the damages that were found on the lower portion of the rear bumper of the Mazda were measured to be approximately between 50cm and 52cm;
- b) the top portion of the Toyota's front number plate frame is within the 50cm to 52cm range;
- c) the height measurements appear to support the findings of possible contact between the rear bumper of the Mazda and the front portion of the Toyota. The damages observed on the lower portion of the rear bumper of the Mazda was a result of this contact and corresponds to the damage observed on the front number plate frame of the Toyota.

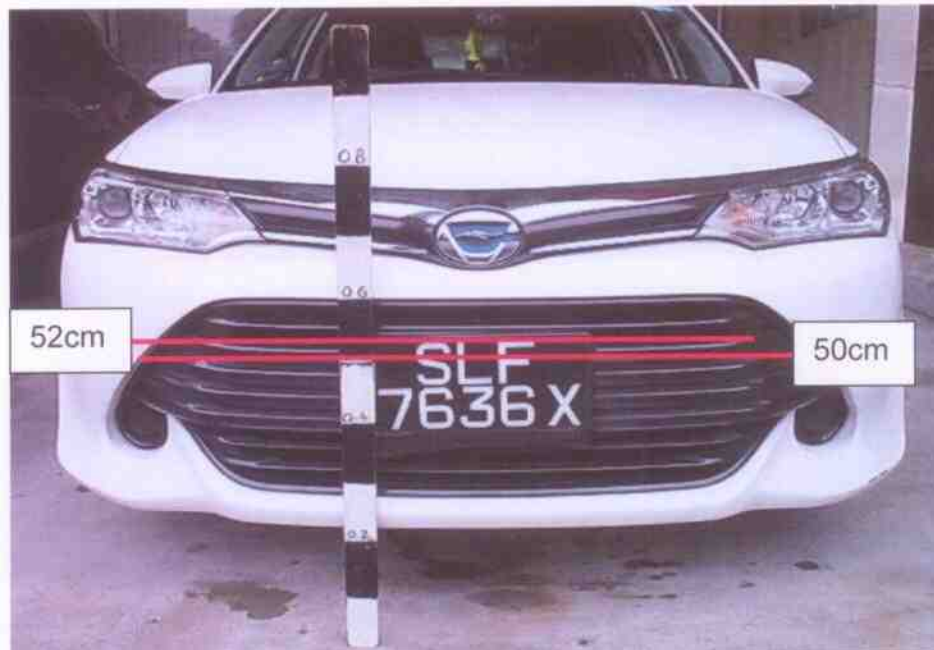
Photo 16 shows the height measurement being conducted on the front portion of the Toyota. The top portion of the Toyota's front number plate frame is within the 50cm to 52cm range.
