Your Ref: S7M005JG
Our Ref : CS/AXA17023790/N

19 December 2017

TECHNICAL INVESTIGATION REPORT OF FIRE INCIDENT INVOLVING THE INSURED VEHICLE SLD 1405X ON 25 OCTOBER 2017

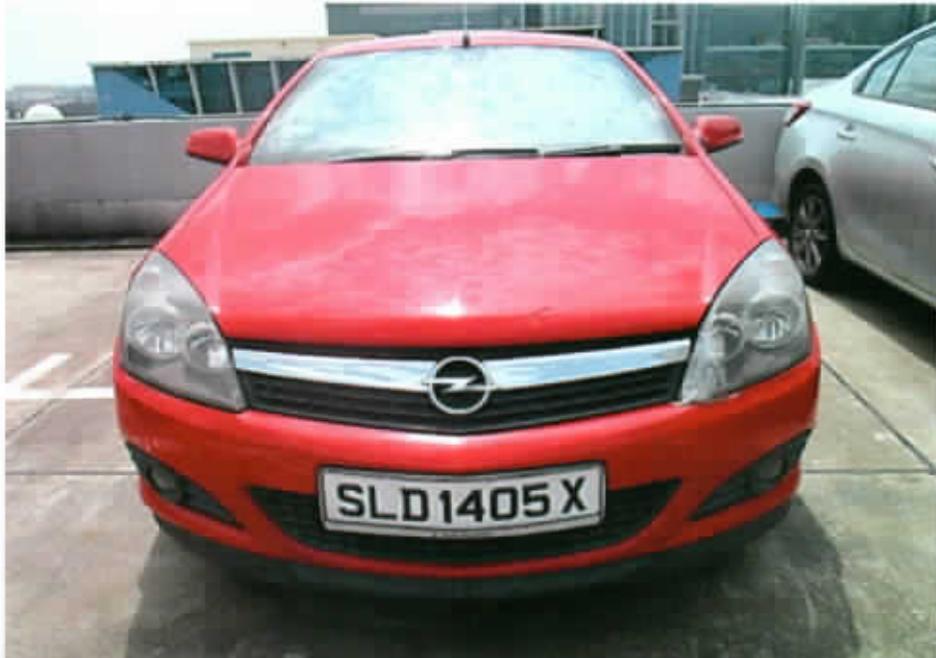
Photo 1 shows the general view of the front portion of the Insured Vehicle at the time of our inspection.

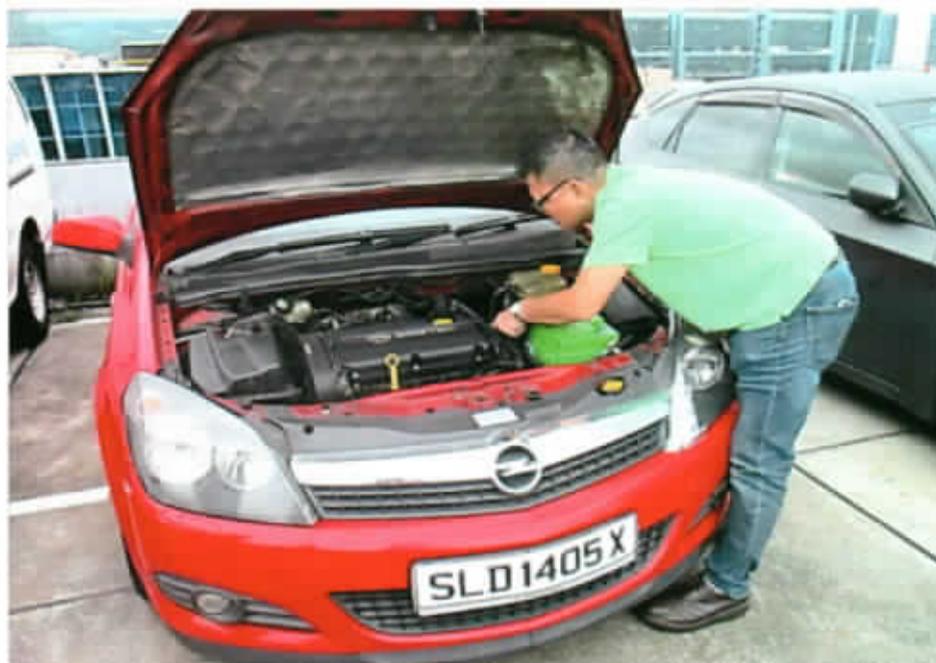
Photo 4 shows a general view of the engine compartment of the Insured Vehicle at the time of our inspection together with Principal Consultant, Mr K K Lau. There was no damage of fire nature to the engine compartment.

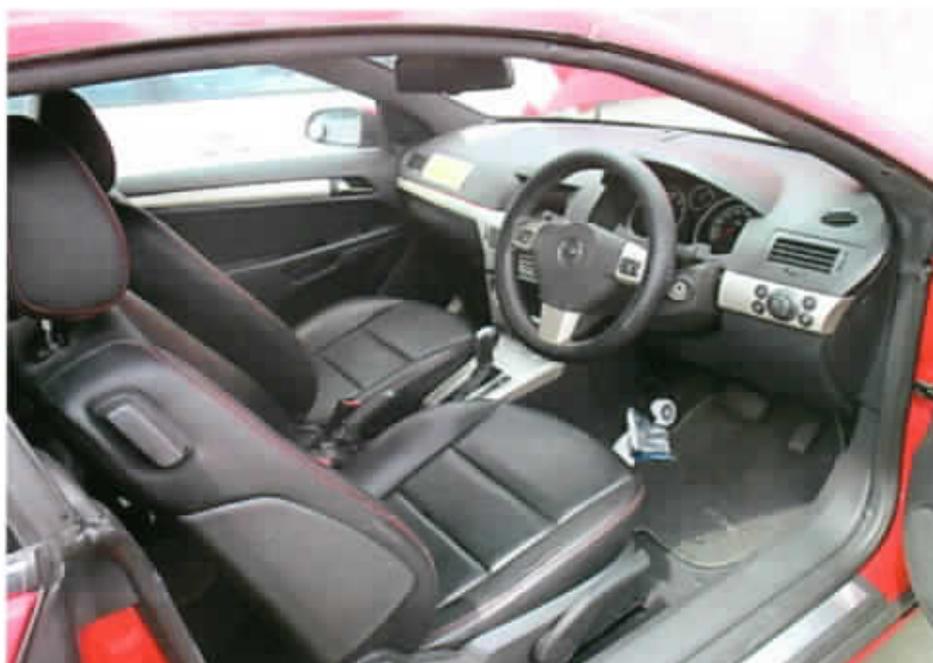
Photo 5 shows the interior compartment of the Insured Vehicle, which was observed not to have sustained any fire damage.

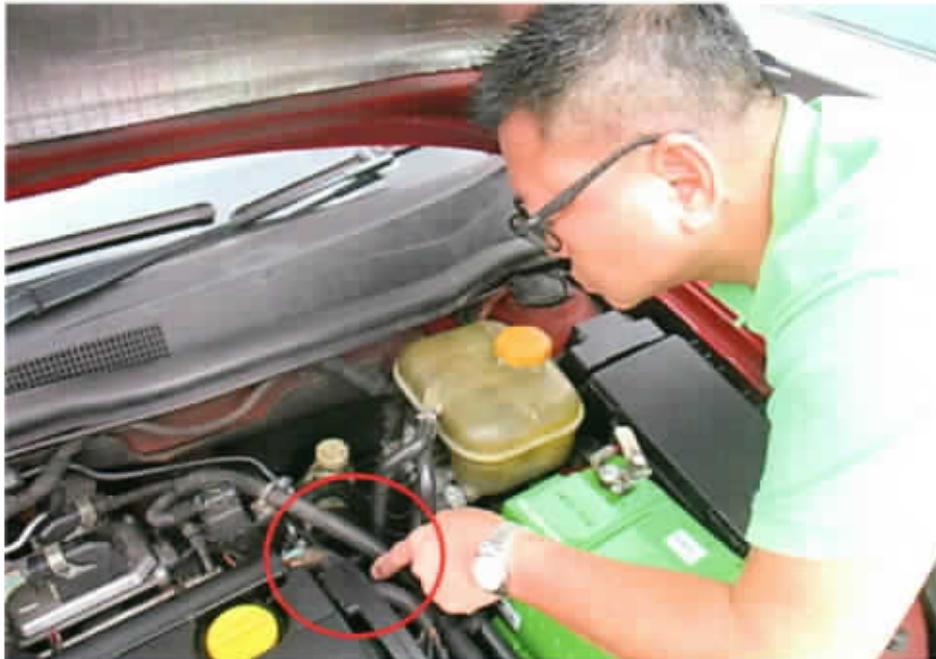
Photo 6 shows a closer inspection of the engine compartment of the Insured Vehicle together with Principal Consultant, Mr K K Lau. We had found worn tubings on some of the wirings (circled). We did not find any burnt and/or melted wirings. There were also no burnt marks on any of the components in the engine compartment.

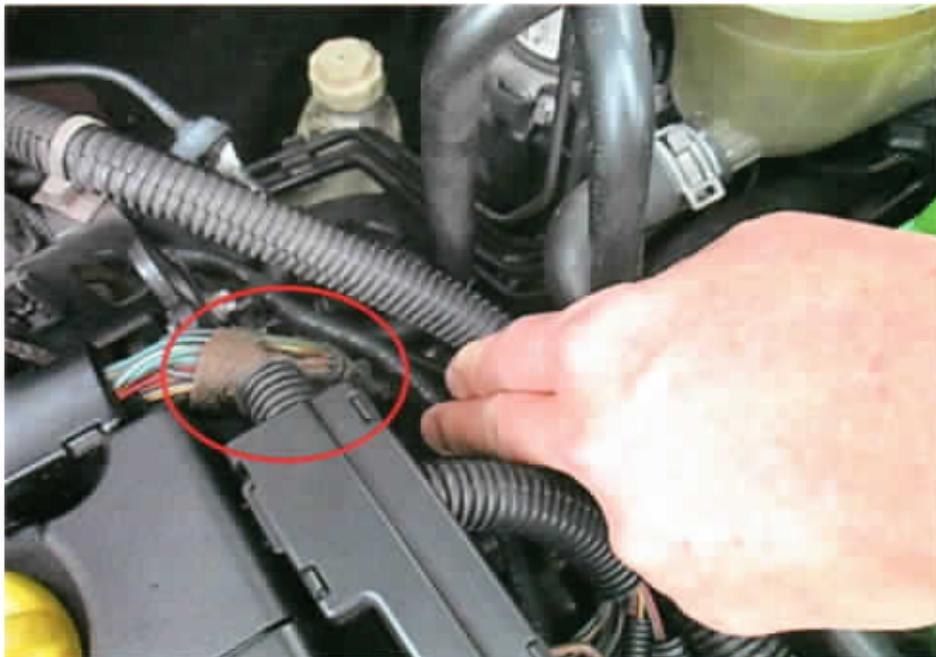
Photo 7 shows a closer view of the worn tubings on some of the wirings (circled).

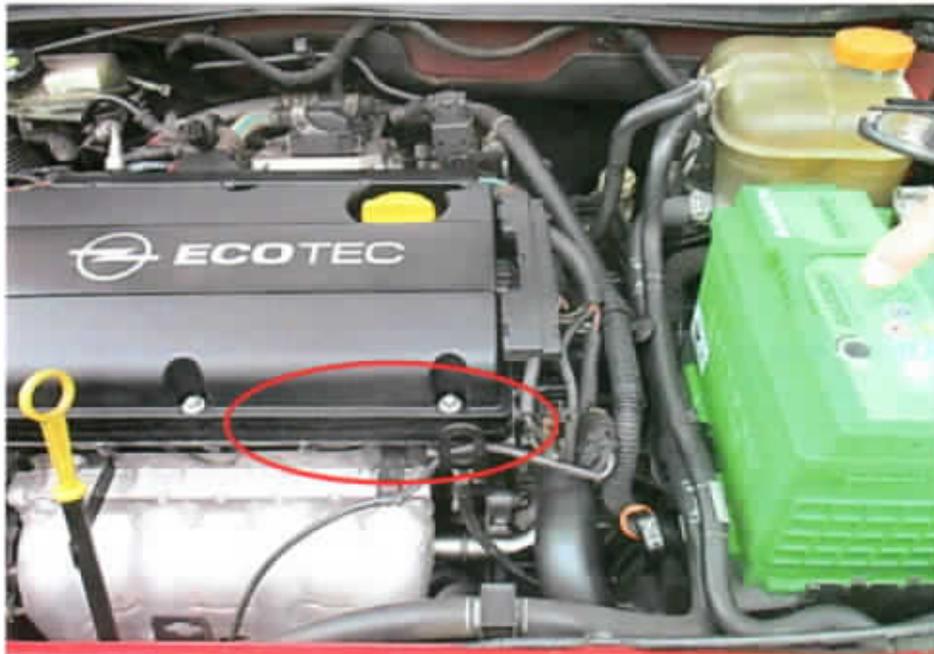
Photo 8 shows fluid stains were observed to have been formed around the front portion of the top camshaft cover of the engine (circled). The presence of dust and/or dirt particles accumulated at the areas where the fluid stains had formed indicates that a fluid leak had occurred. There were also wet fluid stains around the front left corner of the front portion of the top camshaft cover of the engine.

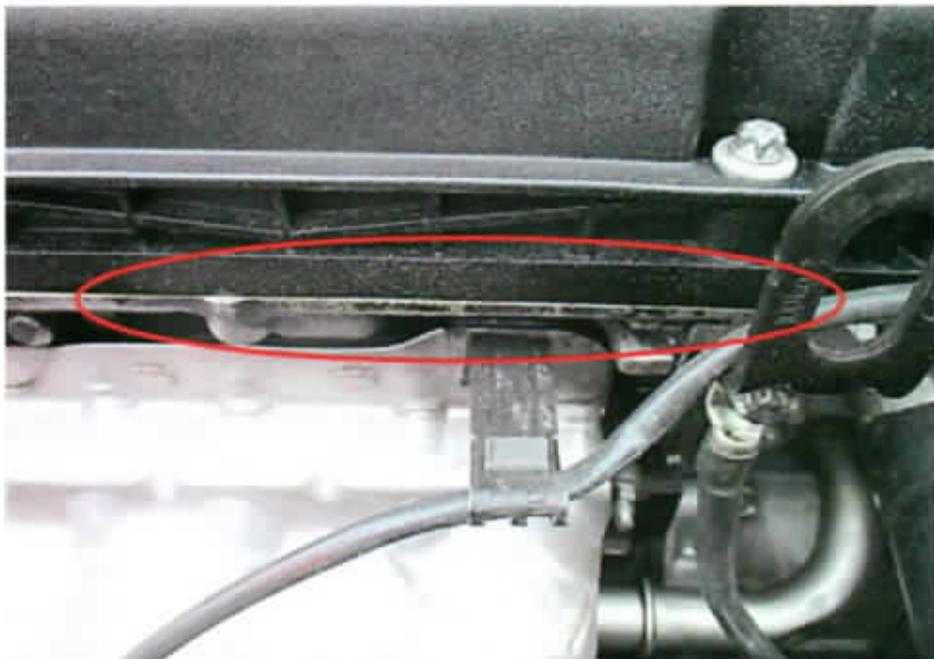
Photo 9 shows a closer view of the presence of dust and/or dirt particles which had accumulated at the areas where the fluid stains had formed (circled), indicating that a fluid leak had occurred.

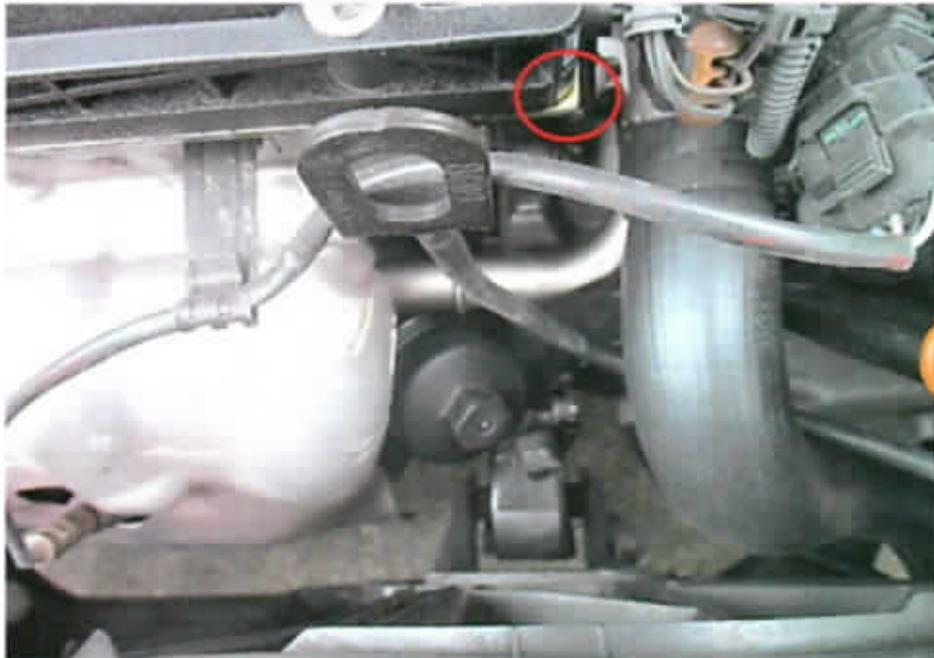
Photo 10 shows a closer view of wet fluid stains found around the front left corner of the front portion of the top camshaft cover of the engine (circled).

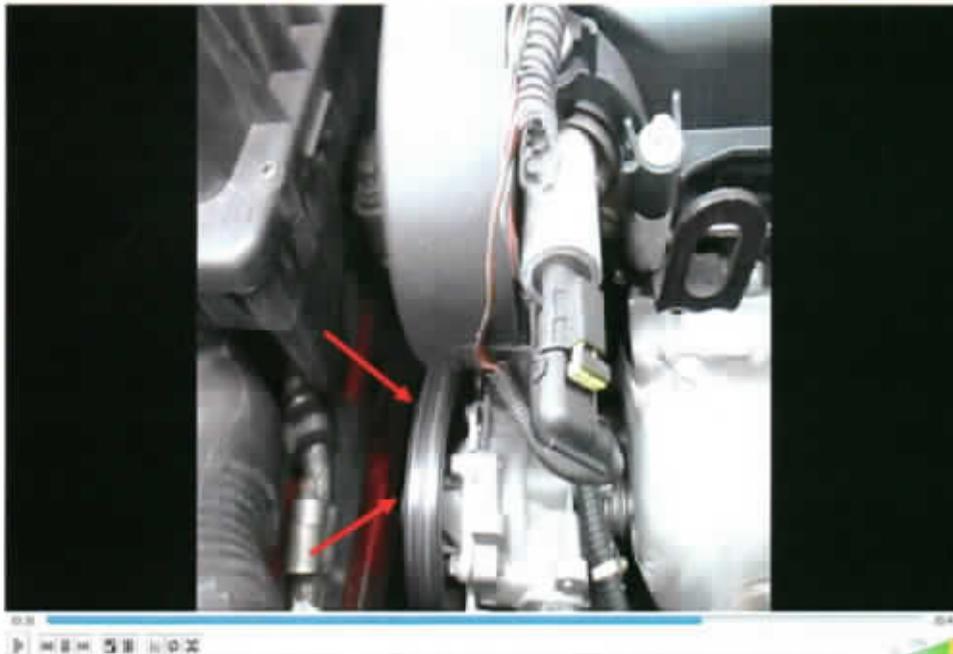
Screenshot 1 of the video recording shows the rotating belting (arrowed) of the Insured Vehicle to indicate that the engine of the Insured Vehicle was started and the engine left to operate for approximately 20 minutes.

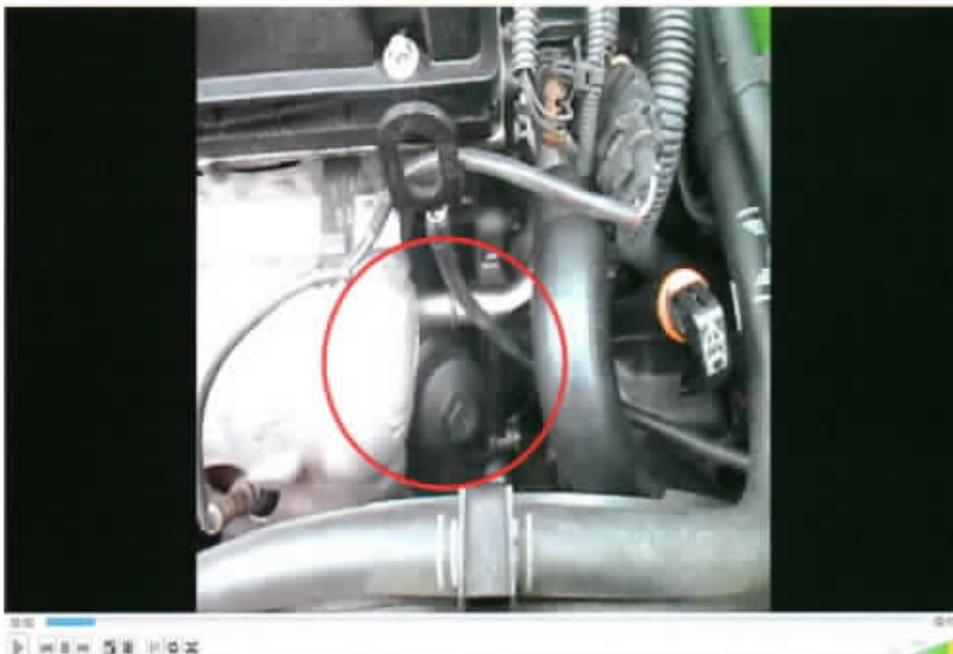
Screenshot 2 of the video recording shows after letting the engine operate for 10 minutes, we observed some engine oil seepage from the front portion of the top camshaft cover of the engine. We also detected a burnt smell followed by white smoke emitting from the front portion of the engine (circled). However one would have to view the recording to see the smoke emission.

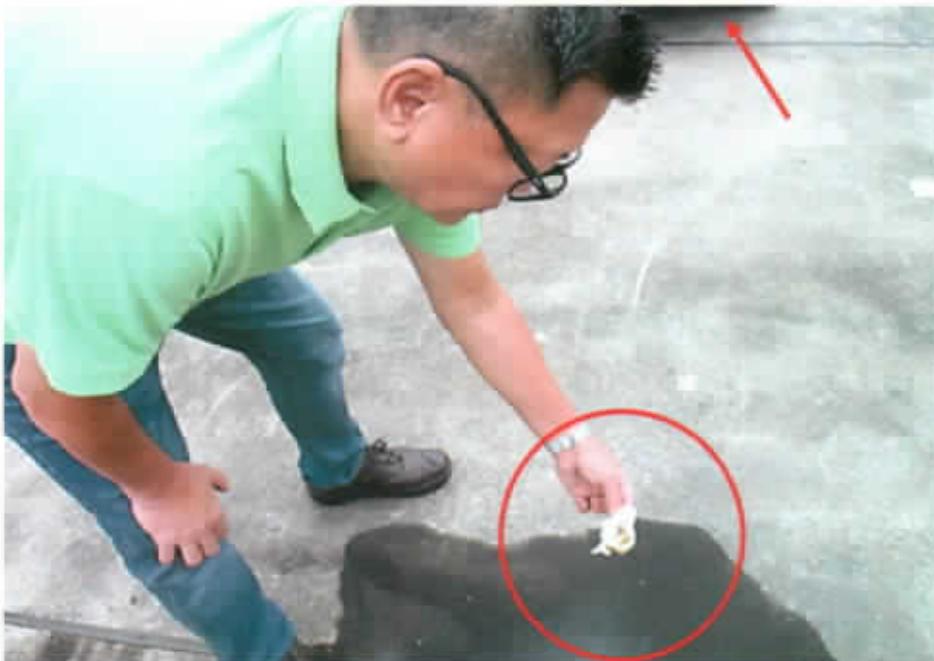
Photo 11 shows Principal Consultant, Mr K K Lau examining the fluid stains on the ground after the Insured Vehicle was driven some distance forward (arrowed). We found wet fluid stains on the ground directly below the engine compartment where the Insured Vehicle was positioned (circled).

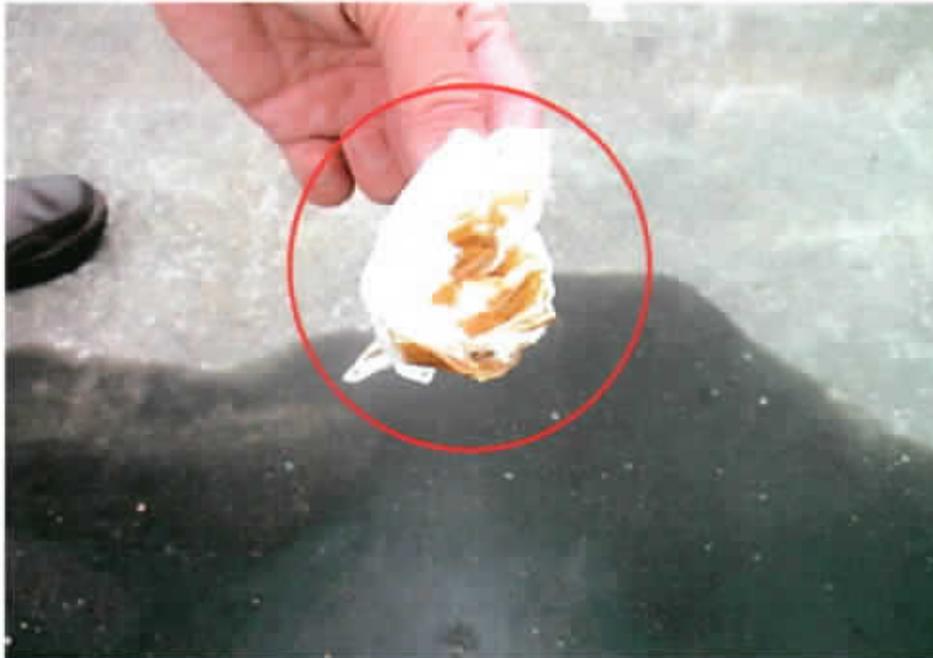
Photo 12 shows a close up view of the wet fluid stains on the ground directly below the engine compartment where the Insured Vehicle was positioned (circled).

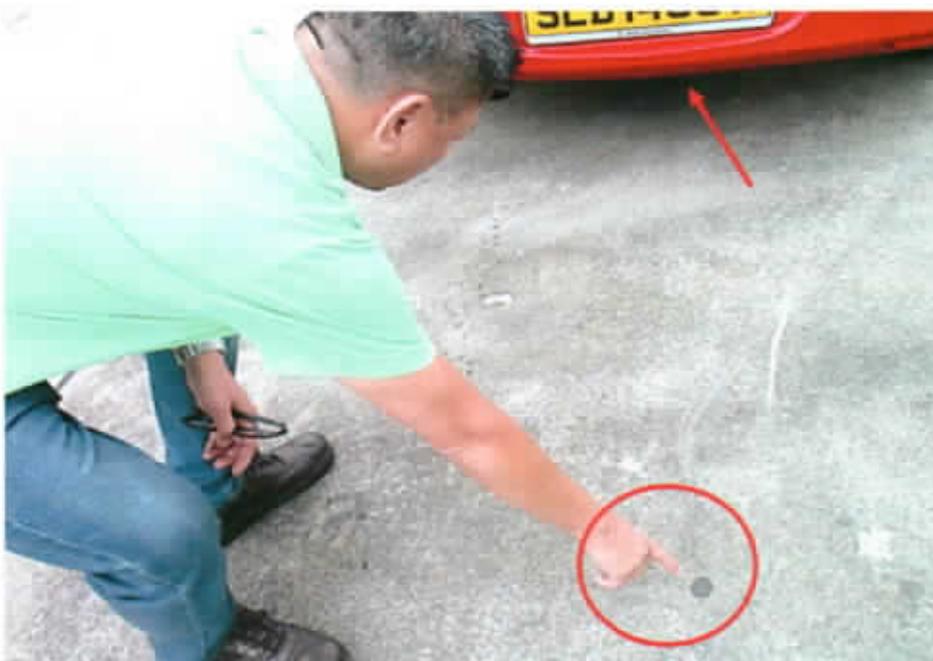
Photo 13 shows Principal Consultant, Mr K K Lau highlighting the second patch of wet fluid stains on the ground (circled) after the Insured Vehicle was driven some distance forward for a second time (arrowed).

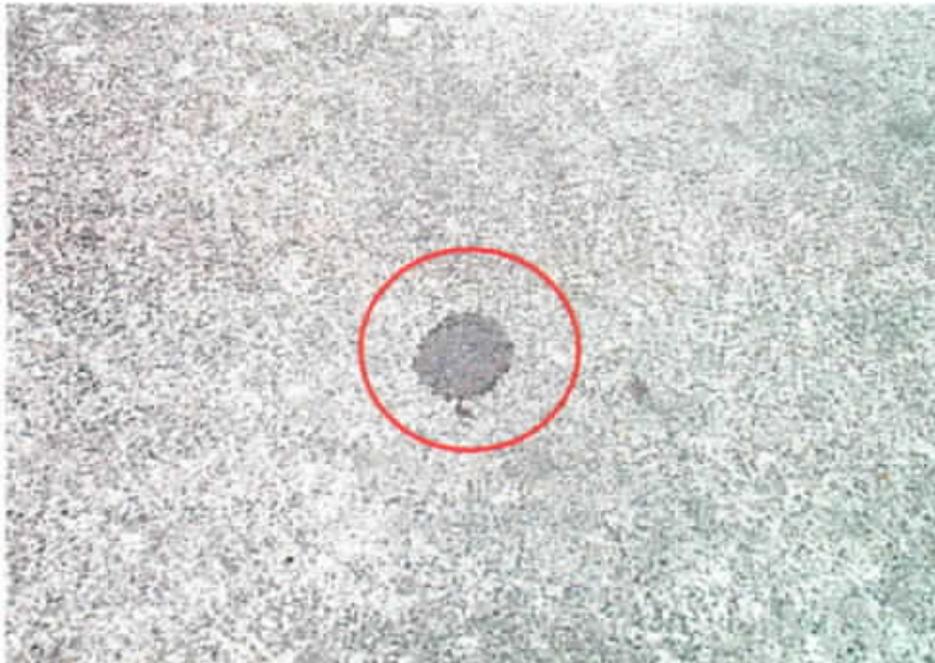
Photo 14 shows a close up view of the second patch of wet fluid stains on the ground (circled) after the Insured Vehicle was driven some distance forward for a second time.
