Your Ref: S7M005JG
Our Ref : CS/AXA17023790/N

19 December 2017

TECHNICAL INVESTIGATION REPORT OF FIRE INCIDENT INVOLVING THE INSURED VEHICLE SLD 1405X ON 25 OCTOBER 2017

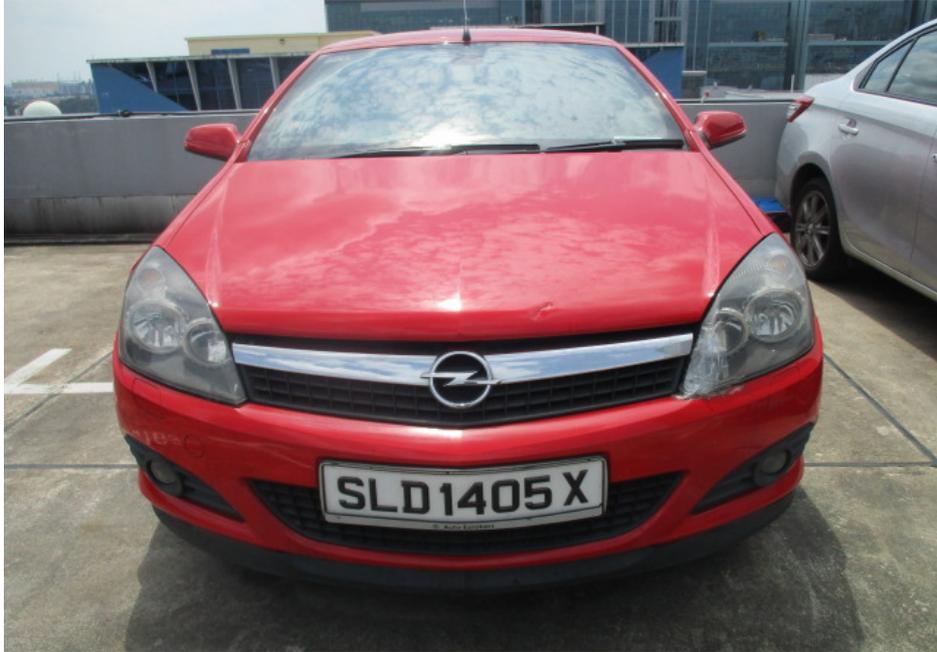
Photo 1 shows the general view of the front portion of the Insured Vehicle at the time of our inspection.

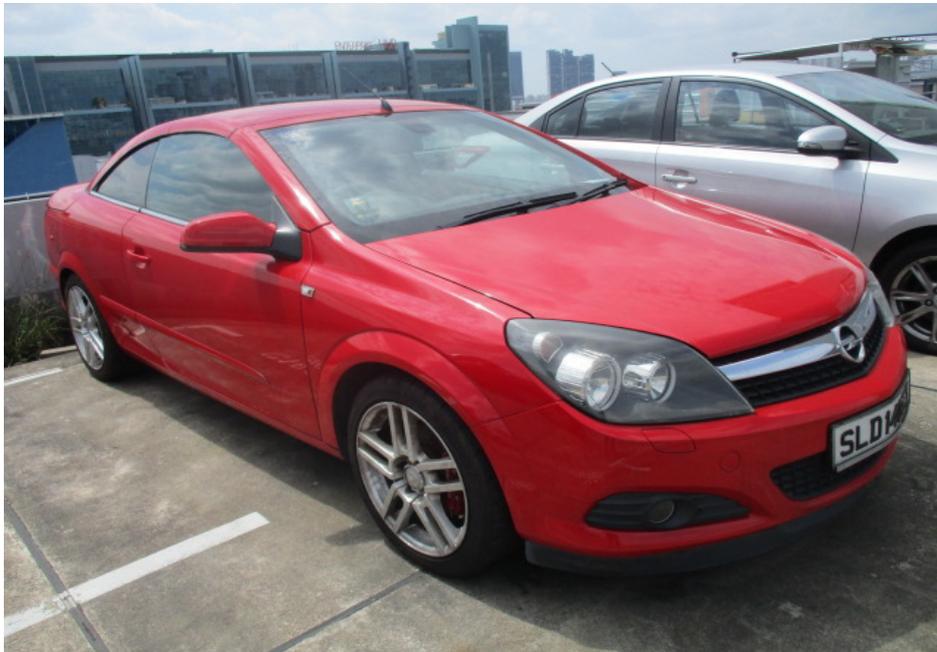
Photo 2 shows the general view of the right portion of the Insured Vehicle at the time of our inspection.

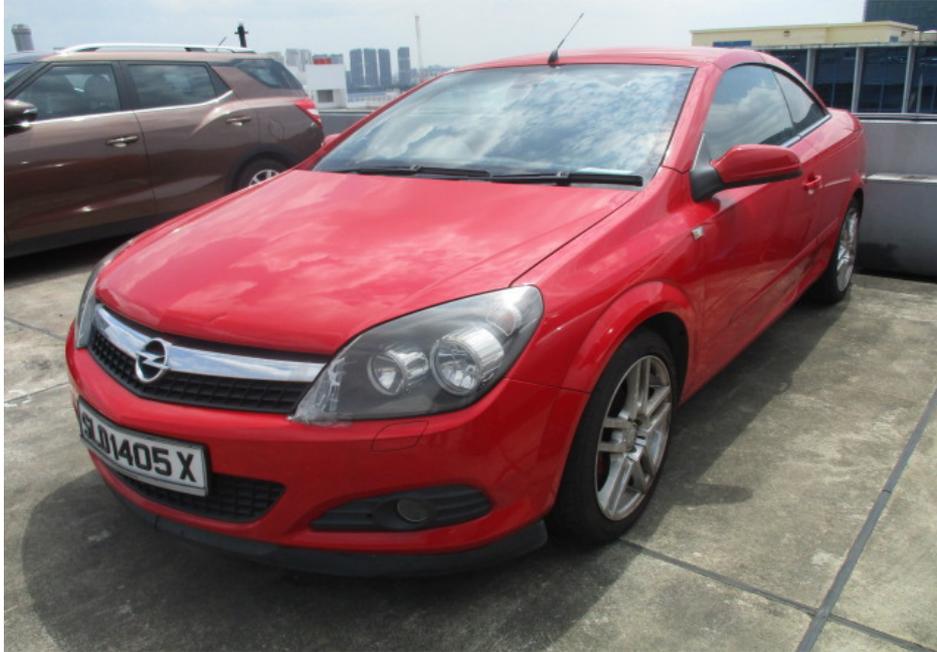
Photo 3 shows the general view of the left portion of the Insured Vehicle at the time of our inspection.

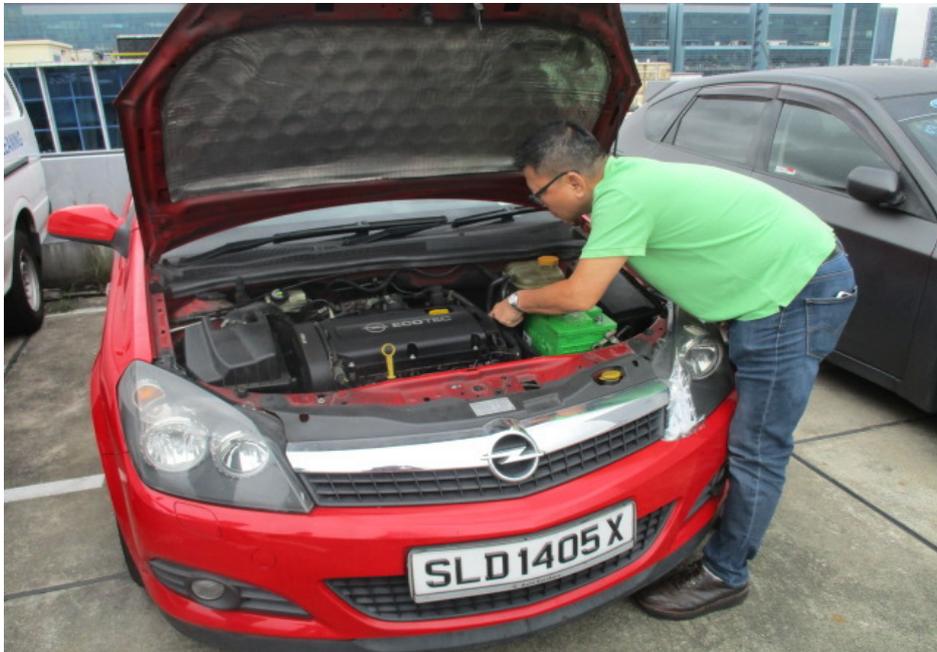
Photo 4 shows a general view of the engine compartment of the Insured Vehicle at the time of our inspection together with Principal Consultant, Mr K K Lau. There was no damage of fire nature to the engine compartment.

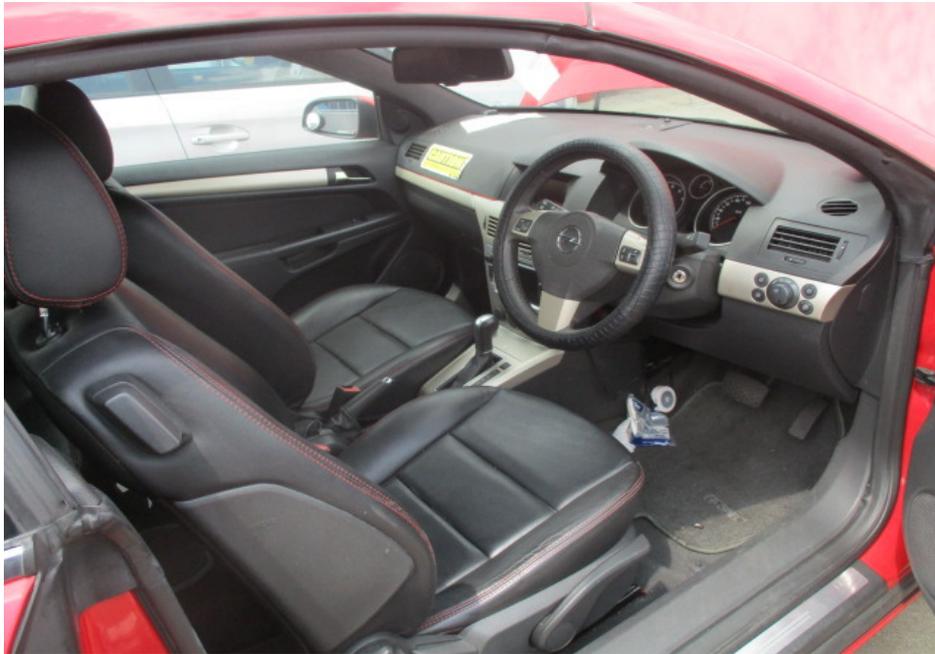
Photo 5 shows the interior compartment of the Insured Vehicle, which was observed not to have sustained any fire damage.

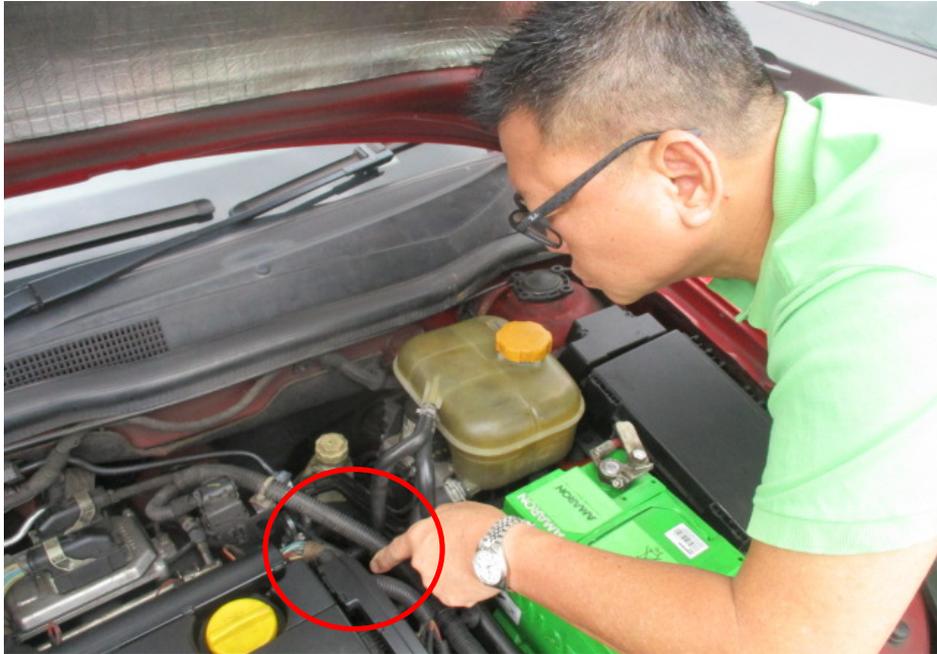
Photo 6 shows a closer inspection of the engine compartment of the Insured Vehicle together with Principal Consultant, Mr K K Lau. We had found worn tubings on some of the wirings (circled). We did not find any burnt and/or melted wirings. There were also no burnt marks on any of the components in the engine compartment.

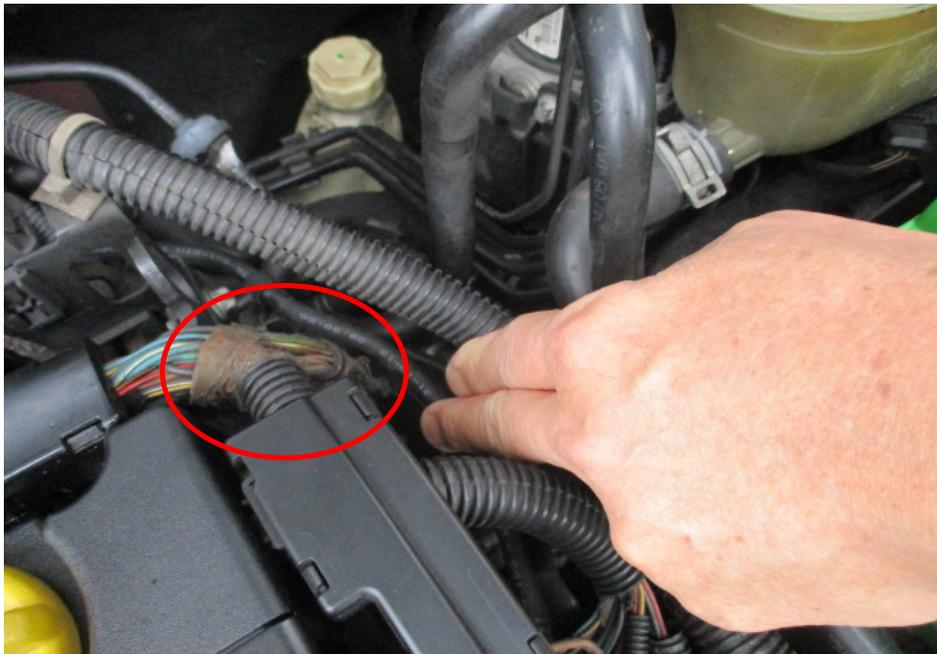
Photo 7 shows a closer view of the worn tubings on some of the wirings (circled).

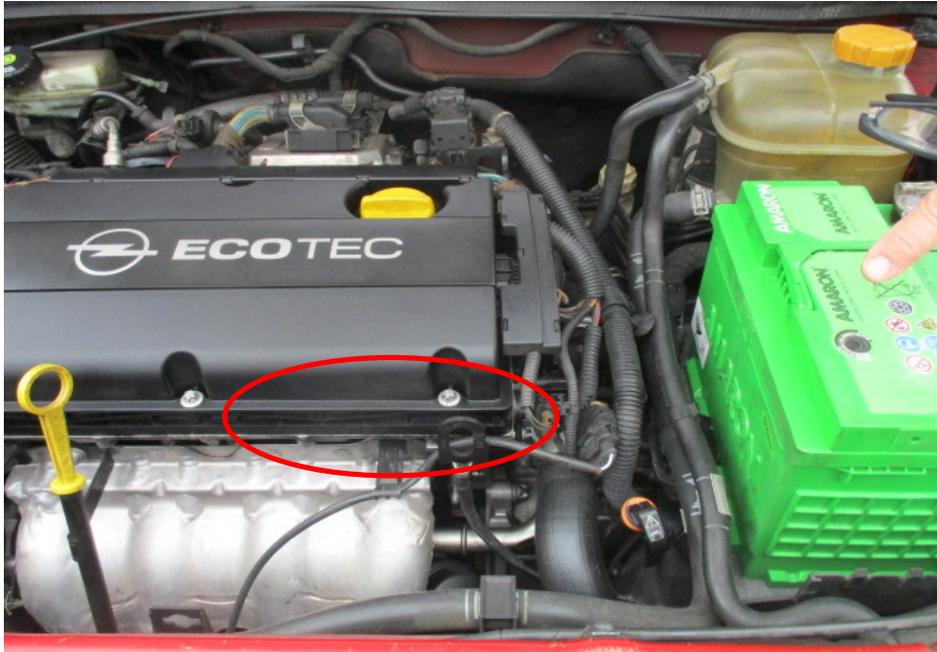
Photo 8 shows fluid stains were observed to have been formed around the front portion of the top camshaft cover of the engine (circled). The presence of dust and/or dirt particles accumulated at the areas where the fluid stains had formed indicates that a fluid leak had occurred. There were also wet fluid stains around the front left corner of the front portion of the top camshaft cover of the engine.

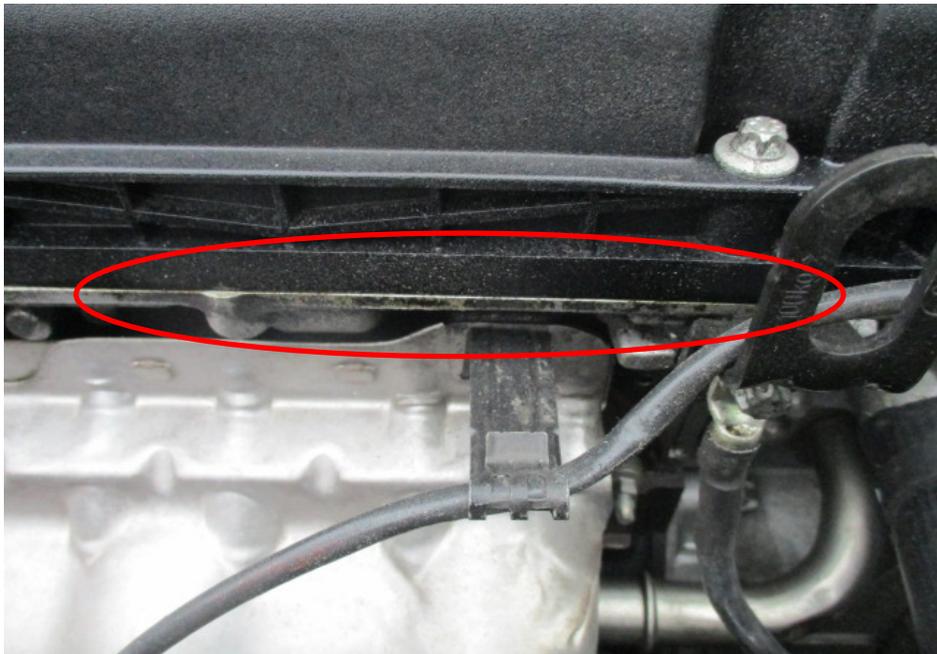
Photo 9 shows a closer view of the presence of dust and/or dirt particles which had accumulated at the areas where the fluid stains had formed (circled), indicating that a fluid leak had occurred.

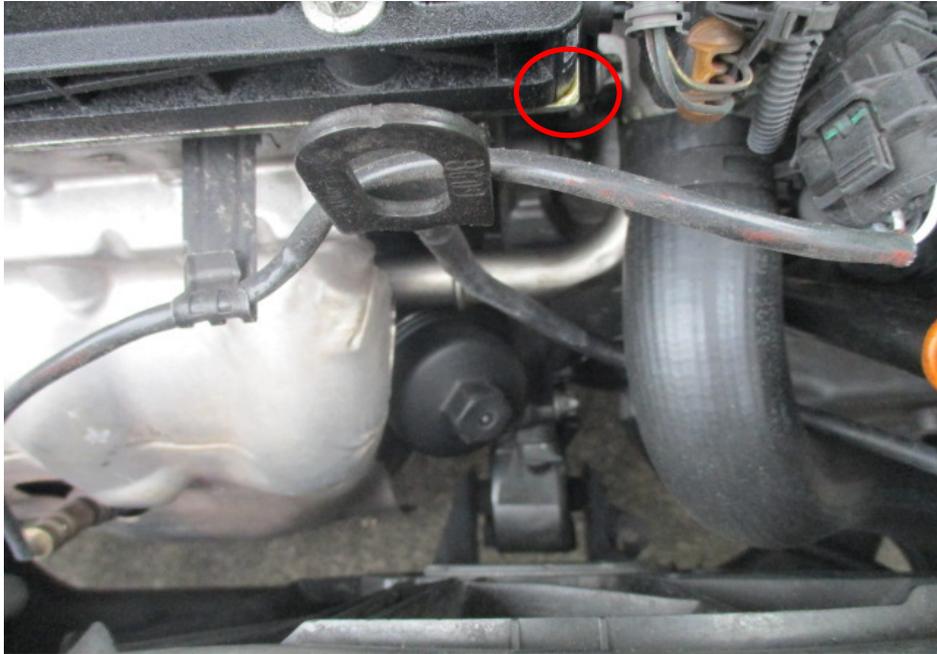
Photo 10 shows a closer view of wet fluid stains found around the front left corner of the front portion of the top camshaft cover of the engine (circled).

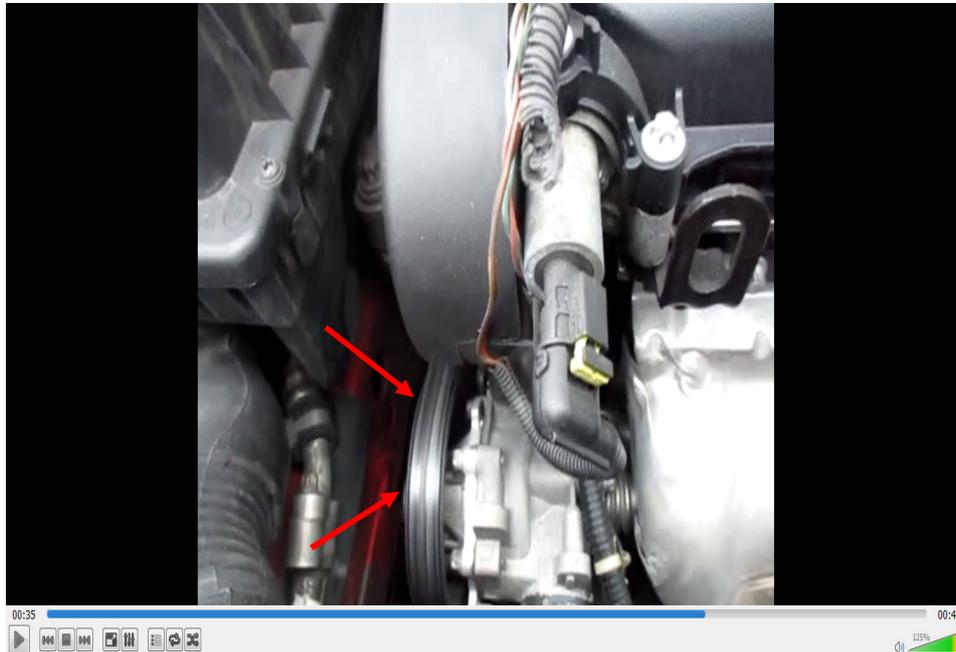
Screenshot 1 of the video recording shows the rotating belting (arrowed) of the Insured Vehicle to indicate that the engine of the Insured Vehicle was started and the engine left to operate for approximately 20 minutes.

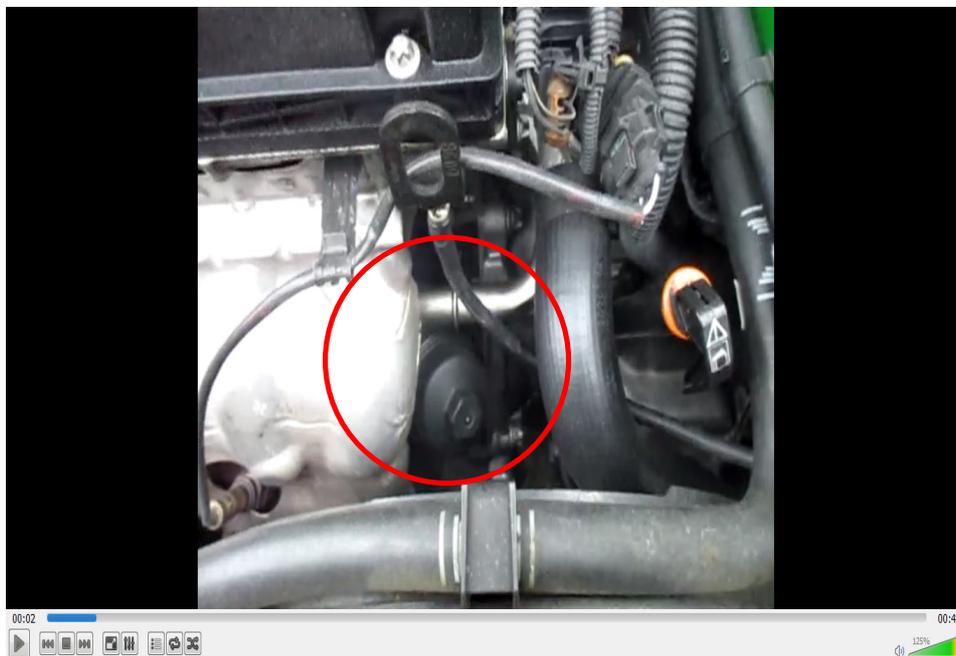
Screenshot 2 of the video recording shows after letting the engine operate for 10 minutes, we observed some engine oil seepage from the front portion of the top camshaft cover of the engine. We also detected a burnt smell followed by white smoke emitting from the front portion of the engine (circled). However one would have to view the recording to see the smoke emission.

28. Having investigated and technically analysed the damages to the Insured Vehicle, we are of the view that there was no fire to the Insured Vehicle.
29. The engine of the Insured Vehicle was able to be started up and continued to operate normally without stalling. Our investigations revealed oil seepage from the front portion of the top cover of the engine followed by oil burning smells and smoke emitting from the front portion of the engine after it was operating for a certain period of time. We did not find evidence of any burnt components in the engine compartment of the Insured Vehicle as a result of fire other than smoke stains caused by the oil leaks.

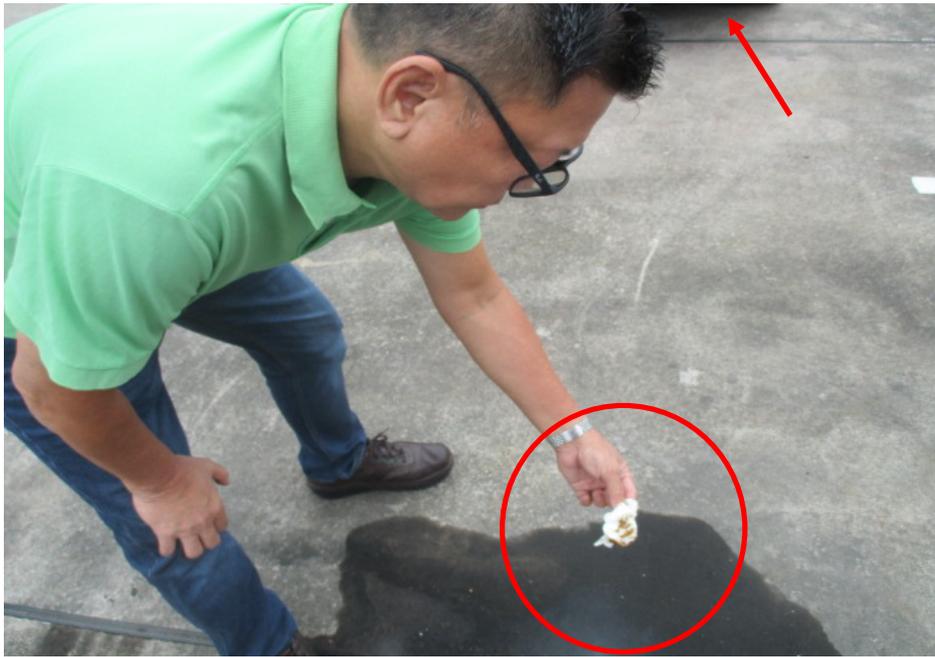
Photo 11 shows Principal Consultant, Mr K K Lau examining the fluid stains on the ground after the Insured Vehicle was driven some distance forward (arrowed). We found wet fluid stains on the ground directly below the engine compartment where the Insured Vehicle was positioned (circled).

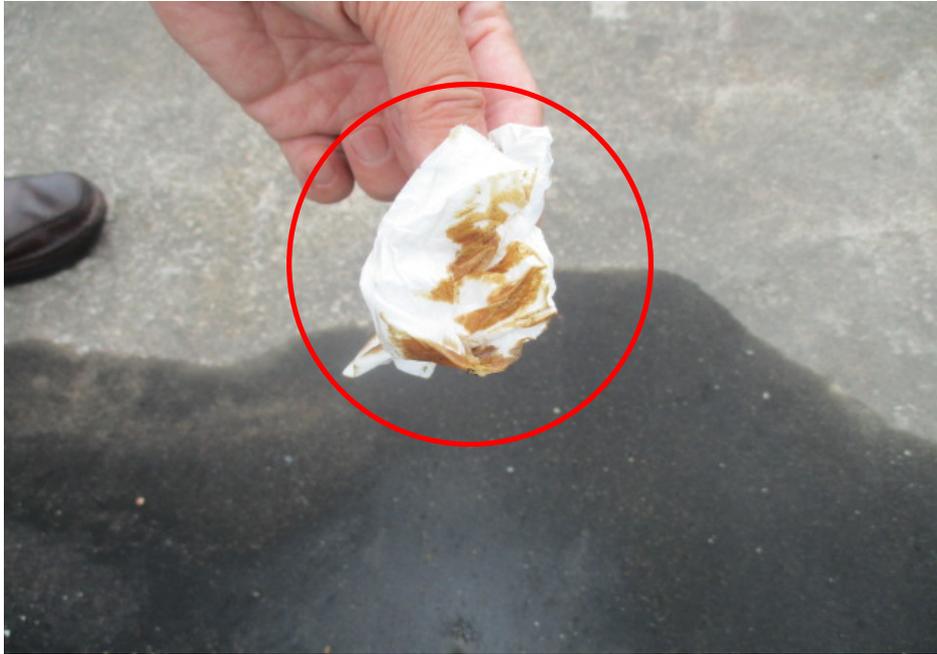
Photo 12 shows a close up view of the wet fluid stains on the ground directly below the engine compartment where the Insured Vehicle was positioned (circled).

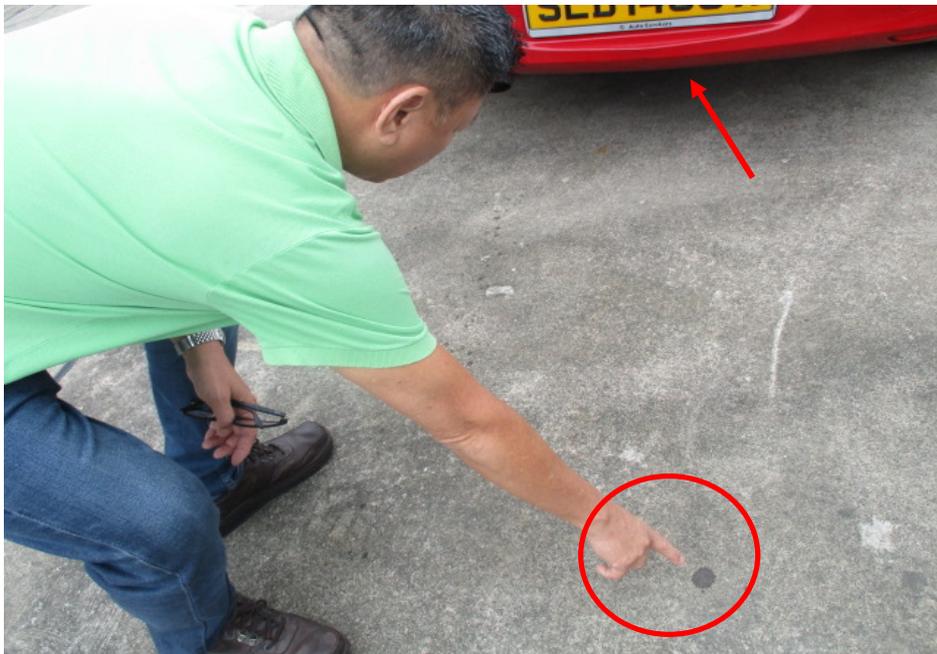
Photo 13 shows Principal Consultant, Mr K K Lau highlighting the second patch of wet fluid stains on the ground (circled) after the Insured Vehicle was driven some distance forward for a second time (arrowed).

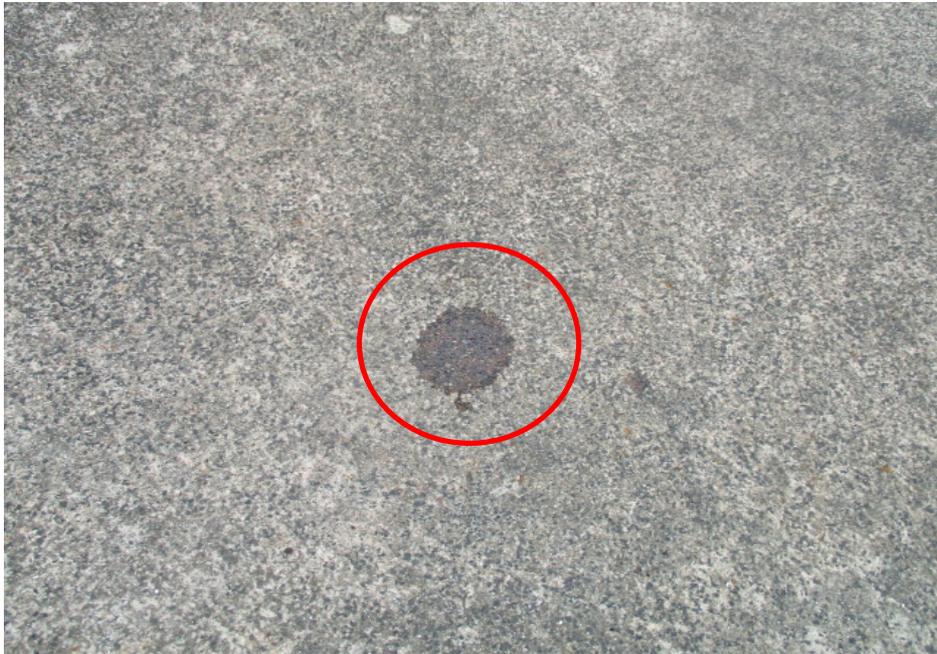
Photo 14 shows a close up view of the second patch of wet fluid stains on the ground (circled) after the Insured Vehicle was driven some distance forward for a second time.
