Your Ref : 541558
Our Ref : CS/MSG17024132/N

28 December 2017

**AUTOMOBILE TECHNICAL INVESTIGATION REPORT OF ACCIDENT
INVOLVING SGH 575H AND XD 7869J ON 18 DECEMBER 2017**

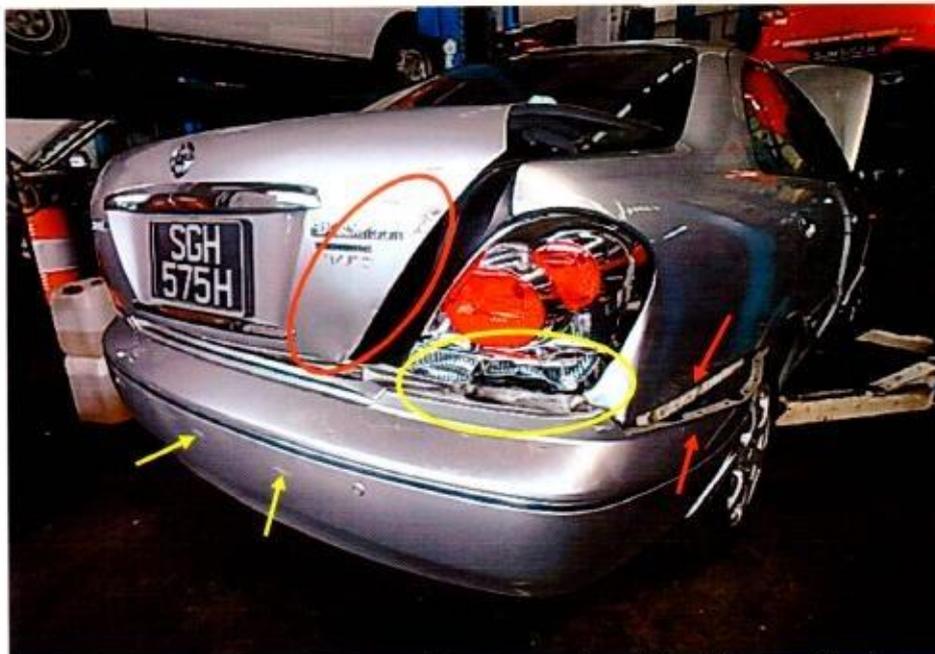
Photo 1 shows the general view of the rear portion of the Nissan at the time of the Pre- Repair Survey conducted by LKK Auto Consultants Pte. Ltd. which was taken 2 days after the accident. There were paint graze marks on the lower centre portion of the rear bumper of the Nissan (yellow arrows). There was a slight dent and 2 horizontal black marks on the right side of the boot lid (red circle). The right tail light had cracked and was pushed inwards (yellow circle). The rear bumper had buckled and was misaligned at the right rear portion (red arrows).

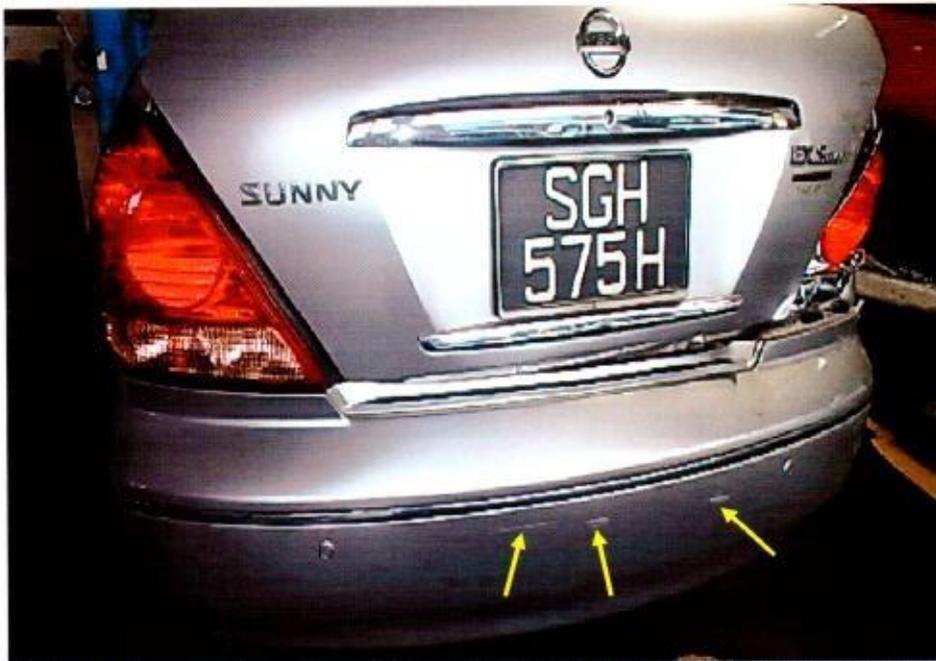
Photo 2 shows a closer view of the paint graze marks found on the lower centre portion of the rear bumper of the Nissan (yellow arrows).

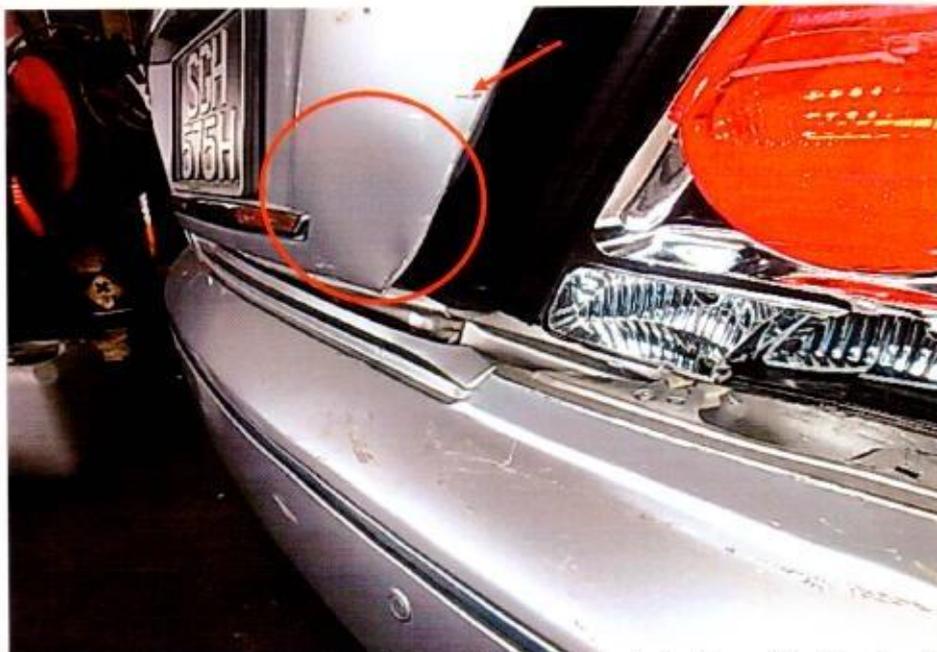
Photo 3 shows a closer view of the slight dent (red circle) and 1st horizontal black mark (red arrow) on the right side of the boot lid

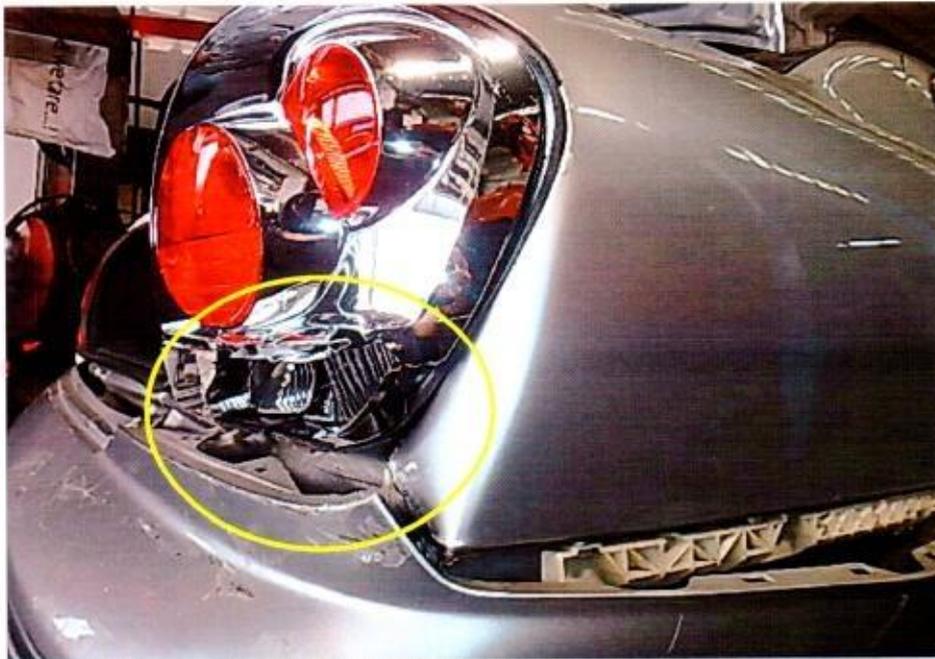
Photo 4 shows a close up view of the right tail light which was cracked and pushed inwards (yellow circle).

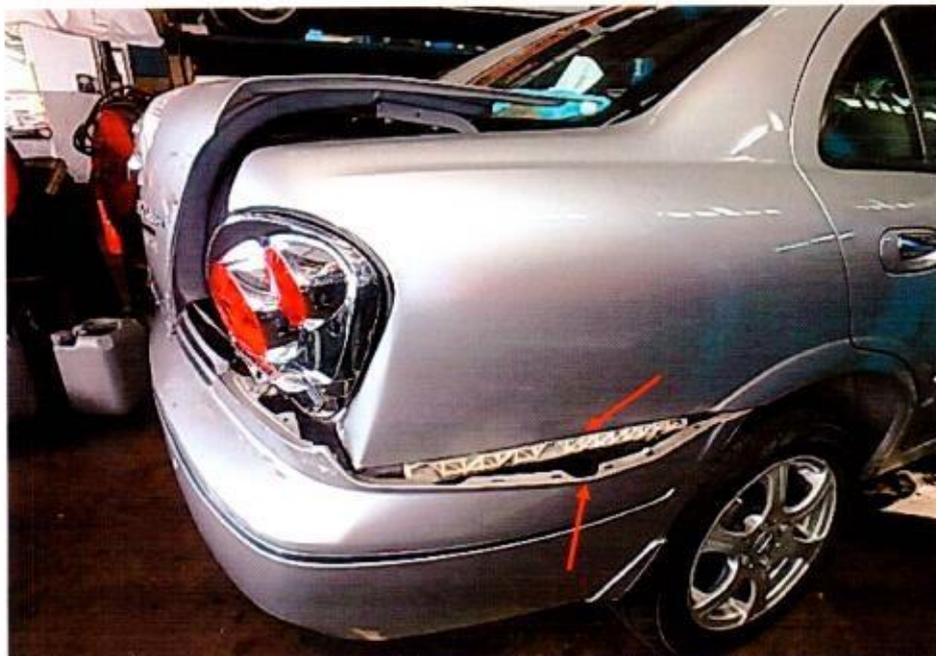
Photo 5 shows a closer view of the rear bumper which had buckled and was misaligned at the right rear portion (red arrows).

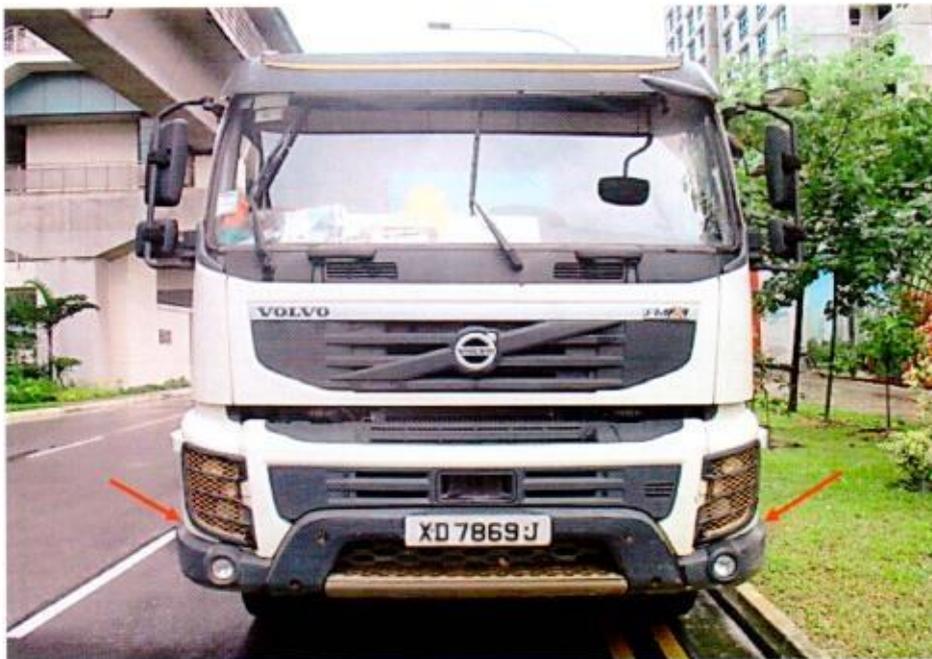
Photo 6 shows the general view of the front portion of the Lorry at the time of inspection. We found several faint scratch marks on the left and right portion side of the front bumper as well as faint graze marks and chip marks on the lower left portion of the front bumper of the Lorry. We also observed scratch marks on the left headlight guard (arrowed) and paint chip marks on the left front portion of the Lorry. However, it was also noted that the front bumper was not misaligned at its corner edges (red arrows).

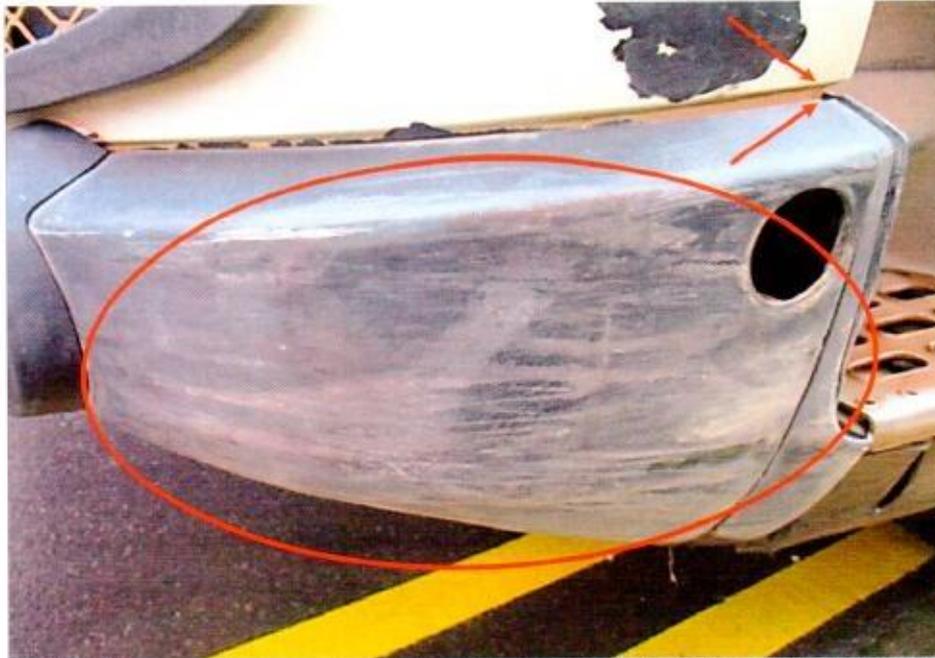
Photo 7 shows a close up view of the faint scratch marks (circled) on the left side of the front bumper of the Lorry. However the front bumper was not misaligned at its left corner edge (red arrows).

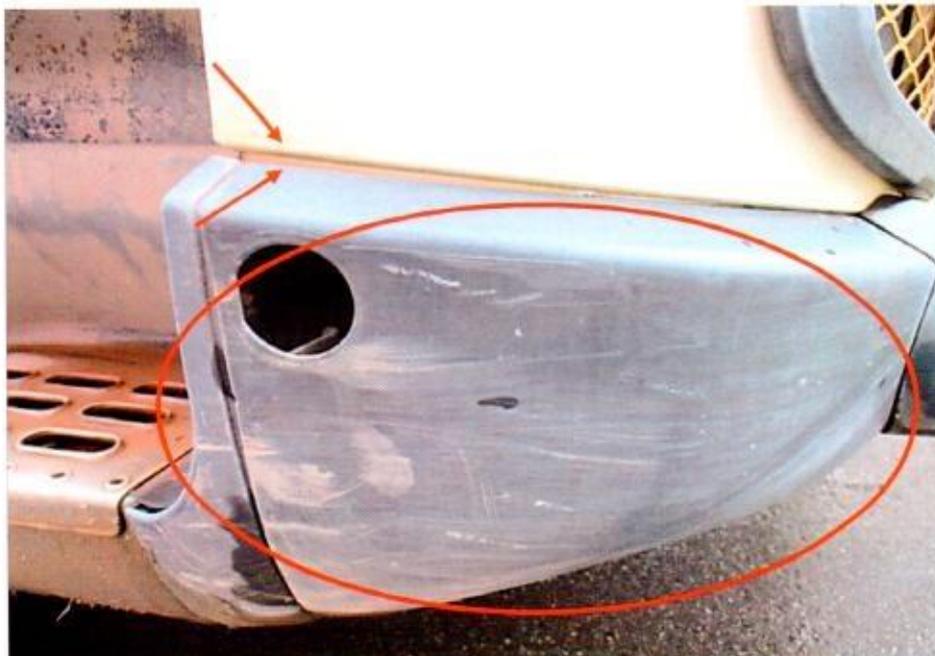
Photo 8 shows a close up view of the faint scratch marks (circled) on the right side of the front bumper of the Lorry. However the front bumper was not misaligned at its right corner edge (red arrows).

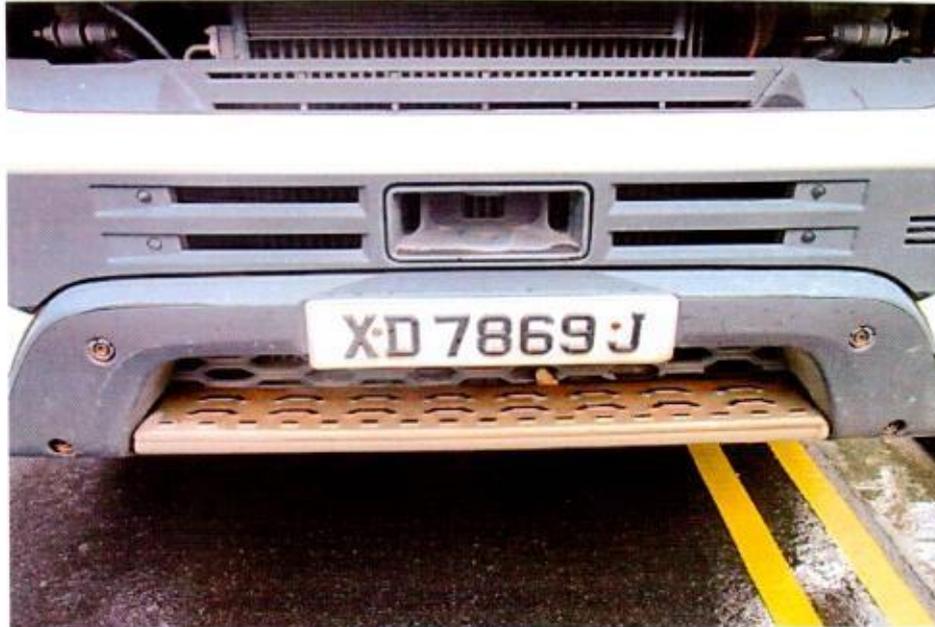
Photo 9 shows a closer view of the front bumper of the Lorry.

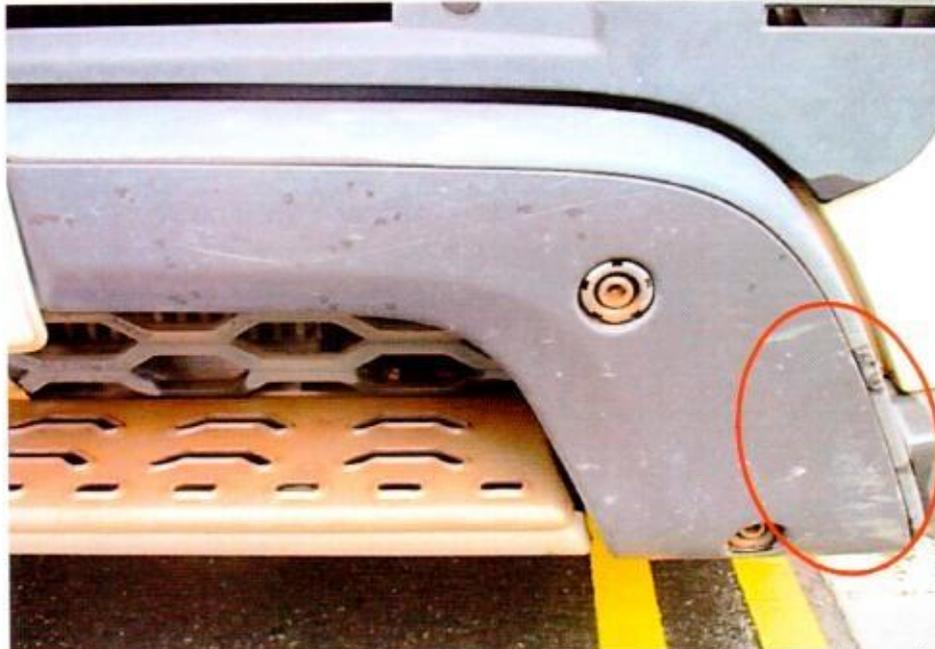
Photo 10 shows a closer view of the faint graze marks and chip marks on the lower left portion (circled) of the front bumper of the Lorry.

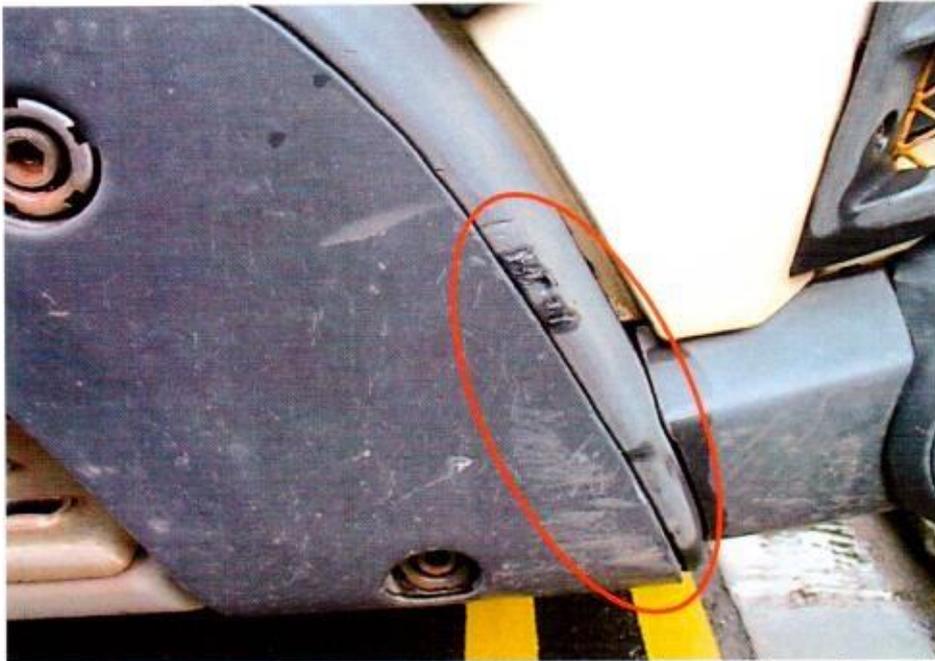
Photo 11 shows a close up view of the faint graze marks and chip marks on the lower left portion (circled) of the front bumper of the Lorry.

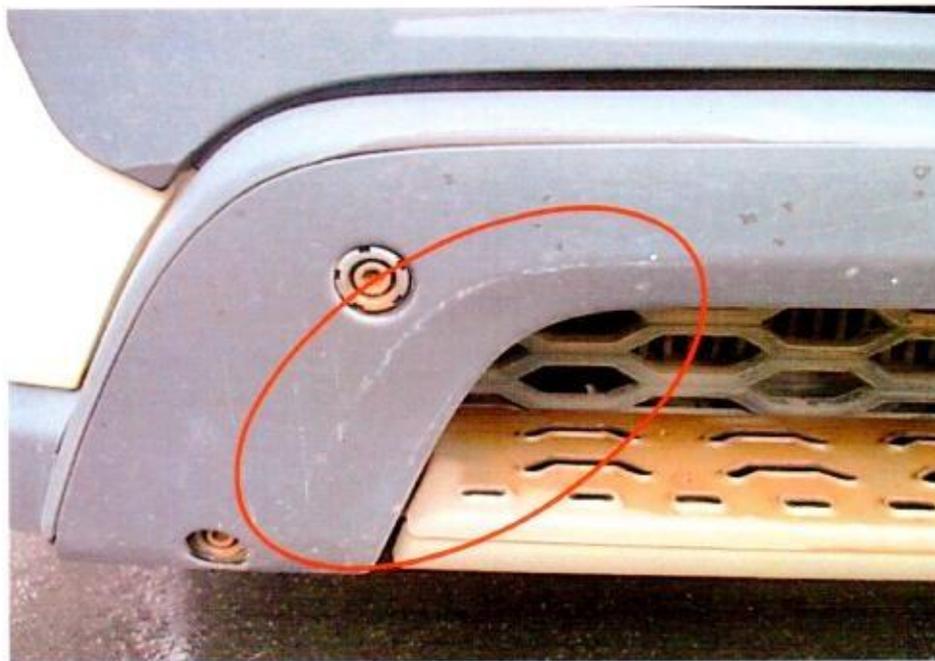
Photo 12 shows a close up view of the faint graze marks (circled) on the lower right portion of the front bumper of the Lorry.

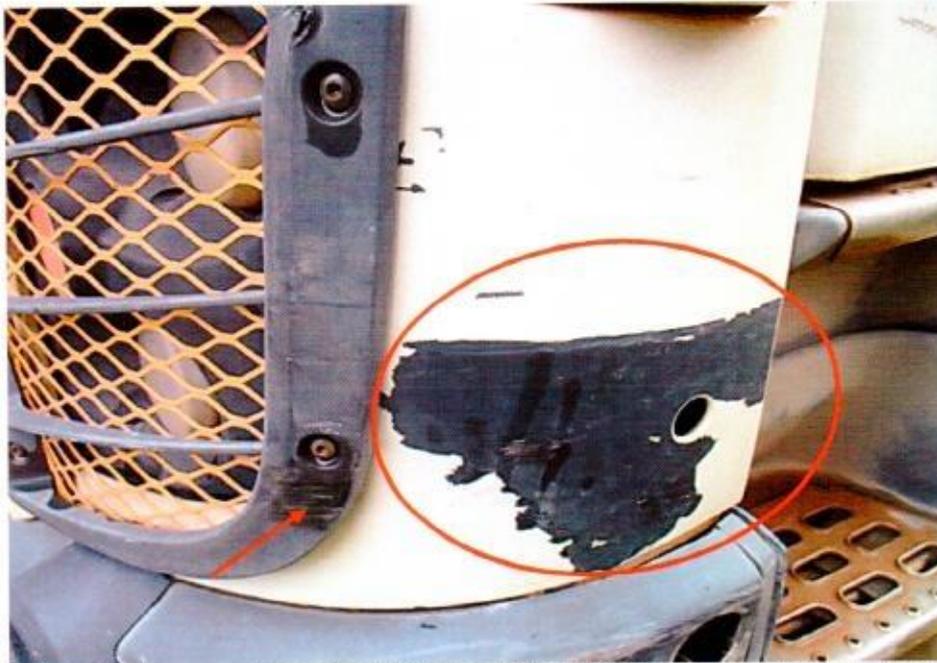
Photo 13 shows a closer view of the scratch marks on the left headlight guard (arrowed) as well as paint chip marks on the left front portion of the Lorry (circled).

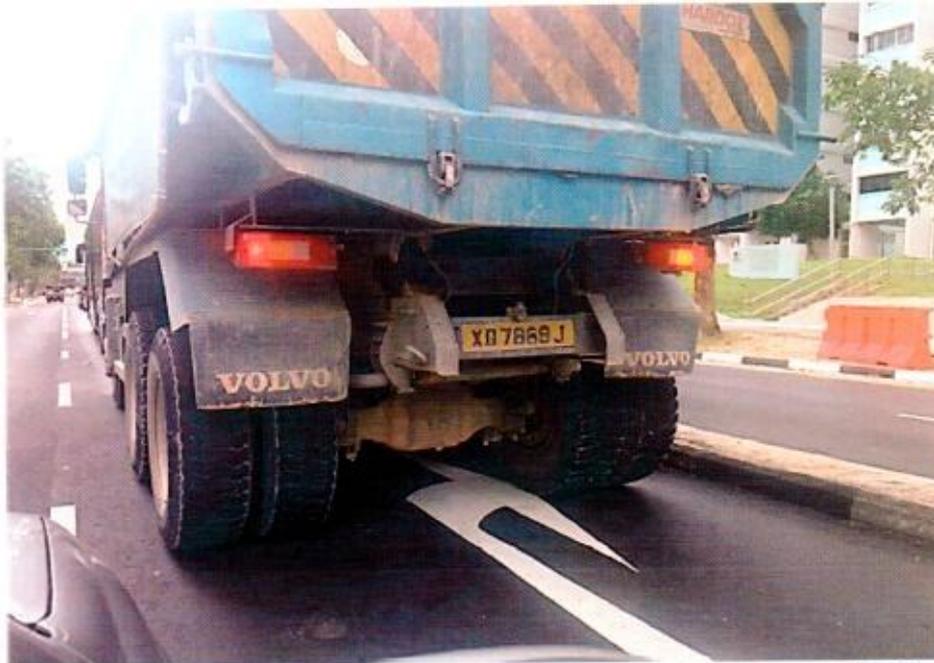
Photo 14 shows the rear portion of the Lorry at the accident scene. No other observations could be made from the photograph.

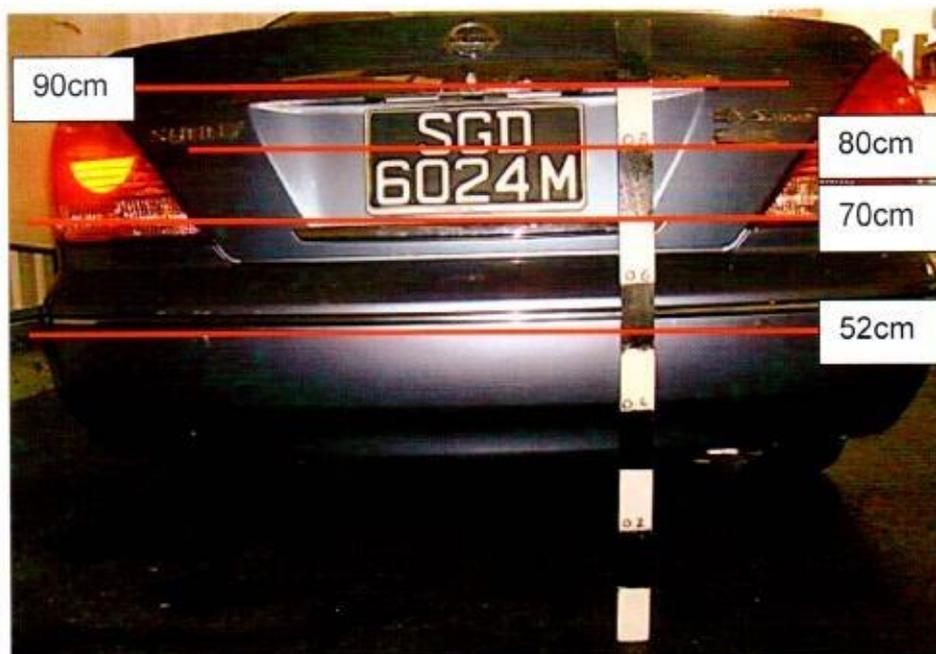
Photo 15 shows the height measurement being conducted on the rear portion of the Nissan (using a similar make and model). The height above ground level of the lower centre portion of the rear bumper, at the area where the paint graze marks were found was measured to be approximately 52cm. The height above ground level of the bottom portion of the right tail light, at the area where the right tail light was pushed inwards was measured to be approximately 70cm. The height above ground level of the centre portion of the rear number plate, at the area where the 1st horizontal black mark was found was measured to be approximately 80cm. The height above ground level of the bottom part of the boot lid chrome trim, at the area where the 2nd horizontal black mark was found was measured to be approximately 90cm. The damages on the rear portion of the Nissan were between the ranges of 52cm to 90cm above ground level.

- a) The height above ground level of the lower centre portion of the rear bumper of the Nissan, at the area where the paint graze marks were found was measured to be approximately 52cm;
- b) the height above ground level of the bottom portion of the right tail light of the Nissan, at the area where the right tail light was pushed inwards was measured to be approximately 70cm;
- c) the height above ground level of the centre portion of the rear number plate of the Nissan, at the area where the 1st horizontal black mark was found was measured to be approximately 80cm;

- d) the height above ground level of the bottom part of the boot lid chrome trim of the Nissan, at the area where the 2nd horizontal black mark was found was measured to be approximately 90cm;

- e) the damages on the rear portion of the Nissan were between the ranges of 52cm to 90cm above ground level;
- f) the height at 52cm above ground does not correspond with any body part of the Lorry;

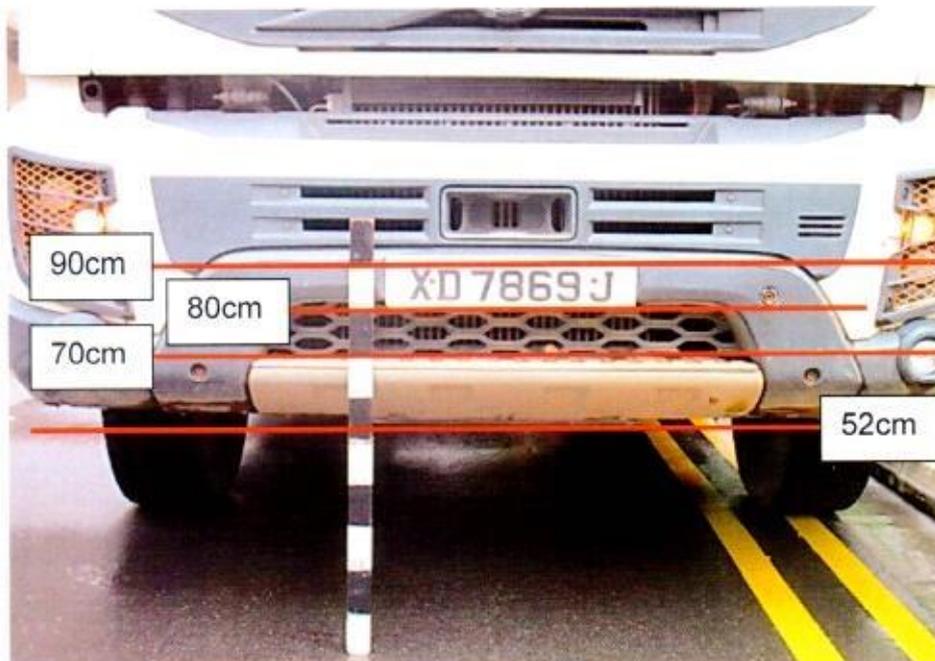
Photo 16 shows the height measurement being conducted on the front portion of the Lorry. The height at 52cm above ground does not correspond with any body part of the Lorry. The body part at 70cm above ground was the lower left portion of the front bumper, which was where the 1st chip mark was found. The body part at 80cm above ground was the centre left portion of the front bumper, which was where the 2nd chip mark was found. The body part at 90cm above ground was the upper left portion of the front bumper.

- g) the body part at 70cm above ground was the lower left portion of the front bumper of the Lorry, which was where the 1st chip mark was found;
- h) the body part at 80cm above ground was the centre left portion of the front bumper of the Lorry, which was where the 2nd chip mark was found;

- i) the body part at 90cm above ground was the upper left portion of the front bumper of the Lorry;
- j) the height measurements appear to support the findings of possible contact between the rear portion of the Nissan and the front portion of the Lorry.
