Your Ref : 541558
Our Ref : CS/MSG17024132/N

**AUTOMOBILE TECHNICAL INVESTIGATION REPORT OF ACCIDENT
INVOLVING SGH 575H AND XD 7869J ON 18 DECEMBER 2017**

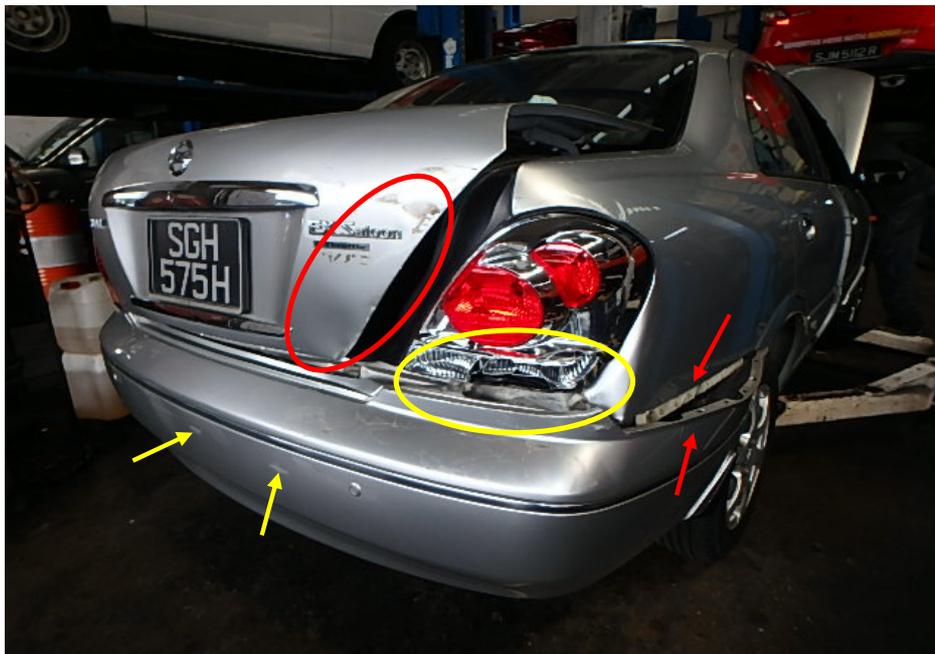
Photo 1 shows the general view of the rear portion of the Nissan at the time of the Pre- Repair Survey conducted by LKK Auto Consultants Pte. Ltd. which was taken 2 days after the accident. There were paint graze marks on the lower centre portion of the rear bumper of the Nissan (yellow arrows). There was a slight dent and 2 horizontal black marks on the right side of the boot lid (red circle). The right tail light had cracked and was pushed inwards (yellow circle). The rear bumper had buckled and was misaligned at the right rear portion (red arrows).

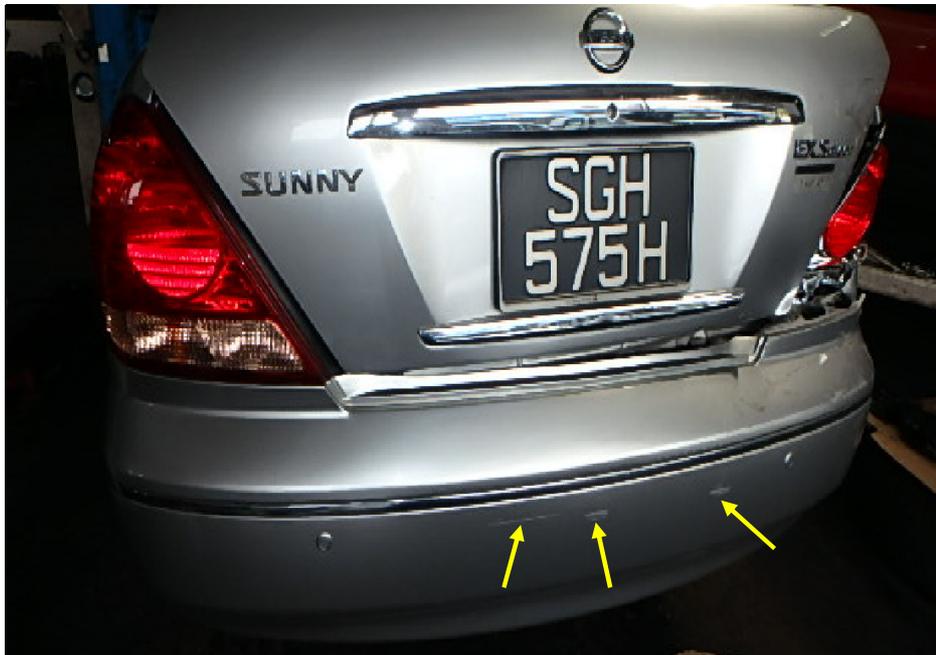
Photo 2 shows a closer view of the paint graze marks found on the lower centre portion of the rear bumper of the Nissan (yellow arrows).

- a) The height above ground level of the lower centre portion of the rear bumper of the Nissan, at the area where the paint graze marks were found was measured to be approximately 52cm;
- b) the height above ground level of the bottom portion of the right tail light of the Nissan, at the area where the right tail light was pushed inwards was measured to be approximately 70cm;
- c) the height above ground level of the centre portion of the rear number plate of the Nissan, at the area where the 1st horizontal black mark was found was measured to be approximately 80cm;

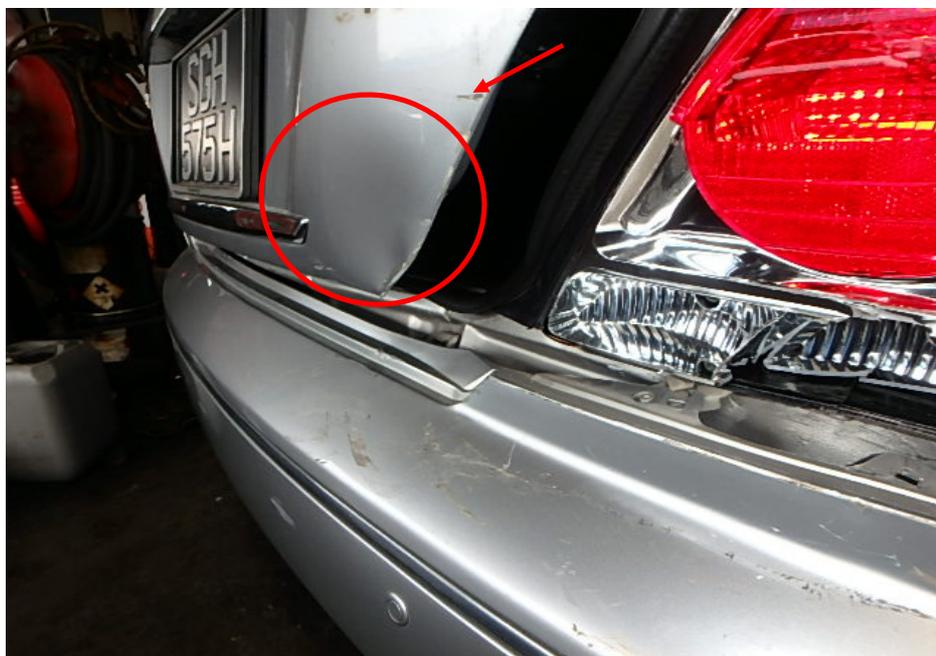
Photo 3 shows a closer view of the slight dent (red circle) and 1st horizontal black mark (red arrow) on the right side of the boot lid

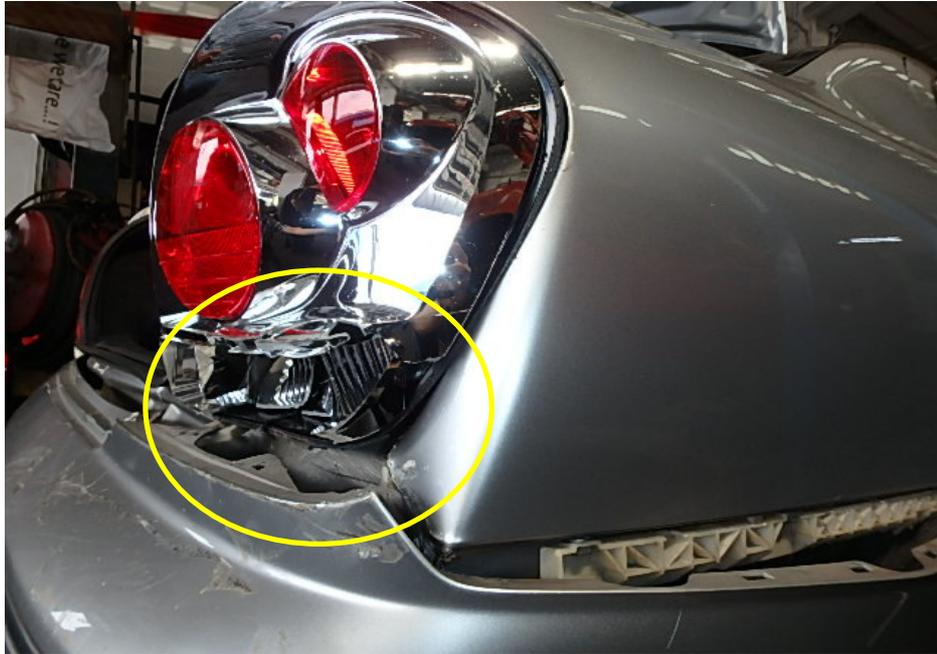
Photo 4 shows a close up view of the right tail light which was cracked and pushed inwards (yellow circle).

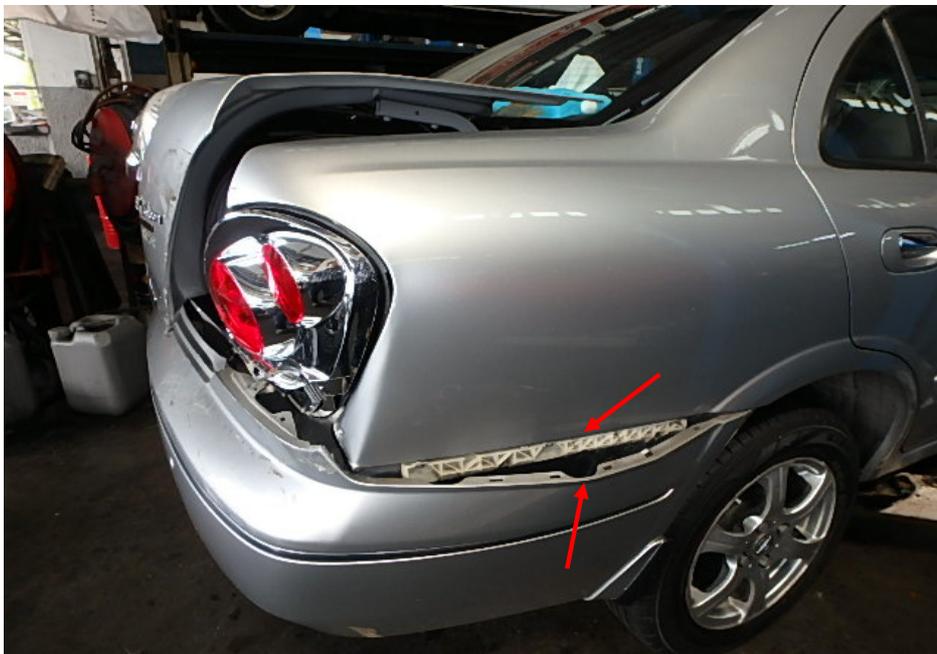
Photo 5 shows a closer view of the rear bumper which had buckled and was misaligned at the right rear portion (red arrows).

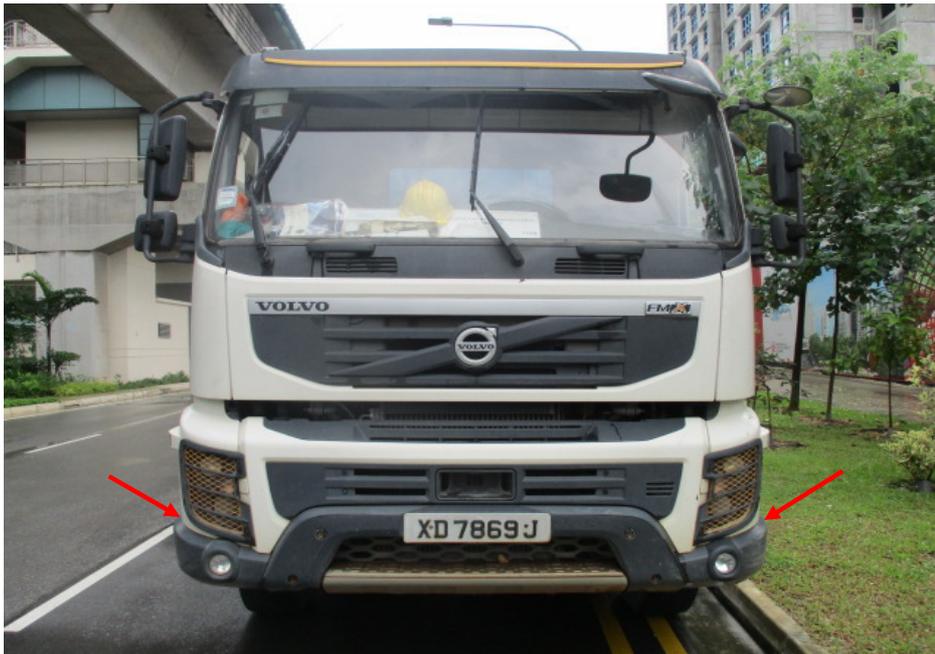
Photo 6 shows the general view of the front portion of the Lorry at the time of inspection. We found several faint scratch marks on the left and right portion side of the front bumper as well as faint graze marks and chip marks on the lower left portion of the front bumper of the Lorry. We also observed scratch marks on the left headlight guard (arrowed) and paint chip marks on the left front portion of the Lorry. However, it was also noted that the front bumper was not misaligned at its corner edges (red arrows).

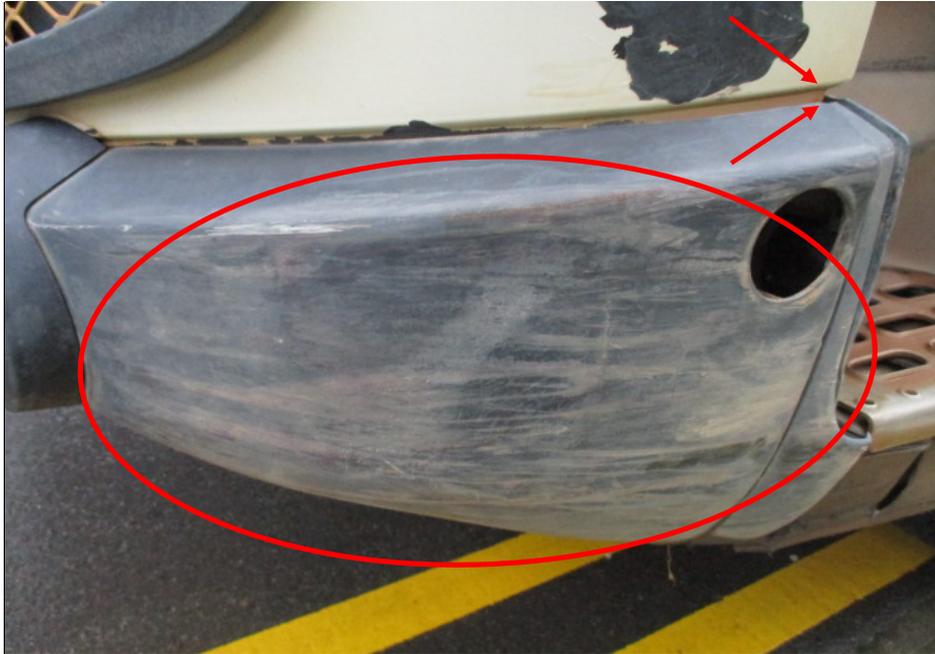
Photo 7 shows a close up view of the faint scratch marks (circled) on the left side of the front bumper of the Lorry. However the front bumper was not misaligned at its left corner edge (red arrows).

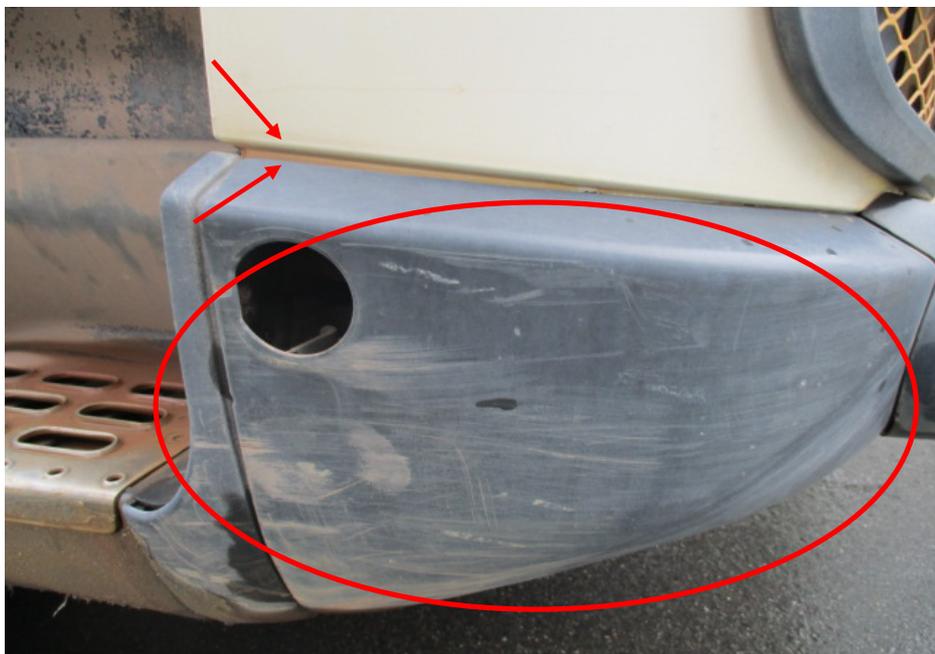
Photo 8 shows a close up view of the faint scratch marks (circled) on the right side of the front bumper of the Lorry. However the front bumper was not misaligned at its right corner edge (red arrows).

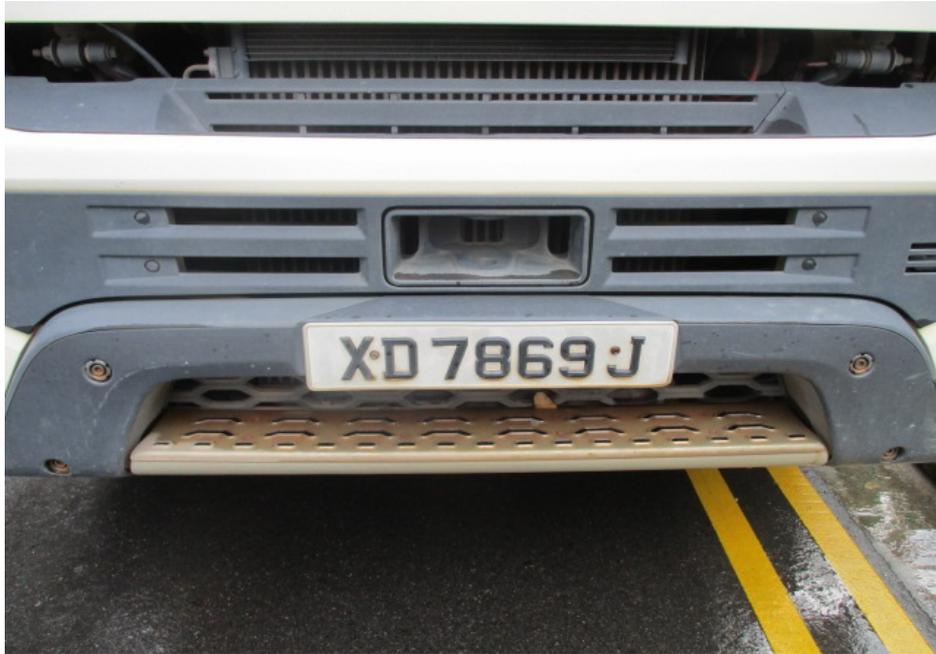
Photo 9 shows a closer view of the front bumper of the Lorry.

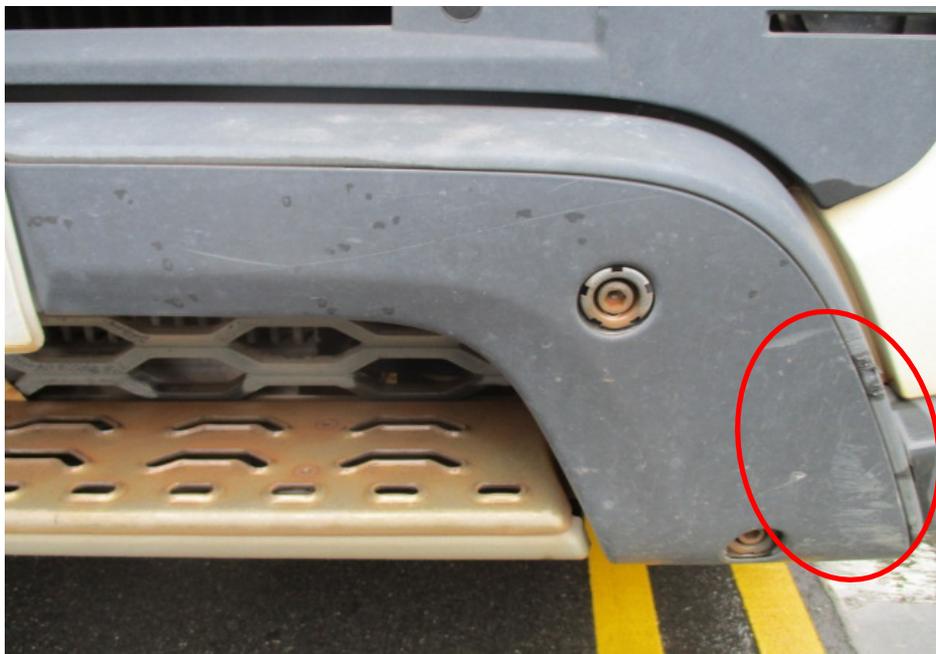
Photo 10 shows a closer view of the faint graze marks and chip marks on the lower left portion (circled) of the front bumper of the Lorry.

- g) the body part at 70cm above ground was the lower left portion of the front bumper of the Lorry, which was where the 1st chip mark was found;
- h) the body part at 80cm above ground was the centre left portion of the front bumper of the Lorry, which was where the 2nd chip mark was found;

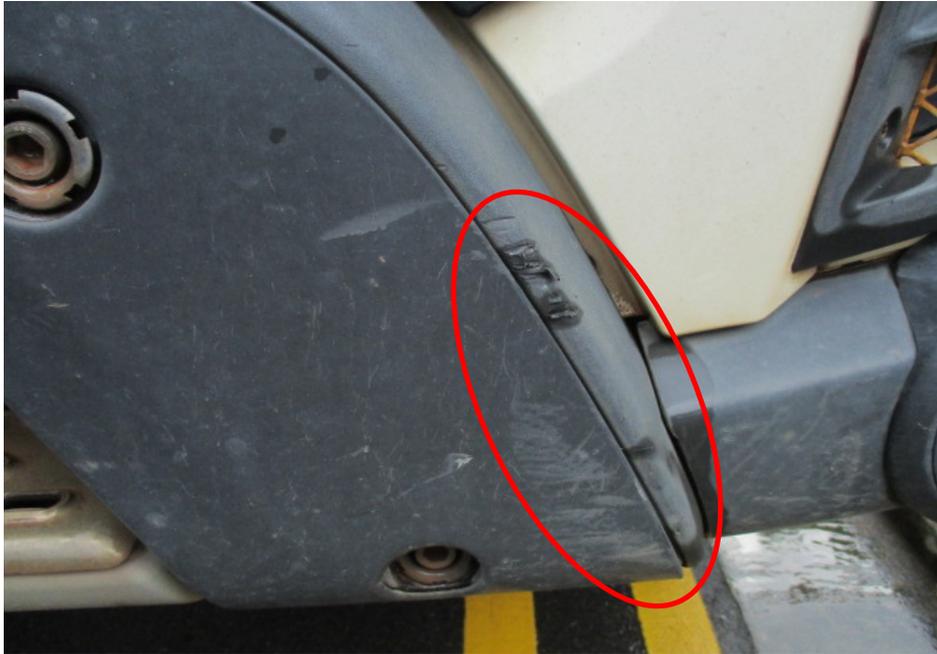
Photo 11 shows a close up view of the faint graze marks and chip marks on the lower left portion (circled) of the front bumper of the Lorry.

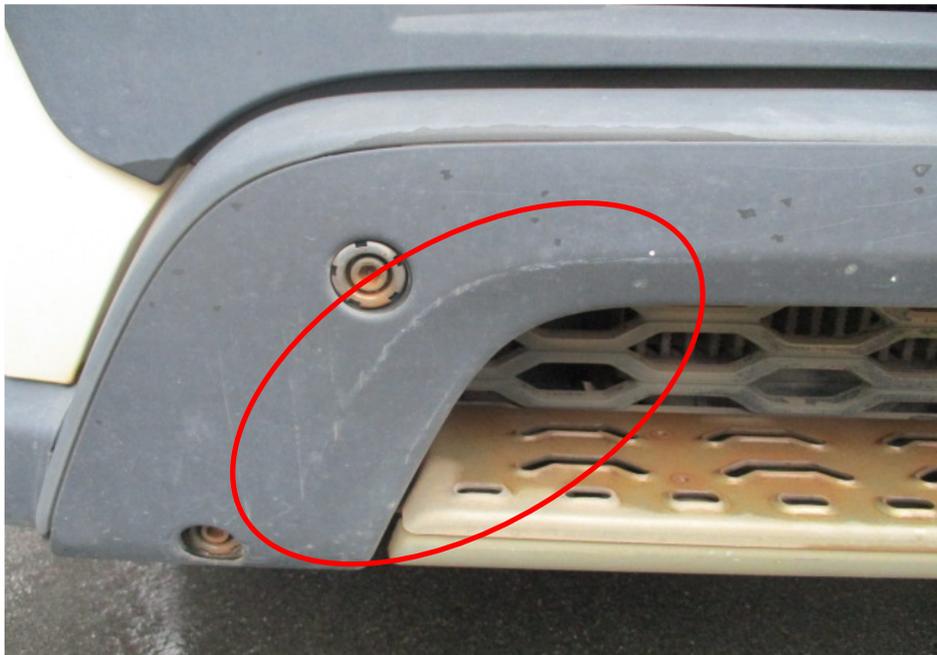
Photo 12 shows a close up view of the faint graze marks (circled) on the lower right portion of the front bumper of the Lorry.

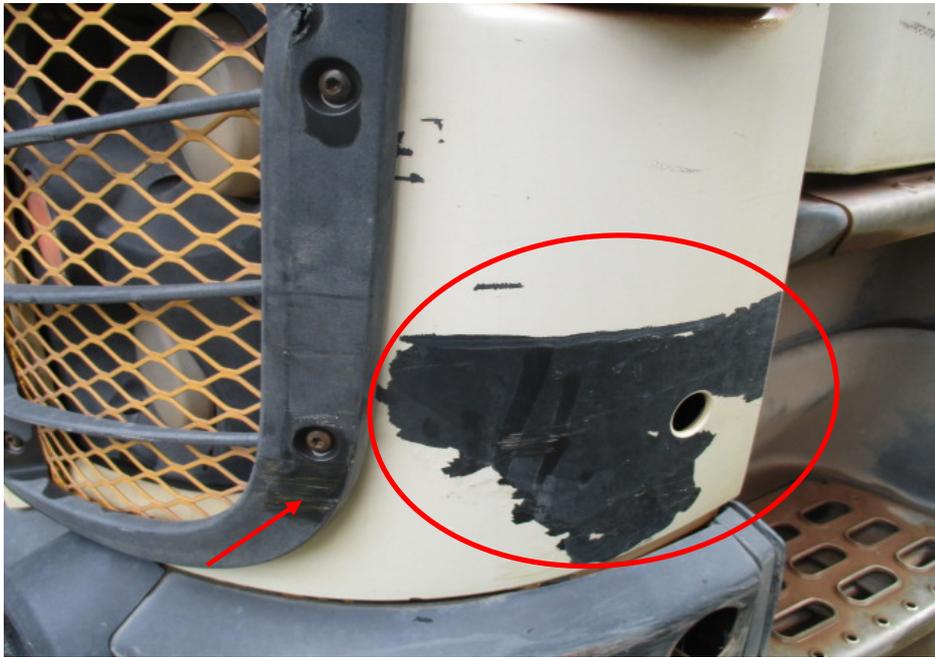
Photo 13 shows a closer view of the scratch marks on the left headlight guard (arrowed) as well as paint chip marks on the left front portion of the Lorry (circled).

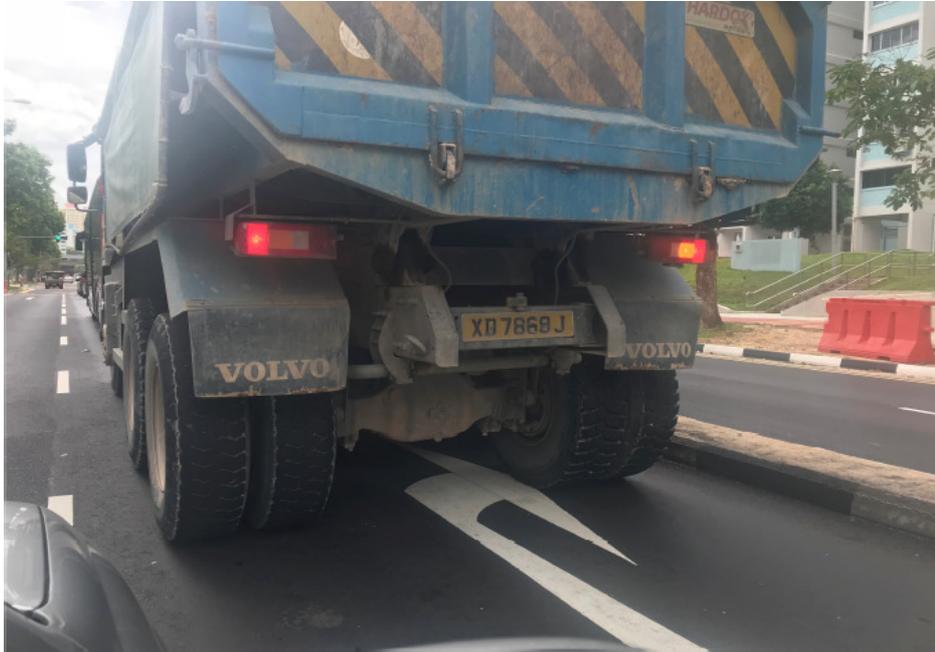
Photo 14 shows the rear portion of the Lorry at the accident scene. No other observations could be made from the photograph.

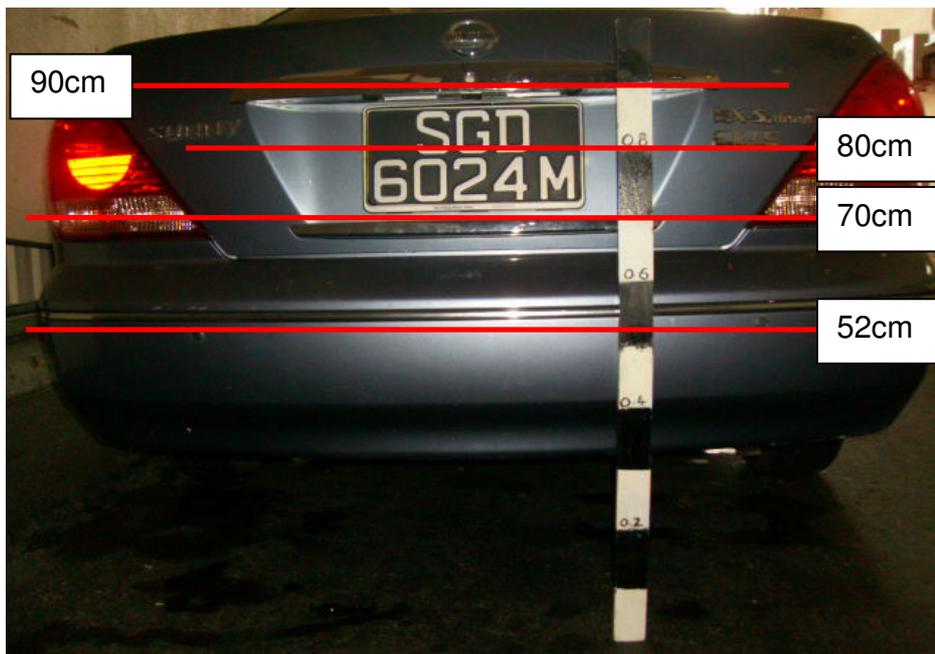
Photo 15 shows the height measurement being conducted on the rear portion of the Nissan (using a similar make and model). The height above ground level of the lower centre portion of the rear bumper, at the area where the paint graze marks were found was measured to be approximately 52cm. The height above ground level of the bottom portion of the right tail light, at the area where the right tail light was pushed inwards was measured to be approximately 70cm. The height above ground level of the centre portion of the rear number plate, at the area where the 1st horizontal black mark was found was measured to be approximately 80cm. The height above ground level of the bottom part of the boot lid chrome trim, at the area where the 2nd horizontal black mark was found was measured to be approximately 90cm. The damages on the rear portion of the Nissan were between the ranges of 52cm to 90cm above ground level.

- e) the damages on the rear portion of the Nissan were between the ranges of 52cm to 90cm above ground level;
- f) the height at 52cm above ground does not correspond with any body part of the Lorry;

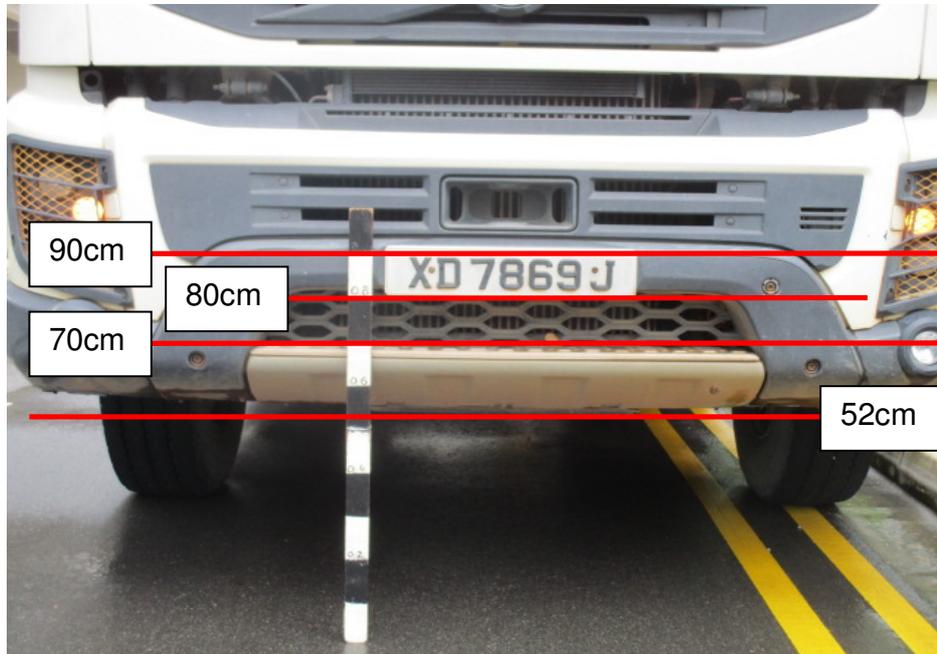
Photo 16 shows the height measurement being conducted on the front portion of the Lorry. The height at 52cm above ground does not correspond with any body part of the Lorry. The body part at 70cm above ground was the lower left portion of the front bumper, which was where the 1st chip mark was found. The body part at 80cm above ground was the centre left portion of the front bumper, which was where the 2nd chip mark was found. The body part at 90cm above ground was the upper left portion of the front bumper.

- i) the body part at 90cm above ground was the upper left portion of the front bumper of the Lorry;
- j) the height measurements appear to support the findings of possible contact between the rear portion of the Nissan and the front portion of the Lorry.
