Your Ref: CMQD1700040
Our Ref : CI/SMO17024557/D

28 December 2017

TECHNICAL REPORT OF TRANSMISSION WARRANTY CLAIM FOR THE INSURED VEHICLE SJR 9891Y

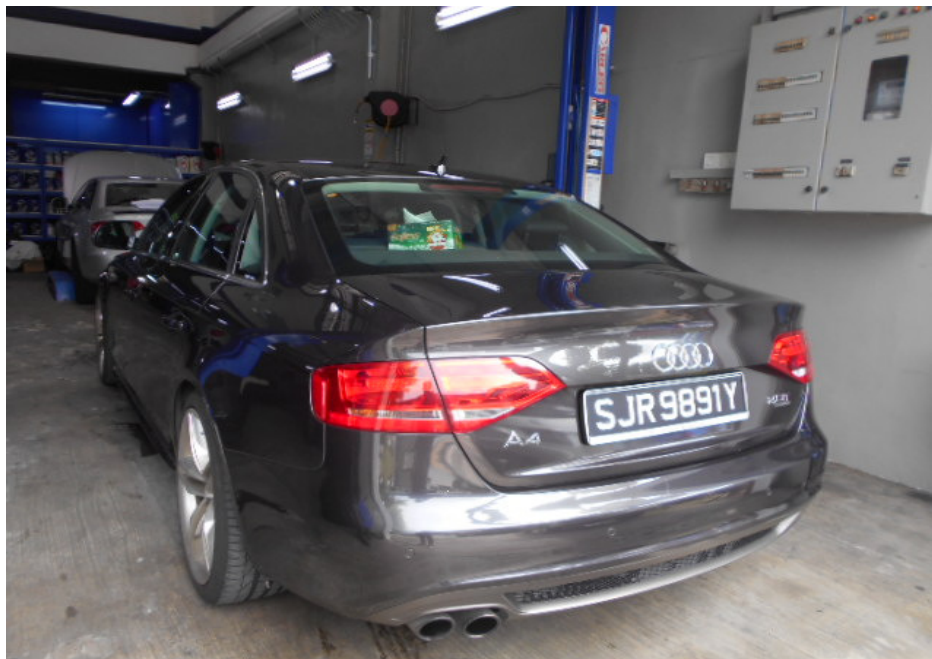
Photo 1 shows a general view of the Insured Vehicle at the time of my inspection. The Insured Vehicle was observed to be in good general condition with no loose exterior fittings or connections.

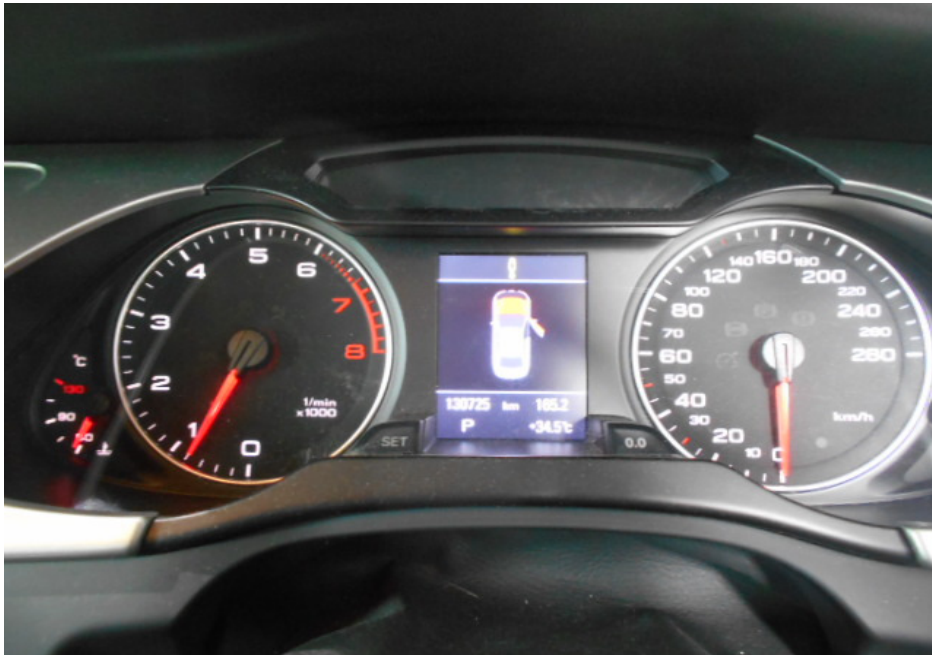
Photo 2 shows no error message appearing on the instrument panel of the Insured Vehicle after its engine was started.

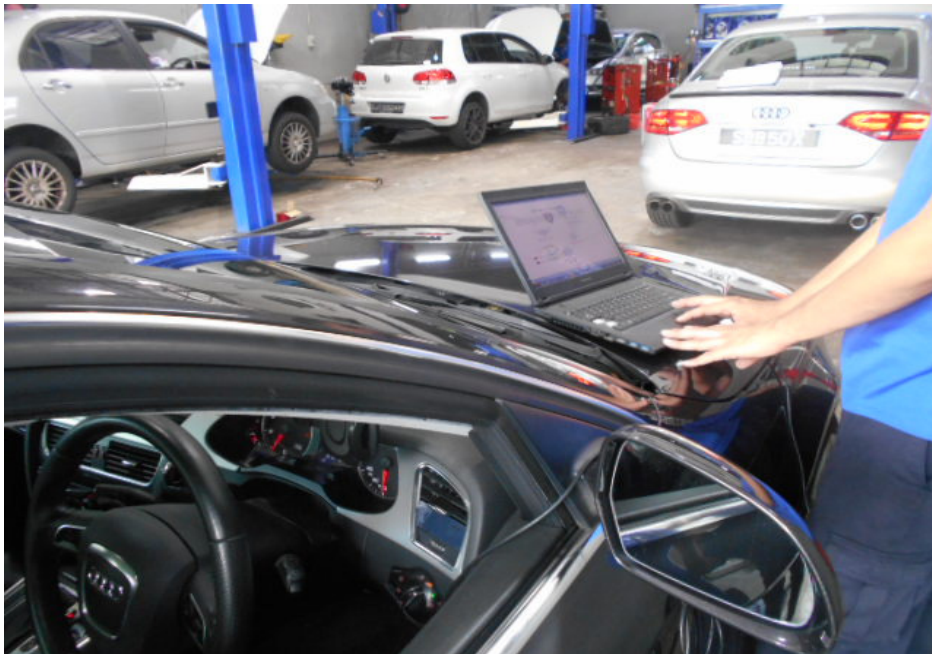
Photo 3 shows the diagnostic test being carried out on the Insured Vehicle to check for any electronic fault(s). Data from the various electronic control modules of the Insured Vehicle were being retrieved.

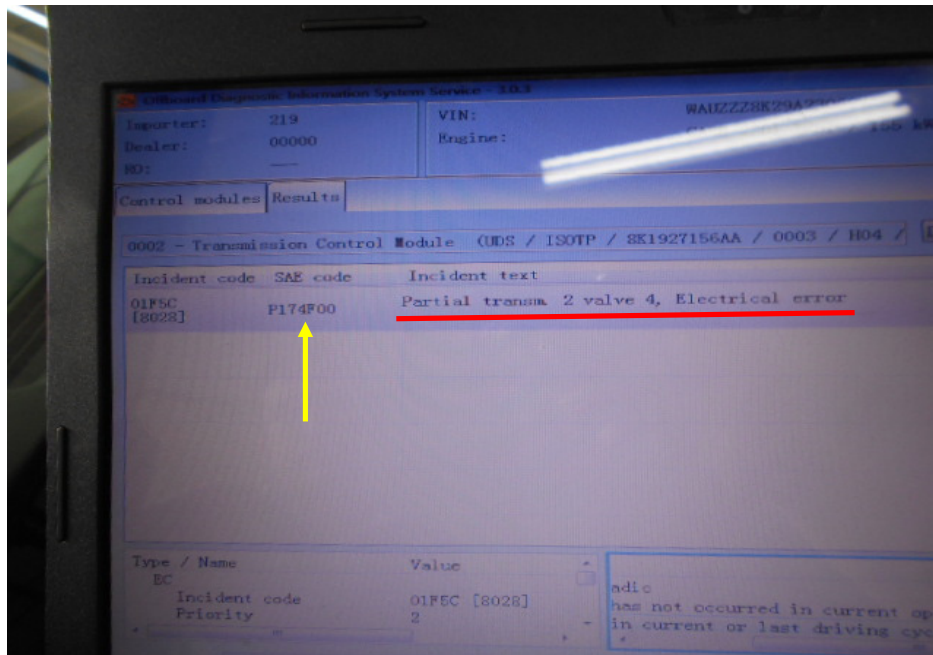
Photo 4 shows the recorded fault code after the completion of the diagnostic test. The fault code recorded was P174F00 (yellow arrow). The description of this fault (red line) was noted to be related to the transmission system of the Insured Vehicle.

8. My checks and enquiries revealed that the fault code P174F00 relating to the transmission system of the Insured Vehicle were for electrical errors to the valve body (mechatronic) of the Insured Vehicle. These fault codes are also amongst the common fault codes that are associated with the type of transmission system that is fitted on most Audi model motor cars. See photo 10 below showing the valve body of the Insured Vehicle.

11. Basing on my inspection of the Insured Vehicle and the information gathered during the course of my investigations, I am of the view that the transmission system of the Insured Vehicle had malfunctioned electronically, resulting in partial operation of its transmission system.
12. Such malfunction is commonly associated with the type of transmission system that is fitted on most Audi model motor cars, where components in the valve body (mechatronic) are known to have failed pre-maturely.
13. For this case, I did not find any evidence to suggest that the malfunction was due to poor maintenance of the Insured Vehicle's transmission system.

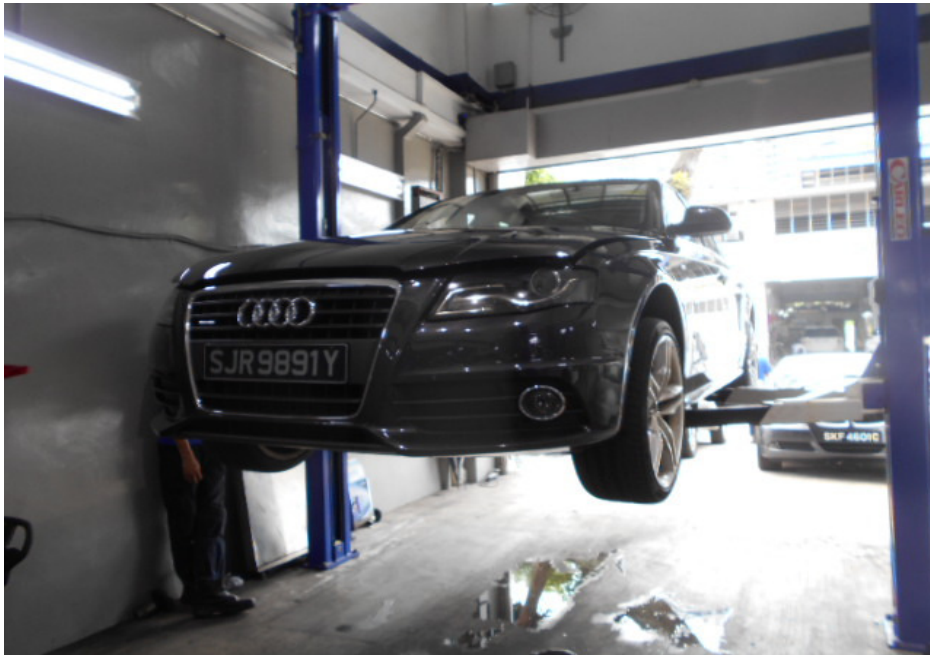
Photo 5 shows the Insured Vehicle being hoisted up for checks on its underside, in particular to its transmission assembly and transmission fluid.

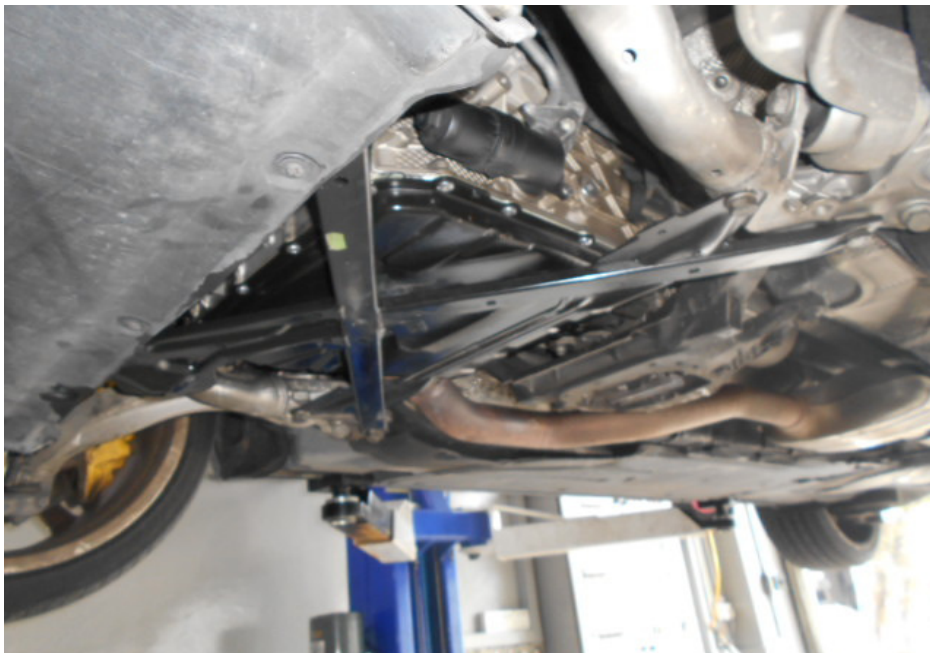
Photo 6 shows a general view of the underside of the Insured Vehicle where the transmission housing was located. There was no sign(s) of fluid stain(s) and/or fluid leakage observed on the underside of the Insured Vehicle.

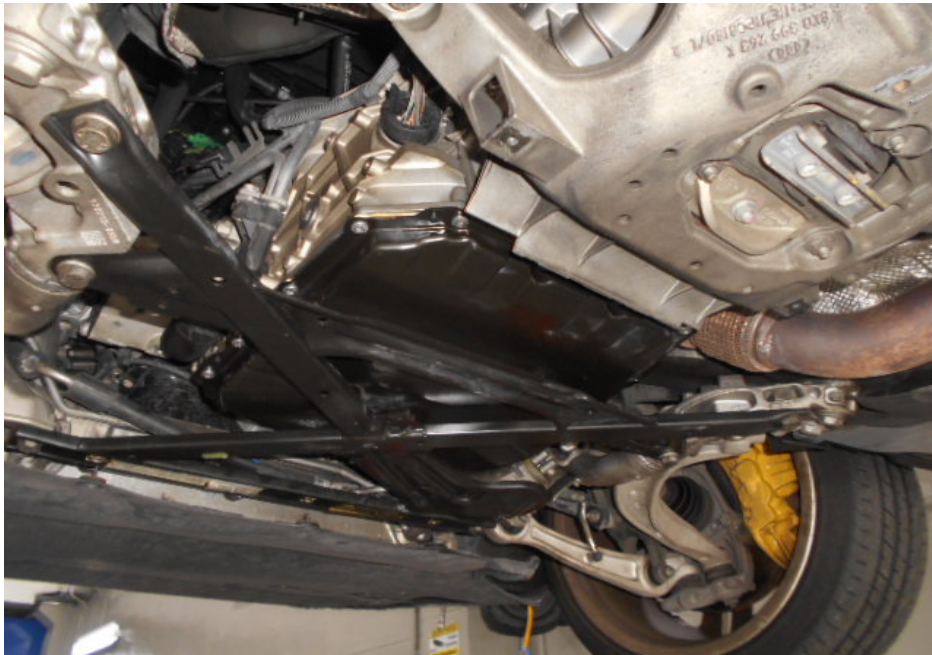
Photo 7 shows a general view of the underside of the Insured Vehicle where the transmission housing was located. There was no sign(s) of fluid stain(s) and/or fluid leakage observed on the underside of the Insured Vehicle.

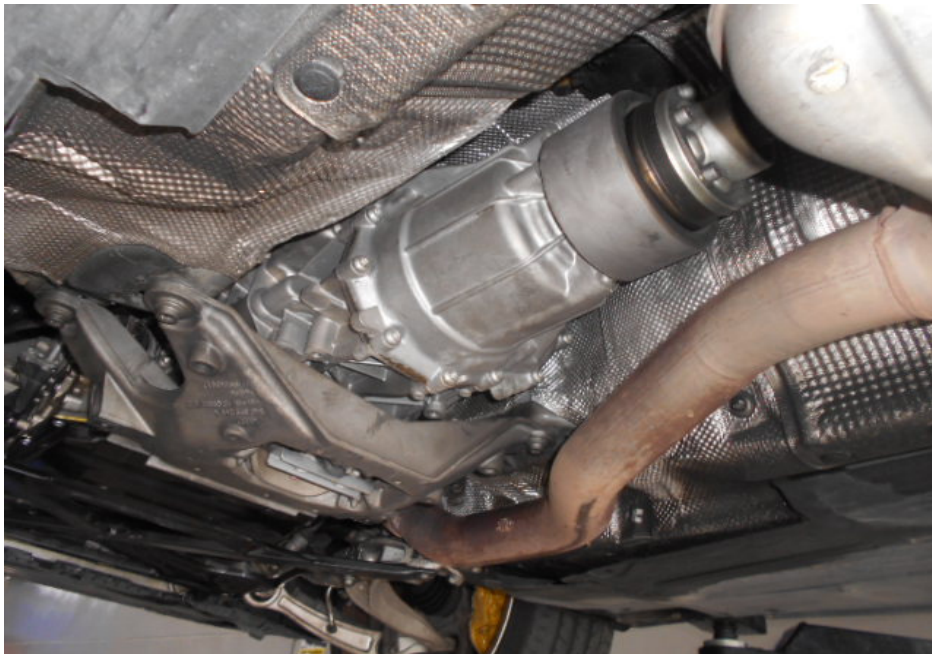
Photo 8 shows a general view of the underside of the Insured Vehicle, at the area where the transmission housing was located. There was no sign(s) of fluid stain(s) and/or fluid leakage observed on the underside of the Insured Vehicle. There was also no visible damage observed on the transmission housing. The electronic sensors were all securely fitted into the connector ports.

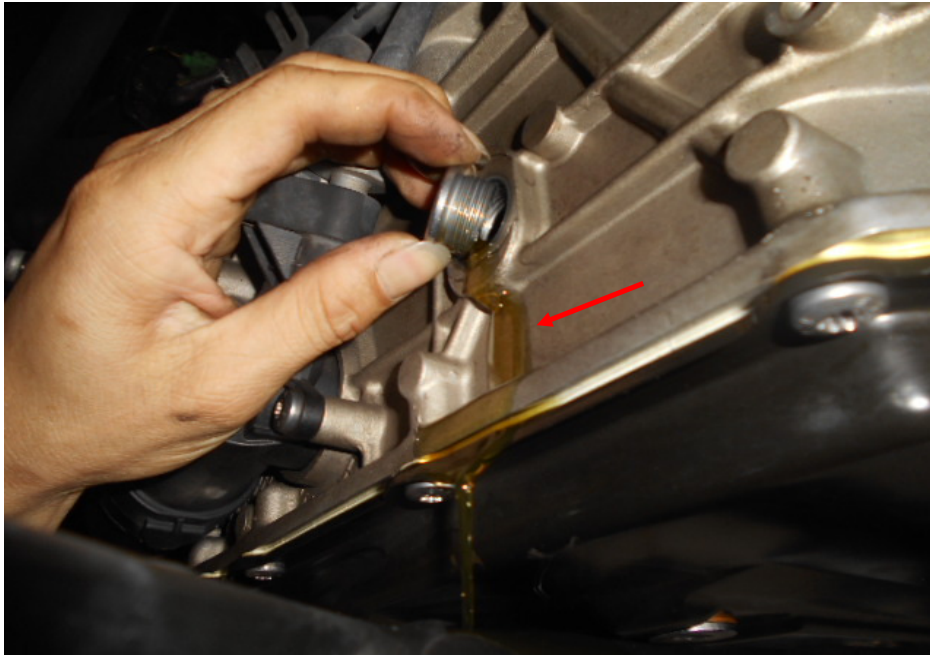
Photo 9 shows checks being carried out on the transmission fluid level of the Insured Vehicle. The transmission fluid (arrowed) was observed to have flowed out from the valve body (mechatronic) of the transmission housing upon releasing of the stopper. Such observations after releasing the stopper is an indication that the transmission fluid was of sufficient level for operating purposes. Visually, there was also no contamination observed to the transmission fluid.

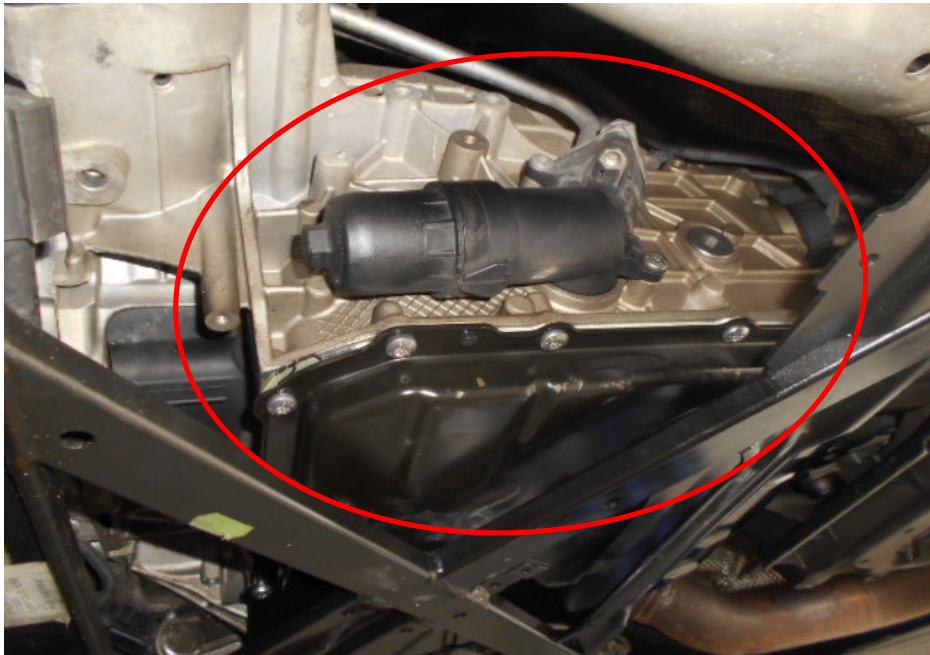
Photo 10 shows a general view of the Insured Vehicle's transmission valve body (mechatronic) (circled).

9. Briefly, the valve body in the transmission system of the Insured Vehicle controls the gear shifting through sensors, actuators, solenoids, valves and hydraulic fluid (transmission fluid). Gear shift is performed through solenoids and valves that are acted upon by hydraulic pressure from the transmission fluid upon input signal from the sensors and actuators. In this case, one of these components had electronically malfunctioned, rendering the transmission system of the Insured Vehicle to function partially.
10. My checks with both local and international bodies and associations revealed that at the time of writing this report, there is no on-going manufacturer recall campaign relating to transmission system issue(s) that involved the Insured Vehicle. See screenshot below showing search result from LTA.
