Your Ref: CMQD1700040  
Our Ref : CI/SMO17024557/D

**Sompo Insurance Singapore Pte Ltd**

**TECHNICAL REPORT OF TRANSMISSION WARRANTY CLAIM FOR THE INSURED VEHICLE SJR 9891Y**

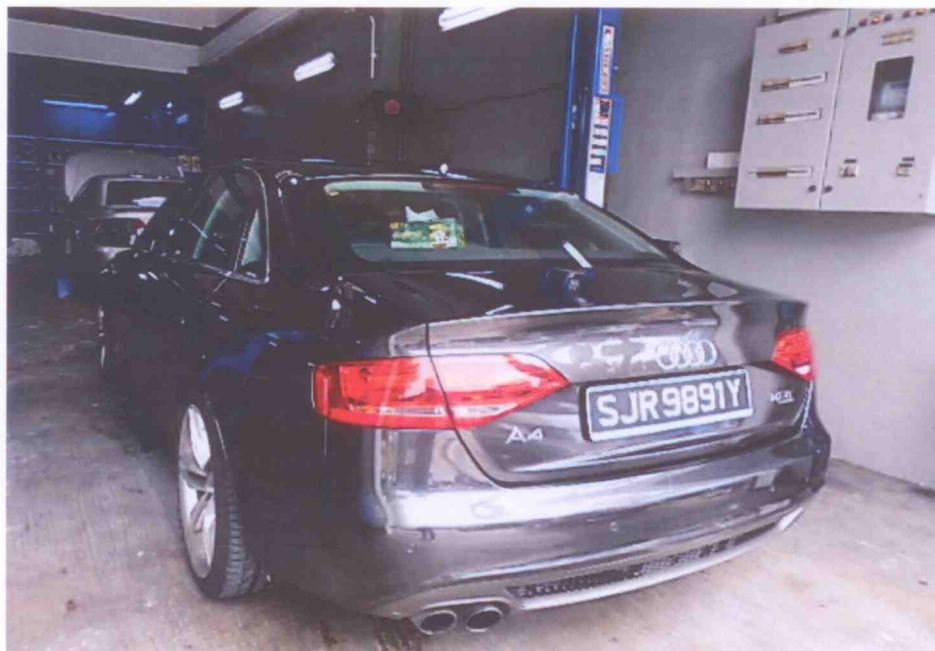
**Photo 1** shows a general view of the Insured Vehicle at the time of my inspection. The Insured Vehicle was observed to be in good general condition with no loose exterior fittings or connections.

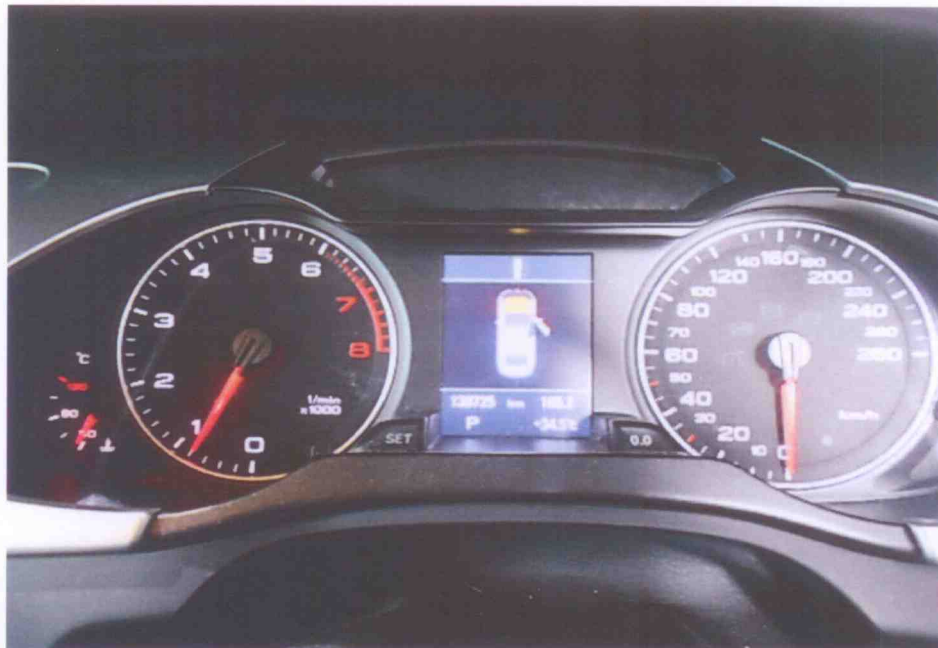
**Photo 2** shows no error message appearing on the instrument panel of the Insured Vehicle after its engine was started.

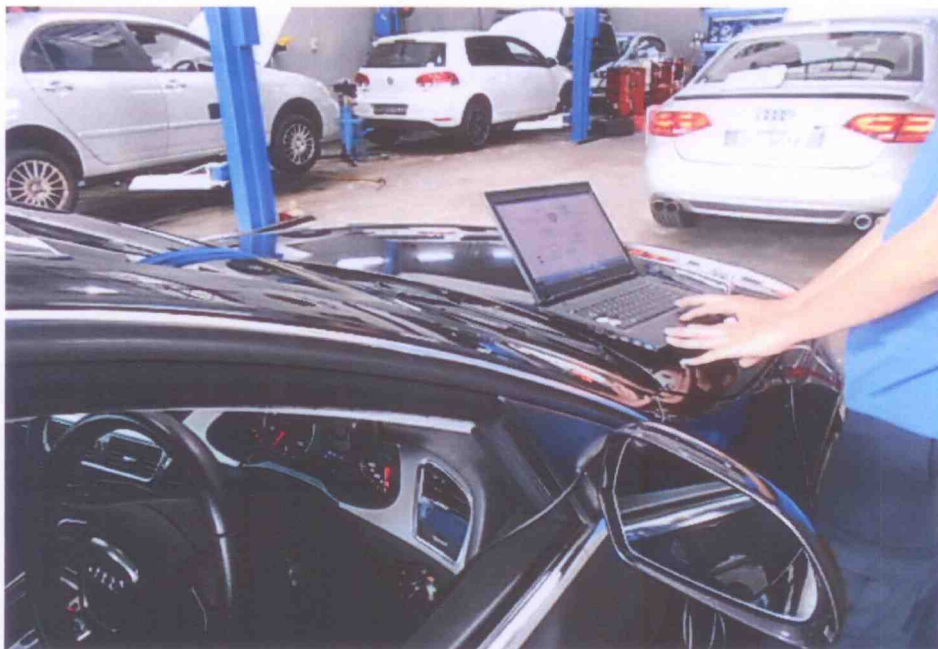
**Photo 3** shows the diagnostic test being carried out on the Insured Vehicle to check for any electronic fault(s). Data from the various electronic control modules of the Insured Vehicle were being retrieved.

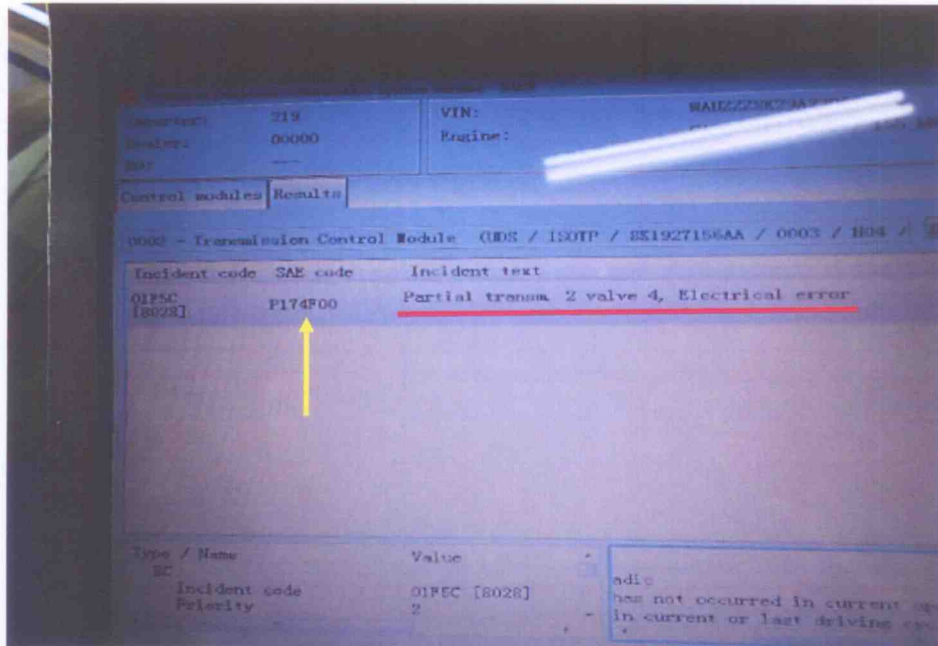
Photo 4 shows the recorded fault code after the completion of the diagnostic test. The fault code recorded was P174F00 (yellow arrow). The description of this fault (red line) was noted to be related to the transmission system of the Insured Vehicle.

8. My checks and enquiries revealed that the fault code P174F00 relating to the transmission system of the Insured Vehicle were for electrical errors to the valve body (mechatronic) of the Insured Vehicle. These fault codes are also amongst the common fault codes that are associated with the type of transmission system that is fitted on most Audi model motor cars. See photo 10 below showing the valve body of the Insured Vehicle.

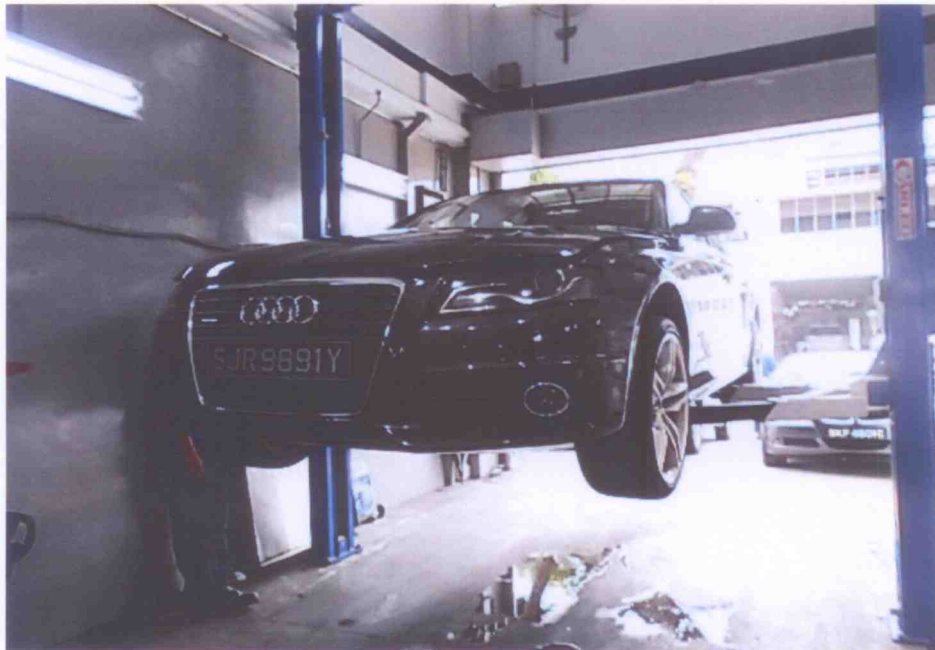
**Photo 5** shows the Insured Vehicle being hoisted up for checks on its underside, in particular to its transmission assembly and transmission fluid.

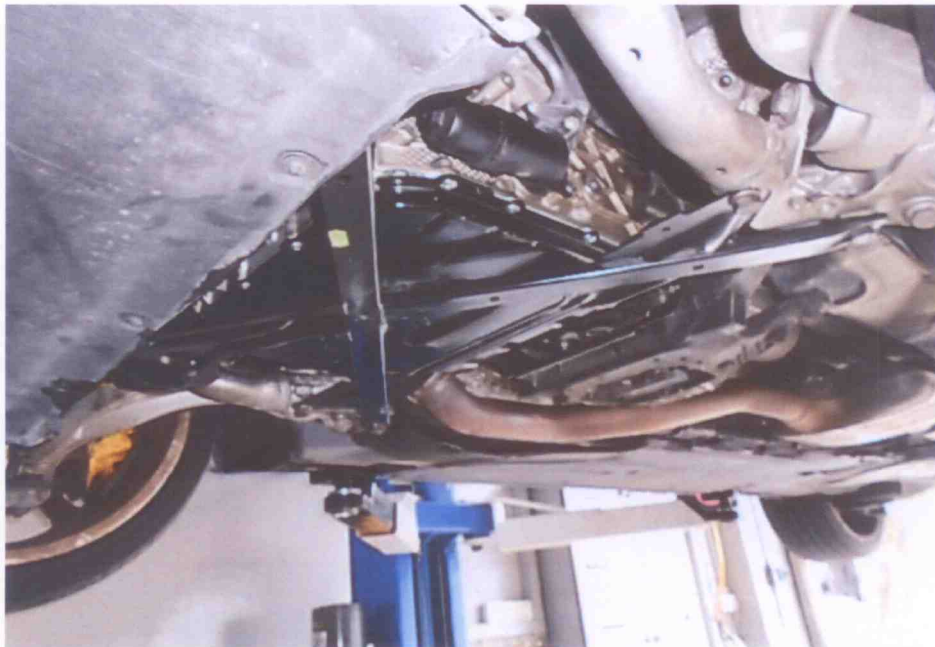
**Photo 6** shows a general view of the underside of the Insured Vehicle where the transmission housing was located. There was no sign(s) of fluid stain(s) and/or fluid leakage observed on the underside of the Insured Vehicle.

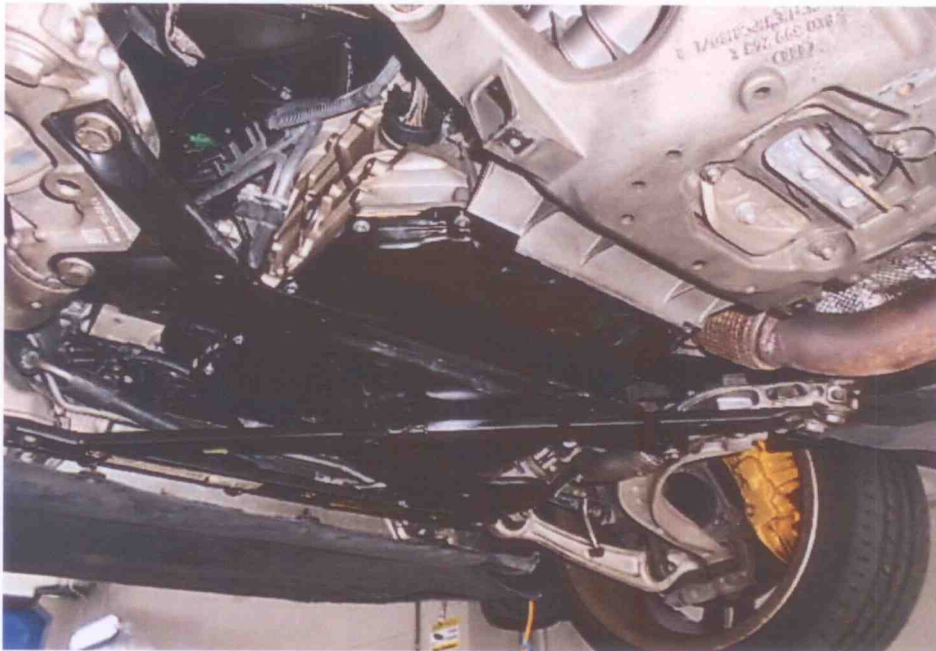
**Photo 7** shows a general view of the underside of the Insured Vehicle where the transmission housing was located. There was no sign(s) of fluid stain(s) and/or fluid leakage observed on the underside of the Insured Vehicle.

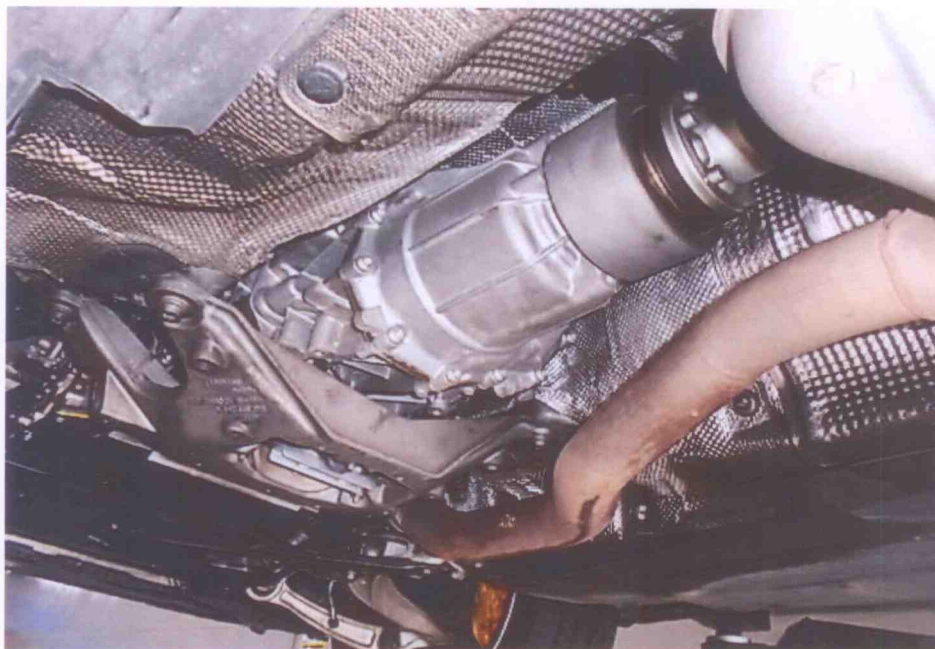
**Photo 8** shows a general view of the underside of the Insured Vehicle, at the area where the transmission housing was located. There was no sign(s) of fluid stain(s) and/or fluid leakage observed on the underside of the Insured Vehicle. There was also no visible damage observed on the transmission housing. The electronic sensors were all securely fitted into the connector ports.

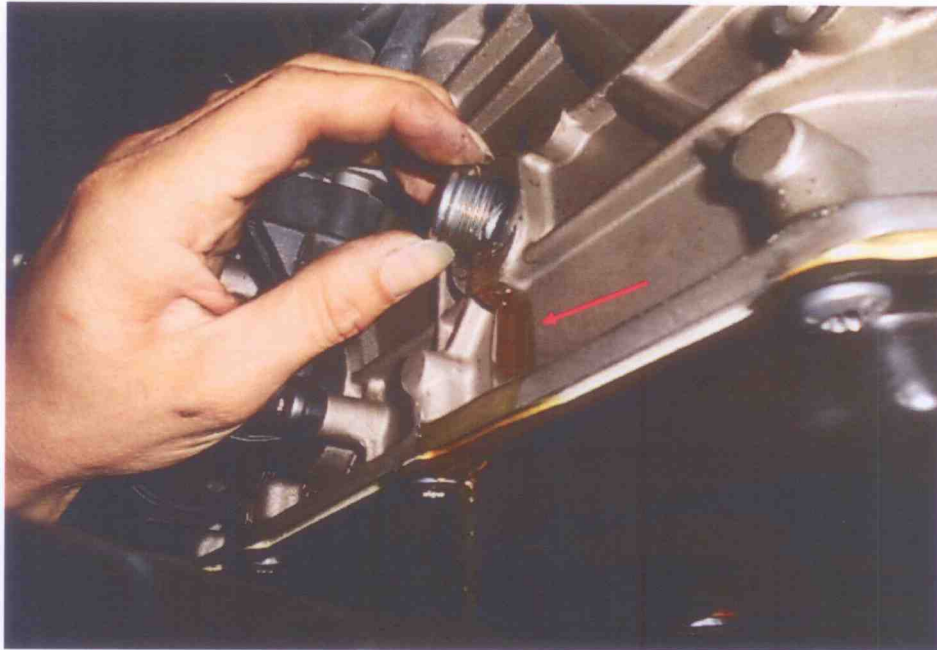
**Photo 9** shows checks being carried out on the transmission fluid level of the Insured Vehicle. The transmission fluid (arrowed) was observed to have flowed out from the valve body (mechatronic) of the transmission housing upon releasing of the stopper. Such observations after releasing the stopper is an indication that the transmission fluid was of sufficient level for operating purposes. Visually, there was also no contamination observed to the transmission fluid.

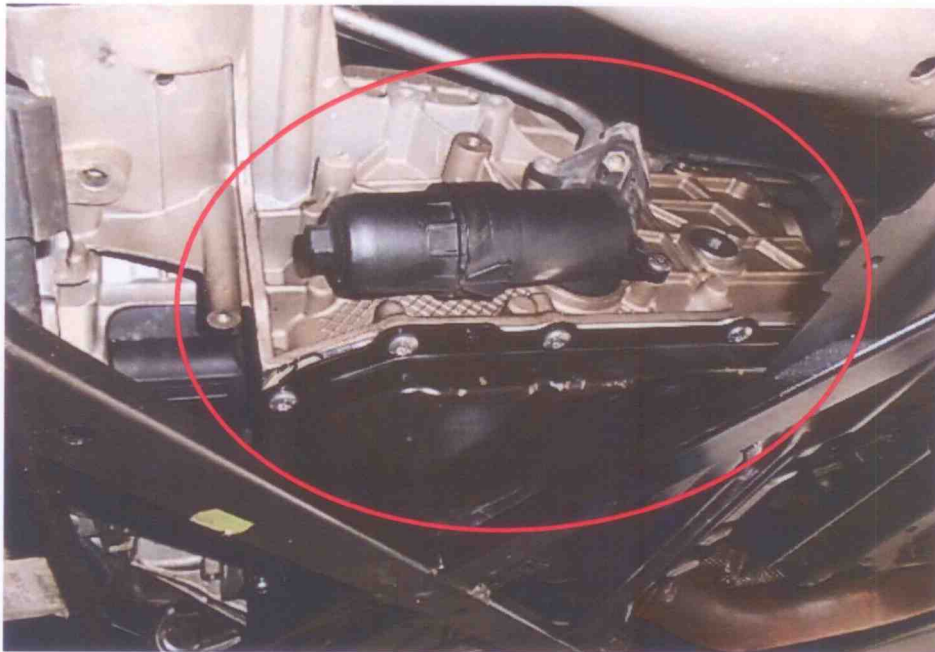
**Photo 10** shows a general view of the Insured Vehicle's transmission valve body (mechatronic) (circled).

9. Briefly, the valve body in the transmission system of the Insured Vehicle controls the gear shifting through sensors, actuators, solenoids, valves and hydraulic fluid (transmission fluid). Gear shift is performed through solenoids and valves that are acted upon by hydraulic pressure from the transmission fluid upon input signal from the sensors and actuators. In this case, one of these components had electronically malfunctioned, rendering the transmission system of the Insured Vehicle to function partially.
10. My checks with both local and international bodies and associations revealed that at the time of writing this report, there is no on-going manufacturer recall campaign relating to transmission system issue(s) that involved the Insured Vehicle. See screenshot below showing search result from LTA.
