Your Ref: TP/IP/65709/2017
Our Ref : CI/TPD17024643/Z

29th December 2017

MECHANICAL INSPECTION REPORT OF MOTOR CAR SJU 8481M

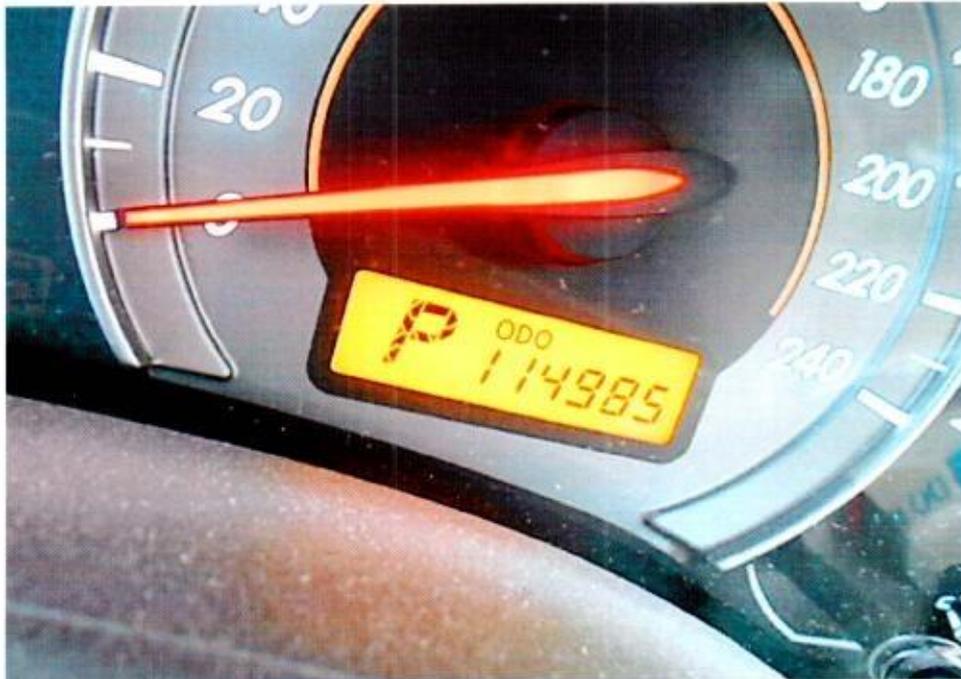
Photo 1 shows the mileage of the Motor Car was 114,985 km.

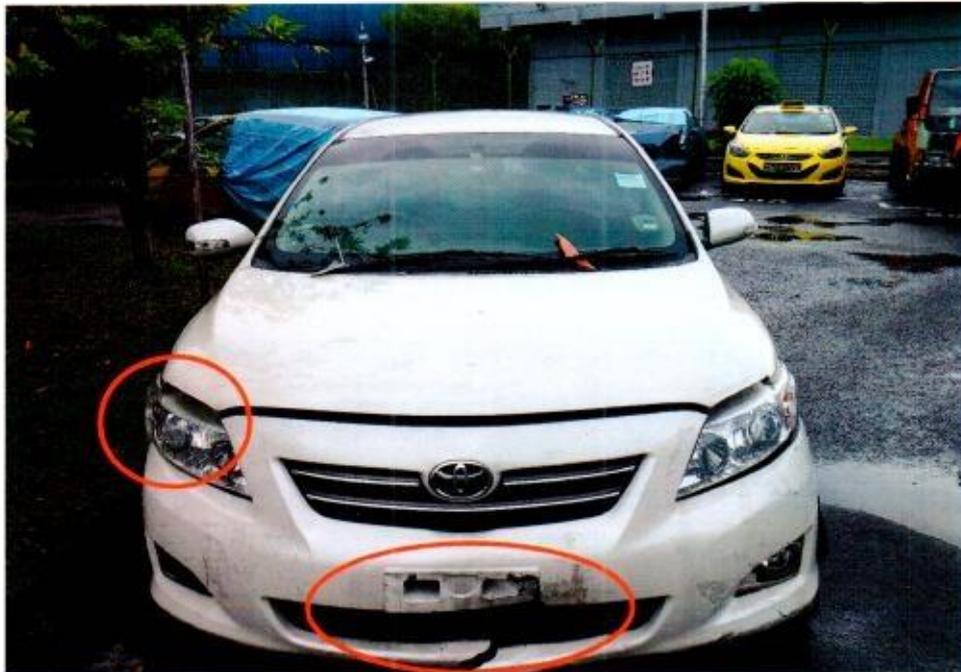
Photo 2 shows a general view of the front body of the Motor Car at the time of our inspection. The Motor Car was observed to have sustained minor damages at the frontal portion inclusive of missing number plate.

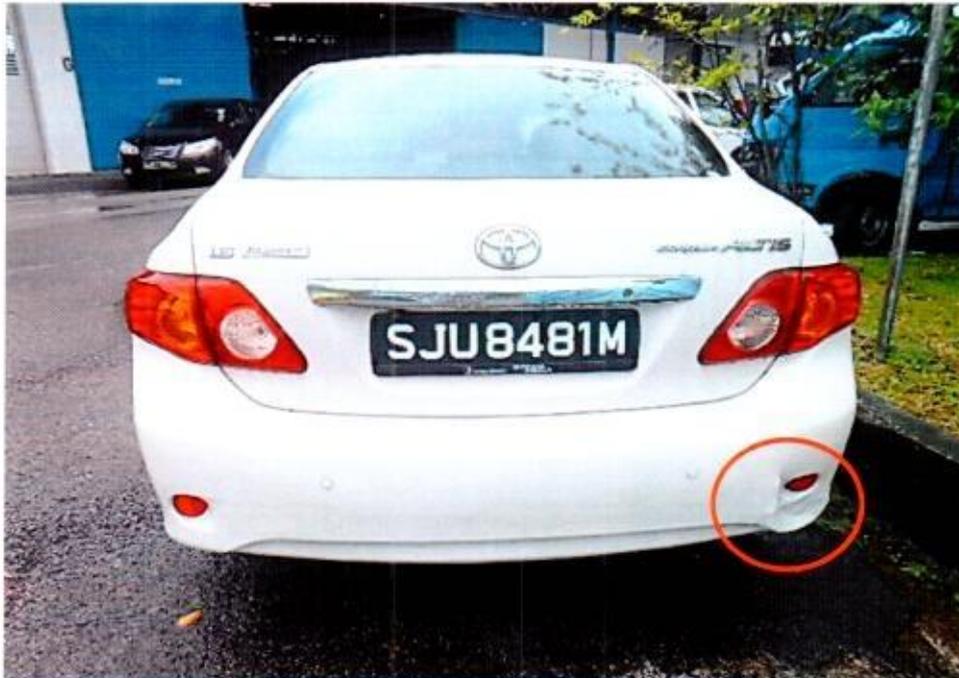
Photo 3 shows a general view of the rear body of the Motor Car at the time of our inspection. The Motor Car was observed to have cracked at the lower rear bumper around the exhaust area.

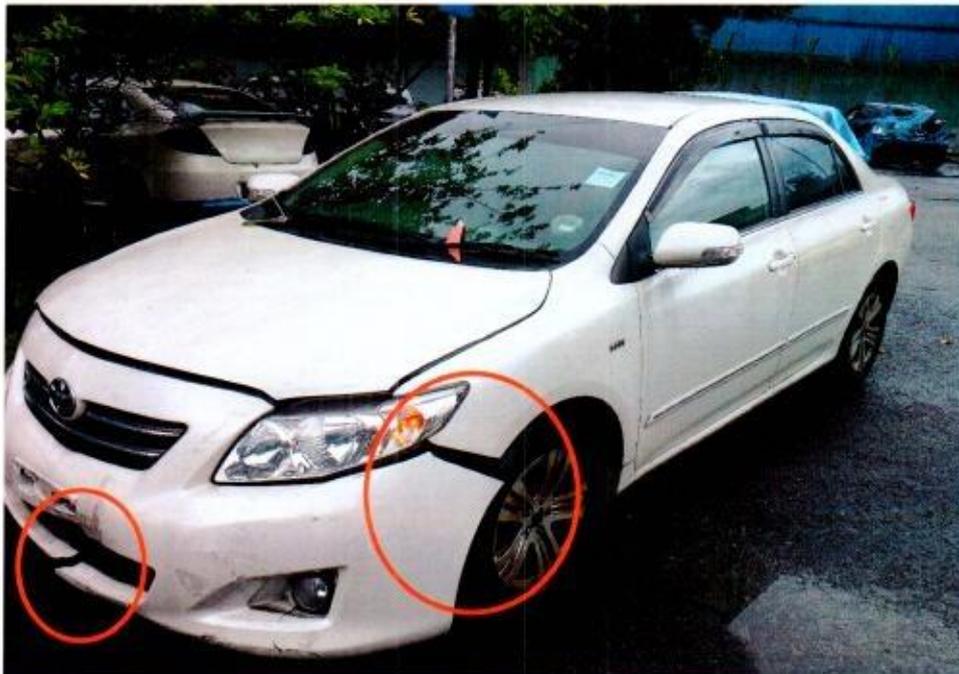
Photo 4 shows a general view of the front left body of the Motor Car at the time of our inspection. The Motor Car was observed to have sustained minor damages at the frontal portion inclusive of missing number plate.

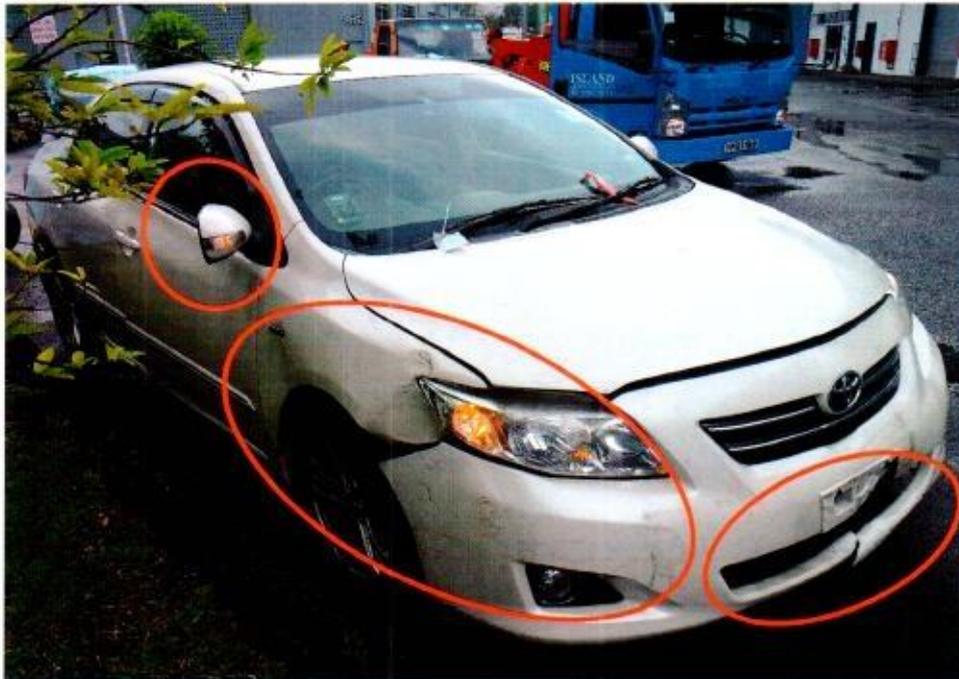
Photo 5 shows a general view of the front right body of the Motor Car at the time of our inspection. The Motor Car was observed to have sustained minor damages at the frontal & right portion inclusive of missing number plate.

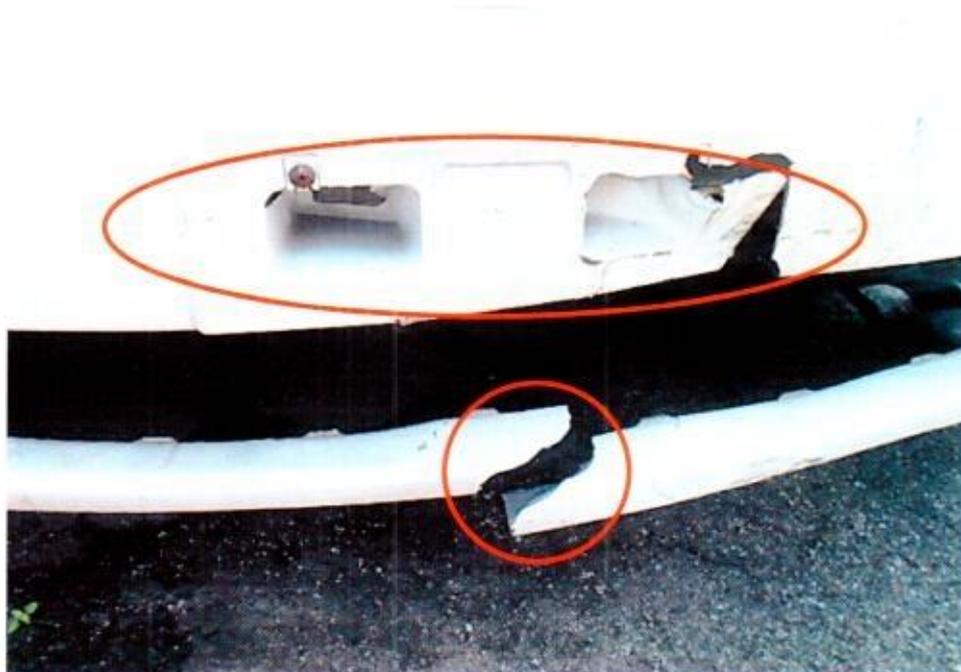
Photo 6 shows a close up view of the front lower bumper of the Motor Car at the time of our inspection. The Motor Car had sustained relatively minor impact at the front sensor of the Motor Car inclusive a missing number plate.

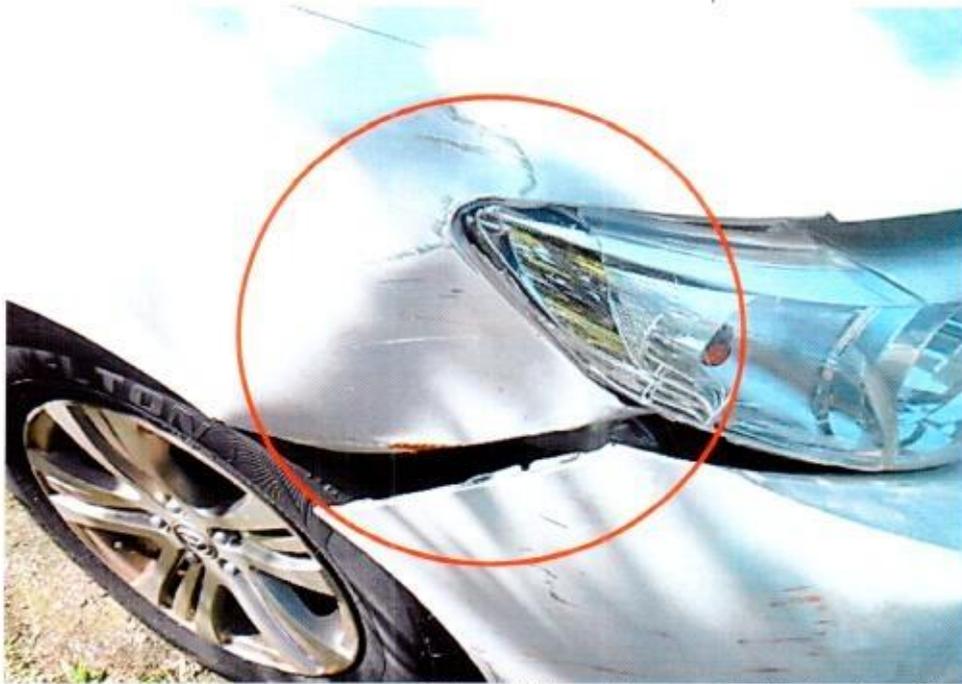
Photo 7 shows a close up view of the right hand bumper & side fender of the Motor Car at the time of our inspection. The Motor Car had sustained relatively minor impact at time of our inspection.

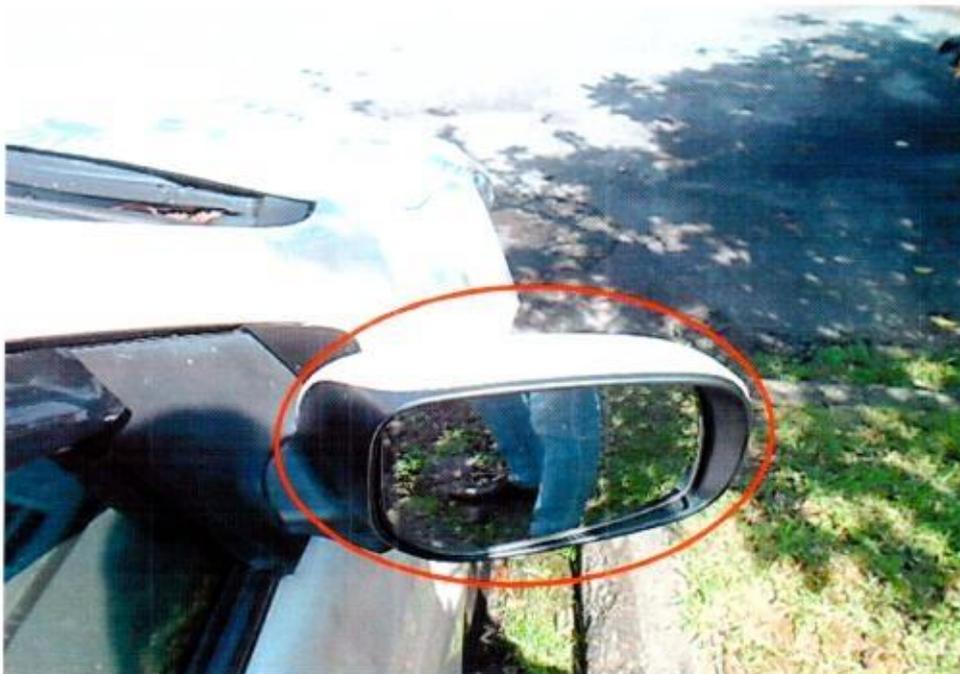
Photo 8 shows a close up view of the right hand side mirror of the Motor Car at the time of my inspection. It was observed to be misaligned when retracted from the interior control button.

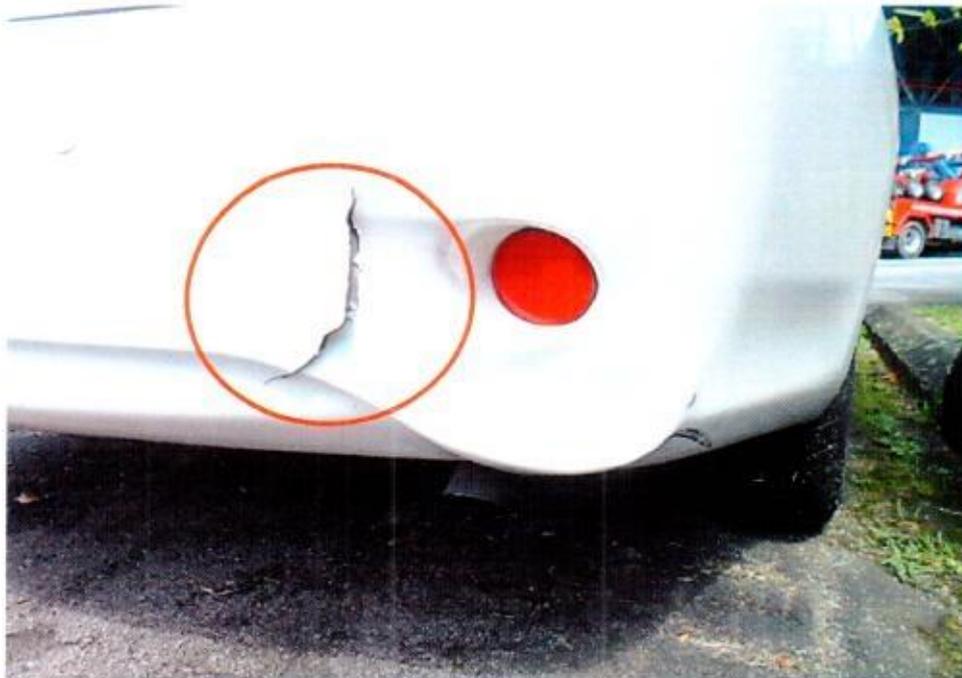
Photo 9 shows a close up view of the rear lower bumper of the Motor Car at the time of our inspection. It was observed to be cracked at time of our inspection.

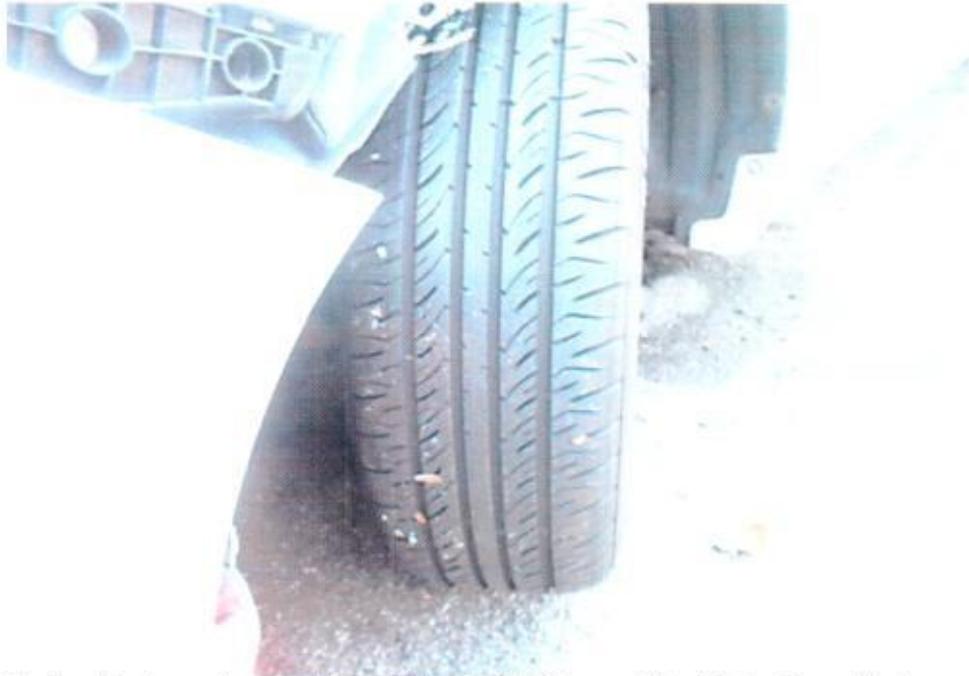
Photo 10 shows the condition of the front left tyre of the Motor Car, which was observed to be in serviceable condition with remaining tread depth of approximately 7mm. The tyre, which was wrapped around alloy wheel rim, was also observed to be sufficiently inflated for vehicular operation. There was no tear, cut or burst mark(s) on the outer and the inner sidewalls as well as across the tread of the 4 tyres.

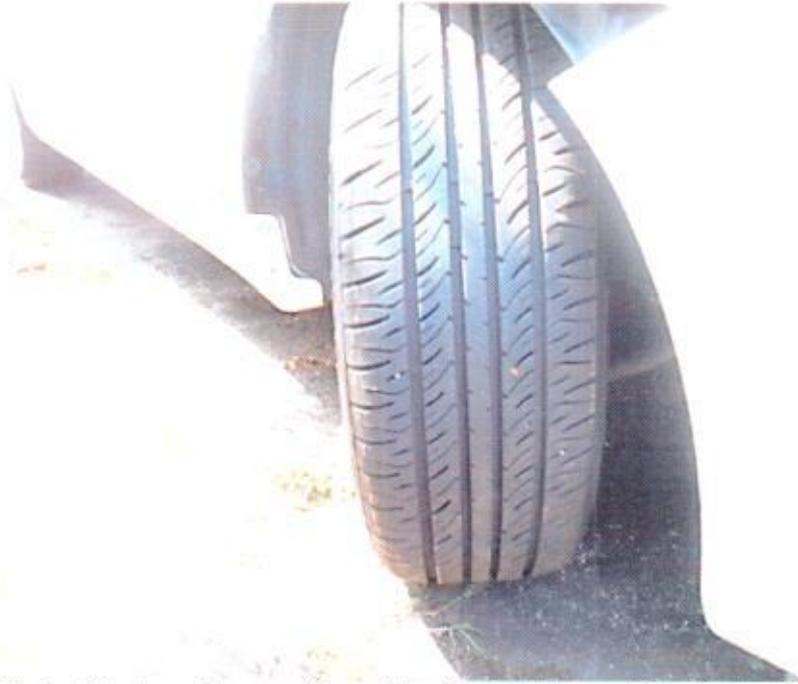
Photo 11 shows the condition of the front right tyre of the Motor Car, which was observed to be in serviceable condition with remaining tread depth of approximately 6mm. The tyre, which was wrapped around alloy wheel rim, was also observed to be sufficiently inflated for vehicular operation.

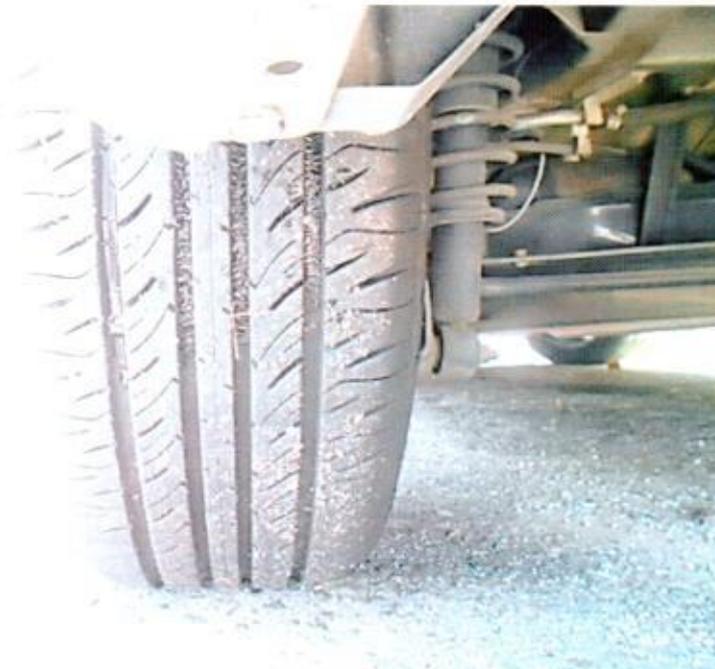
Photo 12 shows the condition of the rear left tyre of the Motor Car, which was observed to be in serviceable condition with remaining tread depth of approximately 7mm. The tyre, which was wrapped around alloy wheel rim, was also observed to be sufficiently inflated for vehicular operation.

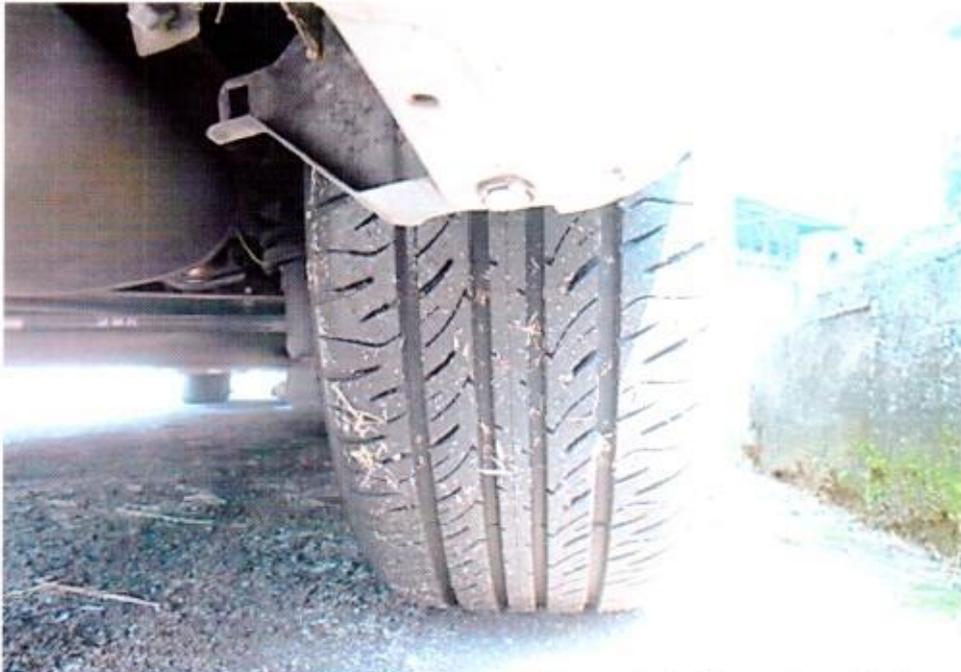
Photo 13 shows the condition of the rear right tyre of the Motor Car, which was observed to be in serviceable condition with remaining tread depth of approximately 7mm. There was also no tear, cut or burst mark(s) on the outer and the inner sidewalls as well as across the tread of the 4 tyres.

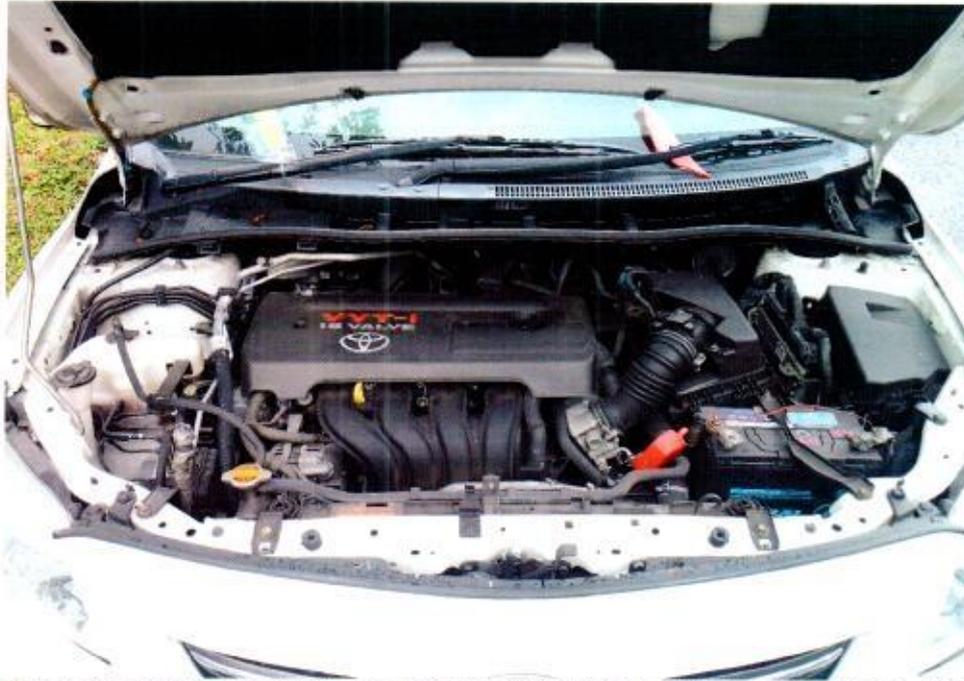
Photo 14 shows a general view of the Motor Car's engine compartment. The various parts and components inside the engine compartment were unaffected by the accident. There was also no sign(s) or indication(s) of fluid leakage and/or fluid stain within the engine compartment.

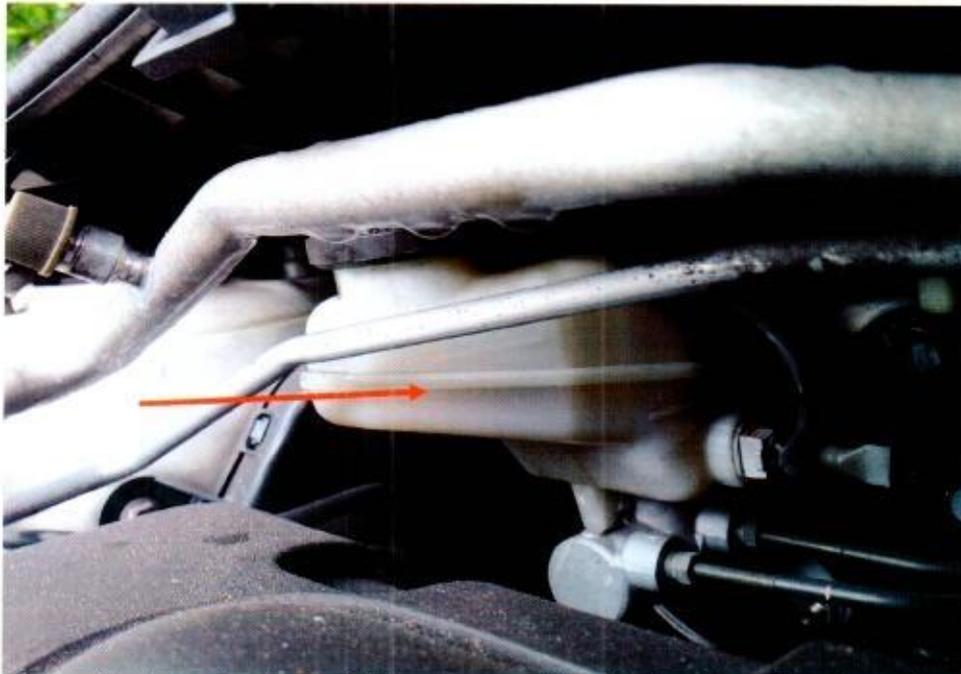
Photo 15 shows the brake fluid reservoir of the Motor Car at the time of our inspection. The brake fluid was observed to be of sufficient level (arrowed) and without any visible contamination.

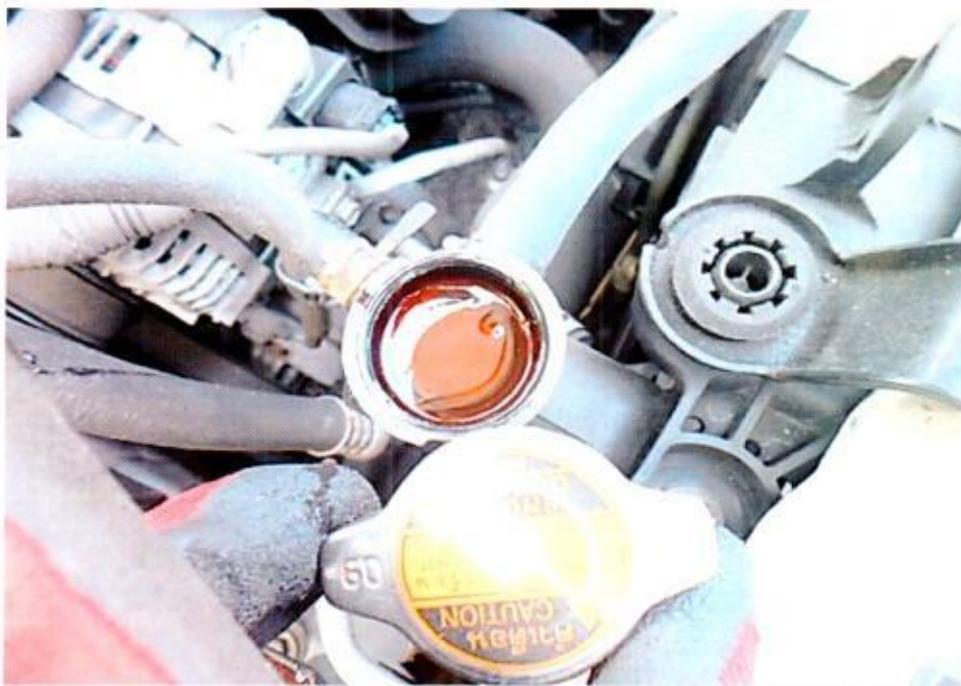
Photo 16 shows the coolant fluid radiator reservoir of the Motor Car at the time of our inspection. The coolant fluid was observed to be of sufficient level and without any visible contamination.

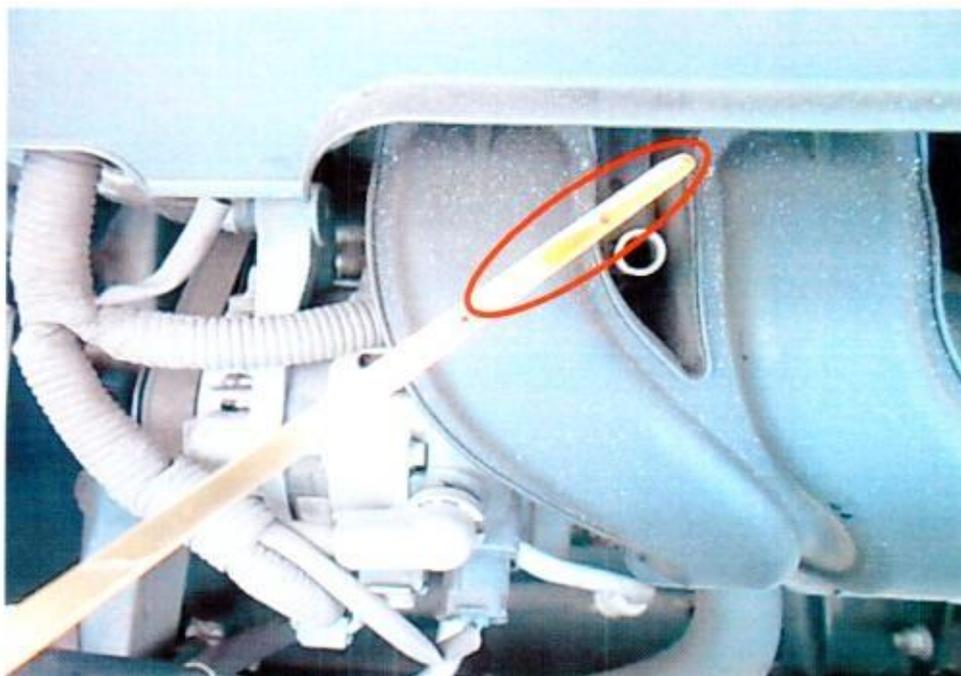
Photo 17 shows the engine oil dip stick of the Motor Car at the time of our inspection. The engine oil was observed to be of sufficient level and without any visible contamination.

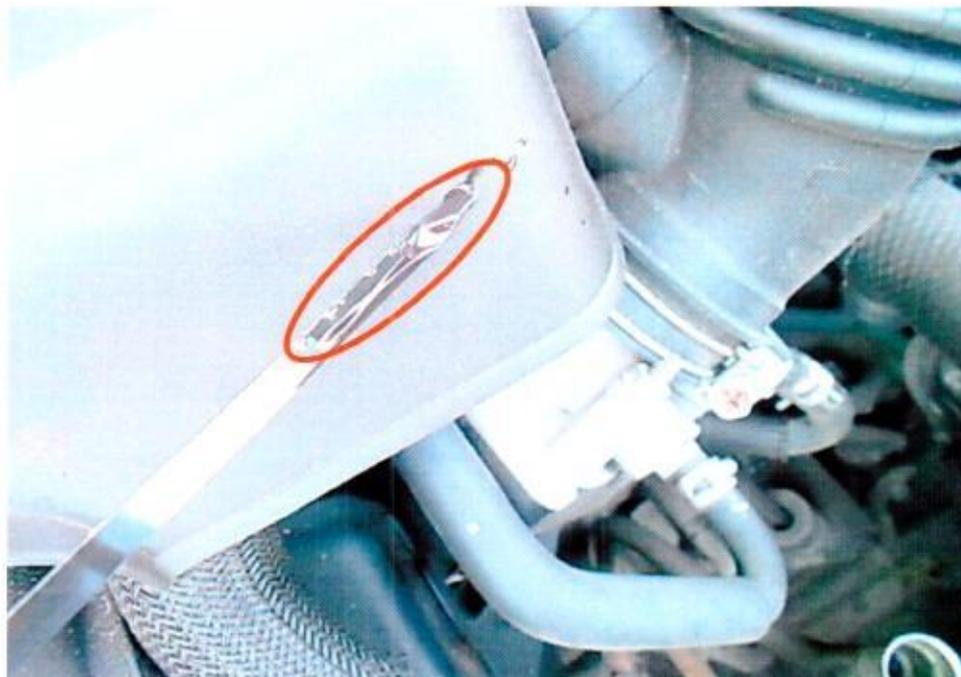
Photo 18 shows the power steering dip stick of the Motor Car at the time of our inspection. The power steering fluid was observed to be of sufficient level and without any visible contamination.

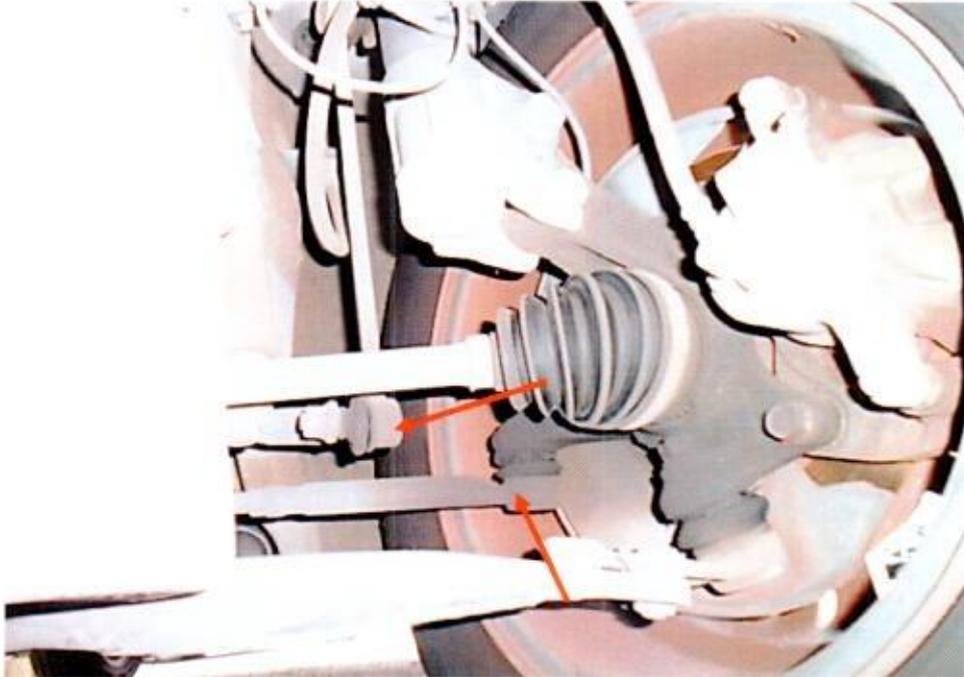
Photo 19 shows the various undercarriage components at the front left wheel of the Motor Car, in particular the steering tie rod (arrowed). The various steering components were all found to be intact, suggesting that the steering system of the Motor Car was likely to be in serviceable condition.

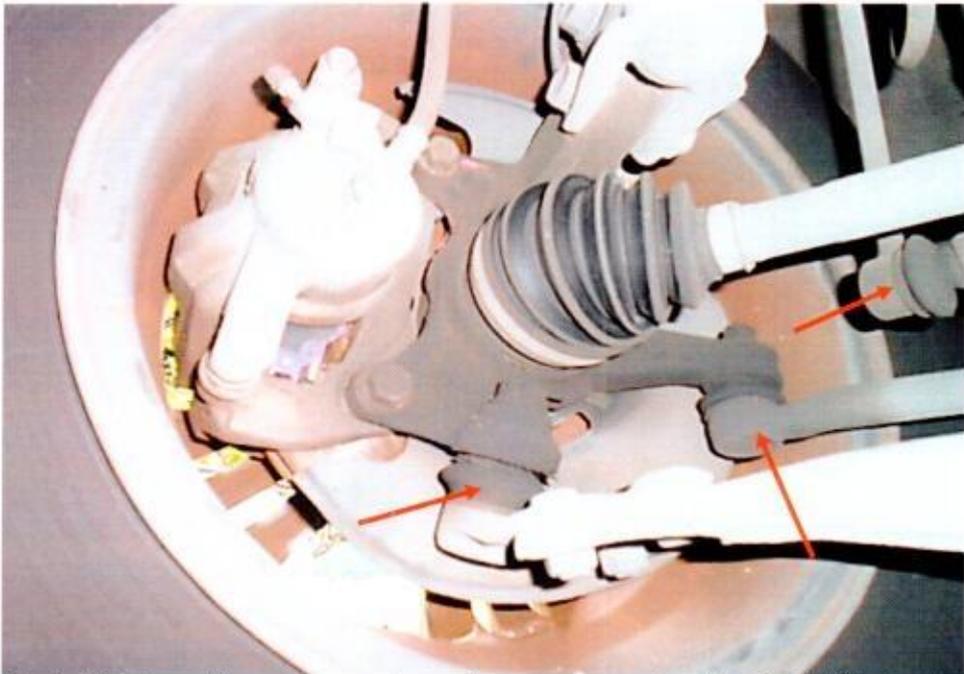
Photo 20 shows the various undercarriage components at the front left wheel of the Motor Car, in particular the steering tie rod (arrowed). The various steering components were all found to be intact, suggesting that the steering system of the Motor Car was likely to be in serviceable condition.

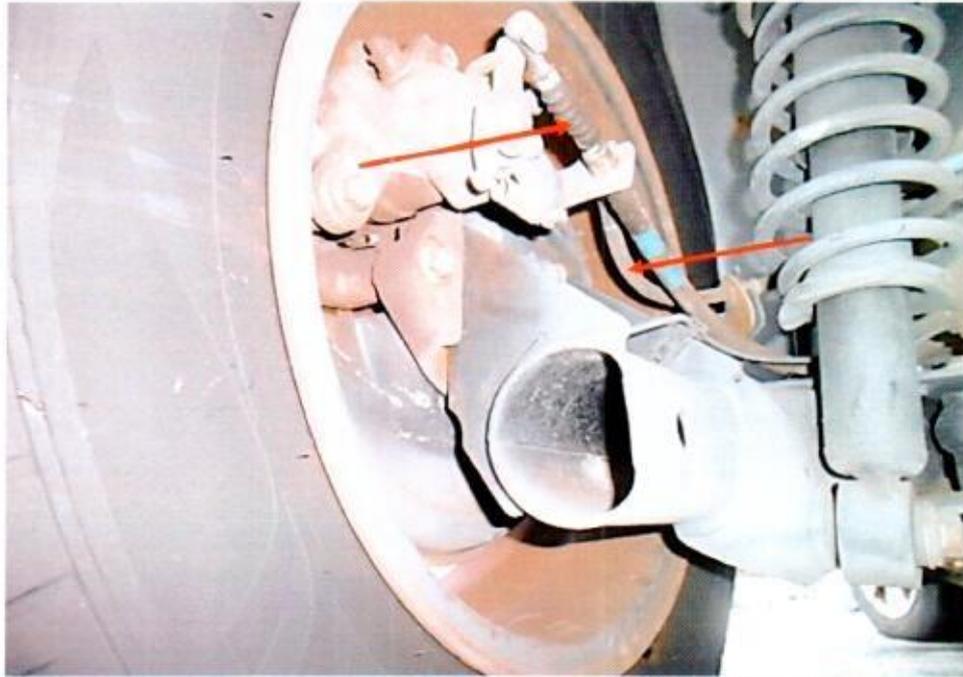
Photo 21 shows the brake hose (arrowed) at the rear left wheel of the Motor Car. We did not observe any leakage of brake fluid at the time of my inspection of the Motor Car. Our visual inspection of the various mechanical components of the Motor Car's braking system revealed all to be intact and without visible damage.

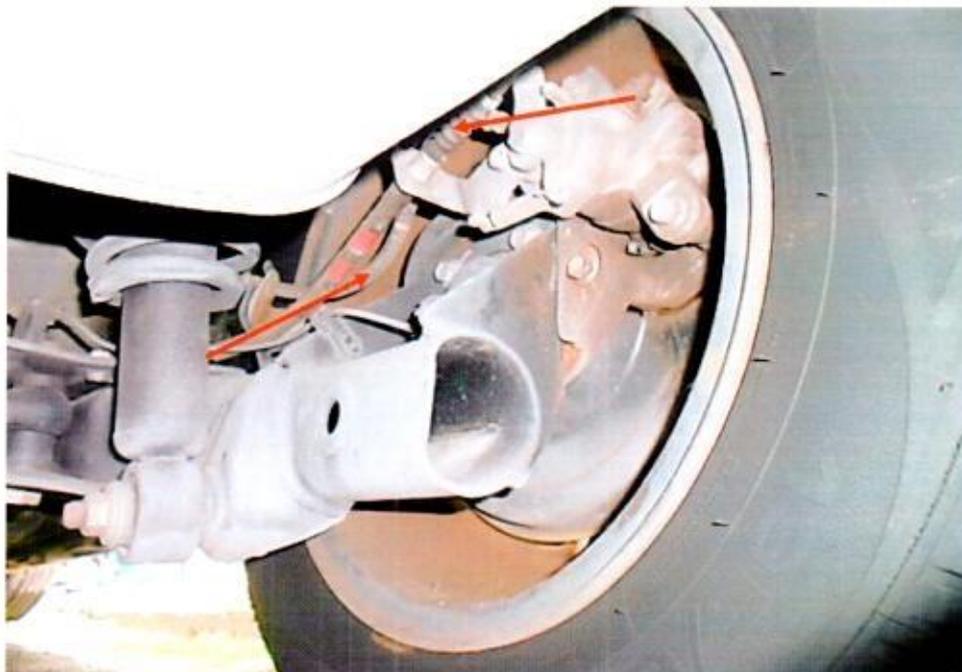
Photo 22 shows the various undercarriage components at the rear right wheel of the Motor Car. We did not observe any leakage of brake fluid at the time of our inspection of the Motor Car. Our visual inspection of the various mechanical components of the Motor Car's braking system revealed all to be intact and without visible damage.

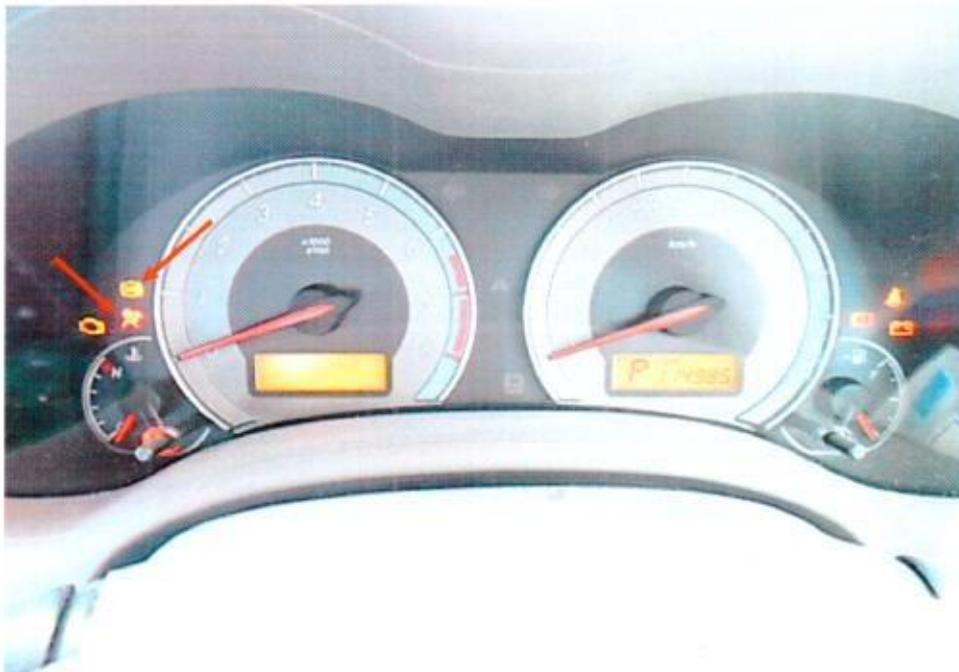
Photo 23 shows the warning lights for the various electronic operating systems of the Motor Car appearing on its instrument panel during the self-test when the engine is cranked, in particular the ABS light and SRS light.

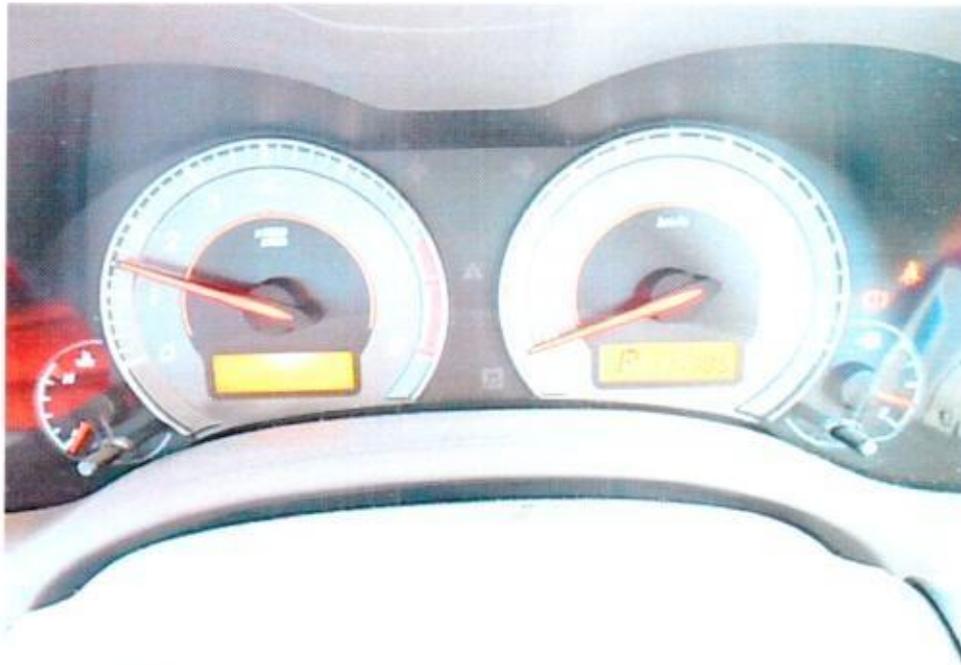
Photo 24 shows no warning lights illuminated on the instrument panel of the Motor Car after the engine was cranked. This would suggest that there was no abnormality to the various electronic operating systems of the Motor Car, like the ABS and SRS.

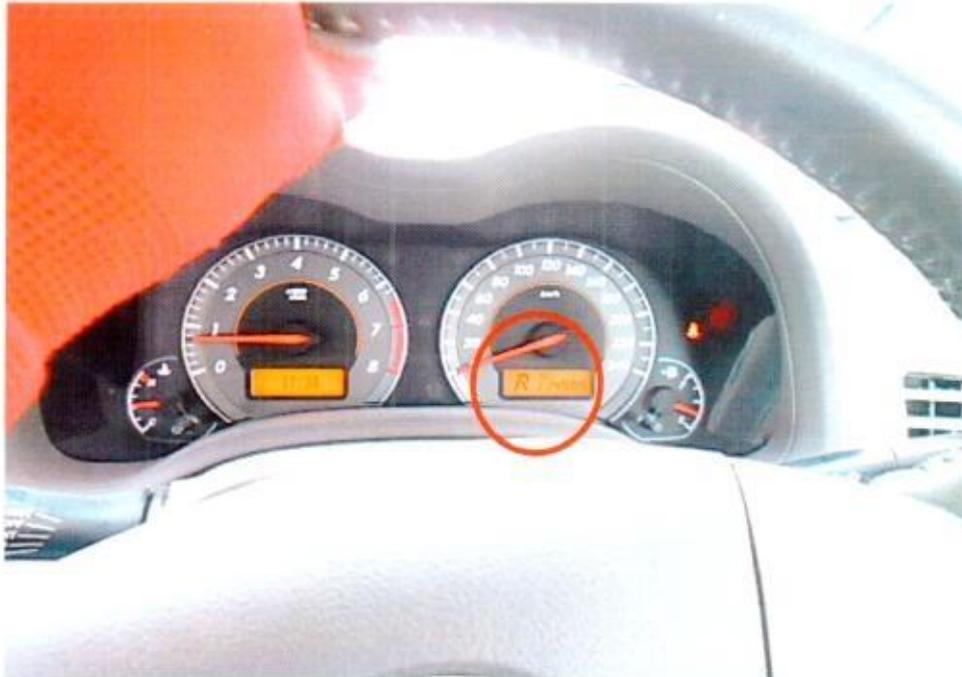
Photo 25 shows the operational test, the transmission system of the Motor Car was able to be shifted to the reverse mode without any difficulty. There were no abnormal sounds heard and/or abnormal behaviour of the Motor Car's engine system. It was able to move forward and backward normally.

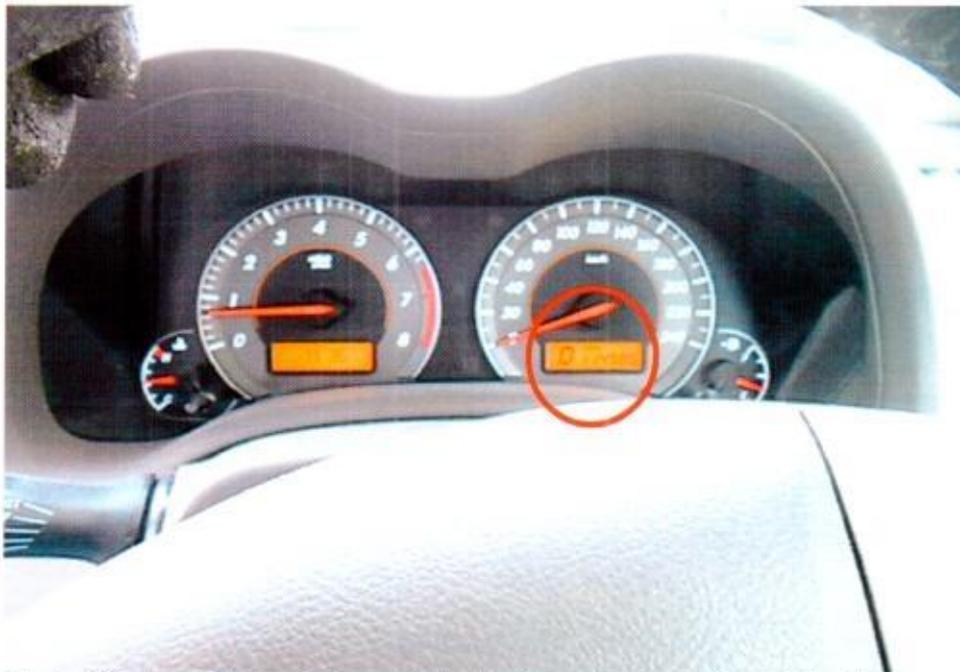
Photo 26 shows the operational test, the transmission system of the Motor Car was able to be shifted to the drive mode without any difficulty. There were no abnormal sounds heard and/or abnormal behaviour of the Motor Car's engine system. It was able to move forward and backward normally.
