Your Ref: TP/IP/65709/2017
Our Ref : CI/TPD17024643/Z

29th December 2017

MECHANICAL INSPECTION REPORT OF MOTOR CAR SJU 8481M

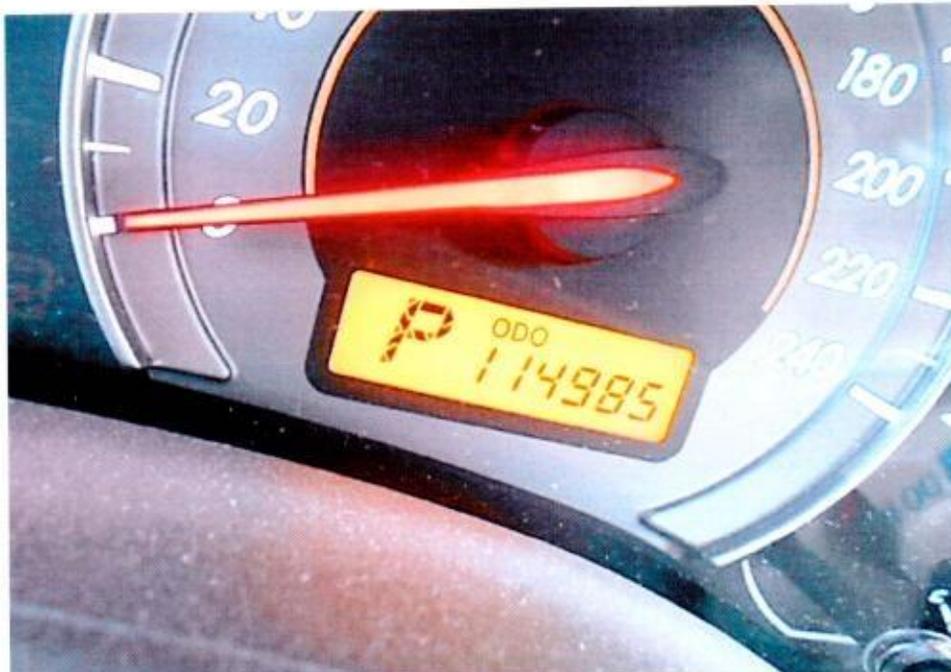
Photo 1 shows the mileage of the Motor Car was 114,985 km.

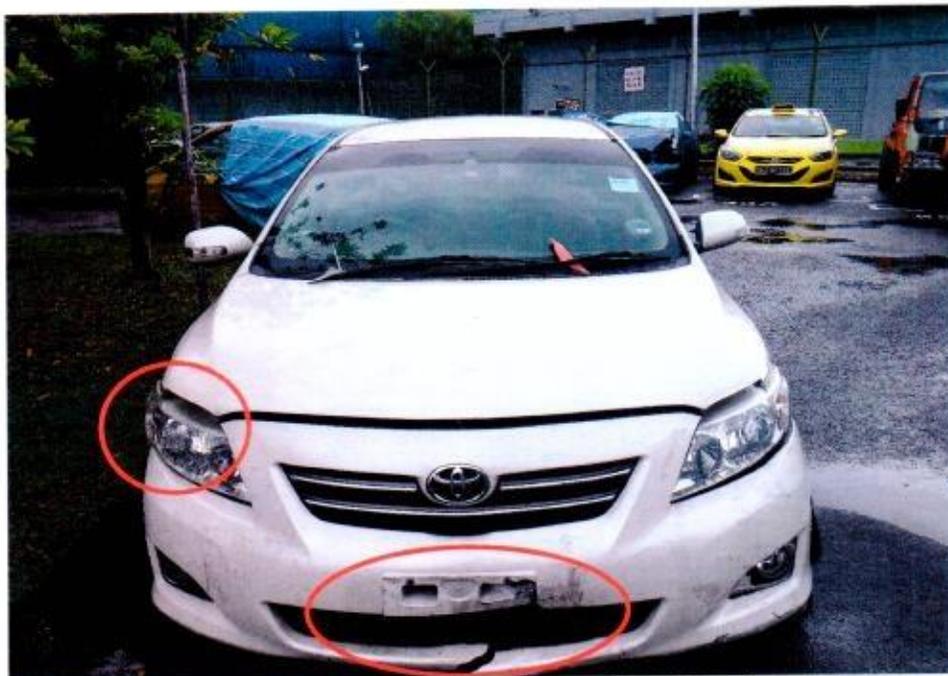
Photo 2 shows a general view of the front body of the Motor Car at the time of our inspection. The Motor Car was observed to have sustained minor damages at the frontal portion inclusive of missing number plate.

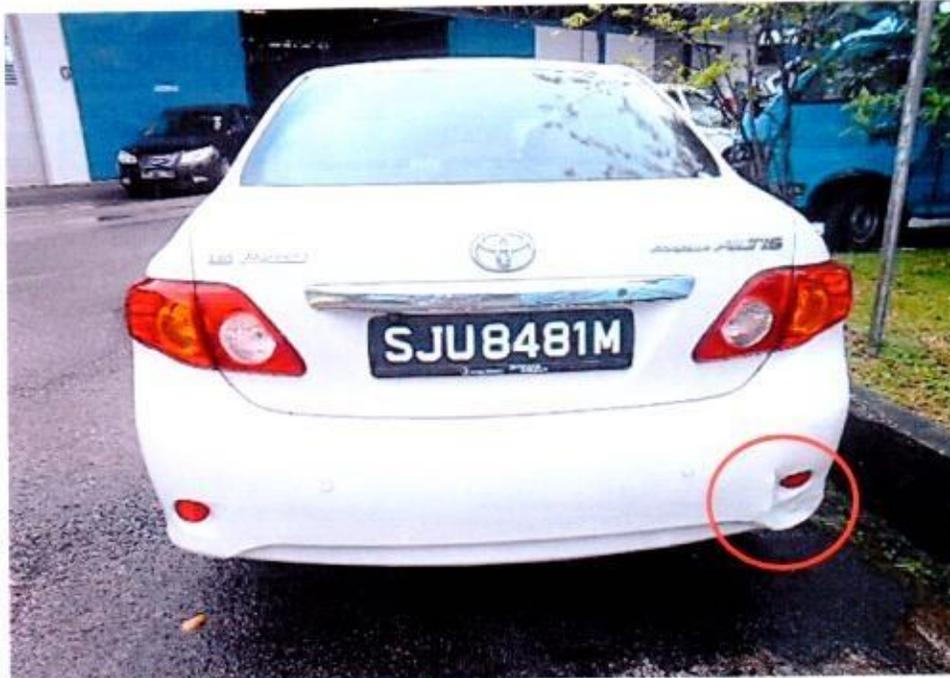
Photo 3 shows a general view of the rear body of the Motor Car at the time of our inspection. The Motor Car was observed to have cracked at the lower rear bumper around the exhaust area.

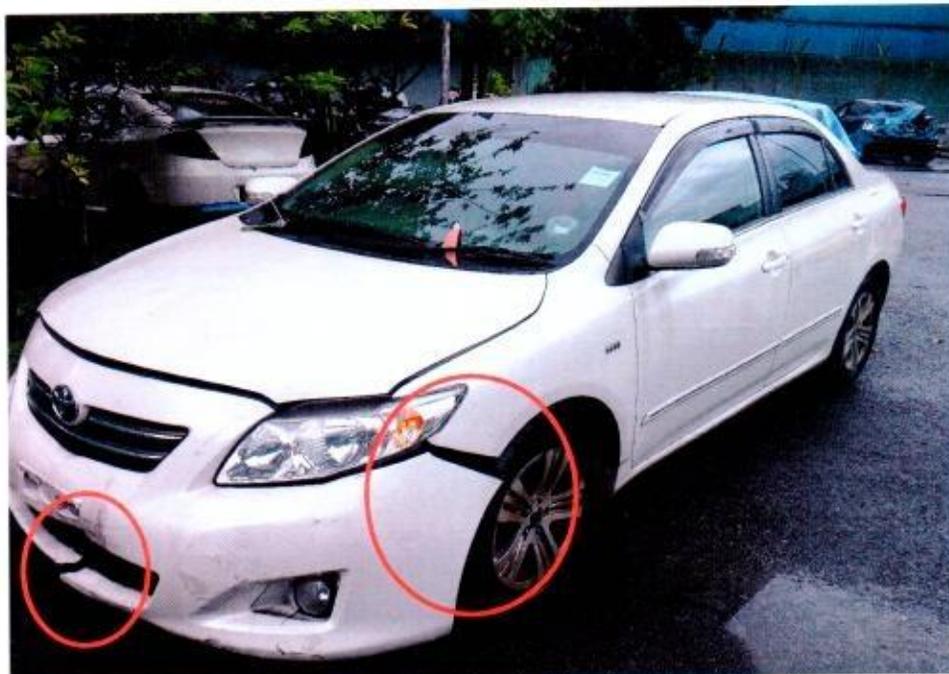
Photo 4 shows a general view of the front left body of the Motor Car at the time of our inspection. The Motor Car was observed to have sustained minor damages at the frontal portion inclusive of missing number plate.

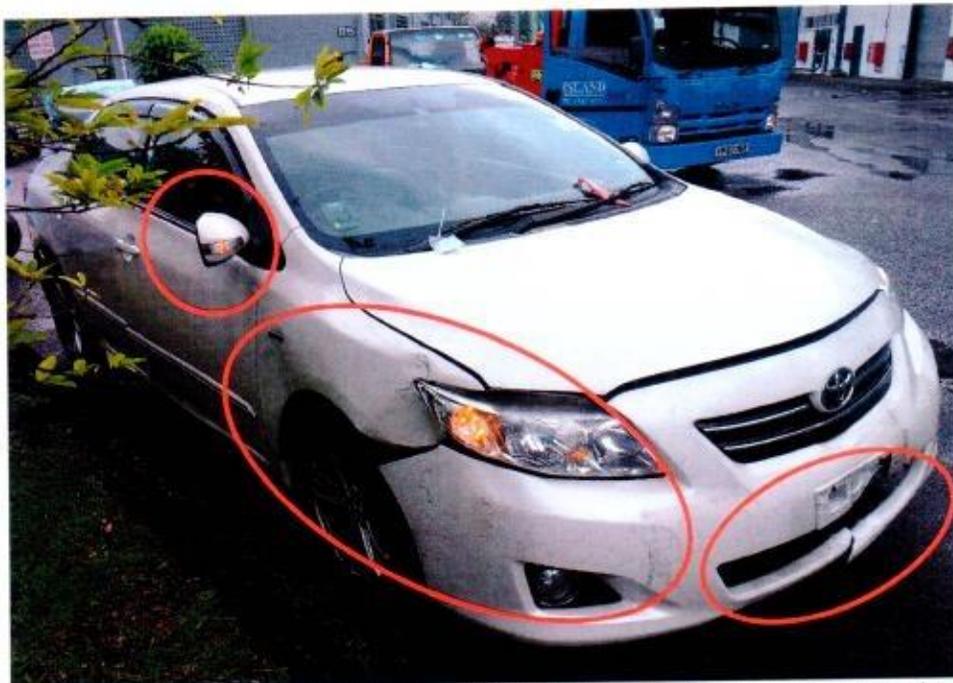
Photo 5 shows a general view of the front right body of the Motor Car at the time of our inspection. The Motor Car was observed to have sustained minor damages at the frontal & right portion inclusive of missing number plate.

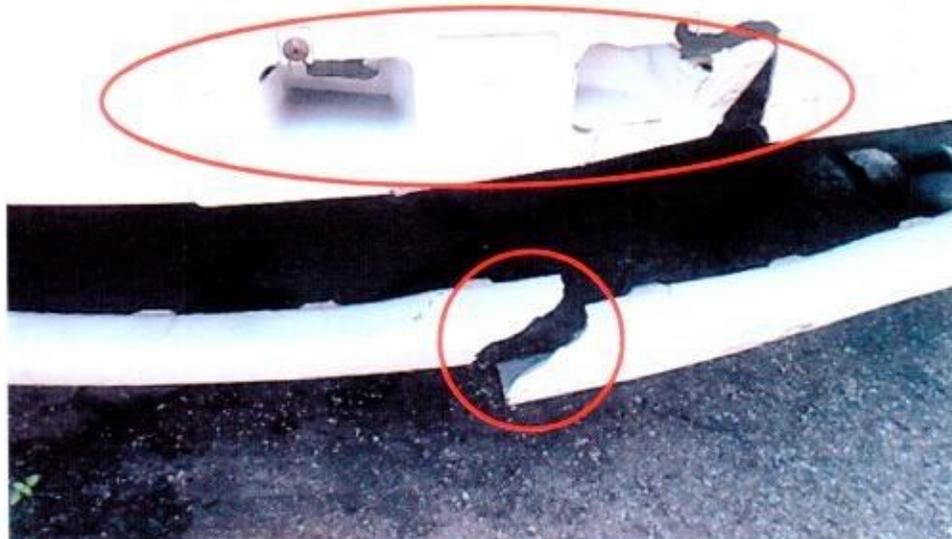
Photo 6 shows a close up view of the front lower bumper of the Motor Car at the time of our inspection. The Motor Car had sustained relatively minor impact at the front sensor of the Motor Car inclusive a missing number plate.

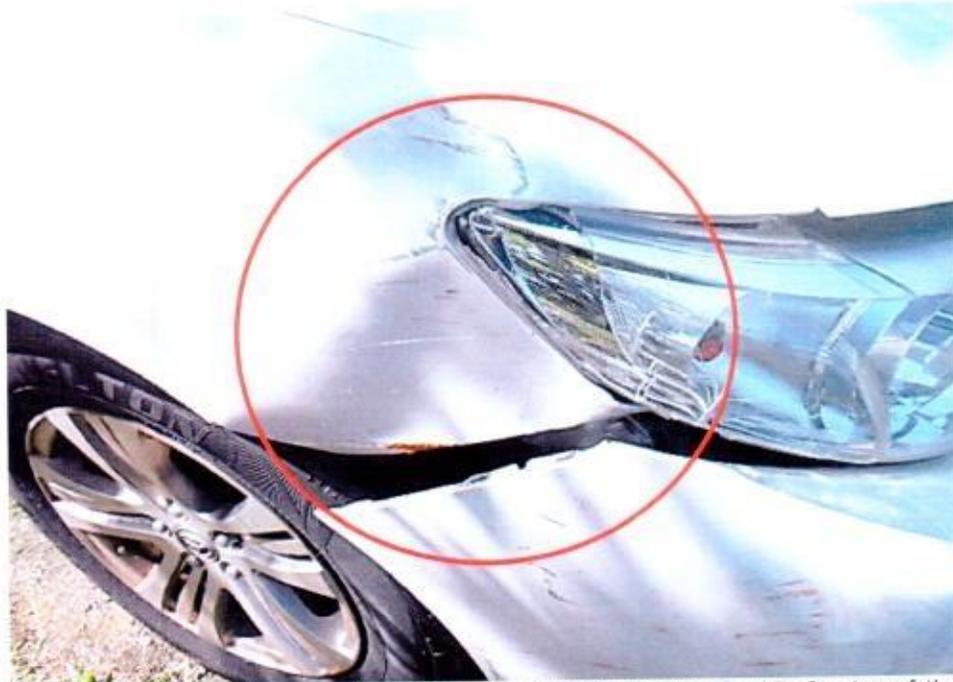
Photo 7 shows a close up view of the right hand bumper & side fender of the Motor Car at the time of our inspection. The Motor Car had sustained relatively minor impact at time of our inspection.

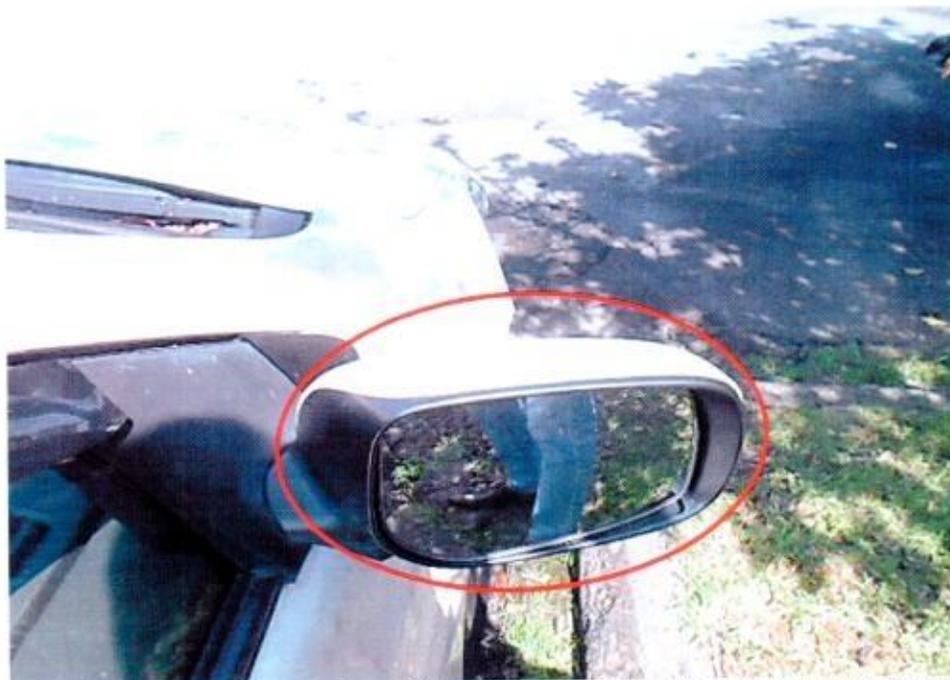
Photo 8 shows a close up view of the right hand side mirror of the Motor Car at the time of my inspection. It was observed to be misaligned when retracted from the interior control button.

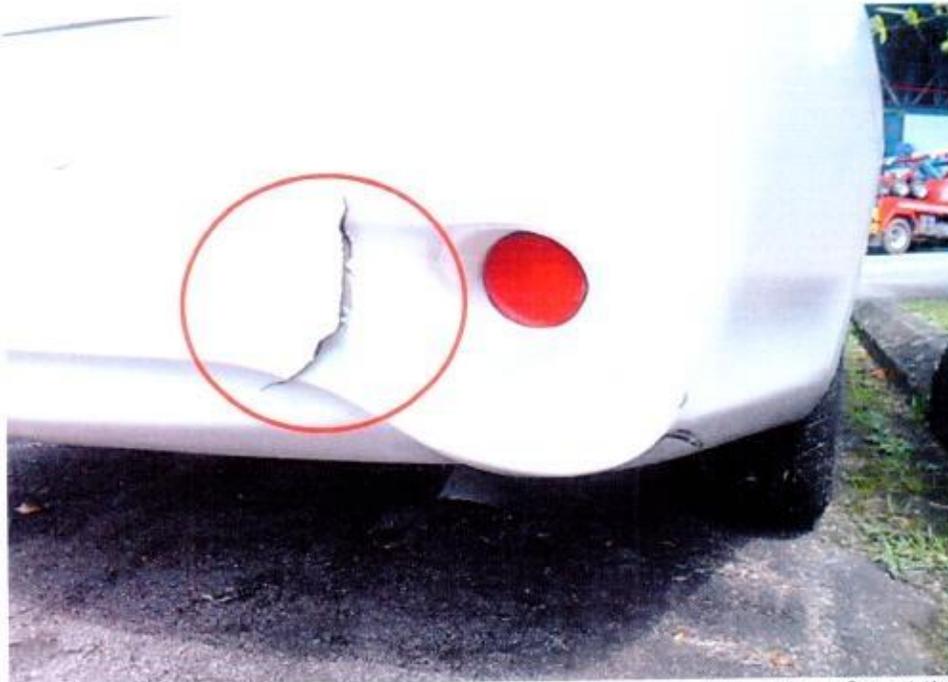
Photo 9 shows a close up view of the rear lower bumper of the Motor Car at the time of our inspection. It was observed to be cracked at time of our inspection.

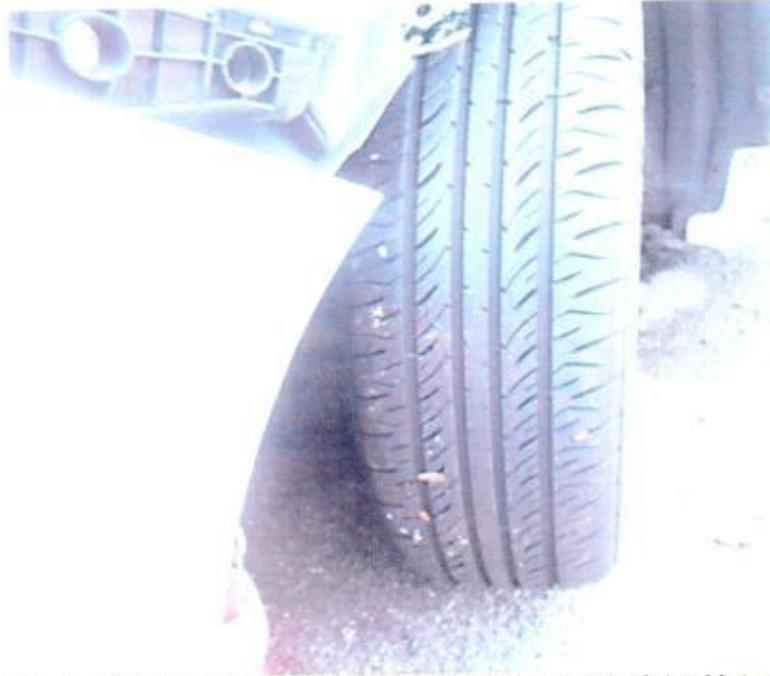
7. The 4 tyres were observed to be wrapped around alloy wheel rims that were found to be without any significant damage except for some marks of grazing nature on the outer spokes of the wheel rims, which are commonly associated to grazing against a road kerb. See photo 10 – 13 below.

Photo 10 shows the condition of the front left tyre of the Motor Car, which was observed to be in serviceable condition with remaining tread depth of approximately 7mm. The tyre, which was wrapped around alloy wheel rim, was also observed to be sufficiently inflated for vehicular operation. There was no tear, cut or burst mark(s) on the outer and the inner sidewalls as well as across the tread of the 4 tyres.

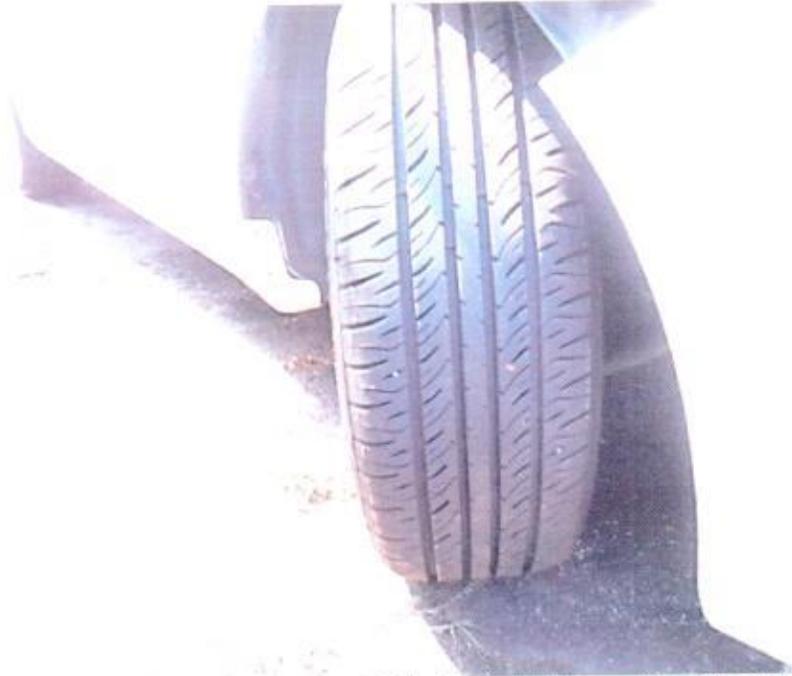
Photo 11 shows the condition of the front right tyre of the Motor Car, which was observed to be in serviceable condition with remaining tread depth of approximately 6mm. The tyre, which was wrapped around alloy wheel rim, was also observed to be sufficiently inflated for vehicular operation.

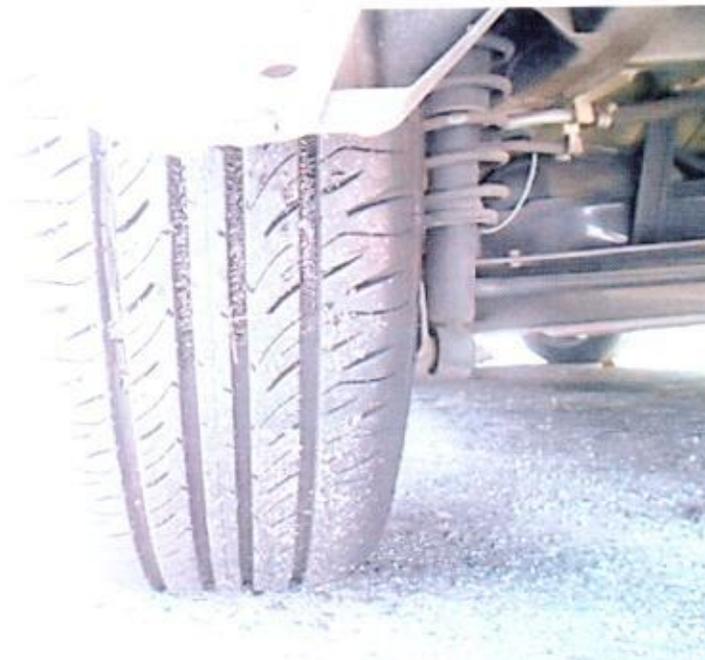
Photo 12 shows the condition of the rear left tyre of the Motor Car, which was observed to be in serviceable condition with remaining tread depth of approximately 7mm. The tyre, which was wrapped around alloy wheel rim, was also observed to be sufficiently inflated for vehicular operation.

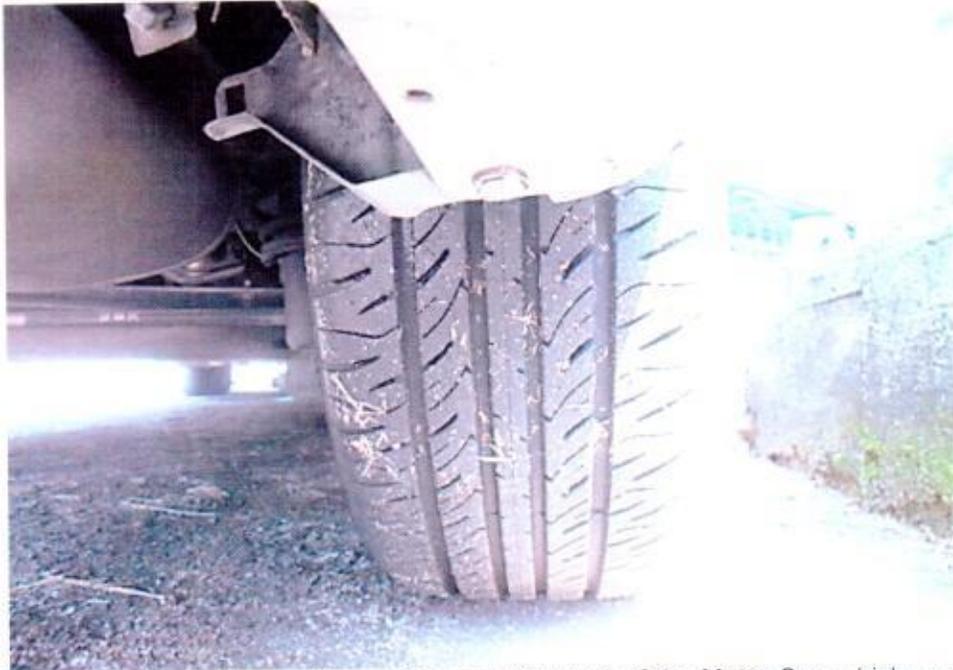
Photo 13 shows the condition of the rear right tyre of the Motor Car, which was observed to be in serviceable condition with remaining tread depth of approximately 7mm. There was also no tear, cut or burst mark(s) on the outer and the inner sidewalls as well as across the tread of the 4 tyres.

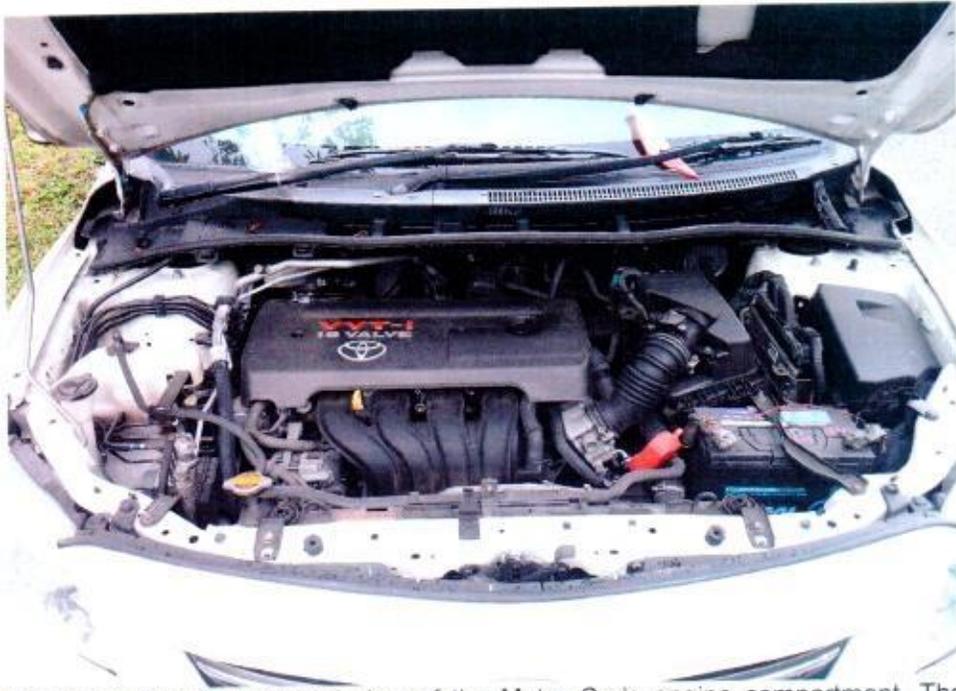
Photo 14 shows a general view of the Motor Car's engine compartment. The various parts and components inside the engine compartment were unaffected by the accident. There was also no sign(s) or indication(s) of fluid leakage and/or fluid stain within the engine compartment.

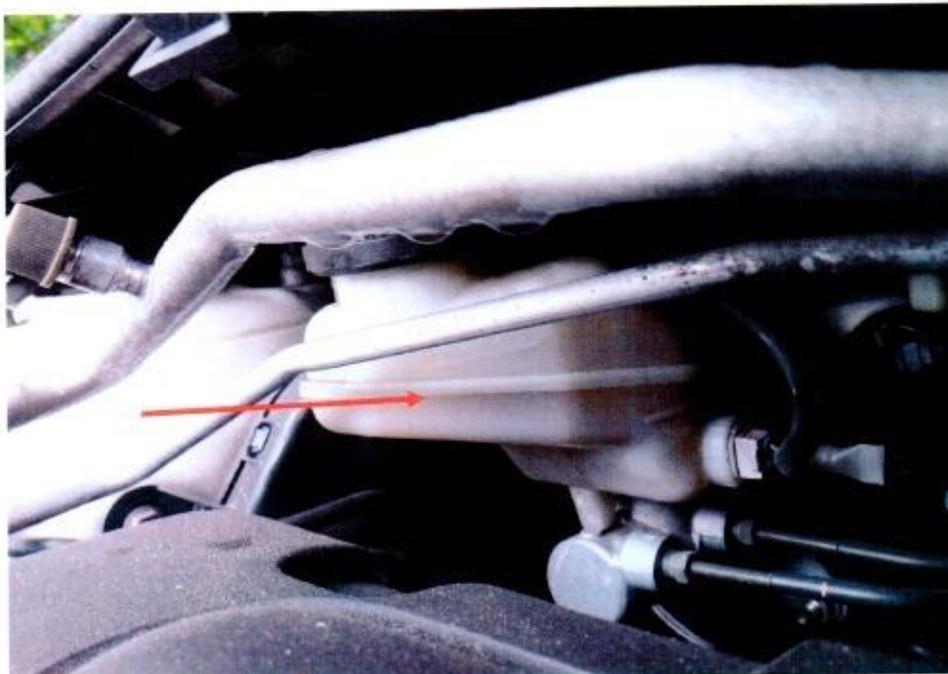
Photo 15 shows the brake fluid reservoir of the Motor Car at the time of our inspection. The brake fluid was observed to be of sufficient level (arrowed) and without any visible contamination.

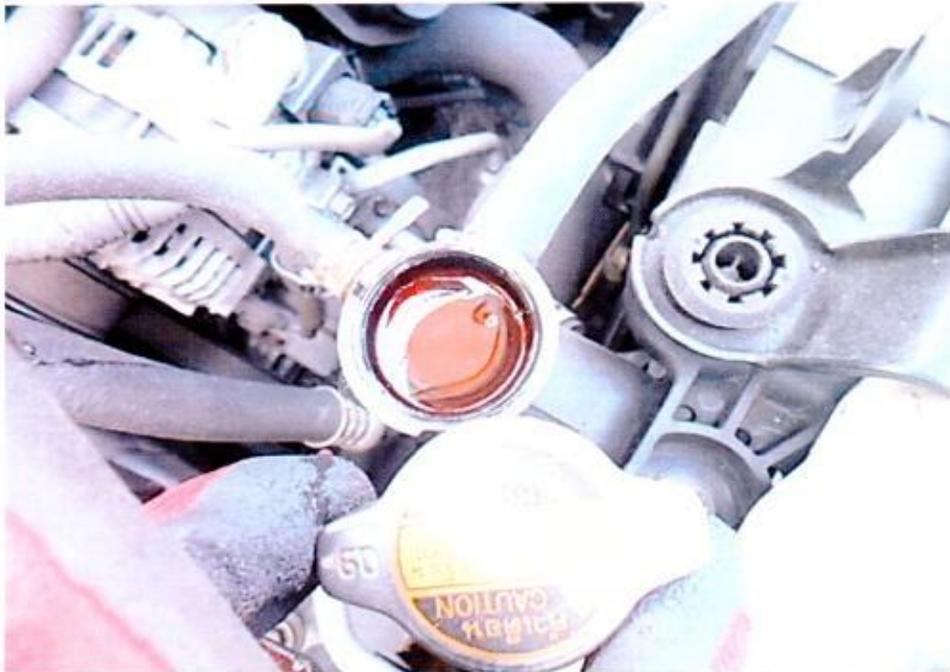
Photo 16 shows the coolant fluid radiator reservoir of the Motor Car at the time of our inspection. The coolant fluid was observed to be of sufficient level and without any visible contamination.

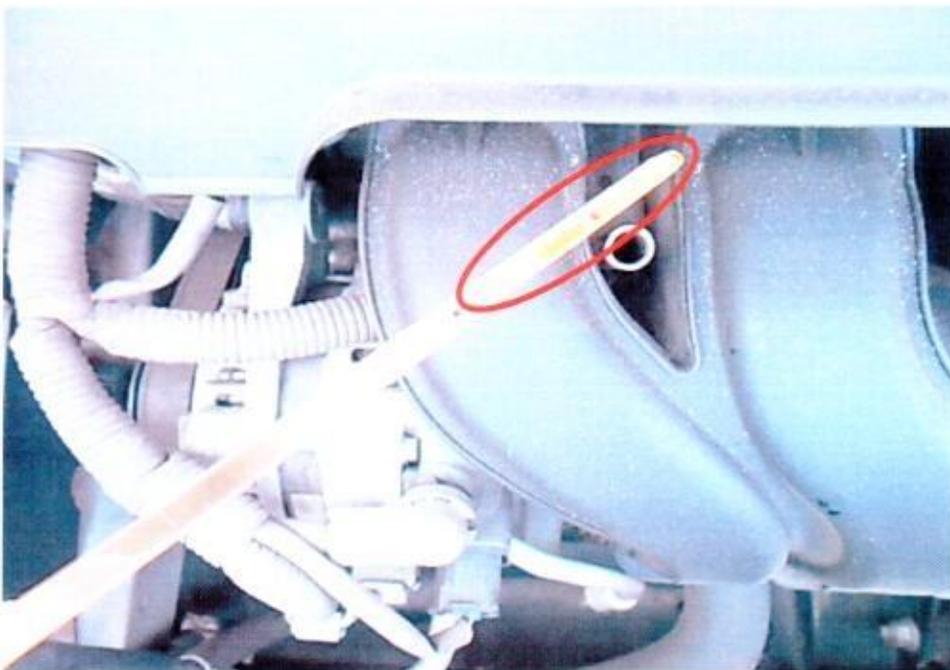
Photo 17 shows the engine oil dip stick of the Motor Car at the time of our inspection. The engine oil was observed to be of sufficient level and without any visible contamination.

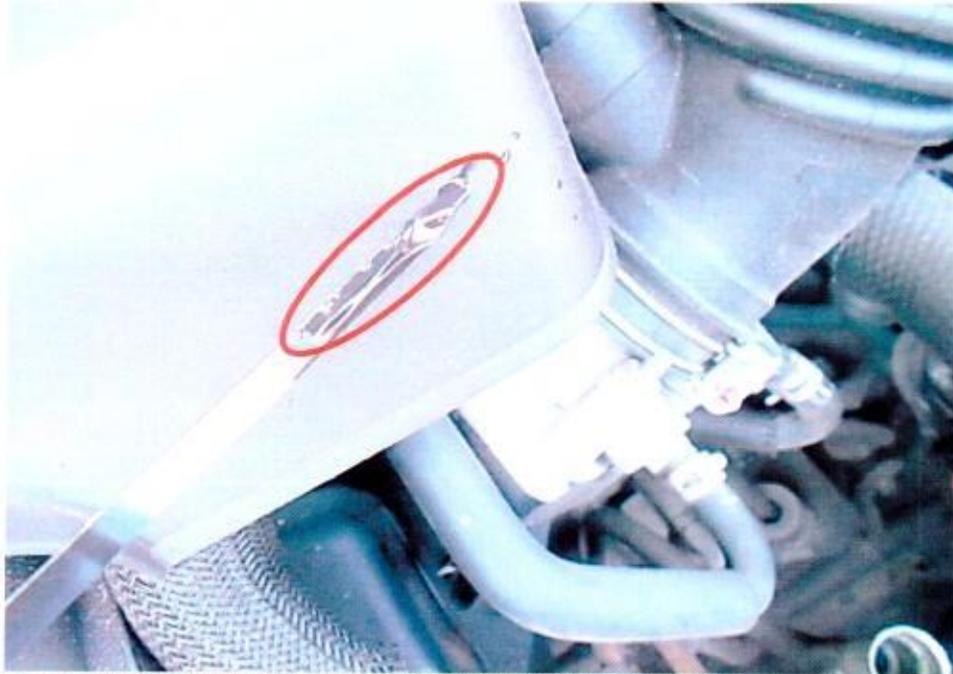
Photo 18 shows the power steering dip stick of the Motor Car at the time of our inspection. The power steering fluid was observed to be of sufficient level and without any visible contamination.

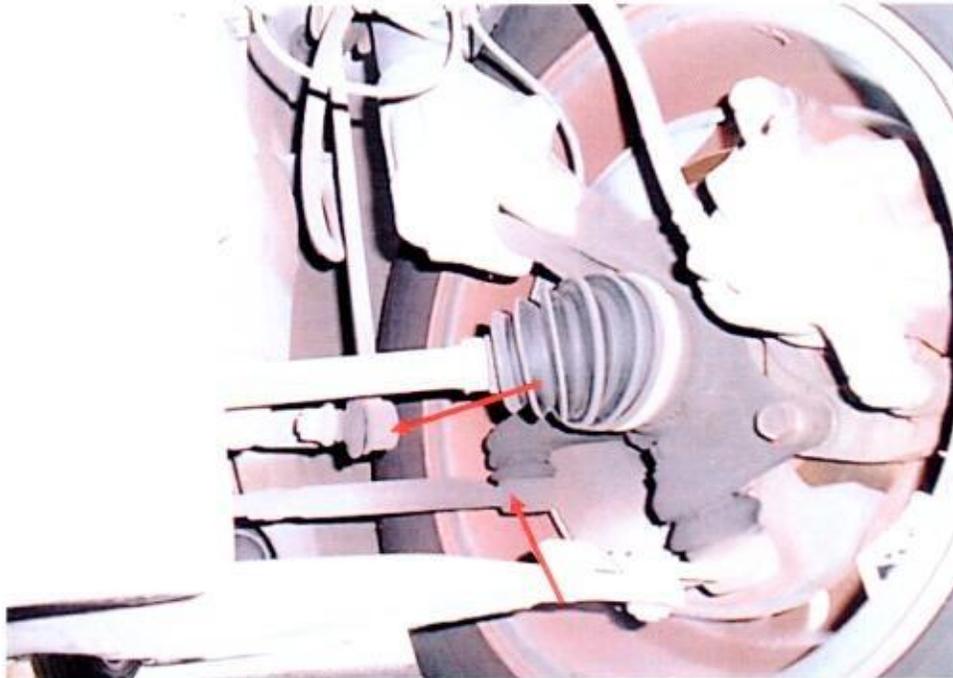
Photo 19 shows the various undercarriage components at the front left wheel of the Motor Car, in particular the steering tie rod (arrowed). The various steering components were all found to be intact, suggesting that the steering system of the Motor Car was likely to be in serviceable condition.

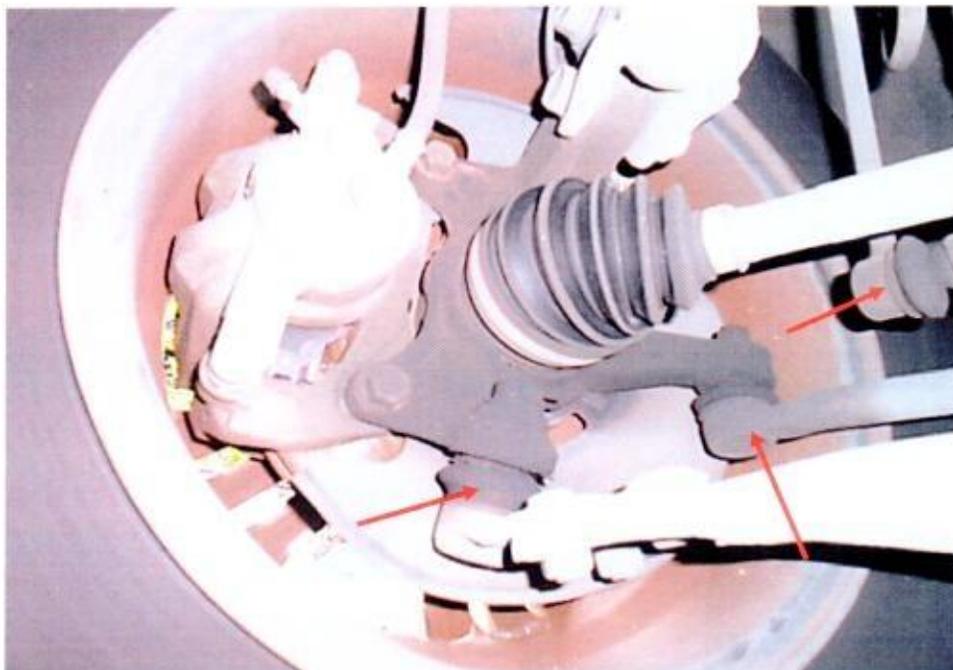
Photo 20 shows the various undercarriage components at the front left wheel of the Motor Car, in particular the steering tie rod (arrowed). The various steering components were all found to be intact, suggesting that the steering system of the Motor Car was likely to be in serviceable condition.

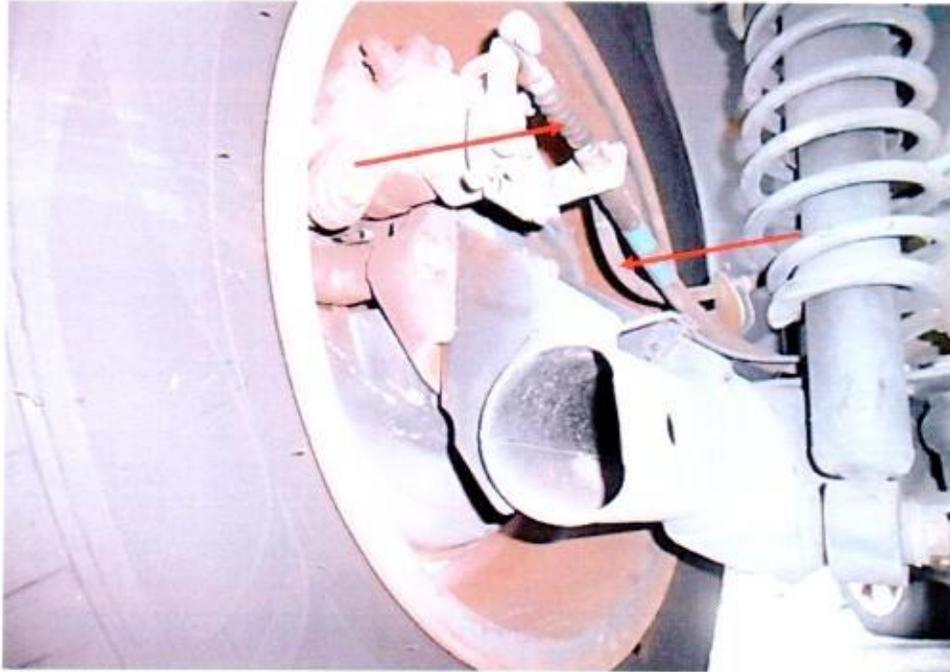
Photo 21 shows the brake hose (arrowed) at the rear left wheel of the Motor Car. We did not observe any leakage of brake fluid at the time of my inspection of the Motor Car. Our visual inspection of the various mechanical components of the Motor Car's braking system revealed all to be intact and without visible damage.

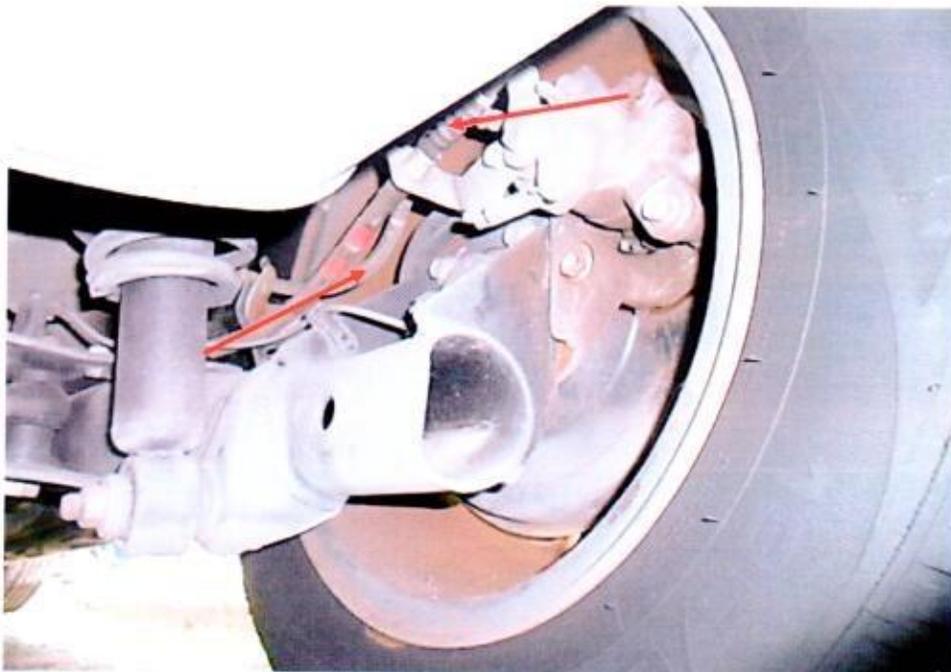
Photo 22 shows the various undercarriage components at the rear right wheel of the Motor Car. We did not observe any leakage of brake fluid at the time of our inspection of the Motor Car. Our visual inspection of the various mechanical components of the Motor Car's braking system revealed all to be intact and without visible damage.

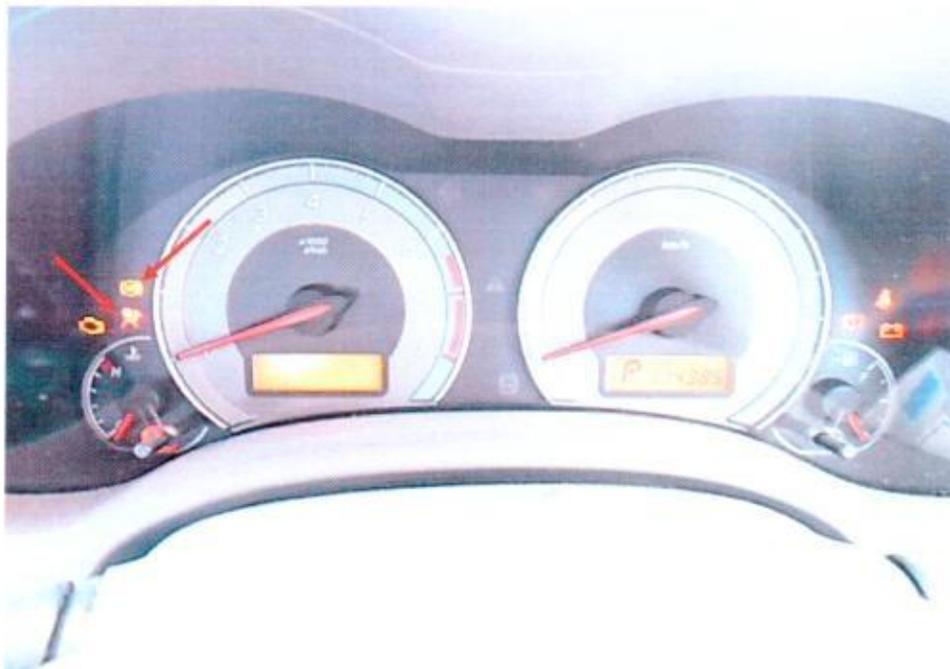
Photo 23 shows the warning lights for the various electronic operating systems of the Motor Car appearing on its instrument panel during the self-test when the engine is cranked, in particular the ABS light and SRS light.

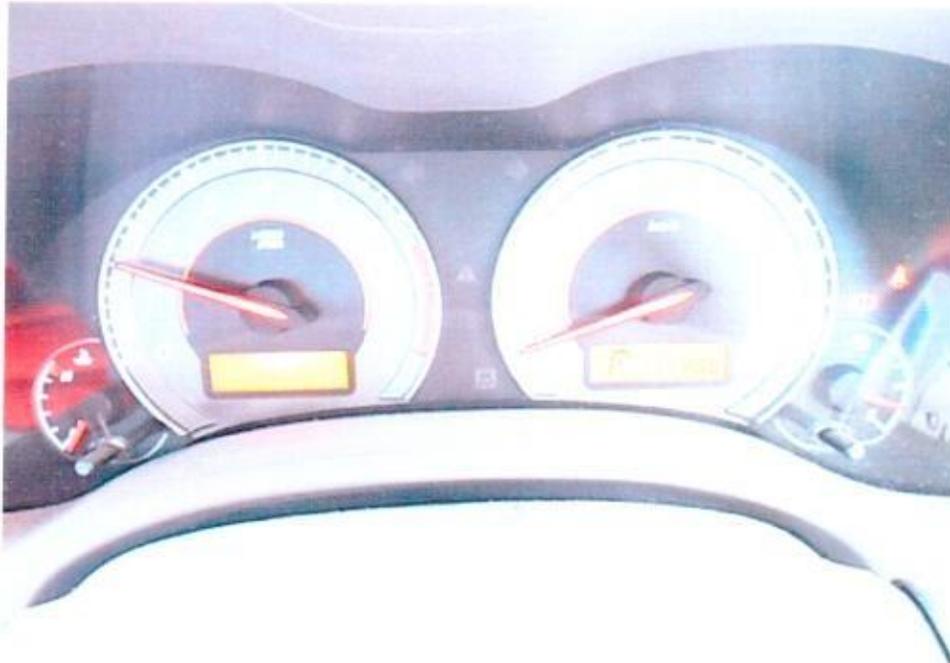
Photo 24 shows no warning lights illuminated on the instrument panel of the Motor Car after the engine was cranked. This would suggest that there was no abnormality to the various electronic operating systems of the Motor Car, like the ABS and SRS.

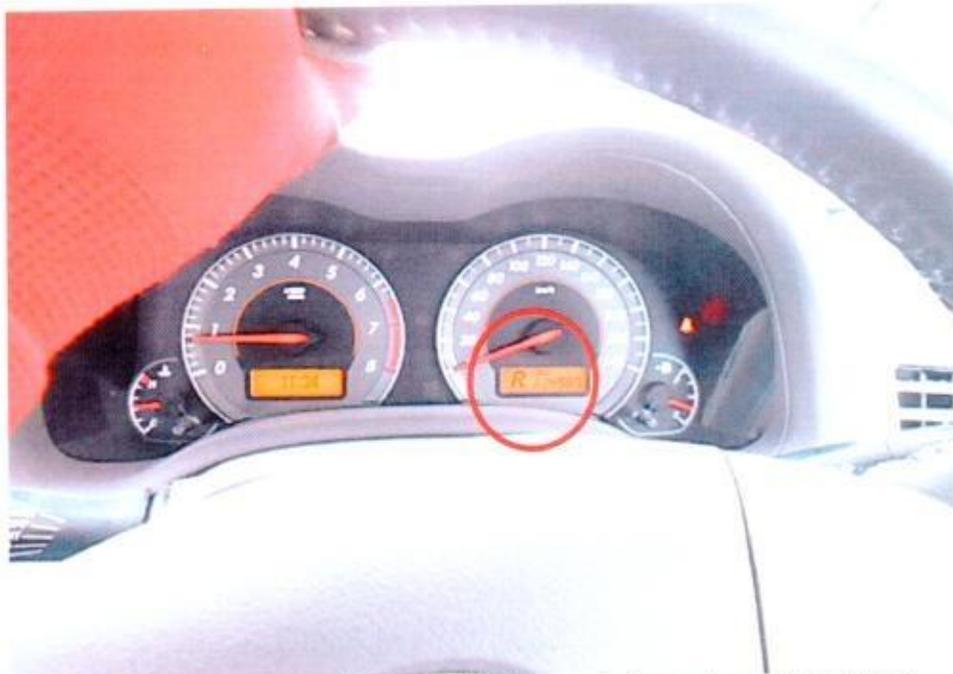
Photo 25 shows the operational test, the transmission system of the Motor Car was able to be shifted to the reverse mode without any difficulty. There were no abnormal sounds heard and/or abnormal behaviour of the Motor Car's engine system. It was able to move forward and backward normally.

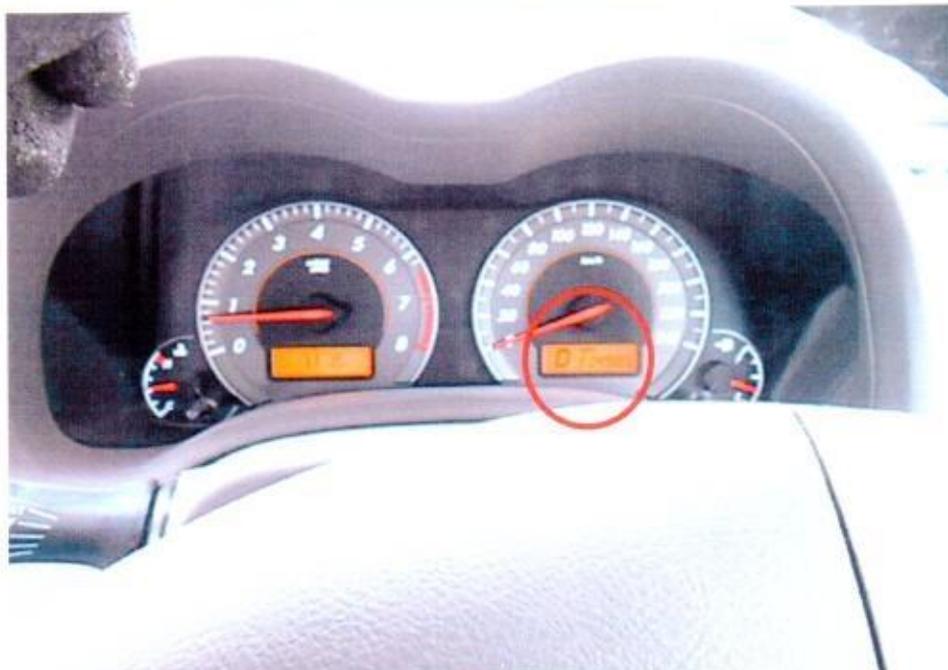
Photo 26 shows the operational test, the transmission system of the Motor Car was able to be shifted to the drive mode without any difficulty. There were no abnormal sounds heard and/or abnormal behaviour of the Motor Car's engine system. It was able to move forward and backward normally.
