Your Ref: TP/IP/64877/2017
Our Ref : CI/TPD17024644/Z

29th December 2017

MECHANICAL INSPECTION REPORT OF MOTOR TAXI SHA 9435U

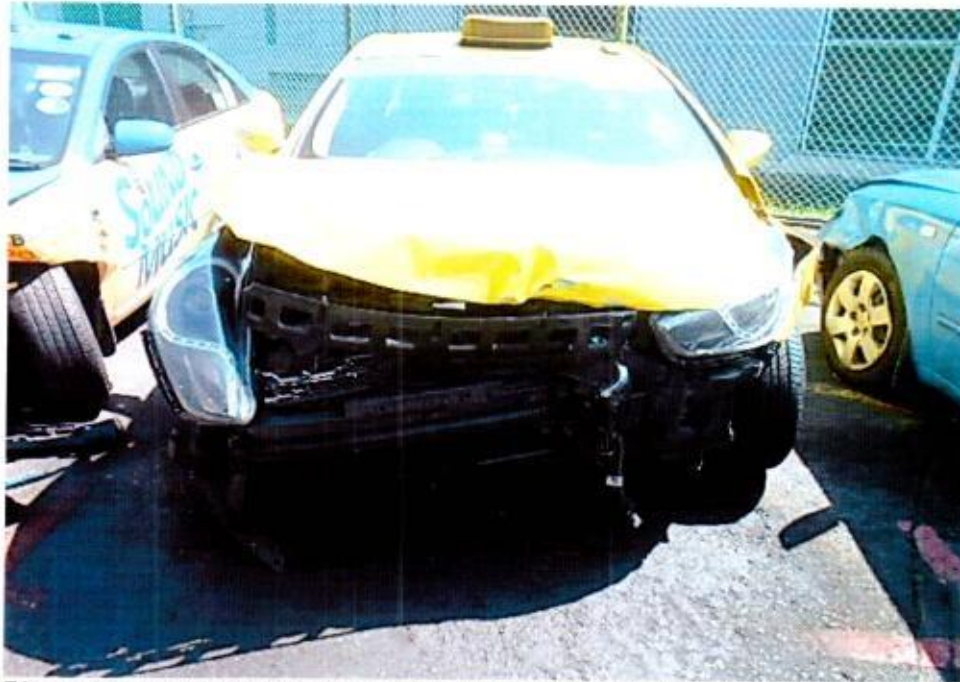
Photo 1 shows a general view of the frontal portion of the Motor Taxi at the time of our inspection. The Motor Taxi was observed to have sustained extensive impact damage at its frontal portion. The impact force was significant, causing the various parts and components inside the engine compartment to be buckled inwards.

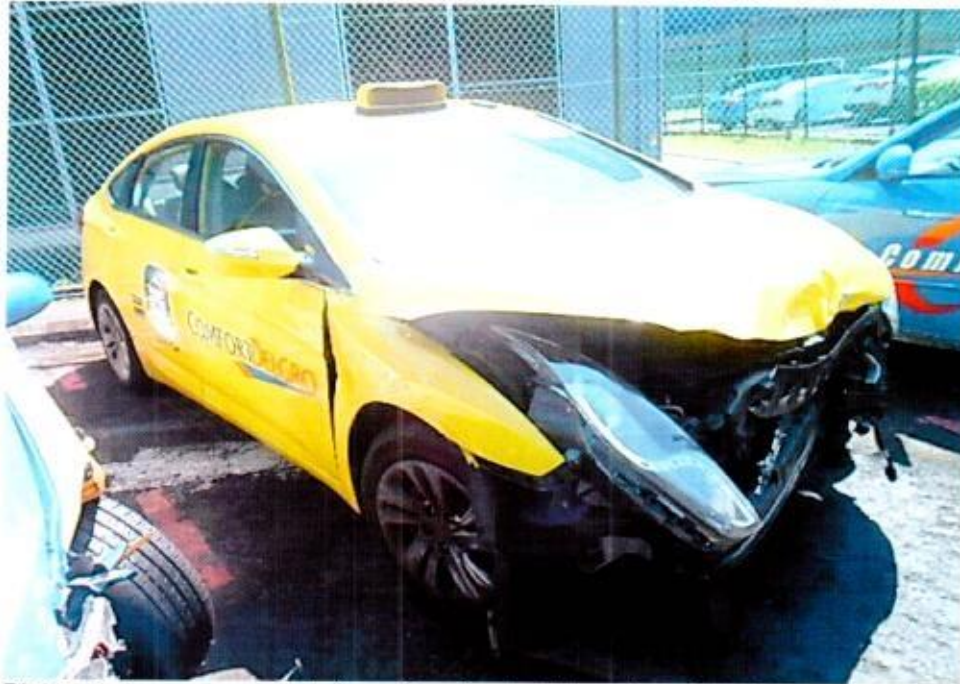
Photo 2 shows a general view of the front right portion of the Motor Taxi at the time of our inspection. The Motor Taxi was observed to have sustained extensive impact damage at its frontal portion.

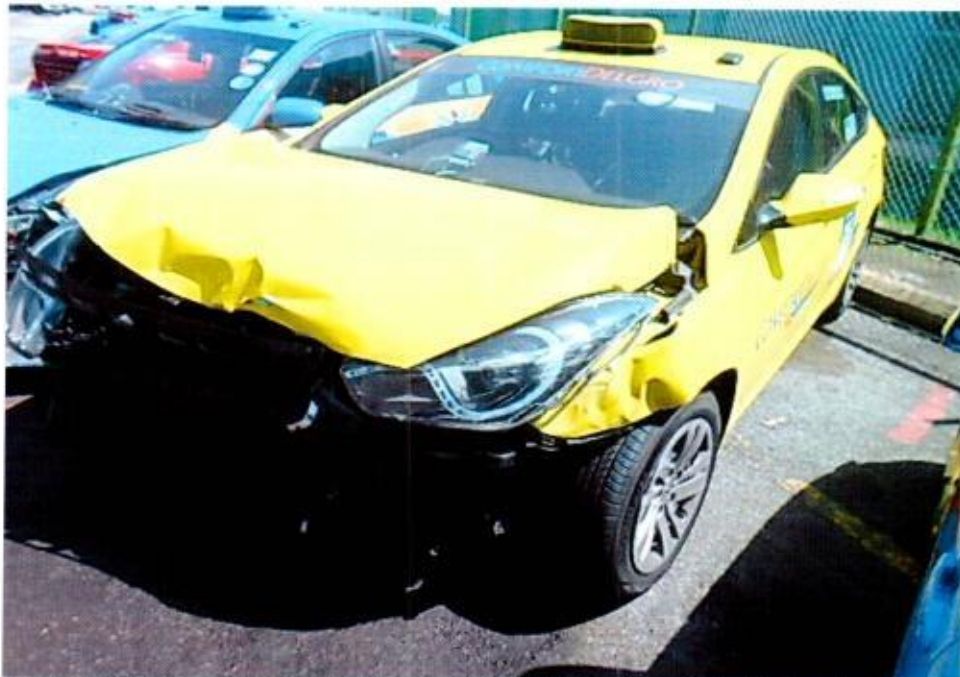
Photo 3 shows a general view of the front left portion of the Motor Taxi at the time of our inspection. The Motor Taxi was observed to have sustained extensive impact damage at its frontal portion.

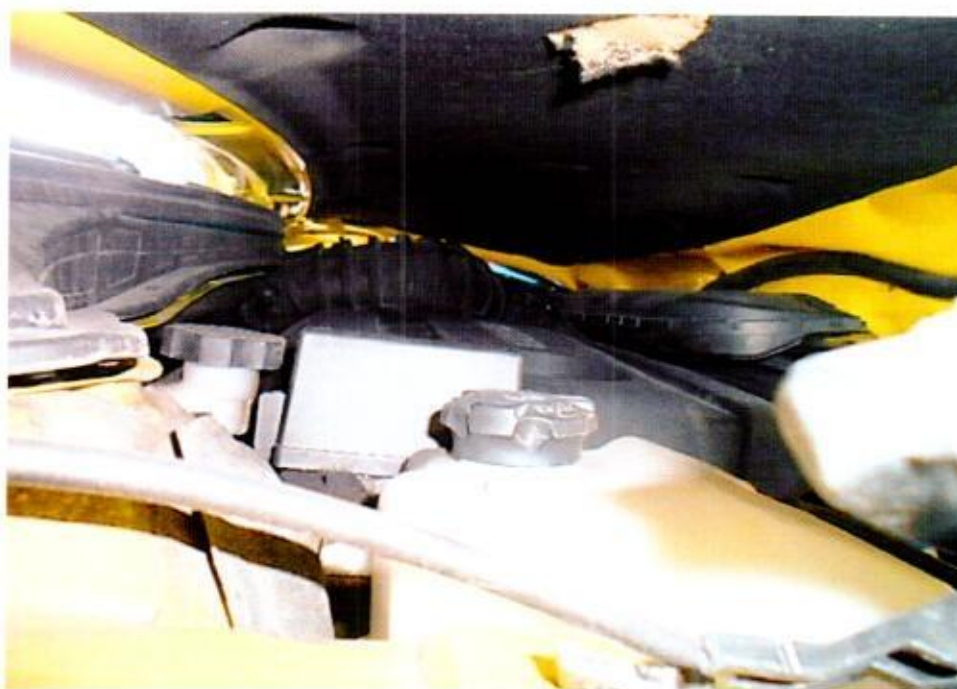
Photo 4 shows a closer view of the damage at the frontal portion of the Motor Taxi. The impact force was significant, causing the various parts and components inside the engine compartment to be pushed inwards, towards the rear of the Motor Car.

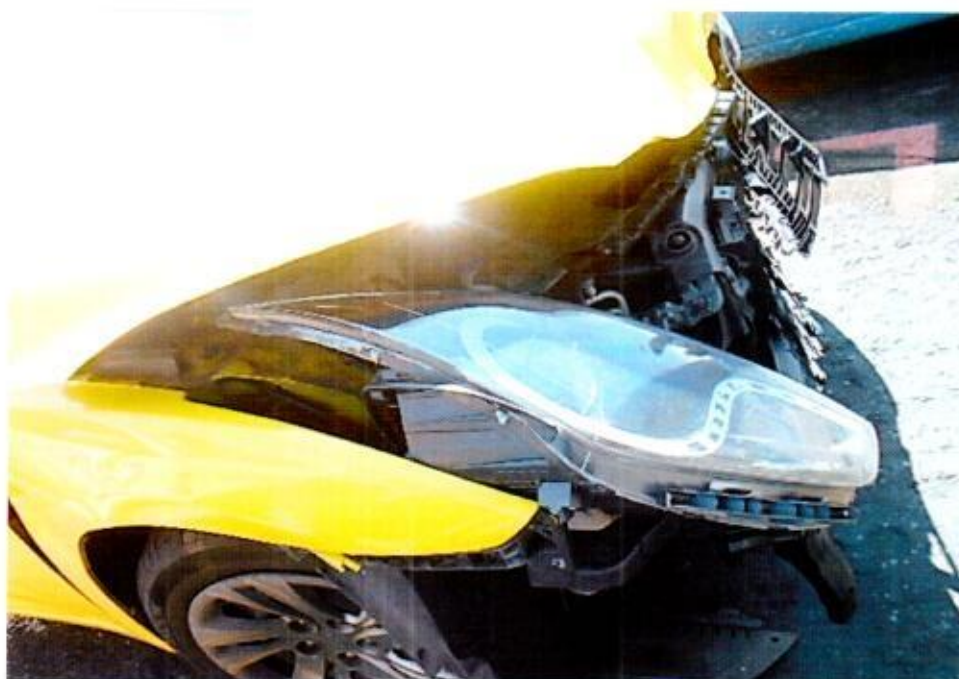
Photo 5 shows a closer view of the damage at the frontal right portion of the Motor Taxi. The impact force was significant, causing the various parts and components inside the engine compartment to be pushed inwards, towards the rear of the Motor Taxi.

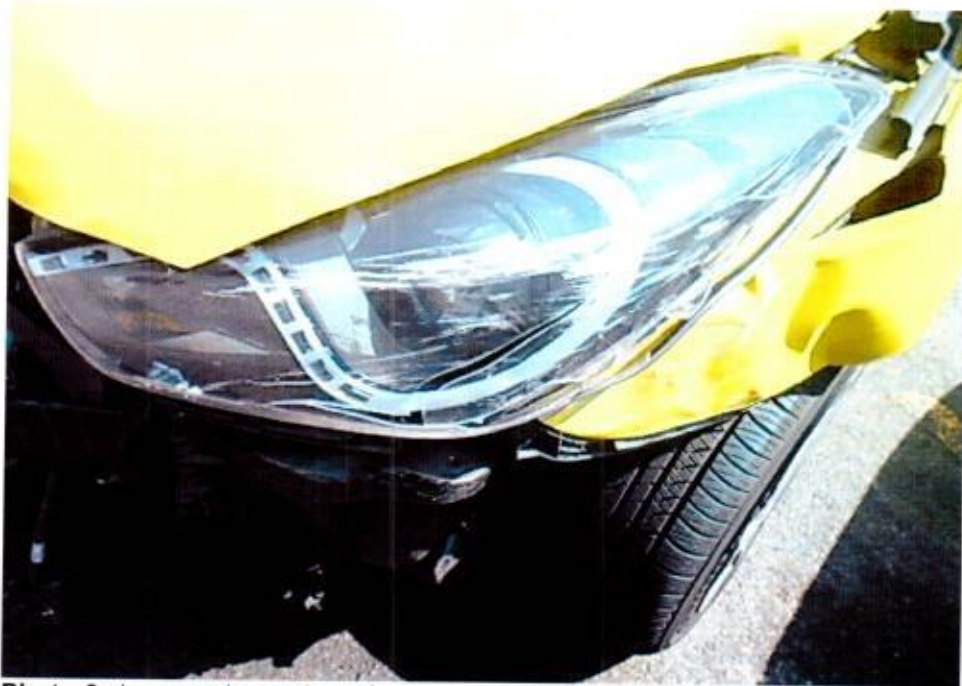
Photo 6 shows a closer view of the damage at the frontal left portion of the Motor Taxi. The impact force was significant, causing the various parts and components inside the engine compartment to be pushed inwards, towards the rear of the Motor Taxi.

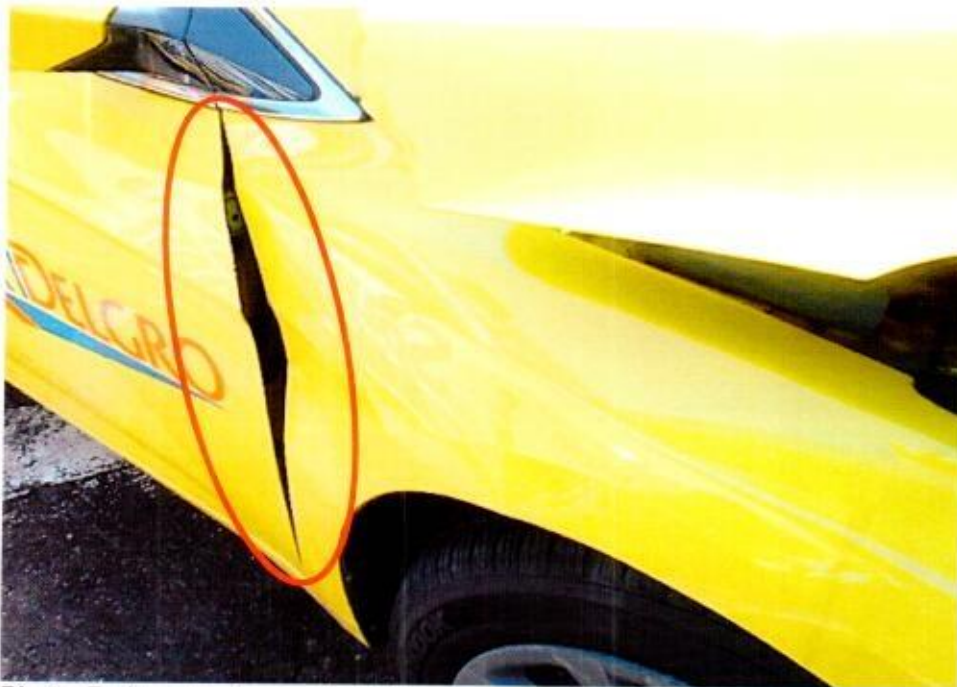
Photo 7 shows a closer view of the damage at the right frontal portion of the Motor Taxi. The impact force was significant, causing the right hand door to be partially stuck, unable to be open smoothly.

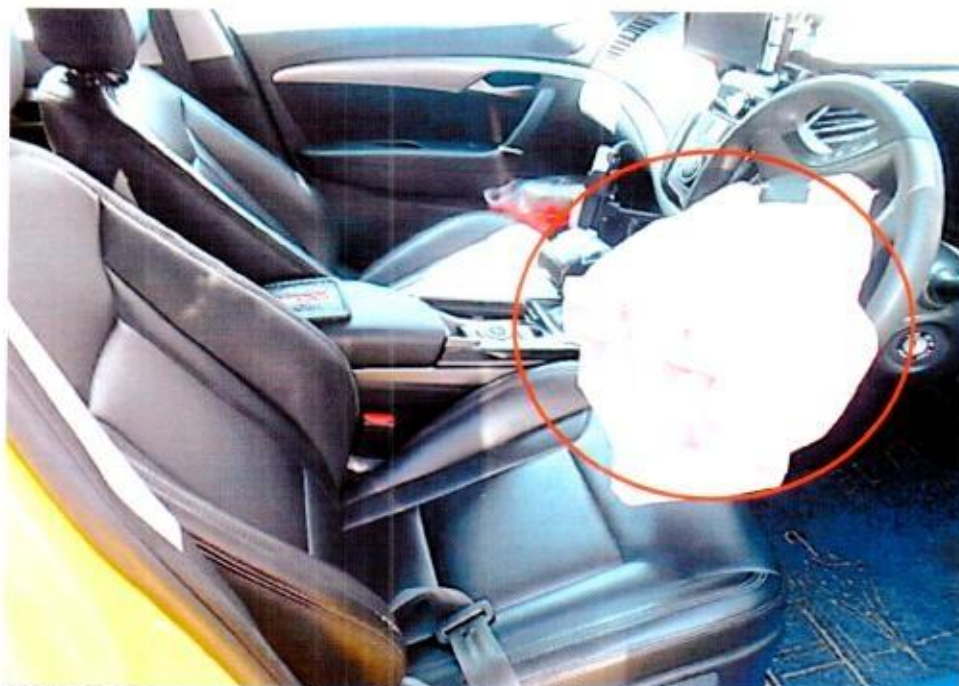
Photo 8 shows a closer view of the interior portion of the Motor Taxi. The impact force was significant, causing the driver's seat air bag activated.

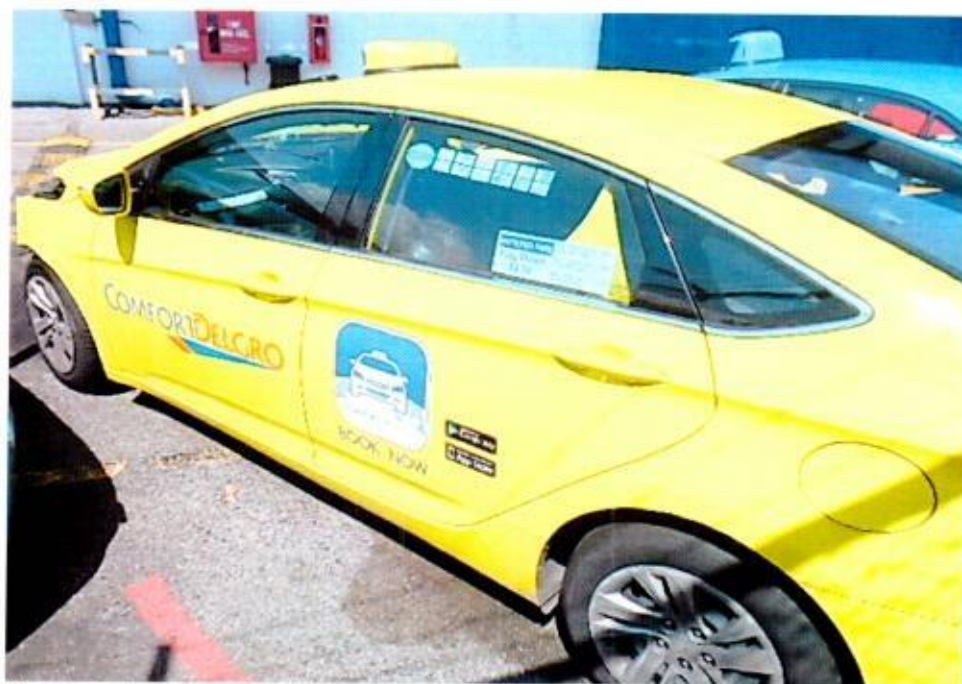
Photo 9 shows a general view of the rear left portion of the Motor Taxi at the time of our inspection. The rear portion was observed to be relatively unaffected by the accident.

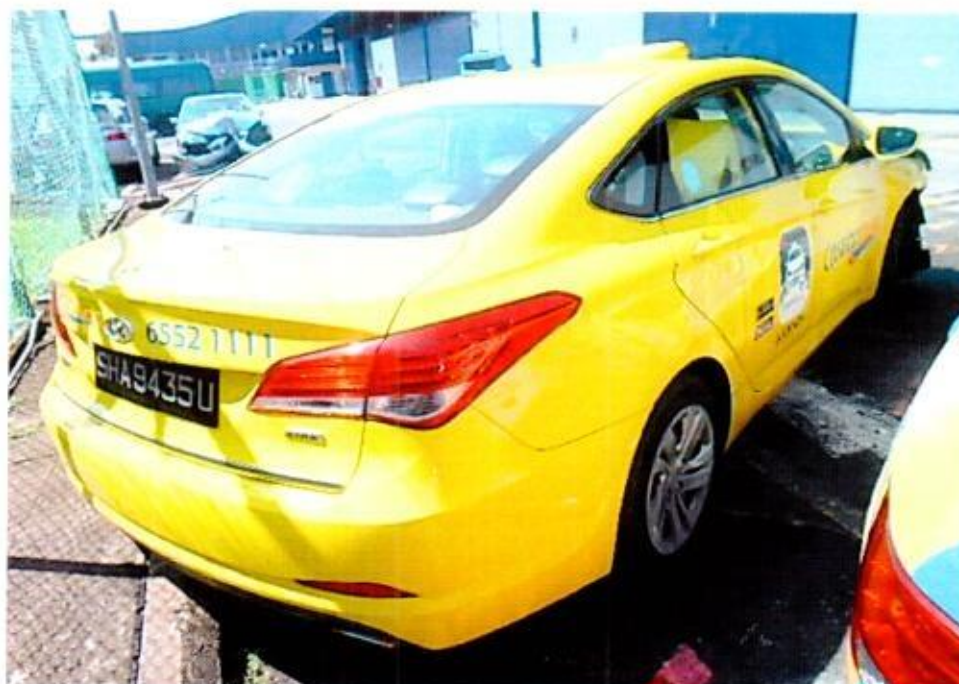
Photo 10 shows a general view of the rear right portion of the Motor Taxi at the time of our inspection. The rear portion was observed to be relatively unaffected by the accident.

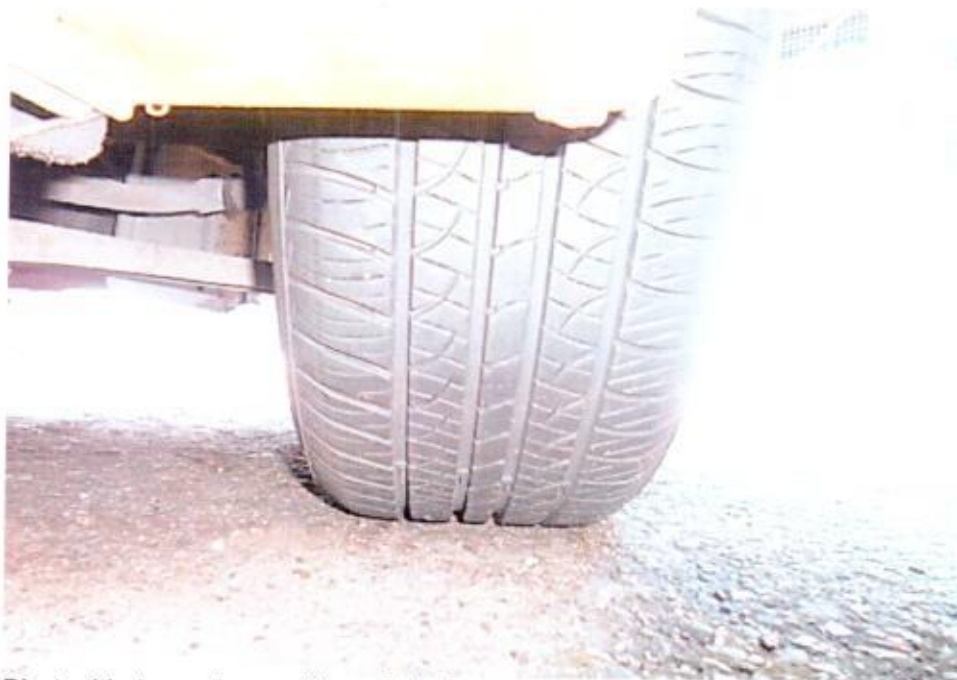
Photo 11 shows the condition of the front right tyre of the Motor Taxi, which was observed to be in serviceable condition with remaining tread depth of approximately 7mm. There was no tear, cut or burst mark(s) on the outer and the inner sidewalls as well as across the tread of this tyre.

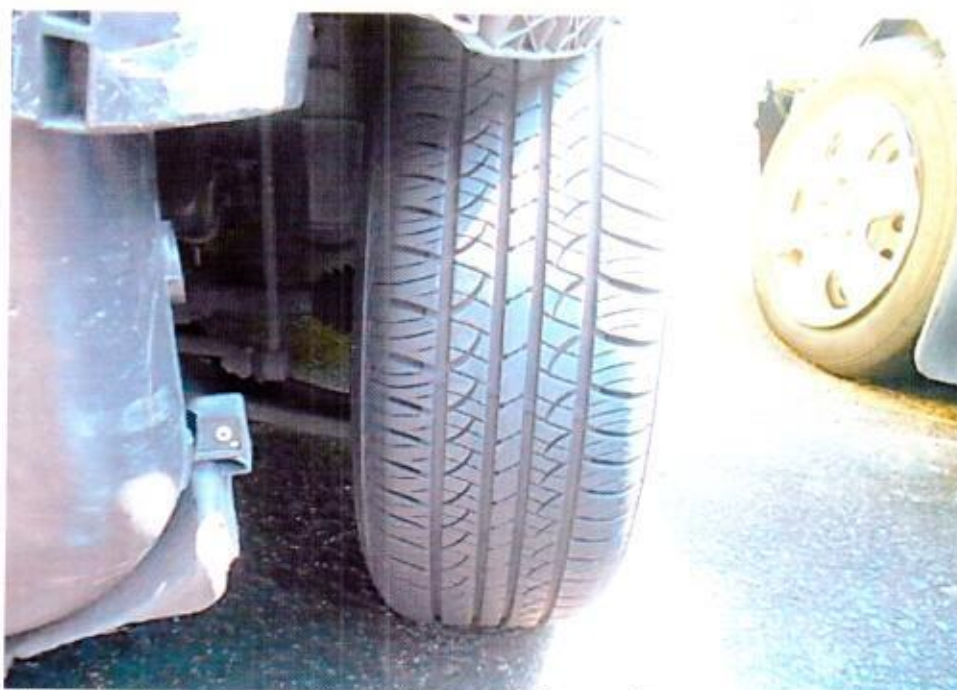
Photo 12 shows the condition of the front left tyre of the Motor Taxi, which was observed to be in serviceable condition with remaining tread depth of approximately 7mm. There was no tear, cut or burst mark(s) on the outer and the inner sidewalls as well as across the tread of this tyre, which was also sufficiently inflated for vehicular operation.

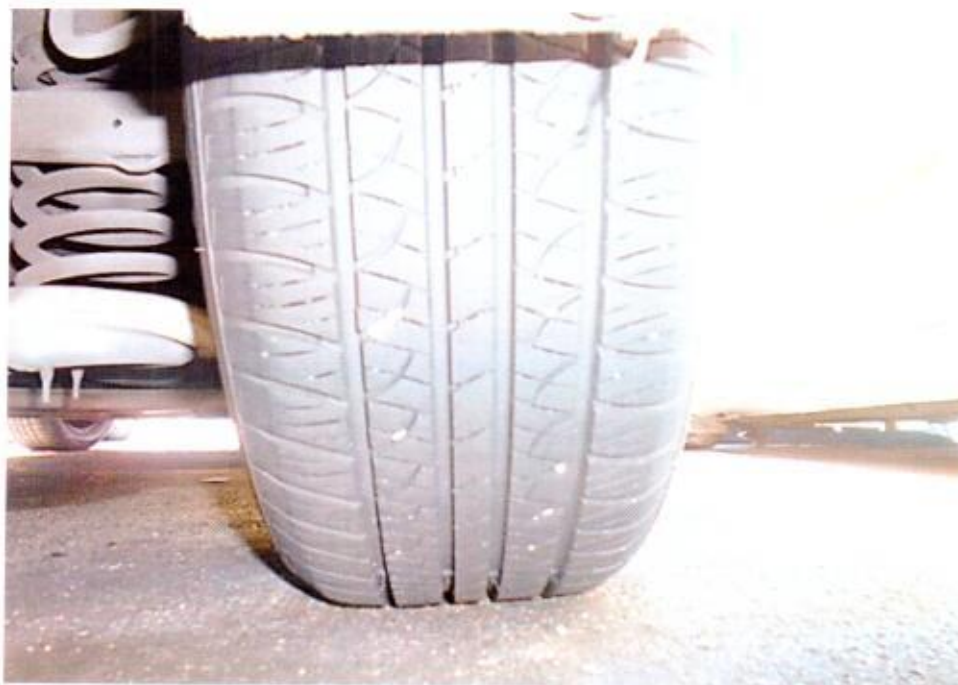
Photo 13 shows the condition of the rear right tyre of the Motor Taxi, which was observed to be in serviceable condition with remaining tread depth of approximately 6mm. There was also no tear, cut or burst mark(s) on the outer and the inner sidewalls as well as across the tread of this tyre.

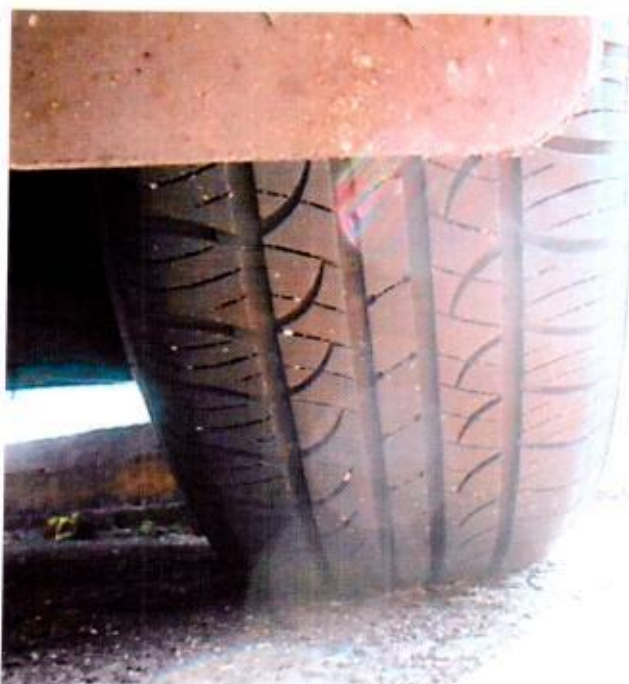
Photo 14 shows the condition of the rear left tyre of the Motor Taxi, which was observed to be in serviceable condition with remaining tread depth of approximately 6mm. There was also no tear, cut or burst mark(s) on the outer and the inner sidewalls as well as across the tread of this tyre.

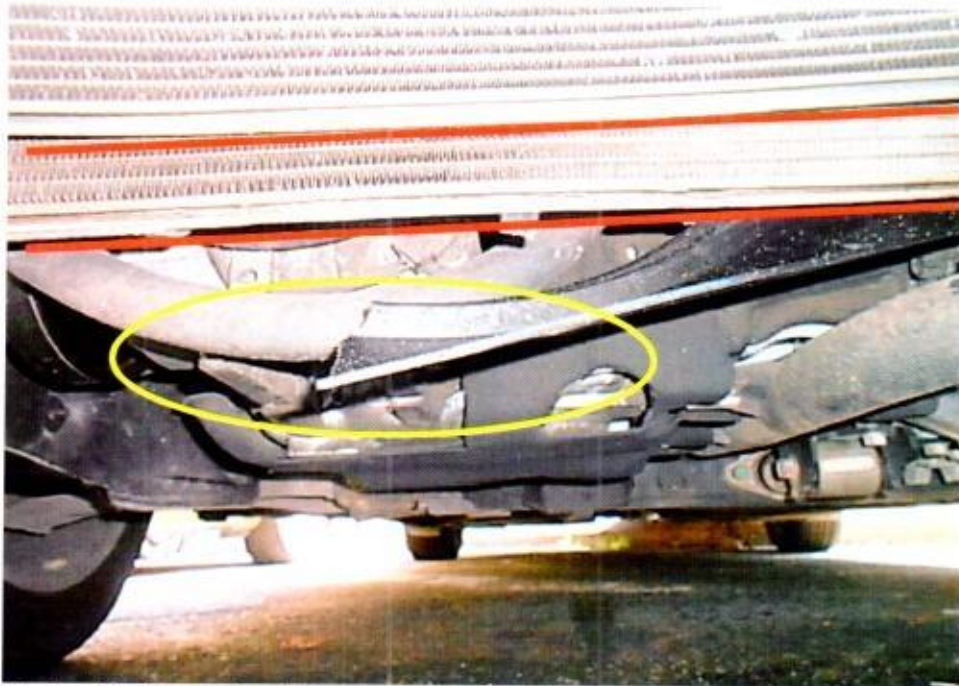
9. The engine compartment of the Motor Taxi was severely affected by the collision. Almost all the parts and components inside the engine compartment were badly damaged. Parts like the radiator, air intake system, fuel rails, exhaust manifold, fuse box and control modules amongst others were found to be damaged.

Photo 15 shows the close up view of the radiator of the Motor Taxi. Dented radiator (Red arrowed) & broken parts (Circled) was observed at time of our inspection.

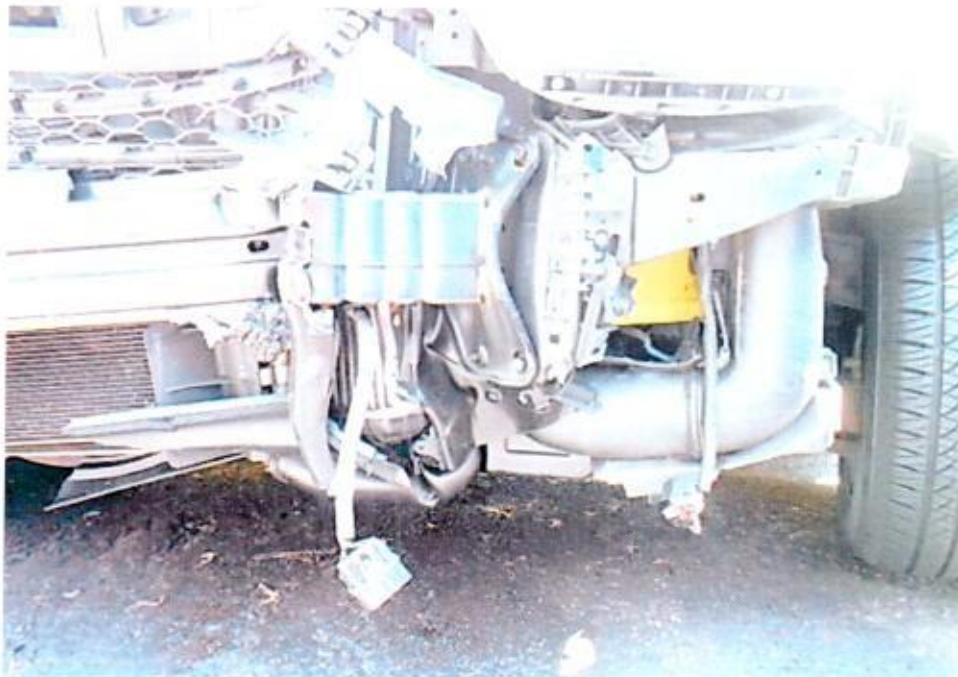
Photo 16 shows the close up view of the re-inforcement bar, air intake system, ignition system, transmission system & cooling system that was observed to be damaged likely due to the accident impact.

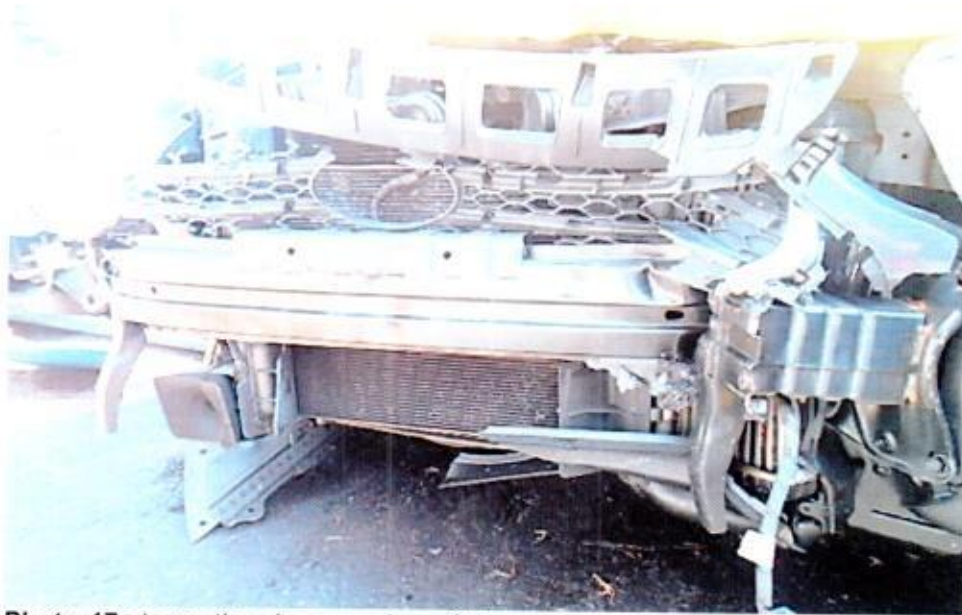
Photo 17 shows the close up view of the re-inforcement bar, air intake system, ignition system, transmission system & cooling system that was observed to be damaged likely due to the accident impact.

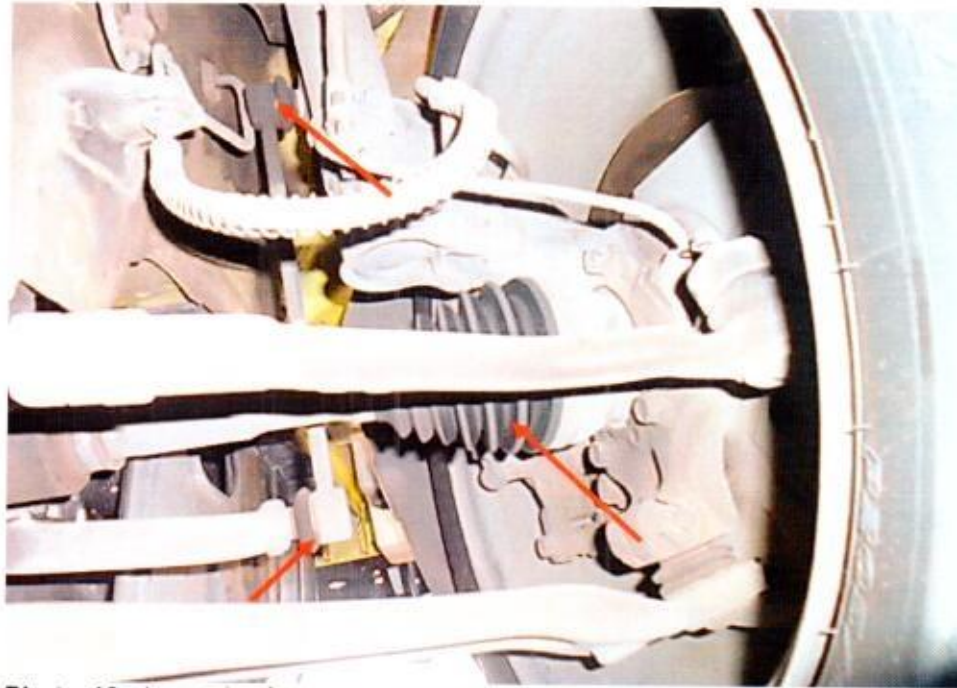
Photo 18 shows the front right steering tie rod & drive shaft of the Motor Taxi. There was no visible fluid leakage around the area. However, we were not able to conduct any tests on the steering system of the Motor Taxi due to the damages to the engine components that links to the steering system.

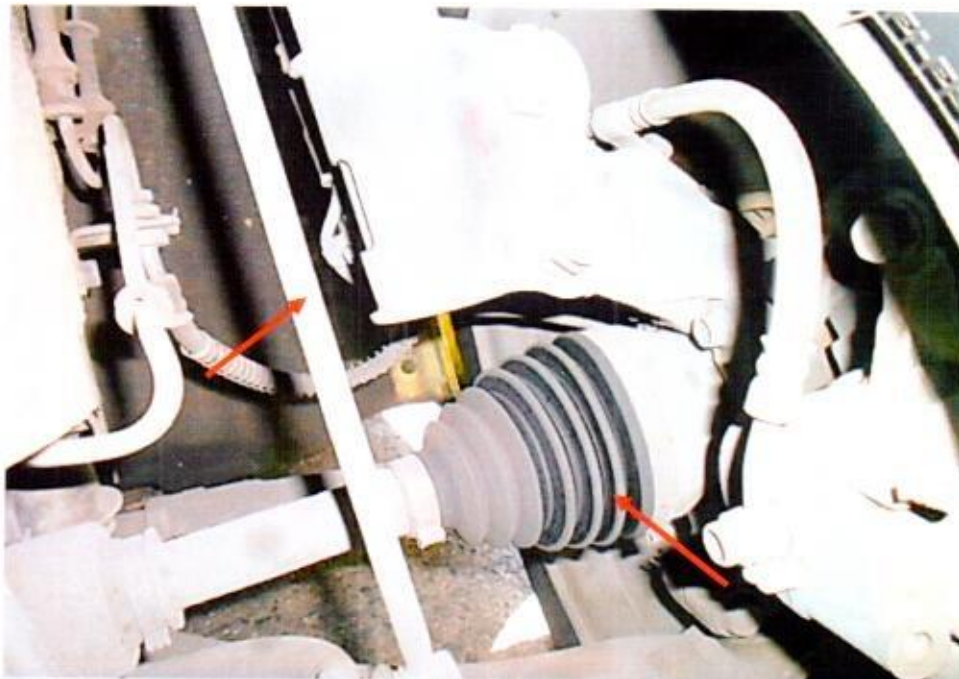
Photo 19 shows the front left steering tie rod & drive shaft of the Motor Taxi. There was no visible fluid leakage around the area. However, we were not able to conduct any tests on the steering system of the Motor Taxi due to the damages to the engine components that links to the steering system.

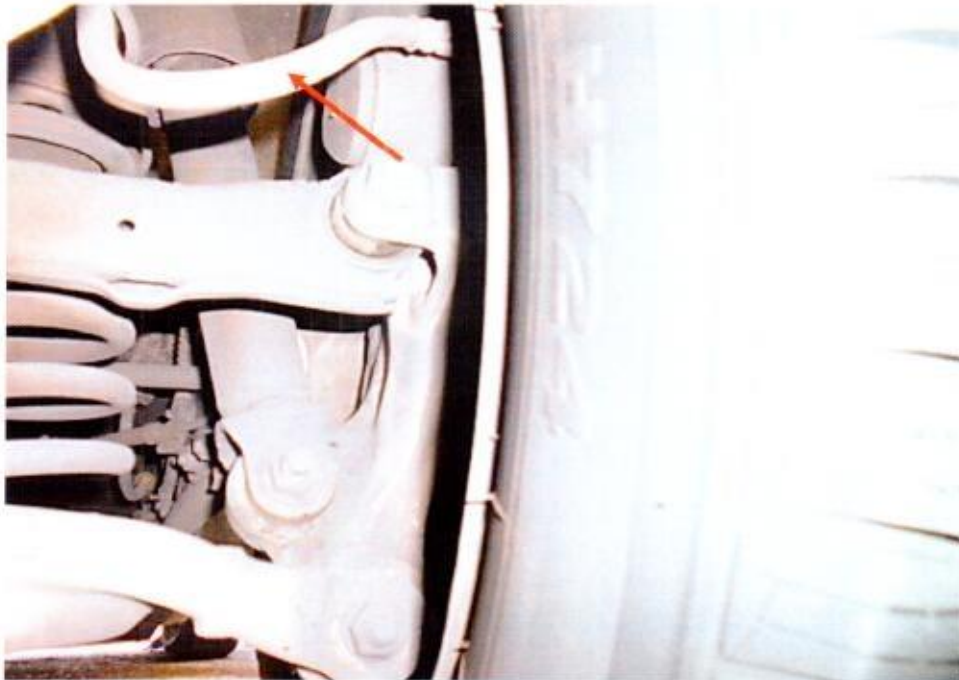
Photo 20 shows the braking components at the rear right wheel of the Motor Taxi. We did not observe any leakage of brake fluid at the time of our inspection of the Motor Taxi.

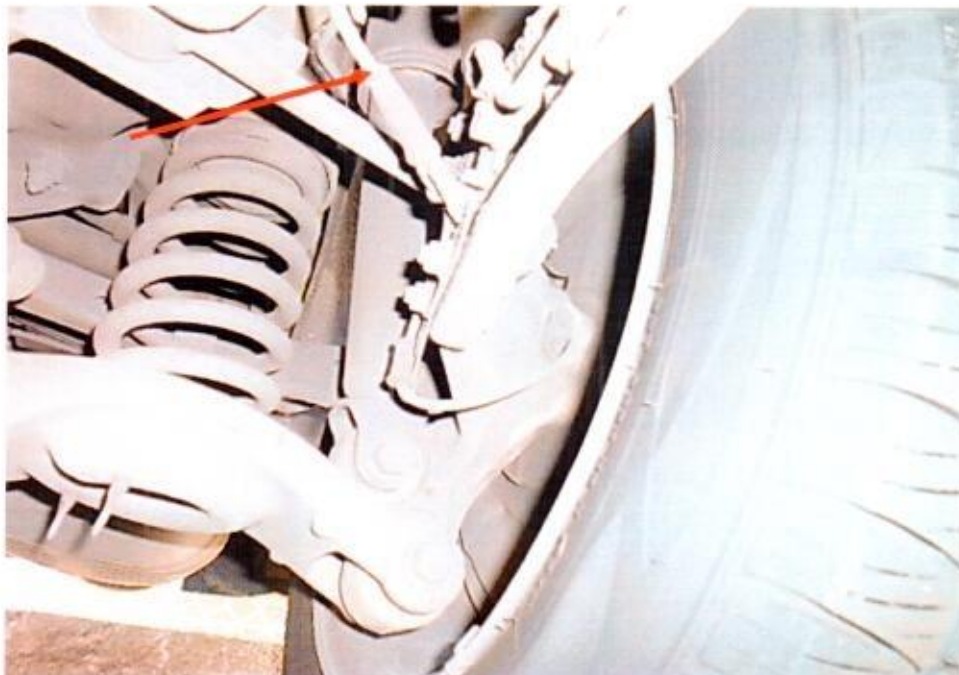
Photo 21 shows the braking components at the rear left wheel of the Motor Taxi. We did not observe any leakage of brake fluid at the time of our inspection of the Motor Taxi.

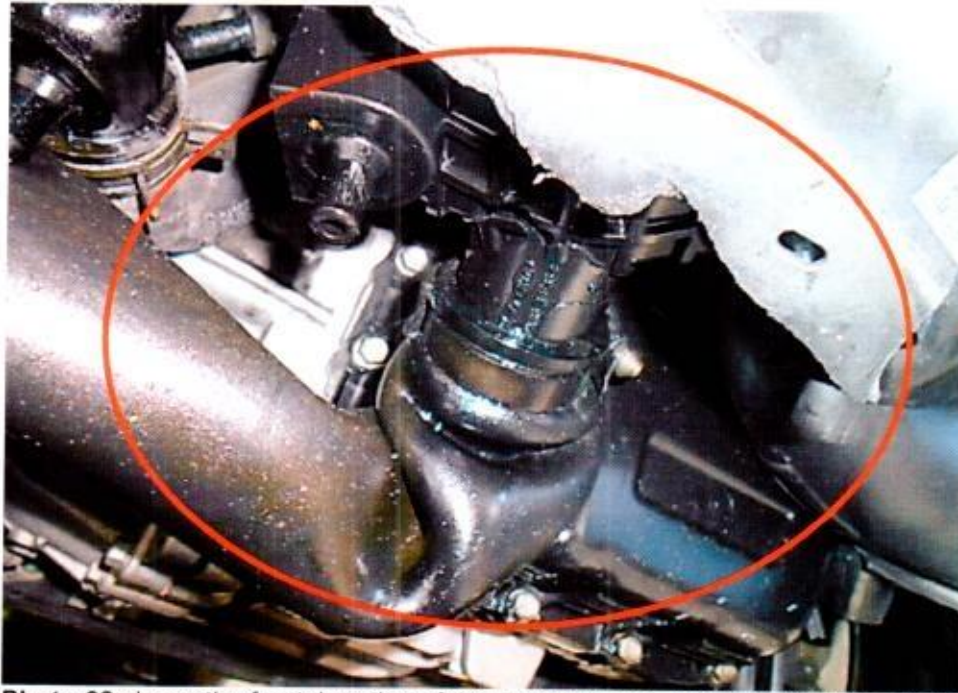
10. Leakage of the various operating fluids like the engine fluid, engine coolant, power steering fluid and brake fluid was also noted. Given the extent of damages to the engine compartment, the leakages were likely due to the accident. The engine undercarriage was however observed to be covered with fluid, suggesting leakage of fluid. There was no accumulation of dust and/or dirt particles on the engine housing where the fluid stains had formed. This would indicate that the fluid leakage was a fresh leak and likely to be a result of the accident. We were therefore unable to comment whether these operating fluids were of sufficient level and without contamination for vehicular operation prior to the accident.

Photo 22 shows the frontal portion of the undercarriage components of the Motor Taxi. We observe signs of fluid leakage at the time of our inspection of the Motor Taxi.

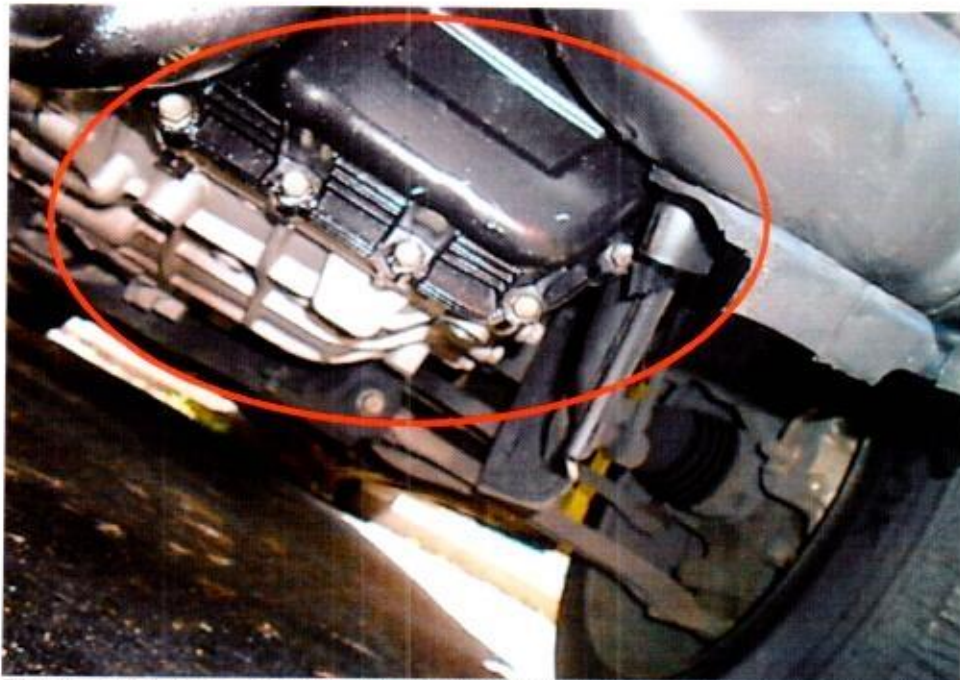
Photo 23 shows the frontal portion of the undercarriage components of the Motor Taxi. We observe signs of fluid leakage at the time of our inspection of the Motor Taxi.
