Your Ref: TP/IP/41005/2017  
Our Ref : CI/TPD18000207/Z

**Fatal Accident Investigation Team**

**MECHANICAL INSPECTION REPORT OF MOTOR LORRY YN 7345P**

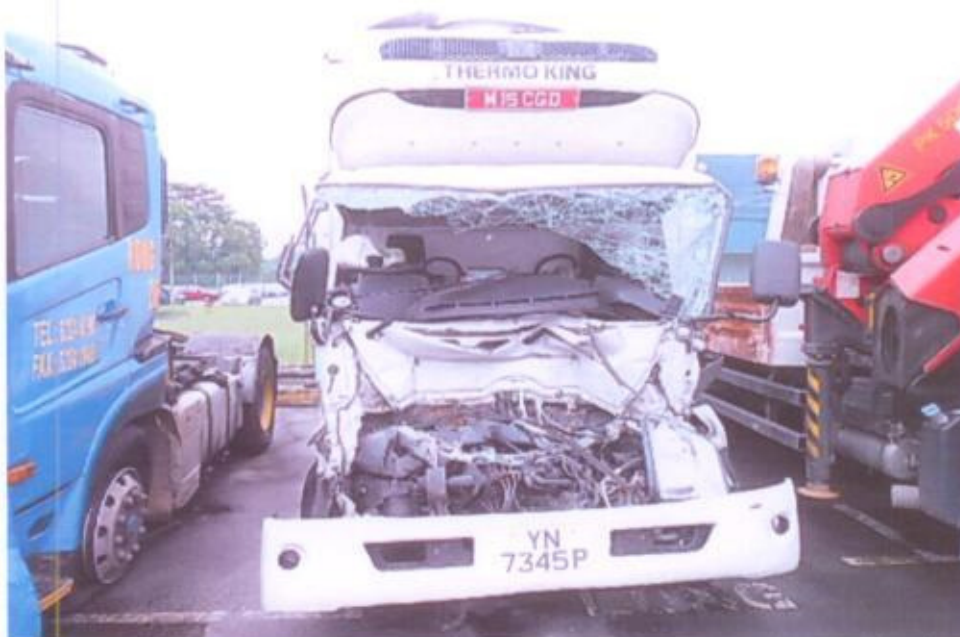
4. The mileage of the Motor Lorry at the time of our inspection was not recorded as its ignition system and front cabin was severely damaged by the collision.
5. The Motor Lorry had sustained extensive impact damage at its frontal portion. The impact force was relatively significant, causing its entire front cabin to be buckled and crumpled. Several mechanical parts and components at the frontal portion were also severely damaged as a result of the accident.
6. The dashboard, steering wheel, seats, floor panel, windshield and roof panel inside the front cabin were all observed to be pushed/buckled inwards, towards the rear of the Motor Lorry. This is consistent to the nature of this accident where the direction of impact onto the Motor Lorry was from the front to the rear direction.

**Photo 1** shows a general view of the frontal portion of the Motor Lorry at the time of my inspection. The Motor Lorry was observed to have sustained extensive impact damage at its frontal portion. The impact force was relatively significant, causing its entire front cabin to be buckled and crumpled.

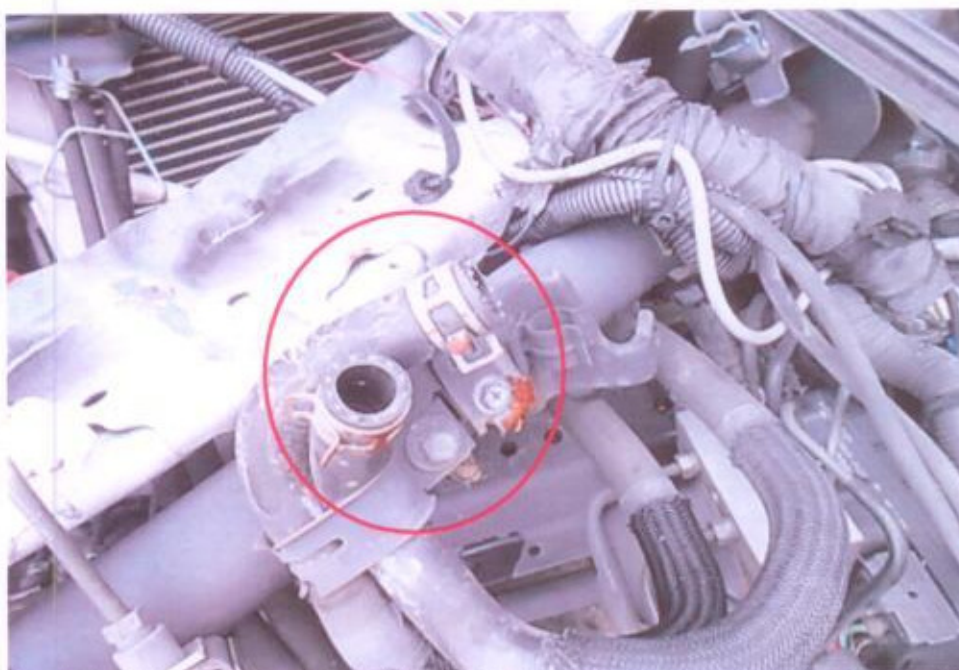
**Photo 2** shows a closer view of the frontal portion (engine) of the Motor Lorry at the time of my inspection. A number of mechanical parts and components at the frontal portion (engine) were also severely damaged as a result of the accident.

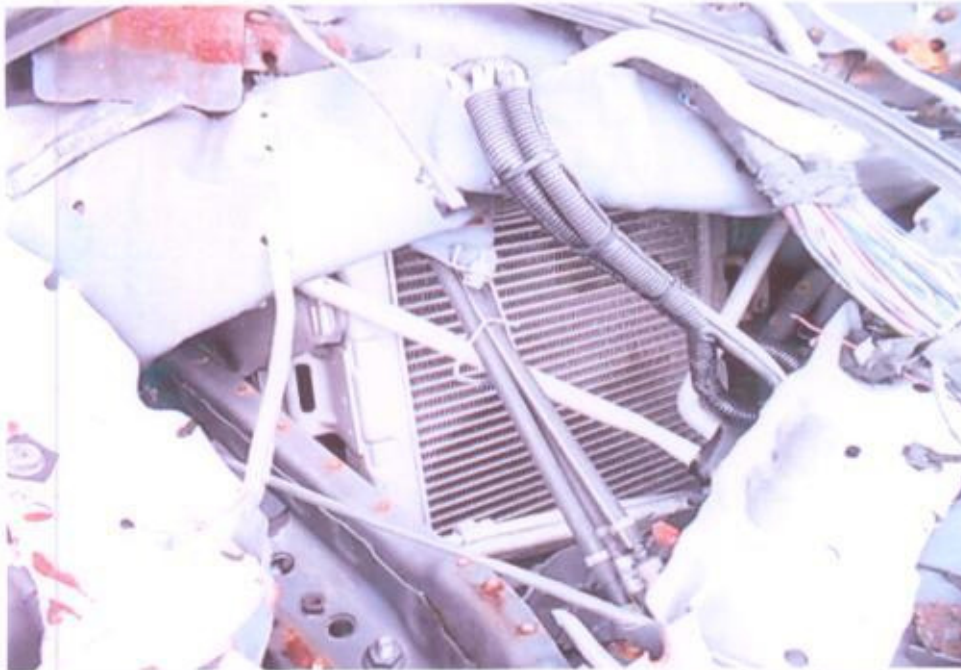
**Photo 3** shows a closer view of the frontal portion (engine) of the Motor Lorry at the time of my inspection. A number of mechanical parts and components at the frontal portion (engine) were also severely damaged as a result of the accident.

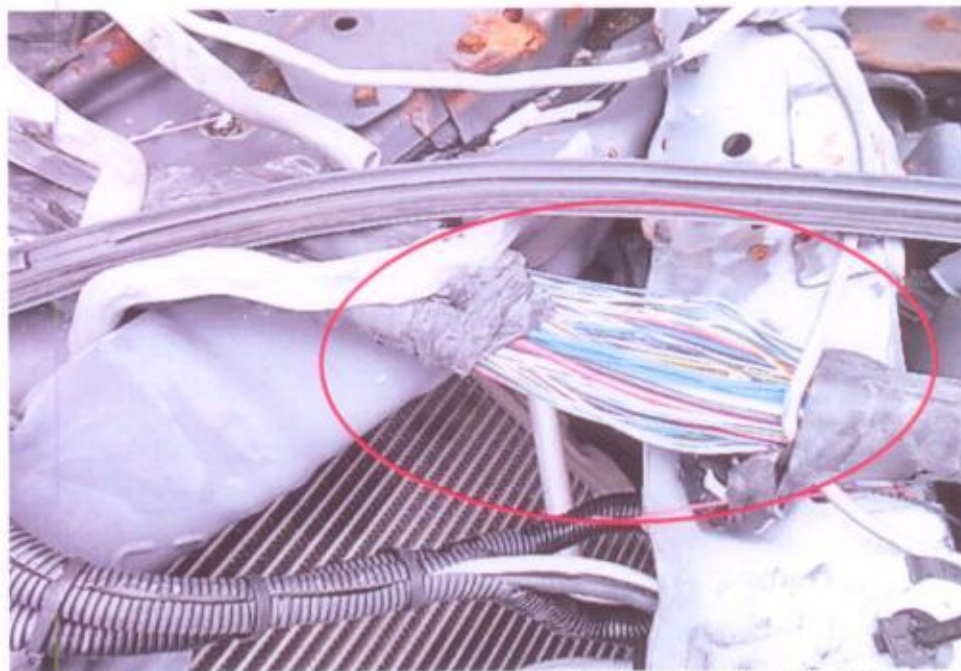
**Photo 4** shows a closer view of the wiring of the Motor Lorry at the time of our inspection. It also sustained damaged as a result of the accident.

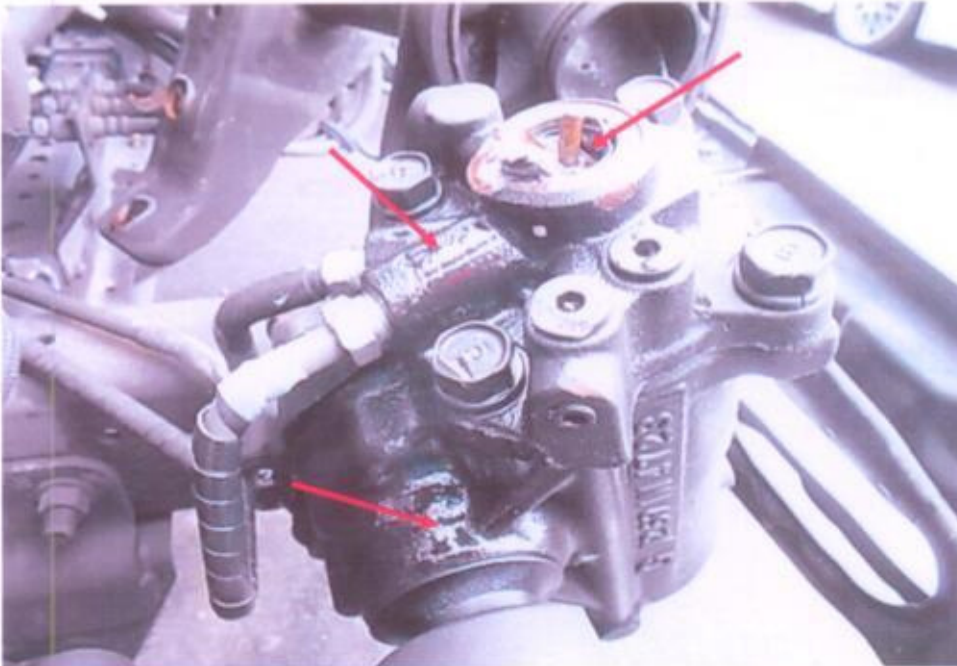
**Photo 5** shows a closer view of the frontal portion of the Motor Lorry at the time of my inspection. A number of mechanical parts and components at the frontal portion were also severely damaged (fluid leakage) as a result of the accident.

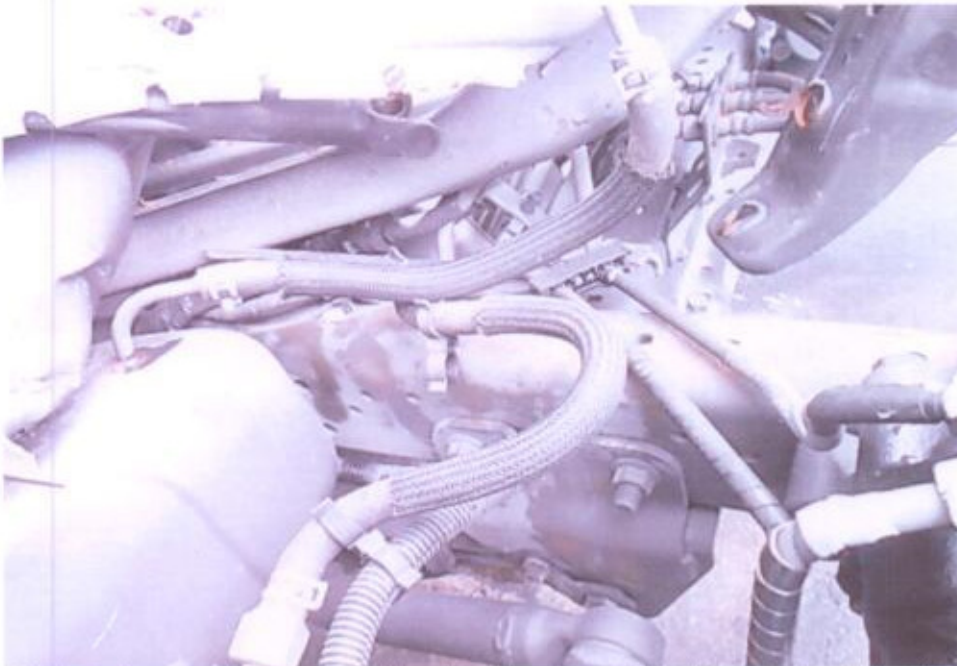
**Photo 6** shows a closer view of the frontal portion of the Motor Lorry at the time of my inspection. A number of mechanical parts and components at the frontal portion were also severely damaged as a result of the accident.

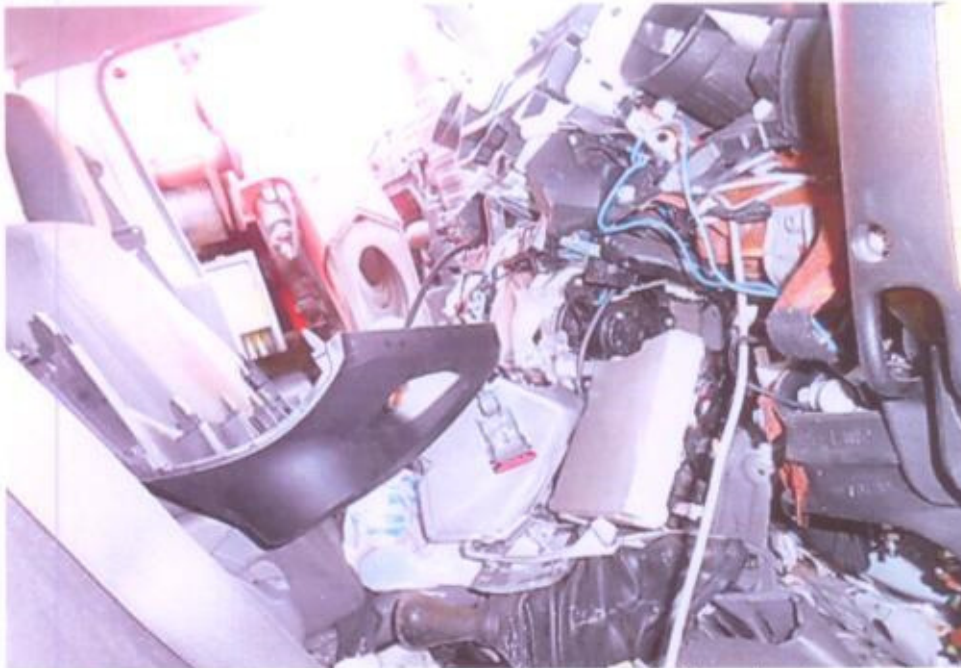
**Photo 7** shows the interior of the front cabin. The dashboard, steering wheel, seats, floor panel and roof panel inside the front cabin were all observed to be pushed/buckled inwards, towards the rear of the Motor Lorry. This is consistent to the nature of this accident where the direction of impact onto the Motor Lorry was from a front to rear direction.

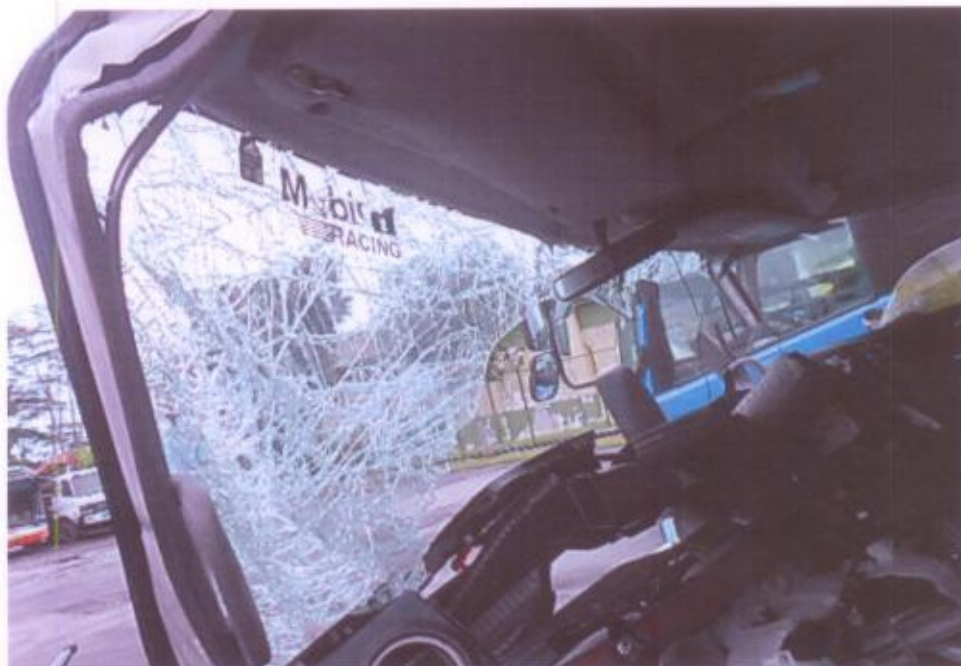
**Photo 8** shows the interior of the front cabin. The windshield was observed to be cracked due to the accident.

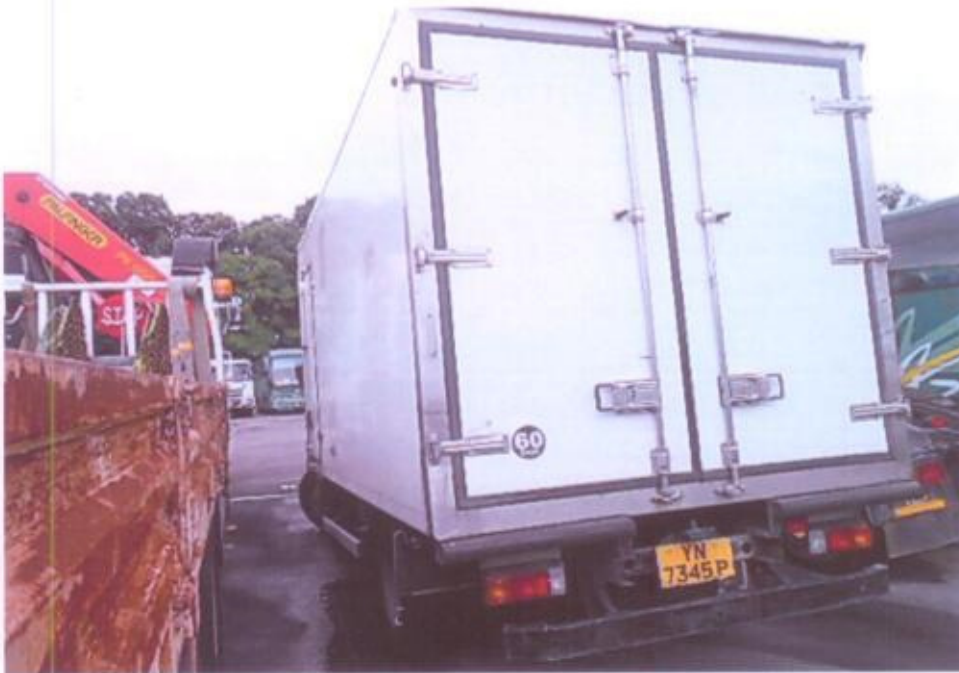
**Photo 9** shows a general view of the rear left portion of the Motor Lorry at the time of my inspection. The rear portion was observed to be relatively unaffected by the accident.

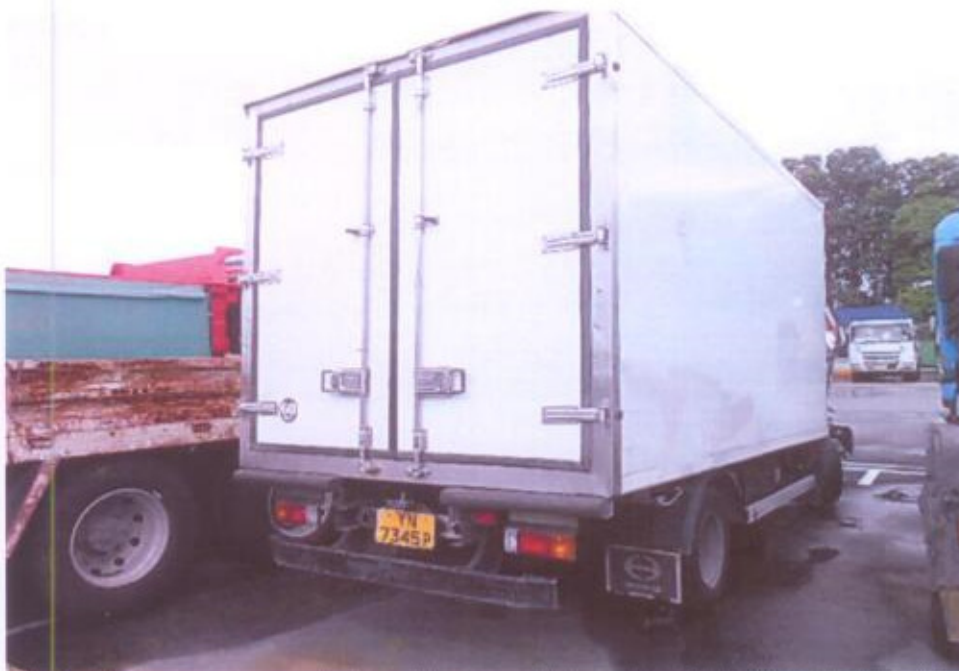
**Photo 10** shows a general view of the rear right portion of the Motor Lorry at the time of my inspection. The rear portion was observed to be relatively unaffected by the accident.

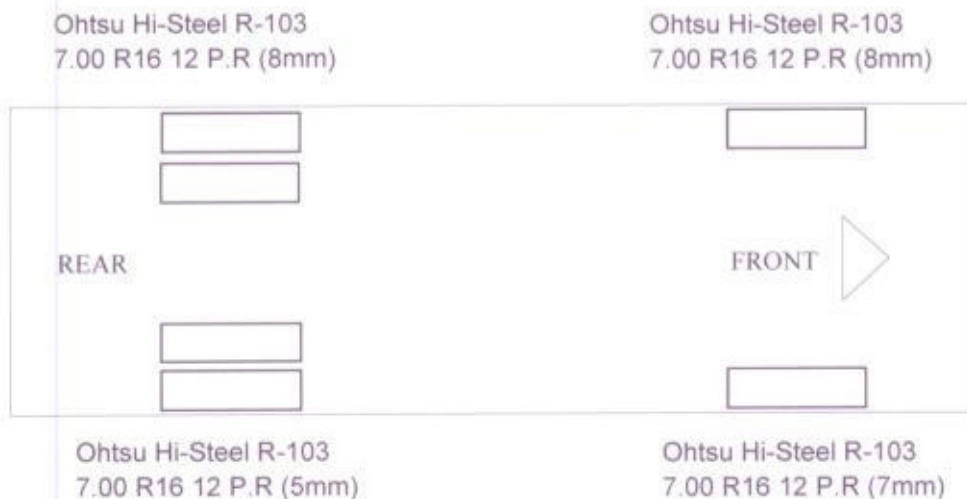
7. The 2 front tyres and 4 rear tyres of the Motor Lorry were observed to be in serviceable condition and sufficiently inflated for vehicular operation. We did not find any tear, cut or burst mark(s) on the outer and the inner sidewalls as well as across the tread of the 6 tyres. The tyre brand, tyre size and remaining tread depth of the 6 tyres were recorded as follows:-

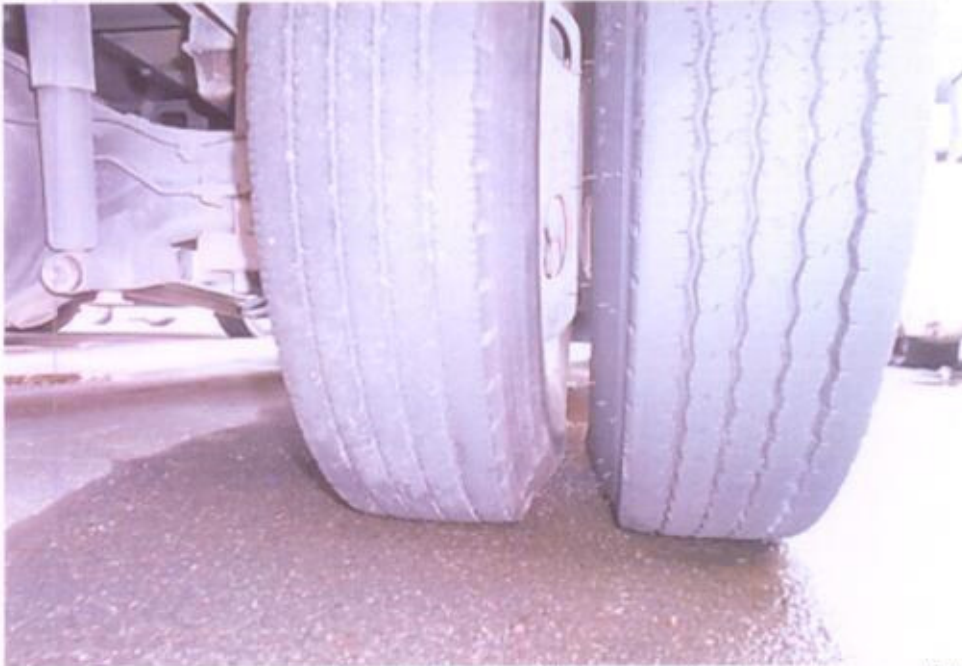
**Photo 11** shows the condition of the rear right tyres of the Motor Lorry, which was observed to be in serviceable condition with remaining tread depth of approximately 5mm.

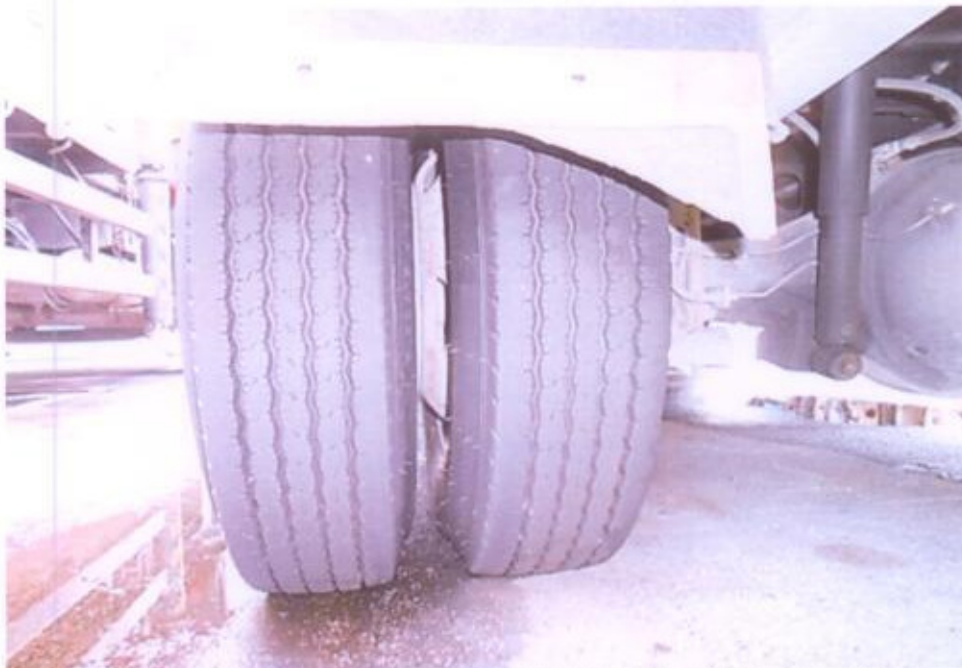
**Photo 12** shows the condition of the rear left tyres of the Motor Lorry, which was observed to be in serviceable condition with remaining tread depth of approximately 8mm. There was no tear, cut or burst mark(s) on the outer and the inner sidewalls as well as across the tread of these 2 tyres, which were also observed to be sufficiently inflated for vehicular operation.

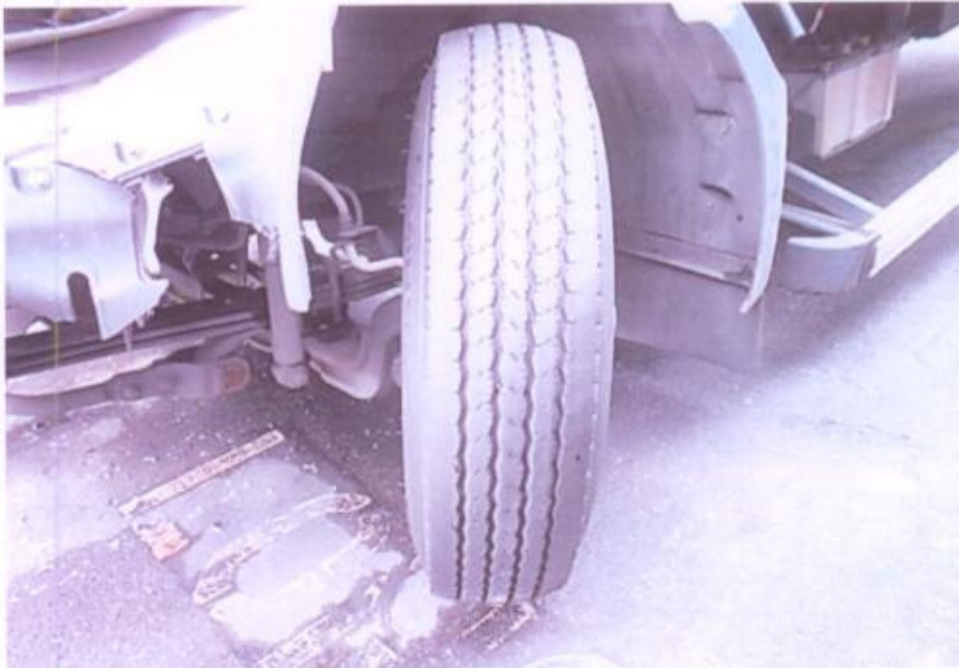
**Photo 13** shows the condition of the front left tyre of the Motor Lorry, which was observed to be in serviceable condition with remaining tread depth of approximately 8mm. There was also no tear, cut or burst mark(s) on the outer and the inner sidewalls as well as across the tread of this tyre.

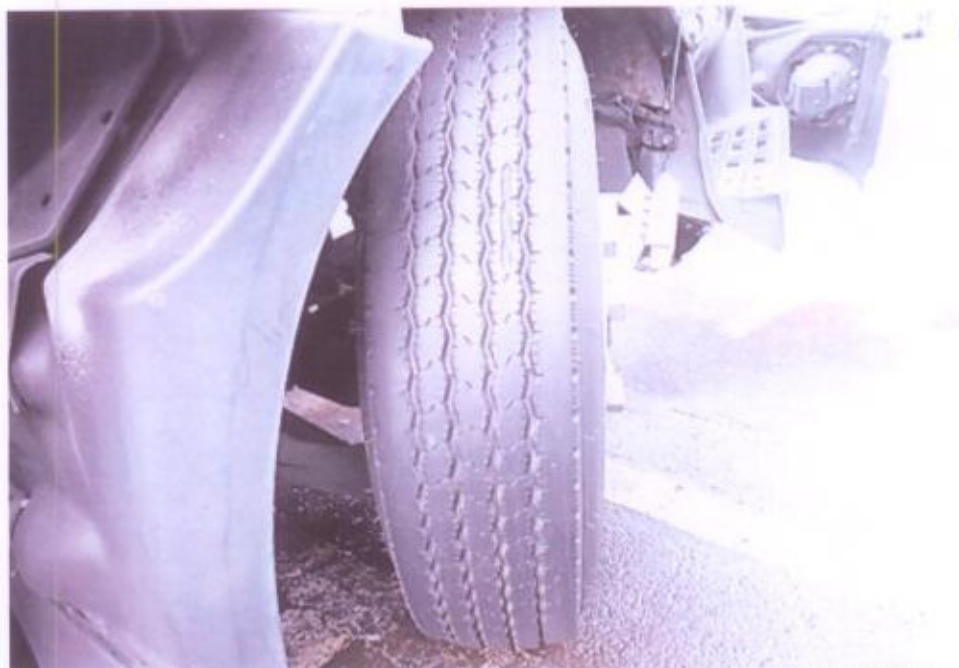
**Photo 14** shows the condition of the front right tyre of the Motor Lorry. The front right tyre was observed to be in serviceable condition with remaining tread depth of approximately 7mm. There was also no tear, cut or burst mark(s) on the outer and the inner sidewalls as well as across the tread of this tyre. The tyre, which was wrapped around alloy wheel rim, was also observed to be sufficiently inflated for vehicular operation.

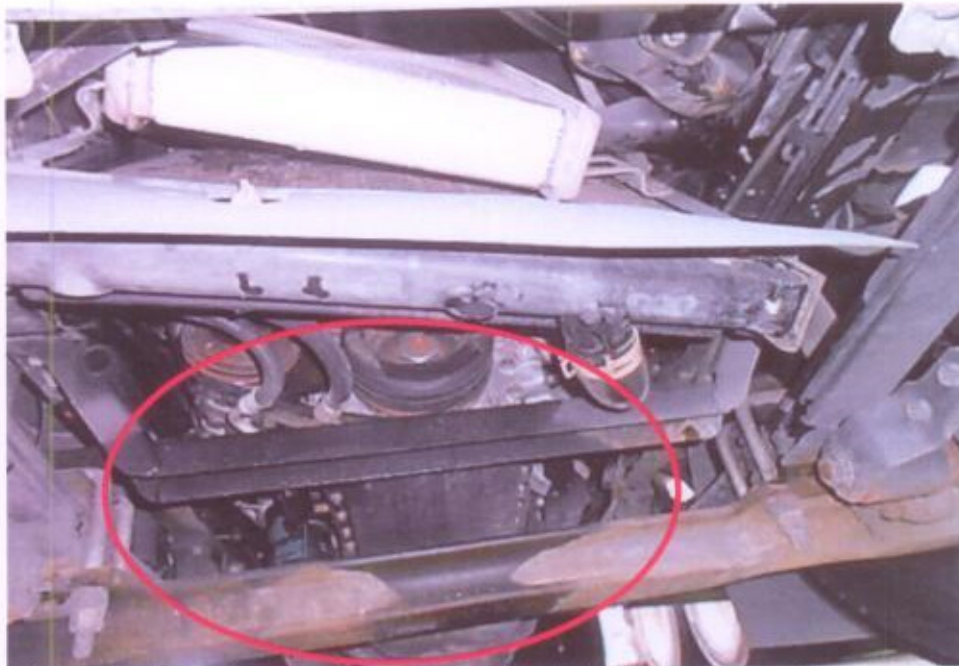
9. The engine compartment of the Motor Lorry, which was located beneath the front cabin, could not be closely inspected given the extensive damage to the front cabin. My visual checks from the underside of the Motor Lorry had however appear to indicate that the engine assembly and transmission assembly were both damaged by the collision. There was also a fresh fluid stains covering the engine underside, indicating fluid leakage that had occurred due to the accident's impact.

**Photo 15** shows that there was also a fresh fluid stains covering the engine underside, indicating fluid leakage that had occurred due to the accident's impact.

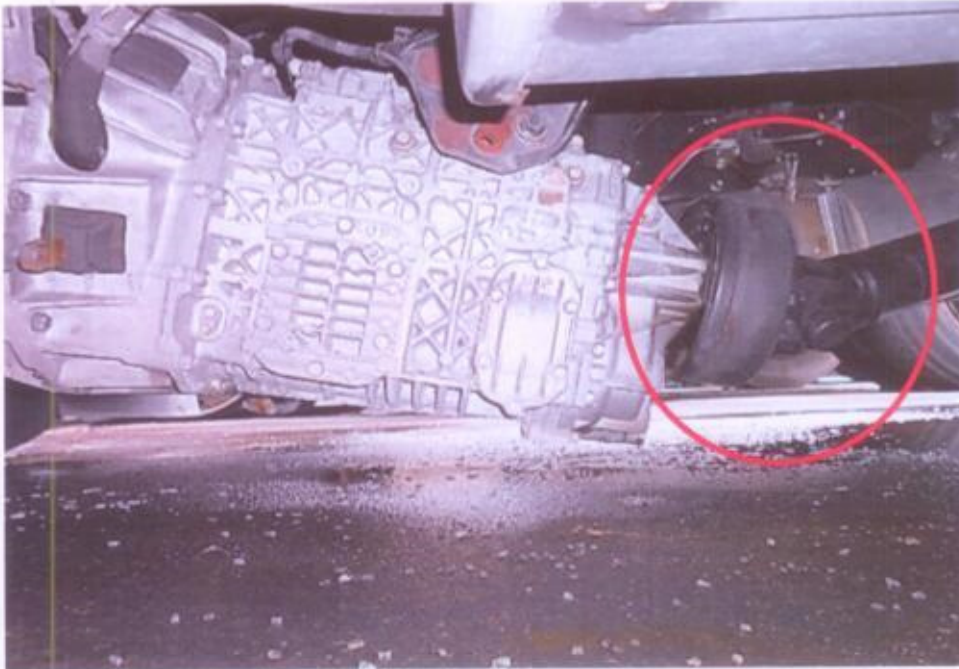
**Photo 16** shows the transmission assembly (circled) of the Motor Lorry was observed to be bent due to the accident's collision.

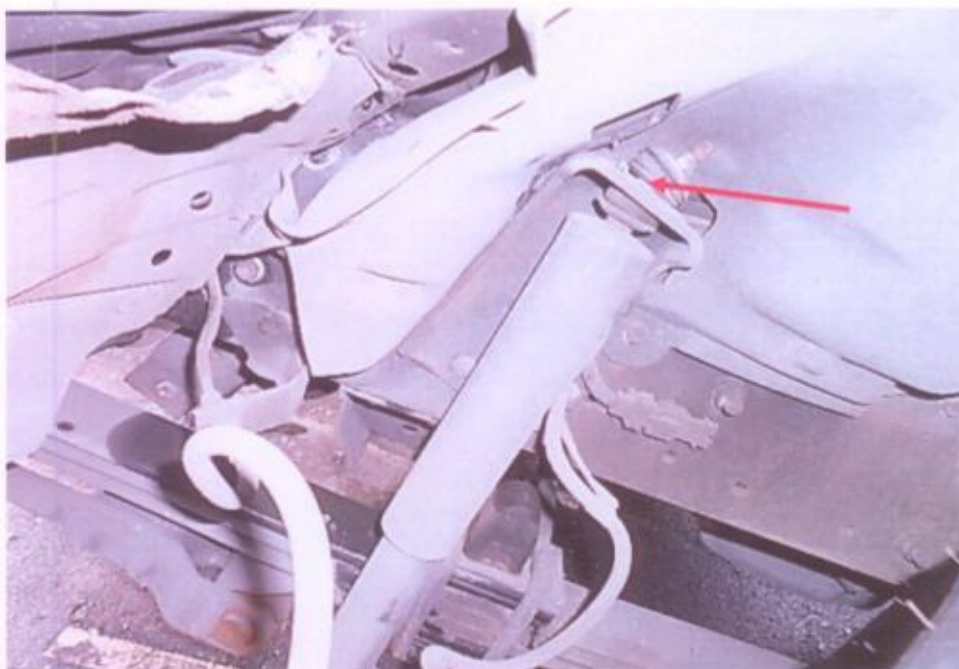
**Photo 17** shows the damaged shock absorber (red arrow) of the Motor Lorry. Hence, we were not able to conduct any tests on the steering system of the Motor Lorry.

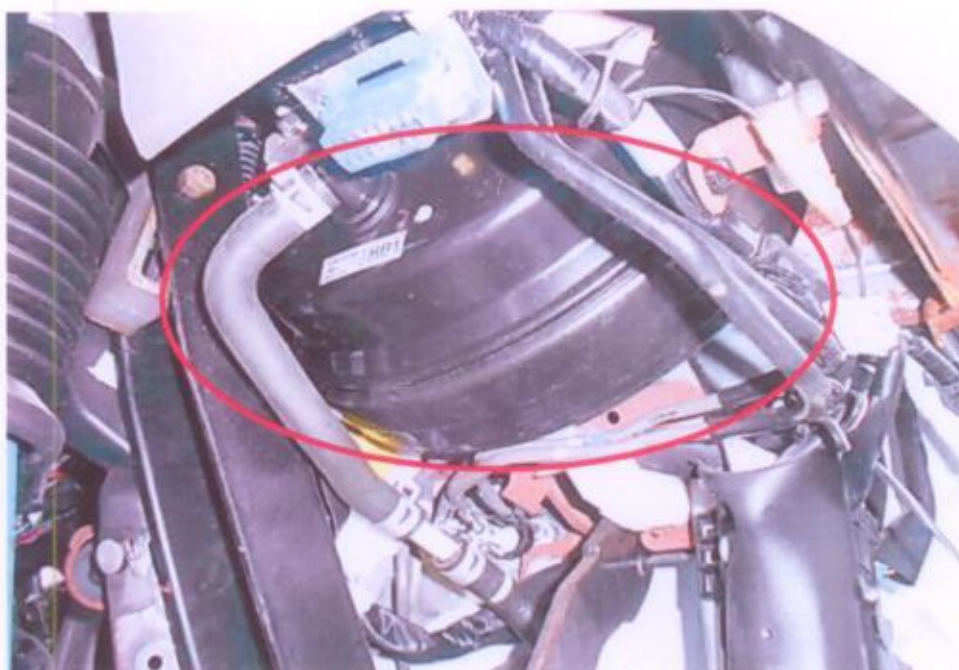
**Photo 18** shows the damaged brake booster due to the accident's impact.

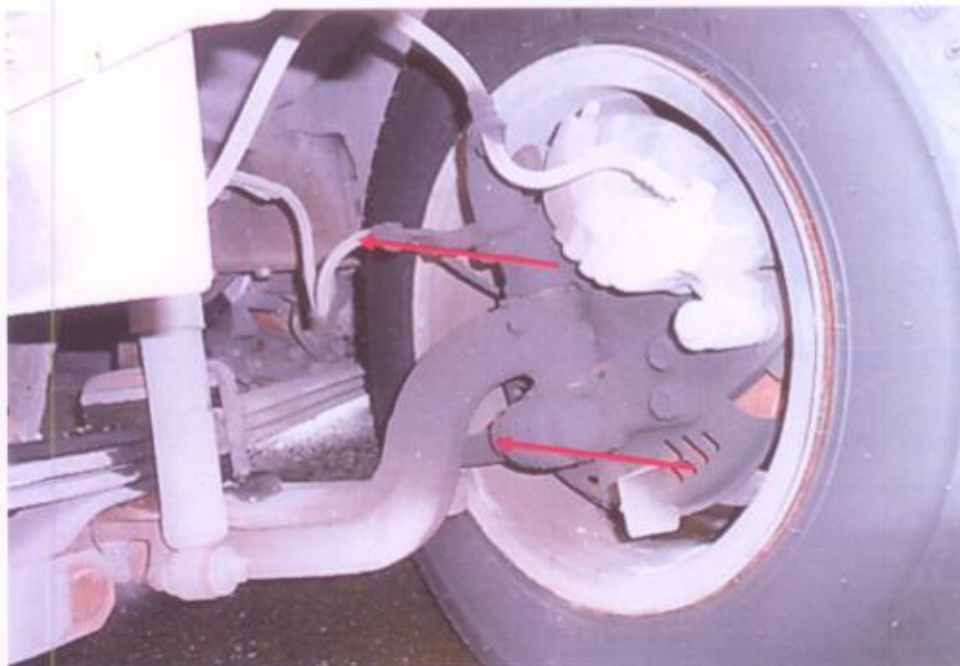
**Photo 19** shows the unaffected mechanical components on the front left wheel of the steering system. The steering shaft and steering rack of the Motor Lorry were observed to be intact and securely attached to the front left wheel. No fluid leakage on the brake fluid hoses.

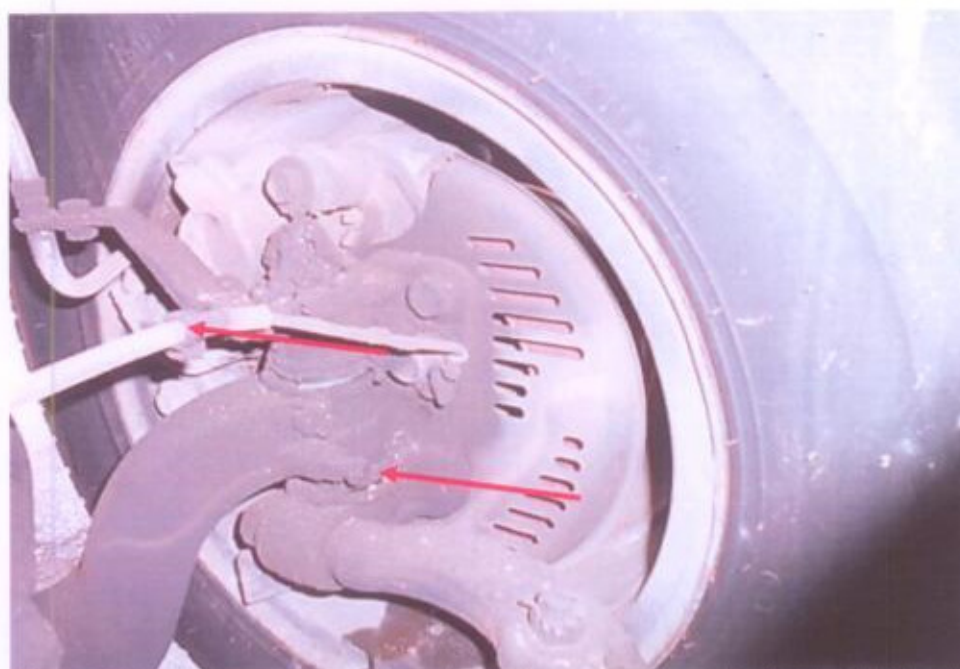
**Photo 20** shows the unaffected mechanical components on the front right wheel of the steering system. The steering shaft and steering rack of the Motor Lorry were observed to be intact and securely attached to the front left wheel. No fluid leakage on the brake fluid hoses.

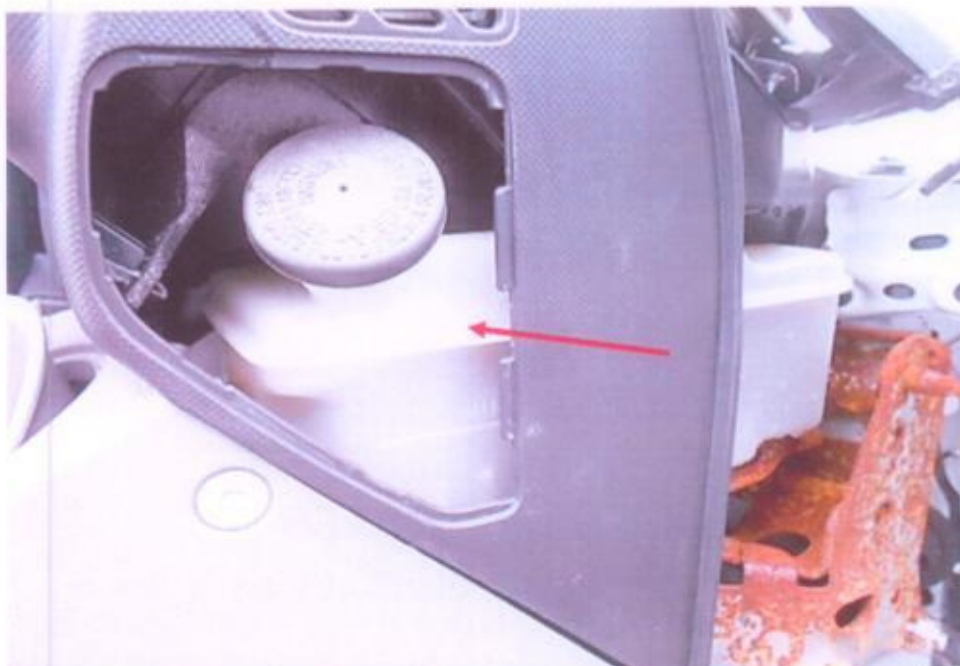
10. With regard to the operating fluids, we was only able to inspect the brake fluid. The power steering fluid, engine oil and engine coolant were inaccessible due to their reservoir tanks and/or dip stick being within the damaged area of the Motor Lorry. For the brake fluid, we had found the brake fluid to be of sufficient level for operational purposes. Visually there was also no contamination found to the brake fluid.

**Photo 21** shows the brake fluid reservoir of the Motor Lorry. I had found the brake fluid to be of sufficient level for operational purposes. Visually there was also no contamination found to the brake fluid.

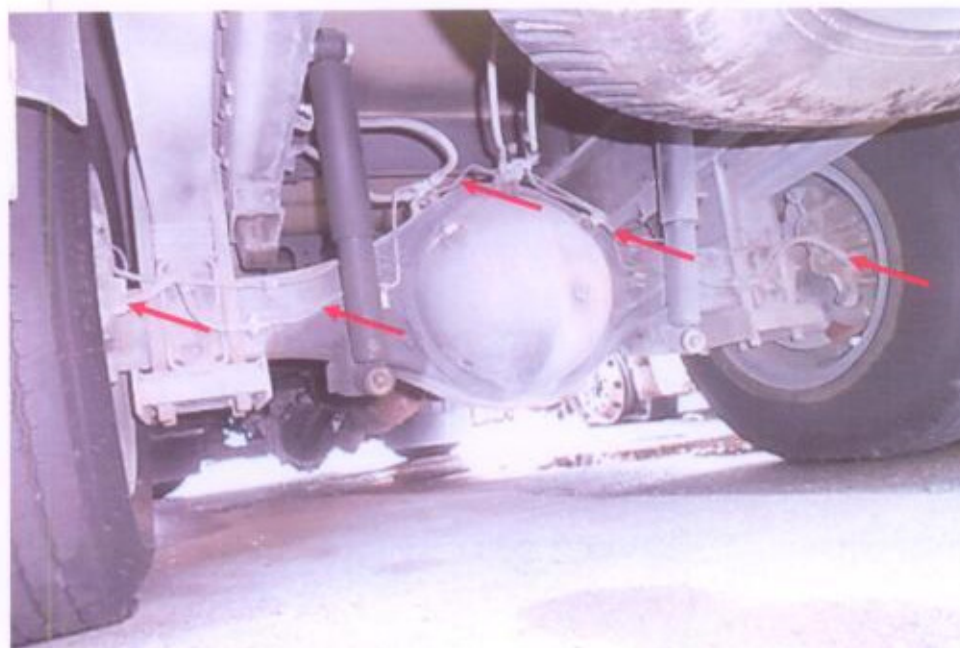
**Photo 22** shows the brake pipes and hoses, which were visibly unaffected by the accident. I was however not able to carry out any operational tests to the braking system of the Motor Lorry due to the extent of damage to its front cabin, which had affected several mechanical components of the braking system like the brake booster and brake pedal amongst others.

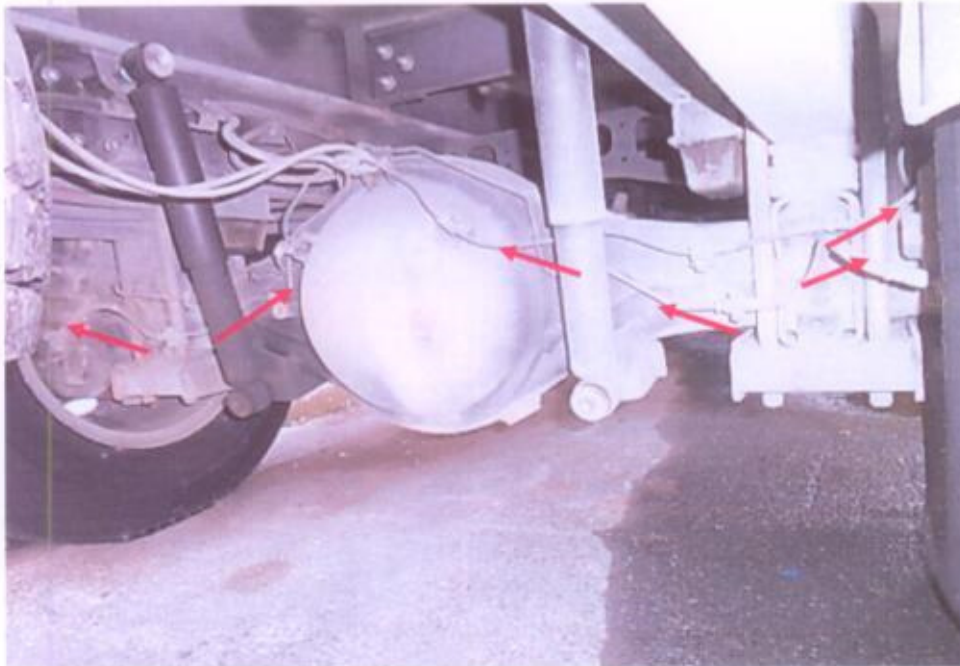
**Photo 23** shows the brake pipes and hoses, which were visibly unaffected by the accident. I was however not able to carry out any operational tests to the braking system of the Motor Lorry due to the extent of damage to its front cabin, which had affected several mechanical components of the braking system like the brake booster and brake pedal amongst others.

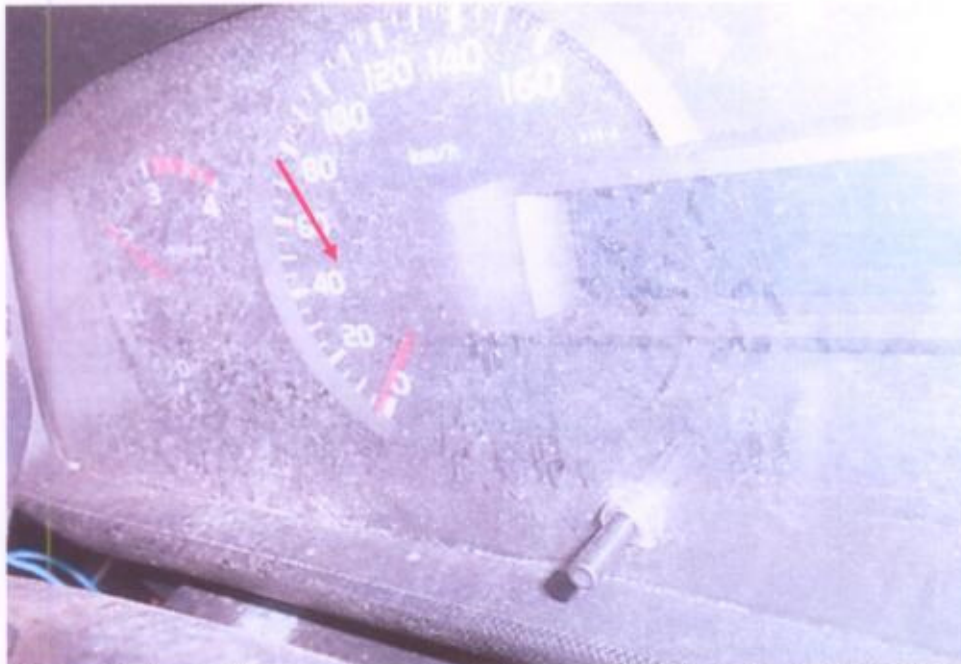
**Photo 24** shows the speedo meter that was observed to be not in working condition due to the damages sustained in the ignition system. However, evidence showed that it is in serviceable condition prior the accident. The driver's airbag was activated at the time of the impact.

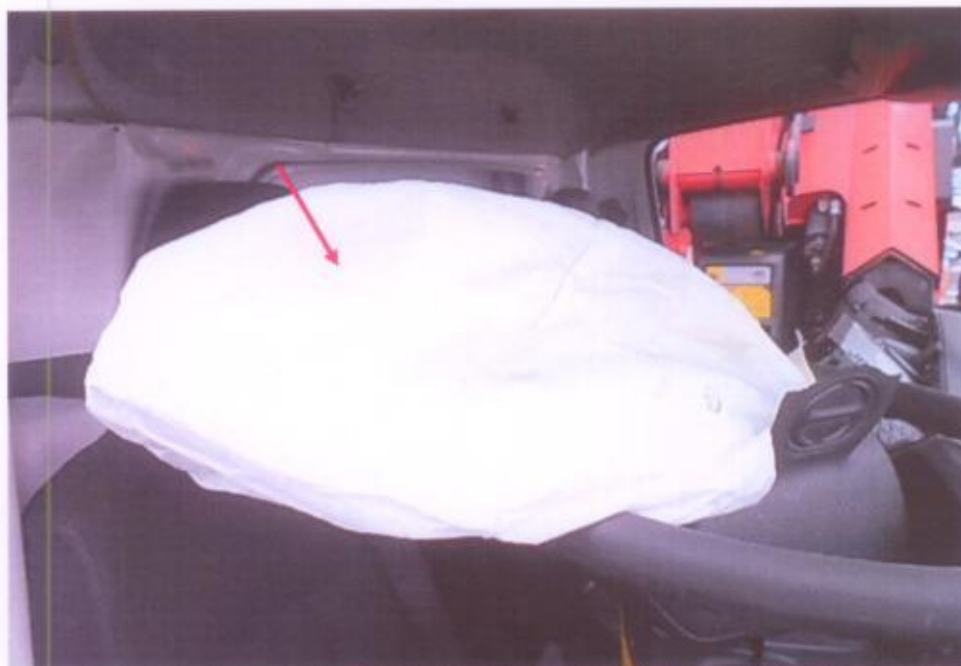
**Photo 25** shows the driver's airbag was activated at the time of the impact.
