**1. Policy Particulars :- THIRD PARTY CLAIM**

| Accident Date | 28/12/2017 | Inspection Date | 04/01/2018 |

3RD PARTY CLAIM ESTIMATION

## VEHICLE DAMAGE INSPECTION REPORT

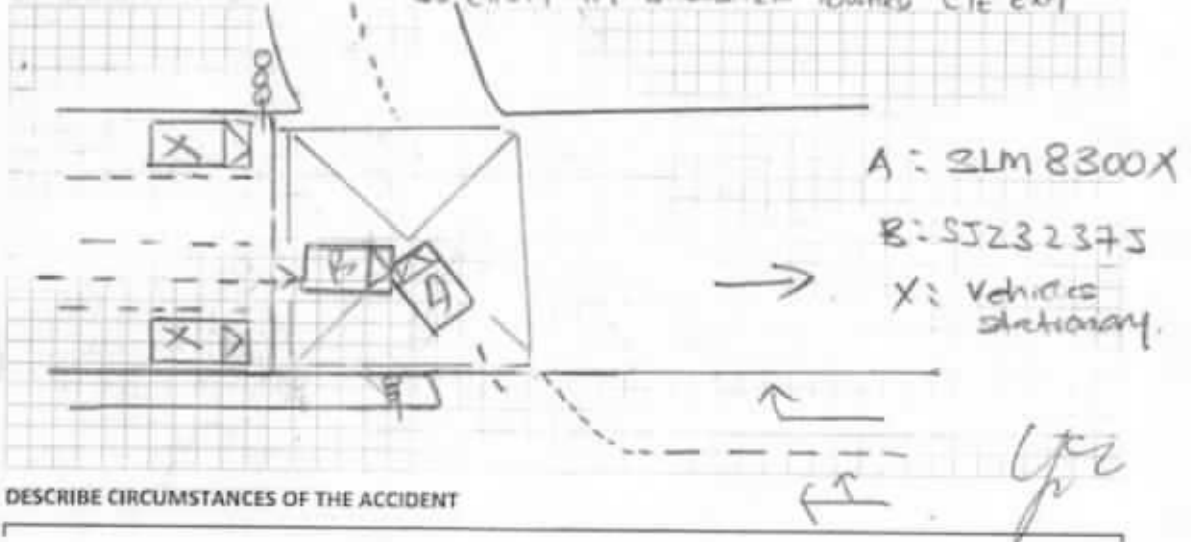
JUNCTION AT BALESTIER TOWARD CTE EX1

My car was travelling along Balestier Road towards CTE. While the traffic light was green in my favor and all the vehicles at the opposite side of the traffic were completely stopped, I make gradually make a right turn towards the slip road of CTE. While my car was in the process of turning, Vehicle B without stopping due to traffic light was red at his direction, travelling in a fast speed beating the red light and hit onto my car left side portion of my car resulting damages and starches along the left side portion of my car.
