Ref : CS3/AIG17010229/vb-1

**1. Policy Particulars :- THIRD PARTY CLAIM (RESURVEY INSPECTION)**

### VEHICLE DAMAGE INSPECTION REPORT

**ADJUSTMENT ON REPAIR COST FOR VEHICLE NO. SLB 8298C**

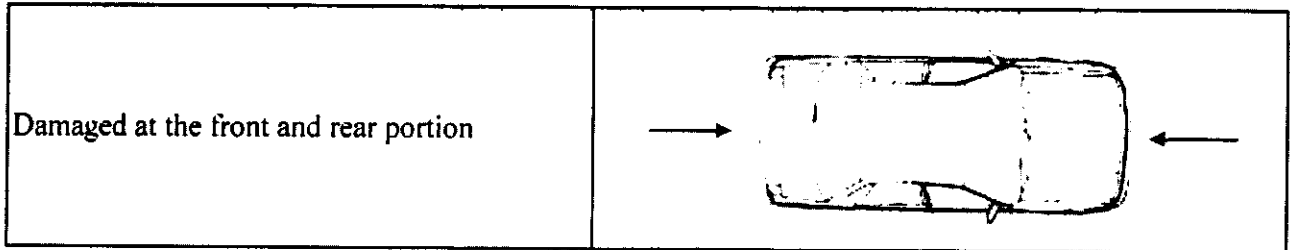
### POINT OF IMPACT

The Insured's vehicle collided onto the Third Party's Vehicle along Havelock towards CTE Expressway.

Our visual inspection of the vehicle revealed that the damages noted are at the front and rear portion.

We have inspected the actual damages found on the vehicle and recommend the replacement of parts and repairs accordingly. The estimated repair cost is \$20,456.70. The repairer has agreed to undertake the repairs at our adjusted lump sum amount of \$13,400.
