REF: NS / INC 18000373 / Svbe2

Veh No: SUC 4628C Yr Regn: 3/9/2019

Make: Toyota Prius c.c 1798

Survey held at SMART

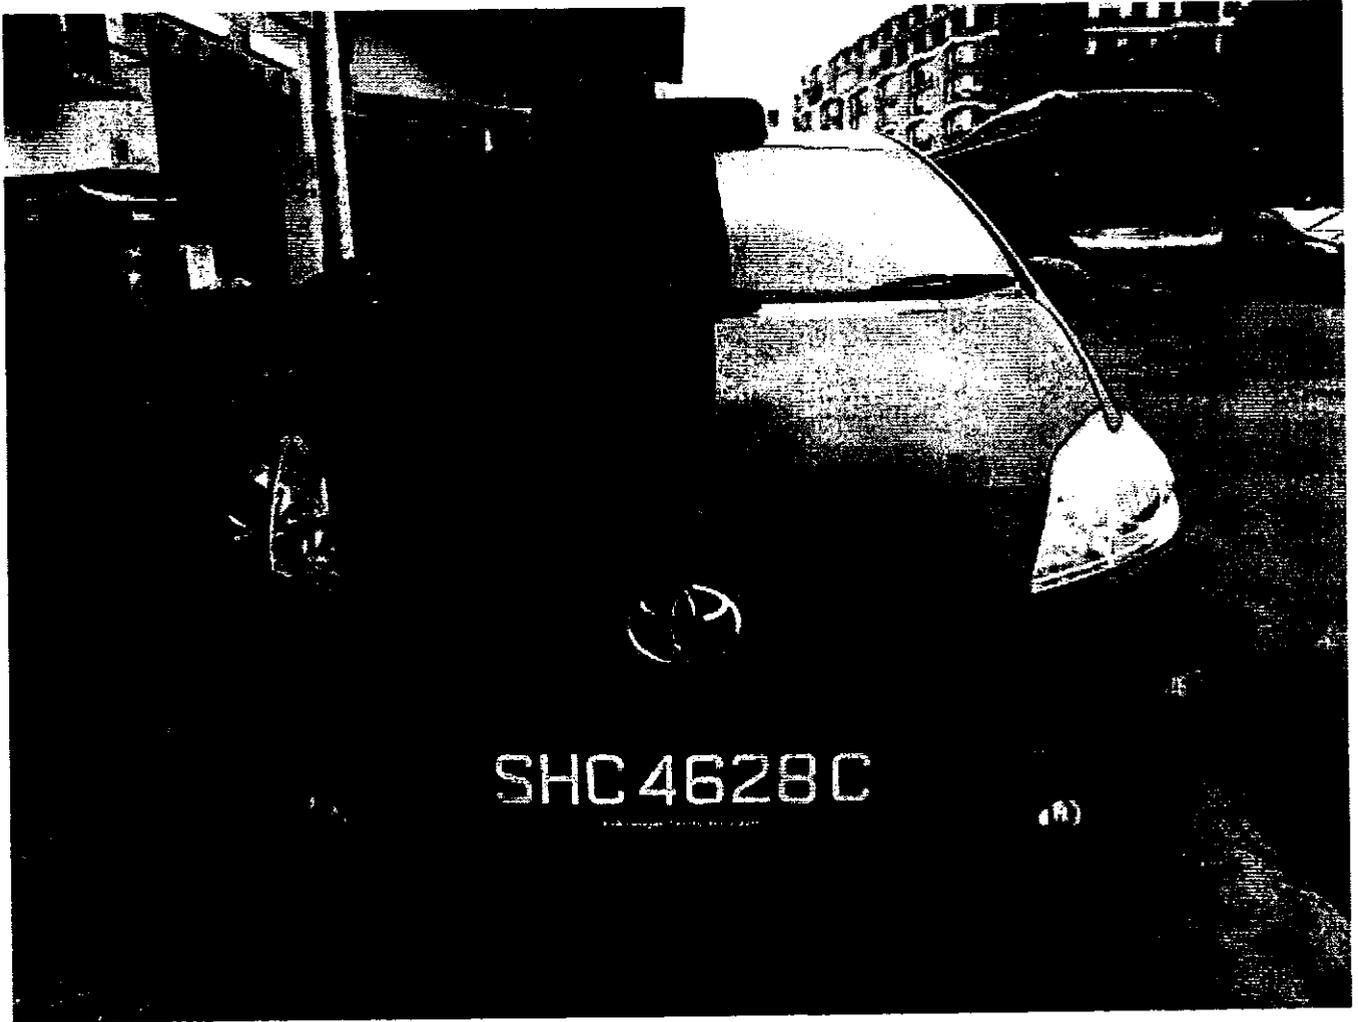
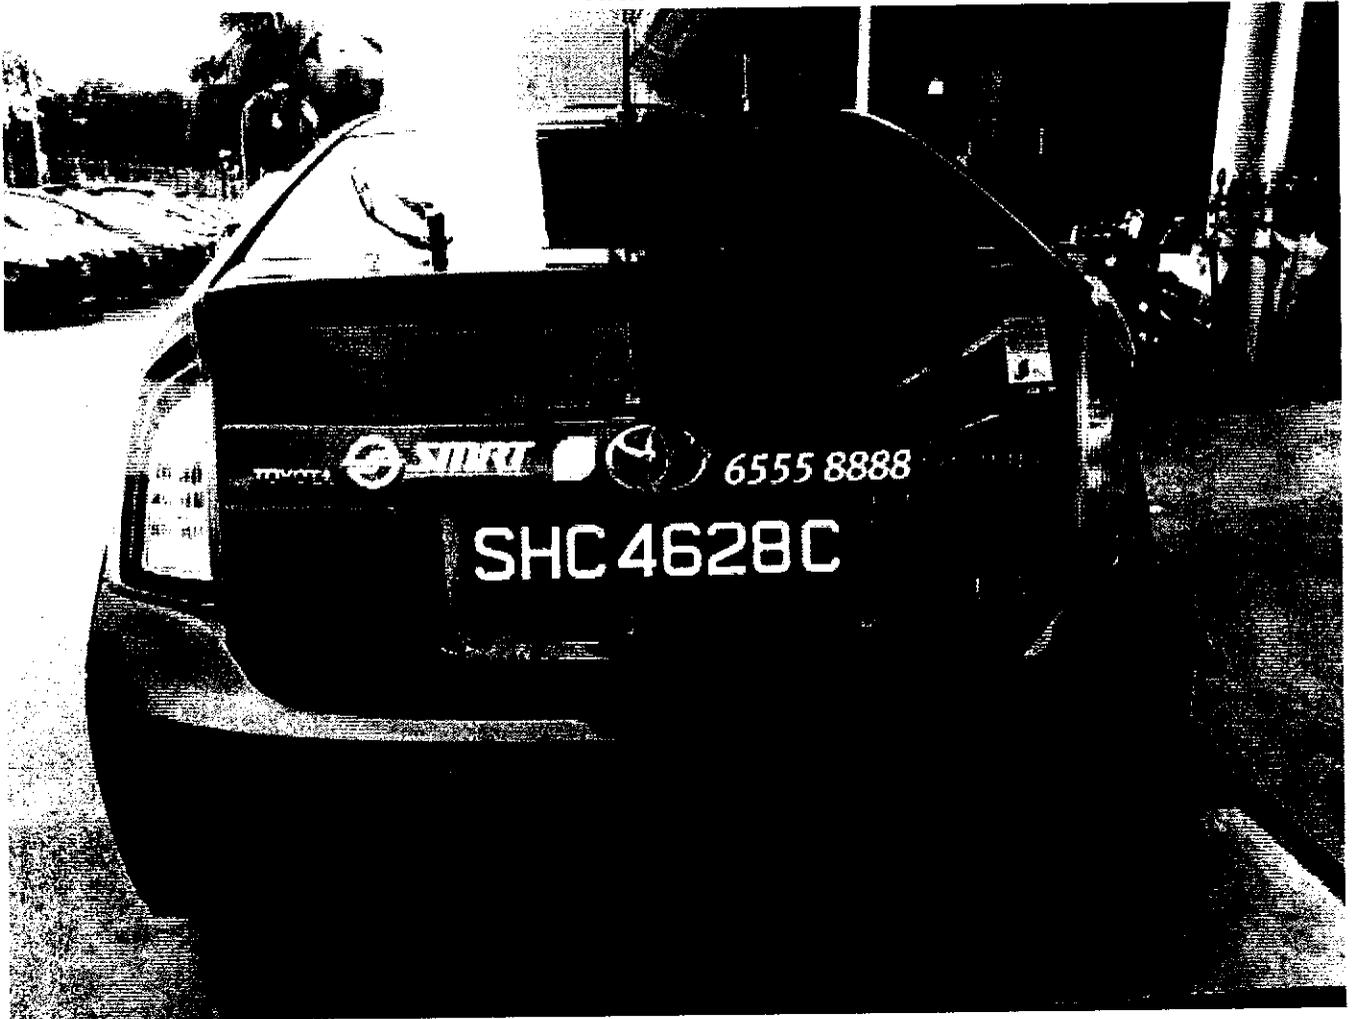
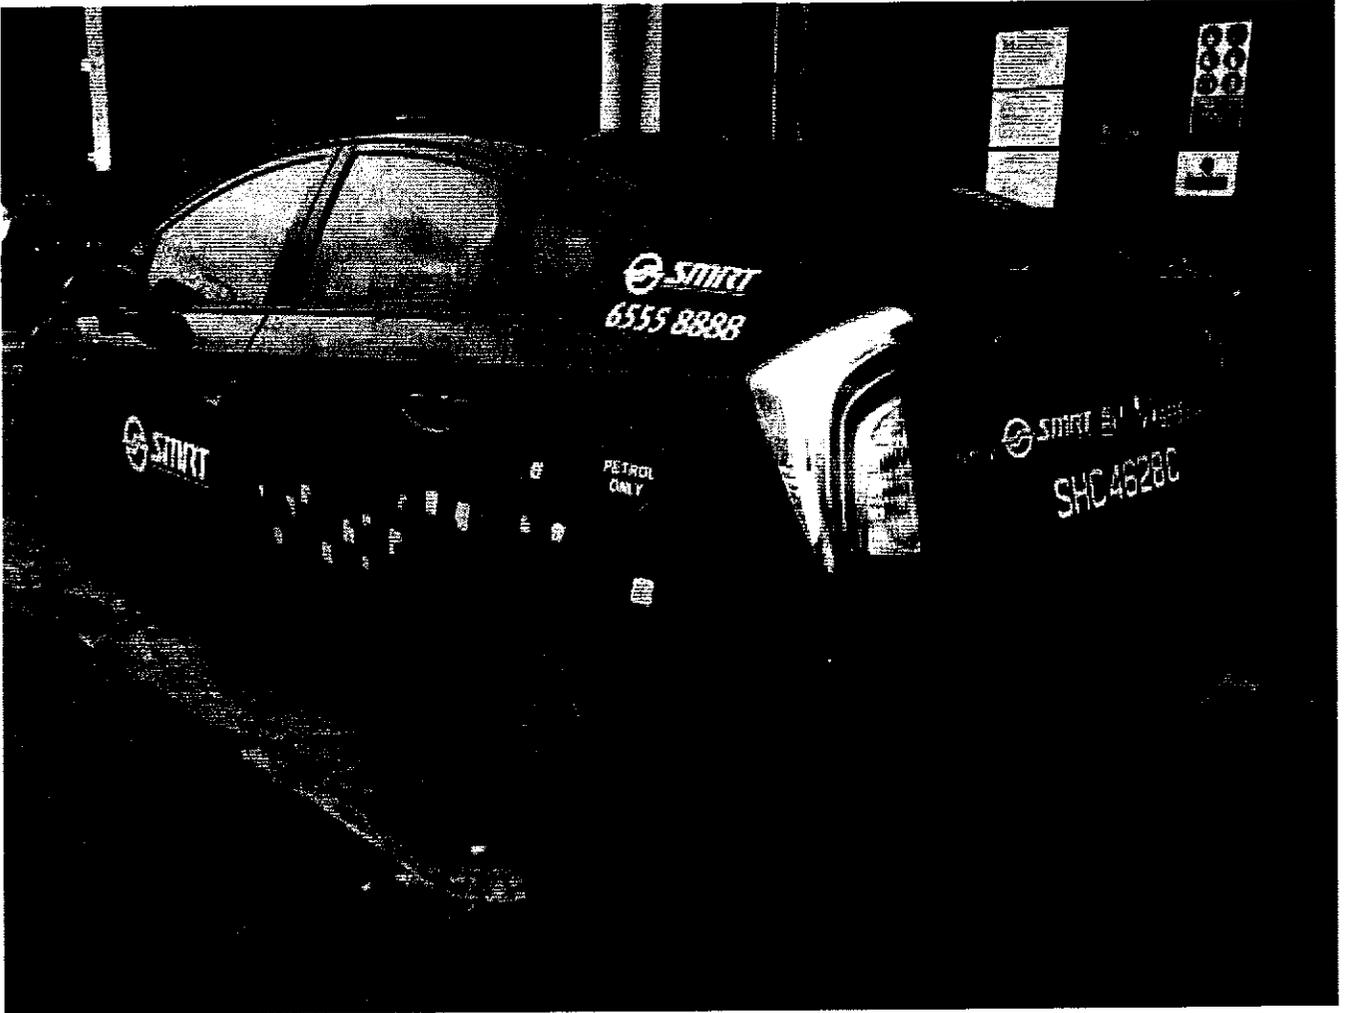
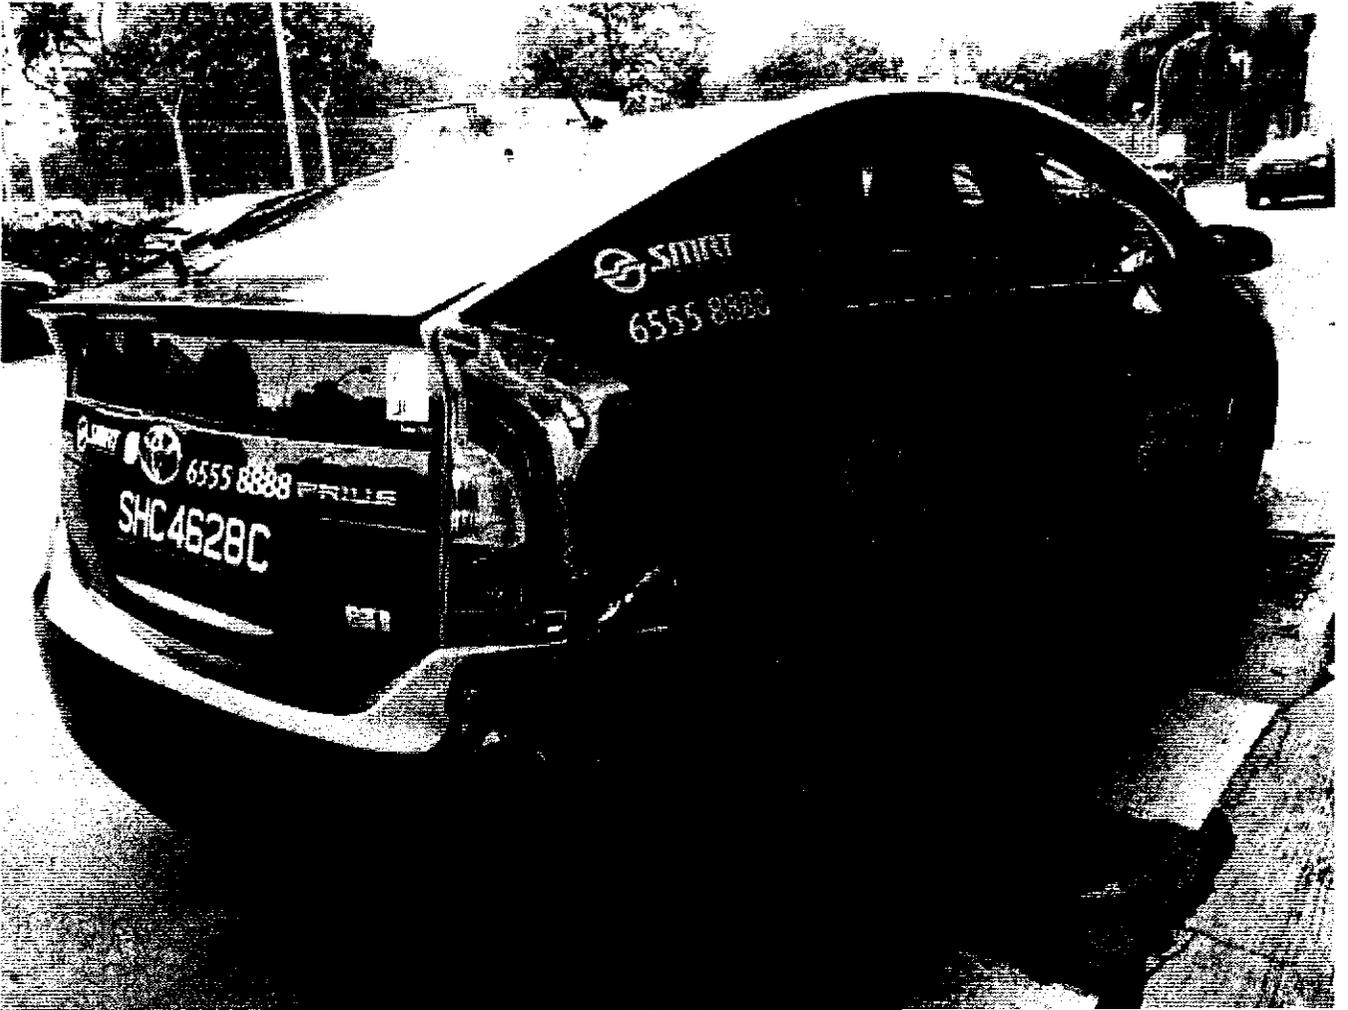
Rear O/S

The UIC / Chassis frame / Body Structure affected due to collision.

THE VEHICLE SUSTAINED DAMAGES AT THE REAR O/S PORTION.
DAMAGES SEE DETAILS.

Qty	Description of Parts	Condition	Estimate By Workshop (\$)	Our Adjusted (\$)
REPLACEMENT OF PARTS				
1	BUMPER REAR (DISC 25%)	CRACKED	458.60	343.95
1	BUMPER SIDE RETAINER RR/RH (DISC 25%)	CRACKED	94.80	71.10
1	FENDER RR/RH (DISC 25%)	BENT	766.80	575.10
1	QUARTER GLASS RR/RH (DISC 25%)	NECESSARY	846.50	634.87
1	DUCT ASSY, QUARTER (DISC 25%)	DEFORMED	70.40	52.80
1	TROUGH, BACK DOOR (DISC 25%)	DENTED	110.90	83.17
1	TAIL LAMP BRACKET, RH (DISC 25%)	CRACKED	30.70	23.02
1	TAIL LAMP RH (DISC 10%)	CRACKED	557.80	502.02
2	PIXEL STICKER @\$60.00 (SN)	NECESSARY	120.00	120.00
1	STICKER DECAL SMRT (SN)	NECESSARY	7.80	7.80
1	STICKER DECAL 6555 8888 (SN)	NECESSARY	21.60	21.60
1	SEALANT SIKAFLEX (SN)	NECESSARY	37.00	37.00
1	SENSOR REVERSE	NOT NECESSARY	180.00	-
1	BUMPER REINFORCEMENT REAR	NOT NECESSARY	205.70	-
1	ARM SUB-ASSY, RR BUMPER RH	NOT NECESSARY	139.60	-
1	END PANEL	NOT NECESSARY	602.10	-
1	BUMPER SEAL, RR RH	NOT NECESSARY	65.70	-
