## VEHICLE APPRAISAL REPORT

Our Reference: TP15-078052-AE  
 Your Reference: -  
 Vehicle Number: SGY7099E

**EVALUATION REPORT (PAPER SURVEY) OF ACCIDENT VEHICLE NO:**  
**SGY 7099E**  
**INSURED VEHICLE: W 3232Q**  
**ACCIDENT DATE: 27/07/2015**

## ADJUSTMENT ON REPAIR COST FOR VEHICLE NO. SGY 7099E

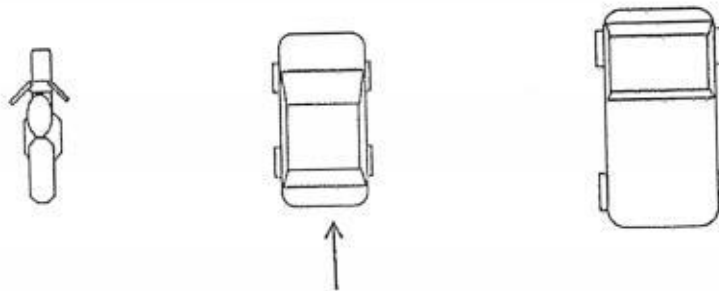
At the time of inspection, this vehicle sustained damages to the **rear portion**. Please see attached scheduled details.

We have not authorised repair. Under normal circumstances, estimated **18 working days** are required to repair the vehicle.
