Your Ref: TP/IP/29951/2017
Our Ref : CI/TPD18000508/Z

09th January 2018

MECHANICAL INSPECTION REPORT OF PRIME MOVER XE 1469P

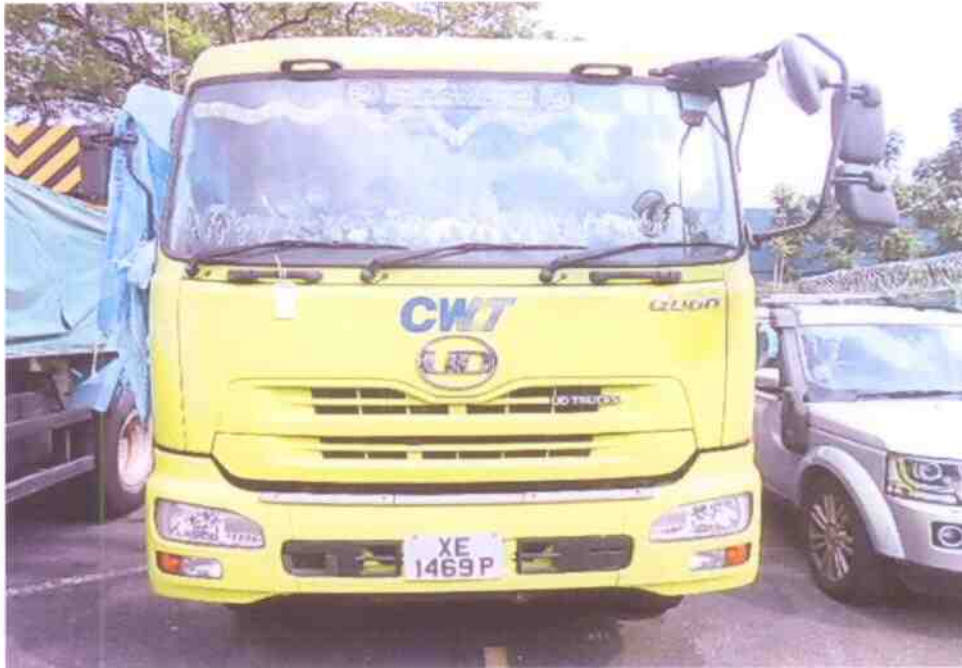
4. The mileage of the Prime Mover at the time of our inspection was not recorded as its engine could not be started due to a flat battery.
5. The Prime Mover was observed to have sustained relatively minor impact damage at its left front body. Its front left lower bumper was observed to be slightly scratched. See photo 1 – 3 below.

Photo 1 shows a general view of the front portion of the Prime Mover at the time of our inspection. The Prime Mover was observed to have sustained relatively minor damage at its front body.

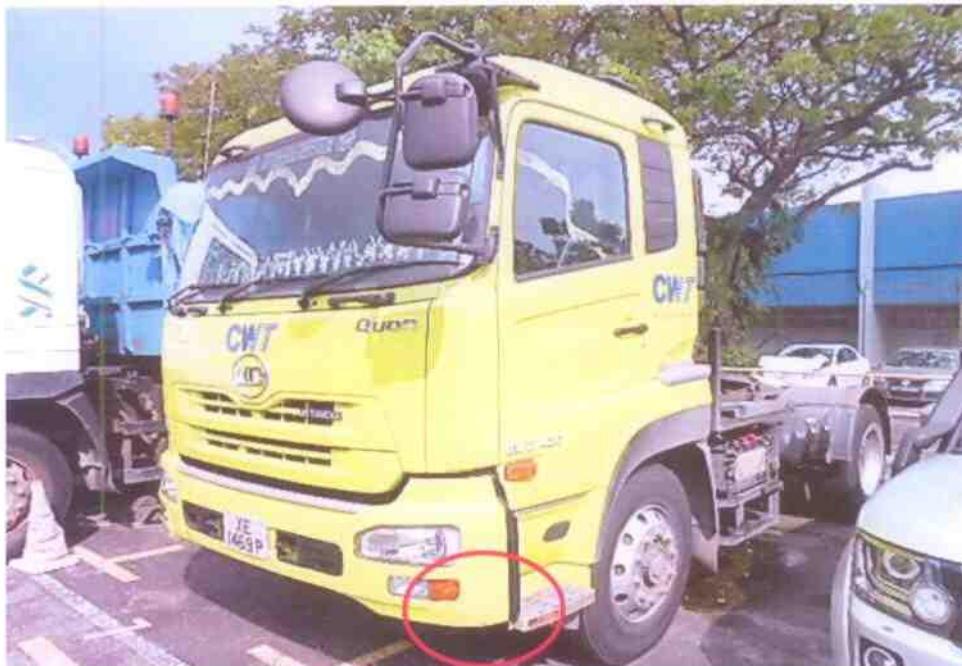
Photo 2 shows a general view of the front left body of the Prime Mover at the time of our inspection. The Prime Mover was observed to have sustained relatively minor damage at its left front lower bumper (circled).

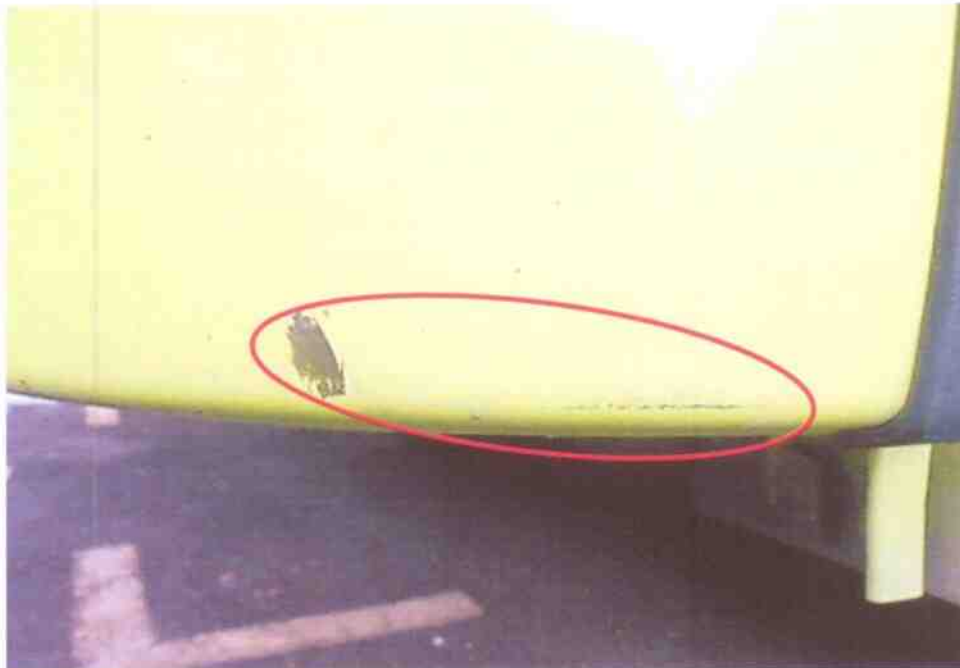
Photo 3 shows a closer view of the minor scratches on the left front lower bumper of the Prime Mover.

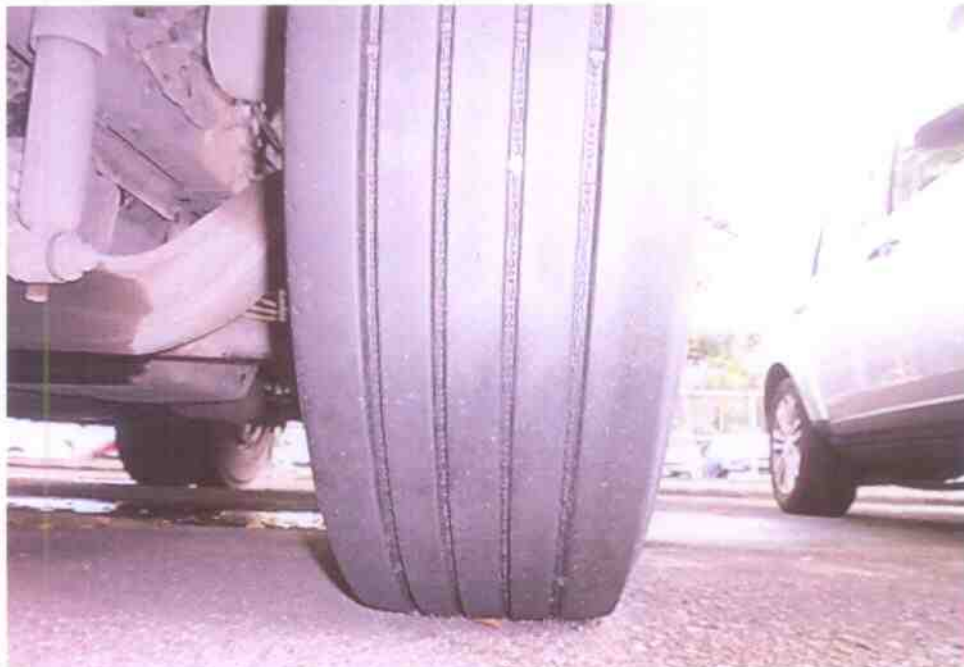
Photo 4 shows the condition of the front left tyre of the Prime Mover, which was observed to be in serviceable condition with remaining tread depth of approximately 8mm.

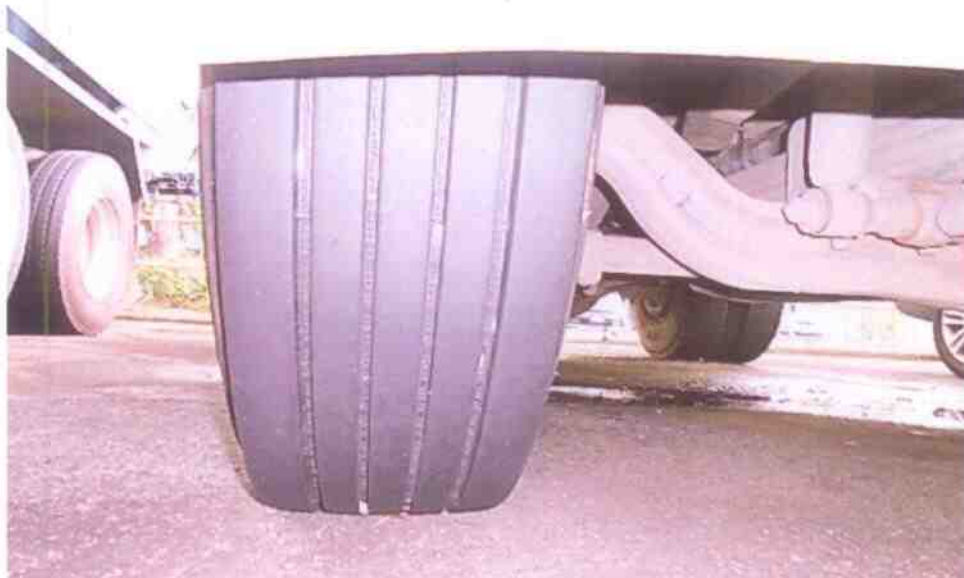
Photo 5 shows the condition of the front right tyre of the Prime Mover, which was observed to be in serviceable condition with remaining tread depth of approximately 8mm.

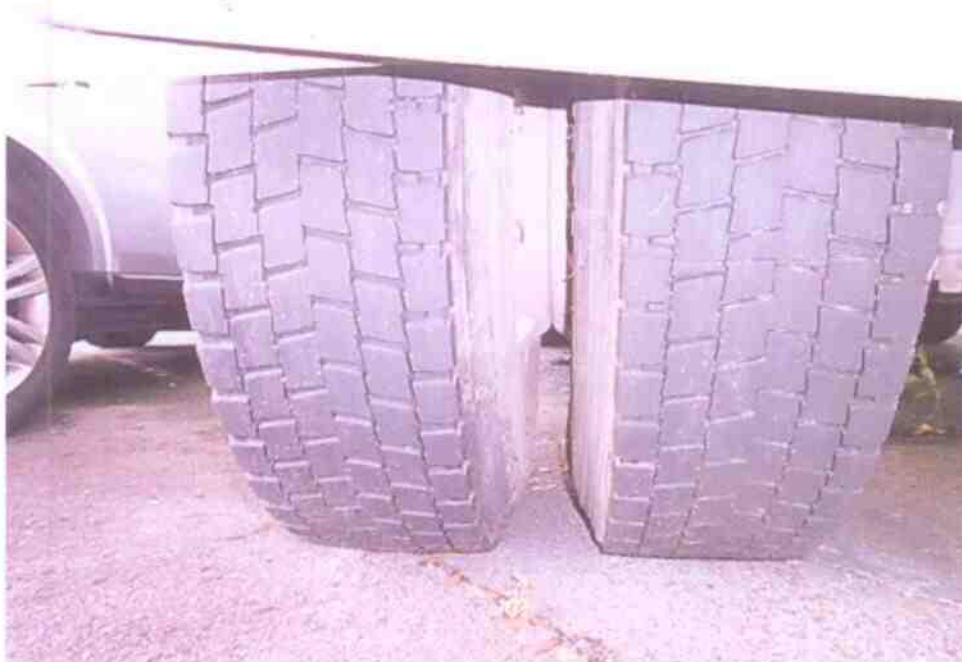
Photo 6 shows the condition of the rear left tyres of the Prime Mover, which were observed to be in serviceable condition with remaining tread depth of approximately 4mm. The tyres were also observed to be sufficiently inflated for vehicular operation.

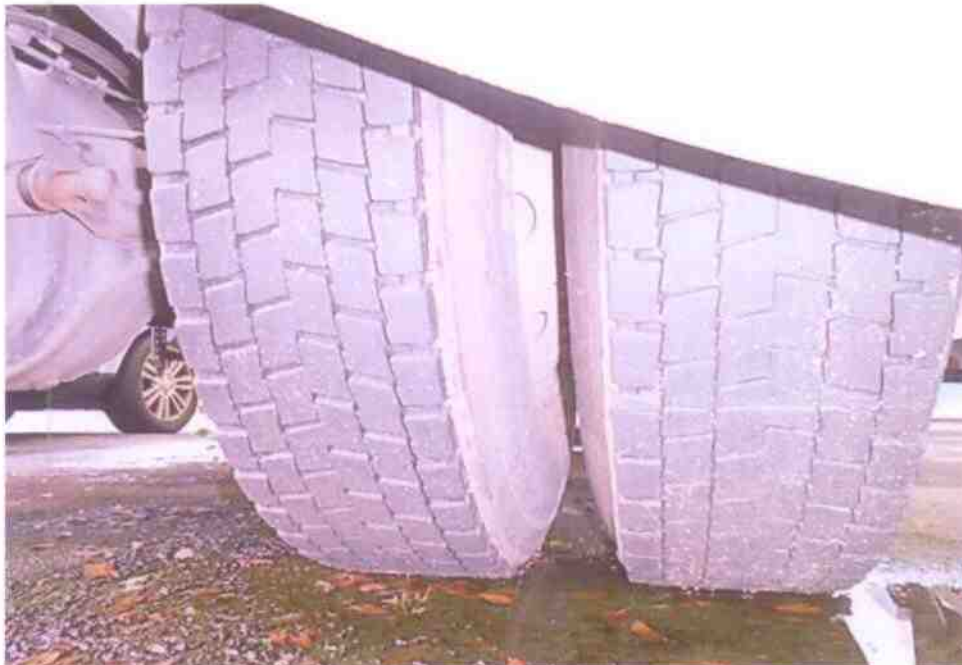
Photo 7 shows the condition of the rear right tyres of the Prime Mover, which were observed to be in serviceable condition with remaining tread depth of approximately 4mm. The tyres were also observed to be sufficiently inflated for vehicular operation.

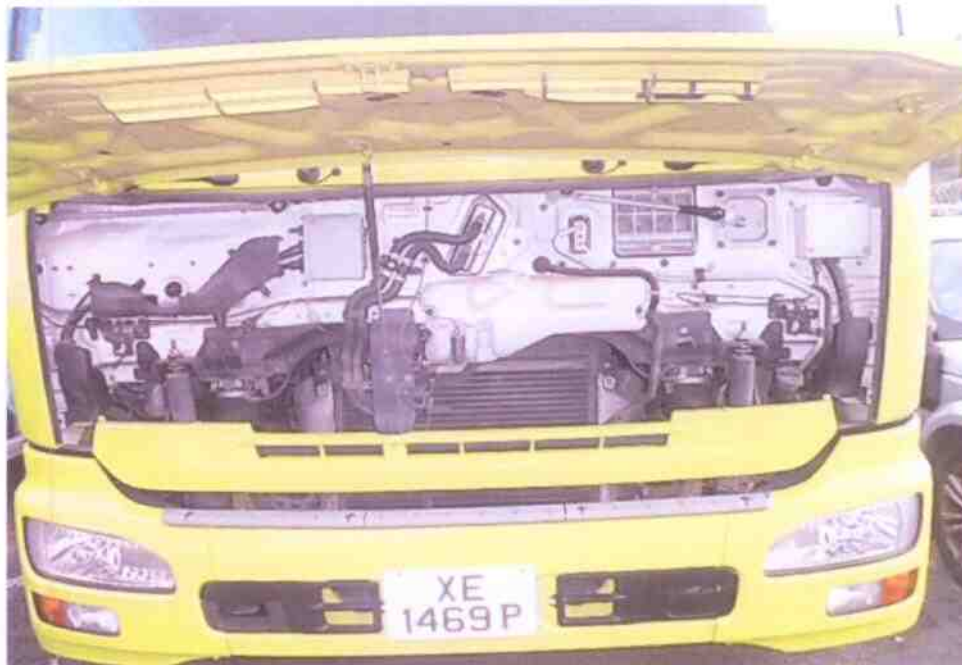
Photo 8 shows the front panel of the Prime Mover lifted for checks on some of the components of the cooling system & engine system.

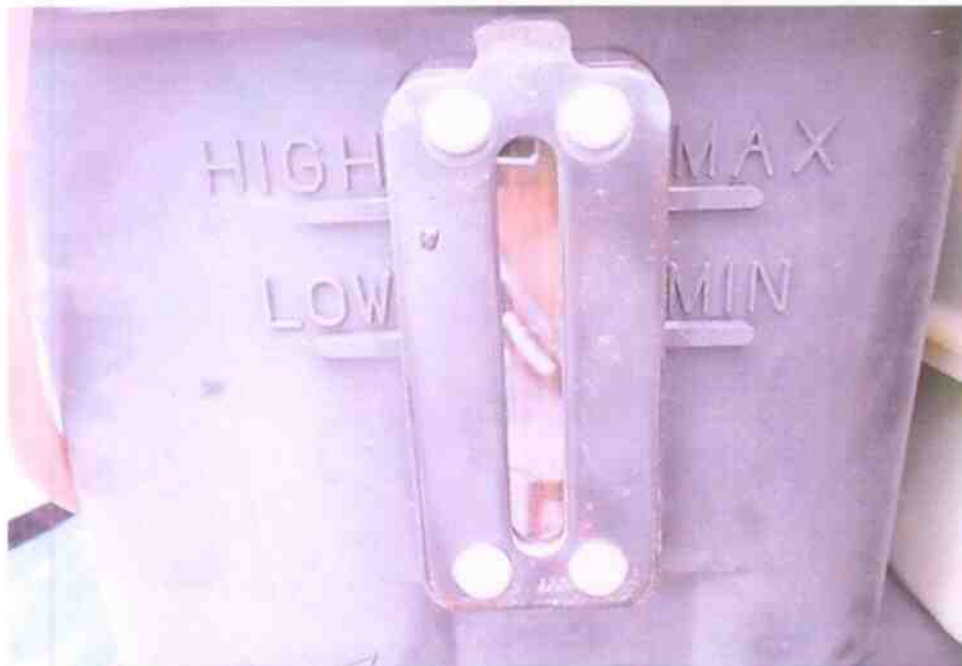
Photo 9 shows the engine coolant reservoir of the Prime Mover at the time of our inspection. The engine coolant was observed to be of sufficient level and without any visible contamination for operational purposes.

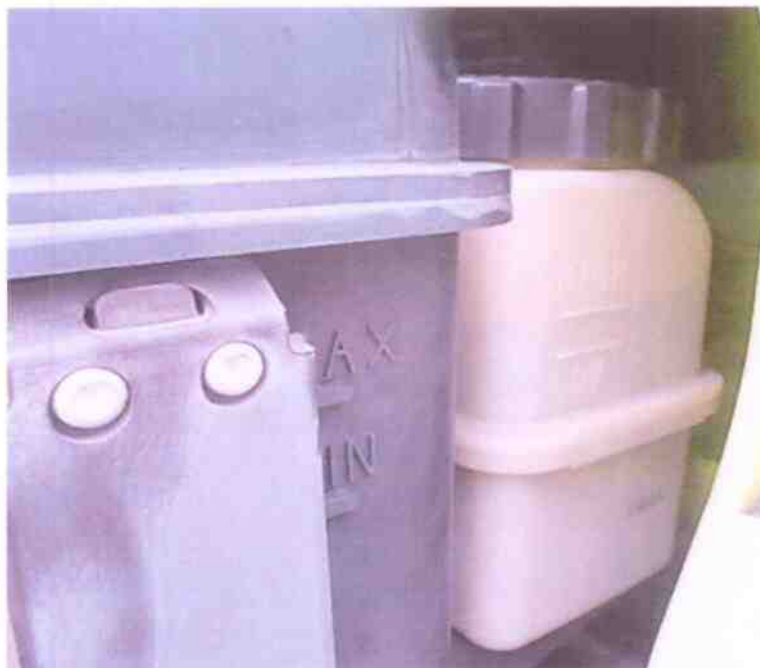
Photo 10 shows checks being carried out to the power steering fluid of the Prime Mover. The power steering fluid was observed to be of sufficient level and without any visible contamination for operational purposes.

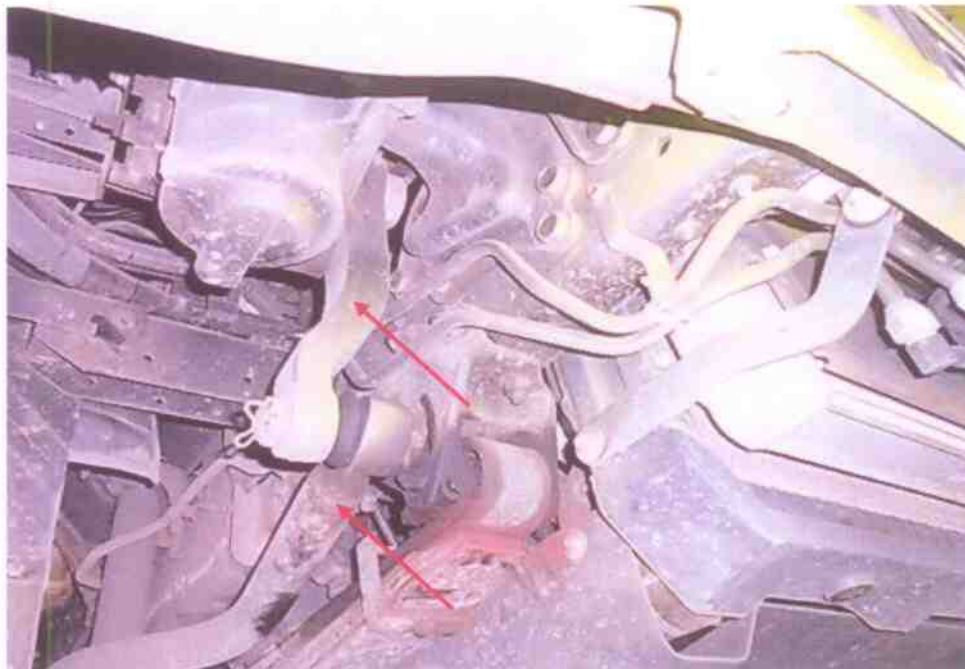
Photo 11 shows some of the undercarriage components at the front right side of the Prime Mover. We were not able to conduct any test(s) on the steering system of the Prime Mover as its engine could not be started. However our visual checks on the various mechanical components of the steering system like its steering shaft (arrowed) revealed all to be intact and in good condition. The steering system of the Prime Mover is hence likely to be in serviceable condition at the time of accident.

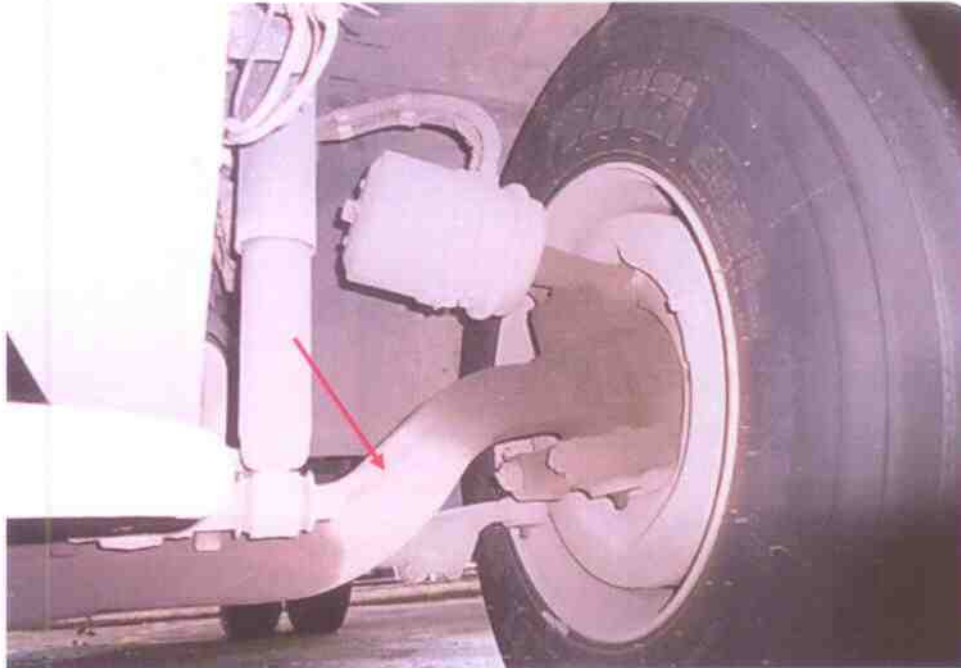
Photo 12 shows the undercarriage components at the front left wheel of the Prime Mover. The various undercarriage components of the Prime Mover were all observed to be intact and without any visible damage. This had included the steering rack (arrowed) of the Prime Mover.

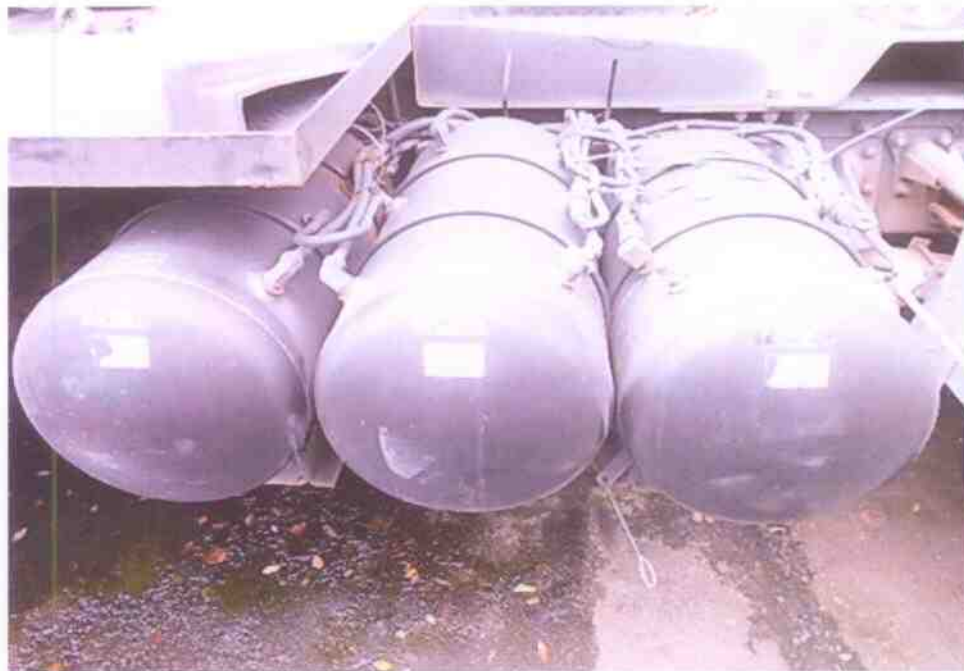
Photo 13 shows a general view of the air tanks, valves, pipes and hoses, which are some of the components for the full air-assisted braking system of the Prime Mover. These components were unaffected by the accident. It had all appeared to be in good general condition and securely fitted upon my visual examination of these parts.

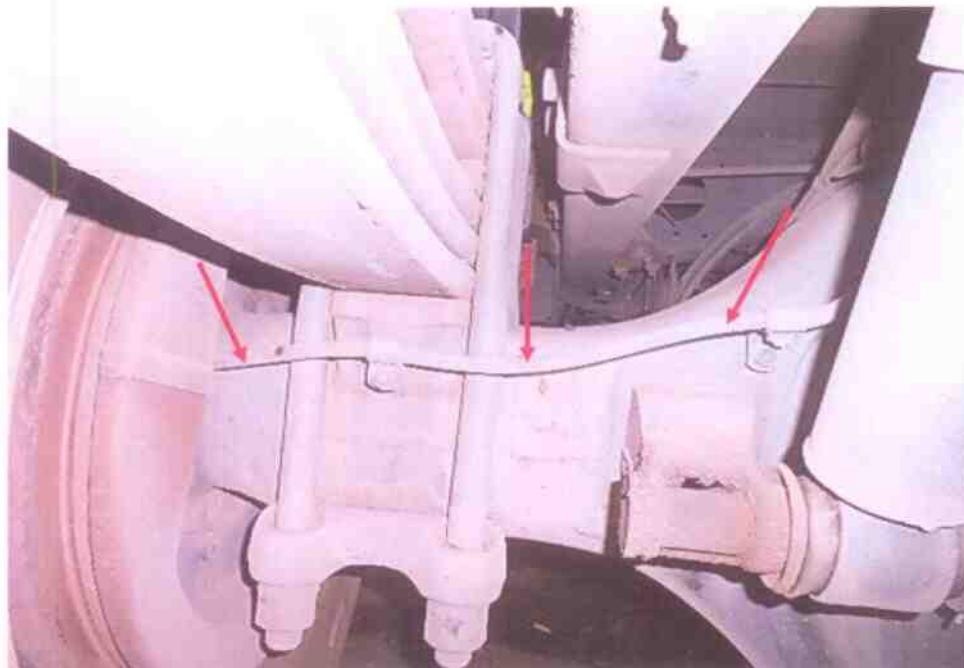
Photo 14 shows the undercarriage components at the rear left wheel of the Prime Mover, in particular the brake hose (arrowed). Visual inspection of the mechanical components of the Prime Mover's braking system appear to suggest that its braking system was in serviceable condition at the material time of accident.

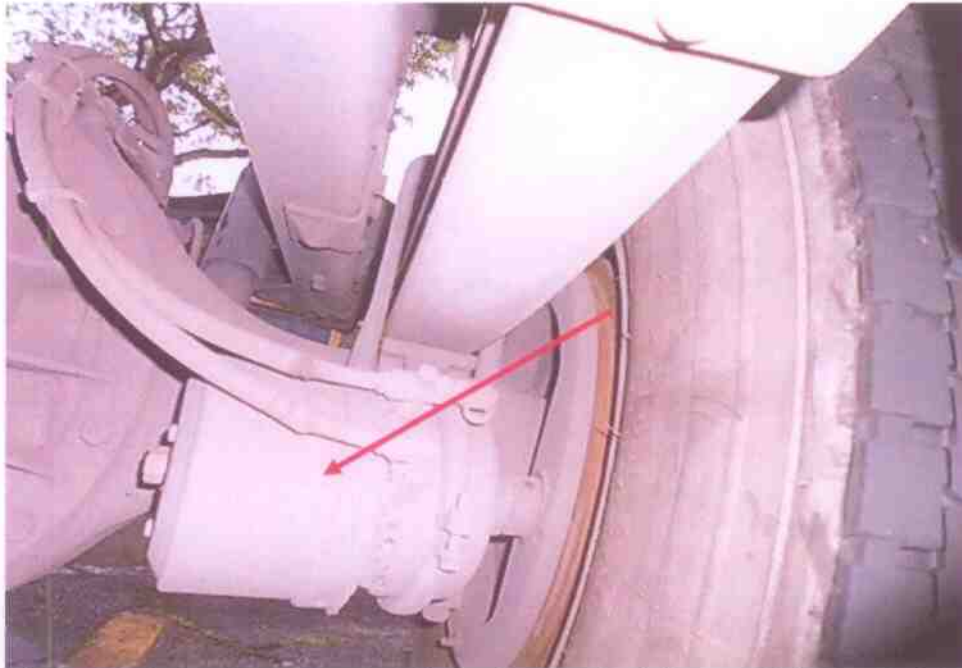
Photo 15 shows the brake air cylinder (arrowed) at the rear left wheel of the Prime Mover. Such air cylinder, which is amongst the various components for the full air-assisted braking system, can be found attached to all the front wheels and all the rear wheels. Upon checking, we had found all the brake air cylinders to be undamaged and securely fitted to all the wheels of the Prime Mover.

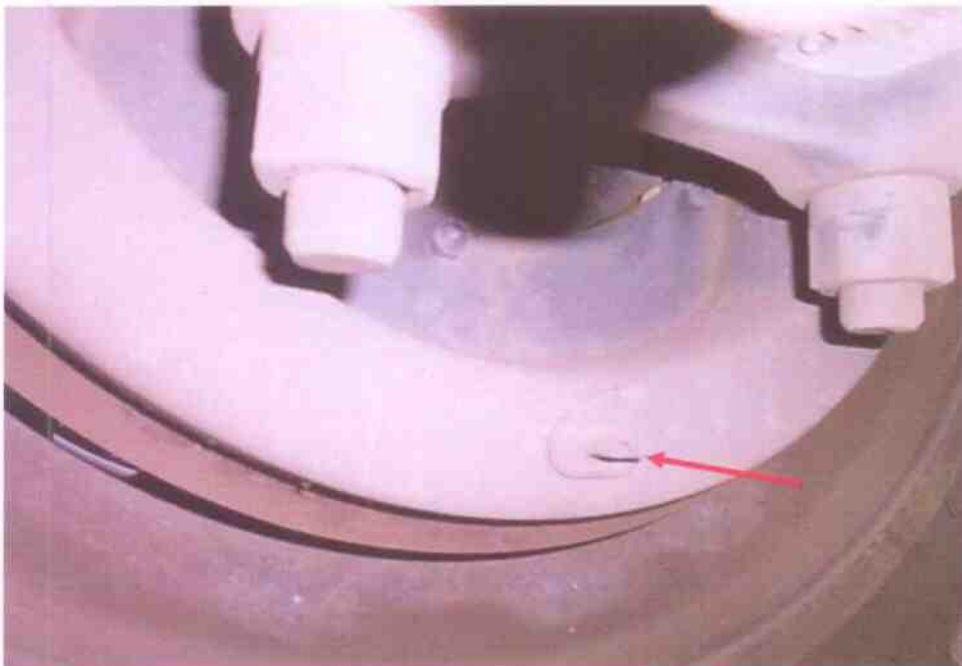
Photo 16 shows the brake shoes (brake pads) location at the rear left wheel of the Prime Mover. The brake shoes (brake pads) window was still protected with a rubber protector at time of our inspection.

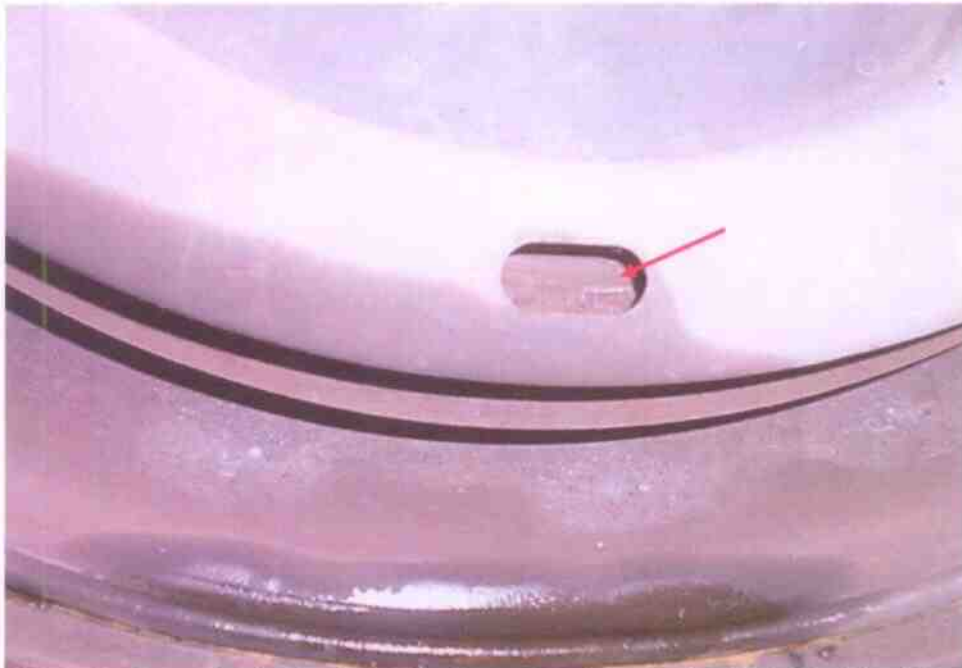
Photo 17 shows the brake shoes (brake pads) at the front left wheel of the Prime Mover. The brake shoes (brake pads) of the Prime Mover were all found to be in serviceable condition with sufficient frictional material for operational purposes.
