Your Ref: TP/IP/49159/2017
Our Ref : CI/TPD18000512/Z

Fatal Accident Investigation Team

MECHANICAL INSPECTION REPORT OF PRIME MOVER XD 3311C

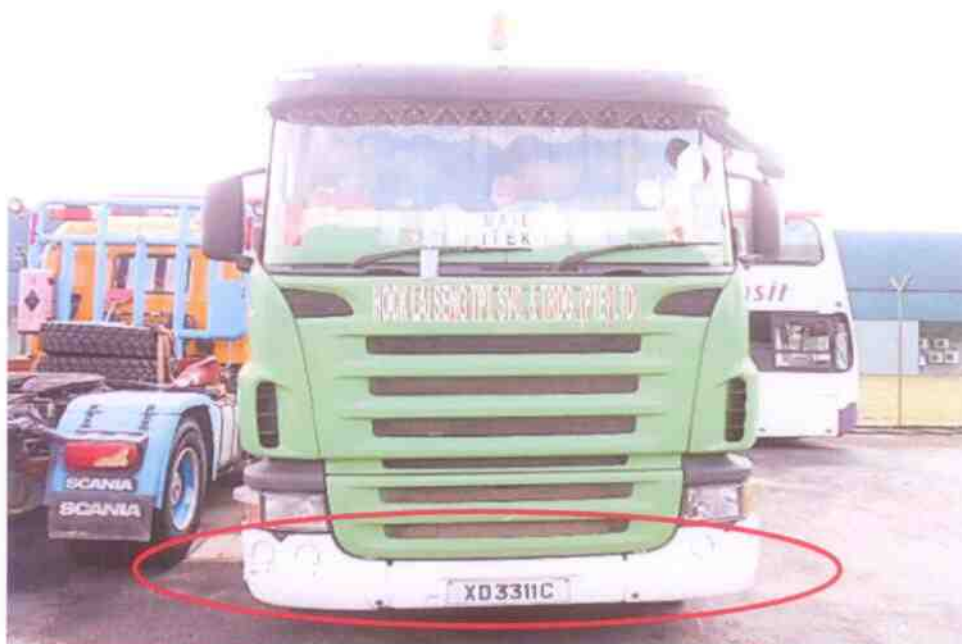
4. The mileage of the Prime Mover at the time of our inspection was not recorded as its engine could not be started due to a flat battery.
5. The Prime Mover was observed to have sustained relatively minor impact damages at its left & right front body. Its front left & front lower bumper was observed to be slightly scratched. Its left hand side headlamp was observed to be broken. See photo 1 – 8 below.

Photo 1 shows a general view of the front portion of the Prime Mover at the time of our inspection. The Prime Mover was observed to have sustained relatively minor damage at its front body.

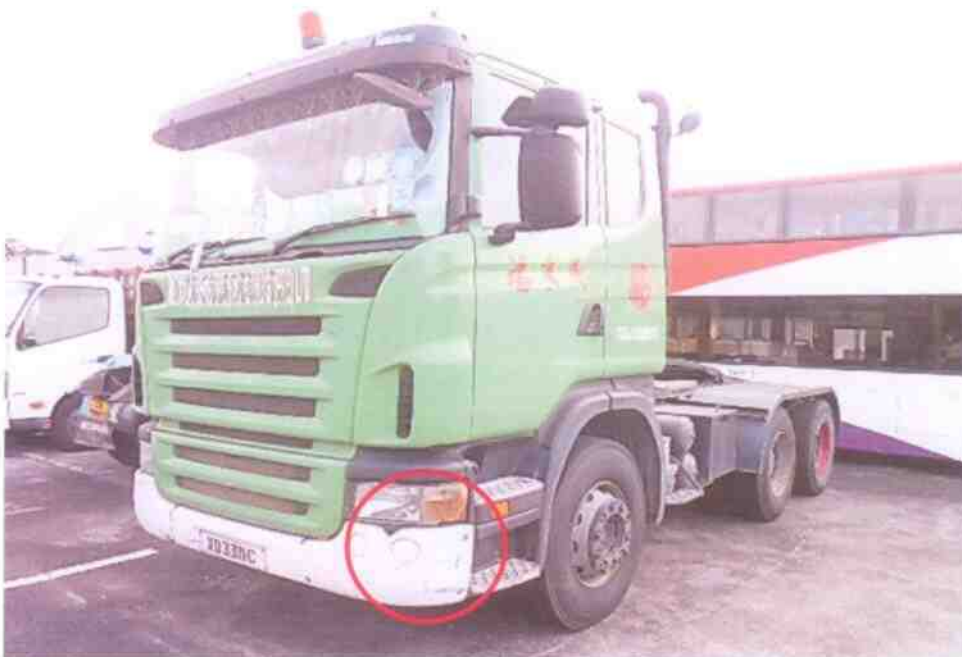
Photo 2 shows a general view of the front left body of the Prime Mover at the time of our inspection. The Prime Mover was observed to have sustained relatively minor damage at its left front lower bumper (circled) & cracked left headlamp.

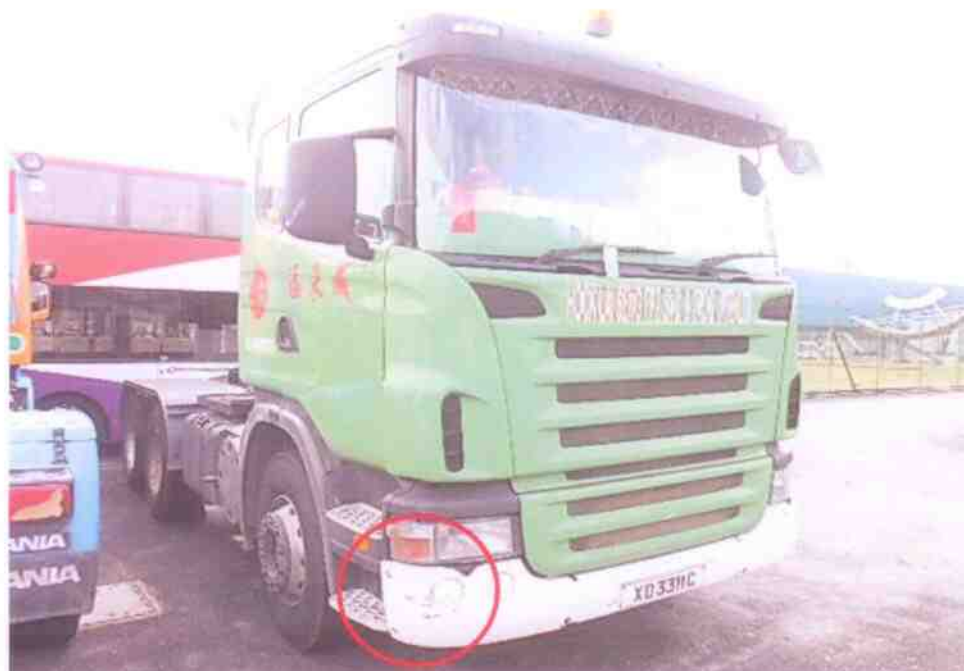
Photo 3 shows a general view of the front right body of the Prime Mover at the time of our inspection. The Prime Mover was observed to have sustained relatively minor damage at its left front lower bumper (circled).

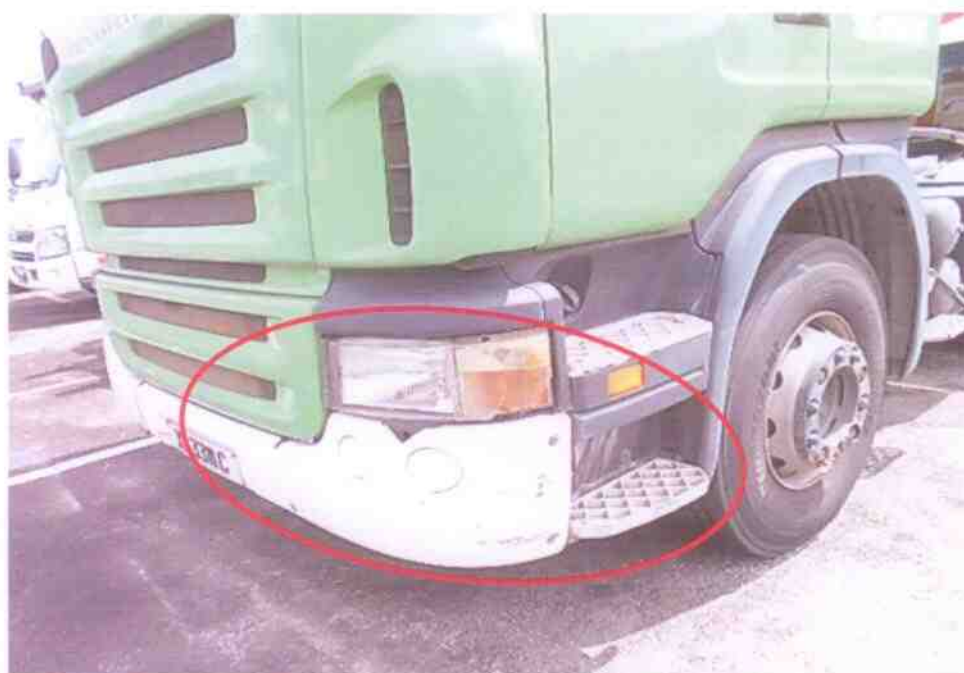
Photo 4 shows a semi-close up view of the minor scratches on the left front lower bumper of the Prime Mover.

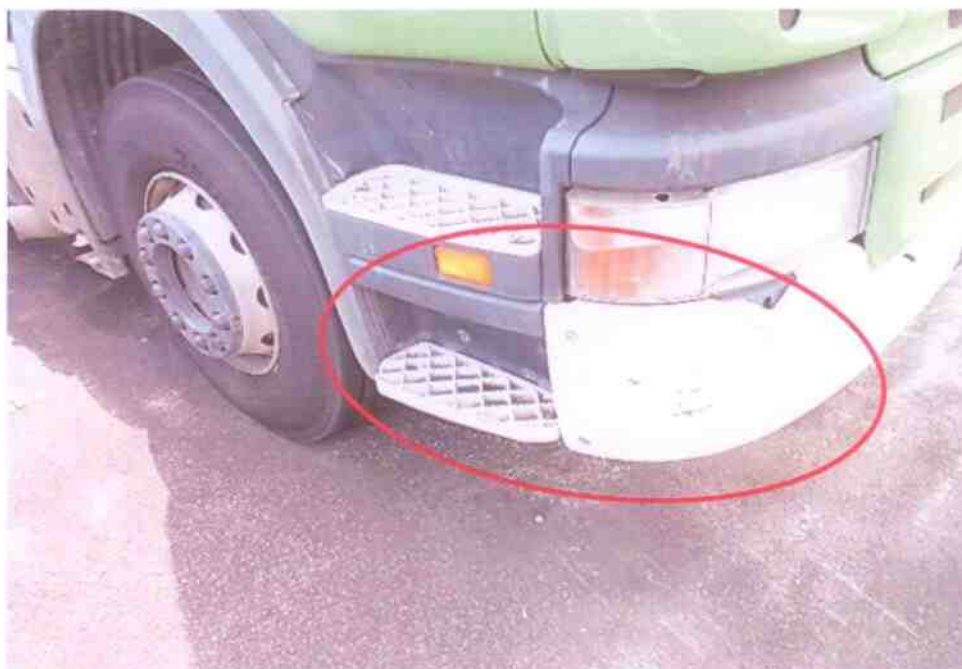
Photo 5 shows a semi-close up view of the front right body of the Prime Mover at the time of our inspection. The Prime Mover was observed to have sustained relatively minor damage at its front right lower bumper (circled).

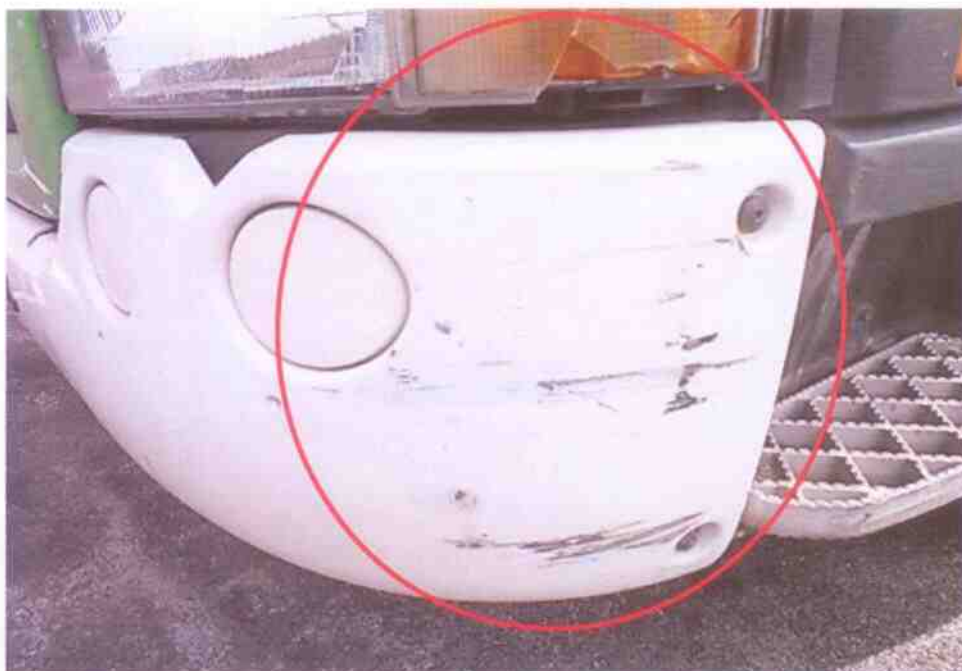
Photo 6 shows a close up view of the minor scratches on the left front lower bumper of the Prime Mover.

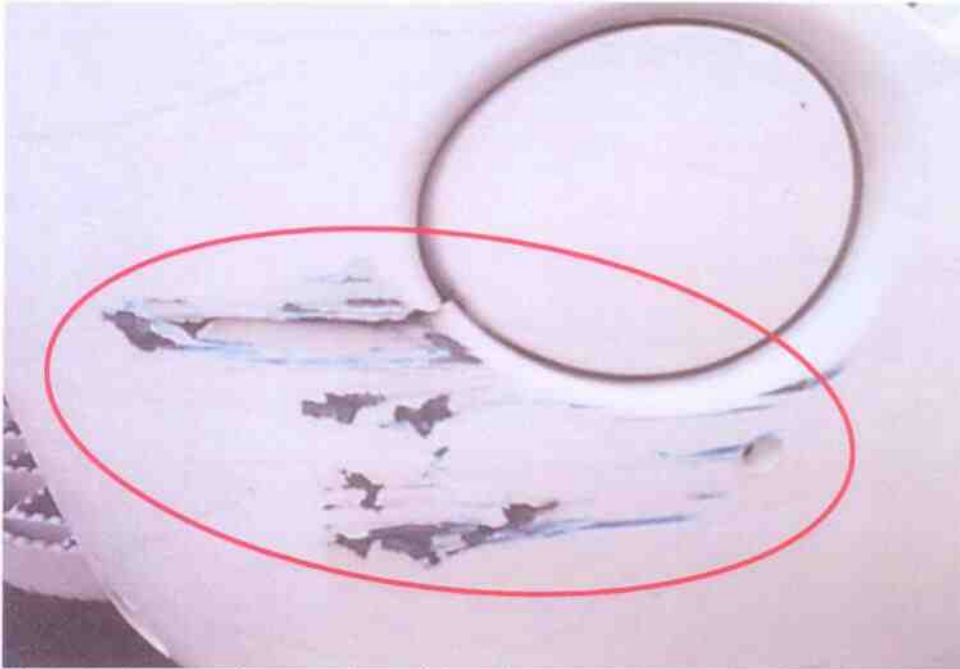
Photo 7 shows a close up view of the minor scratches on the front right lower bumper of the Prime Mover.

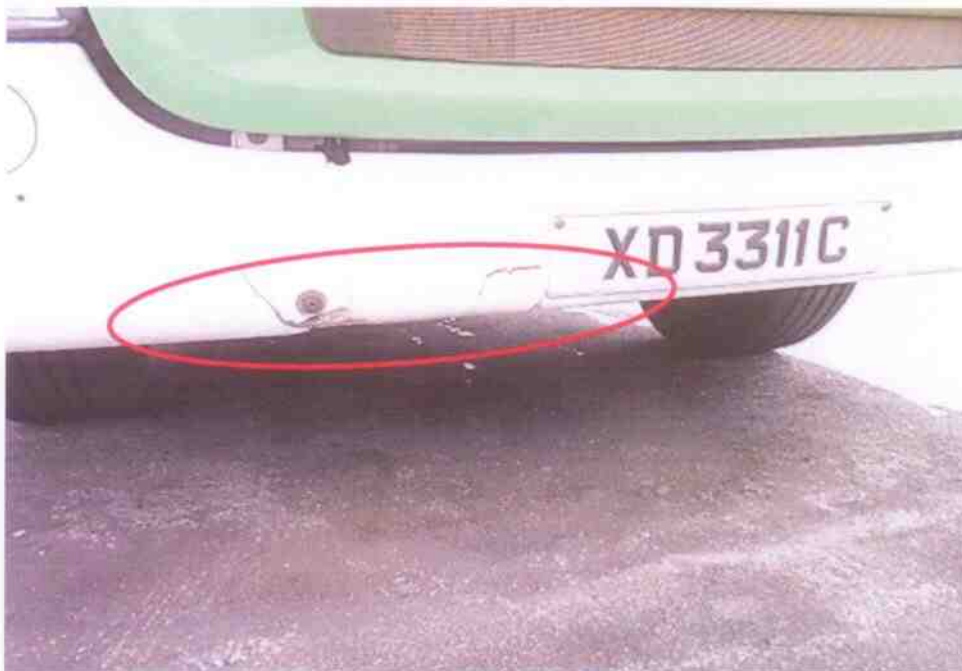
Photo 8 shows a semi-close up view of the minor scratches on the front lower bumper of the Prime Mover.

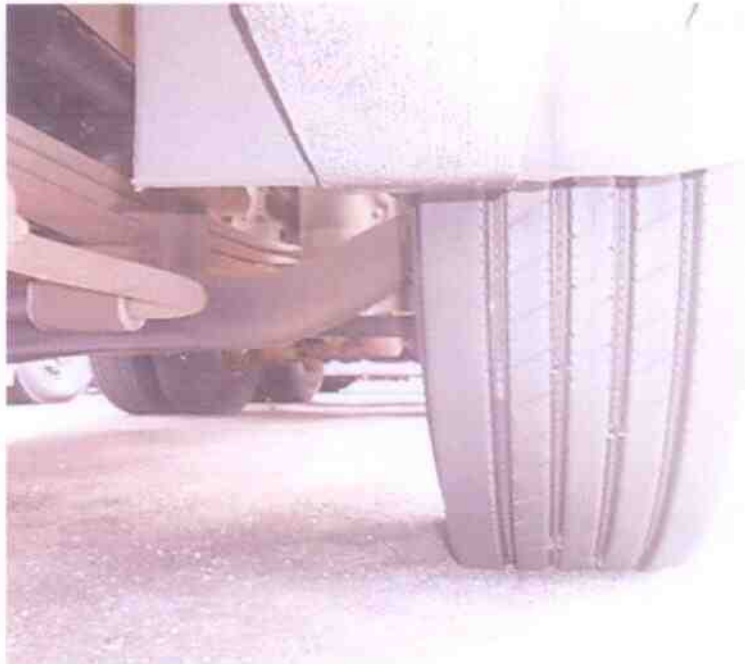
Photo 9 shows the condition of the front left tyre of the Prime Mover, which was observed to be in serviceable condition with remaining tread depth of approximately 11mm.

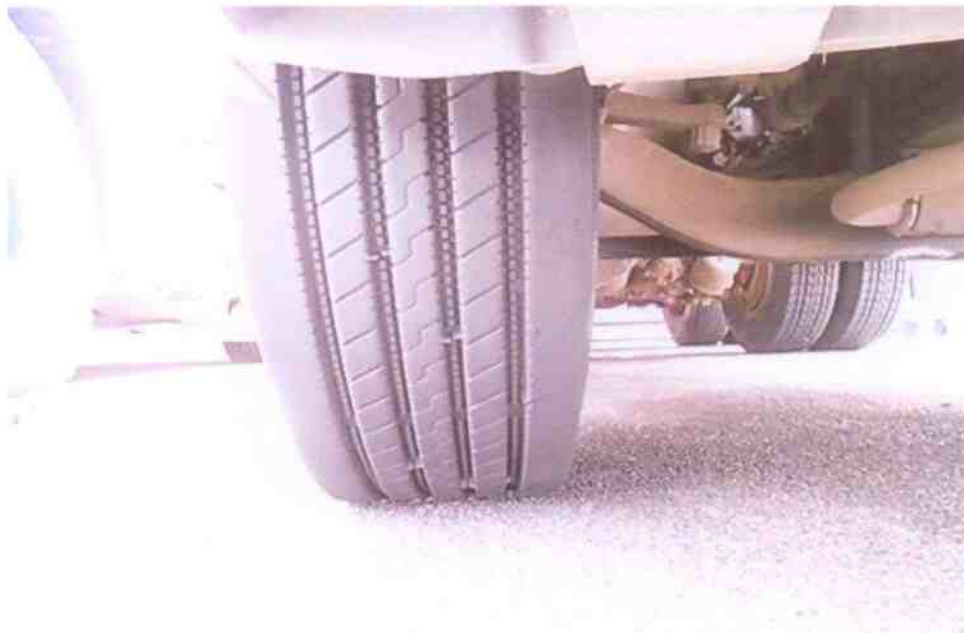
Photo 10 shows the condition of the front right tyre of the Prime Mover, which was observed to be in serviceable condition with remaining tread depth of approximately 10mm.

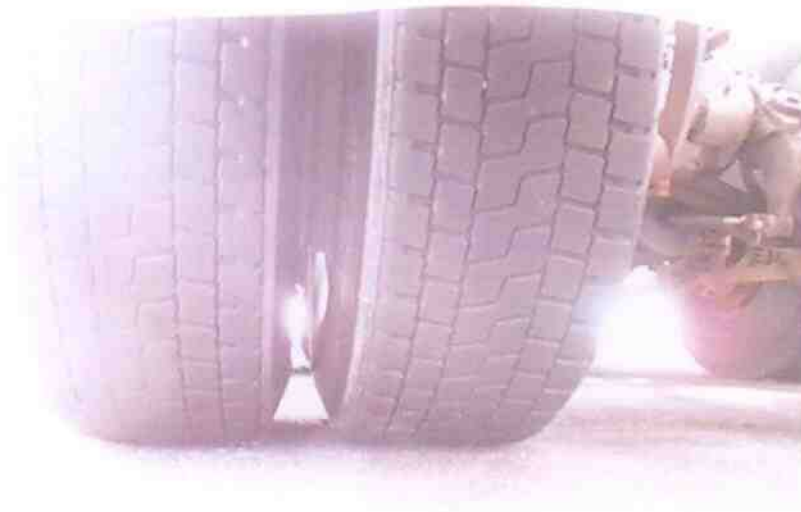
Photo 11 shows the condition of the rear left tyres of the Prime Mover, which were observed to be in serviceable condition with remaining tread depth of approximately 3mm. The tyres were also observed to be sufficiently inflated for vehicular operation.

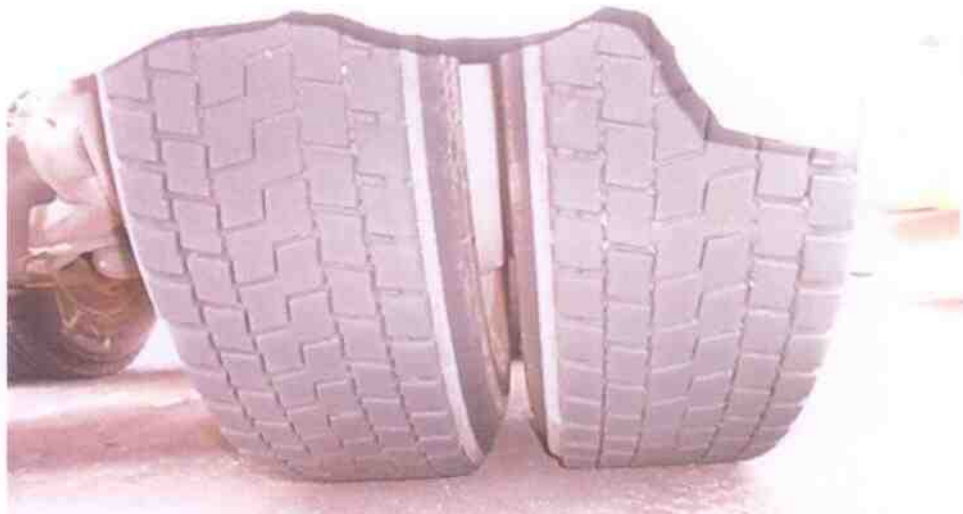
Photo 12 shows the condition of the rear right tyres of the Prime Mover, which were observed to be in serviceable condition with remaining tread depth of approximately 6mm. The tyres were also observed to be sufficiently inflated for vehicular operation.

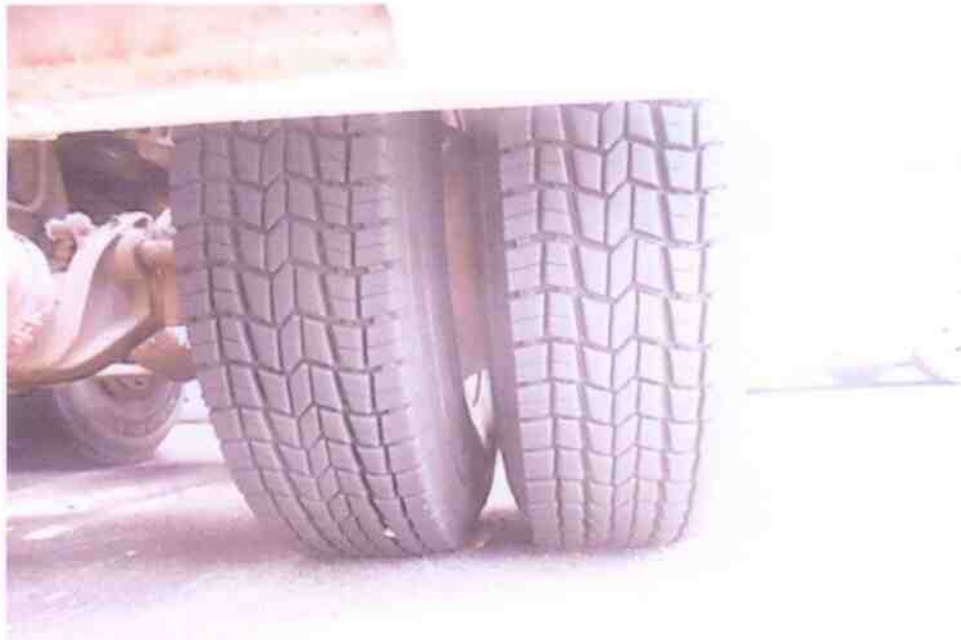
Photo 13 shows the condition of the rear left tyres (Centre Axle) of the Prime Mover, which were observed to be in serviceable condition with remaining, tread depth of approximately 11mm. The tyres were also observed to be sufficiently inflated for vehicular operation.

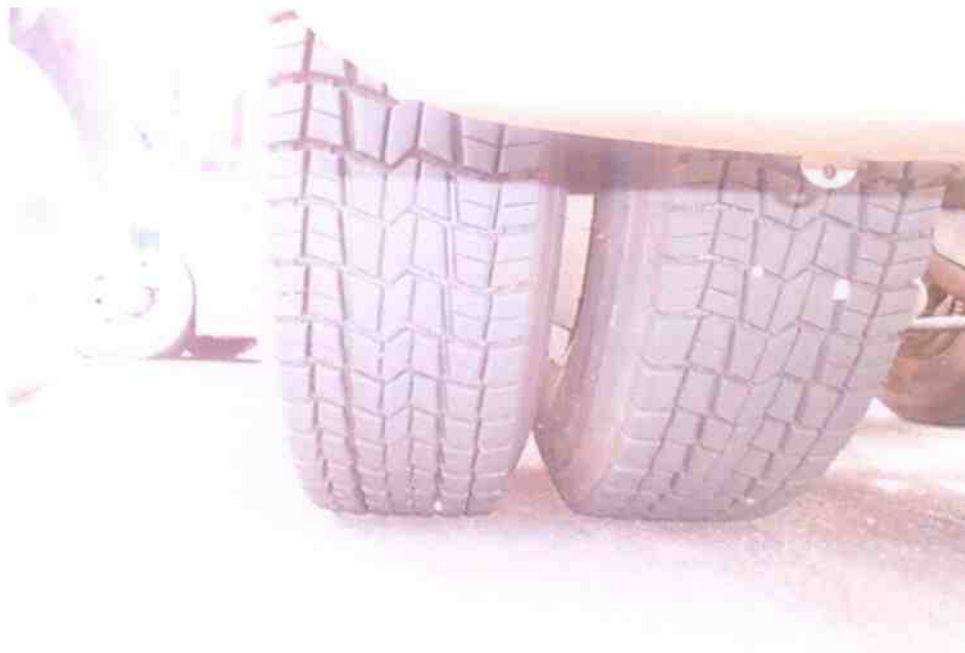
Photo 14 shows the condition of the rear right tyres (Centre Axle) of the Prime Mover, which were observed to be in serviceable condition with remaining, tread depth of approximately 10mm. The tyres were also observed to be sufficiently inflated for vehicular operation.

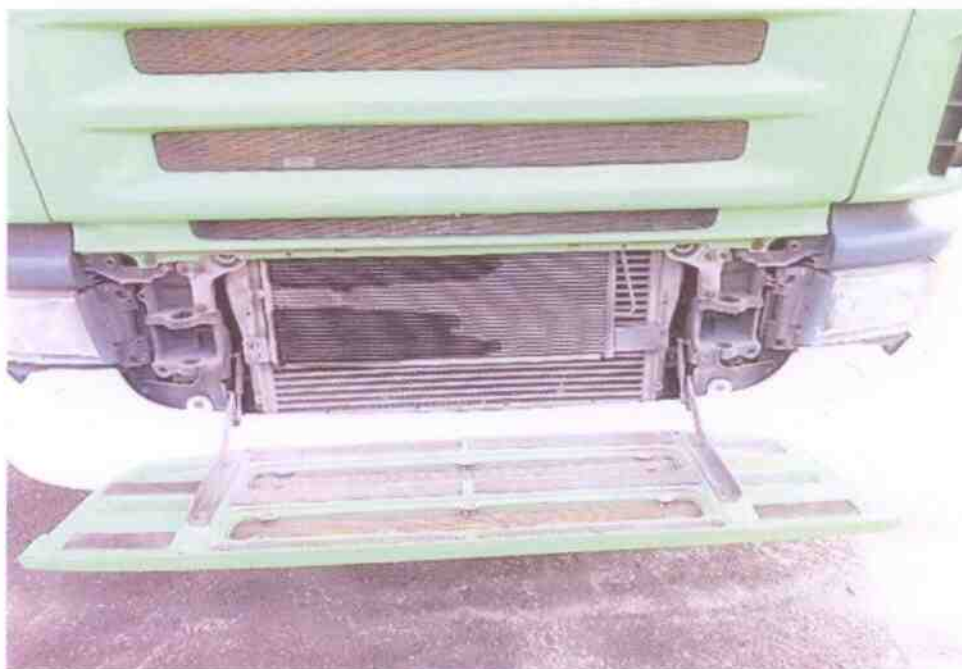
Photo 15 shows the front panel of the Prime Mover open for checks on some of the components of the cooling system.

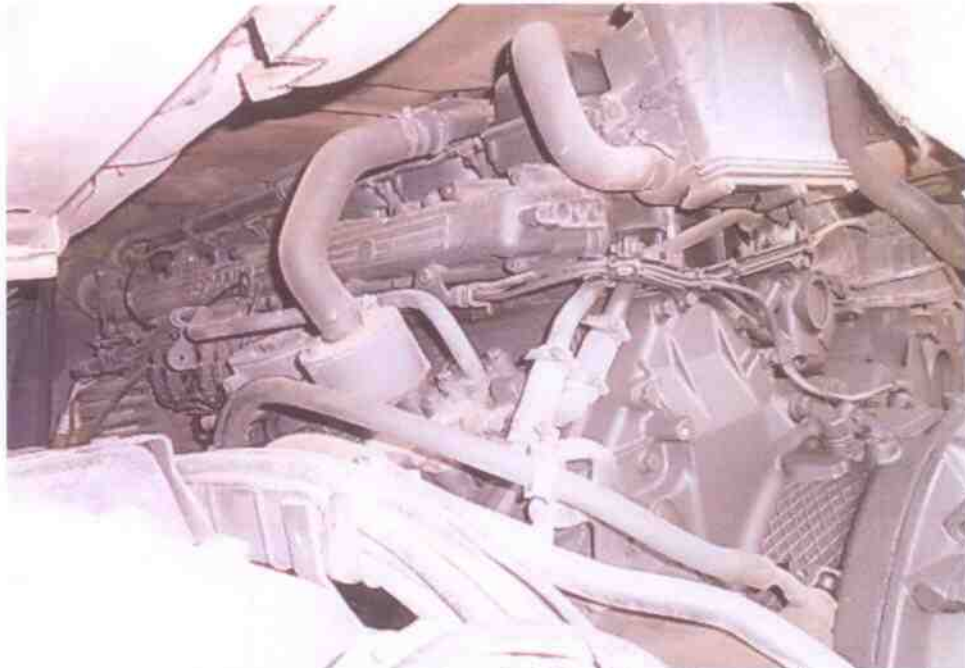
Photo 16 shows the engine compartment of the Prime Mover at the time of our inspection. The engine compartment of the Prime Mover could not be closely examined as it was located directly under the front cabin.

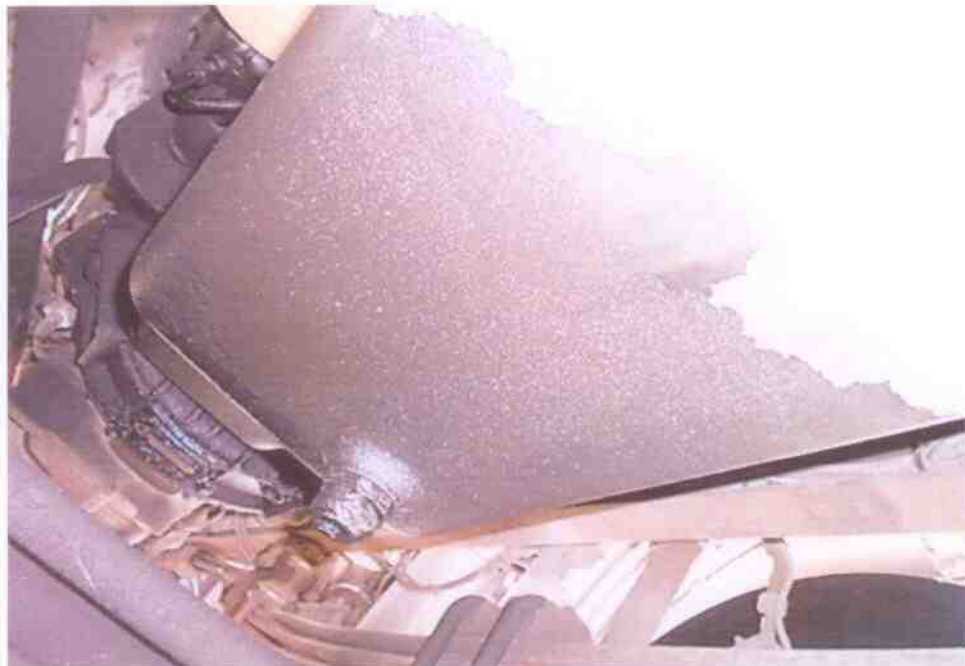
9. From the underside, the engine assembly and transmission assembly of the Prime Mover were both observed to be covered with fresh fluid. Suggesting that fluid leakage had occurred as a result of the accident.

Photo 17 shows from the underside, the engine assembly and transmission assembly of the Prime Mover were both observed to be covered with fresh fluid, suggesting that fluid leakage had occurred as a result of the accident.

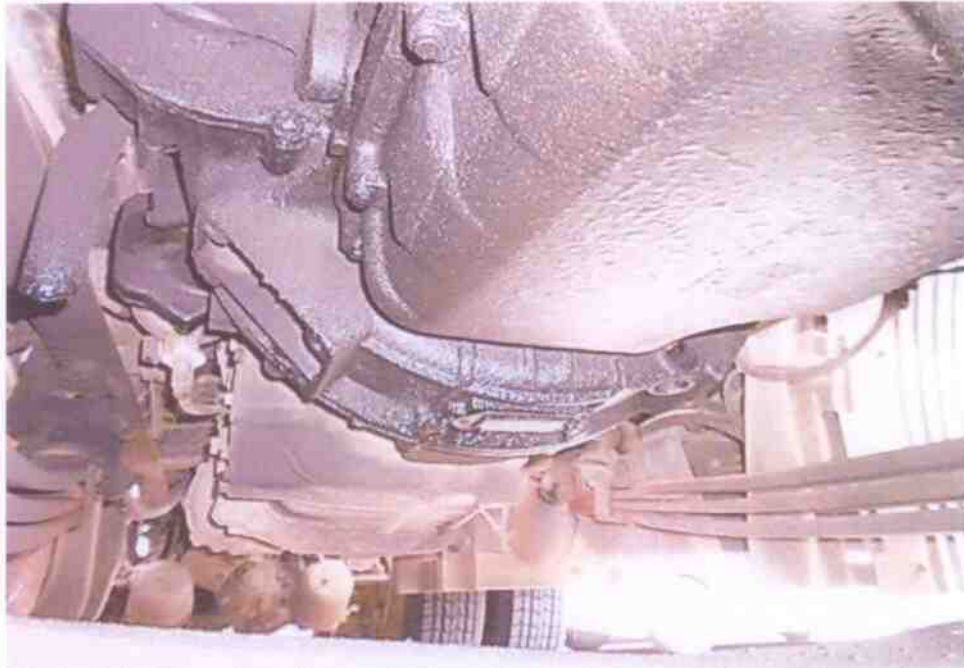
Photo 18 shows from the underside, the engine assembly and transmission assembly of the Prime Mover were both observed to be covered with fresh fluid, suggesting that fluid leakage had occurred as a result of the accident.

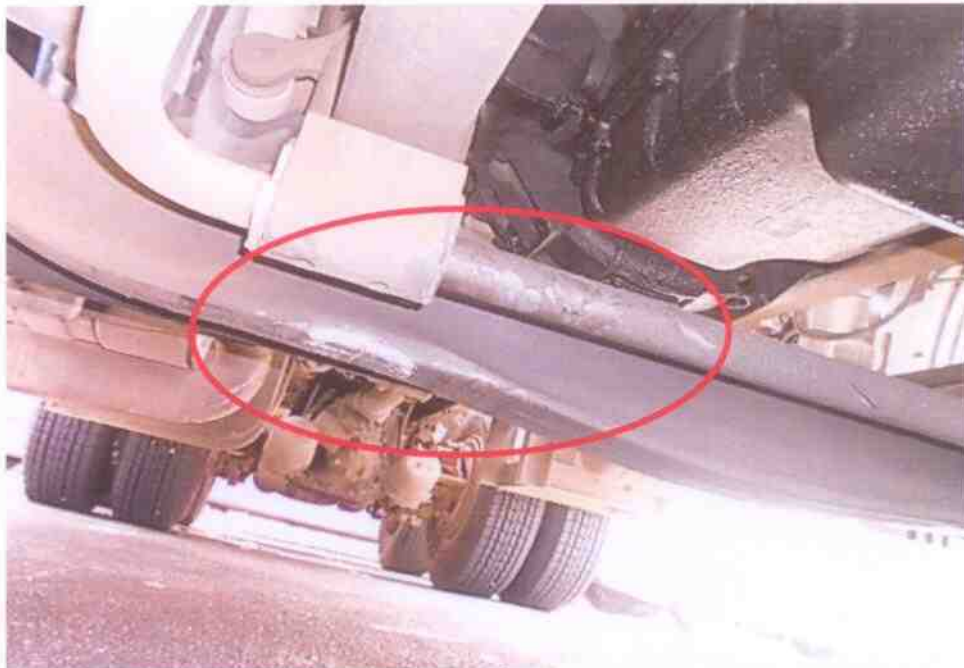
Photo 19 shows from the underside, a deep scratch had occurred as a result of the accident. However, it does not affect the alignment of the steering rack.

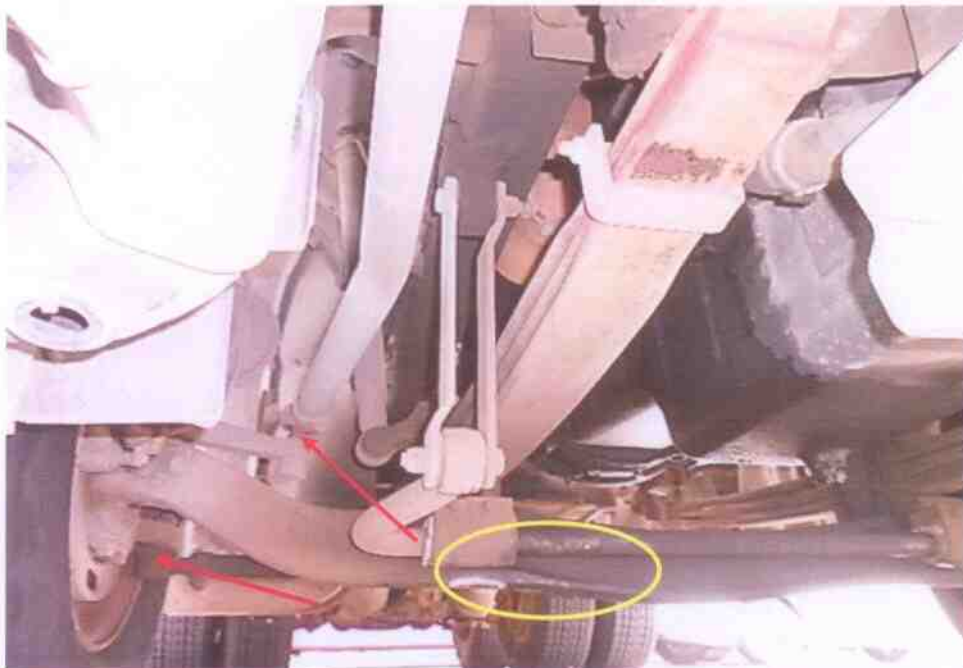
Photo 20 shows some of the undercarriage components at the front right side of the Prime Mover. We were not able to conduct any test(s) on the steering system of the Prime Mover as its engine could not be started. However our visual checks on the various mechanical components of the steering system like its steering shaft (arrowed) revealed all to be intact and in good condition. The steering system of the Prime Mover is hence likely to be in serviceable condition at the time of accident despite deep scratch observed on the below portion of the steering rack likely due to the consistency of the accident. Visually it does not show any misalignment on the steering system.

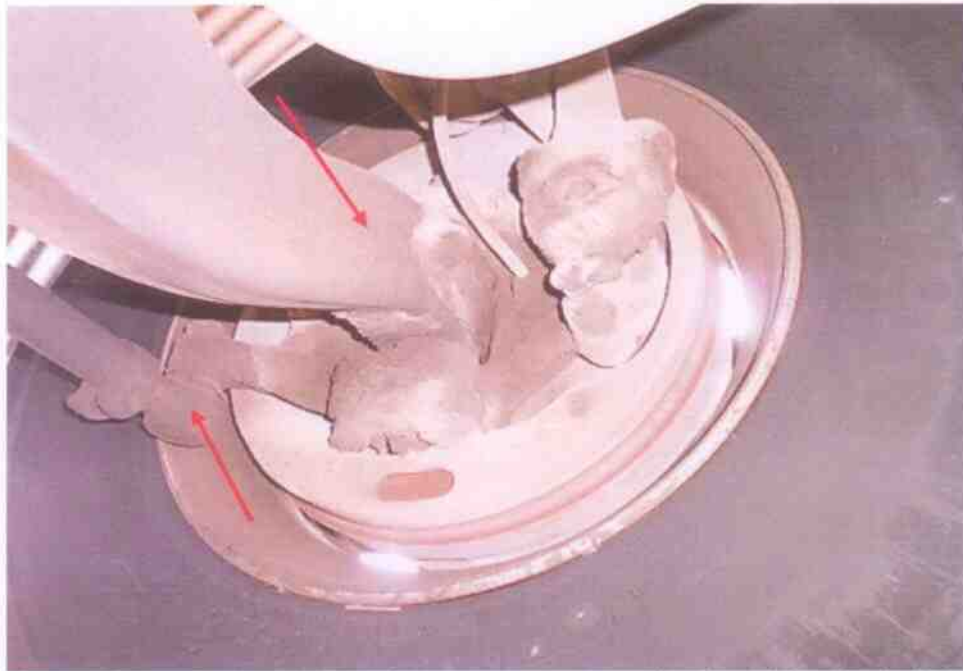
Photo 21 shows the undercarriage components at the front left wheel of the Prime Mover. The various undercarriage components of the Prime Mover were all observed to be intact and without any visible damage. This had included the steering rack (arrowed) of the Prime Mover.

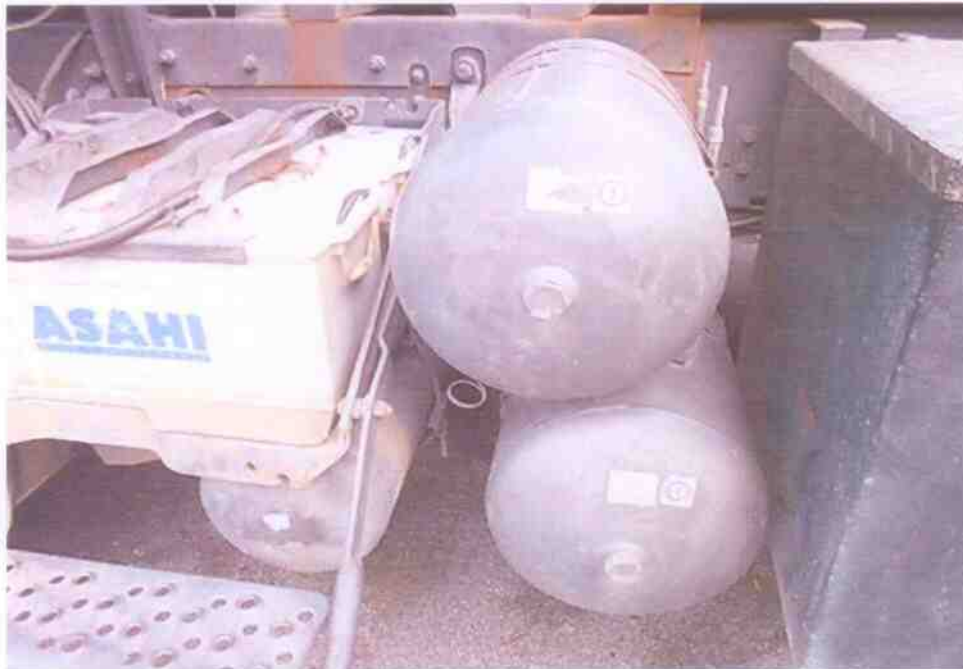
Photo 22 shows a general view of the air tanks, valves, pipes and hoses, which are some of the components for the full air-assisted braking system of the Prime Mover. These components were unaffected by the accident. It had all appeared to be in good general condition and securely fitted upon my visual examination of these parts.

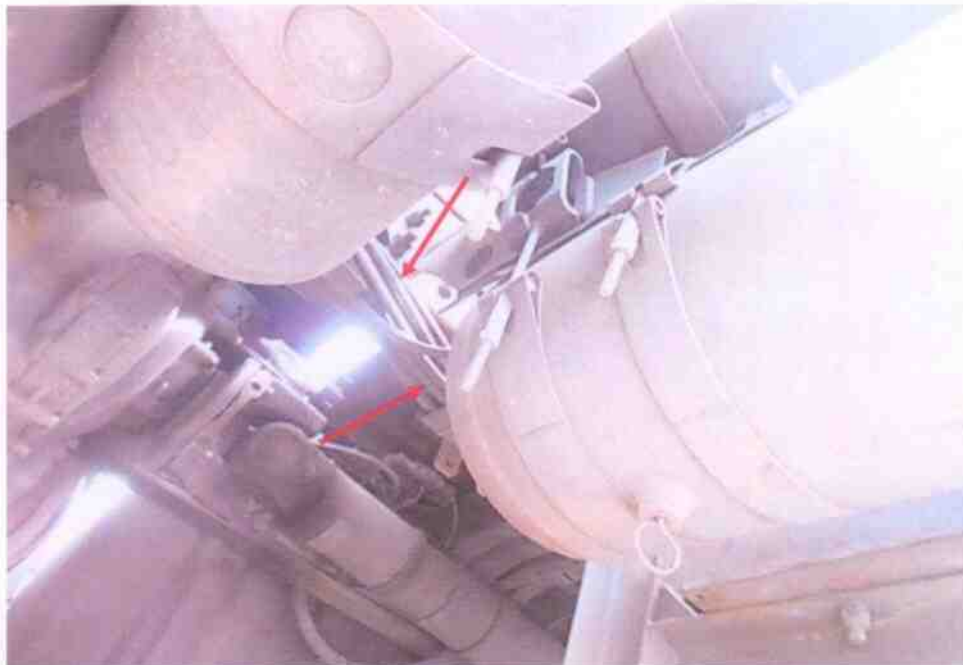
Photo 23 shows a general view of the air tanks, valves, pipes and hoses, which are some of the components for the full air-assisted braking system of the Prime Mover. These components were unaffected by the accident. It had all appeared to be in good general condition and securely fitted upon my visual examination of these parts.

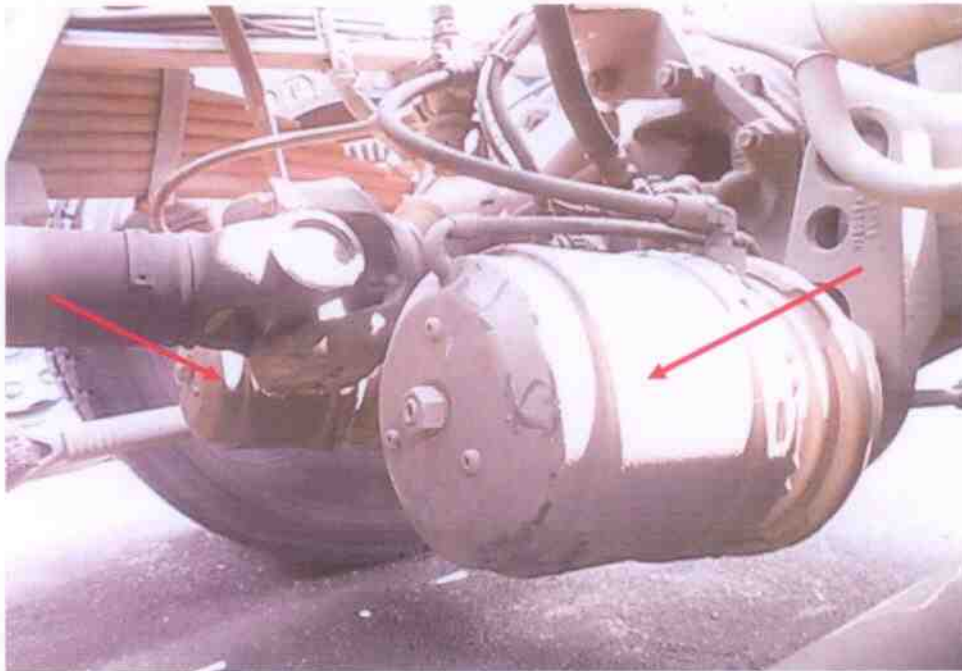
Photo 24 shows the brake air cylinder (arrowed) at the rear left & right wheel of the Prime Mover. Such air cylinder, which is amongst the various components for the full air-assisted braking system, can be found attached to all the front wheels and all the rear wheels. Upon checking, we had found all the brake air cylinders to be undamaged and securely fitted to all the wheels of the Prime Mover.

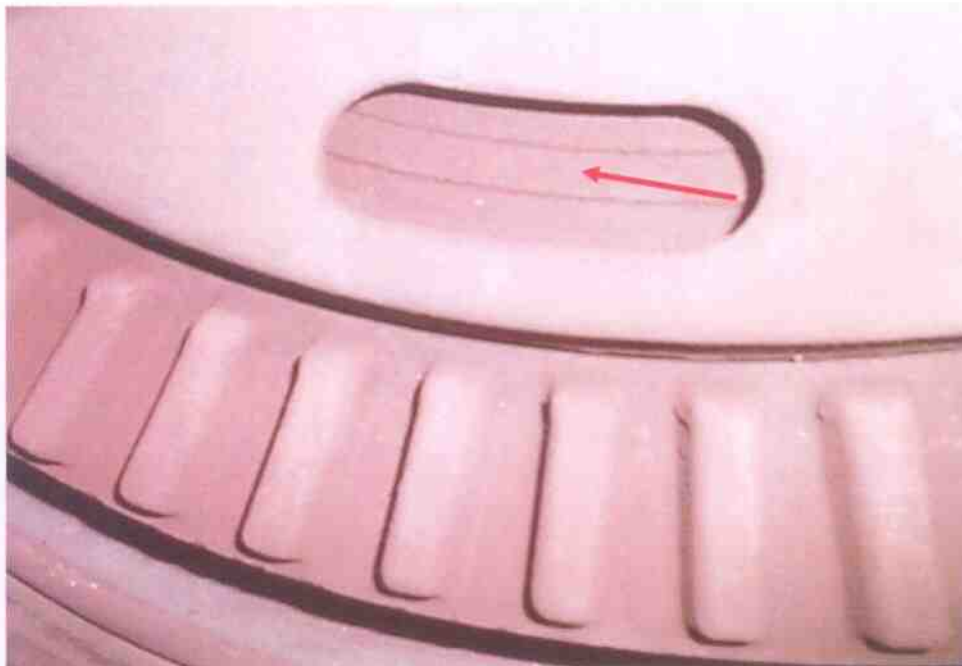
Photo 25 shows the brake shoes (brake pads) location at the rear left wheel of the Prime Mover. The brake shoes (brake pads) of the Prime Mover were all found to be in serviceable condition with sufficient frictional material for operational purposes.

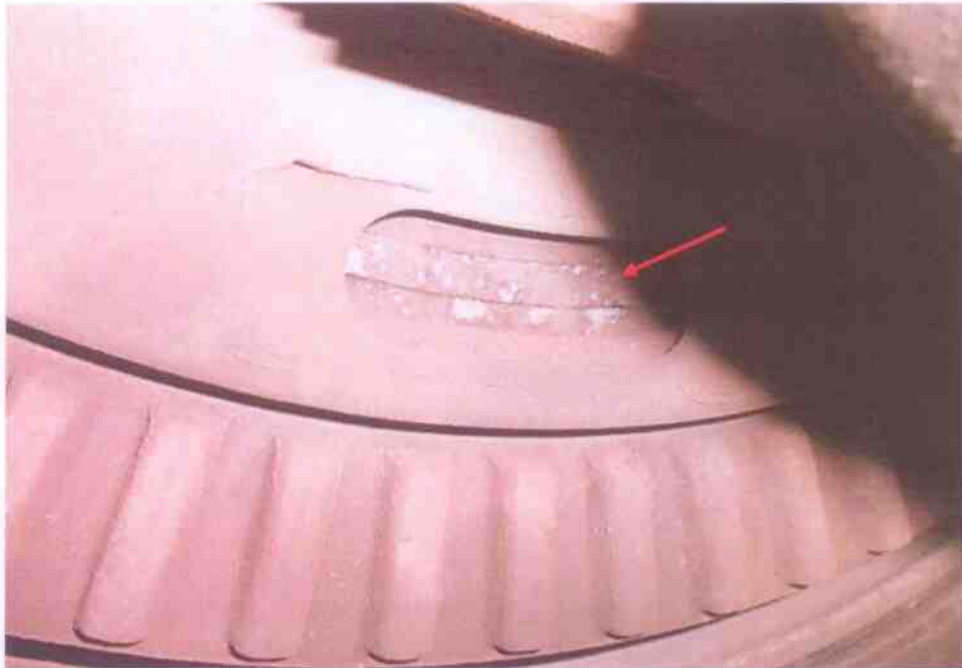
Photo 26 shows the brake shoes (brake pads) at the rear right wheel of the Prime Mover. The brake shoes (brake pads) of the Prime Mover were all found to be in serviceable condition with sufficient frictional material for operational purposes.
