Your Ref: TP/IP/44003/2017
Our Ref : CI/TPD18000516/Z

Fatal Accident Investigation Team

MECHANICAL INSPECTION REPORT OF MOTOR BUS SMB 1541J

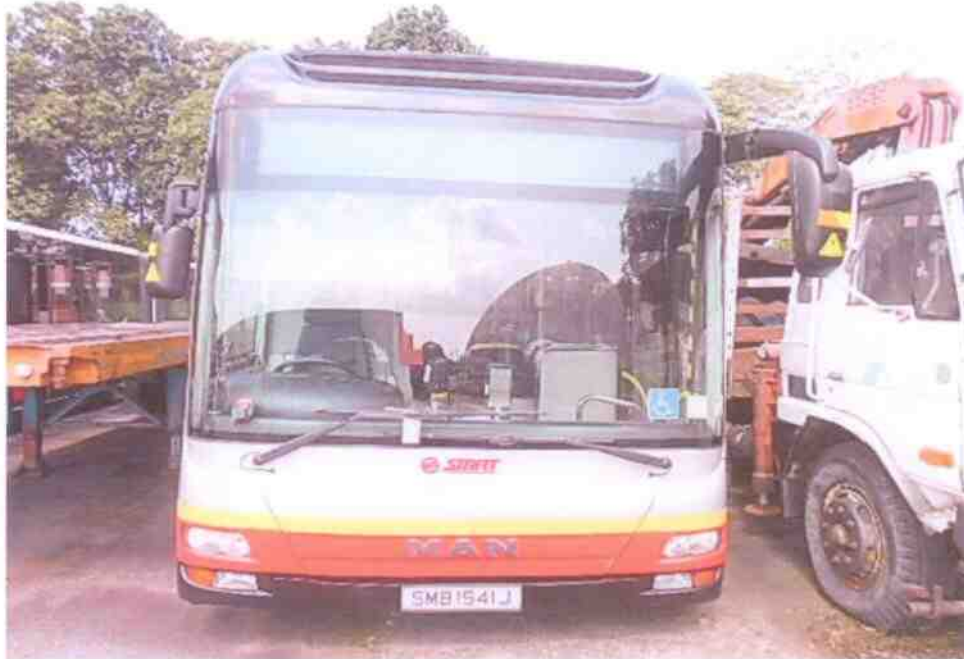
Photo 1 shows a general view of the front body of the Motor Bus at the time of our inspection. The Motor Bus was observed to be in good condition. This is likely due to the consistency of the accident's case facts that the Motor Bus collided & ran over a pedestrian whom was crossing from the Motor Bus left to right.

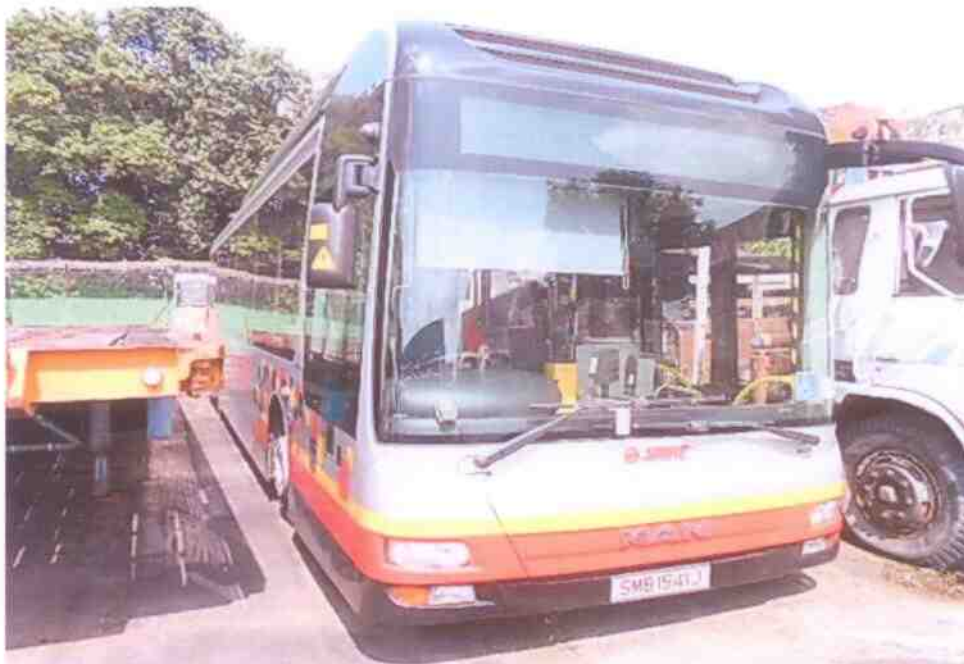
Photo 2 shows a general view of the front right body of the Motor Bus at the time of our inspection. The Motor Bus was observed to be in good condition. This is likely due to the consistency of the accident's case facts that the Motor Bus collided & ran over a pedestrian whom was crossing from the Motor Bus left to right.

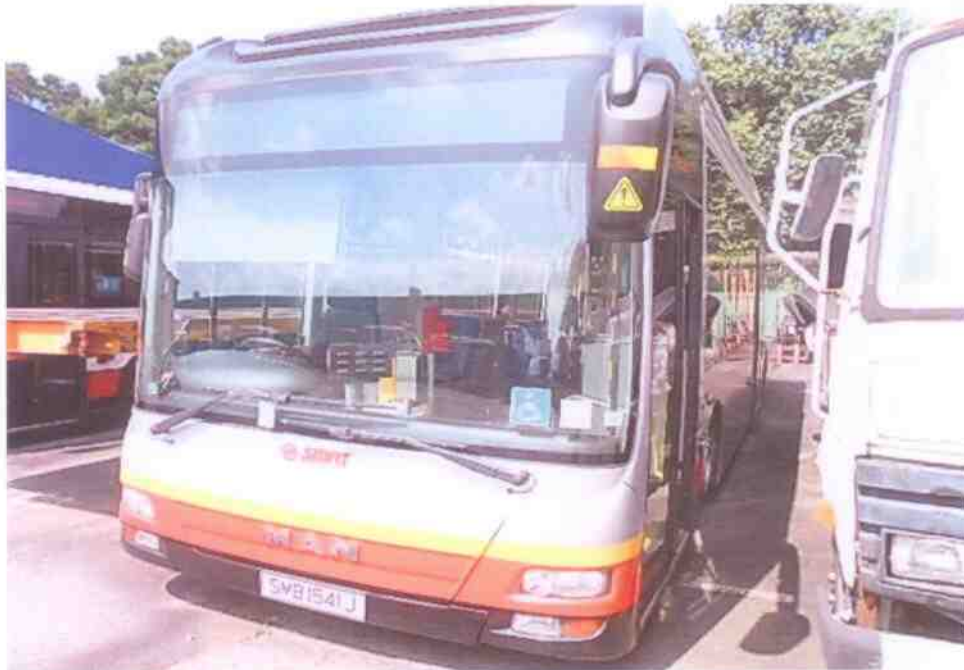
Photo 3 shows a general view of the front left body of the Motor Bus at the time of our inspection. The Motor Bus was observed to in good condition. No damages were noted on this side of the Motor Bus.

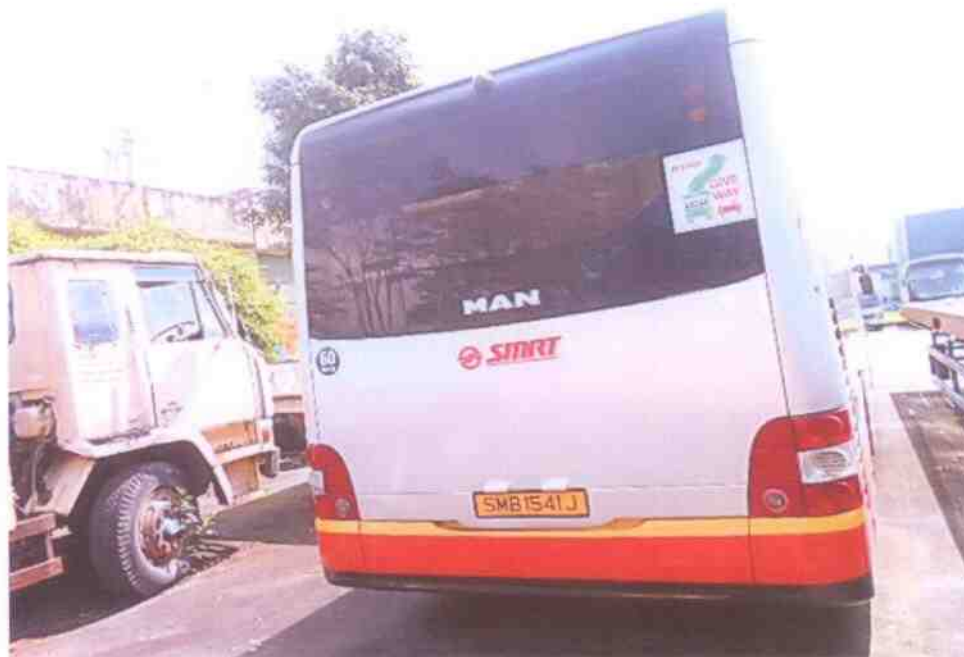
Photo 4 shows a general view of the Motor Bus's rear left body at the time of our inspection. There was no impact damage found at the rear portion of the Motor Bus.

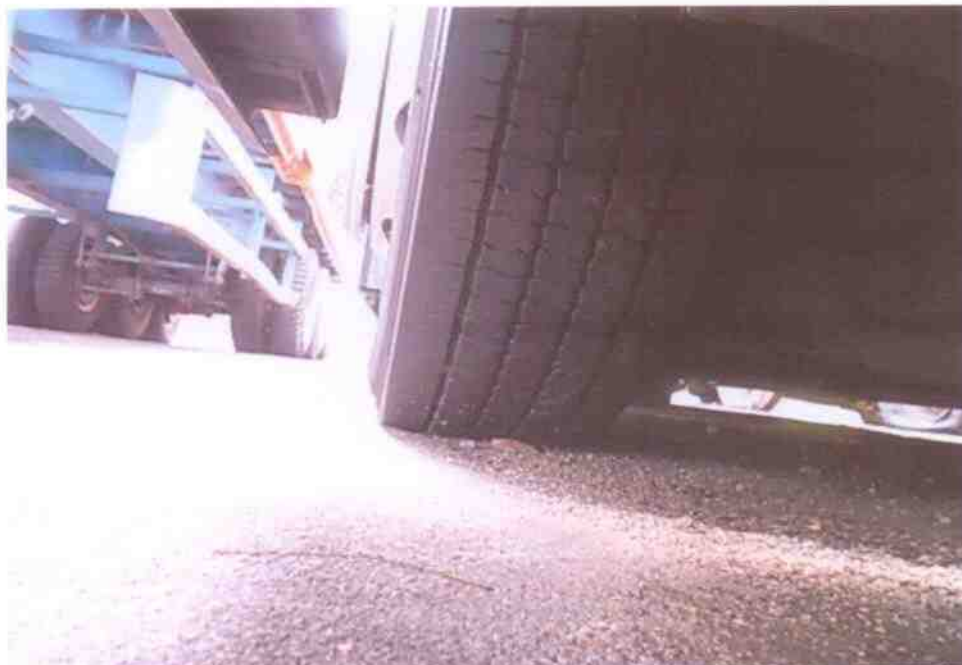
Photo 5 shows the condition of the front right tyre of the Motor Bus, which was with remaining tread depth of approximately 12mm. The tyre was also observed to be sufficiently inflated for vehicular operation.

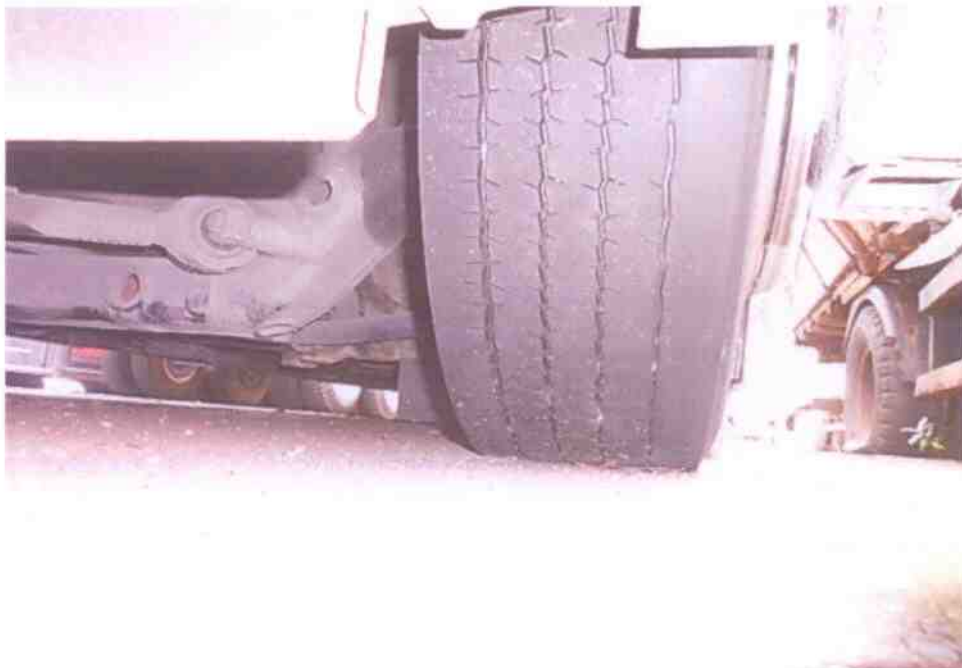
Photo 6 shows the condition of the front left tyre of the Motor Bus, which was observed to be in serviceable condition with remaining tread depth of approximately 9mm. The tyre was also observed to be sufficiently inflated for vehicular operation.

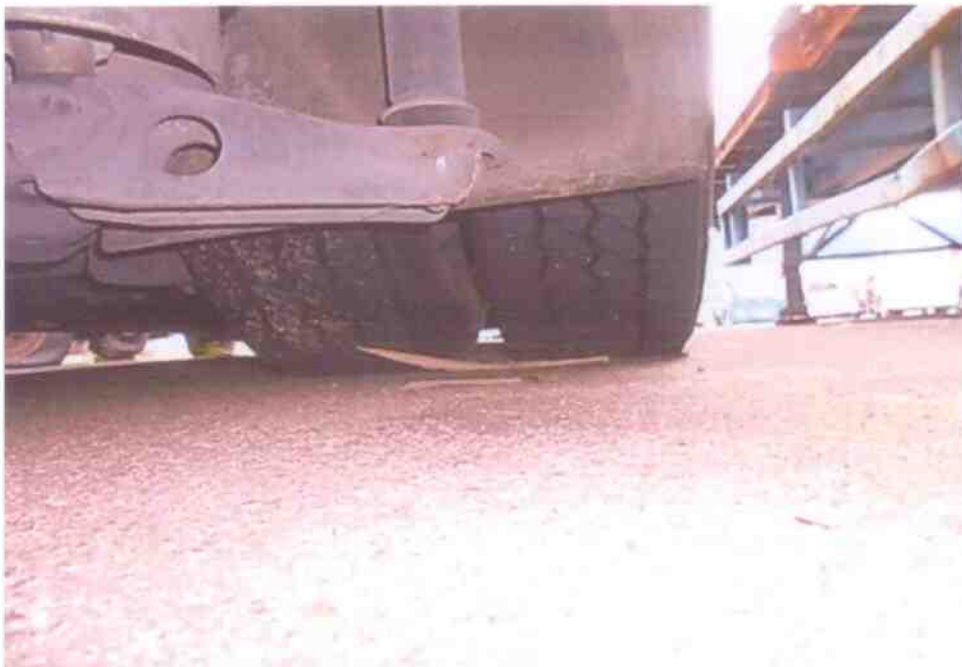
Photo 7 shows the condition of the rear right tyres of the Motor Bus, which were observed to be in serviceable condition with remaining tread depth of approximately 11mm. The tyres, which were wrapped around standard alloy wheels rims, were also observed to be sufficiently inflated for vehicular operation.

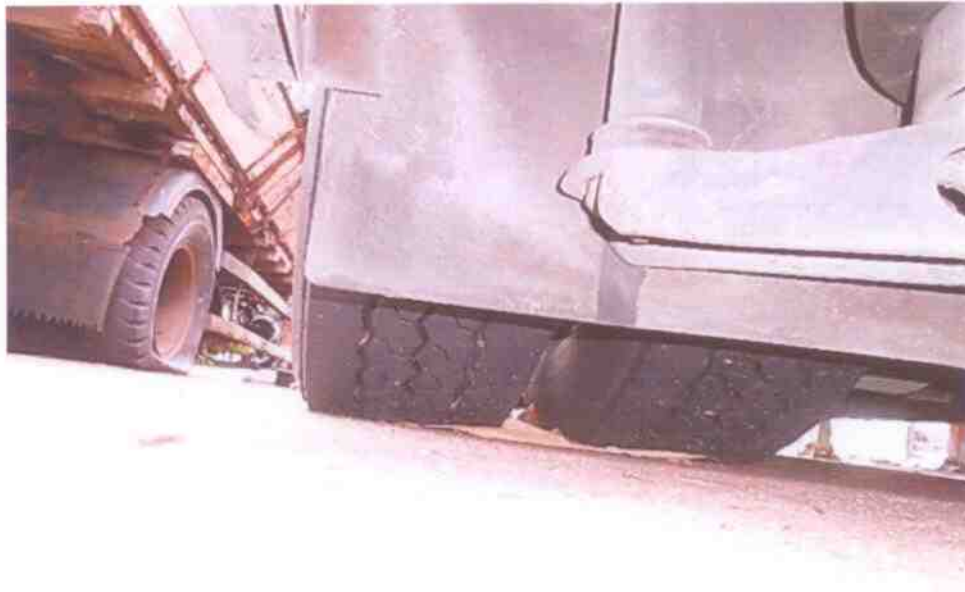
Photo 8 shows the condition of the rear left tyres of the Motor Bus, which were observed to be in serviceable condition with remaining tread depth of approximately 11mm. The tyres, which were wrapped around standard alloy wheel rims, were also observed to be sufficiently inflated for vehicular operation.

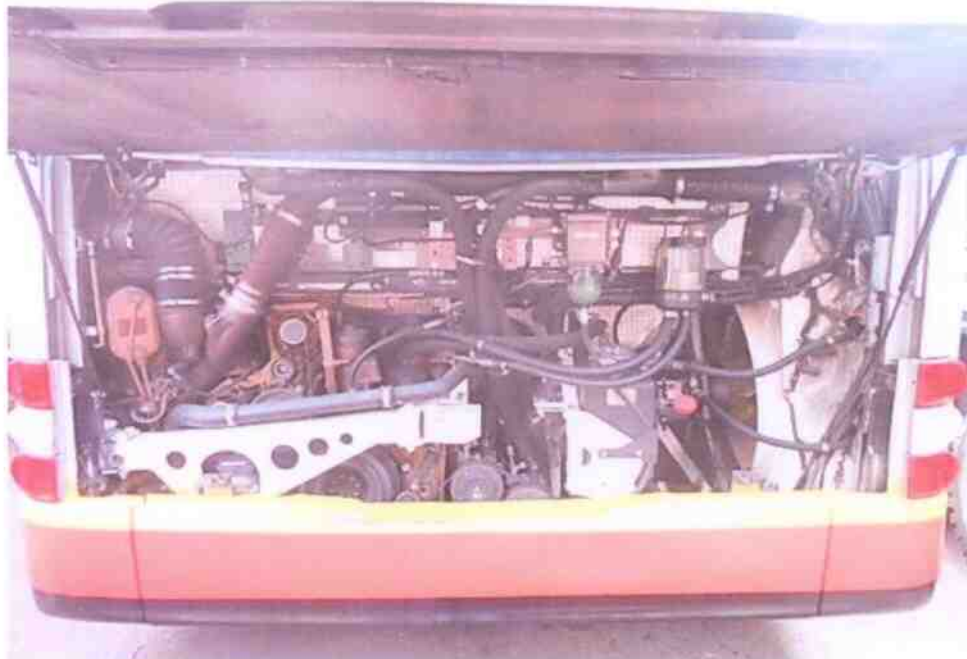
8. Upon examination of the engine compartment of the Motor Bus, we had observed all the parts and components inside the engine compartment to be intact and unaffected by the accident. The engine fluid was found to be of sufficient level for operating purposes. Visually, there was also no contamination found to these fluids.

9. Further examination of the engine compartment revealed no sign(s) or indication(s) of fluid leakage and/or fluid stain within the engine compartment of the Motor Bus.

Photo 9 shows the engine compartment of the Motor Bus was located at the rear of the Motor Bus.

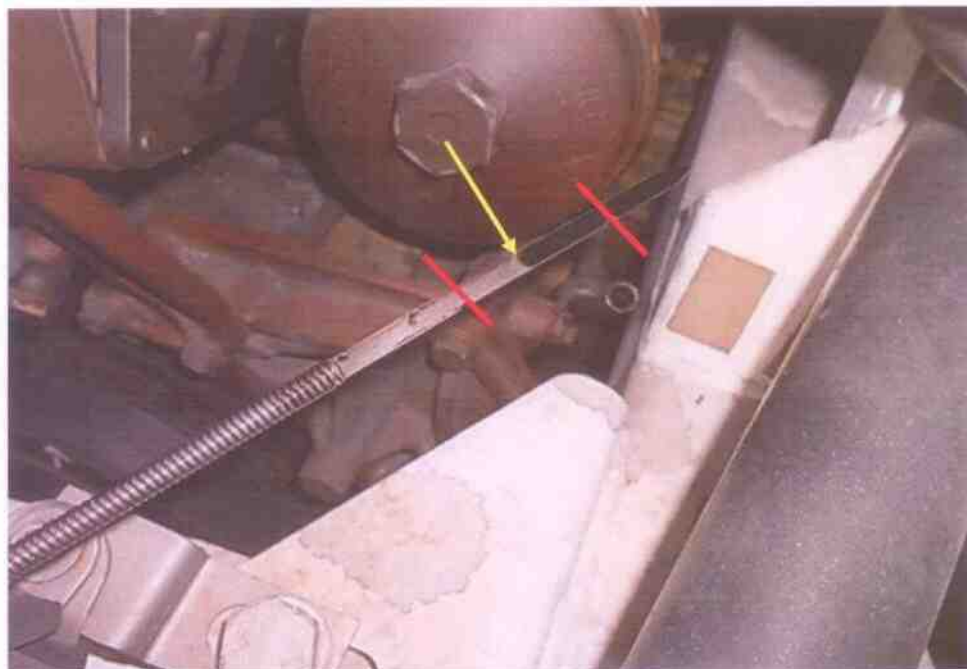
Photo 10 shows the engine fluid of the Motor Bus. It was observed to be of sufficient level (Yellow) without any contamination at time of our inspection.

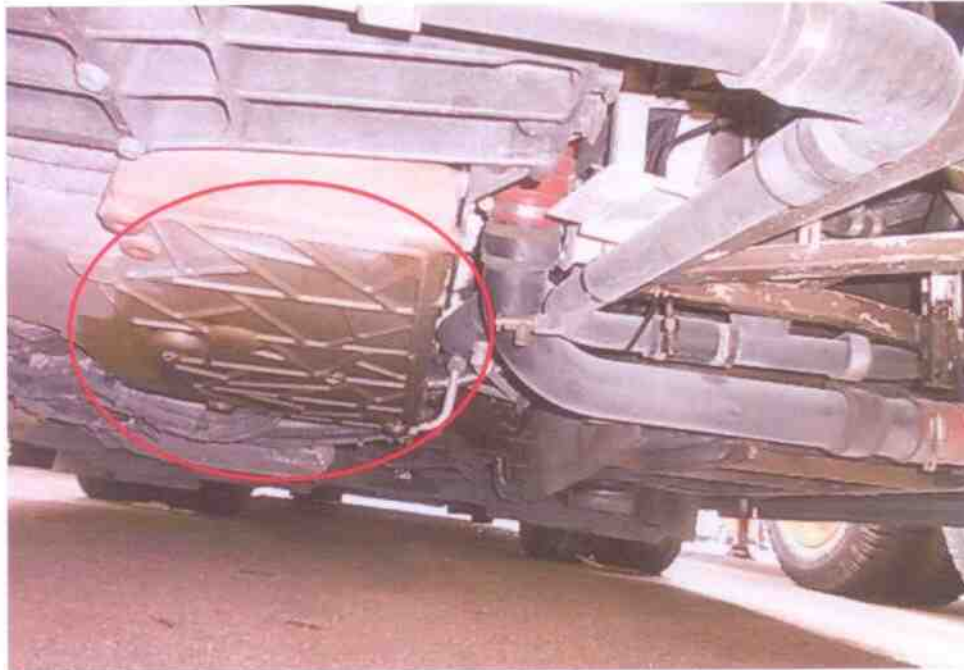
10. Our subsequent checks on the underside of the Motor Bus reveals some fluid stain sighted under the engine compartment. Further investigation found that the fluid stain was a pre-existed prior the accident & not a fresh fluid. This was due to some dirt observed on the fluid stain. Conclusive, it is not likely to be related to the accident. Visually, the various undercarriage components of the Motor Bus were all observed to be intact and without any visible damage. See photo 9 – 11 below.

Photo 11 shows the engine underside of the Motor Bus. Our subsequent checks on the underside of the Motor Bus reveals some fluid stain sighted under the engine compartment. Further investigation found that the fluid stain was a pre-existed prior the accident & not a fresh fluid. This was due to some dirt observed on the fluid stain. Conclusive, it is not likely to be related to the accident. Visually, the various undercarriage components of the Motor Bus were all observed to be intact and without any visible damage.

20. Although our subsequent checks on the underside of the Motor Bus reveals some fluid stain sighted under the engine compartment. Further investigation found that the fluid stain was a pre-existed prior the accident & not a fresh fluid. This was due to some dirt observed on the fluid stain. Conclusive, it is not likely to be related to the accident. Visually, the various undercarriage components of the Motor Bus were all observed to be intact and without any visible damage.

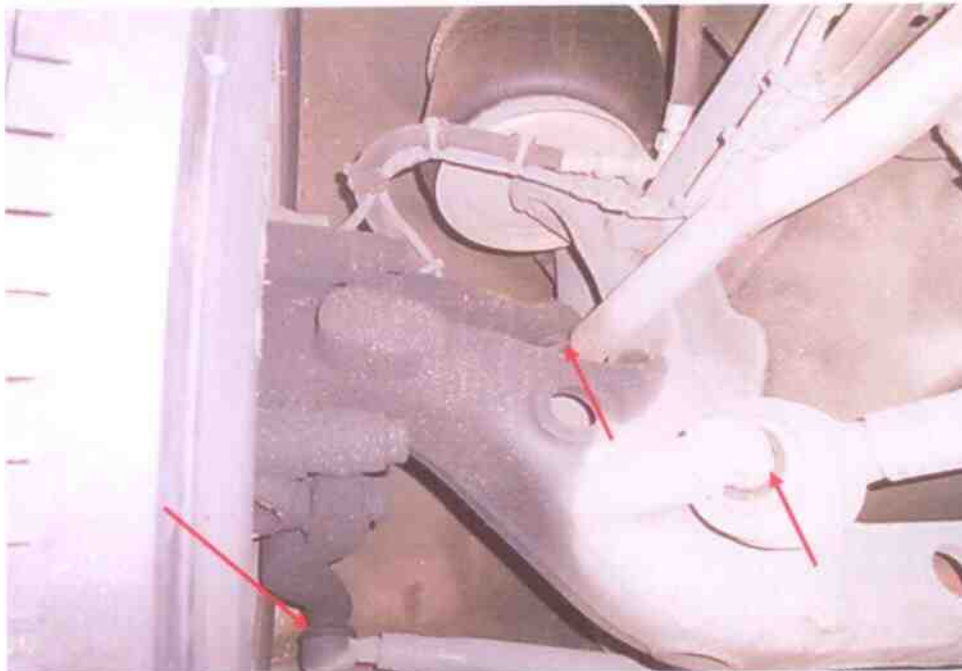
11. The mechanical components of the Motor Bus's steering system were all found to be visually intact and undamaged. The steering shaft and steering rack of the Motor Bus were observed to be intact and securely attached to the front left wheel and front right wheel. The steering ball joints were also observed to be in a serviceable condition.
12. Although the steering system could not be tested at the time of our inspection (engine unable to be started), it is likely that the steering system of the Motor Bus was in serviceable condition since its mechanical components were all found to be generally intact and securely fitted. See photo 12 & 13 below.

Photo 12 shows some of the mechanical components (arrowed) of the Motor Bus's steering system. Our visual checks on the various mechanical components of the steering system revealed all to be intact and in good condition. The steering system of the Motor Bus is hence likely to be in serviceable condition at the time of accident.

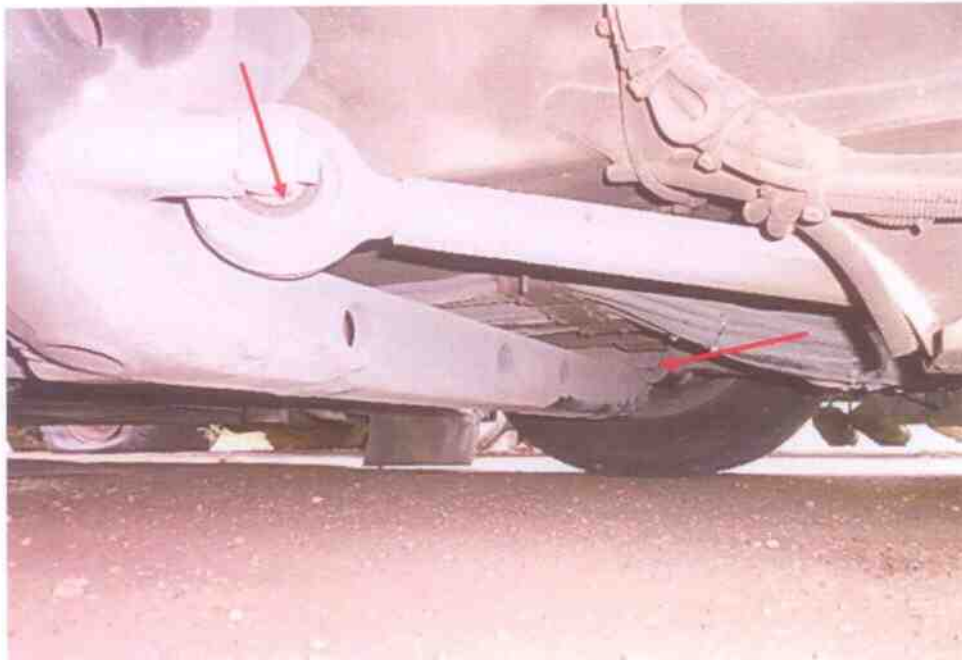
Photo 13 shows the undercarriage components at the front right wheel of the Motor Bus. The various undercarriage components of the Motor Bus were all observed to be intact and without any visible damage. This had included the steering rack and steering ball joints (arrowed) of the Motor Bus.

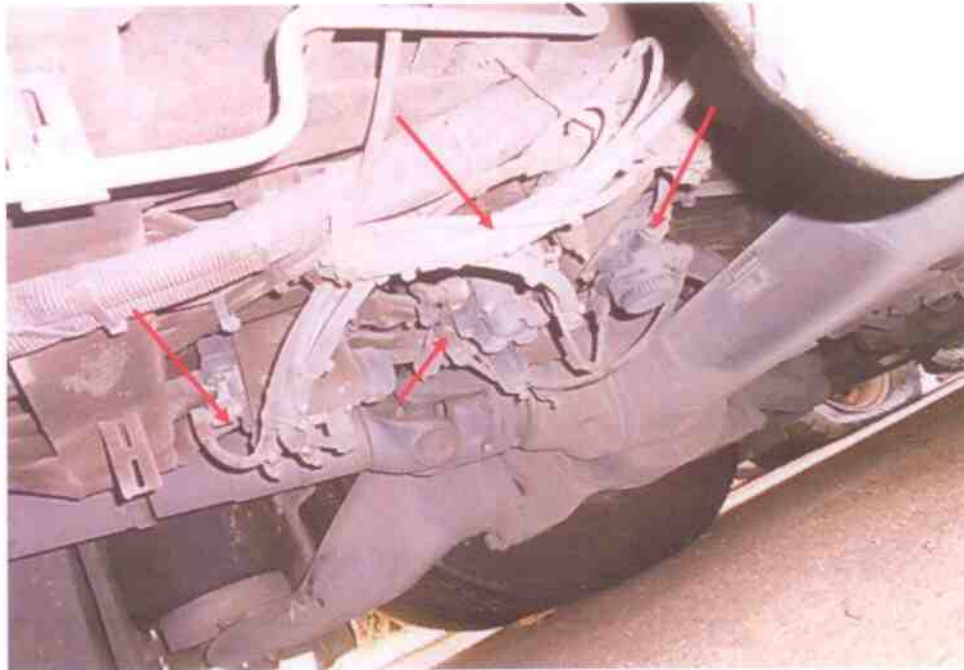
14. Since the engine of the Motor Bus could not be started, we were hence not able to carry out test(s) on whether there was any leakage of compressed air that could have affected the braking efficiency of the Motor Bus. However the air pipes, air tanks and connecting valves had all appear to be in good general condition and securely fitted upon our visual examination of these parts.

15. In general, our visual inspection of the mechanical components of the Motor Bus's braking system appear to suggest that its braking system was in serviceable condition at the material time of accident. See photo 14 below.

Photo 14 shows a general view of the air tank, valves, pipes and hoses, which are some of the components for the air-assisted braking system of the Motor Bus. This was at the underside of the Motor Bus. We were however not able to carry out any operational test(s) to the braking system of the Motor Bus as its engine was unable to be started.

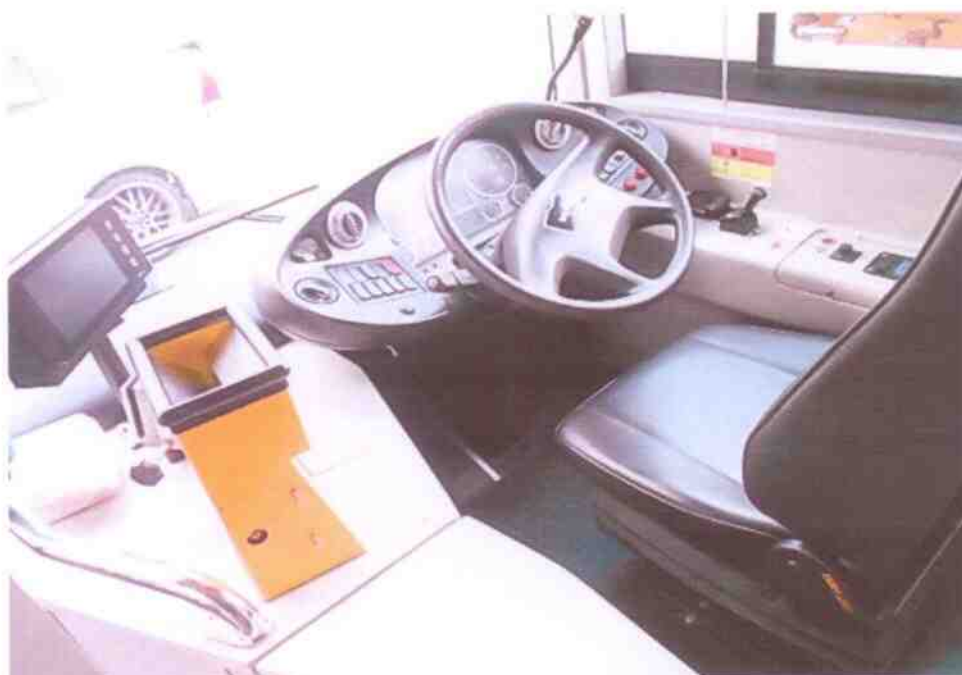
Photo 15 shows the indicators at the driver's seat. Other operational indicators were unable to be initialize due to the flat battery. Hence, no test was carried out to the Motor Bus operational indicators.

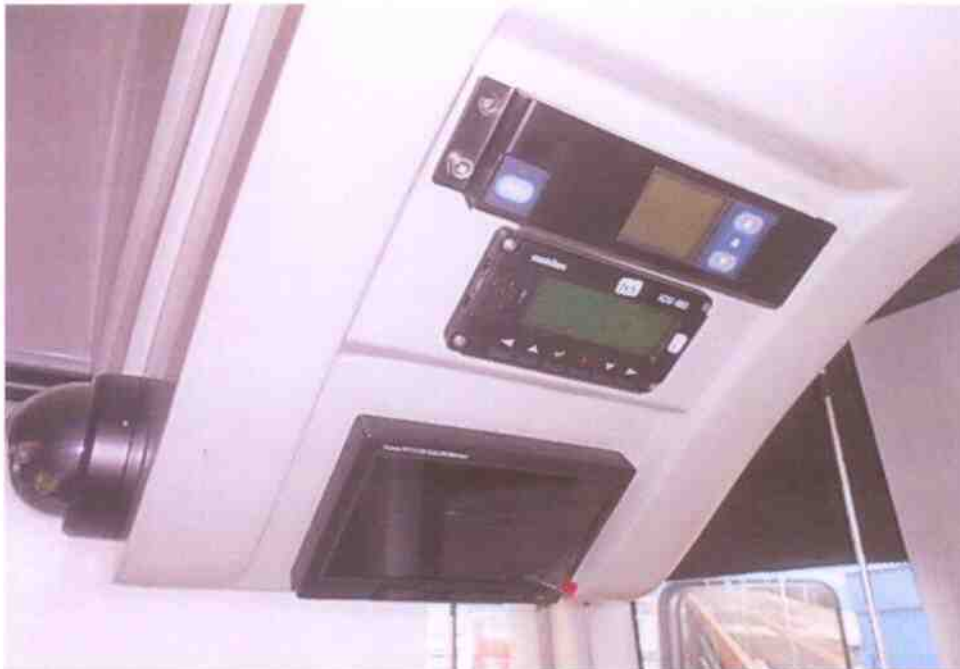
Photo 16 shows the indicators at the driver's seat. Other operational indicators were unable to be initialize due to the flat battery. Hence, no test was carried out to the Motor Bus operational indicators.
