Your Ref : TP/IP/56467/2017  
Our Ref : CI/TPD18000520/Z

23<sup>rd</sup> January 2018

**Fatal Accident Investigation Team**

**MECHANICAL INSPECTION REPORT OF GARBAGE TRUCK XD 4591D**

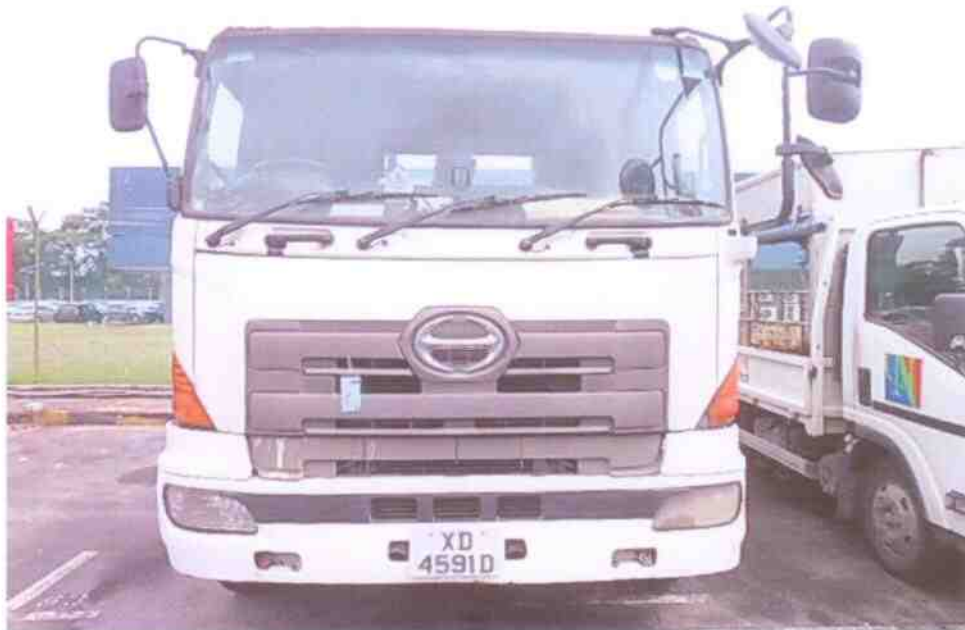
**Photo 1** shows a general view of the front body of the Garbage Truck at the time of our inspection. The Garbage Truck was observed to have no signs of fresh damages on its body portion.

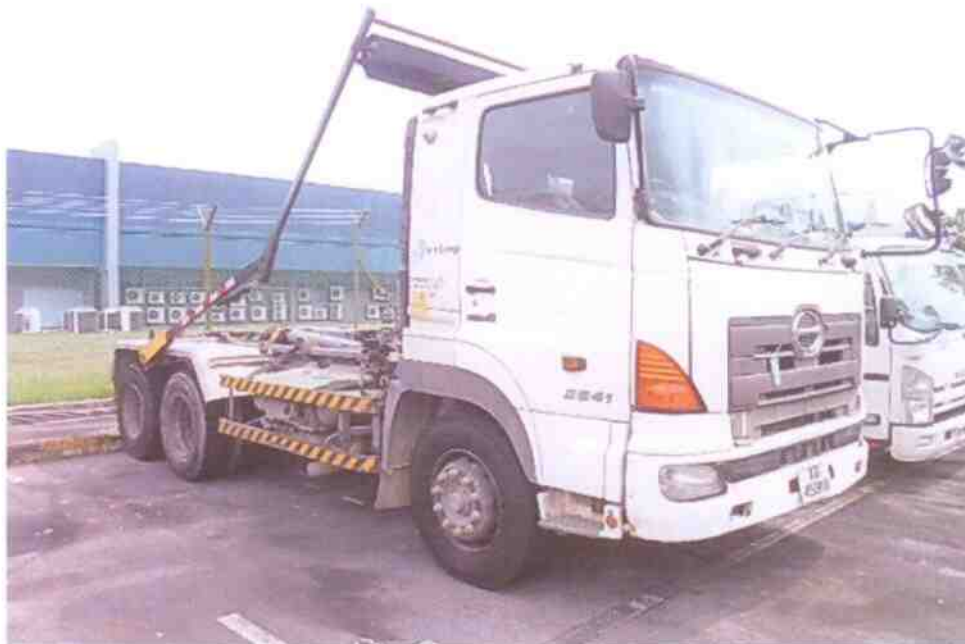
**Photo 2** shows a general view of the front right body of the Garbage Truck at the time of our inspection. The Garbage Truck was observed to have no signs of fresh damages on its body portion.

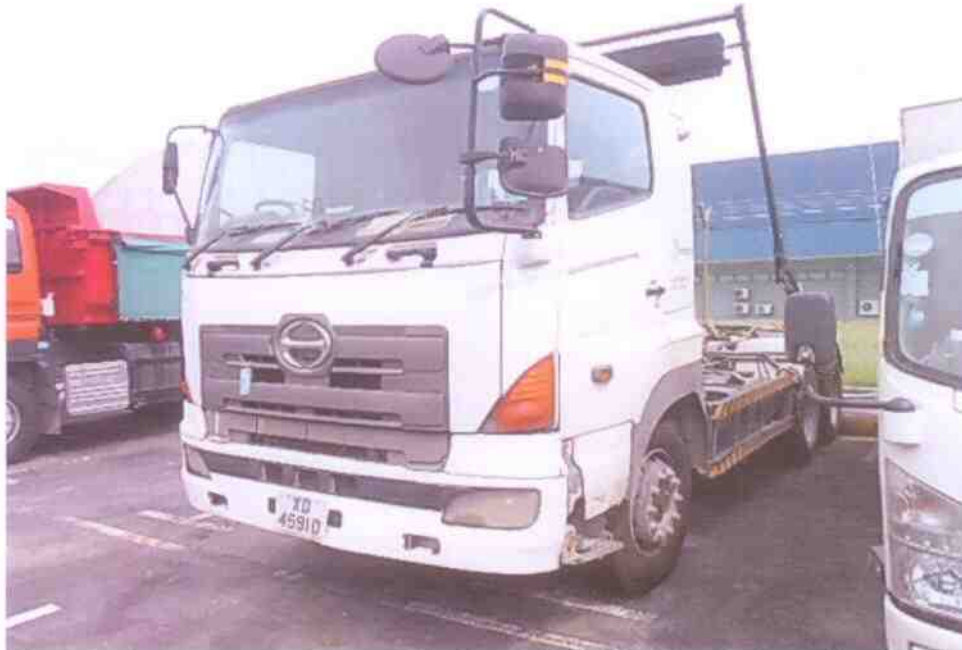
**Photo 3** shows a general view of the front left body of the Garbage Truck at the time of our inspection. The Garbage Truck was observed to have no signs of fresh damages on its body portion.

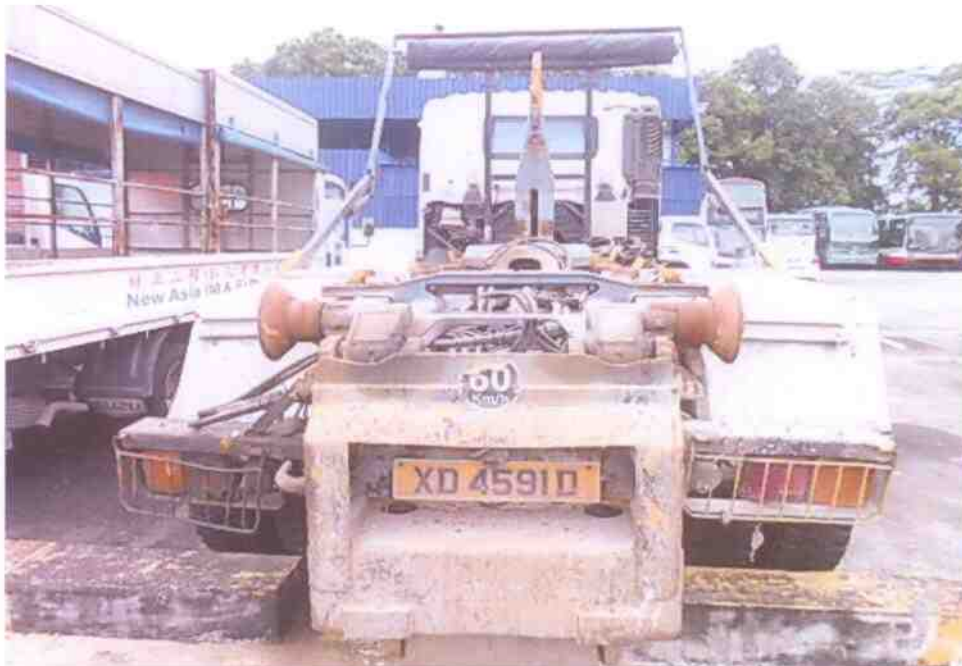
**Photo 4** shows a general view of the rear body of the Garbage Truck at the time of our inspection. The Garbage Truck was observed to have no signs of fresh damages on its body portion.

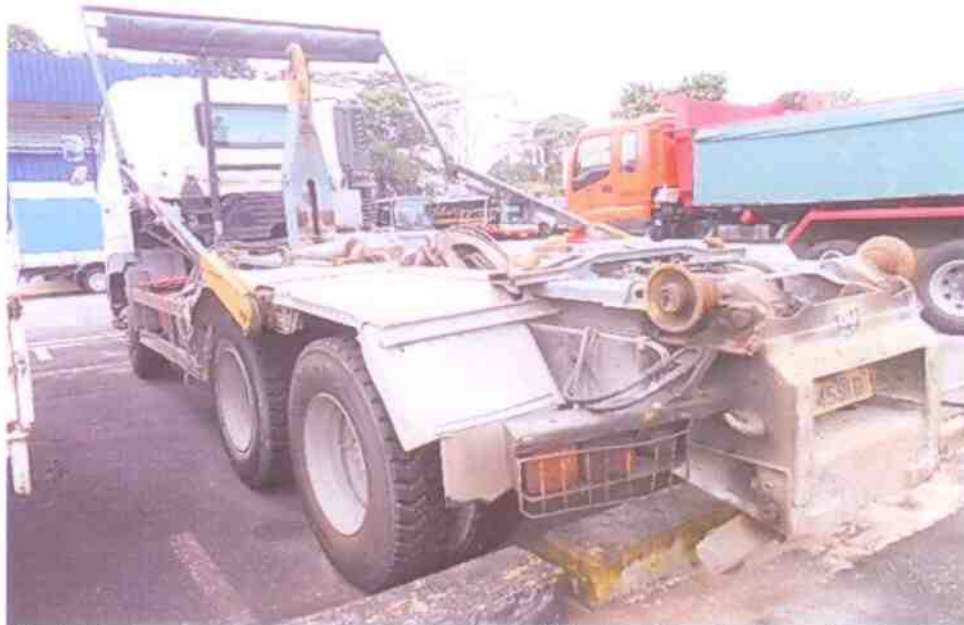
**Photo 5** shows a general view of the rear left body of the Garbage Truck at the time of our inspection. The Garbage Truck was observed to have no signs of fresh damages on its body portion.

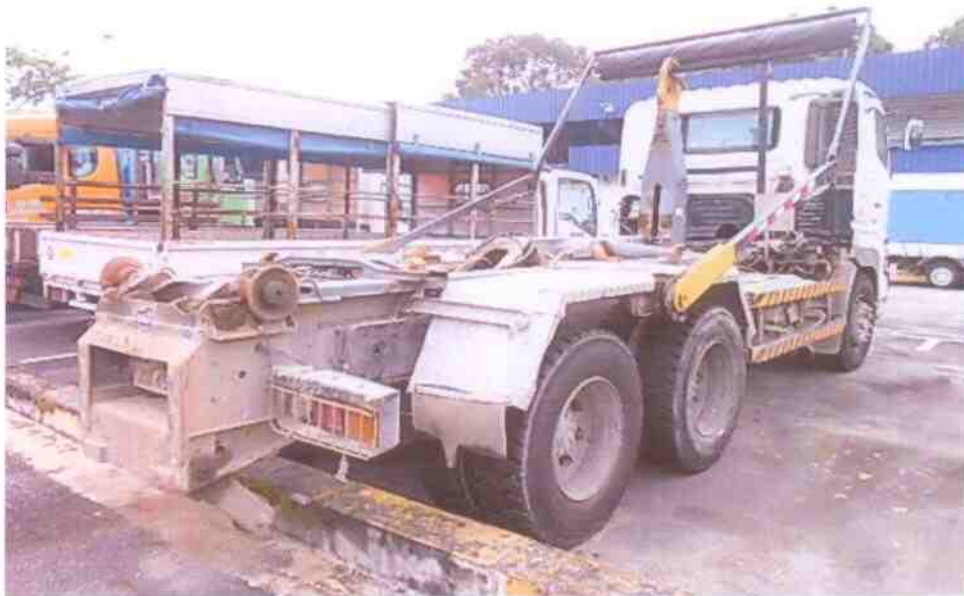
**Photo 6** shows a general view of the rear right body of the Garbage Truck at the time of our inspection. The Garbage Truck was observed to have no signs of fresh damages on its body portion.

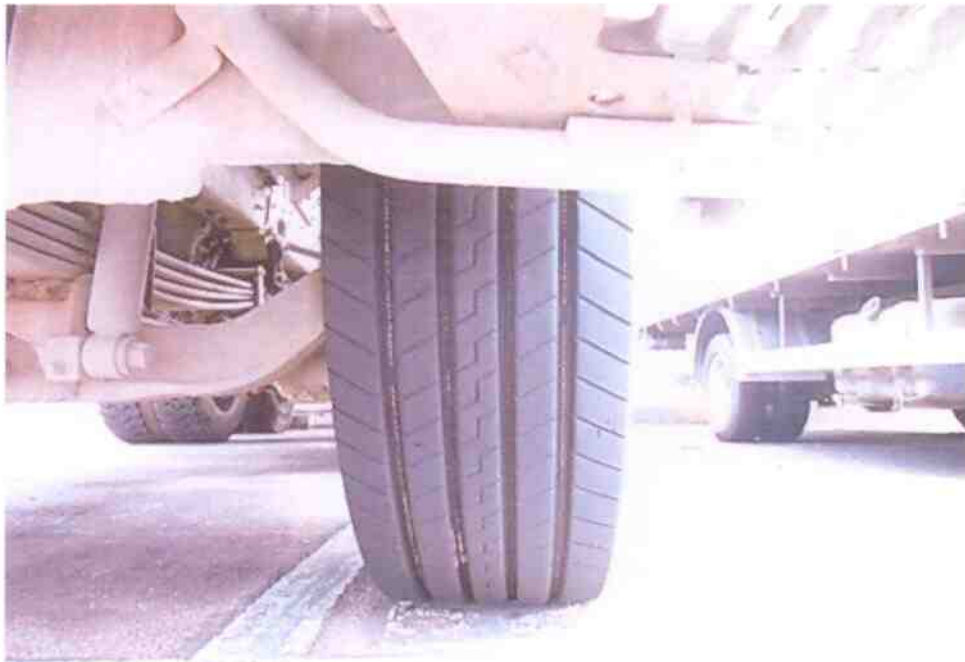
**Photo 7** shows the condition of the front left tyre of the Garbage Truck, which was observed to be in serviceable condition with remaining tread depth of approximately 8mm.

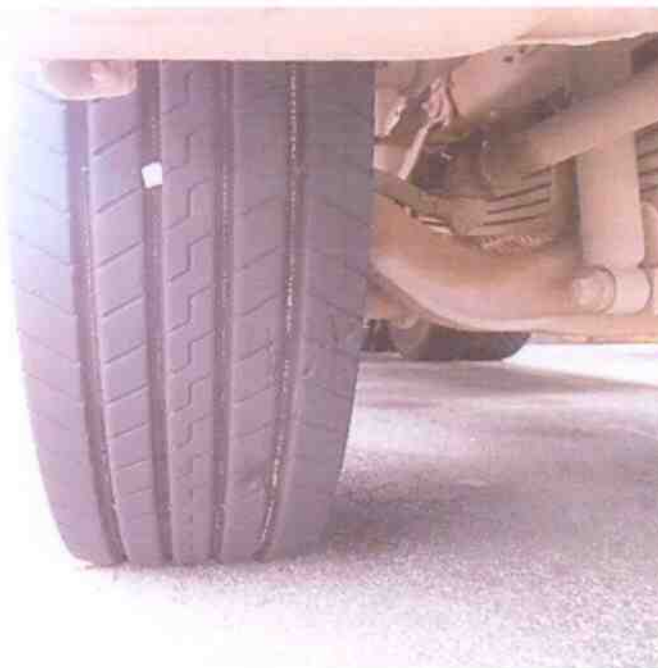
**Photo 8** shows the condition of the front right tyre of the Garbage Truck, which was observed to be in serviceable condition with remaining tread depth of approximately 10mm.

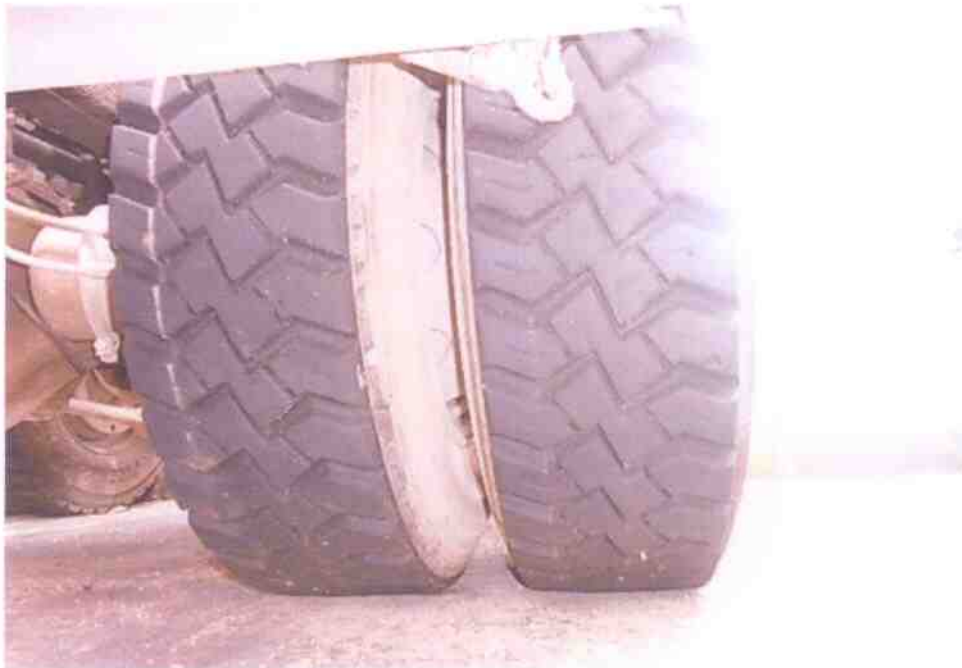
**Photo 9** shows the condition of the rear left tyres (centre axle) of the Garbage Truck, which were observed to be in serviceable condition with remaining tread depth of approximately 8mm. The tyres were also observed to be sufficiently inflated for vehicular operation.

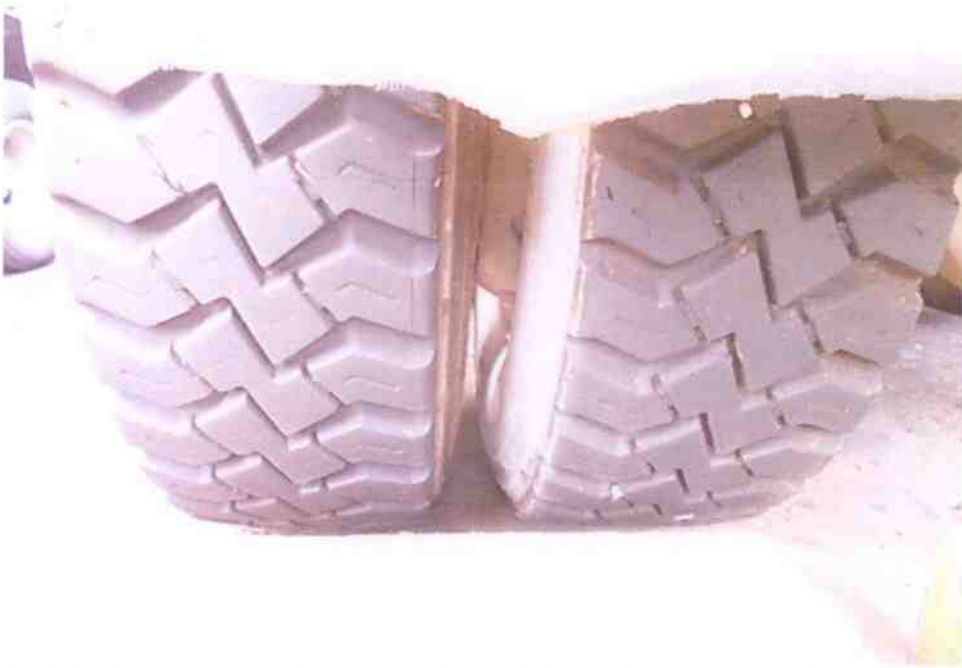
**Photo 10** shows the condition of the rear left tyres of the Garbage Truck, which were observed to be in serviceable condition with remaining tread depth of approximately 13mm. The tyres were also observed to be sufficiently inflated for vehicular operation.

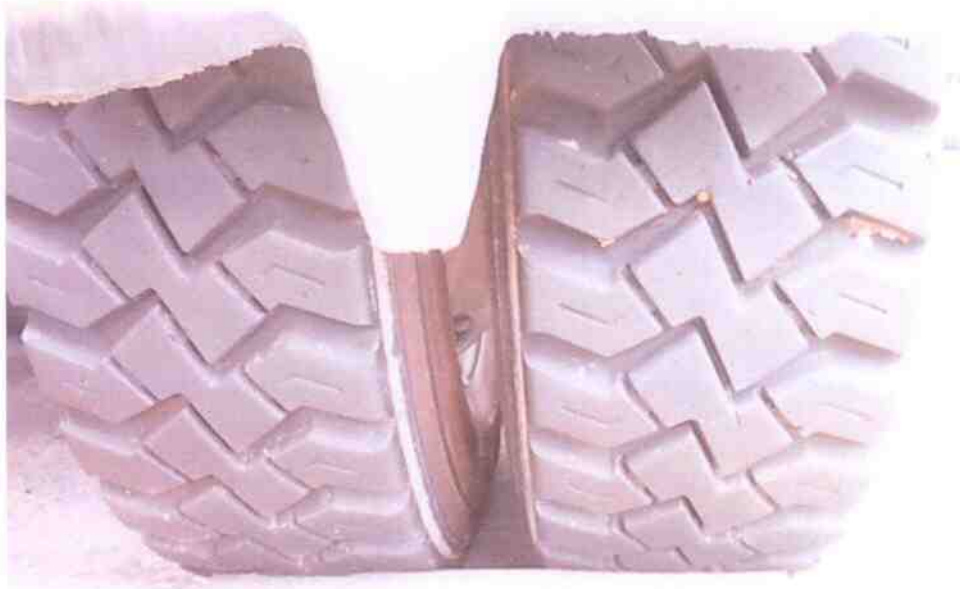
**Photo 11** shows the condition of the rear right tyres of the Garbage Truck, which were observed to be in serviceable condition with remaining, tread depth of approximately 13mm. The tyres were also observed to be sufficiently inflated for vehicular operation with no tear, cut or burst mark(s) on the outer and the inner sidewalls.

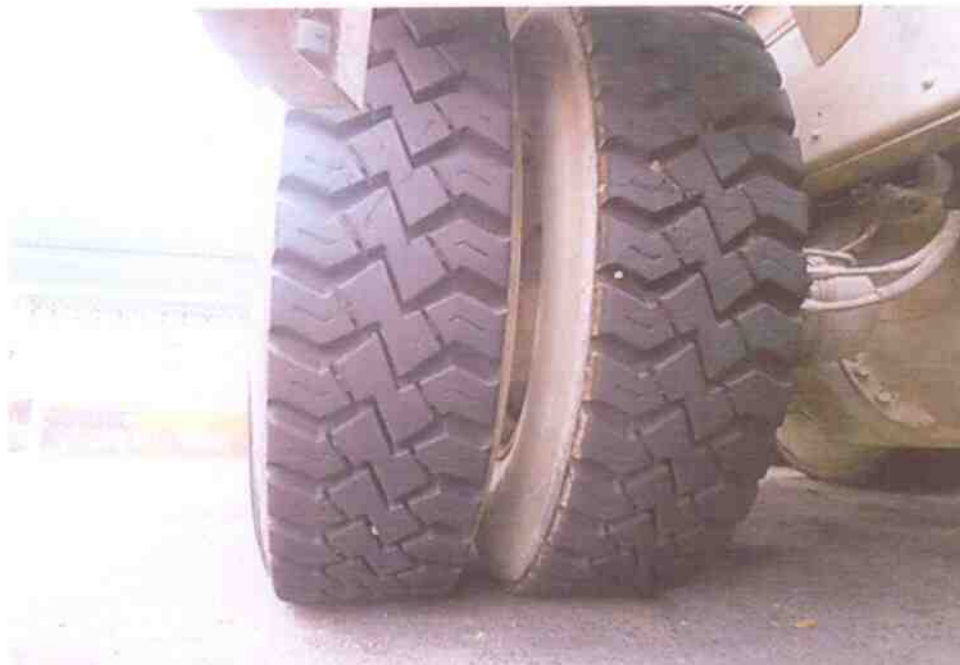
**Photo 12** shows the condition of the rear right tyres (centre axle) of the Garbage Truck, which were observed to be in serviceable condition with remaining, tread depth of approximately 14mm. The tyres, which were wrapped around standard alloy wheel rims, were also observed to be sufficiently inflated for vehicular operation.

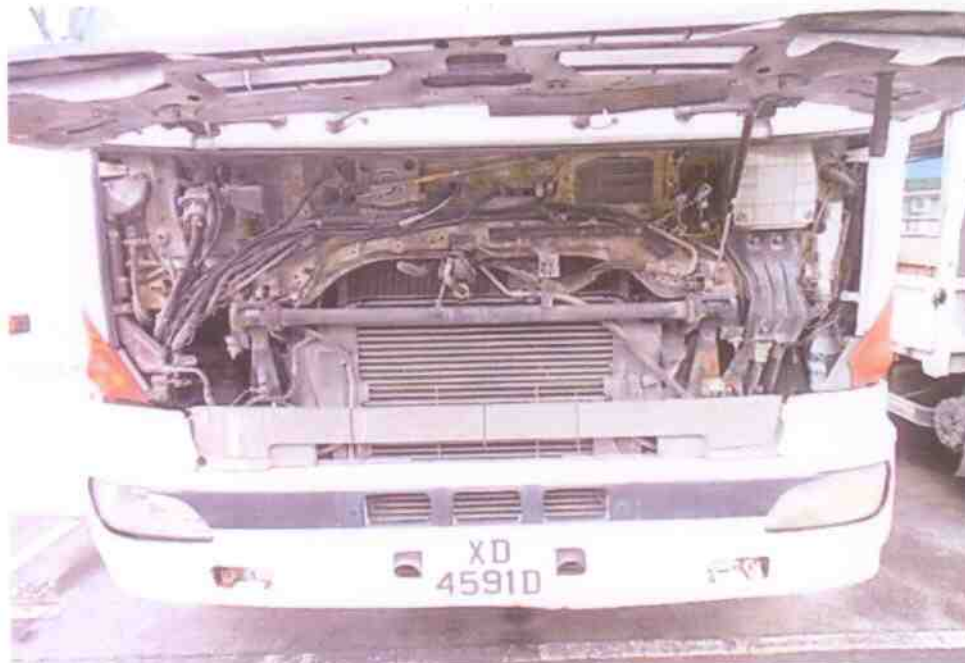
**Photo 13** shows a general view of the engine compartment area from the front bonnet of the Tipper Truck.

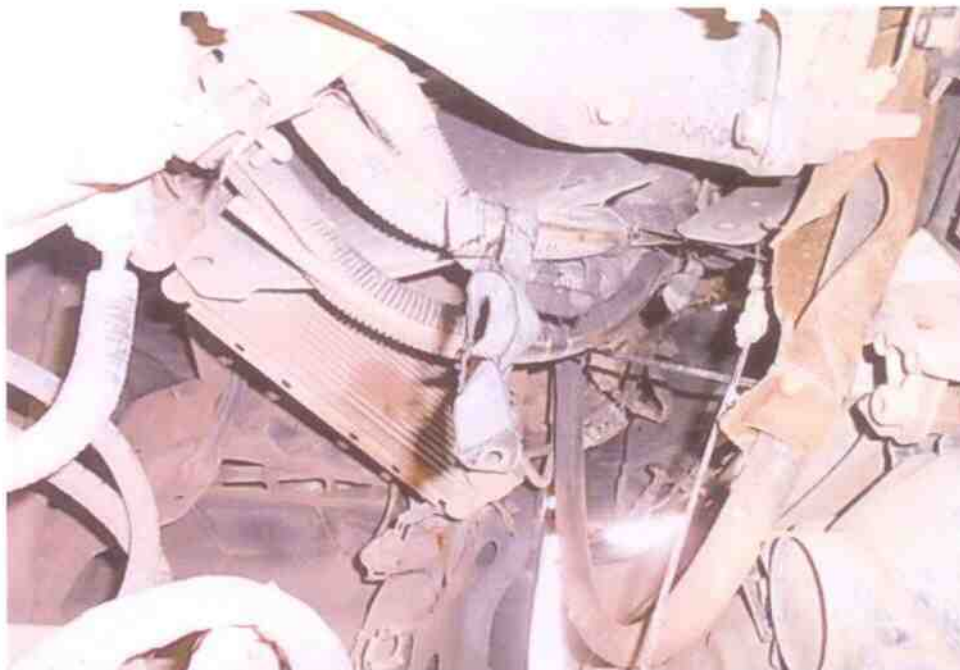
**Photo 14** shows a general view of the engine area from the underside of the Tipper Truck. The engine assembly and transmission assembly were both observed to be intact and unaffected by the collision. There was also no sign(s) or indication(s) of fresh fluid leak and/or fluid stain found.

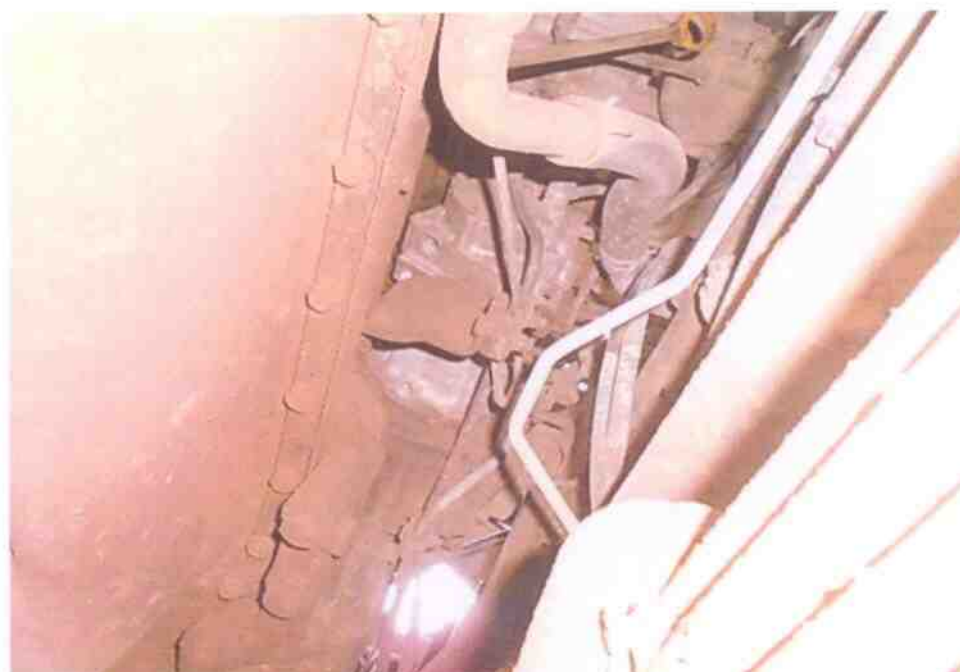
**Photo 15** shows a general view of the engine compartment of the Tipper Truck, which was located directly under the front cabin. Although the engine compartment of the Garbage Truck could not be closely examined, we were still able to observe that the engine assembly and transmission assembly were intact and unaffected by the collision. There was also no sign(s) or indication(s) of fresh fluid leak and/or fluid stain found.

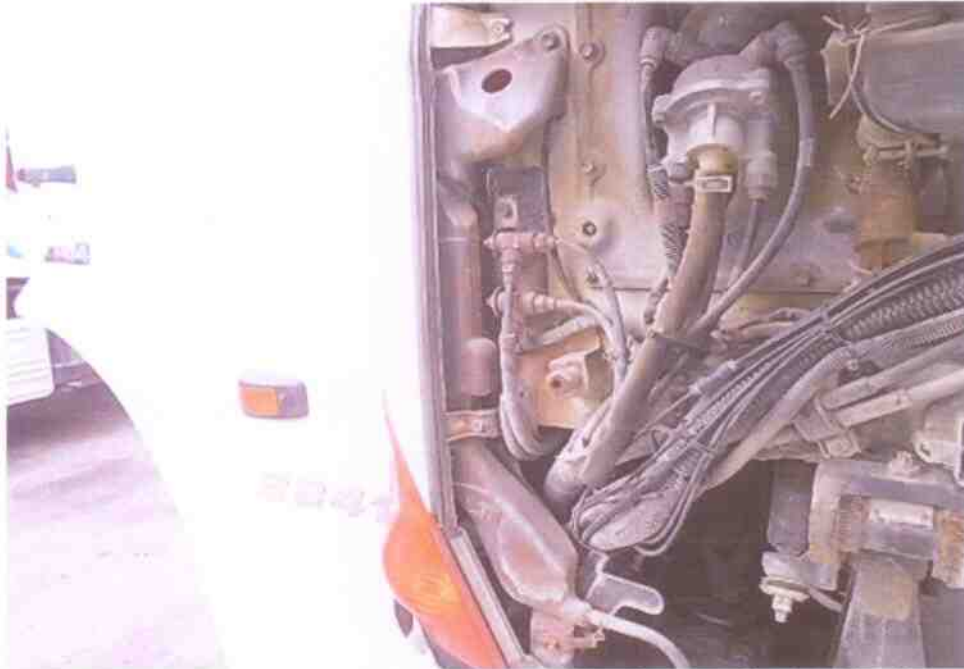
**Photo 16** shows the engine coolant reservoir of the Garbage Truck at the time of our inspection. The engine coolant was observed to be of sufficient level and without any visible contamination for operational purposes.

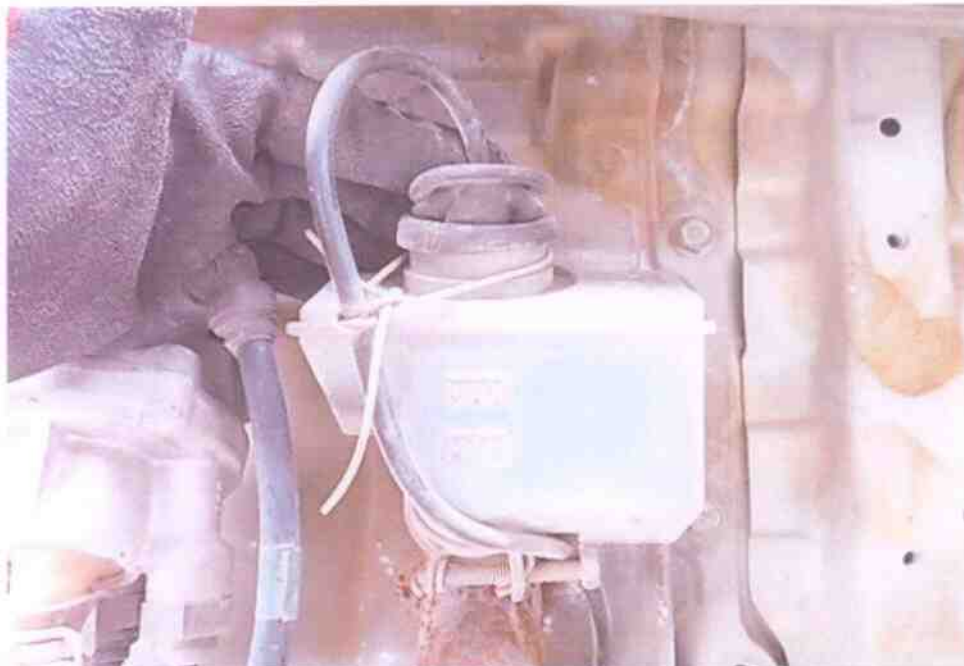
**Photo 17** shows the brake fluid reservoir of the Garbage Truck at the time of our inspection. It was observed to be of sufficient level and without any visible contamination for operational purposes.

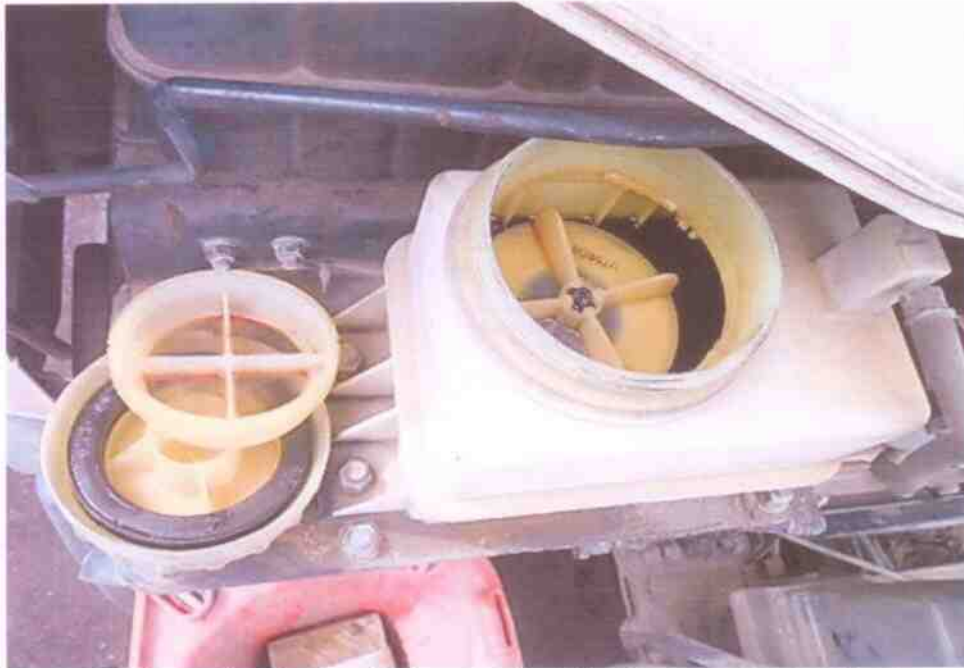
**Photo 18** shows the steering fluid reservoir of the Garbage Truck at the time of our inspection. It was observed to be of sufficient level and without any visible contamination for operational purposes.

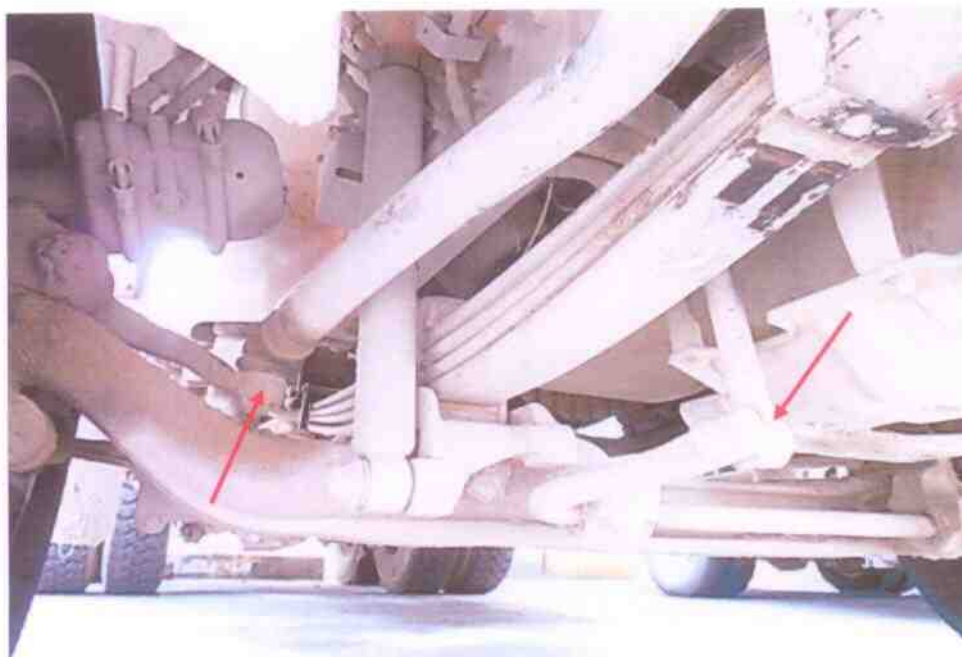
**Photo 19** shows the undercarriage components at the front right wheel of the Garbage Truck. The various undercarriage components of the Garbage Truck were all observed to be intact and without any visible damage. This had included the steering rack and steering linkages (arrowed) of the Garbage Truck.

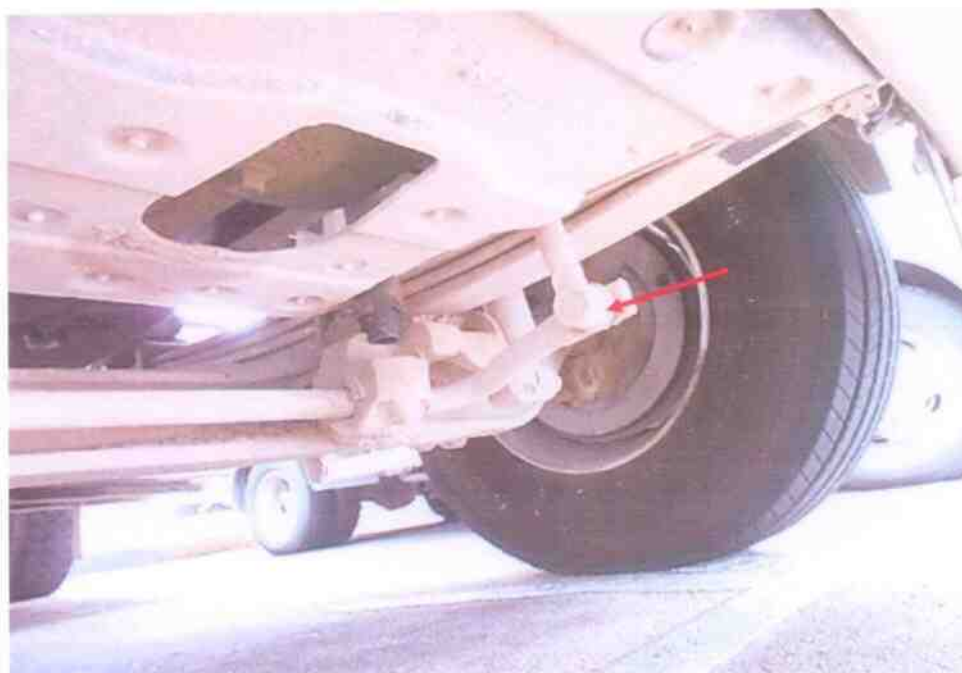
**Photo 20** shows the undercarriage components at the front left wheel of the Garbage Truck. The various undercarriage components of the Garbage Truck were all observed to be intact and without any visible damage. This had included the steering rack (arrowed) of the Garbage Truck, which was observed to be securely attached to the front left wheel.

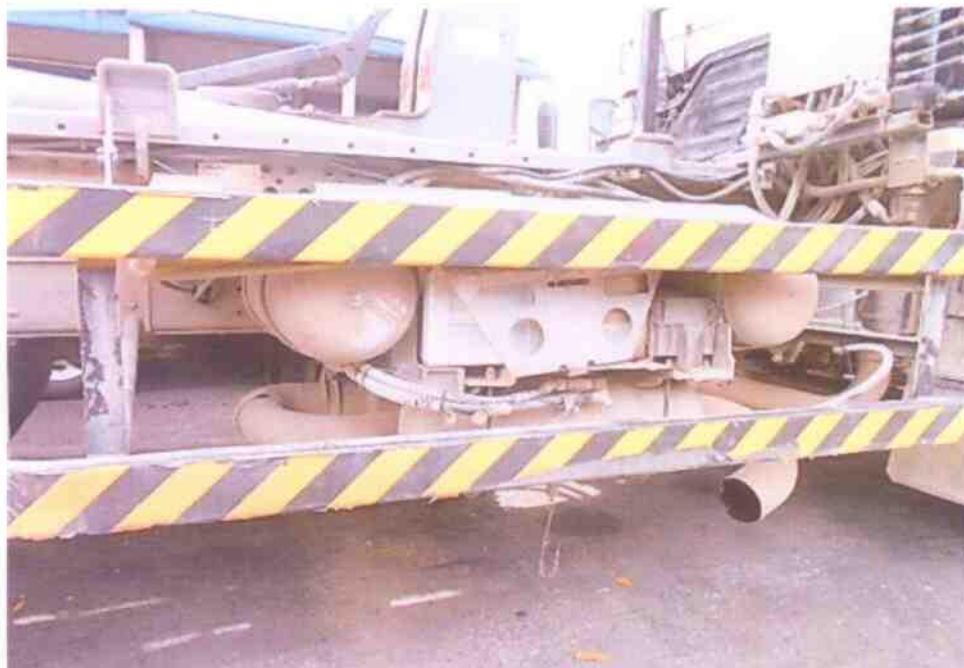
**Photo 21** shows the air tanks, valves, pipes and hoses, which are some of the components for the air-assisted braking system of the Garbage Truck.

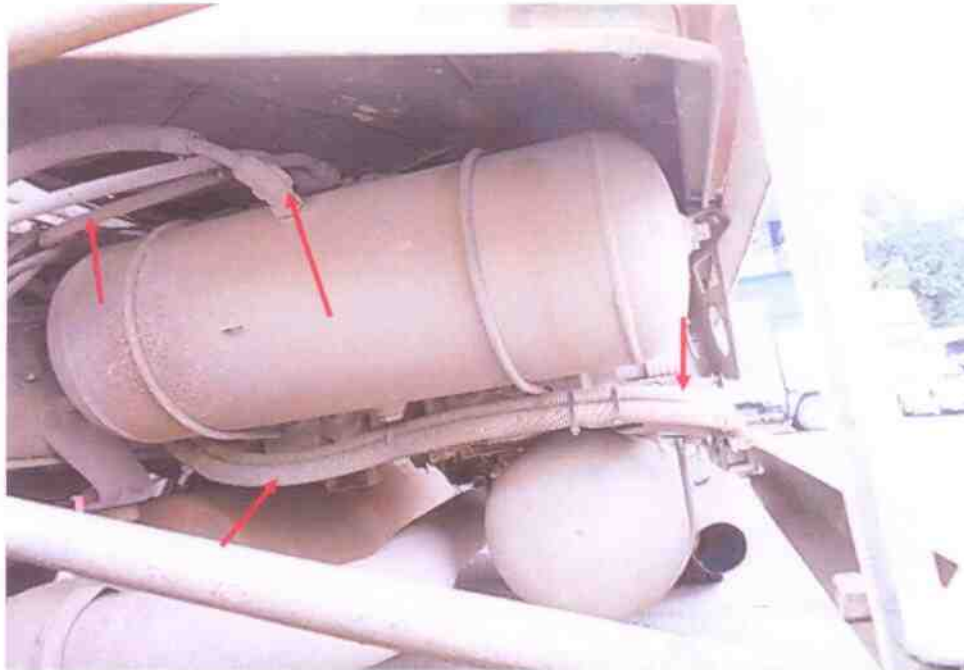
**Photo 22** shows the valves, brake hoses and pipes, which are some of the components for the air-assisted braking system of the Garbage Truck. These components were mainly located around the right centre body of the Garbage Truck, and were unaffected by the accident. Our visual examination of these parts revealed all to be in good general condition and securely fitted.

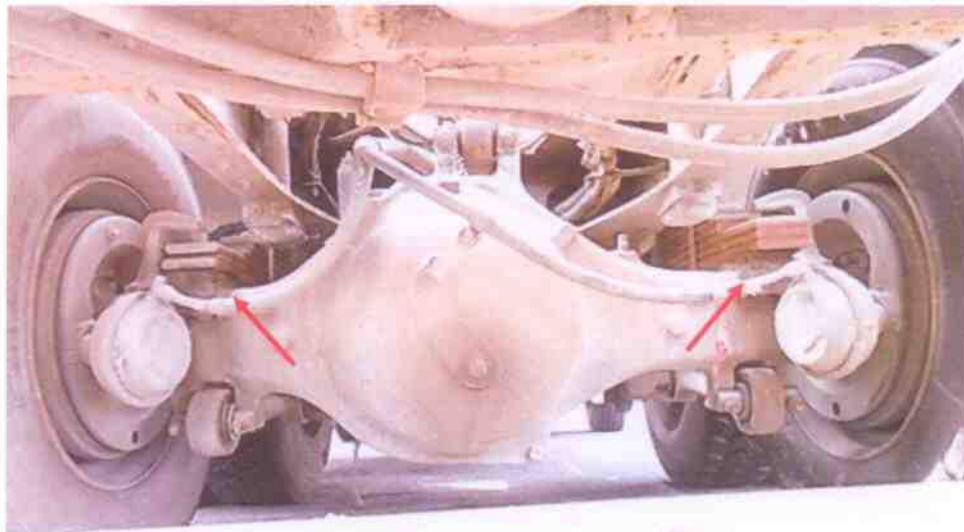
**Photo 23** shows the brake hoses (arrowed) leading to the rear left wheel and rear right wheel of the Garbage Truck. At the time of our inspection, the various mechanical components of the air-assisted hydraulic braking system of the Garbage Truck were all found to be in good general condition and securely fitted.

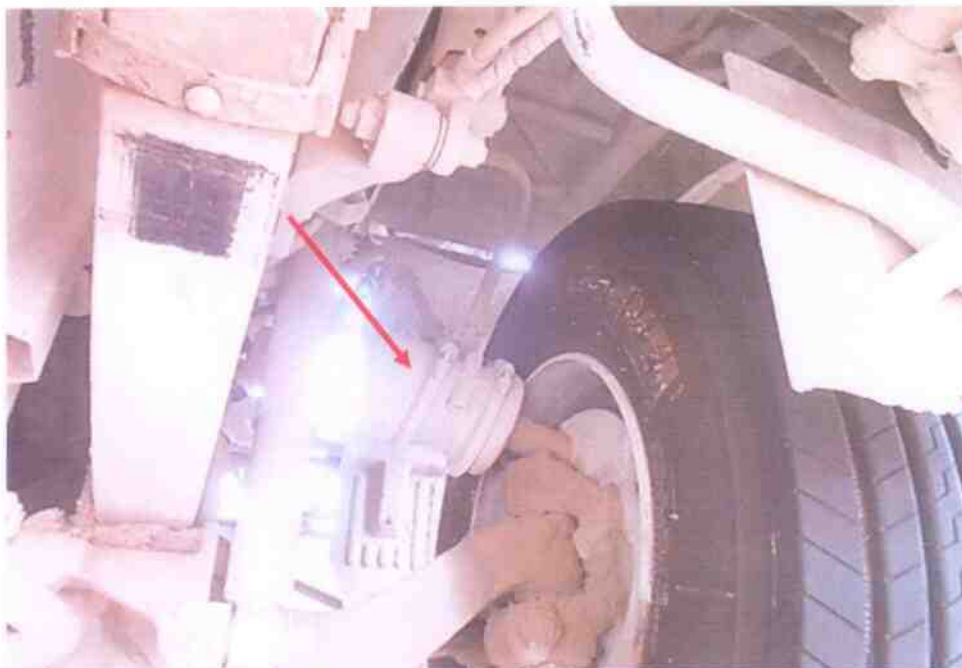
**Photo 24** shows the brake air cylinder (arrowed) at the front left rear wheel of the Garbage Truck. Such air cylinder, which is amongst the various components for the air-assisted hydraulic braking system, can be found attached to all the front wheels and all the wheels of the Garbage Truck. Upon our checks, we had found all the brake air cylinders to be undamaged and securely fitted to all the wheels of the Garbage Truck.

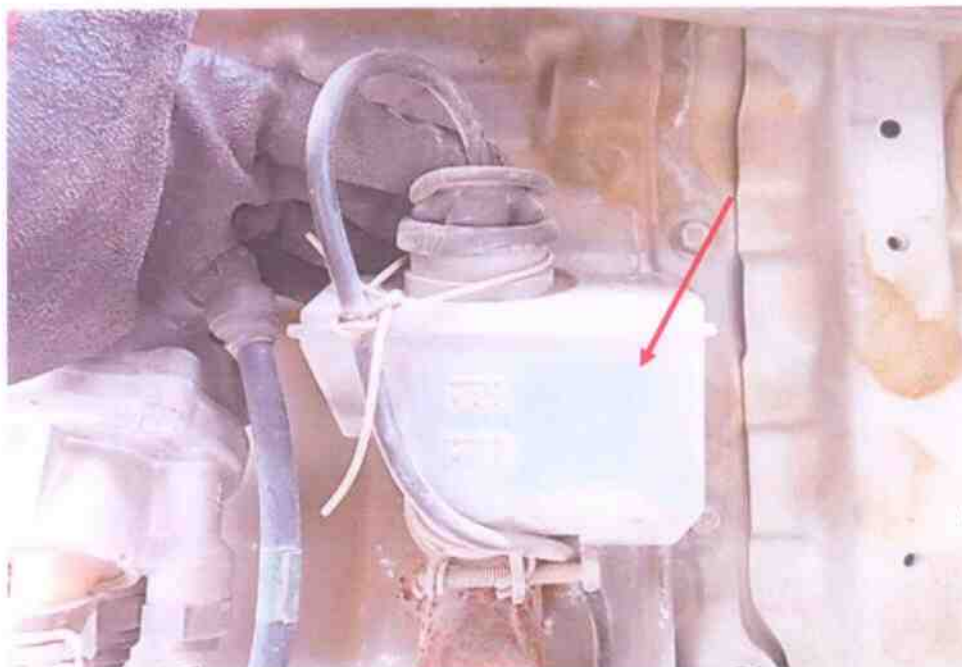
**Photo 25** shows the brake fluid at the front bonnet of the Garbage Truck. The brake fluid was found to be of sufficient level for operating purposes. Visually, there was also no contamination found to these fluids.

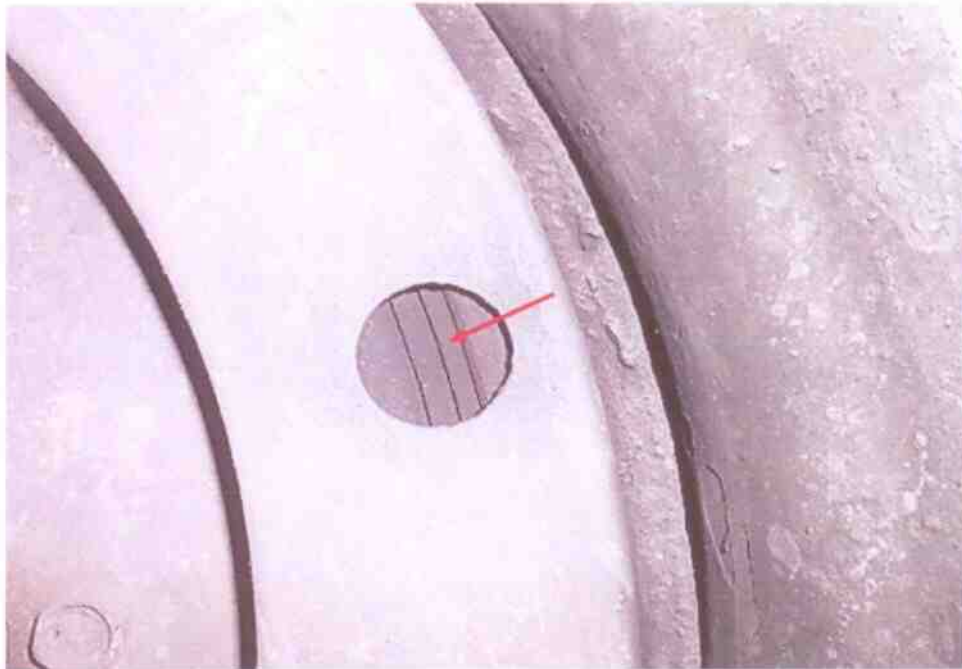
**Photo 26** shows the brake shoes (brake pads) at the front right wheel of the Garbage Truck. The brake shoes (brake pads) of the Garbage Truck were all found to be in serviceable condition with sufficient frictional material for operational purposes.
