Your Ref: TP/IP/51283/2017
Our Ref : CI/TPD18000524/Z

Fatal Accident Investigation Team

MECHANICAL INSPECTION REPORT OF MOTOR BUS PC 5461P

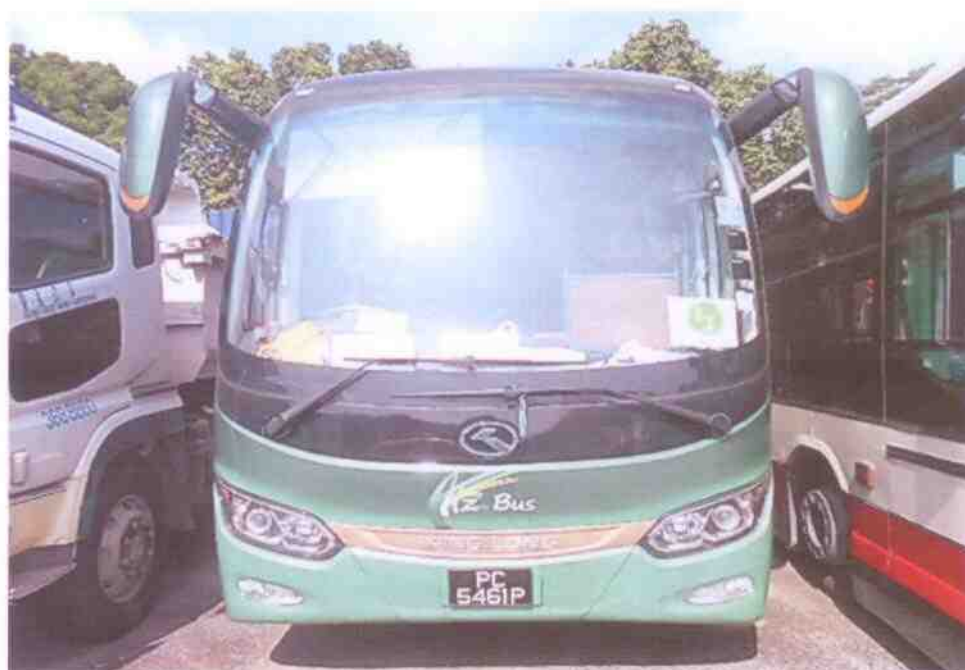
Photo 1 shows a general view of the front body of the Motor Bus at the time of our inspection. The Motor Bus was observed to be in good condition. No damage was noted at time of our inspection.

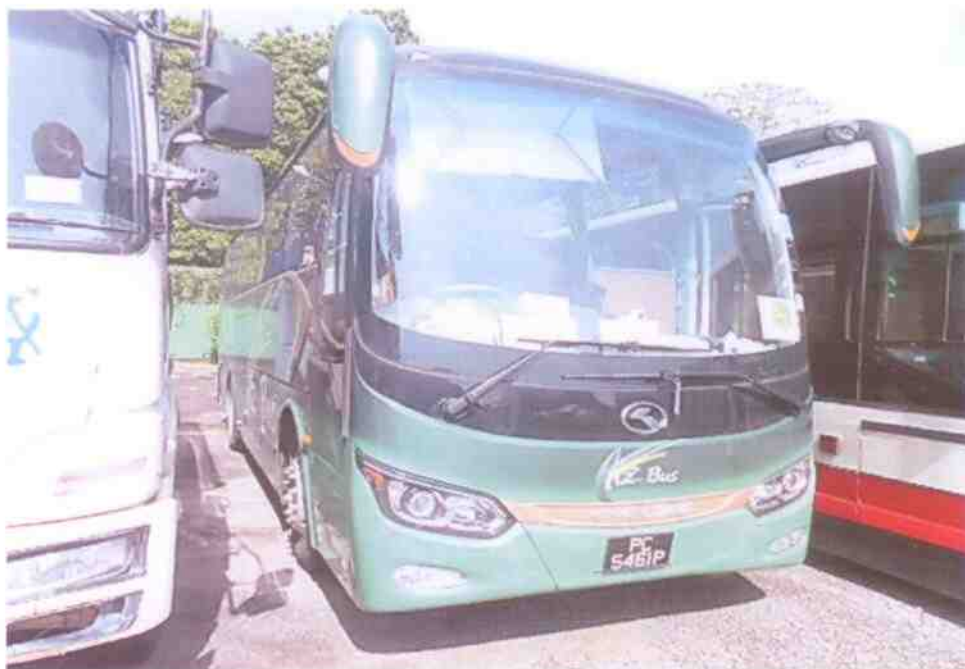
Photo 2 shows a general view of the front right body of the Motor Bus at the time of our inspection. The Motor Bus was observed to be in good condition. No damage was noted at time of our inspection.

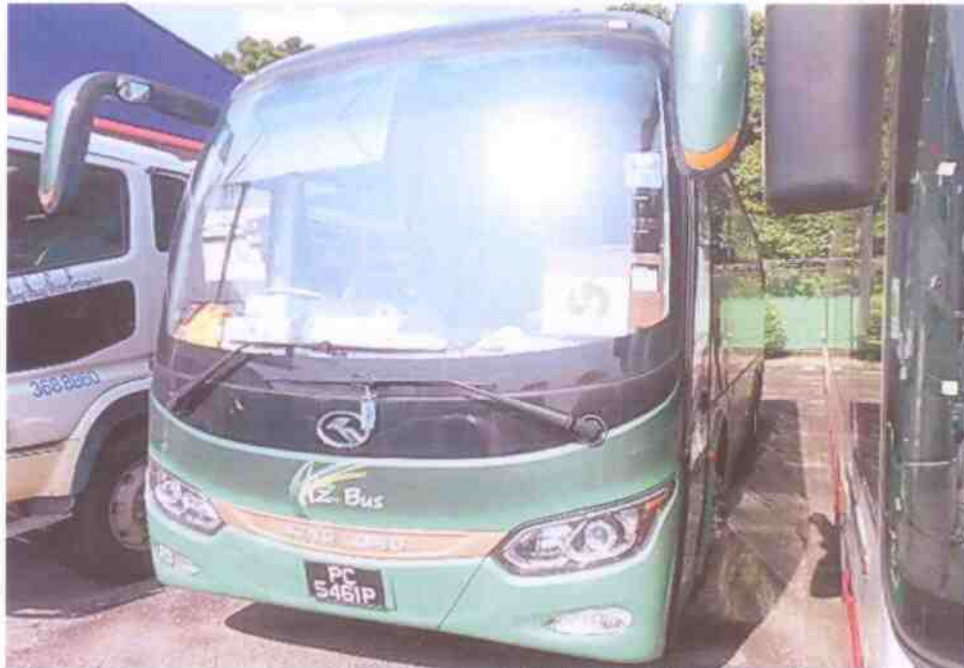
Photo 3 shows a general view of the front left body of the Motor Bus at the time of our inspection. The Motor Bus was observed to be in good condition. No damage was noted at time of our inspection.

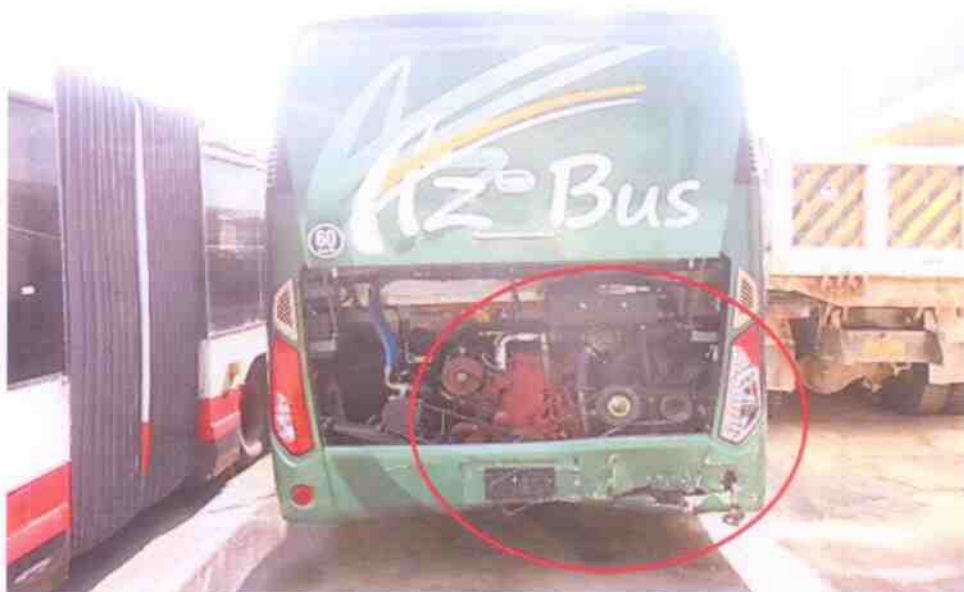
Photo 4 shows a general view of the Motor Bus's rear body at the time of our inspection. The Motor Bus was observed to have sustained relatively minor impact damage at its rear body portion due to the accident's impact.

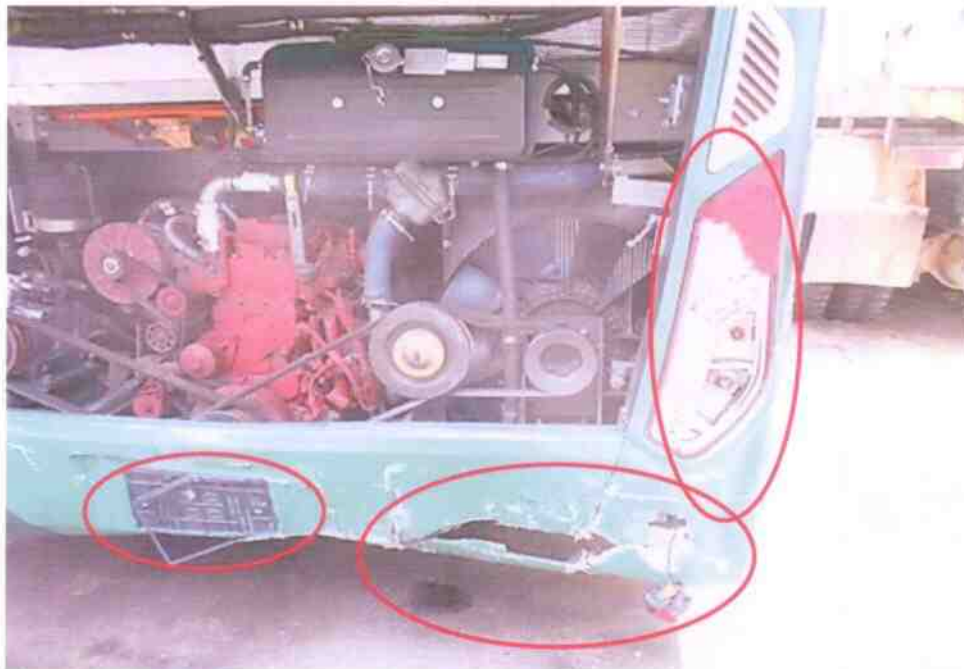
Photo 5 shows a semi close-up view of the Motor Bus's rear body at the time of our inspection. The Motor Bus was observed to have sustained relatively minor impact damage at its rear body portion due to the accident's impact.

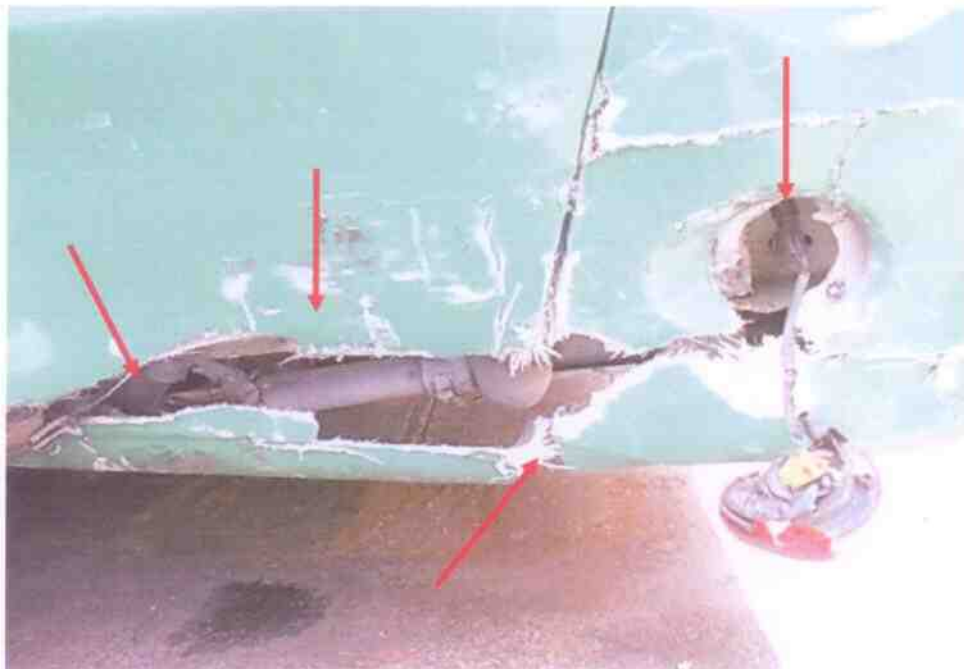
Photo 6 shows a close-up view of the Motor Bus's rear body at the time of our inspection. The Motor Bus rear lower bumper was observed to be cracked & the spot light was dislodged from its bracket.

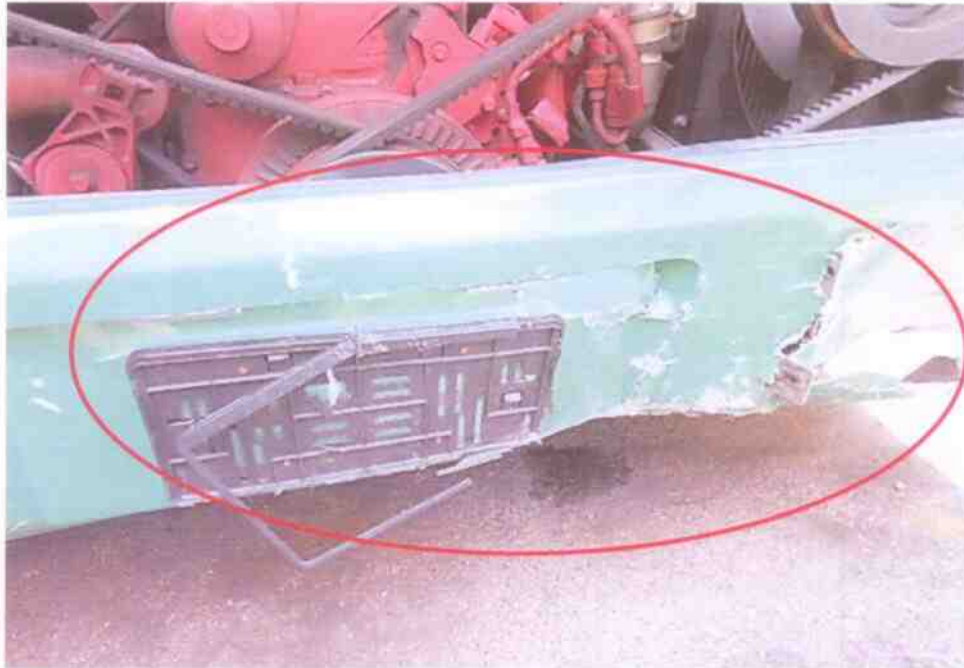
Photo 7 shows a close-up view of the Motor Bus's rear body at the time of our inspection. The Motor Bus rear number plate was missing at time of our inspection.

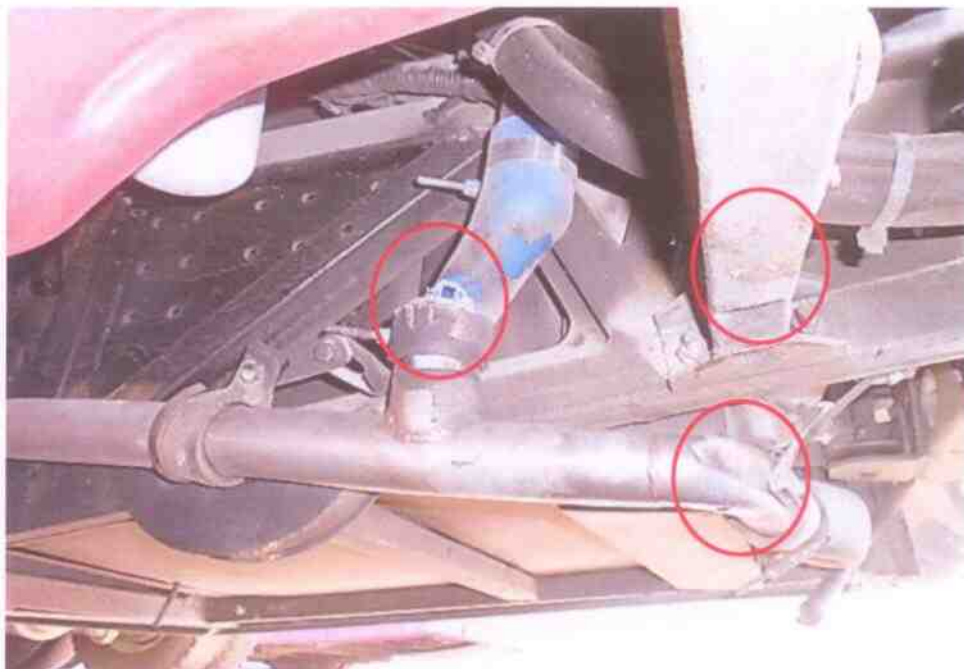
Photo 8 shows a close-up view of the Motor Bus's rear body at the time of our inspection. Its rear right reinforcement bar, hose & steel pipe was observed to be scratched, cut & dented likely due to the accident's collision impact.

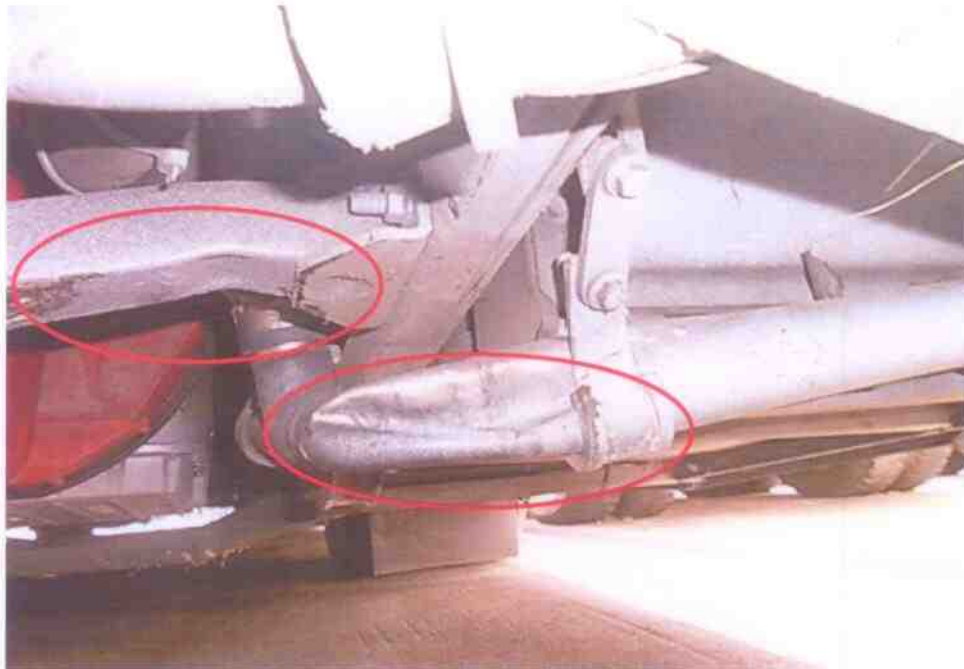
Photo 9 shows a close-up view of the Motor Bus's rear body at the time of our inspection. Its rear right reinforcement bar & steel pipe was observed to be scratched & dented likely due to the accident's collision impact.

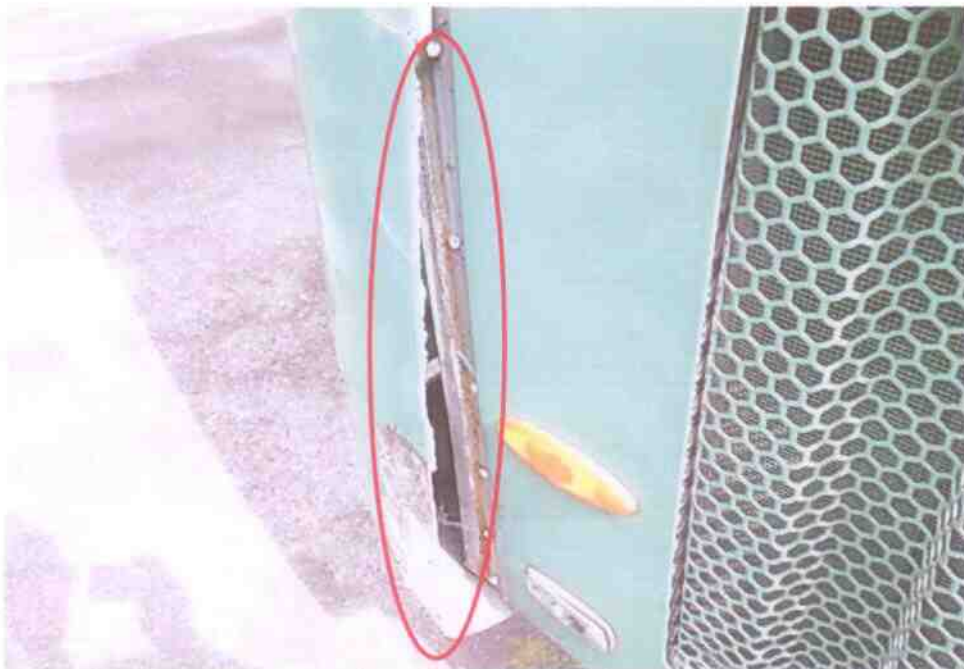
Photo 10 shows a close-up view of the Motor Bus's rear body at the time of our inspection. Its rear right lower bumper was observed to be misaligned & cracked likely due to the accident's collision impact.

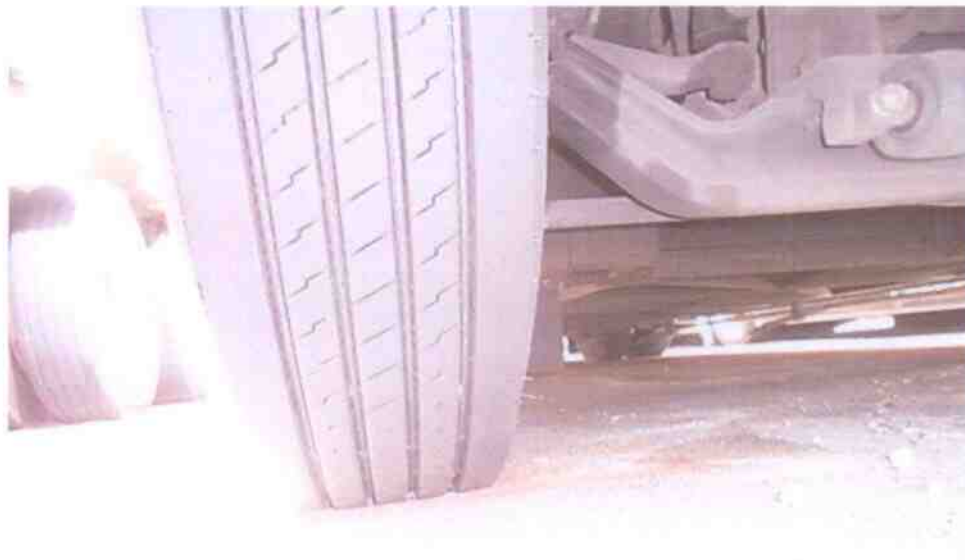
Photo 11 shows the condition of the front right tyre of the Motor Bus, which was with remaining tread depth of approximately 8mm. The tyre was also observed to be sufficiently inflated for vehicular operation.

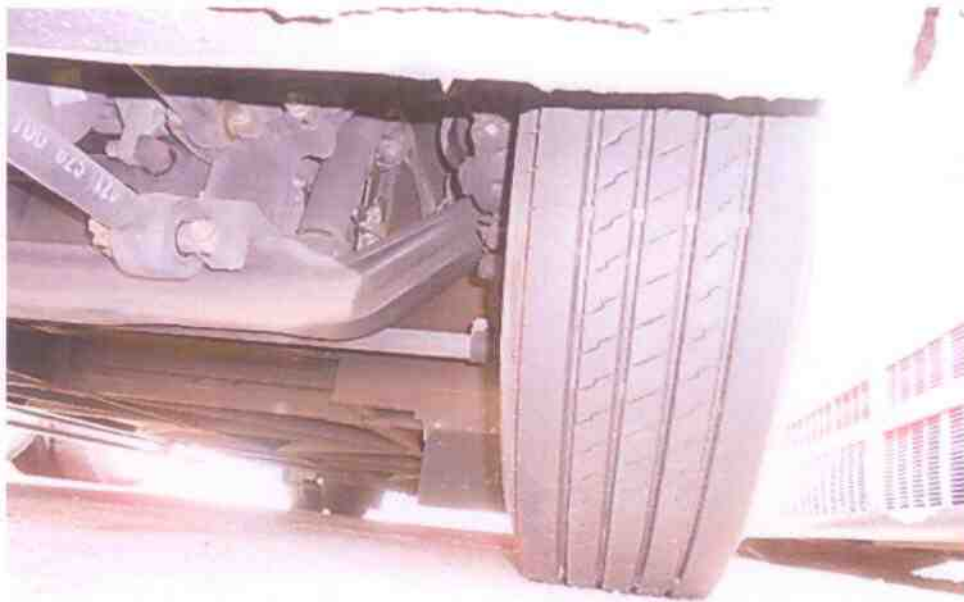
Photo 12 shows the condition of the front left tyre of the Motor Bus, which was observed to be in serviceable condition with remaining tread depth of approximately 6mm. The tyre was also observed to be sufficiently inflated for vehicular operation.

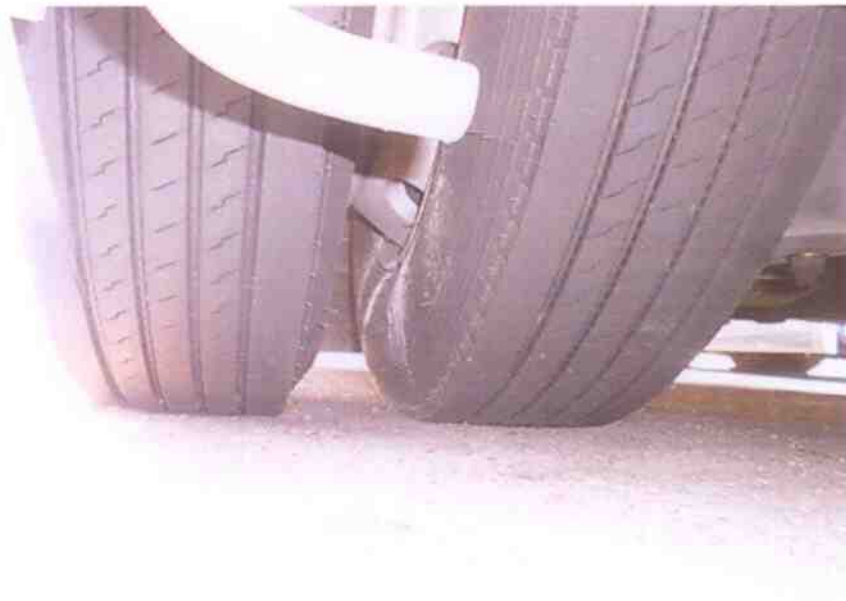
Photo 13 shows the condition of the rear right tyres of the Motor Bus, which were observed to be in serviceable condition with remaining tread depth of approximately 6mm. The tyres, which were wrapped around standard alloy wheels rims, were also observed to be sufficiently inflated for vehicular operation.

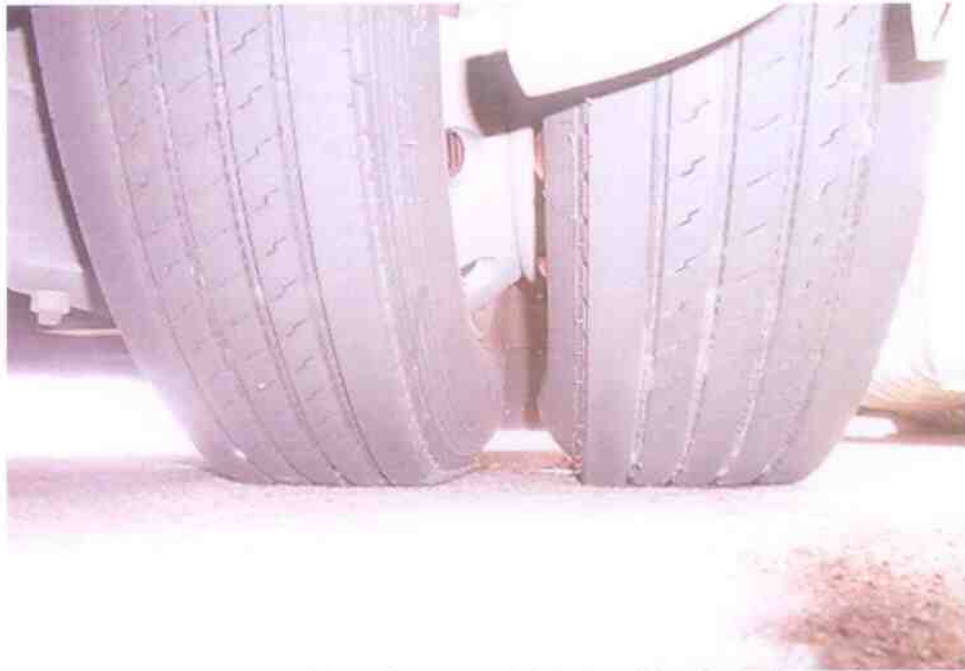
Photo 14 shows the condition of the rear left tyres of the Motor Bus, which were observed to be in serviceable condition with remaining tread depth of approximately 6mm. The tyres, which were wrapped around standard alloy wheel rims, were also observed to be sufficiently inflated for vehicular operation.

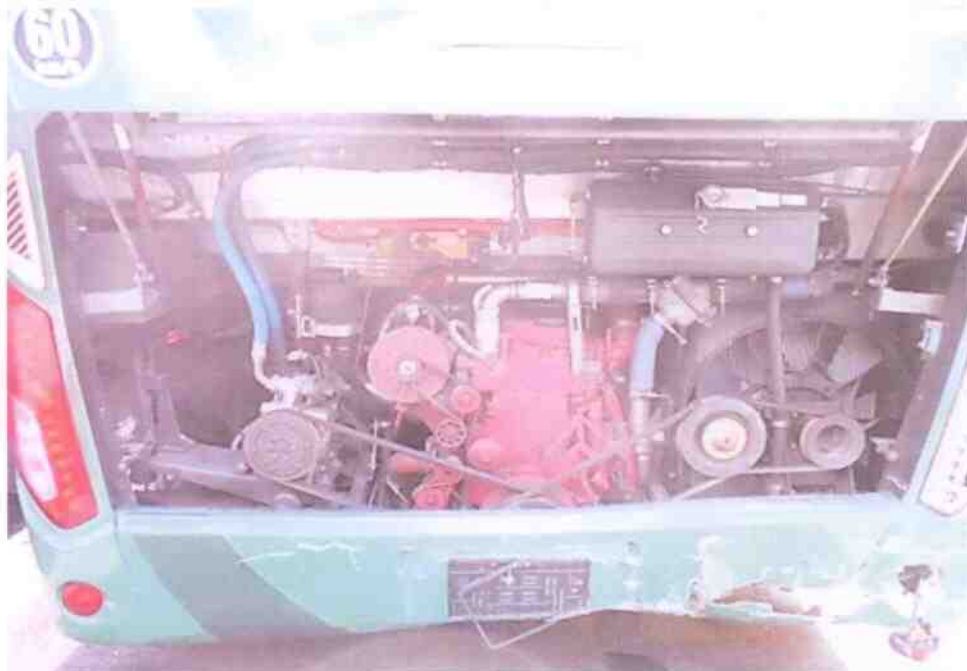
Photo 15 shows the engine compartment of the Motor Bus was located at the rear of the Motor Bus.

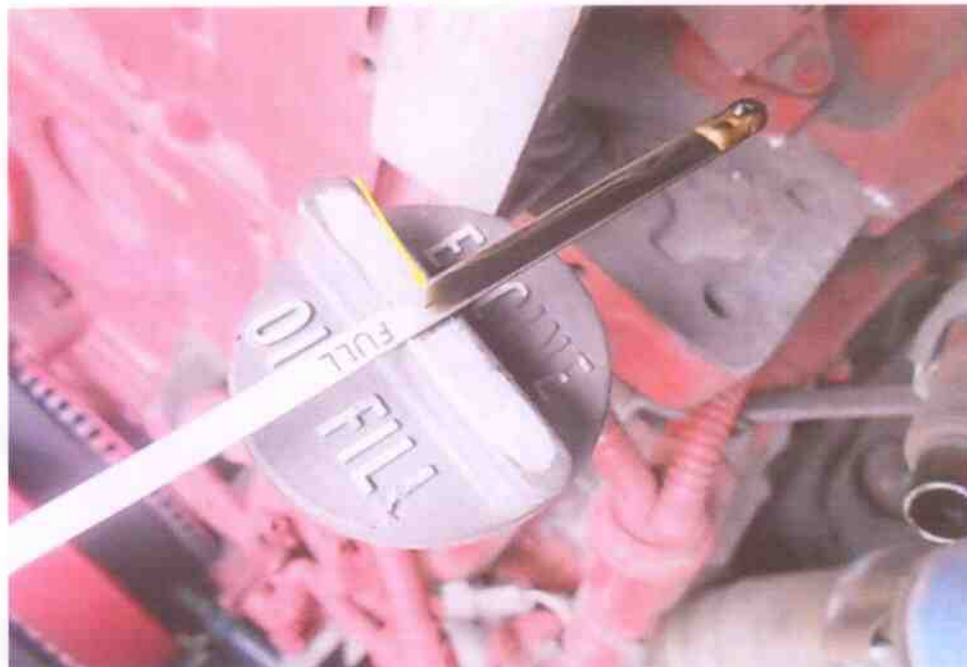
Photo 16 shows the engine fluid of the Motor Bus. It was observed to be of sufficient level (Yellow) without any contamination at time of our inspection.

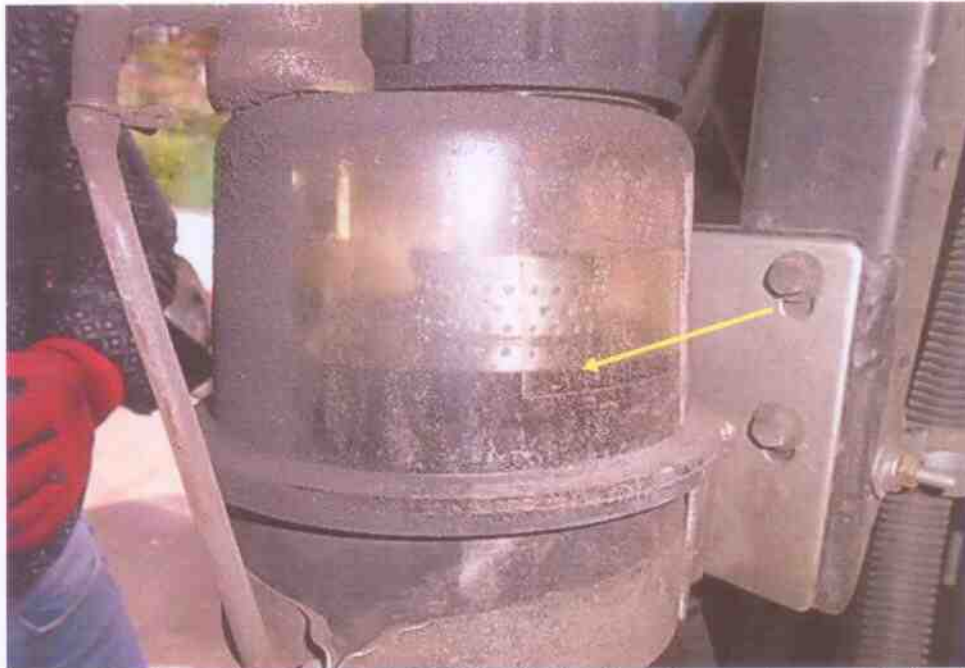
Photo 17 shows the steering fluid of the Motor Bus. It was observed to be of sufficient level (Yellow) without any contamination at time of our inspection.

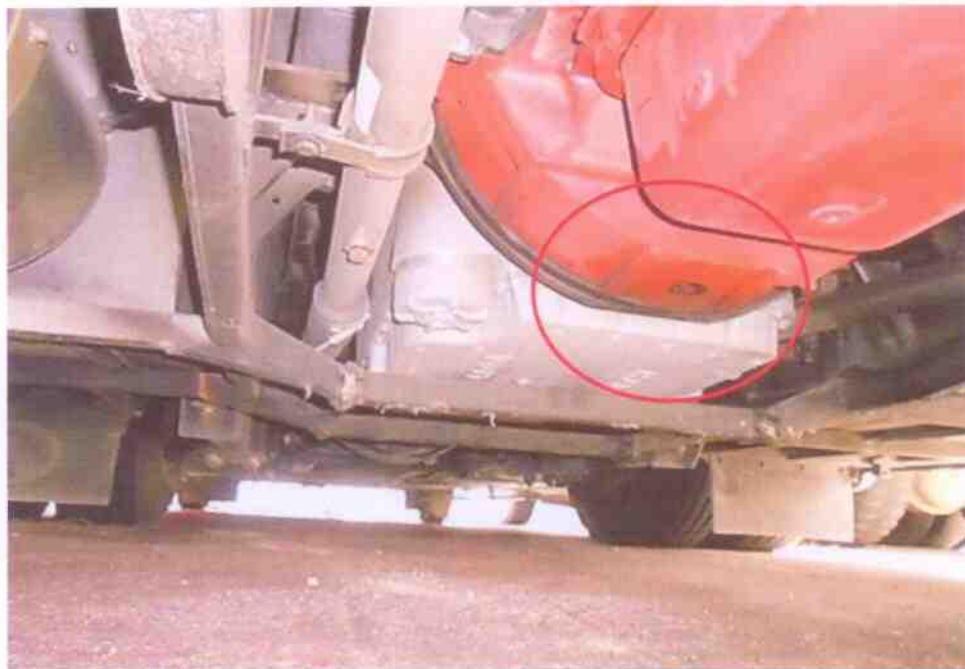
11. Our subsequent checks on the underside of the Motor Bus reveals some fluid stain sighted under the engine compartment. Further investigation found that the fluid stain was a pre-existed prior the accident & not a fresh fluid. This was due to some dirt observed on the fluid stain. Conclusively, it is not likely to be related to the accident. Visually, the various undercarriage components of the Motor Bus were observed to be intact and without any visible damage except for the damages caused by the accident. See photo 15 – 18 below.

Photo 18 shows the engine underside of the Motor Bus. Our subsequent checks on the underside of the Motor Bus reveals some fluid stain sighted under the engine compartment. Further investigation found that the fluid stain was a pre-existed prior the accident & not a fresh fluid. This was due to some dirt observed on the fluid stain. Conclusively, it is not likely to be related to the accident. Visually, the various undercarriage components of the Motor Bus were observed to be intact and without any visible damage except for the damages caused by the accident.

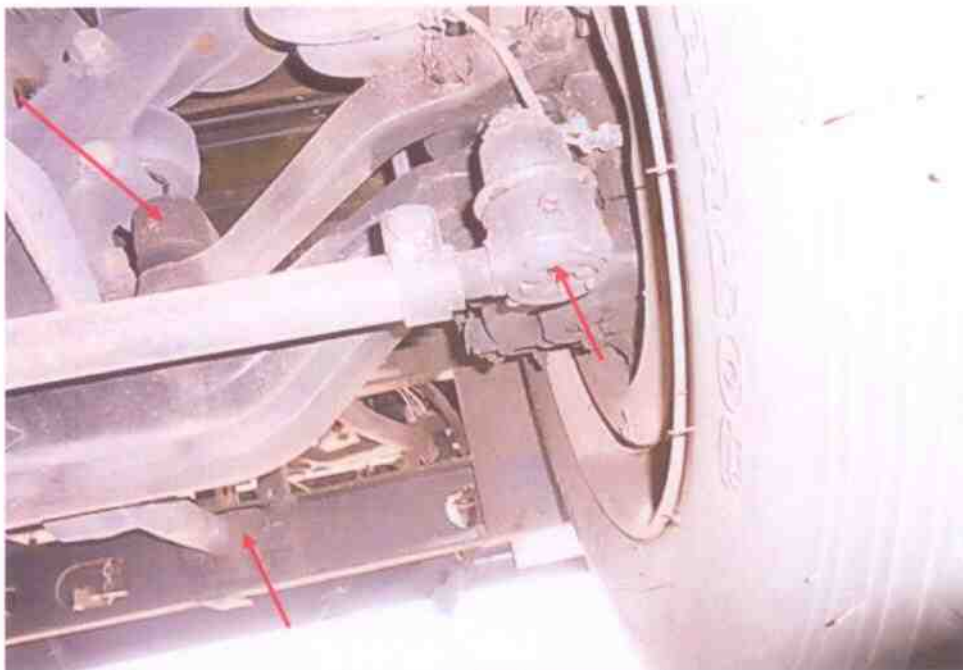
Photo 19 shows some of the mechanical components (arrowed) of the Motor Bus's steering system. Our visual checks on the various mechanical components of the steering system revealed all to be intact and in good condition. The steering system of the Motor Bus is hence likely to be in serviceable condition at the time of accident.

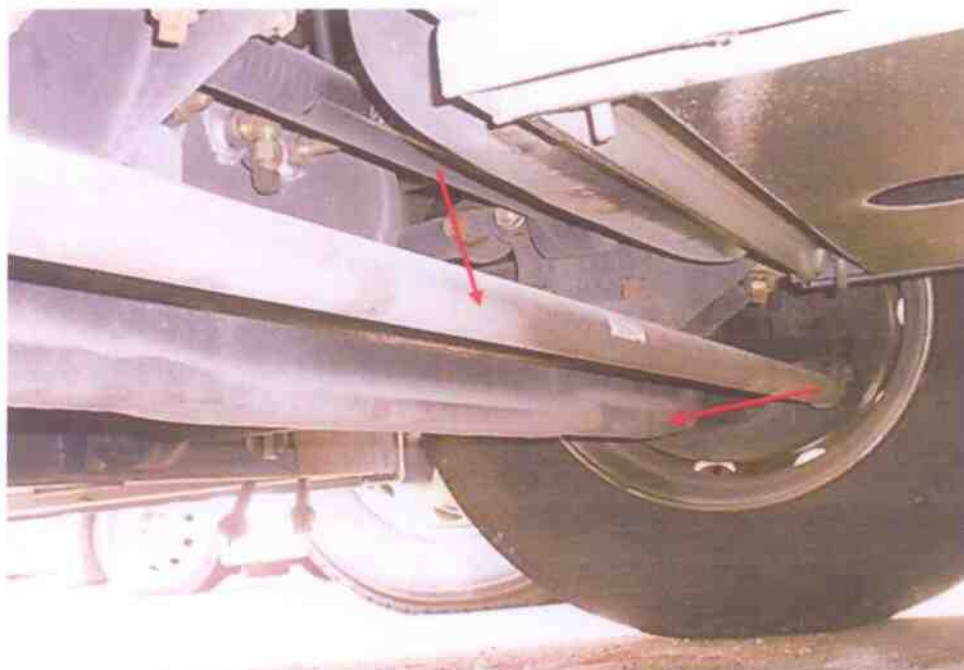
Photo 20 shows the undercarriage components at the front right wheel of the Motor Bus. The various undercarriage components of the Motor Bus were all observed to be intact and without any visible damage. This had included the steering rack and steering ball joints (arrowed) of the Motor Bus.

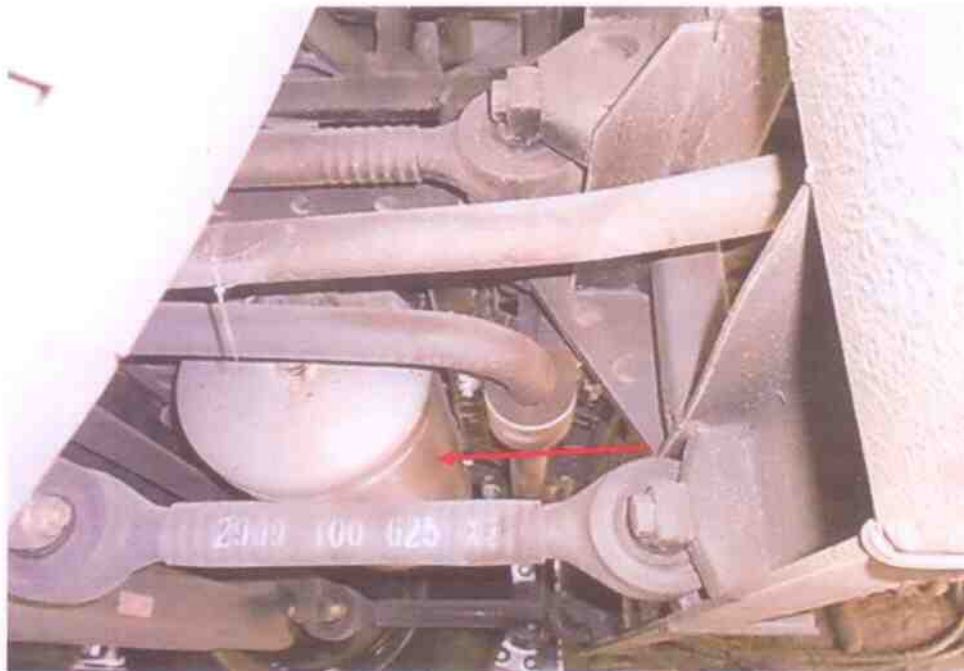
15. Since the engine of the Motor Bus could not be started, we were hence not able to carry out test(s) on whether there was any leakage of compressed air that could have affected the braking efficiency of the Motor Bus. However the air pipes, air tanks and connecting valves had all appear to be in good general condition and securely fitted upon our visual examination of these parts.

Photo 21 shows a general view of the air tank, valves, pipes and hoses, which are some of the components for the air-assisted braking system of the Motor Bus. This was at the underside of the Motor Bus. We were however not able to carry out any operational test(s) to the braking system of the Motor Bus as its engine was unable to be started.

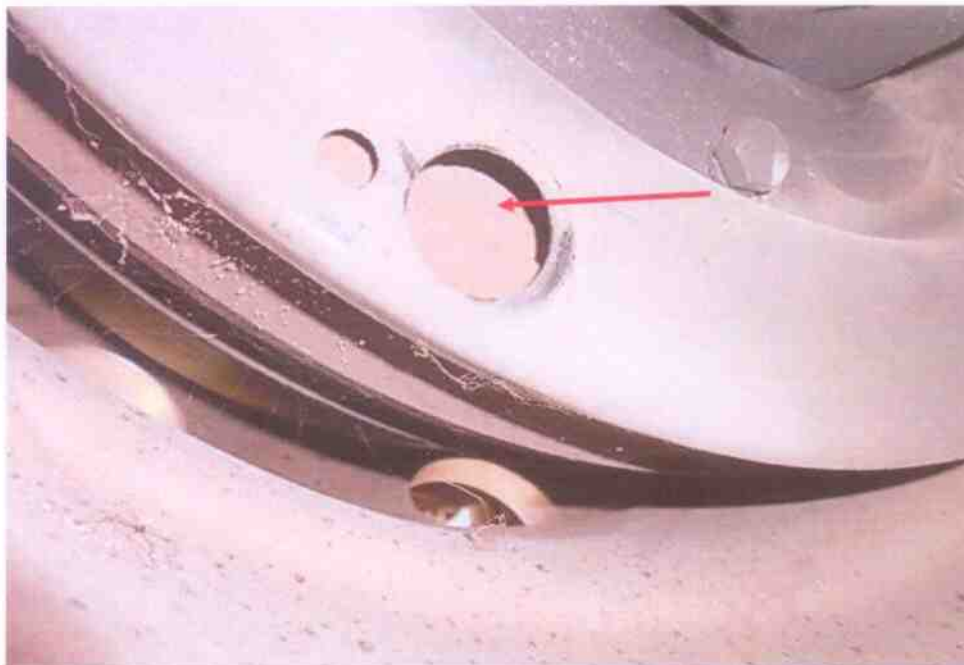
Photo 22 shows a close-up view of the brake pads for the Motor Bus which was still in a serviceable condition.
