Your Ref: TP/IP/59659/2017  
Our Ref : CI/TPD18000534/Z

### **Fatal Accident Investigation Team**

### **MECHANICAL INSPECTION REPORT OF TIPPER TRUCK XE 2780H**

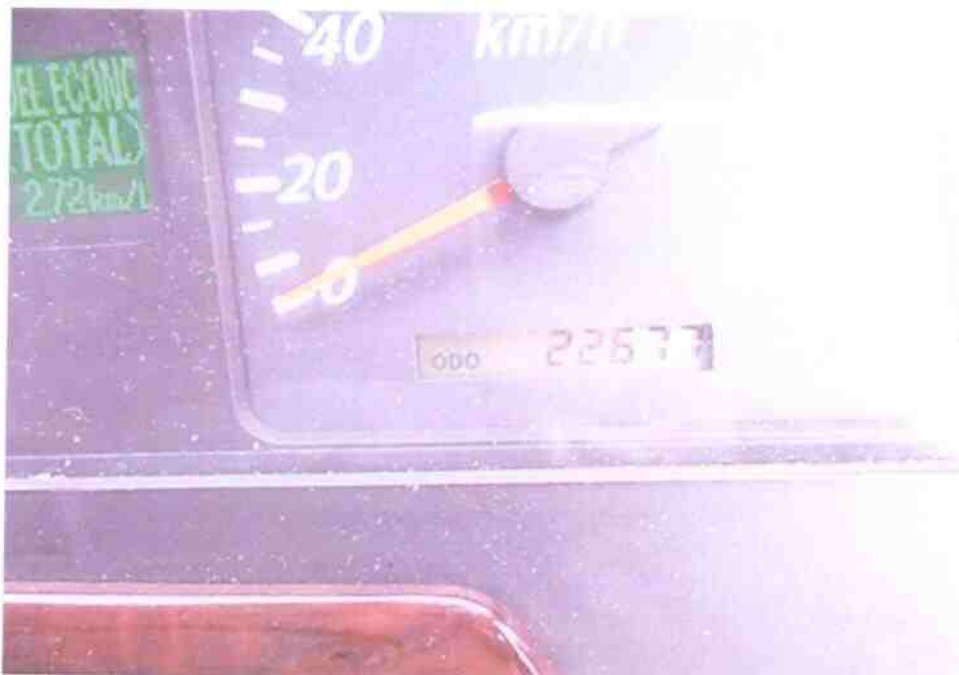
**Photo 1** shows the mileage of the Tipper Truck at the time of our inspection was recorded as 22,677 km.

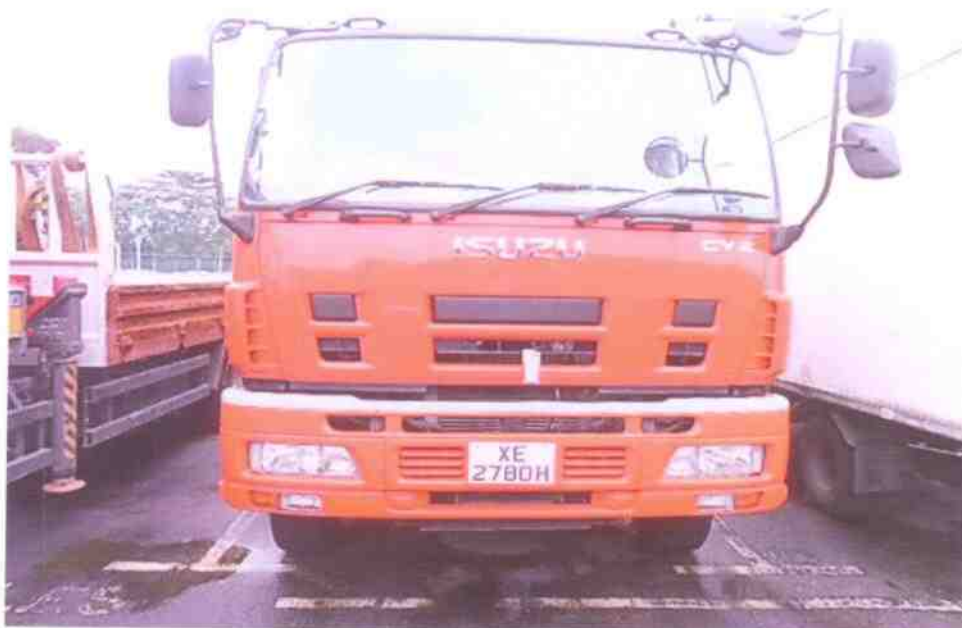
**Photo 2** shows a general view of the front body of the Tipper Truck at the time of our inspection. The Tipper Truck was observed to have no signs of fresh damages on its body portion, this is likely due to the consistency of the accident's case facts that the Tipper Truck ran over the other involved party (bicycle).

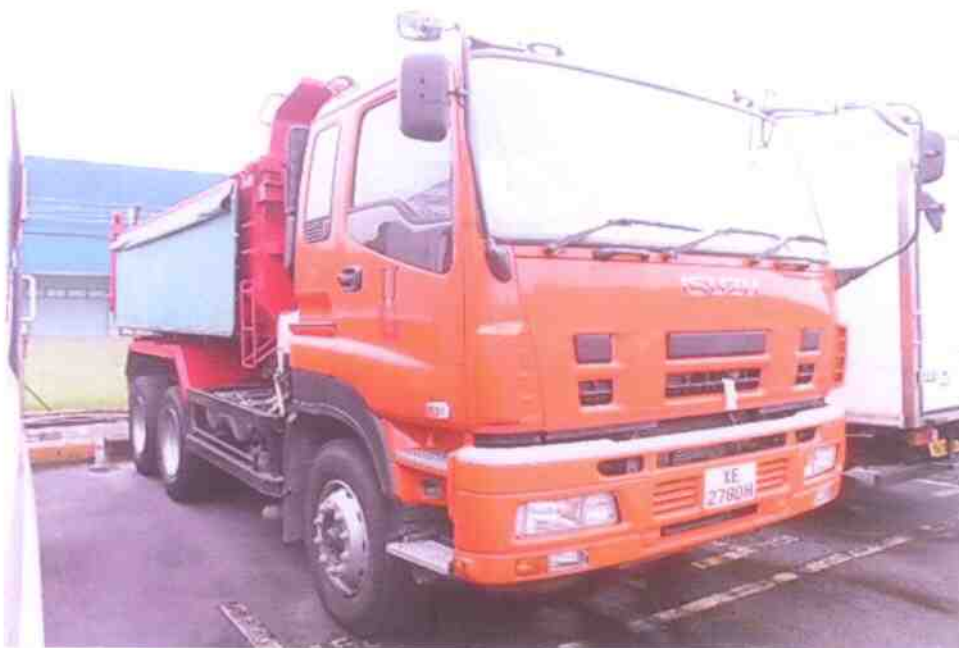
**Photo 3** shows a general view of the front right body of the Tipper Truck at the time of our inspection. The Tipper Truck was observed to have no signs of fresh damages on its body portion, this is likely due to the consistency of the accident's case fact that the Tipper Truck ran over the other involved party (bicycle).

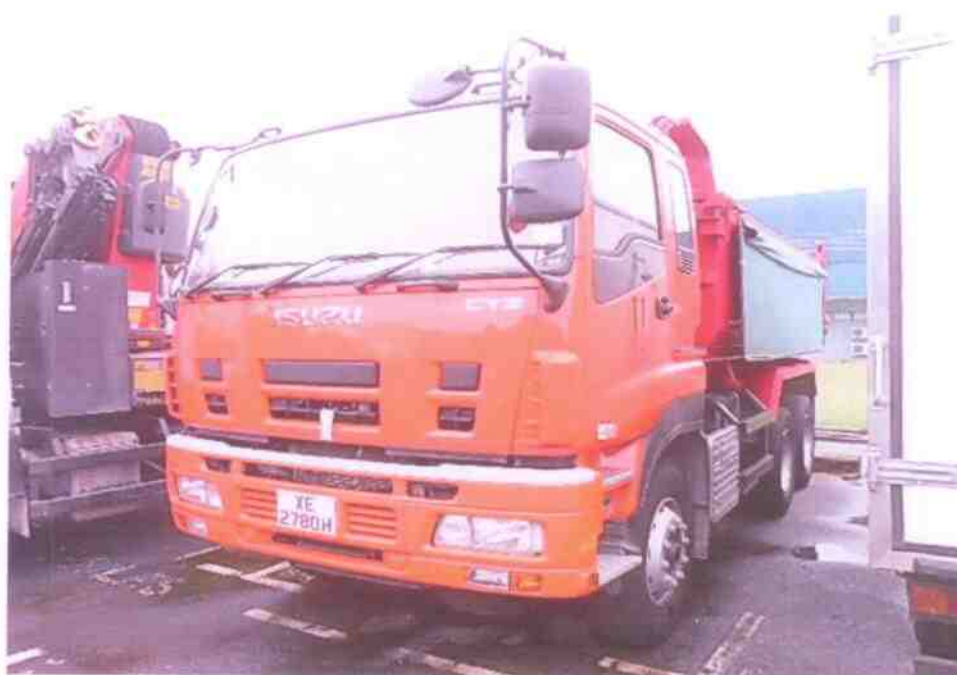
**Photo 4** shows a general view of the front left body of the Tipper Truck at the time of our inspection. The Tipper Truck was observed to have no signs of fresh damages on its body portion, this is likely due to the consistency of the accident's case fact that the Tipper Truck ran over the other involved party (bicycle).

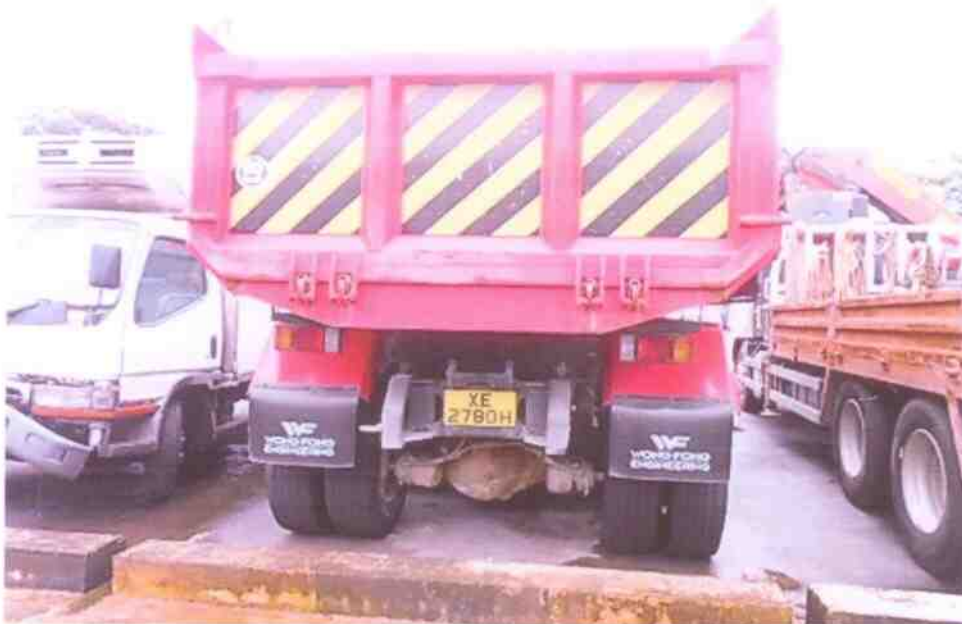
**Photo 5** shows a general view of the rear body of the Tipper Truck at the time of our inspection. The Tipper Truck was observed to have no signs of fresh damages on its body portion, this is likely due to the consistency of the accident's case fact that the Tipper Truck ran over the other involved party (bicycle).

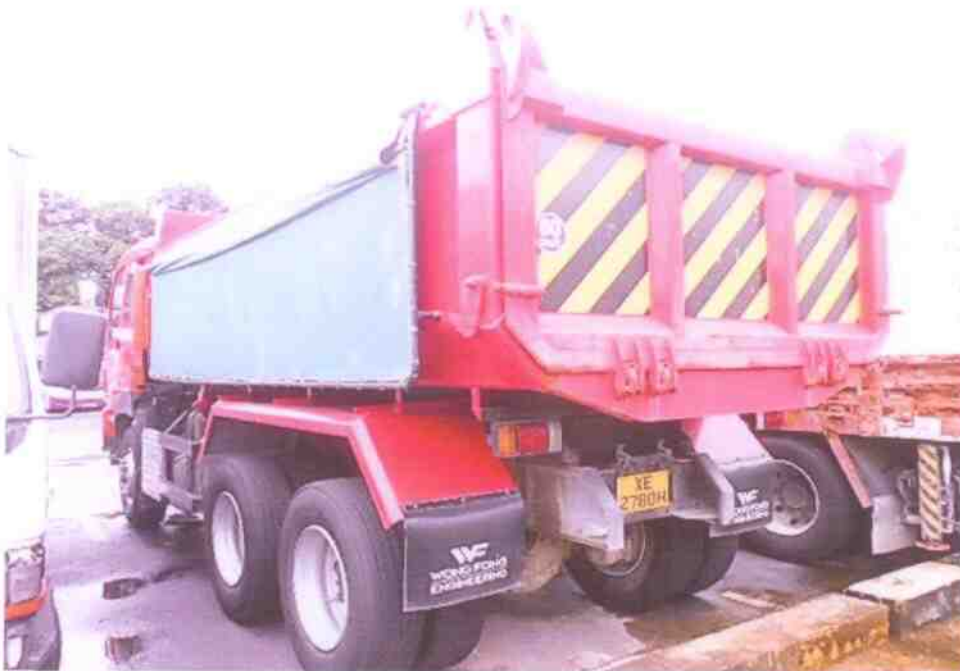
**Photo 6** shows a general view of the rear left body of the Tipper Truck at the time of our inspection. The Tipper Truck was observed to have no signs of fresh damages on its body portion, this is likely due to the consistency of the accident's case fact that the Tipper Truck ran over the other involved party (bicycle).

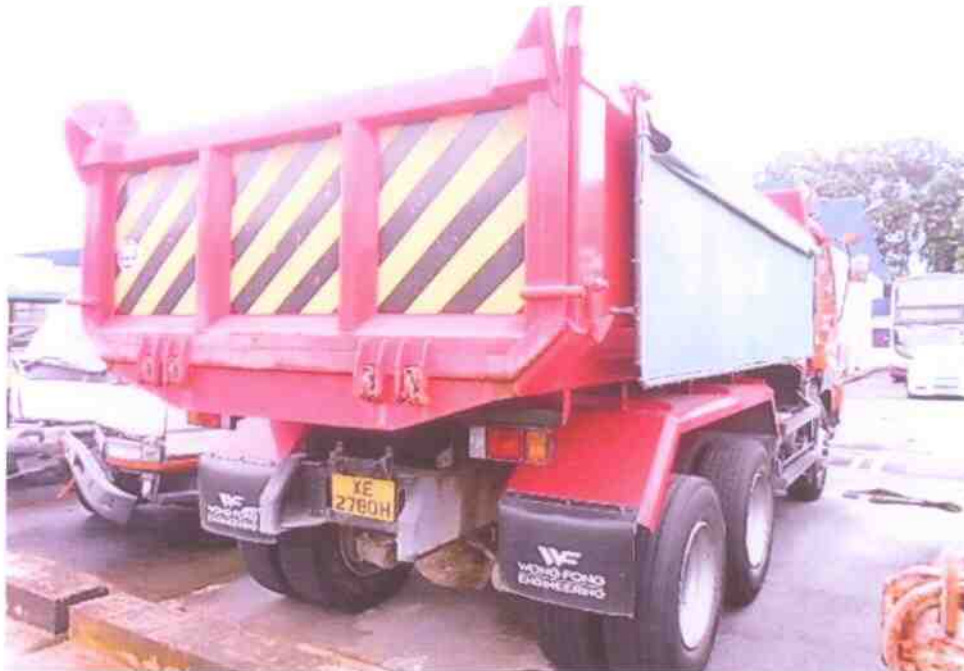
**Photo 7** shows a general view of the rear right body of the Tipper Truck at the time of our inspection. The Tipper Truck was observed to have no signs of fresh damages on its body portion, this is likely due to the consistency of the accident's case fact that the Tipper Truck ran over the other involved party (bicycle).

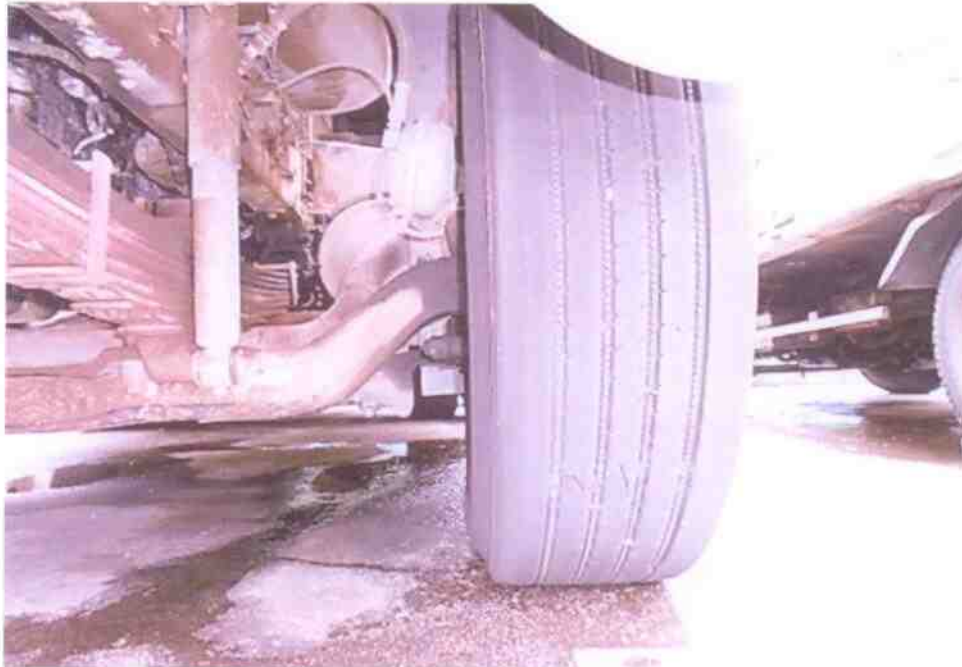
**Photo 8** shows the condition of the front left tyre of the Tipper Truck, which was observed to be in serviceable condition with remaining tread depth of approximately 3mm.

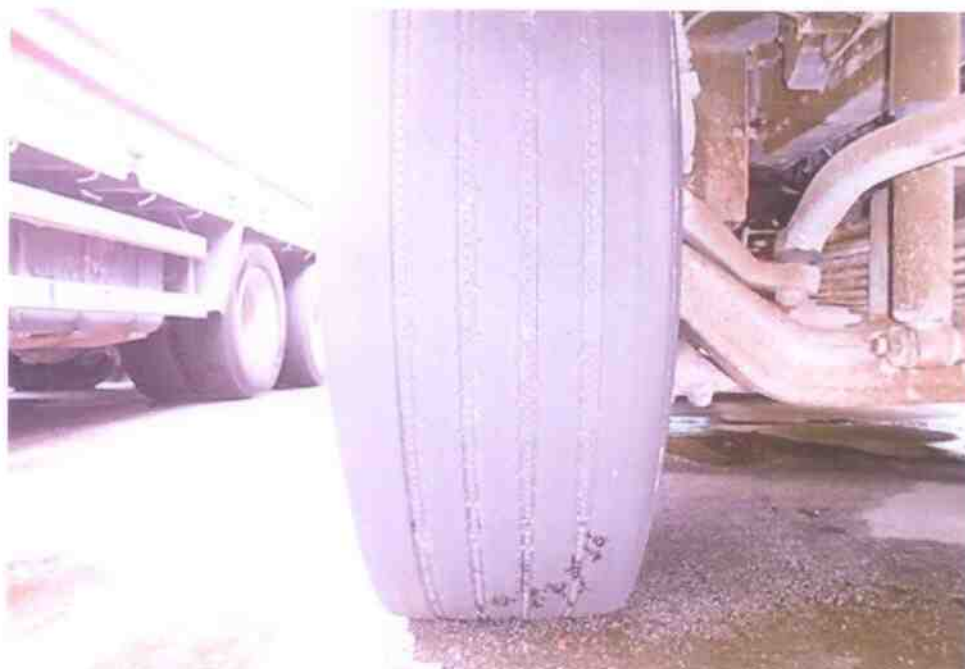
**Photo 9** shows the condition of the front right tyre of the Tipper Truck, which was observed to be in serviceable condition with remaining tread depth of approximately 6mm.

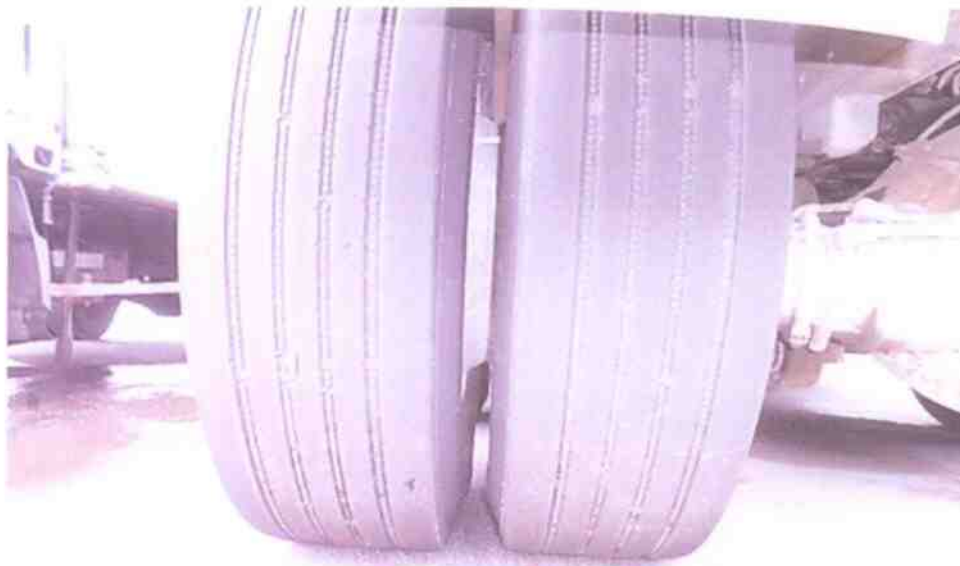
**Photo 10** shows the condition of the rear left tyres of the Tipper Truck, which were observed to be in serviceable condition with remaining tread depth of approximately 6mm. The tyres were also observed to be sufficiently inflated for vehicular operation.

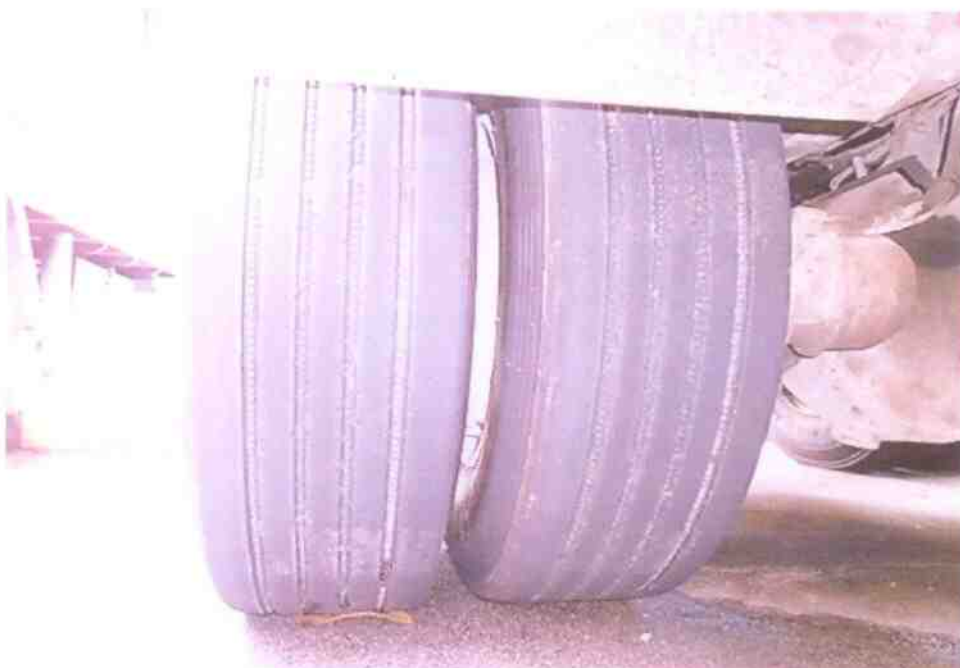
**Photo 11** shows the condition of the rear left tyres (centre axle) of the Tipper Truck, which were observed to be in serviceable condition with remaining tread depth of approximately 6mm. The tyres were also observed to be sufficiently inflated for vehicular operation.

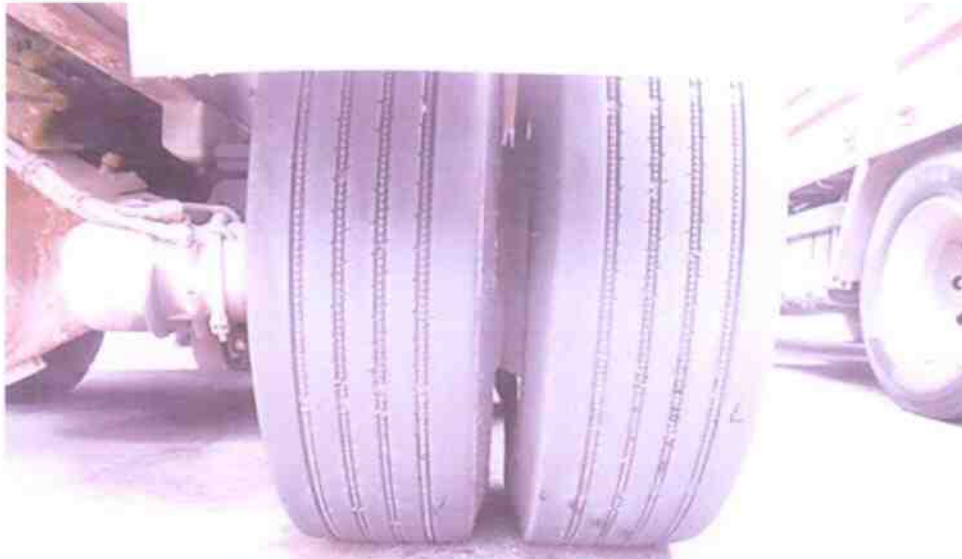
**Photo 12** shows the condition of the rear right tyres of the Tipper Truck, which were observed to be in serviceable condition with remaining, tread depth of approximately 6mm. The tyres were also observed to be sufficiently inflated for vehicular operation with no tear, cut or burst mark(s) on the outer and the inner sidewalls.

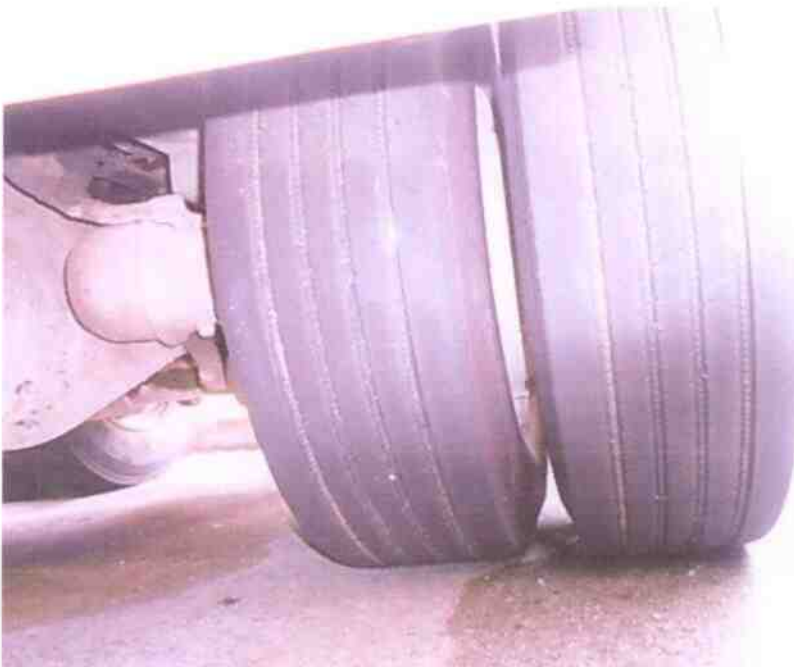
**Photo 13** shows the condition of the rear right tyres (centre axle) of the Tipper Truck, which were observed to be in serviceable condition with remaining, tread depth of approximately 3mm. The tyres, which were wrapped around standard alloy wheel rims, were also observed to be sufficiently inflated for vehicular operation.

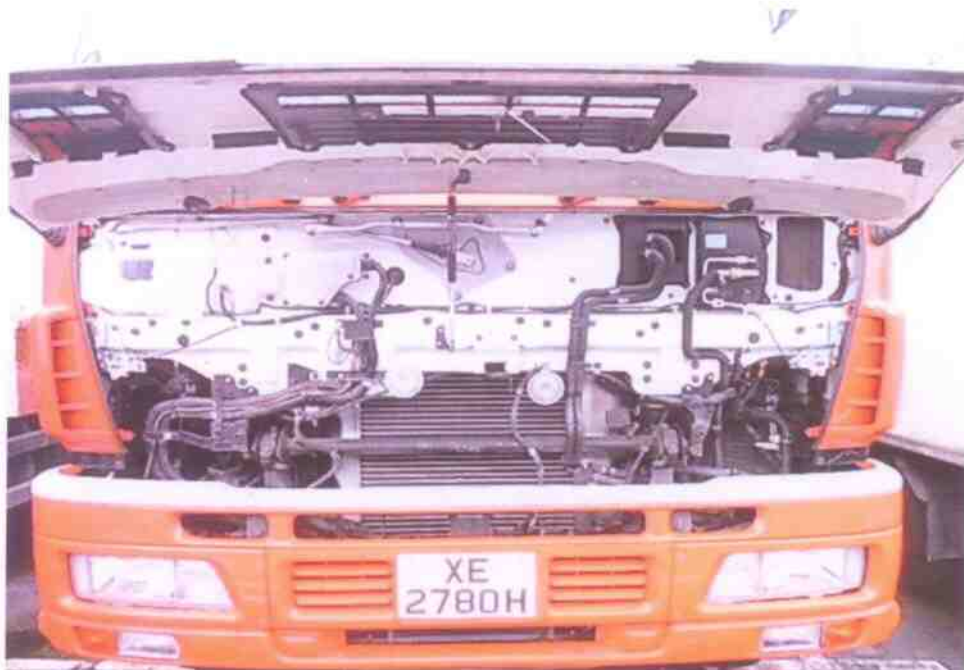
**Photo 14** shows a general view of the engine compartment area from the front bonnet of the Tipper Truck. It was observed to be intact and unaffected by the collision. There was also no sign(s) or indication(s) of fluid leak and/or fluid stain found.

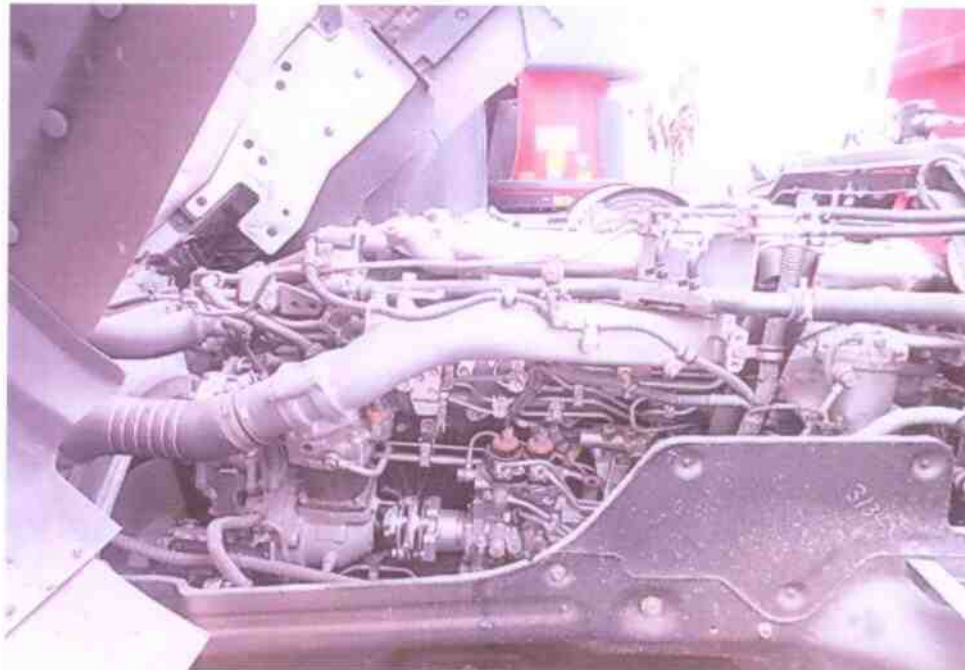
**Photo 15** shows a general view of the engine area from under the front cabin of the Tipper Truck. The engine assembly and transmission assembly of the Tipper Truck were both observed to be intact and unaffected by the collision. There was also no sign(s) or indication(s) of fluid leak and/or fluid stain found.

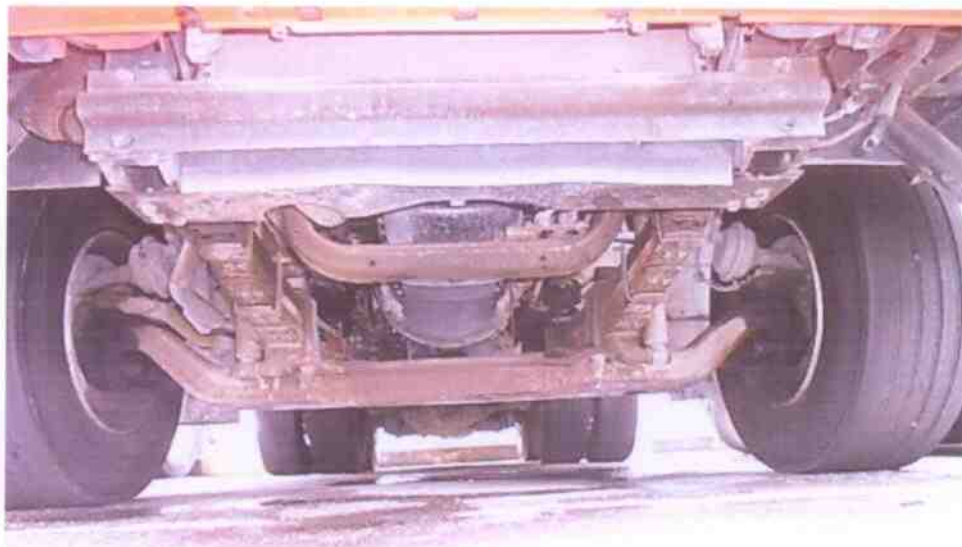
**Photo 16** shows a general view of the engine area from the underside of the Tipper Truck. The engine assembly and transmission assembly of the Tipper Truck were both observed to be intact and unaffected by the collision. There was also no sign(s) or indication(s) of fluid leak and/or fluid stain found.

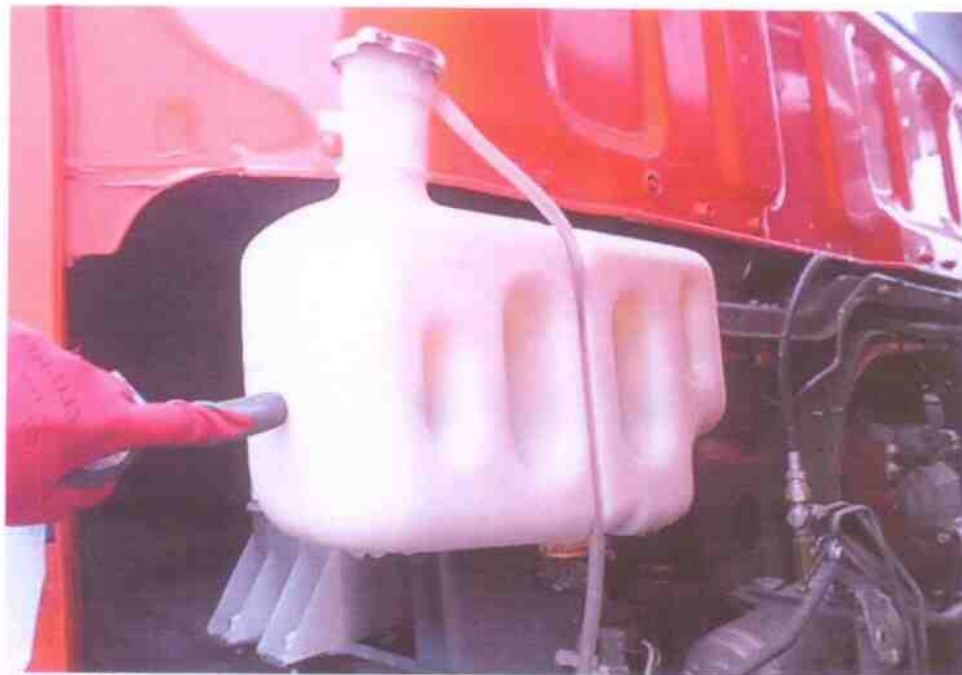
**Photo 17** shows the engine coolant reservoir of the Tipper Truck at the time of our inspection. The engine coolant was observed to be of sufficient level and without any visible contamination for operational purposes.

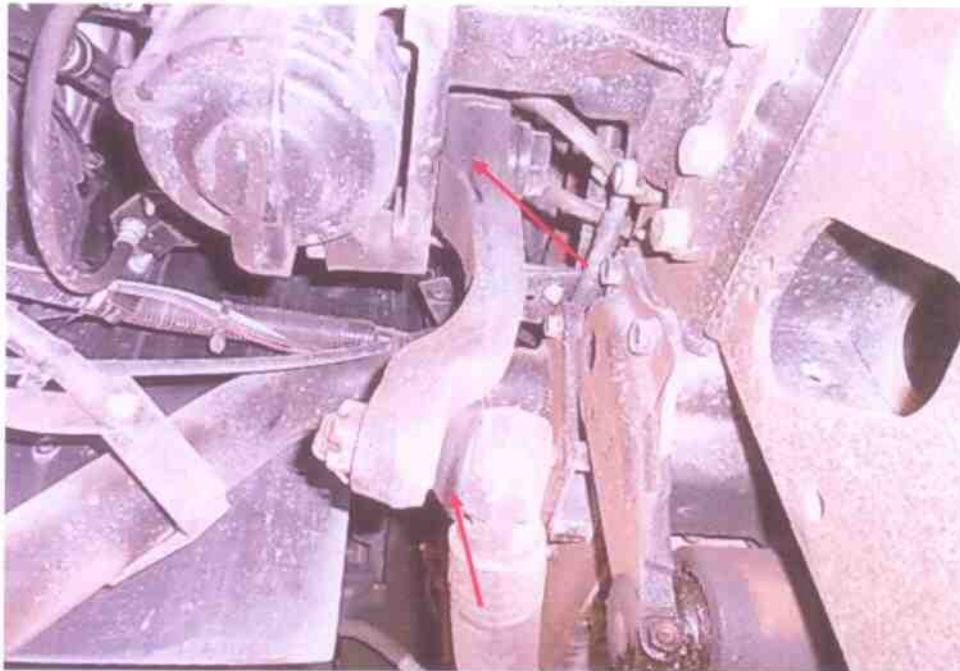
**Photo 18** shows some of the mechanical components (arrowed) of the Tipper Truck's steering system. Our visual checks on the various mechanical components of the steering system revealed all to be intact and in good condition. The steering system of the Tipper Truck is hence likely to be in serviceable condition at the time of accident.

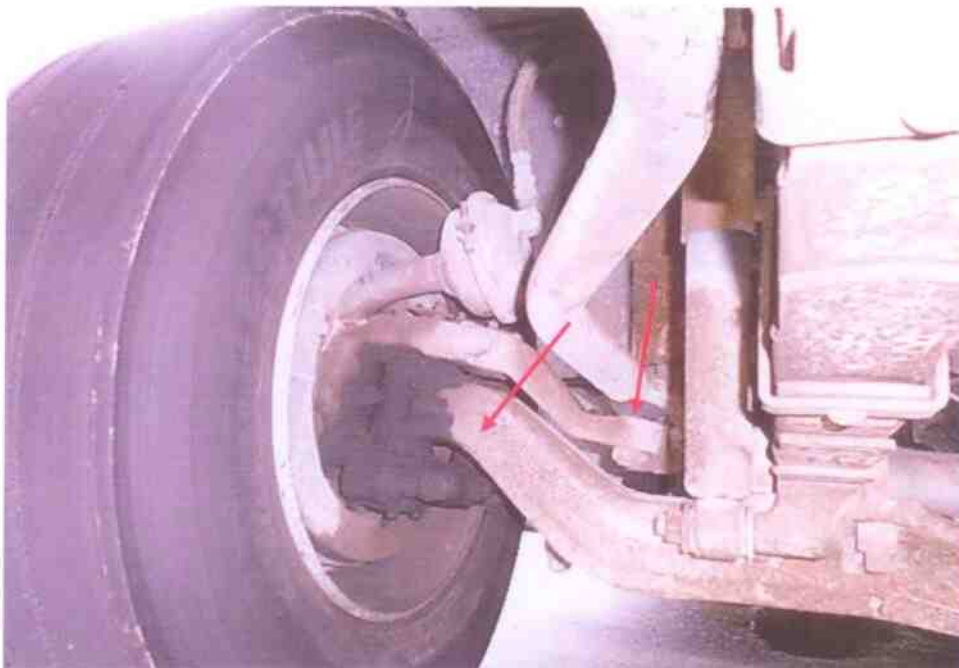
**Photo 19** shows the undercarriage components at the front right wheel of the Tipper Truck. The various undercarriage components of the Tipper Truck were all observed to be intact and without any visible damage. This had included the steering rack and steering linkages (arrowed) of the Tipper Truck.

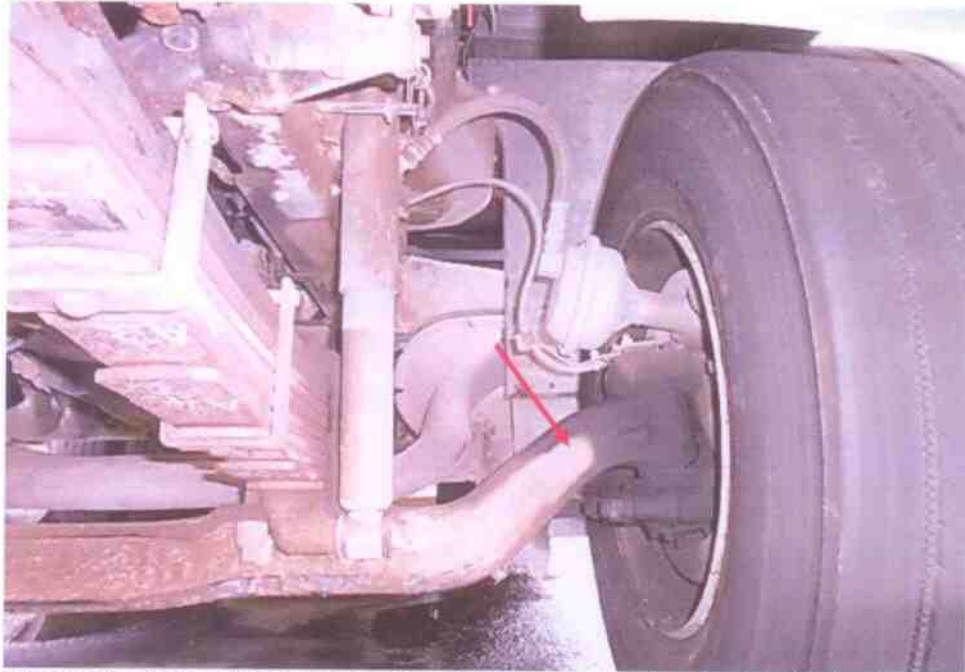
**Photo 20** shows the undercarriage components at the front left wheel of the Tipper Truck. The various undercarriage components of the Tipper Truck were all observed to be intact and without any visible damage. This had included the steering rack (arrowed) of the Tipper Truck, which was observed to be securely attached to the front left wheel and front right wheel.

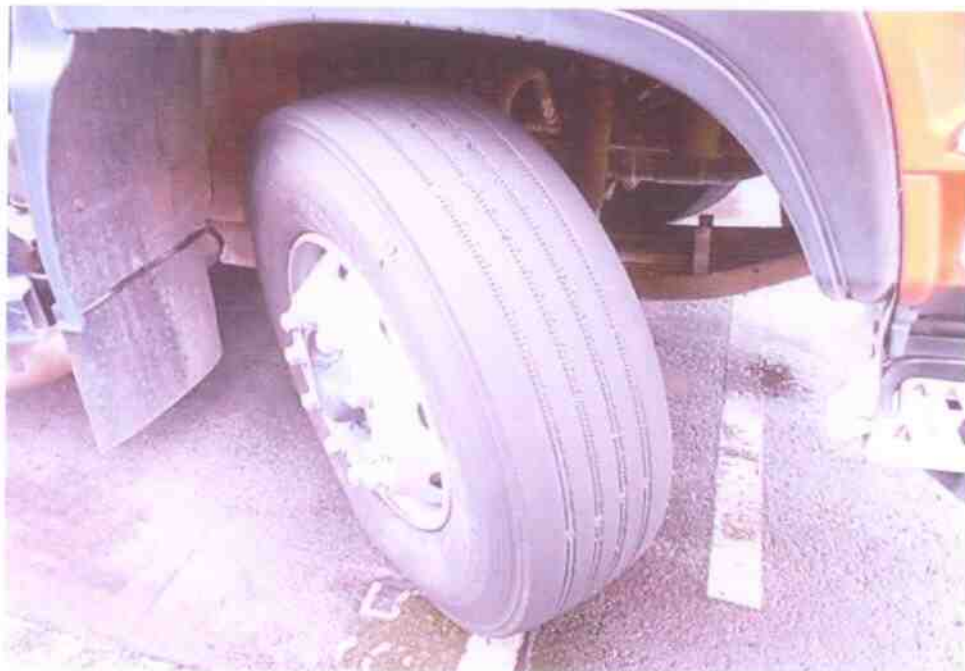
**Photo 21** shows that we did not experience any abnormal free play and/or other resistance when turning the steering wheel left and right to full lock positions.

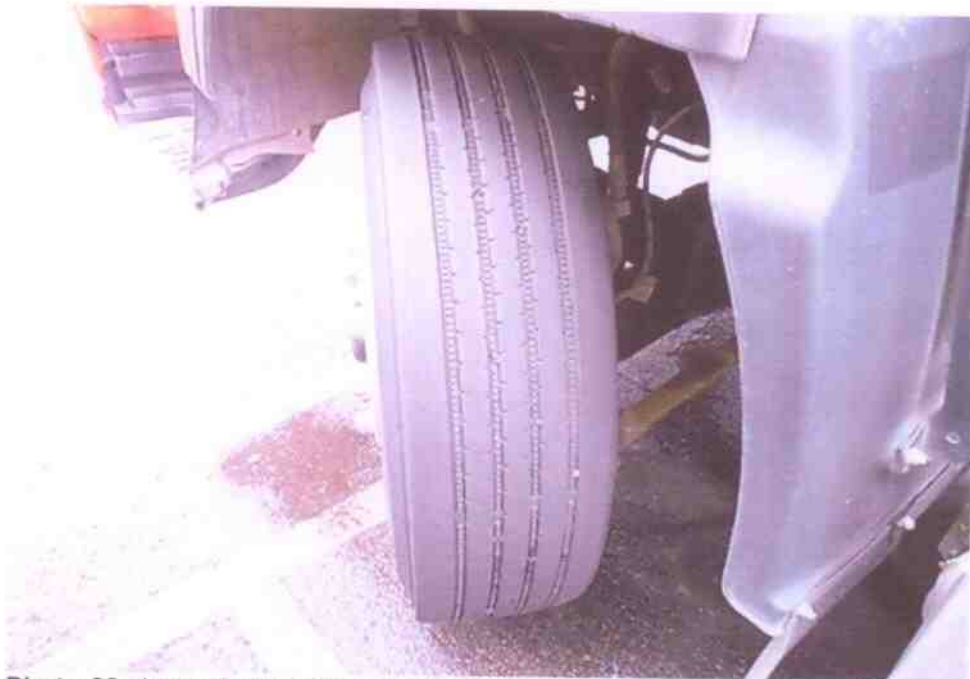
**Photo 22** shows that we did not experience any abnormal free play and/or other resistance when turning the steering wheel left and right to full lock positions.

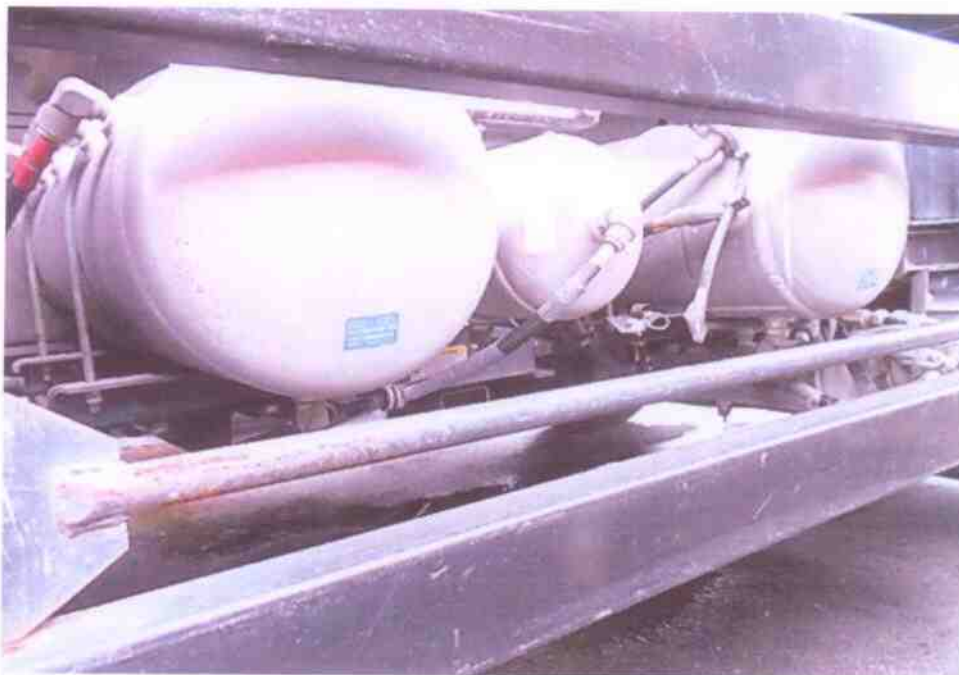
**Photo 20** shows the air tanks, valves, pipes and hoses, which are some of the components for the air-assisted braking system of the Tipper Truck. These components were mainly located around the right centre body of the Tipper Truck, and were unaffected by the accident.

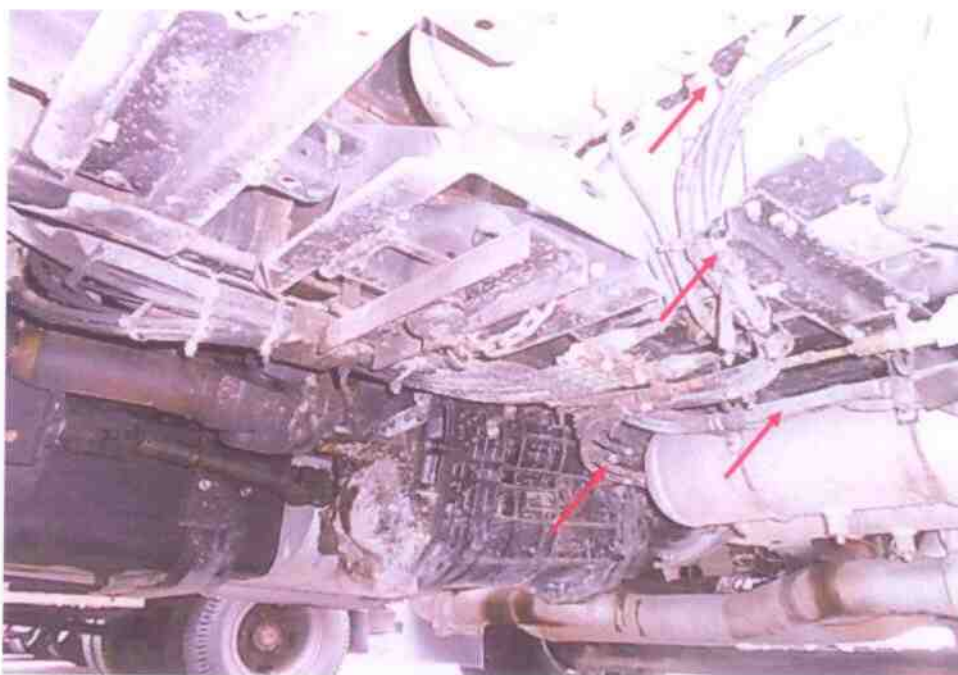
**Photo 21** shows the valves, brake hoses and pipes, which are some of the components for the air-assisted braking system of the Tipper Truck. These components were mainly located around the right centre body of the Tipper Truck, and were unaffected by the accident. Our visual examination of these parts revealed all to be in good general condition and securely fitted.

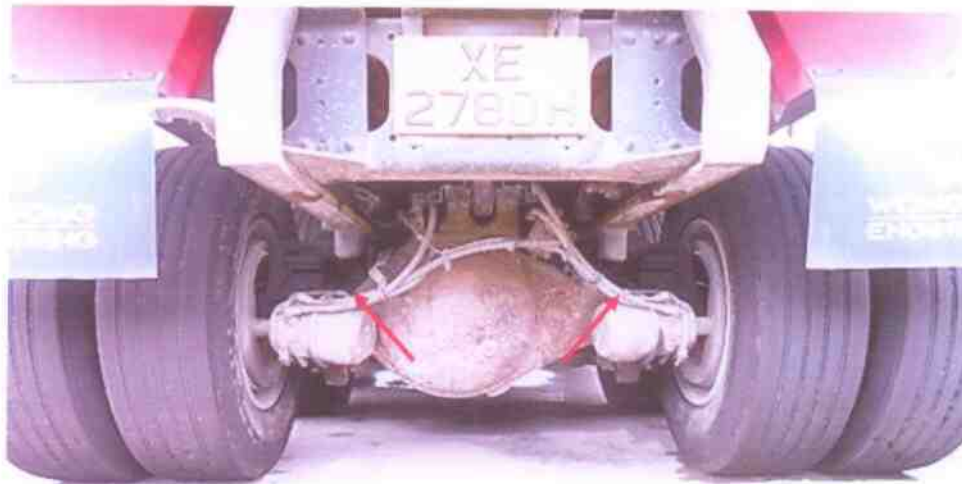
**Photo 22** shows the brake hoses (arrowed) leading to the rear left wheel and rear right wheel of the Tipper Truck. At the time of our inspection, the various mechanical components of the air-assisted hydraulic braking system of the Tipper Truck were all found to be in good general condition and securely fitted.

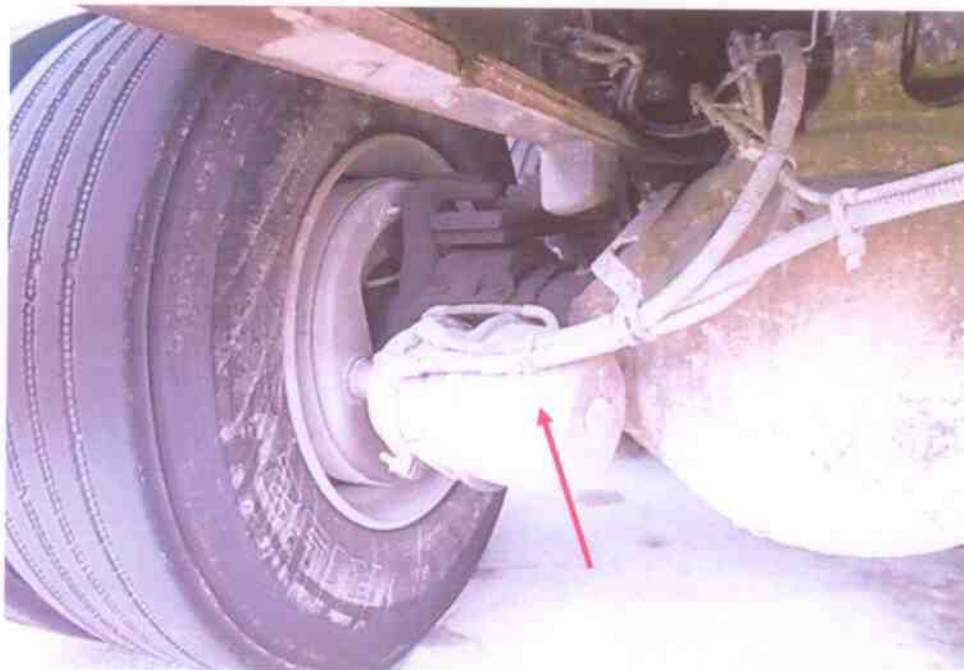
**Photo 23** shows the brake air cylinder (arrowed) at the rear left rear wheel of the Tipper Truck. Such air cylinder, which is amongst the various components for the air-assisted hydraulic braking system, can be found attached to all the front wheels and all the rear wheels of the Tipper Truck. Upon our checks, we had found all the brake air cylinders to be undamaged and securely fitted to all the wheels of the Tipper Truck.

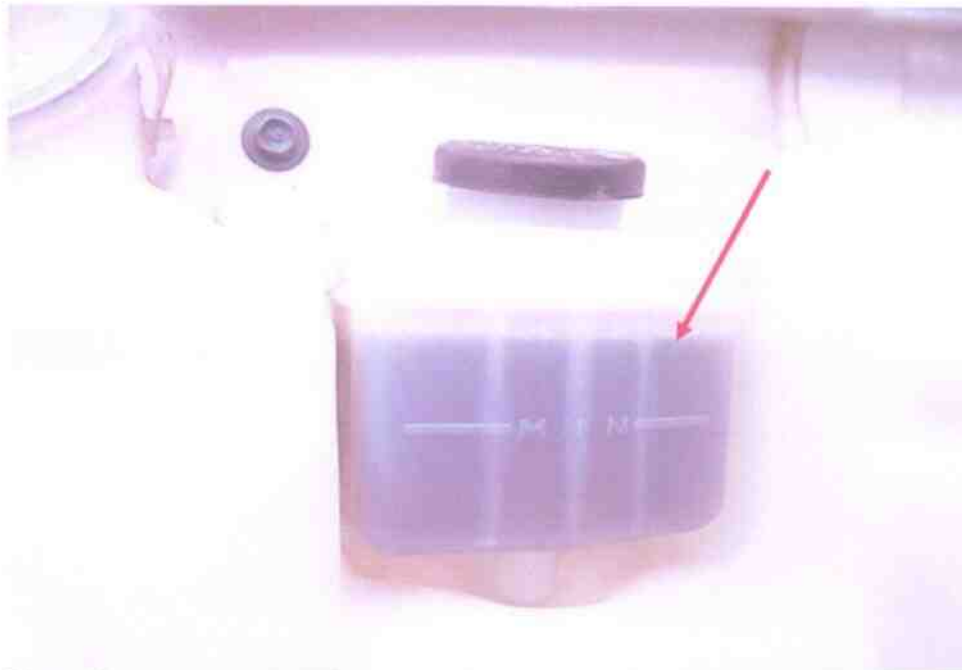
**Photo 24** shows the brake fluid at the front bonnet of the Tipper Truck. The brake fluid was found to be of sufficient level for operating purposes. Visually, there was also no contamination found to these fluids.

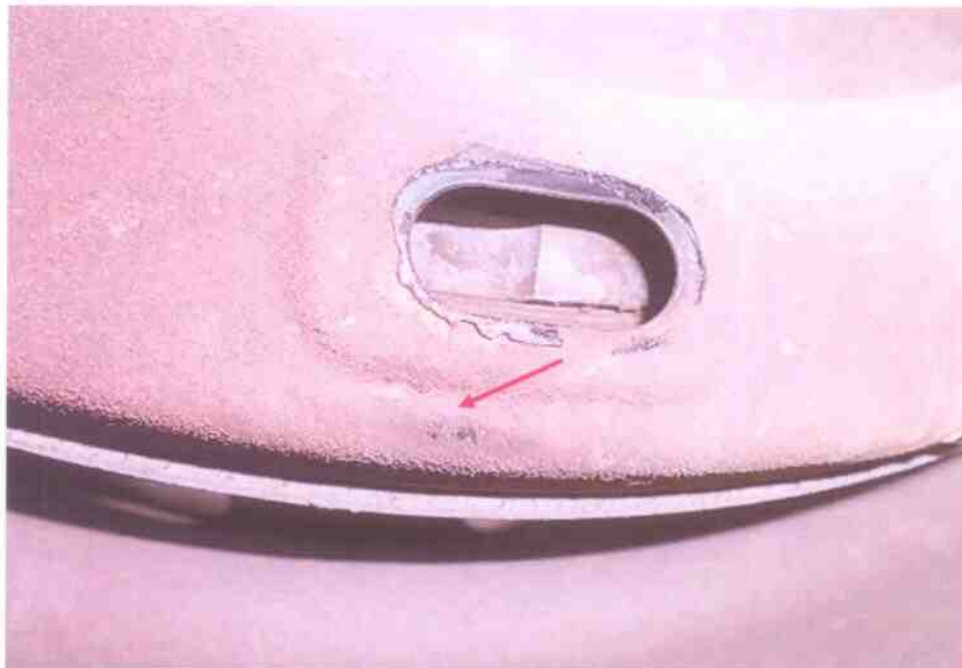
**Photo 25** shows the brake shoes (brake pads) at the rear left wheel (rear axle) of the Tipper Truck. The brake shoes (brake pads) of the Tipper Truck were all found to be in serviceable condition with sufficient frictional material for operational purposes.

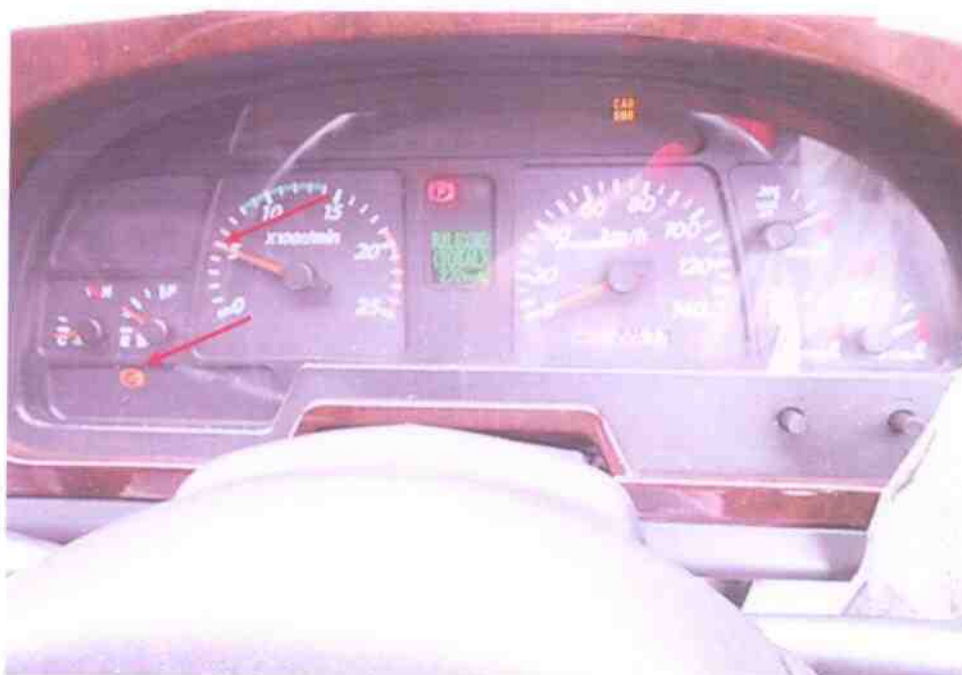
**Photo 26** shows the warning indicator for Anti-Brake Lock System (ABS) was observed to be lighted up during cranking & after engine was in idling speed.

20. The Anti-Brake Lock System (ABS) indicator was noted to stay lighted up even after the engine was in idling speed. This would indicate that there was an electronic fault to the Anti-Brake Lock System (ABS). However, we are of the opinion that this did not cause and/or contributed to the accident as the braking system was still able to function normally.

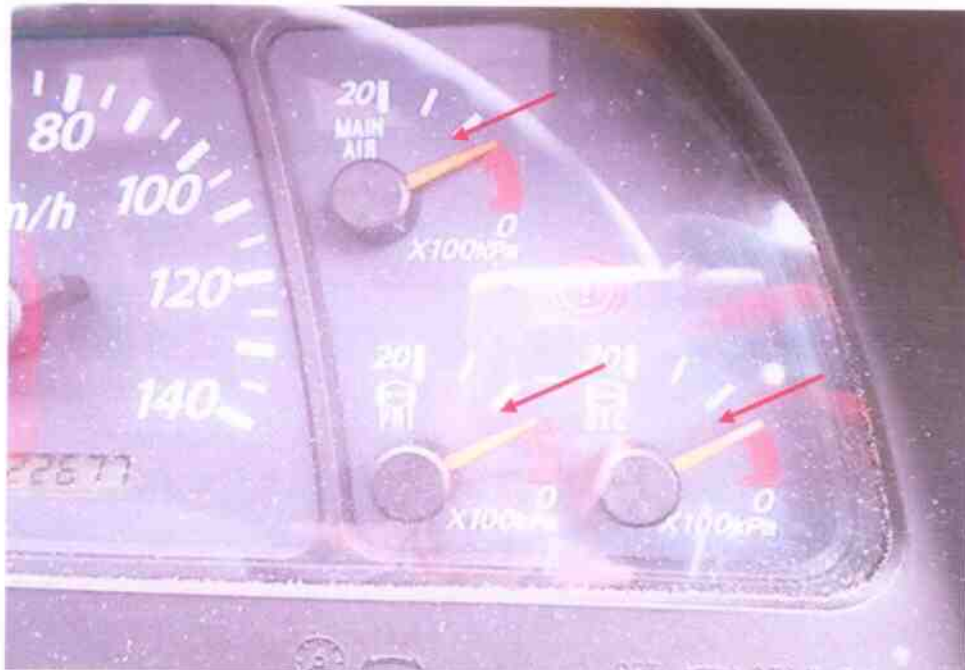
**Photo 27** shows the compressed air meters for braking system. This shows that there's no dropped of pressure. Hence, revealed that no air leakage at the time of our inspection.

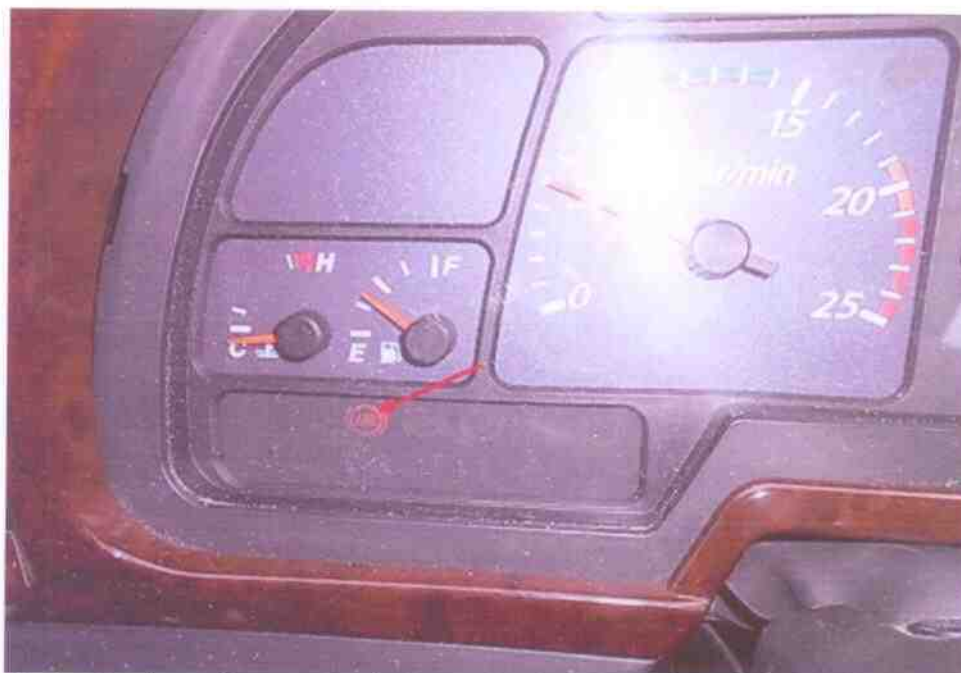
**Photo 28** shows the warning indicator for Anti-Brake Lock System (ABS) was observed to be lighted up during cranking & after engine was in idling speed.
