Your Ref: TP/IP/59659/2017
Our Ref : CI/TPD18000534/Z

12th January 2018

Fatal Accident Investigation Team

MECHANICAL INSPECTION REPORT OF TIPPER TRUCK XE 2780H

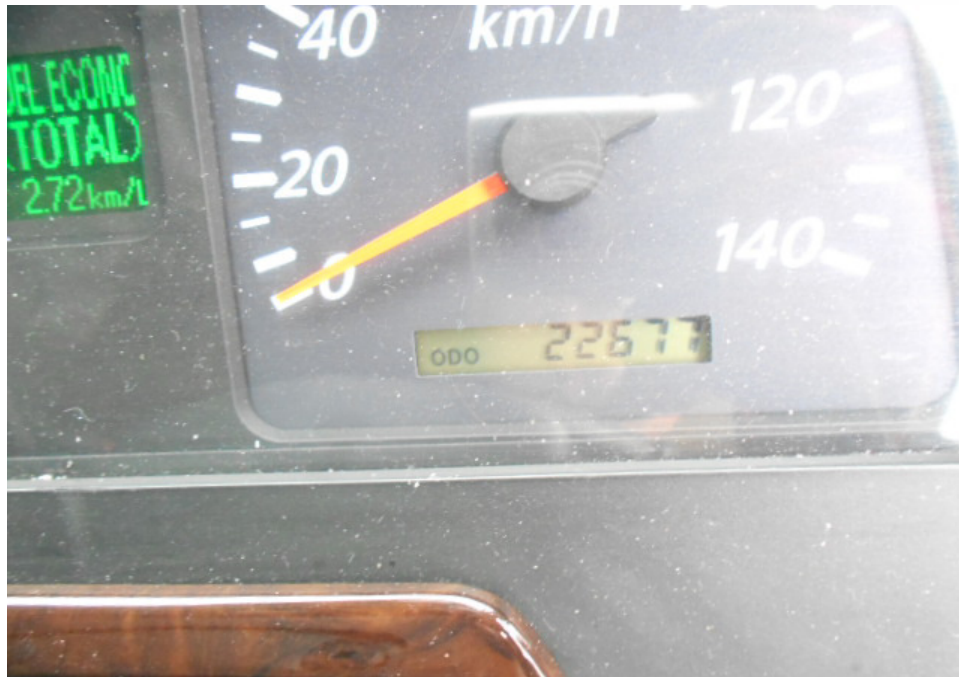
Photo 1 shows the mileage of the Tipper Truck at the time of our inspection was recorded as 22,677 km.

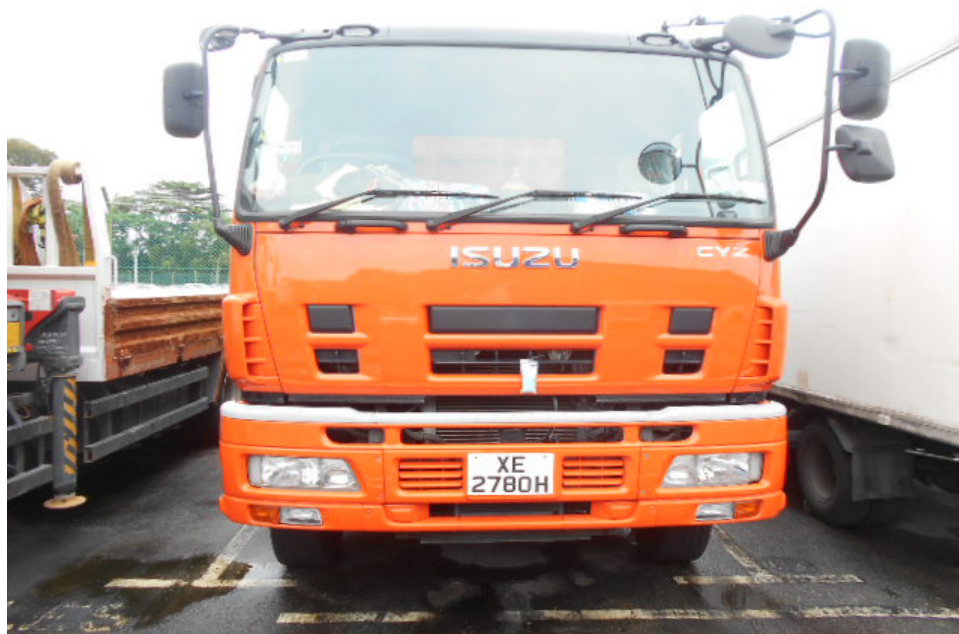
Photo 2 shows a general view of the front body of the Tipper Truck at the time of our inspection. The Tipper Truck was observed to have no signs of fresh damages on its body portion, this is likely due to the consistency of the accident's case facts that the Tipper Truck ran over the other involved party (bicycle).

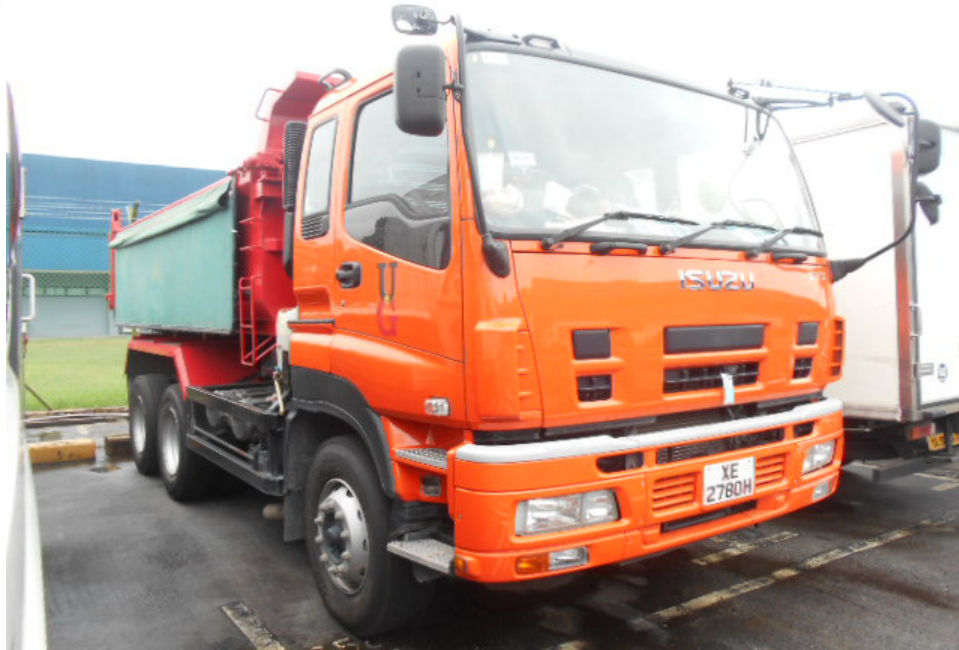
Photo 3 shows a general view of the front right body of the Tipper Truck at the time of our inspection. The Tipper Truck was observed to have no signs of fresh damages on its body portion, this is likely due to the consistency of the accident's case fact that the Tipper Truck ran over the other involved party (bicycle).

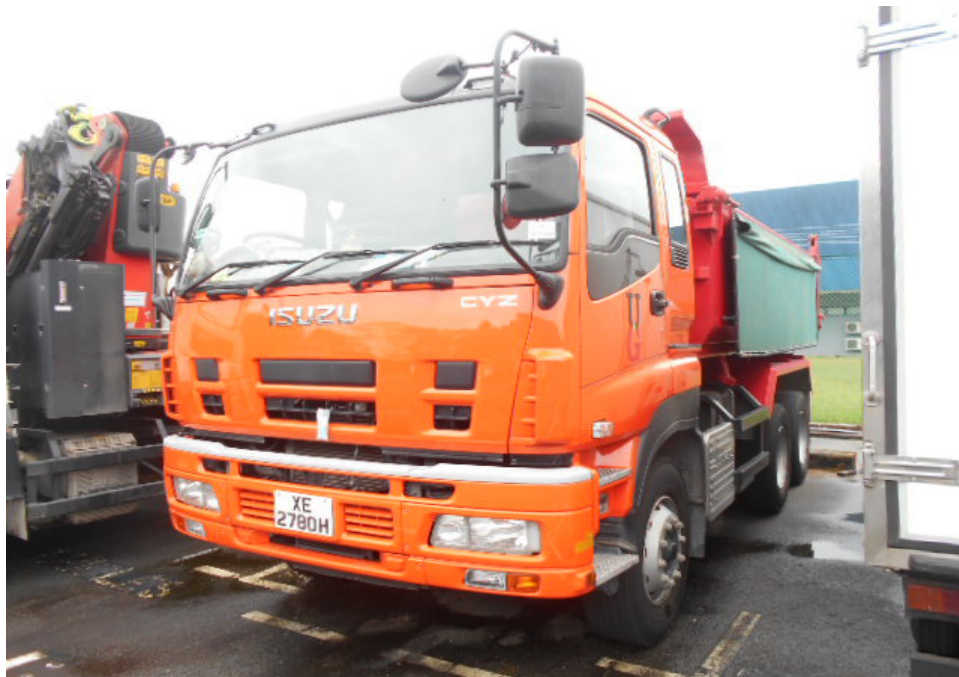
Photo 4 shows a general view of the front left body of the Tipper Truck at the time of our inspection. The Tipper Truck was observed to have no signs of fresh damages on its body portion, this is likely due to the consistency of the accident's case fact that the Tipper Truck ran over the other involved party (bicycle).

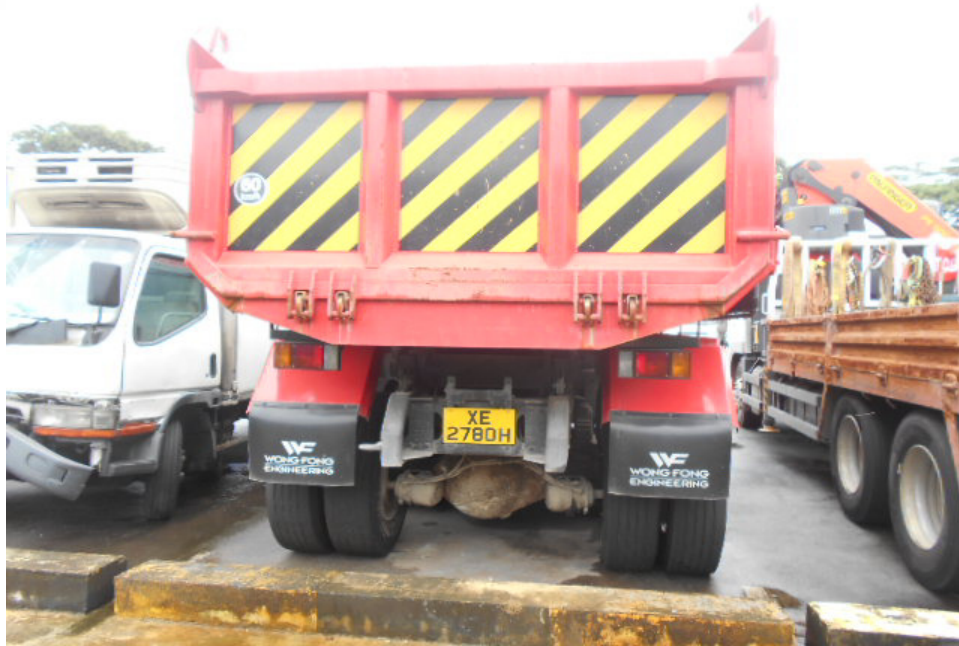
Photo 5 shows a general view of the rear body of the Tipper Truck at the time of our inspection. The Tipper Truck was observed to have no signs of fresh damages on its body portion, this is likely due to the consistency of the accident's case fact that the Tipper Truck ran over the other involved party (bicycle).

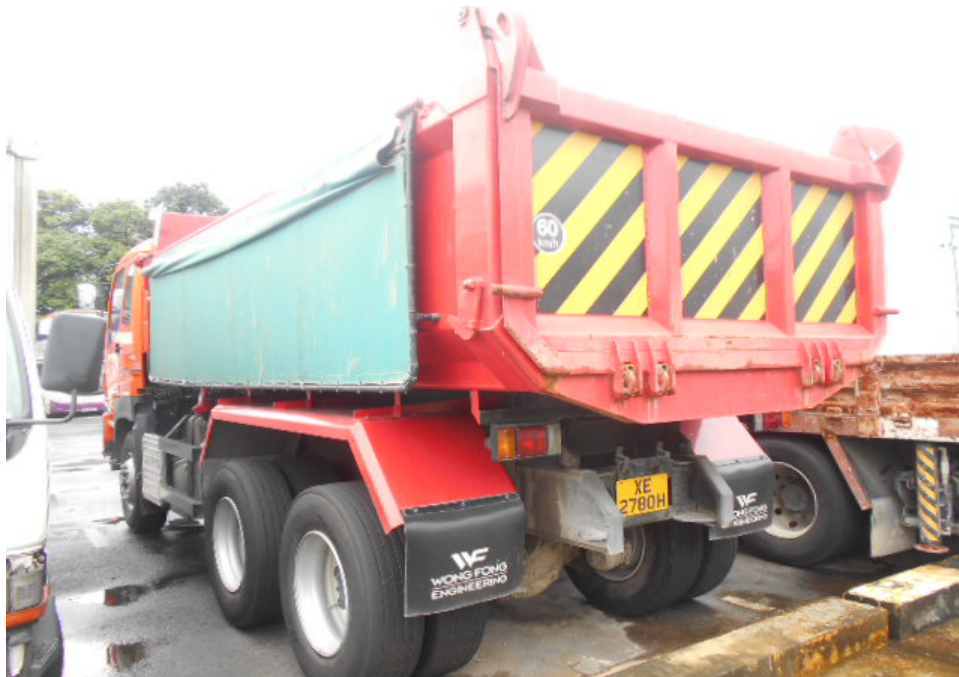
Photo 6 shows a general view of the rear left body of the Tipper Truck at the time of our inspection. The Tipper Truck was observed to have no signs of fresh damages on its body portion, this is likely due to the consistency of the accident's case fact that the Tipper Truck ran over the other involved party (bicycle).

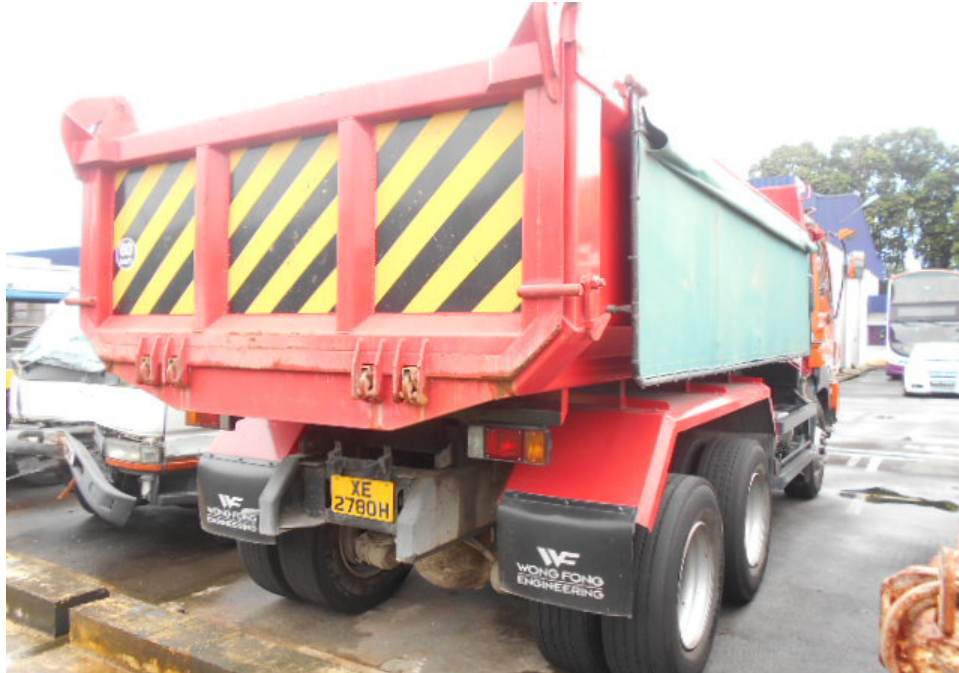
Photo 7 shows a general view of the rear right body of the Tipper Truck at the time of our inspection. The Tipper Truck was observed to have no signs of fresh damages on its body portion, this is likely due to the consistency of the accident's case fact that the Tipper Truck ran over the other involved party (bicycle).

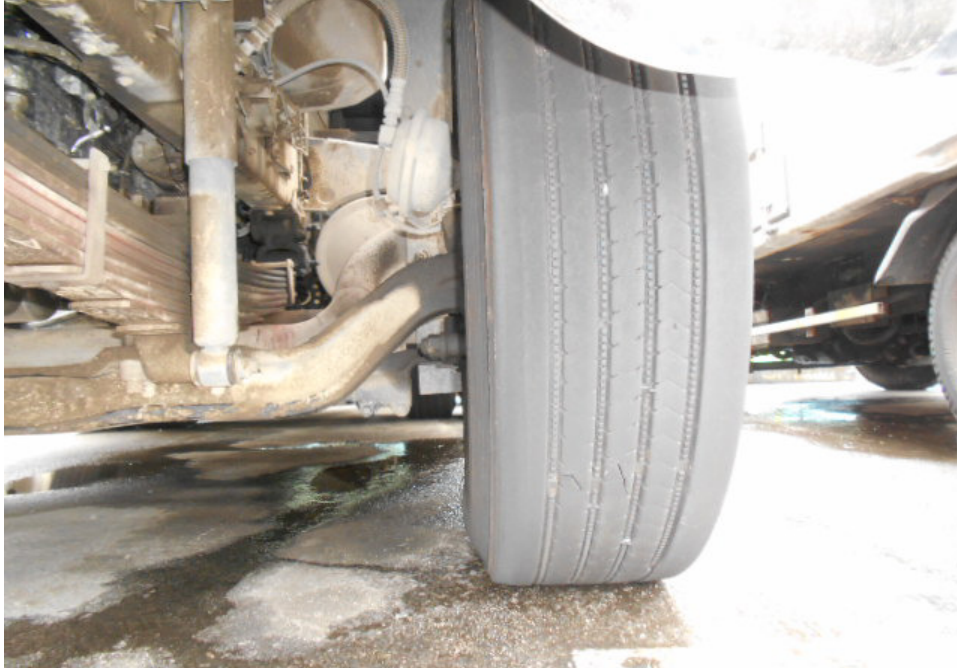
Photo 8 shows the condition of the front left tyre of the Tipper Truck, which was observed to be in serviceable condition with remaining tread depth of approximately 3mm.

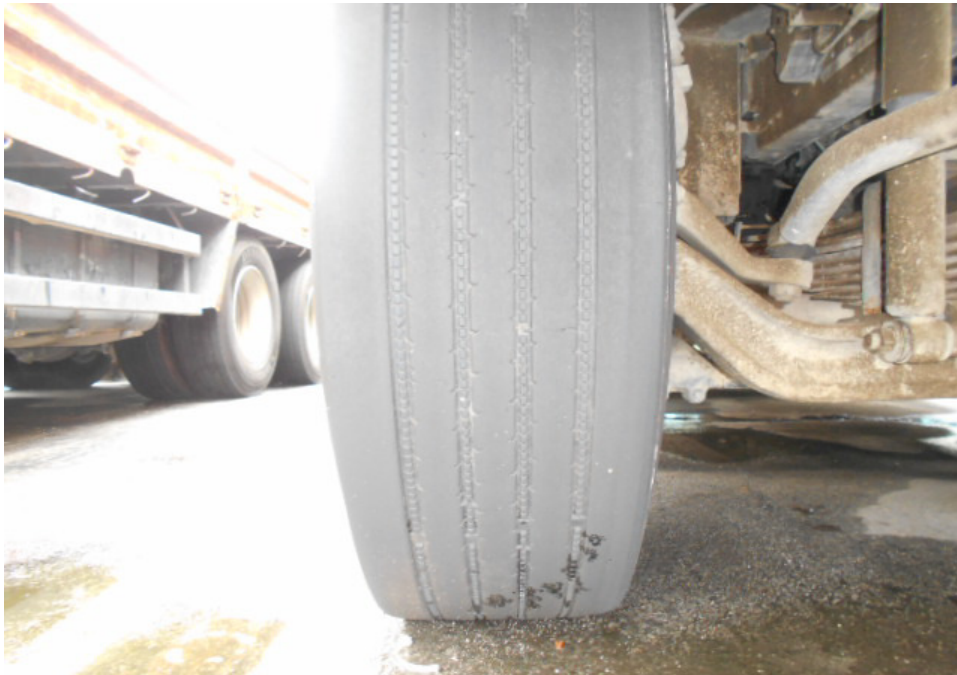
Photo 9 shows the condition of the front right tyre of the Tipper Truck, which was observed to be in serviceable condition with remaining tread depth of approximately 6mm.

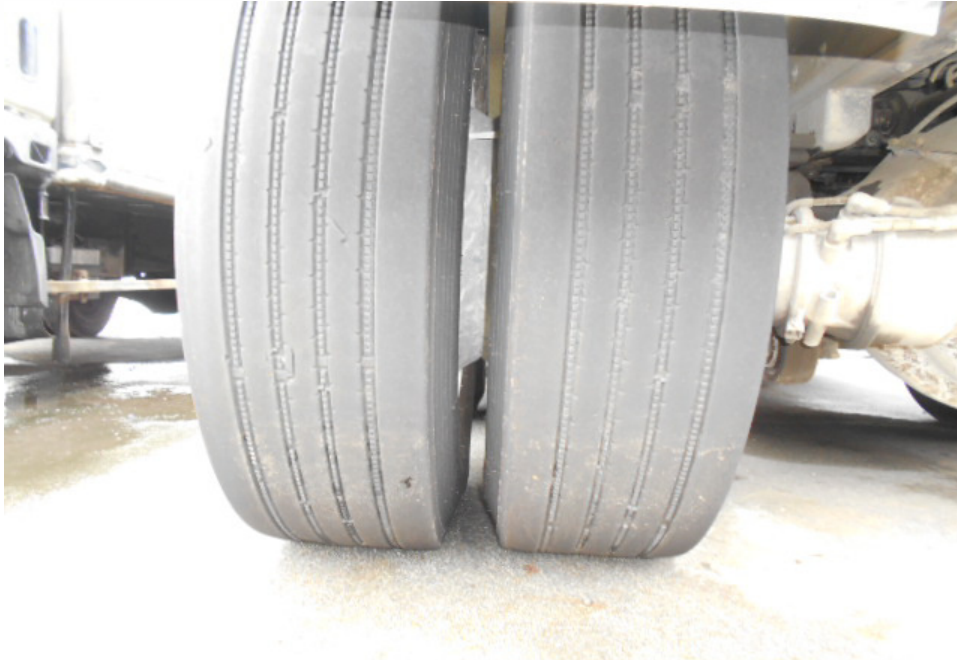
Photo 10 shows the condition of the rear left tyres of the Tipper Truck, which were observed to be in serviceable condition with remaining tread depth of approximately 6mm. The tyres were also observed to be sufficiently inflated for vehicular operation.

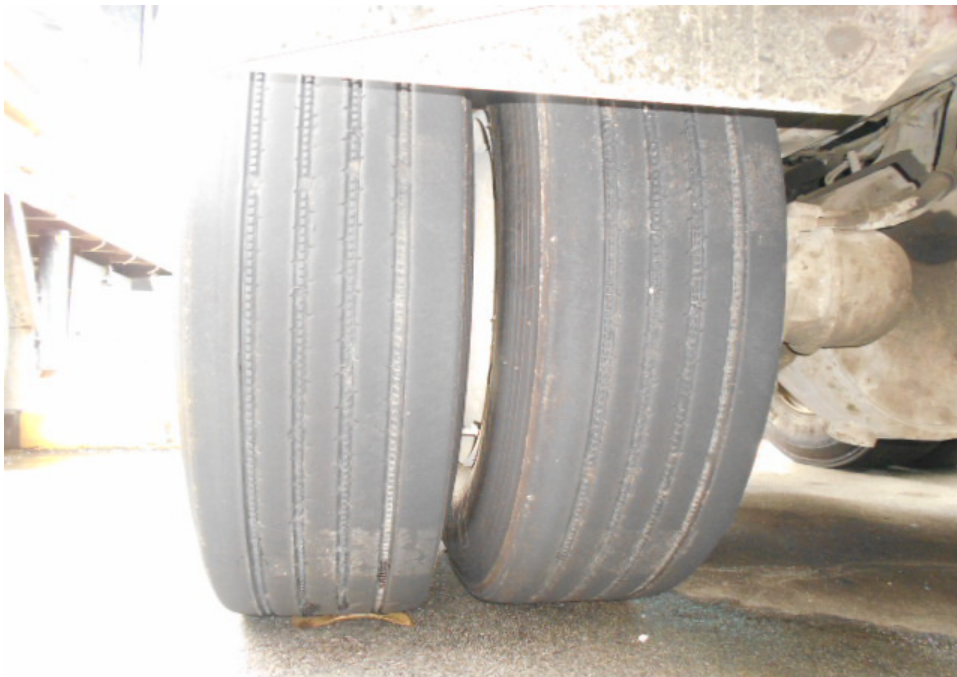
Photo 11 shows the condition of the rear left tyres (centre axle) of the Tipper Truck, which were observed to be in serviceable condition with remaining tread depth of approximately 6mm. The tyres were also observed to be sufficiently inflated for vehicular operation.

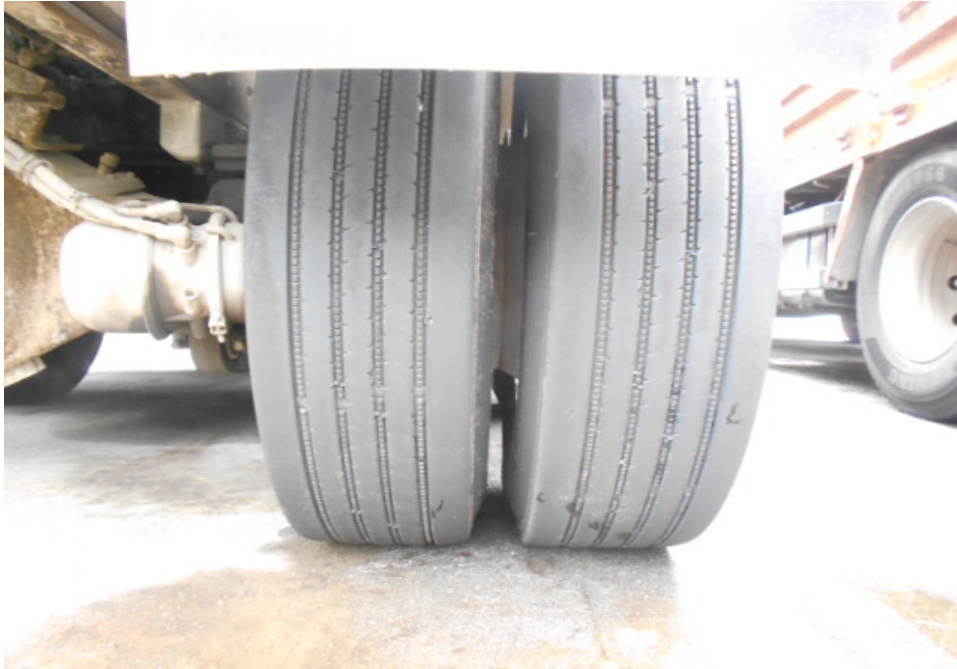
Photo 12 shows the condition of the rear right tyres of the Tipper Truck, which were observed to be in serviceable condition with remaining, tread depth of approximately 6mm. The tyres were also observed to be sufficiently inflated for vehicular operation with no tear, cut or burst mark(s) on the outer and the inner sidewalls.

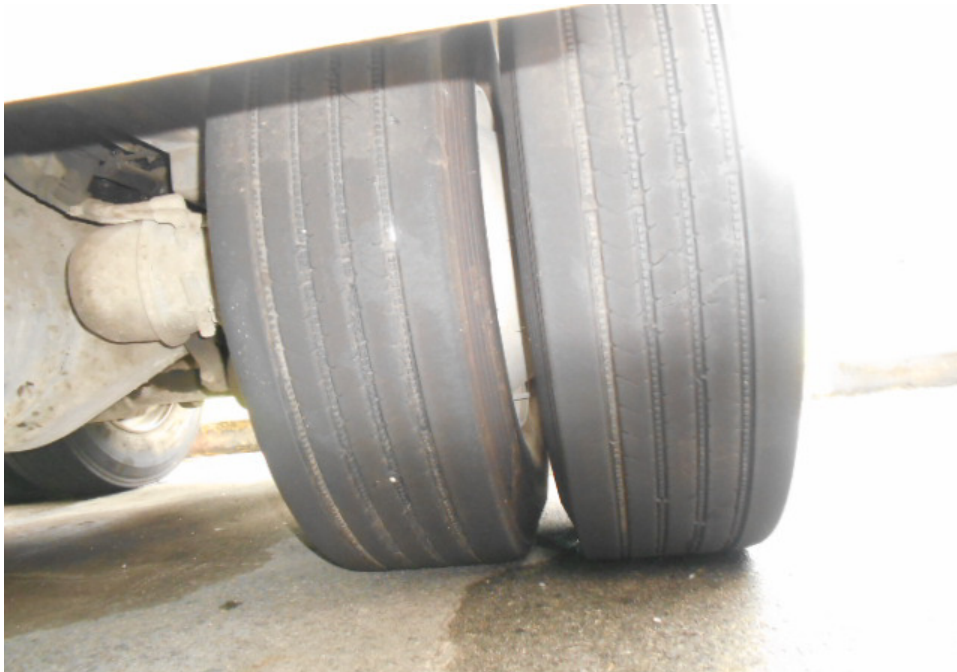
Photo 13 shows the condition of the rear right tyres (centre axle) of the Tipper Truck, which were observed to be in serviceable condition with remaining, tread depth of approximately 3mm. The tyres, which were wrapped around standard alloy wheel rims, were also observed to be sufficiently inflated for vehicular operation.

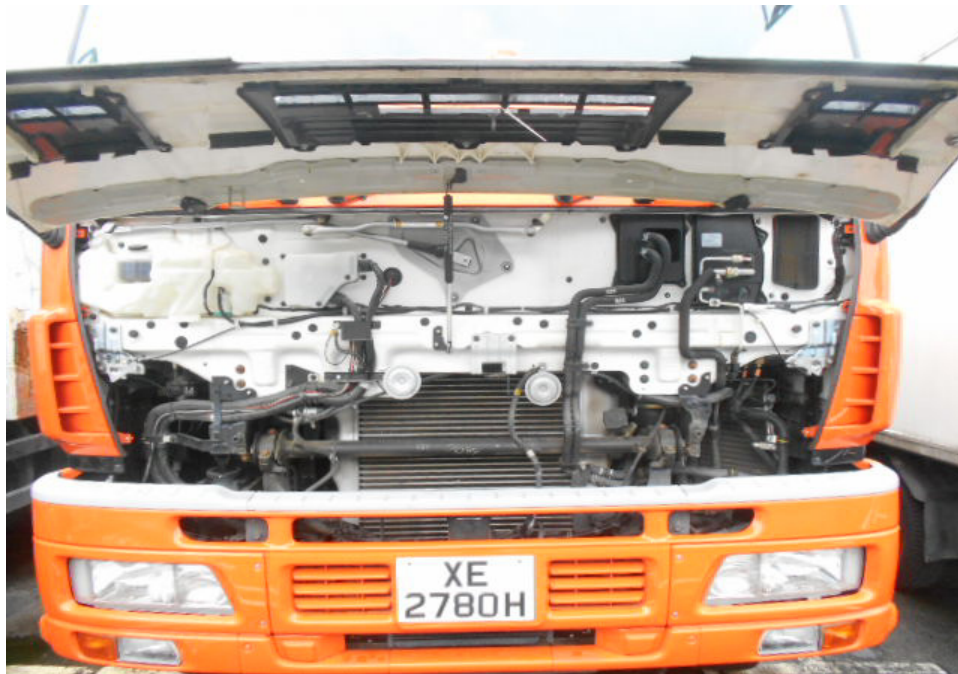
Photo 14 shows a general view of the engine compartment area from the front bonnet of the Tipper Truck. It was observed to be intact and unaffected by the collision. There was also no sign(s) or indication(s) of fluid leak and/or fluid stain found.

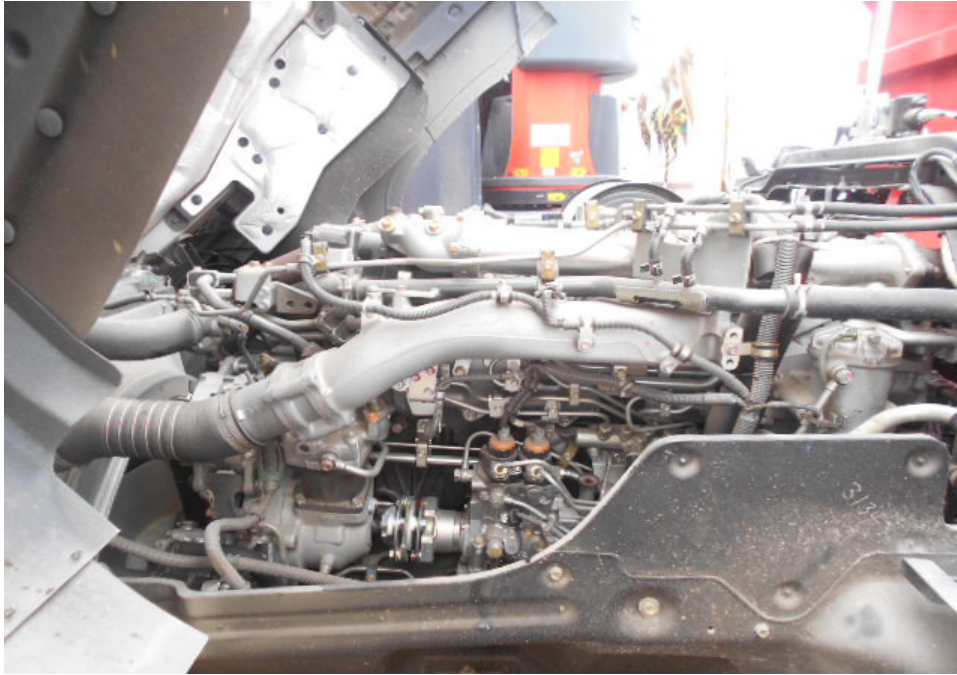
Photo 15 shows a general view of the engine area from under the front cabin of the Tipper Truck. The engine assembly and transmission assembly of the Tipper Truck were both observed to be intact and unaffected by the collision. There was also no sign(s) or indication(s) of fluid leak and/or fluid stain found.

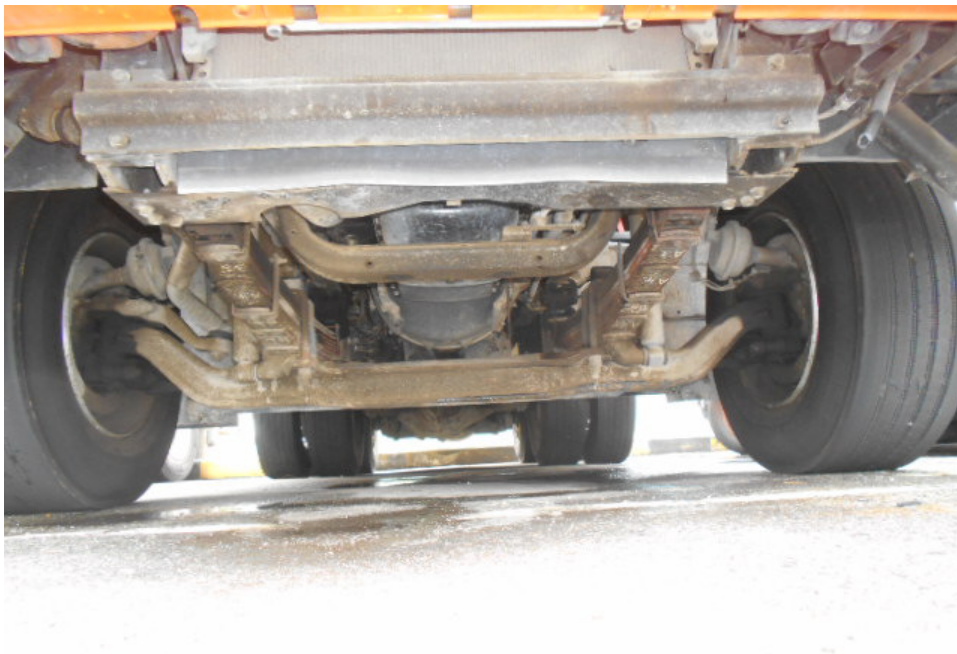
Photo 16 shows a general view of the engine area from the underside of the Tipper Truck. The engine assembly and transmission assembly of the Tipper Truck were both observed to be intact and unaffected by the collision. There was also no sign(s) or indication(s) of fluid leak and/or fluid stain found.

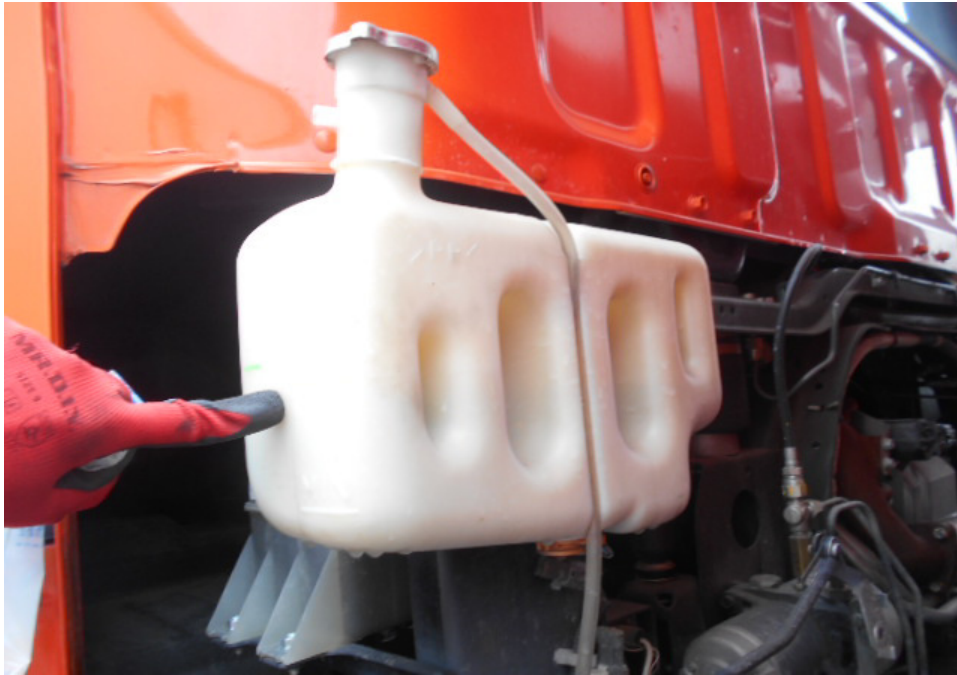
Photo 17 shows the engine coolant reservoir of the Tipper Truck at the time of our inspection. The engine coolant was observed to be of sufficient level and without any visible contamination for operational purposes.

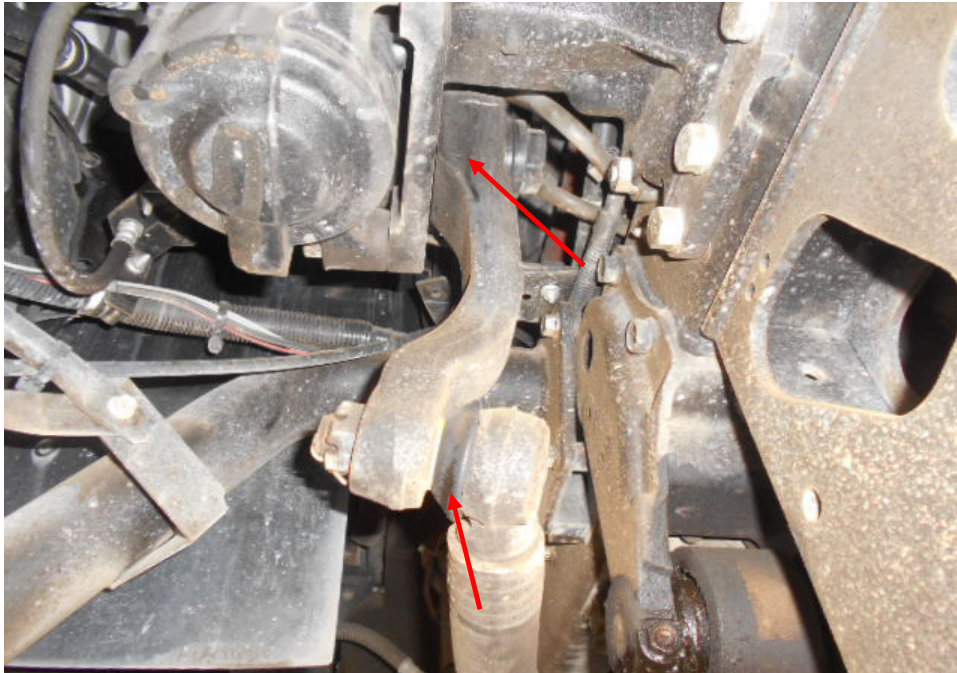
Photo 18 shows some of the mechanical components (arrowed) of the Tipper Truck's steering system. Our visual checks on the various mechanical components of the steering system revealed all to be intact and in good condition. The steering system of the Tipper Truck is hence likely to be in serviceable condition at the time of accident.

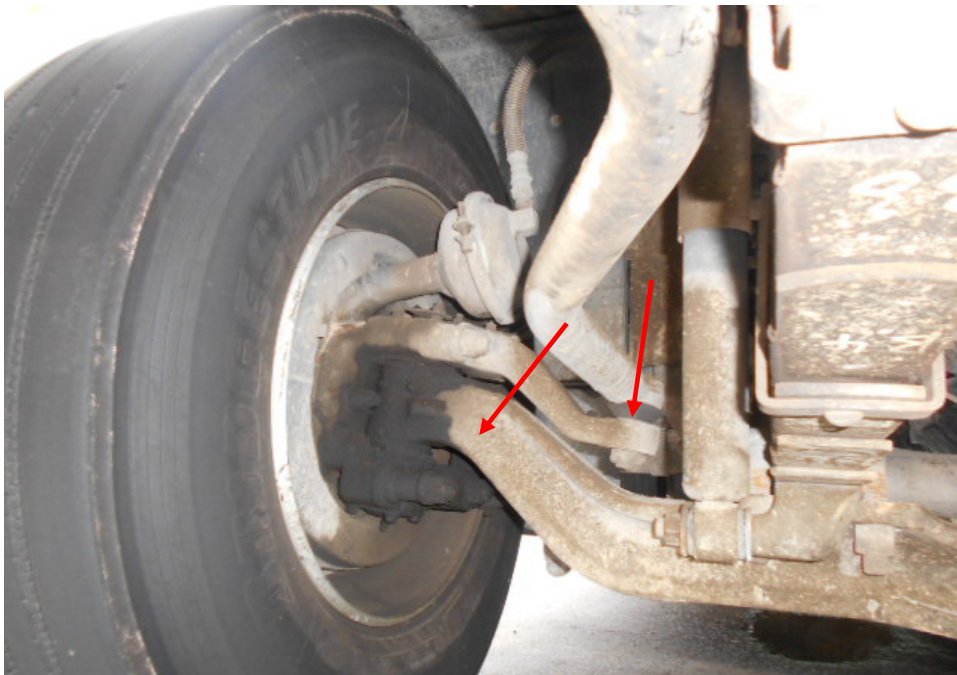
Photo 19 shows the undercarriage components at the front right wheel of the Tipper Truck. The various undercarriage components of the Tipper Truck were all observed to be intact and without any visible damage. This had included the steering rack and steering linkages (arrowed) of the Tipper Truck.

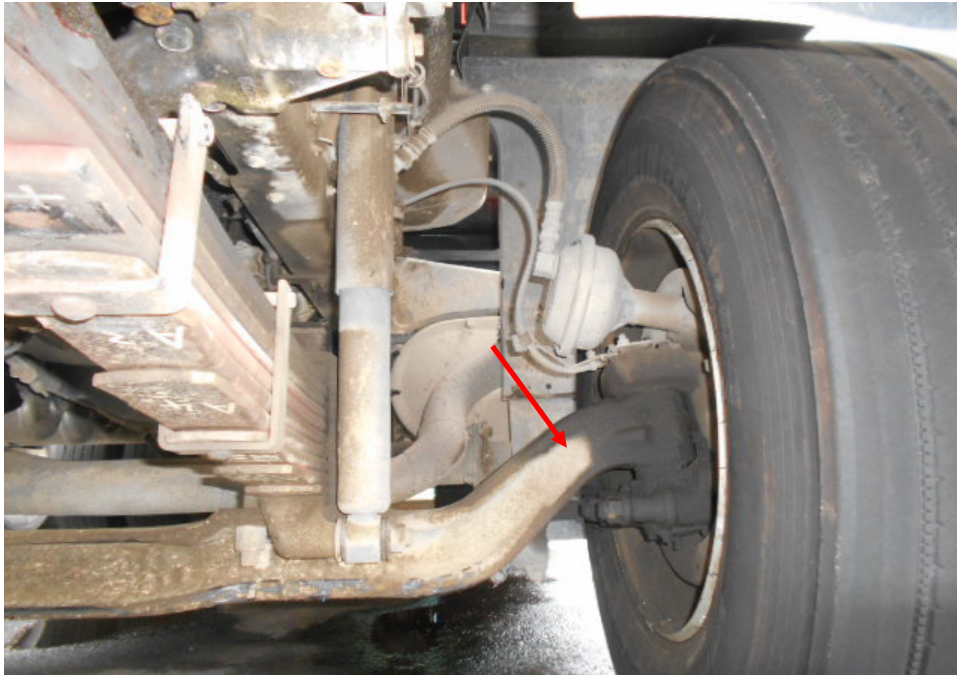
Photo 20 shows the undercarriage components at the front left wheel of the Tipper Truck. The various undercarriage components of the Tipper Truck were all observed to be intact and without any visible damage. This had included the steering rack (arrowed) of the Tipper Truck, which was observed to be securely attached to the front left wheel and front right wheel.

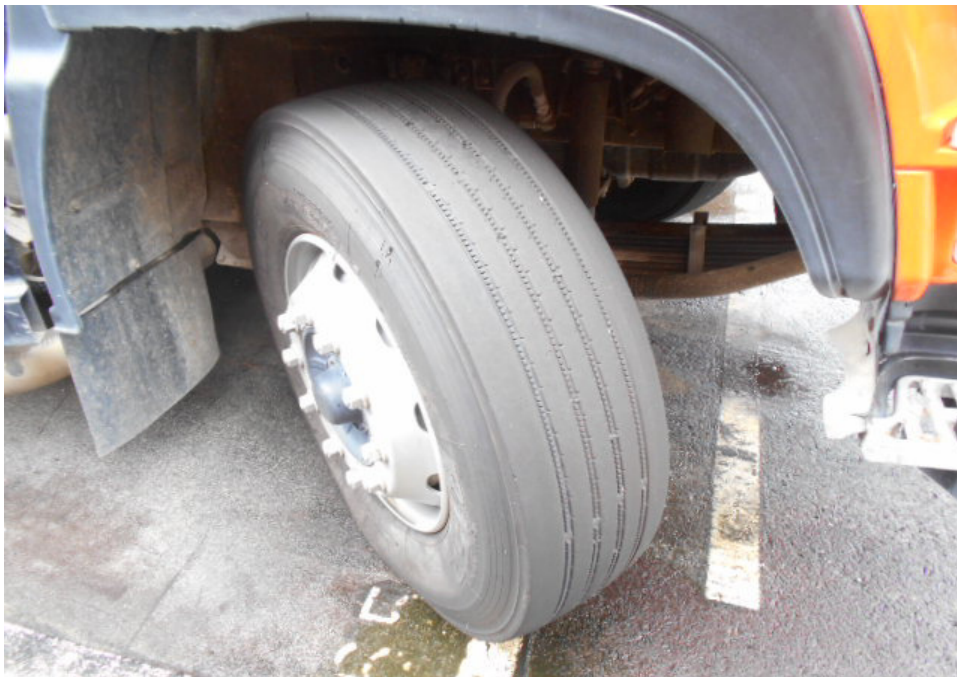
Photo 21 shows that we did not experience any abnormal free play and/or other resistance when turning the steering wheel left and right to full lock positions.

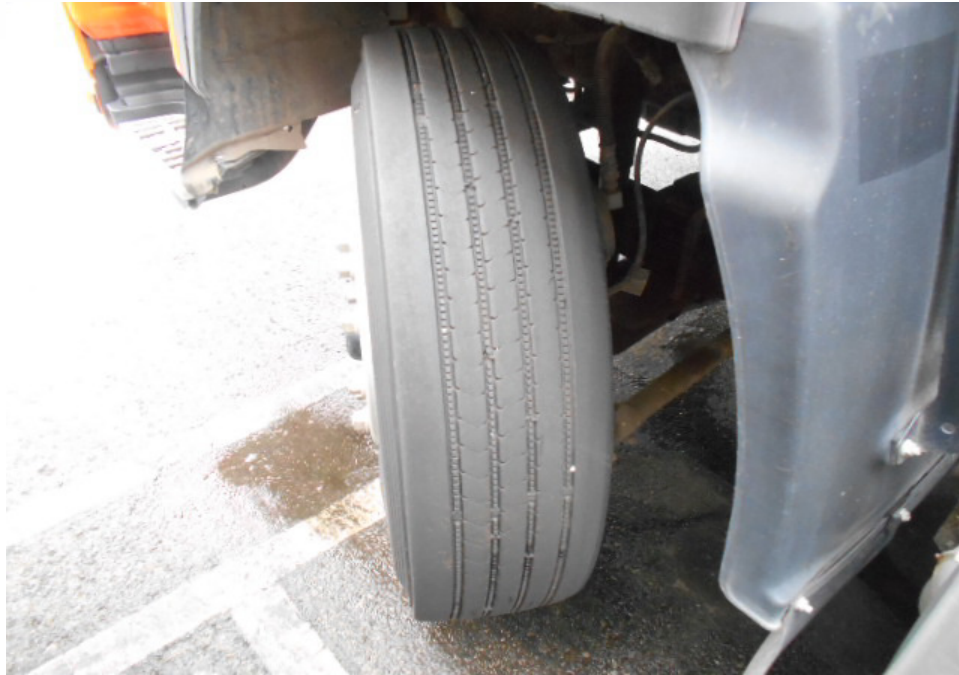
Photo 22 shows that we did not experience any abnormal free play and/or other resistance when turning the steering wheel left and right to full lock positions.

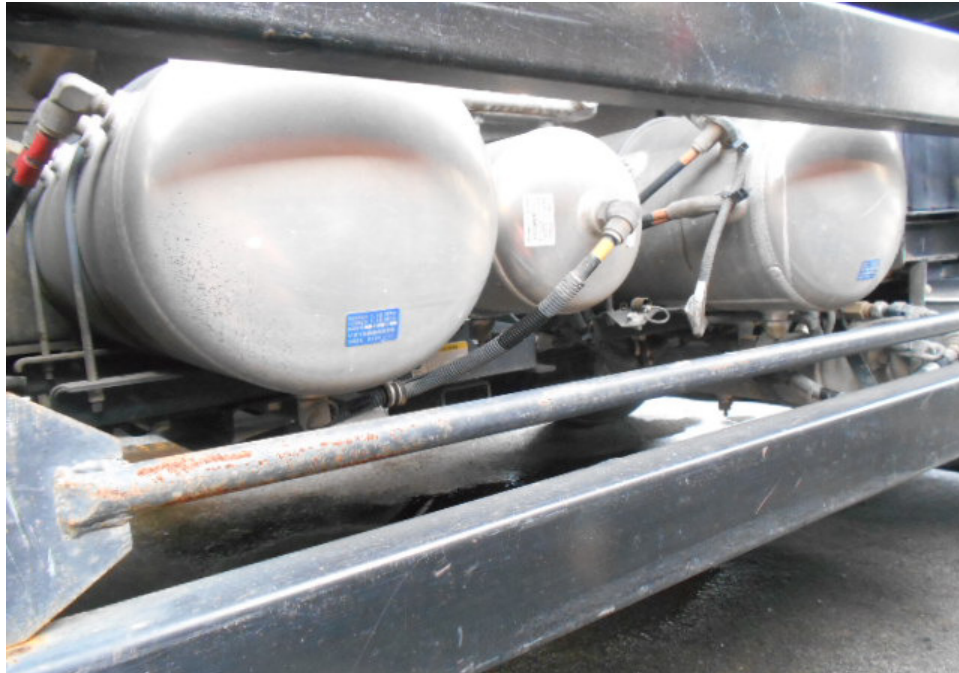
Photo 20 shows the air tanks, valves, pipes and hoses, which are some of the components for the air-assisted braking system of the Tipper Truck. These components were mainly located around the right centre body of the Tipper Truck, and were unaffected by the accident.

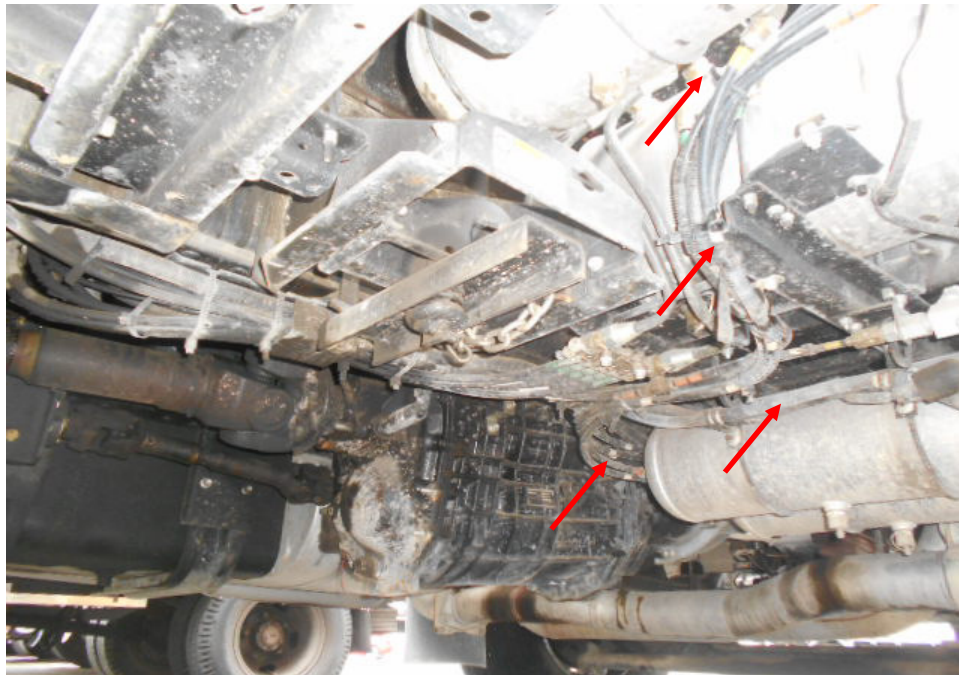
Photo 21 shows the valves, brake hoses and pipes, which are some of the components for the air-assisted braking system of the Tipper Truck. These components were mainly located around the right centre body of the Tipper Truck, and were unaffected by the accident. Our visual examination of these parts revealed all to be in good general condition and securely fitted.

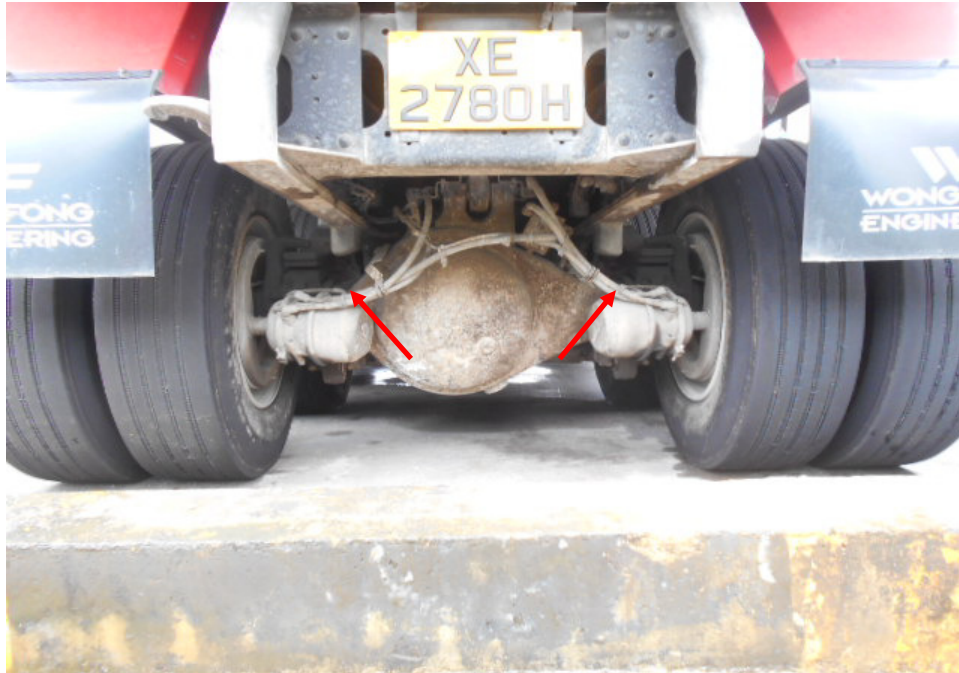
Photo 22 shows the brake hoses (arrowed) leading to the rear left wheel and rear right wheel of the Tipper Truck. At the time of our inspection, the various mechanical components of the air-assisted hydraulic braking system of the Tipper Truck were all found to be in good general condition and securely fitted.

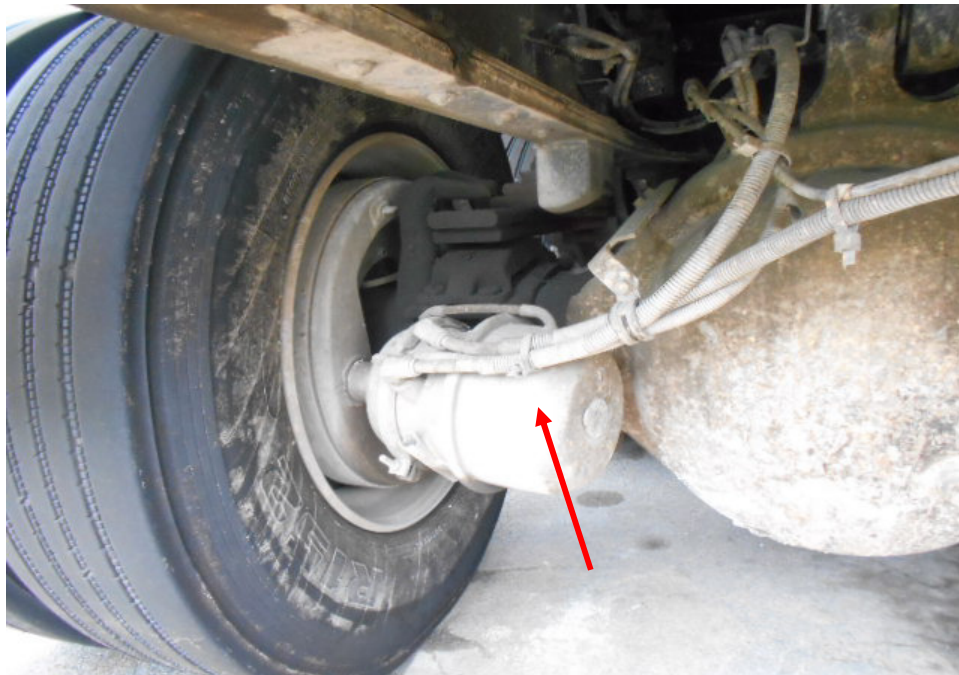
Photo 23 shows the brake air cylinder (arrowed) at the rear left rear wheel of the Tipper Truck. Such air cylinder, which is amongst the various components for the air-assisted hydraulic braking system, can be found attached to all the front wheels and all the rear wheels of the Tipper Truck. Upon our checks, we had found all the brake air cylinders to be undamaged and securely fitted to all the wheels of the Tipper Truck.

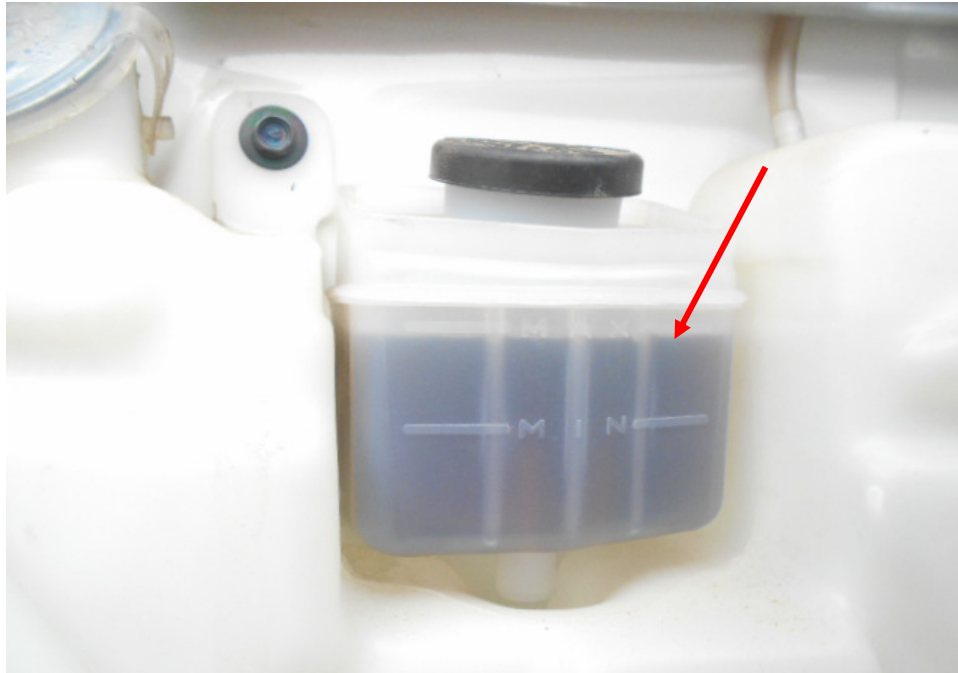
Photo 24 shows the brake fluid at the front bonnet of the Tipper Truck. The brake fluid was found to be of sufficient level for operating purposes. Visually, there was also no contamination found to these fluids.

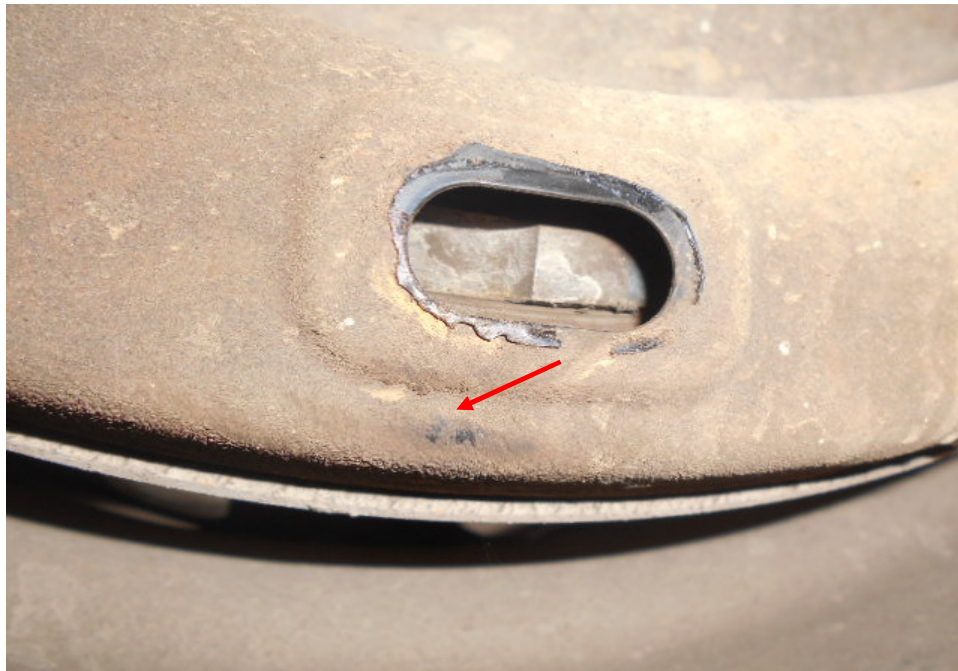
Photo 25 shows the brake shoes (brake pads) at the rear left wheel (rear axle) of the Tipper Truck. The brake shoes (brake pads) of the Tipper Truck were all found to be in serviceable condition with sufficient frictional material for operational purposes.

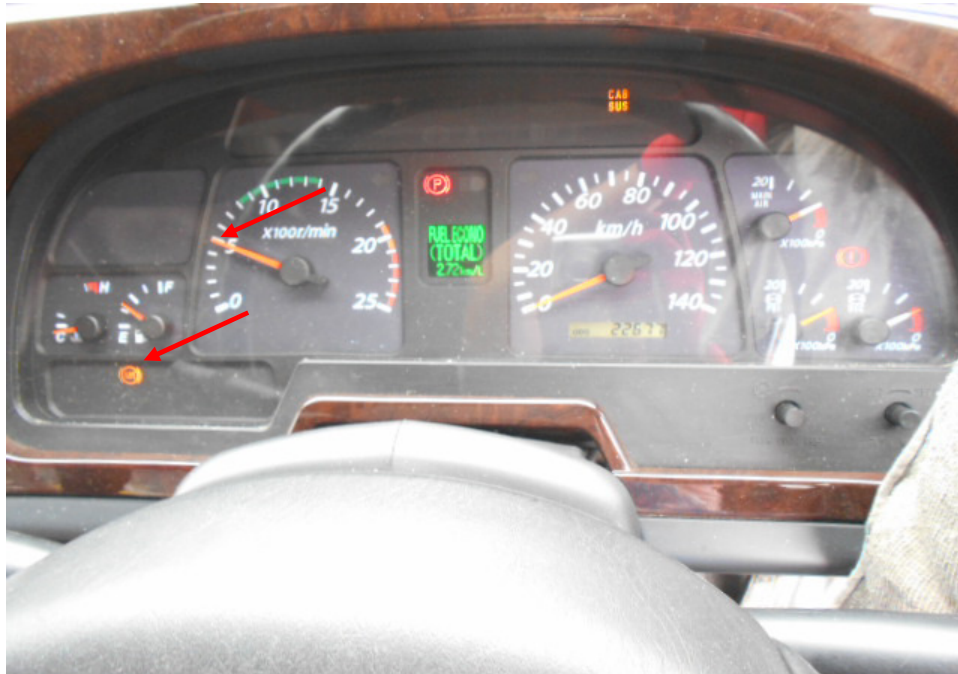
16. The Tipper Truck's automatic self-test of the functionality of its electronic operating systems such as the Anti-Brake Lock System (ABS) during cranking of the engine was observed to be lighted up. The indicator was noted to stay lighted up even after the engine was in idling speed.

Photo 26 shows the warning indicator for Anti-Brake Lock System (ABS) was observed to be lighted up during cranking & after engine was in idling speed.

20. The Anti-Brake Lock System (ABS) indicator was noted to stay lighted up even after the engine was in idling speed. This would indicate that there was an electronic fault to the Anti-Brake Lock System (ABS). However, we are of the opinion that this did not cause and/or contributed to the accident as the braking system was still able to function normally.

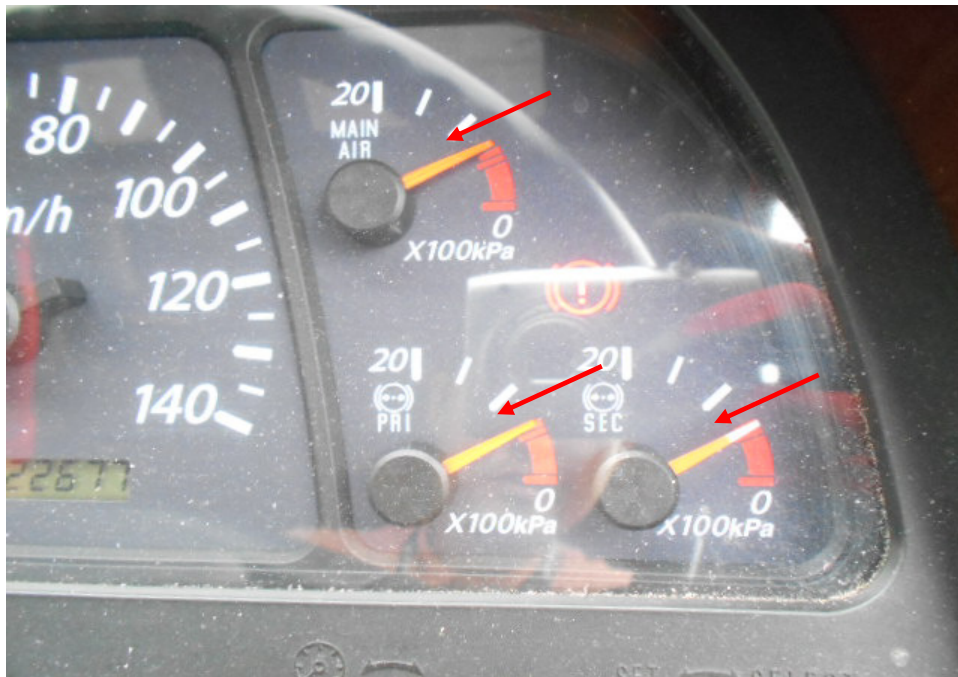
Photo 27 shows the compressed air meters for braking system. This shows that there's no dropped of pressure. Hence, revealed that no air leakage at the time of our inspection.

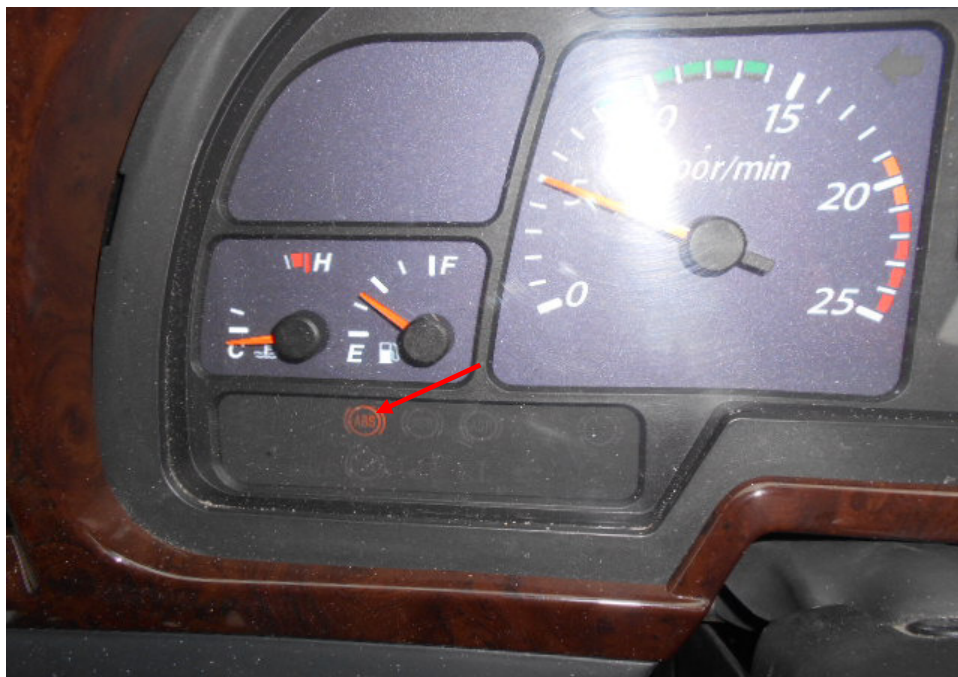
Photo 28 shows the warning indicator for Anti-Brake Lock System (ABS) was observed to be lighted up during cranking & after engine was in idling speed.
