Your Ref: TP/IP/62215/2017
Our Ref : CI/TPD18000537/Z

30th January 2018

MECHANICAL INSPECTION REPORT OF MOTOR BUS SBS 6226C

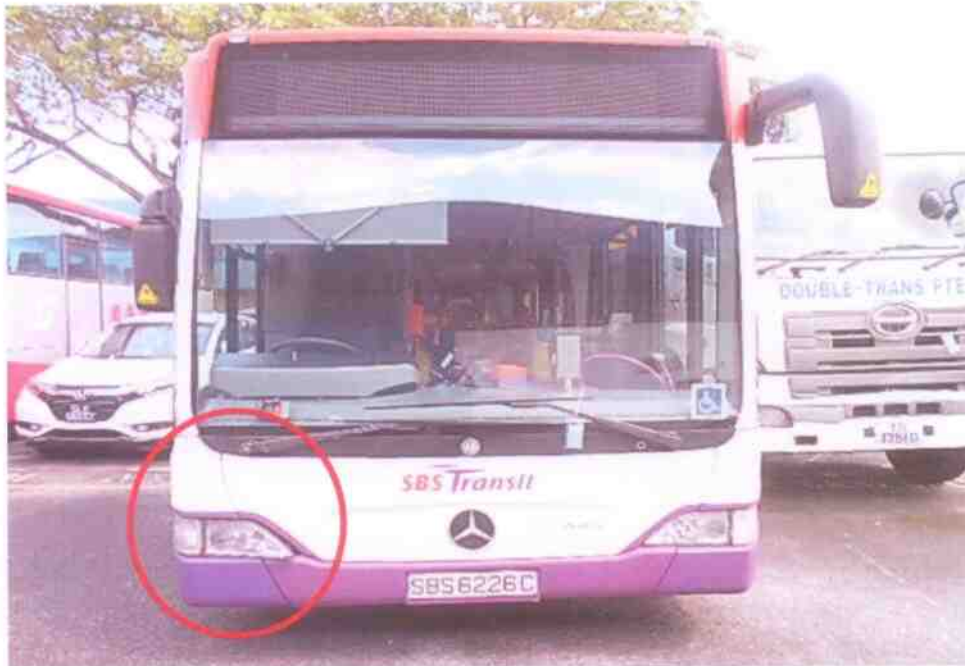
Photo 1 shows a general view of the front body of the Motor Bus at the time of our inspection. The Motor Bus was observed to have sustained relatively minor damage at its front right body. Its front right lower bumper was observed to be cracked & misaligned; its front right headlamp was observed to be dislodged from the original installation.

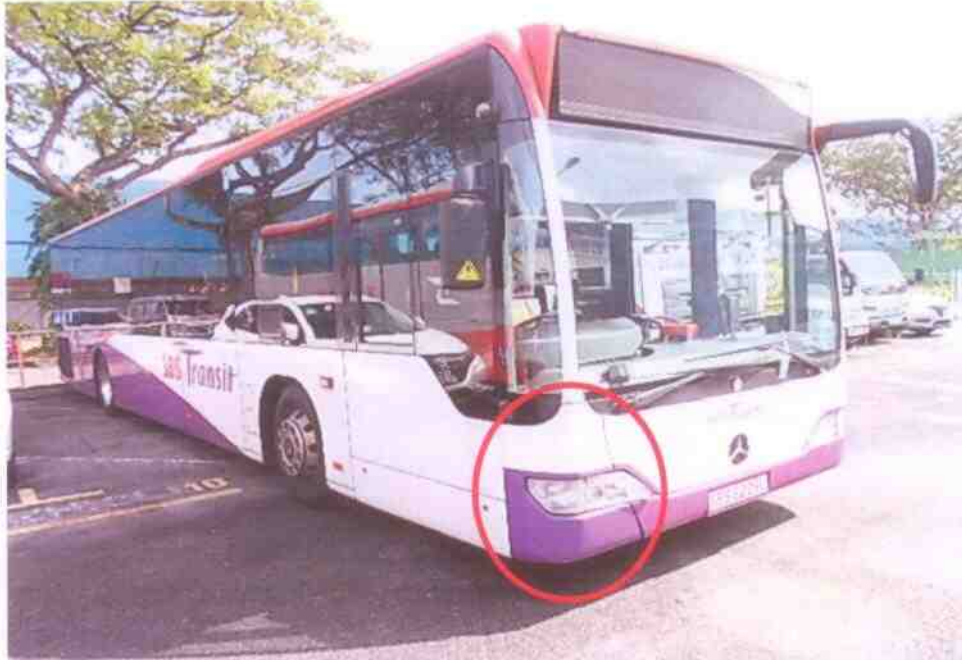
Photo 2 shows a general view of the front right body of the Motor Bus at the time of our inspection. The Motor Bus was observed to have sustained relatively minor damage at its front right body. Its front right lower bumper was observed to be cracked & misaligned; its front right headlamp was observed to be dislodged from the original installation.

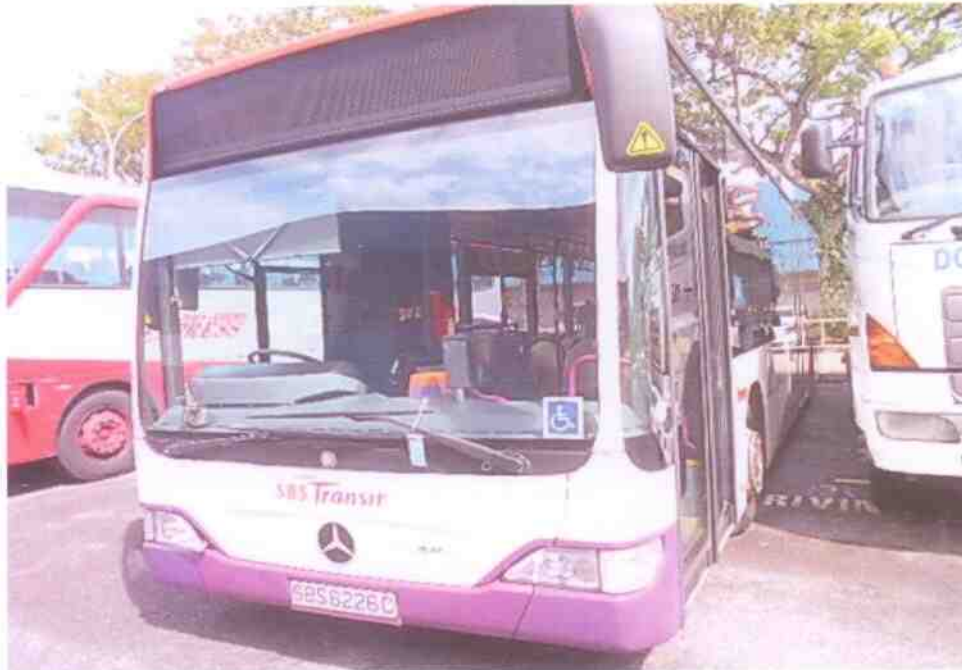
Photo 3 shows a general view of the front left body of the Motor Bus at the time of our inspection. The Motor Bus was observed to in good condition. No damages were noted on this side of the Motor Bus.

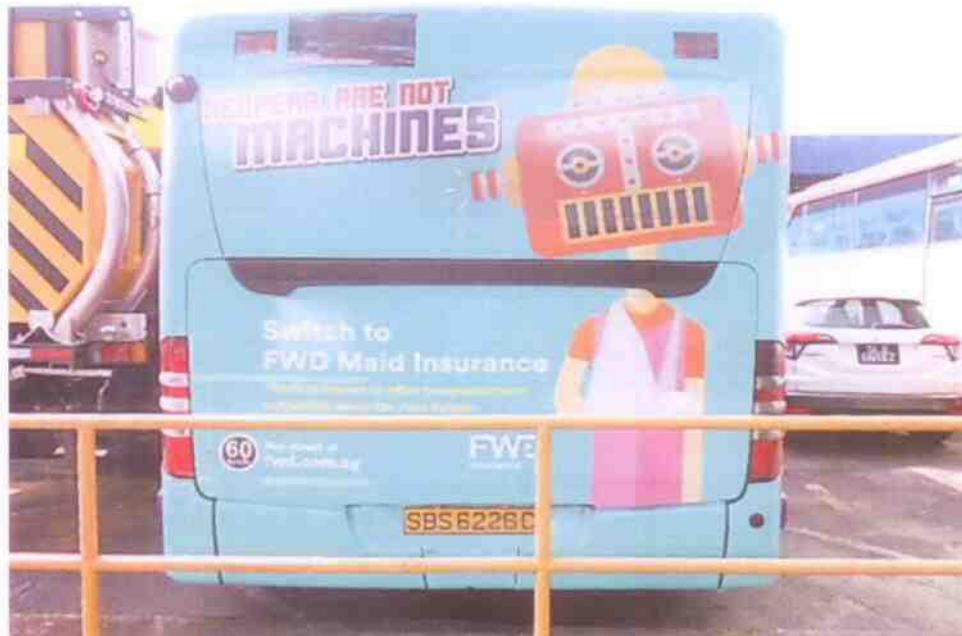
Photo 4 shows a general view of the Motor Bus's rear left body at the time of our inspection. There was no impact damage found at the rear portion of the Motor Bus.

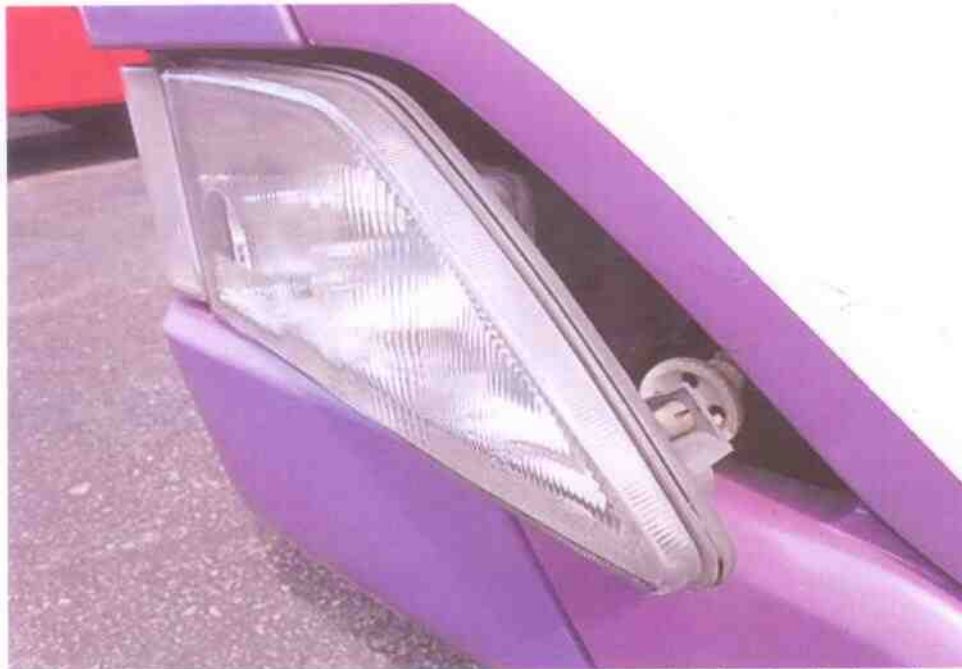
Photo 5 shows a close-up view of the Motor Bus's right hand side headlamp observed to be dislodged from its original installation likely due to the accident's impact.

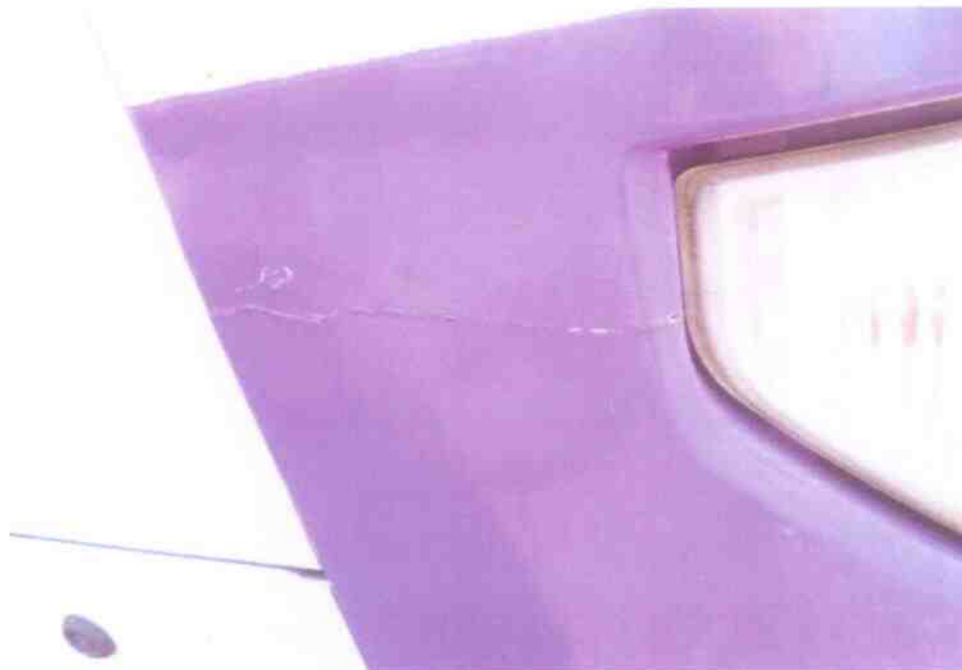
Photo 6 shows a close-up view of the Motor Bus's right hand lower bumper observed to be cracked likely due to the accident's impact.

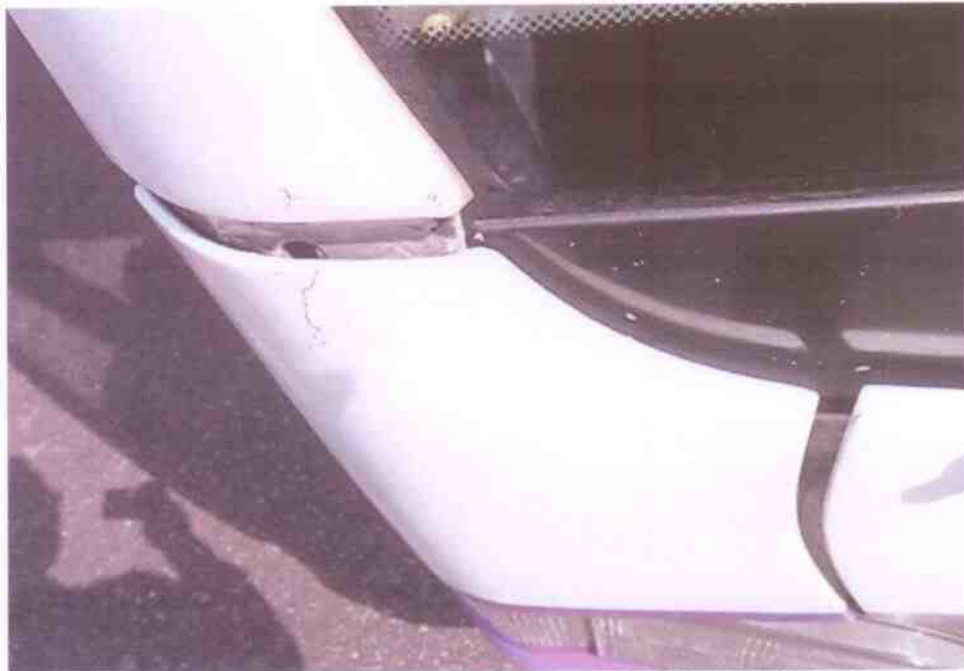
Photo 7 shows a close-up view of the Motor Bus's right hand side fender next to wiper garnish was observed to be misaligned likely due to the accident's impact.

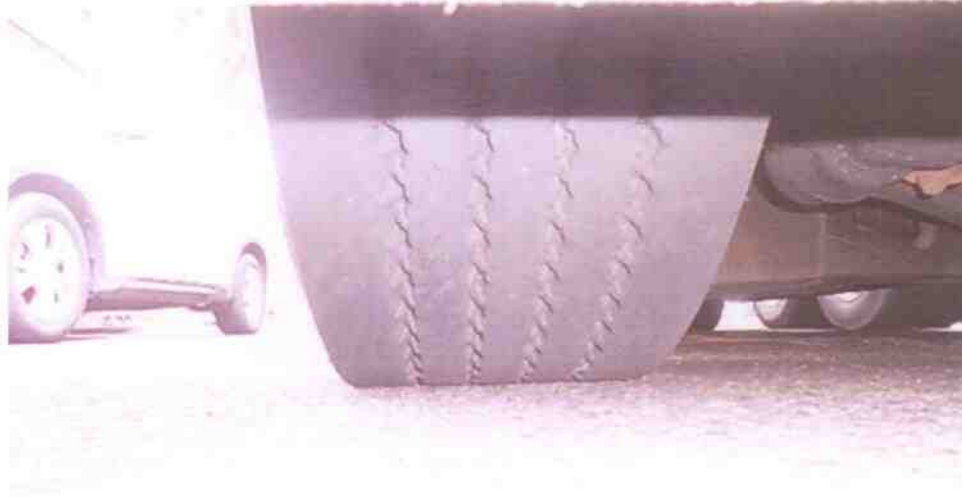
Photo 8 shows the condition of the front right tyre of the Motor Bus, which was observed to be in serviceable condition with remaining tread depth of approximately 3mm. The tyre was also observed to be sufficiently inflated for vehicular operation.

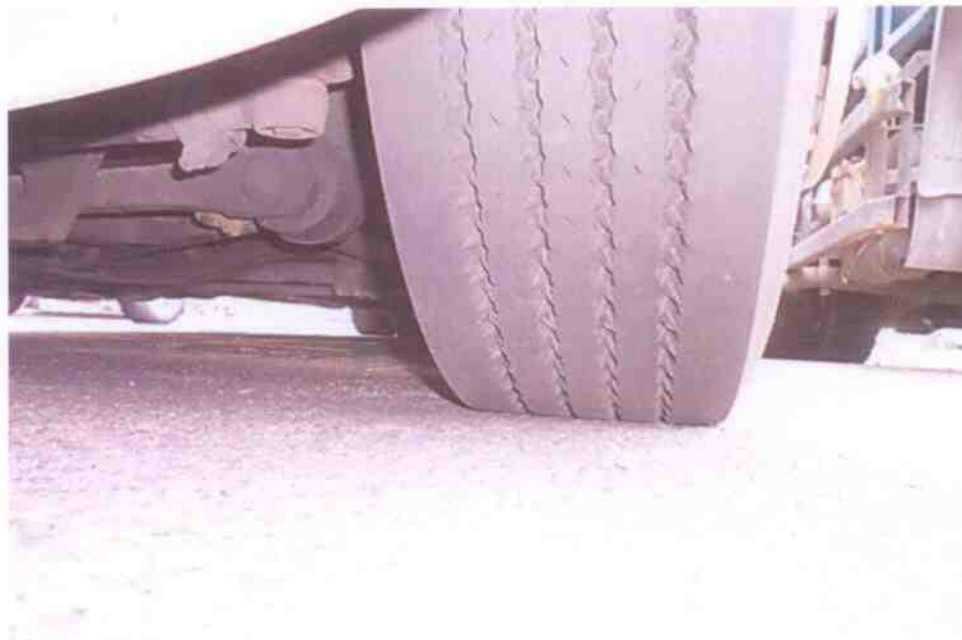
Photo 9 shows the condition of the front left tyre of the Motor Bus, which was observed to be in serviceable condition with remaining tread depth of approximately 3mm. The tyre was also observed to be sufficiently inflated for vehicular operation.

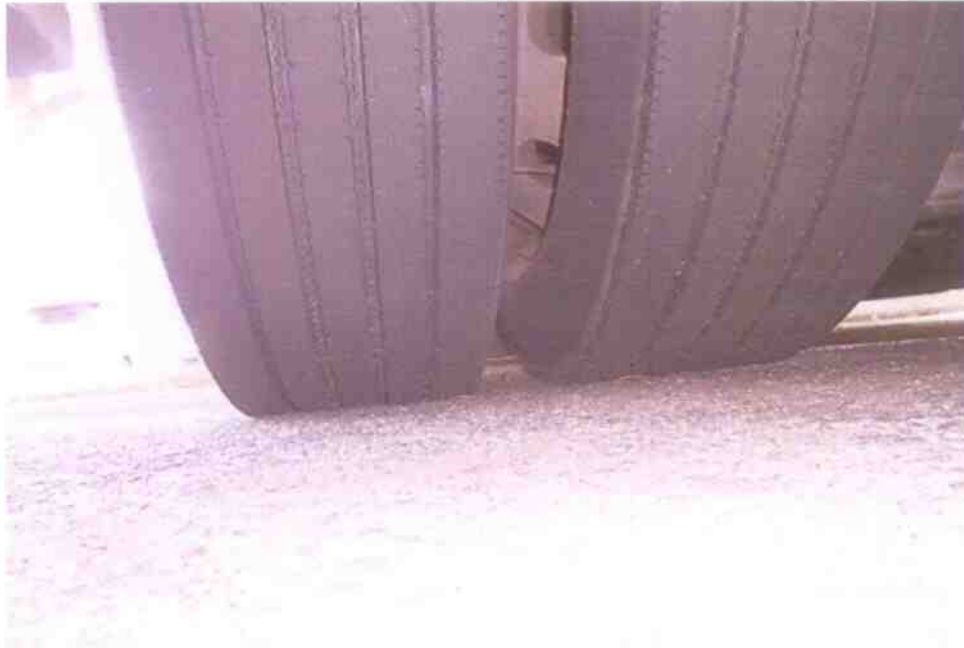
Photo 10 shows the condition of the rear right tyres of the Motor Bus, which were observed to be in serviceable condition with remaining tread depth of approximately 3mm. The tyres, which were wrapped around standard alloy wheels rims, were also observed to be sufficiently inflated for vehicular operation.

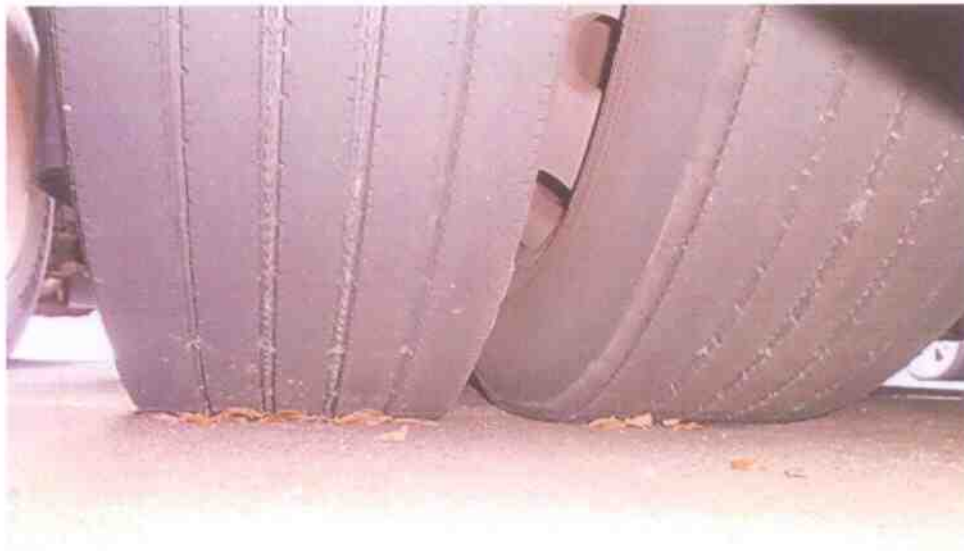
Photo 11 shows the condition of the rear left tyres (centre axle) of the Motor Bus, which were observed to be in serviceable condition with remaining tread depth of approximately 3mm. The tyres, which were wrapped around standard alloy wheel rims, were also observed to be sufficiently inflated for vehicular operation.

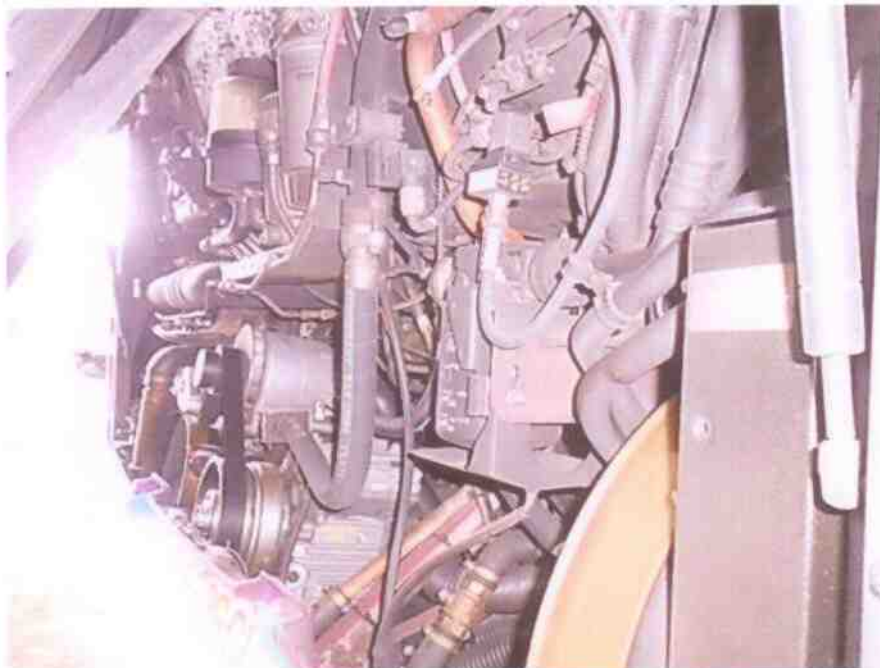
Photo 12 shows the engine compartment of the Motor Bus was located at the rear of the Motor Bus.

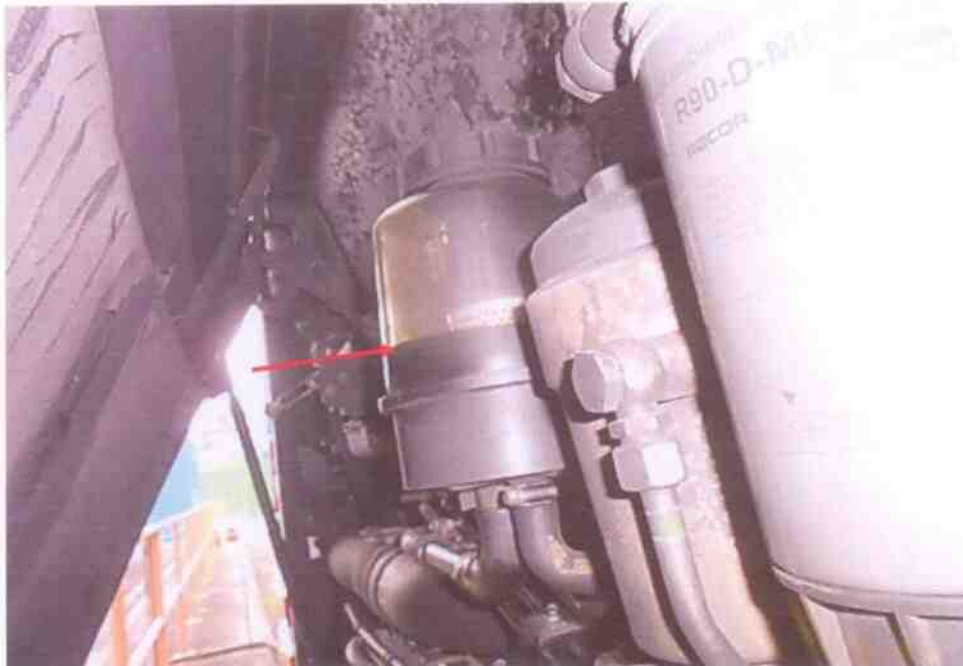
Photo 13 shows the steering fluid of the Motor Bus. It was observed to be of sufficient level without any contamination at time of our inspection.

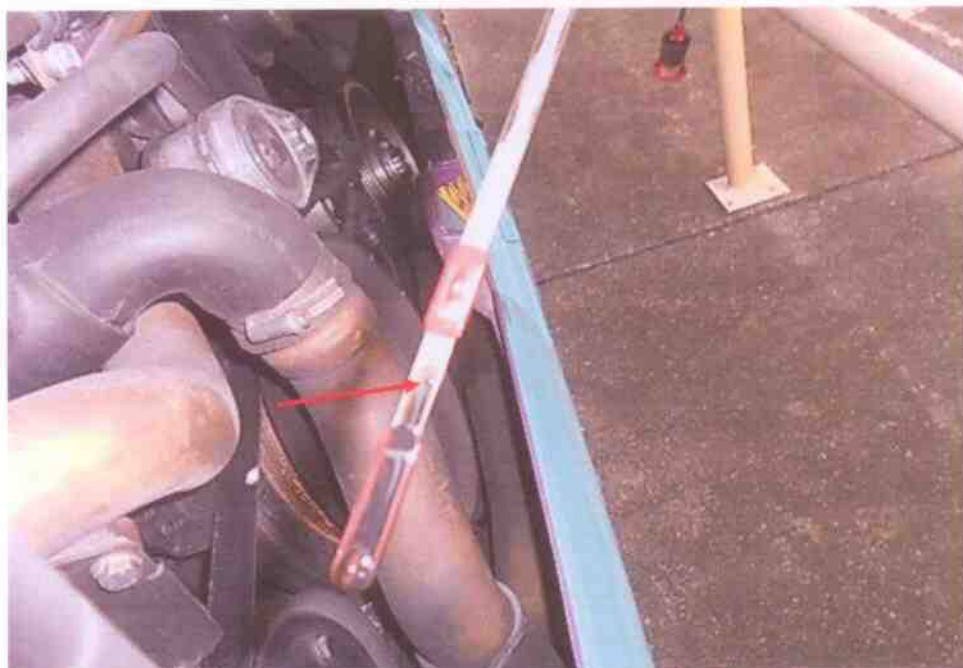
Photo 14 shows the engine fluid of the Motor Bus. It was observed to be of sufficient level without any contamination at time of our inspection.

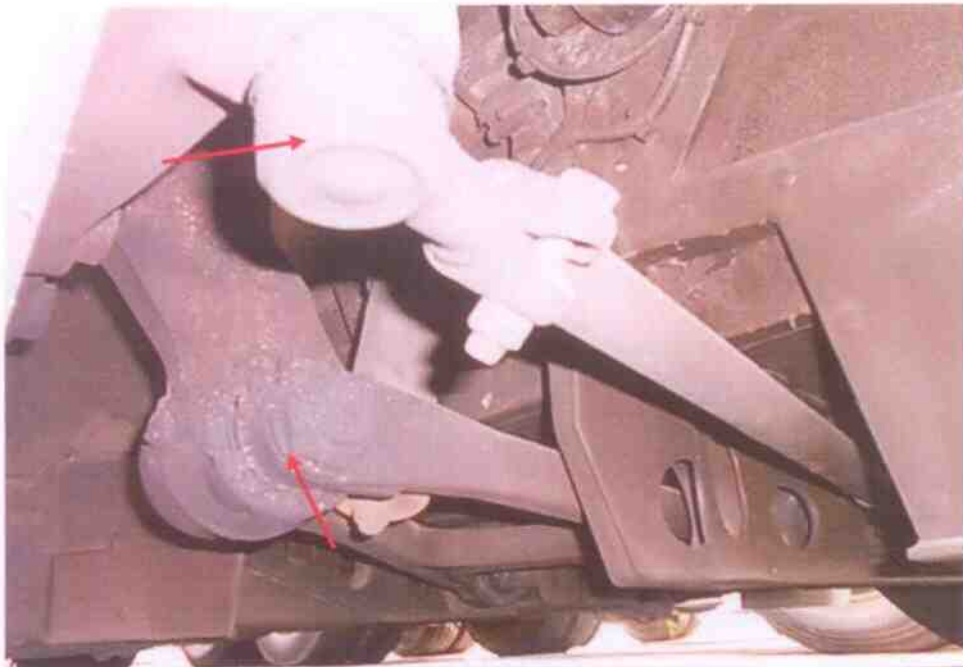
Photo 15 shows some of the mechanical components (arrowed) of the Motor Bus's steering system. We were not able to conduct any test(s) on the steering system of the Motor Bus as the engine of the Motor Bus could not be started. However our visual checks on the various mechanical components of the steering system revealed all to be intact and in good condition. The steering system of the Motor Bus is hence likely to be in serviceable condition at the time of accident.

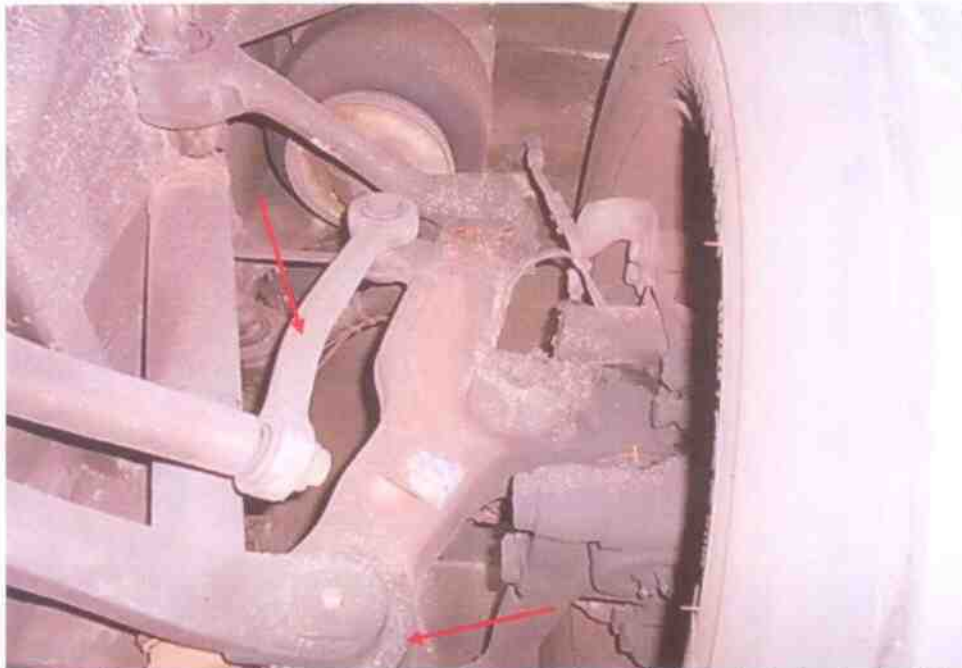
Photo 16 shows the undercarriage components at the front right wheel of the Motor Bus. The various undercarriage components of the Motor Bus were all observed to be intact and without any visible damage. This had included the steering rack and steering ball joints (arrowed) of the Motor Bus.

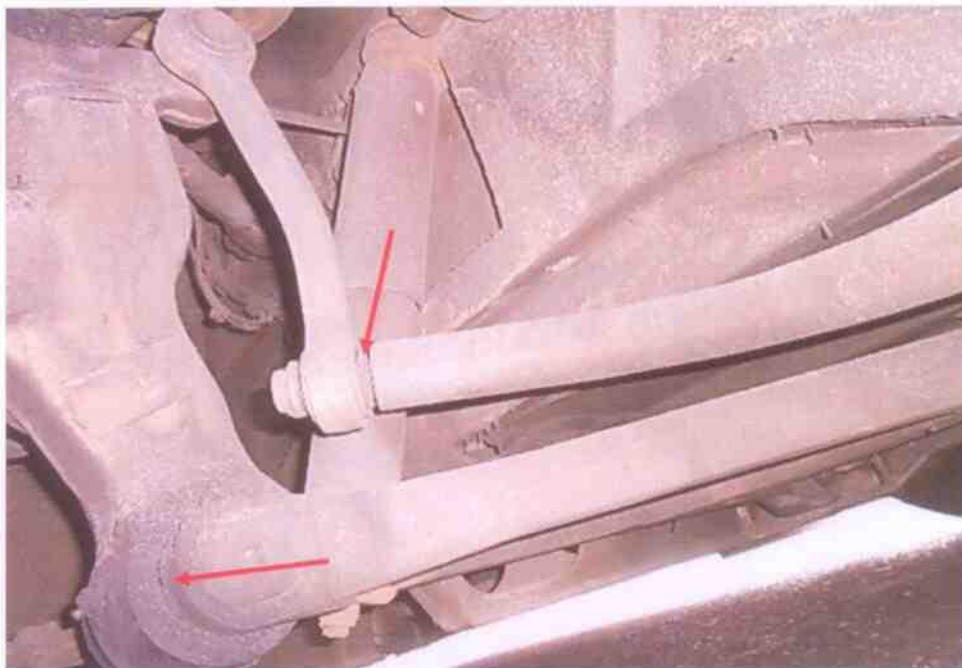
Photo 17 shows the undercarriage components at the front left wheel of the Motor Bus. The various undercarriage components of the Motor Bus were all observed to be intact and without any visible damage. This had included the steering rack and steering ball joints (arrowed) of the Motor Bus, which were observed to be securely attached to the front left wheel and front right wheel.

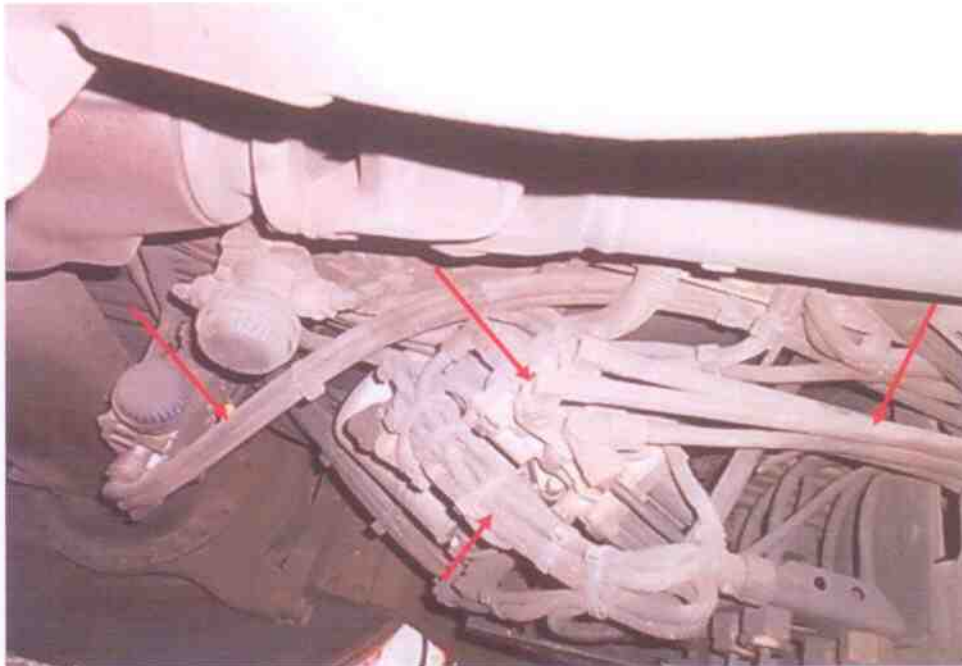
15. Since the engine of the Motor Bus could not be started, we were hence not able to carry out test(s) on whether there was any leakage of compressed air that could have affected the braking efficiency of the Motor Bus. However the air pipes, air tanks and connecting valves had all appear to be in good general condition and securely fitted upon our visual examination of these parts.

16. In general, our visual inspection of the mechanical components of the Motor Bus's braking system appear to suggest that its braking system was in serviceable condition at the material time of accident. See photo 18 below.

Photo 18 shows a general view of the air tank, valves, pipes and hoses, which are some of the components for the air-assisted braking system of the Motor Bus. This was at the underside of the Motor Bus's front right body. We were however not able to carry out any operational test(s) to the braking system of the Motor Bus as its engine was unable to be started.

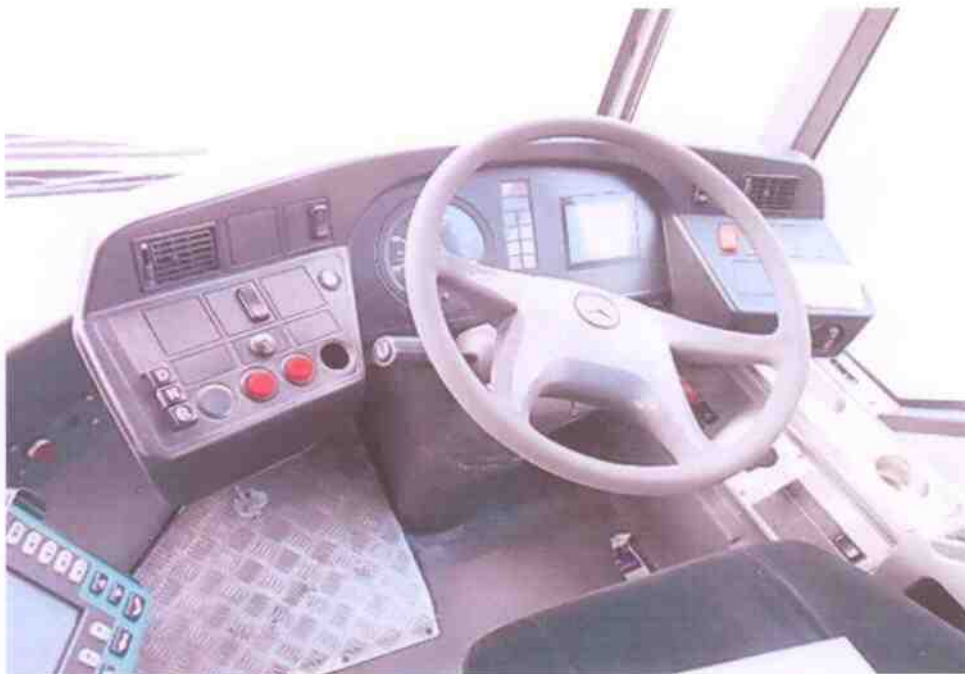
Photo 19 shows the indicators at the driver's seat. Other operational indicators were unable to be initialize due to the flat battery. Hence, no test was carried out to the Motor Bus additional devices.

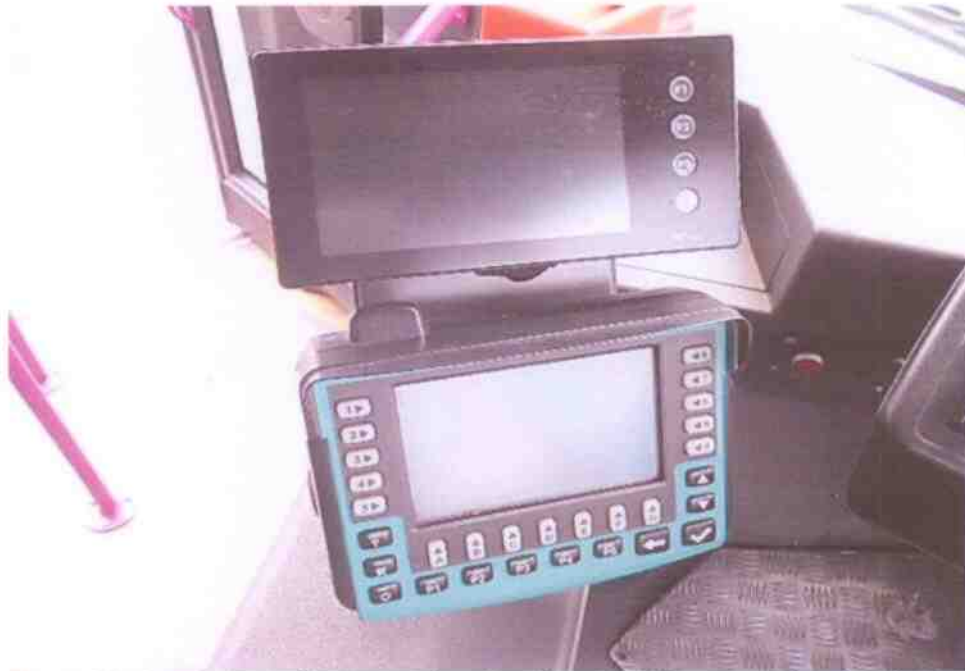
Photo 20 shows the indicators at the driver's seat. Other operational indicators were unable to be initialize due to the flat battery. Hence, no test was carried out to the Motor Bus additional devices.
