MECHANICAL INSPECTION REPORT OF TOW TRUCK XD 8880T

1. We refer to your request on 13th December 2017 to conduct a physical inspection of a tow truck bearing registration number XD 8880T (herein referred to as "**Tow Truck**"), which was involved in a road traffic accident on 13th November 2017.
2. The objective of this inspection is to determine if there was any possible mechanical failure to the Tow Truck that may have contributed to the accident.
3. Following the request, we had carried out a physical inspection of the Garbage Truck on 23rd January 2018 at the premises of Traffic Police vehicle pound, 517 Airport Road Singapore 539942. We now set out below our observations and comments with respect to this inspection.

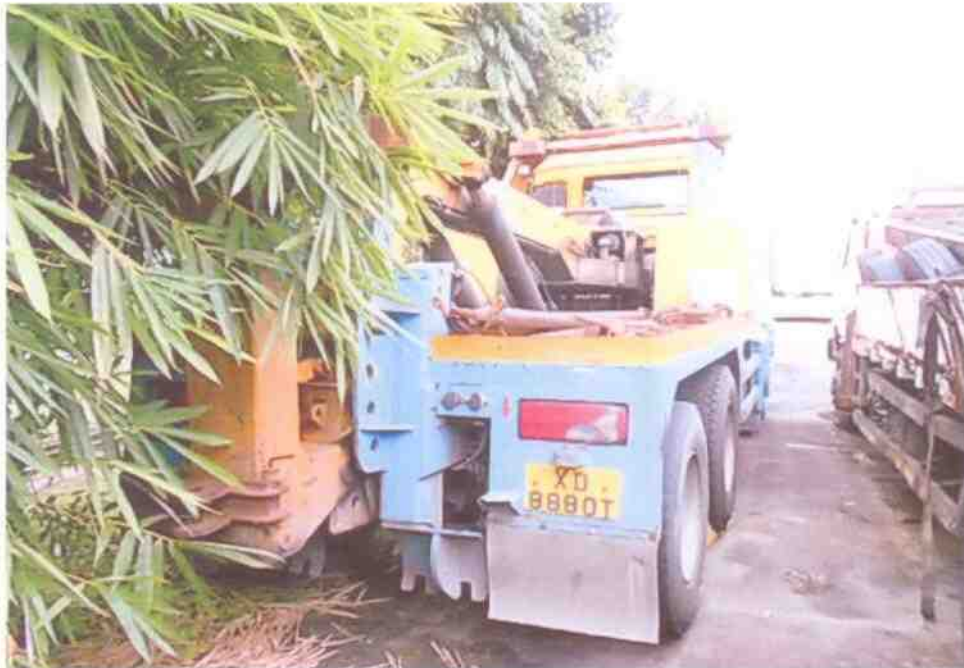
Photo 1 shows a general view of the rear body of the Tow Truck at the time of our inspection. The Tow Truck was observed to be in good condition without any damages on its rear body portion.

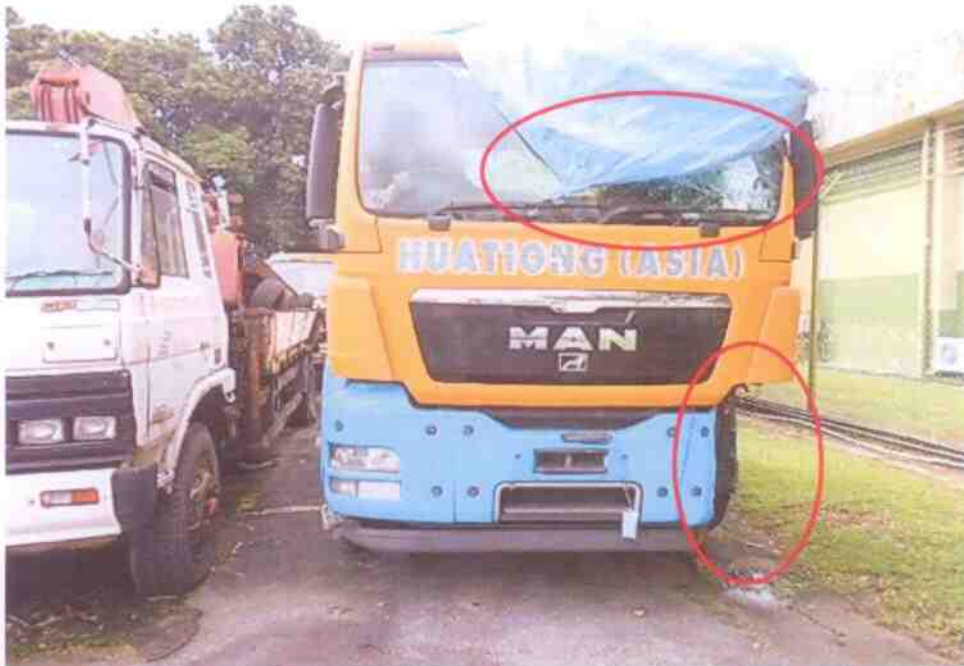
Photo 2 shows a general view of the front body of the Tow Truck at the time of our inspection. The Tow Truck was observed to have sustained damages at its left front body. Its front left lower bumper was observed to be buckled inwards pushing towards the rear of the Tow Truck. Its windshield was observed to be cracked. Its steering systems, breaking systems & transmission systems were amongst the affected components observed to be damaged due to the accident's collision impact.

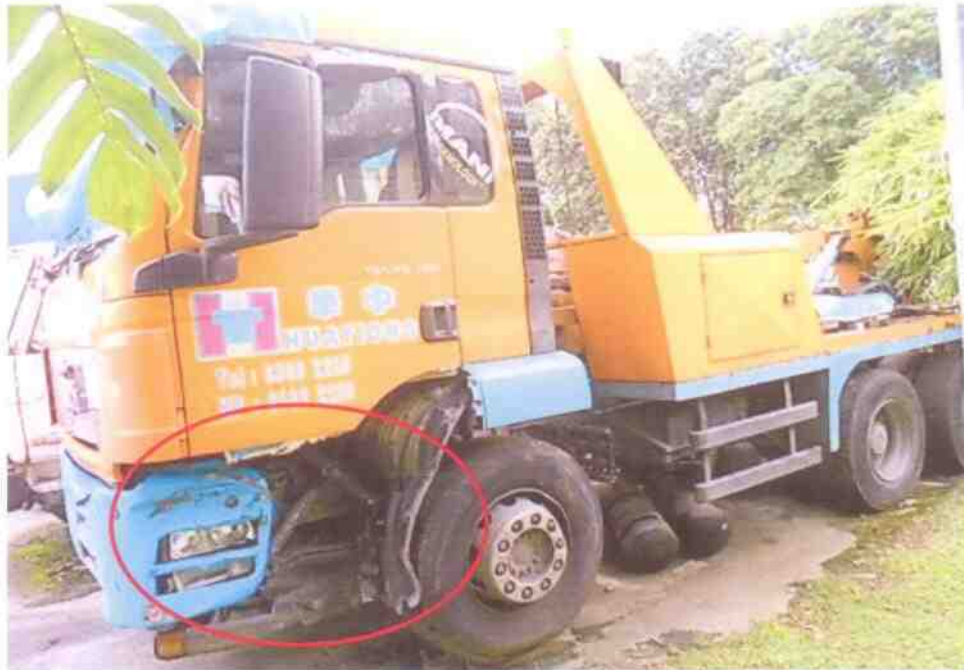
Photo 3 shows a general view of the front left body of the Tow Truck at the time of our inspection. Its front left lower bumper was observed to be buckled inwards pushing towards the rear of the Tow Truck. Its windshield was observed to be cracked. Its steering systems, breaking systems & transmission systems were amongst the affected components observed to be damaged due to the accident's collision impact.

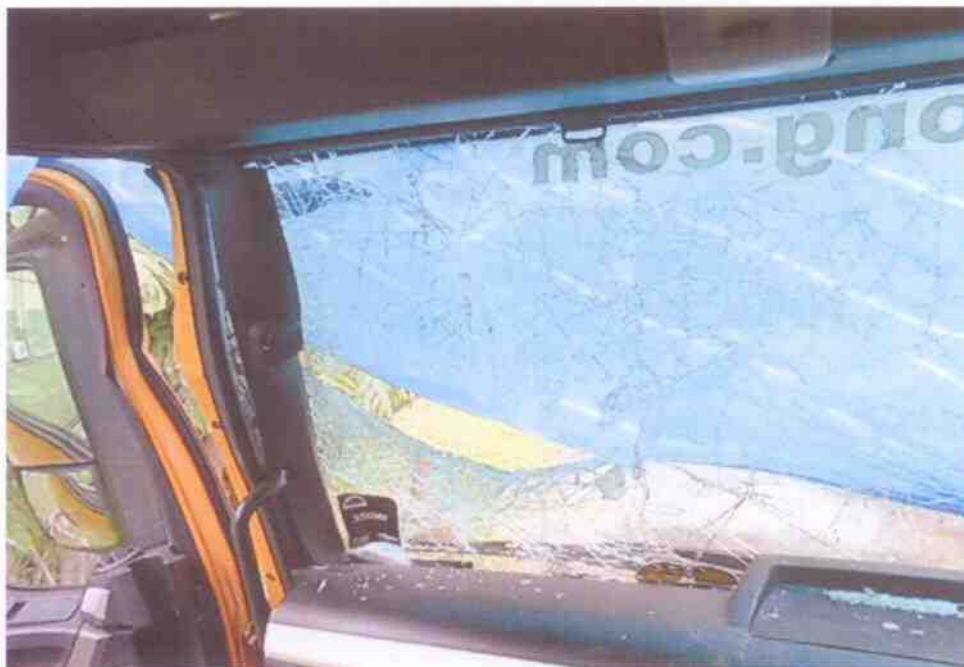
Photo 4 shows a semi close-up view of the cracked windshield.

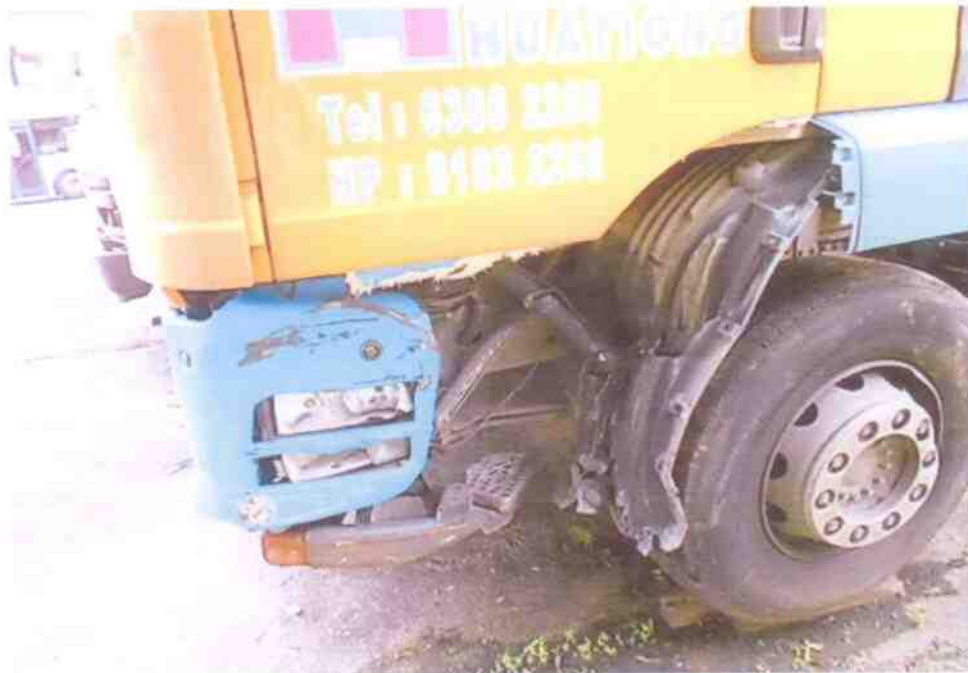
Photo 5 shows a semi close-up view of the damaged area on the front left hand side of the Tow Truck.

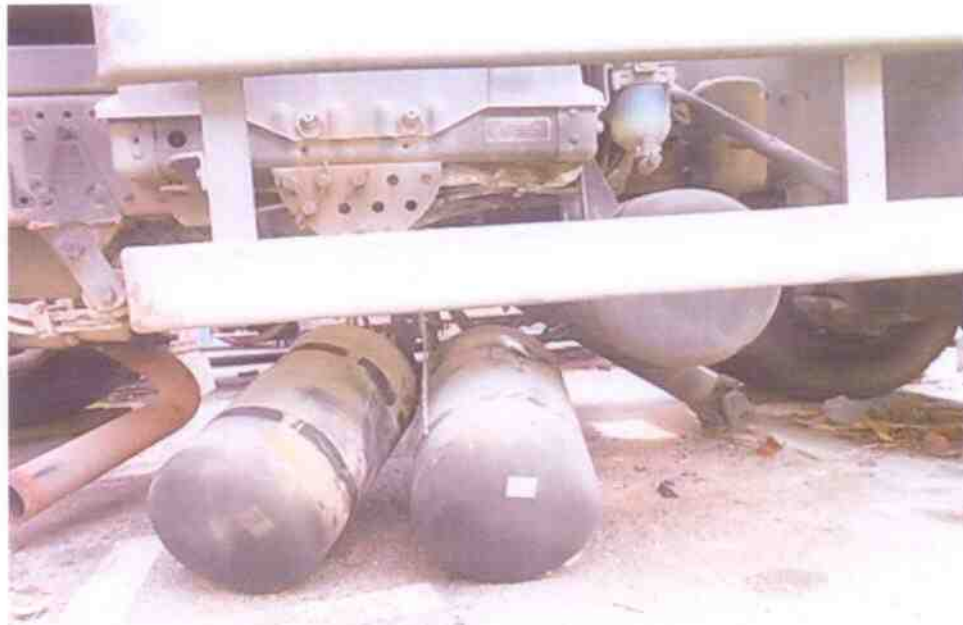
Photo 6 shows a semi close-up view of the damaged air pressure tank. It was dislodged from the original installation likely due to the accident's impact.

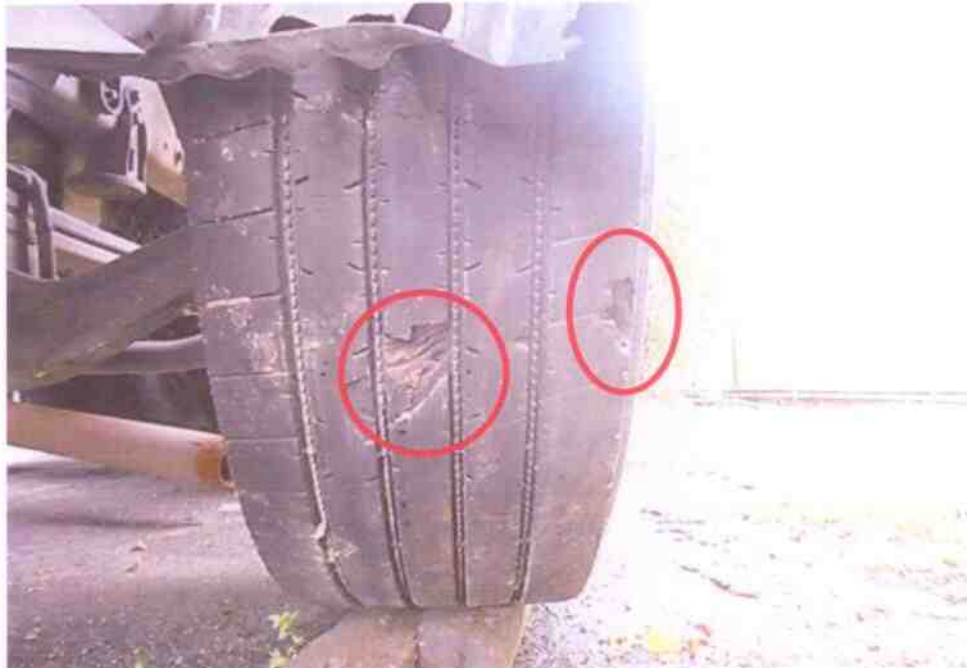
7. The 10 tyres fitted on the Tow Truck were found to be in serviceable condition despite 01 tyre from the front left was found to be with damages. The front left tyre on the tread pattern surface was found to be chipped off. However, further investigation revealed there was no tear, cut or burst mark(s) on the outer and the inner sidewalls as well as across the tread of the 10 tyres. The 10 tyres were sufficiently inflated for vehicular operation.
8. We did not find any tear, cut or burst mark(s) on the outer and the inner sidewalls as well as across the tread of the tyres. The tyre brand, tyre size and remaining tread depth of the Tow Truck's 10 tyres were recorded as follows:-

Photo 7 shows the condition of the front left tyre of the Tow Truck, which was observed to be chipped off at time of our inspection. However, it was still in serviceable condition with remaining tread depth of approximately 10mm.

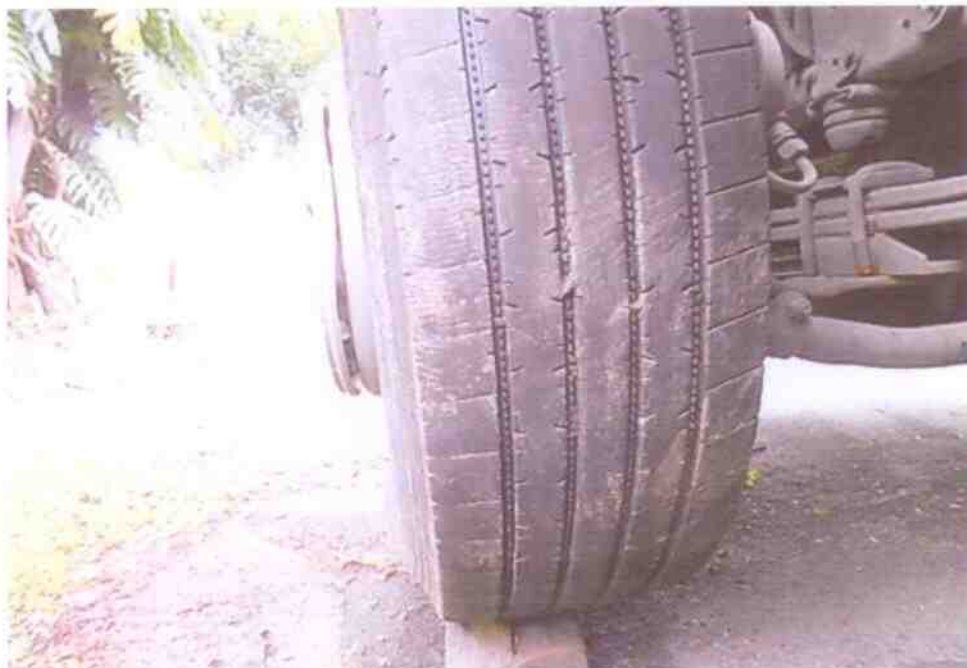
Photo 8 shows the condition of the front right tyre of the Tow Truck, which was observed to be in serviceable condition with remaining tread depth of approximately 8mm.

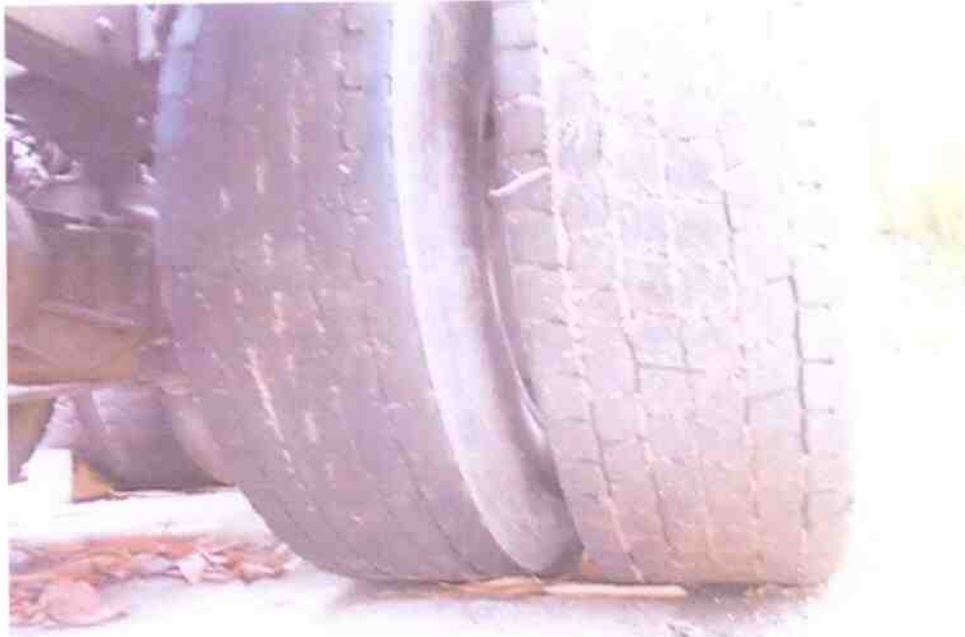
Photo 9 shows the condition of the rear left tyres (centre axle) of the Tow Truck, which were observed to be in serviceable condition with remaining tread depth of approximately 10mm. The tyres were also observed to be sufficiently inflated for vehicular operation.

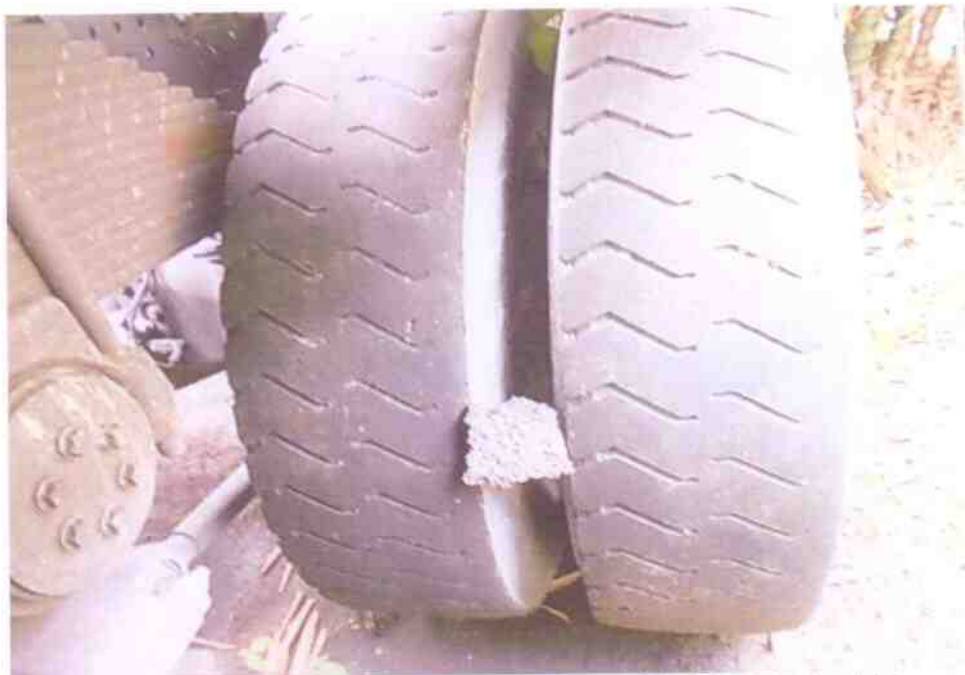
Photo 10 shows the condition of the rear left tyres of the Tow Truck, which were observed to be in serviceable condition with remaining tread depth of approximately 10mm. The tyres were also observed to be sufficiently inflated for vehicular operation.

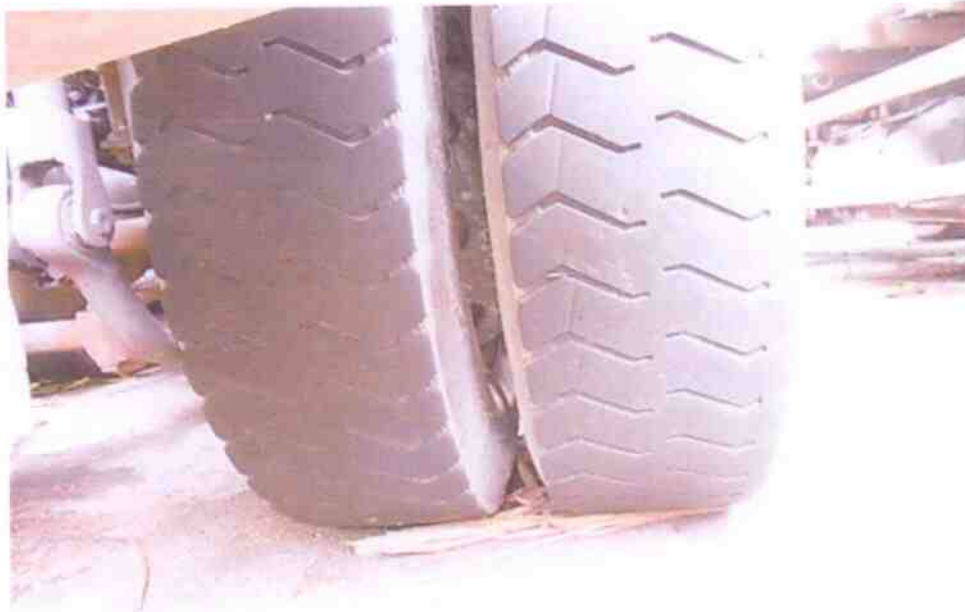
Photo 11 shows the condition of the rear right tyres of the Tow Truck, which were observed to be in serviceable condition with remaining, tread depth of approximately 8mm. The tyres were also observed to be sufficiently inflated for vehicular operation with no tear, cut or burst mark(s) on the outer and the inner sidewalls.

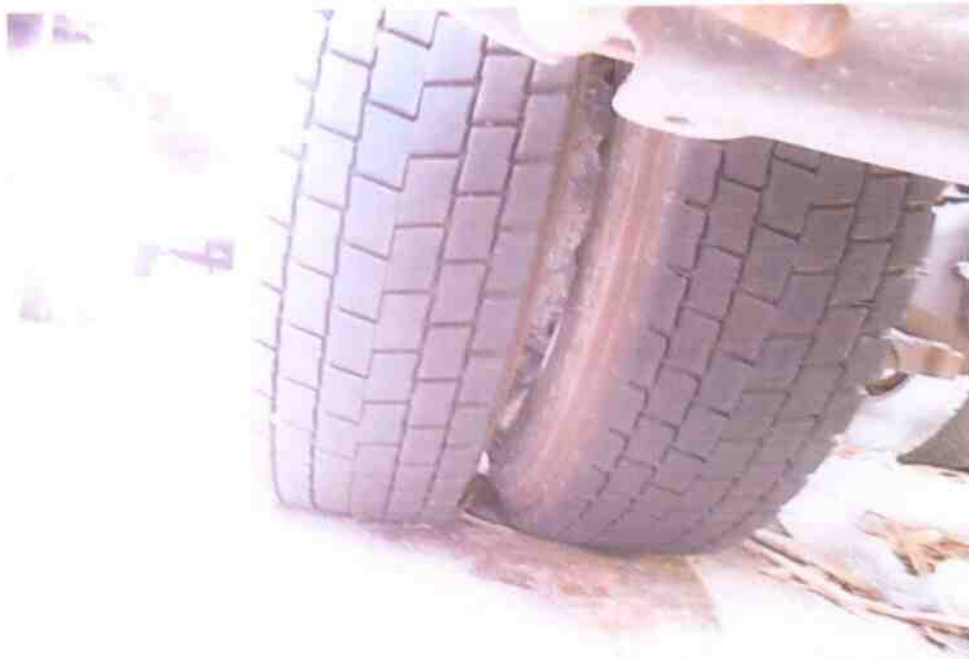
Photo 12 shows the condition of the rear right tyres (centre axle) of the Garbage Truck, which were observed to be in serviceable condition with remaining, tread depth of approximately 5mm. The tyres, which were wrapped around standard alloy wheel rims, were also observed to be sufficiently inflated for vehicular operation.

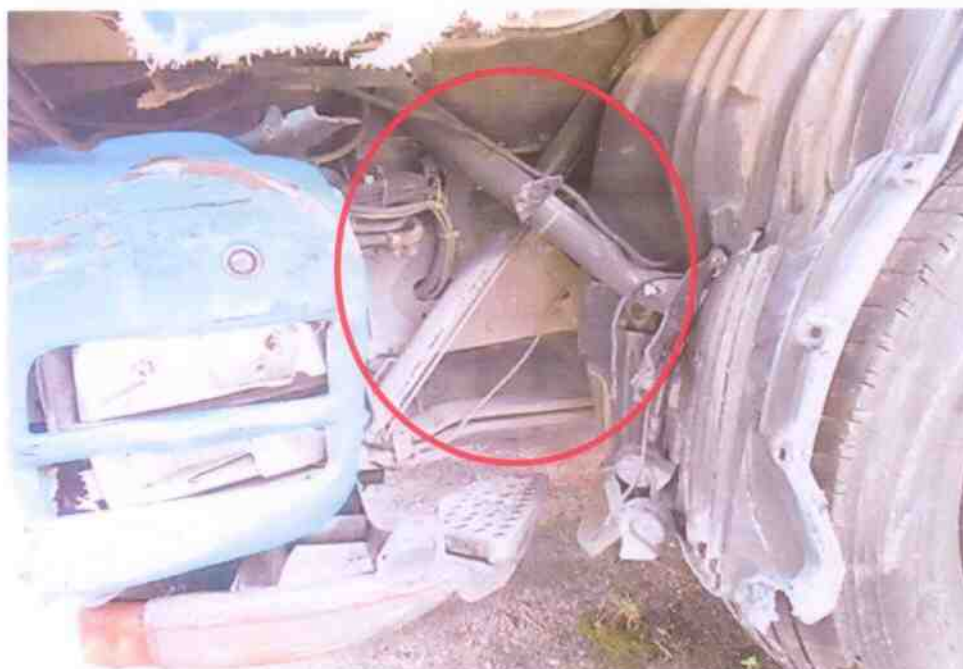
10. The engine compartment of the Tow Truck could not be closely examined as it was located directly under the front cabin. To access the engine compartment, the front cabin of the Tow Truck would have to be manually lifted by using the hydraulic jack fitted on the Tow Truck that is specific for this purpose. At the time of our inspection, the motor for this hydraulic jack was not able to operate due to some supporting components were affected due to the damages sustained from the accidents impact. We were thus only able to inspect the engine area from the underside of the Tow Truck.

Photo 13 shows a semi close-up view of the damaged hydraulic jack that lifted up the front cabin likely due to the accident's collision impact.

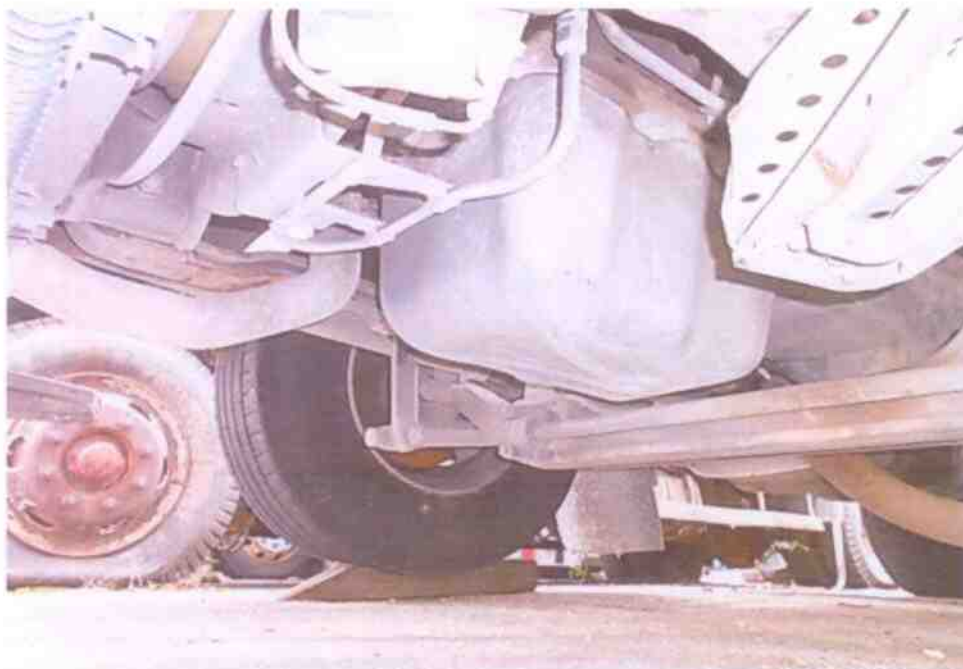
Photo 14 shows a general view of the underside of the engine compartment area. The engine assembly was observed to be intact and unaffected by the collision. There was also no sign(s) or indication(s) of fresh fluid leak and/or fluid stain found.

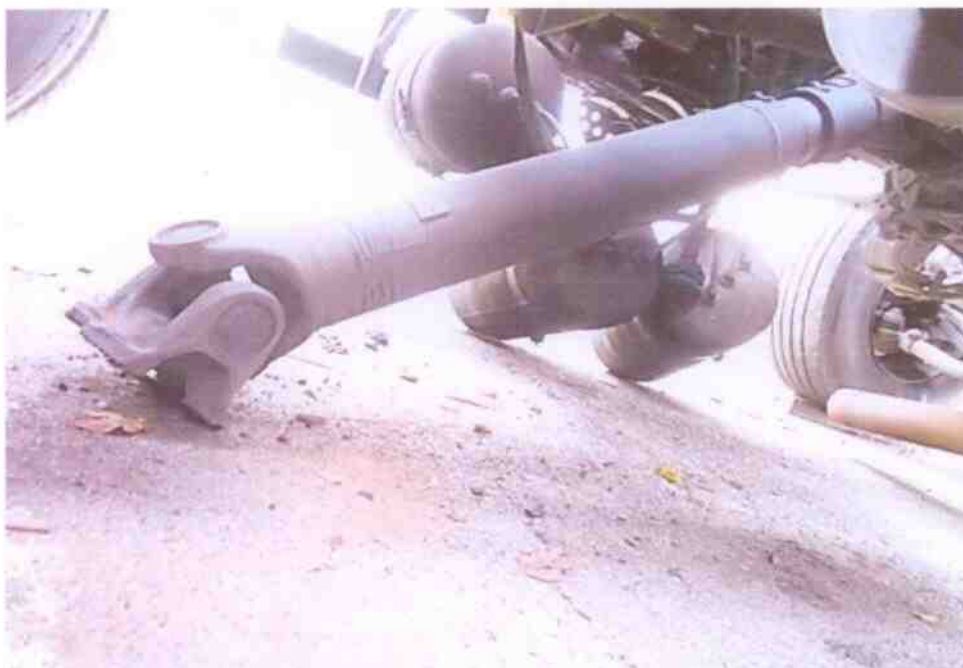
11. From the underside, the engine assembly was observed to be intact and unaffected by the collision. Except for the transmission assembly, the propeller shaft that was connected to the centre axle was observed to be dislodged from the original installation. It was believe to be broken due to the accident's impact. However, there was no sign(s) or indication(s) of fresh fluid leak and/or fluid stain found.

Photo 15 shows the propeller shaft of the Tow Truck at the time of our inspection. It was observed to be dislodged from the original installation likely due to the accident's collision impact.

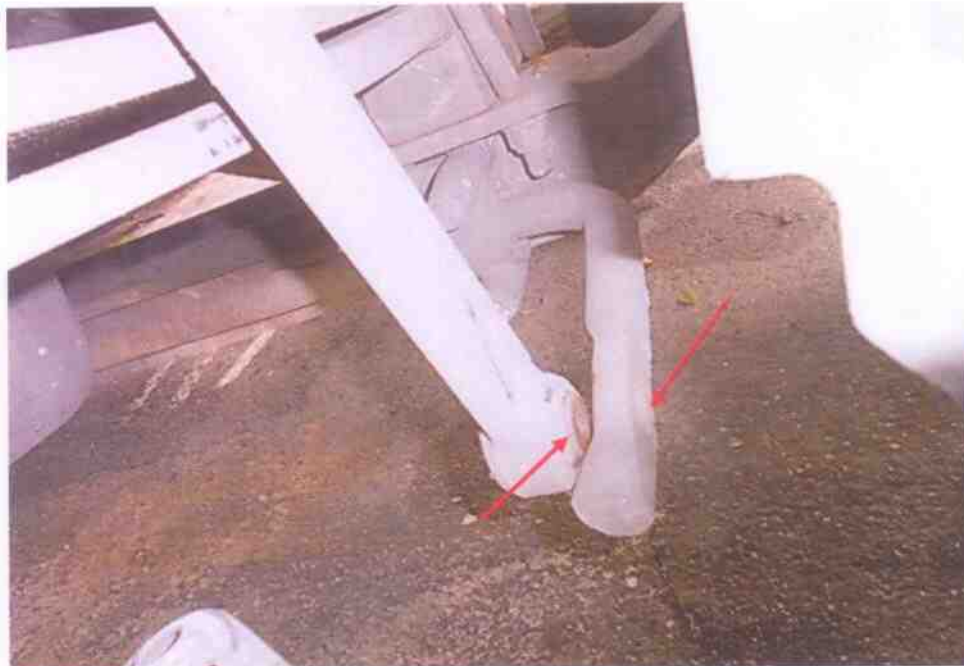
13. The mechanical components of the Tow Truck's steering systems were found to be damaged due to the accident's collision impact. The steering shaft of the Tow Truck was observed to be dislodged from the front left wheel. The steering ball joint was observed to be missing from its housing bracket. Hence, disabling the basic operational function of the steering system. Therefore, steering test could not be conducted. See photo 16 & 17 below.

Photo 16 shows the steering rod at the front left wheel of the Tow Truck. It was observed to be dislodged from the original installation likely due to the accident's collision impact.

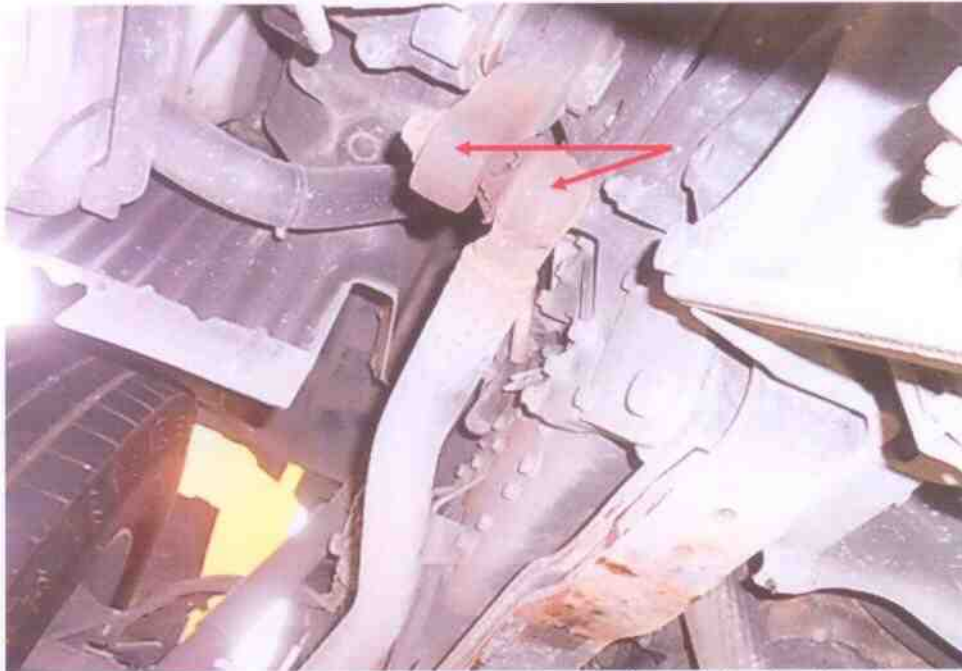
Photo 17 shows the steering components at the front right wheel of the Tow Truck. It was observed to be intact and without any visible damage.

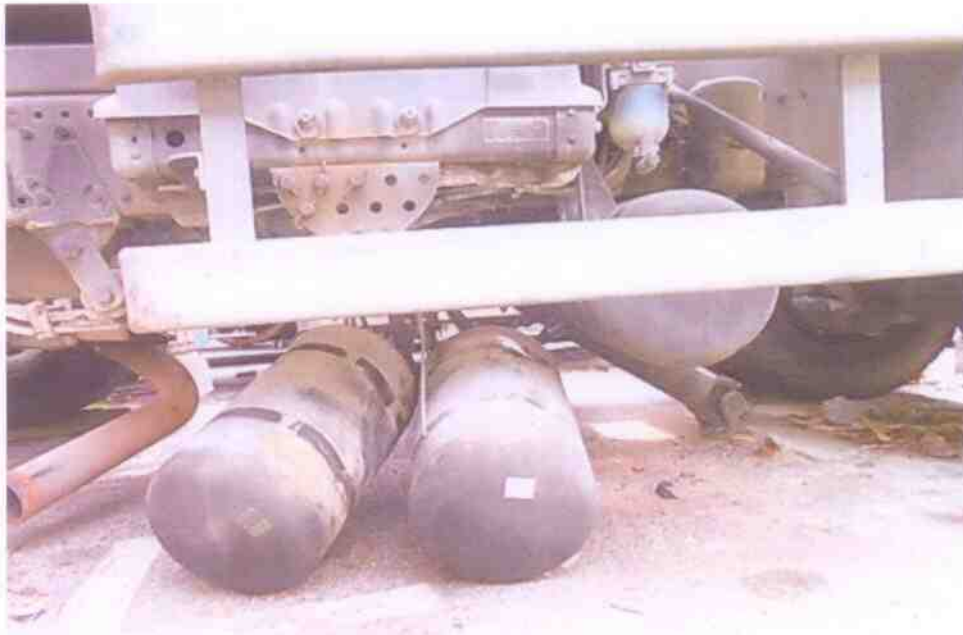
15. Upon starting the engine of the Tow Truck; there was an abnormal hissing sound while in idling mode. Further investigation on the abnormal sound found that it came from the air pressure tank. A checked on the air pressure meter display on the dashboard revealed that the pressure was not up to the operational range. Hence, concludes that there's air leakage of compressed air that comes from the air tanks, hoses and connecting valves likely due to the accidents collision impact.

Photo 18 shows the air tanks, valves, pipes and hoses, which was found to be damaged as a result of the accident's impact.

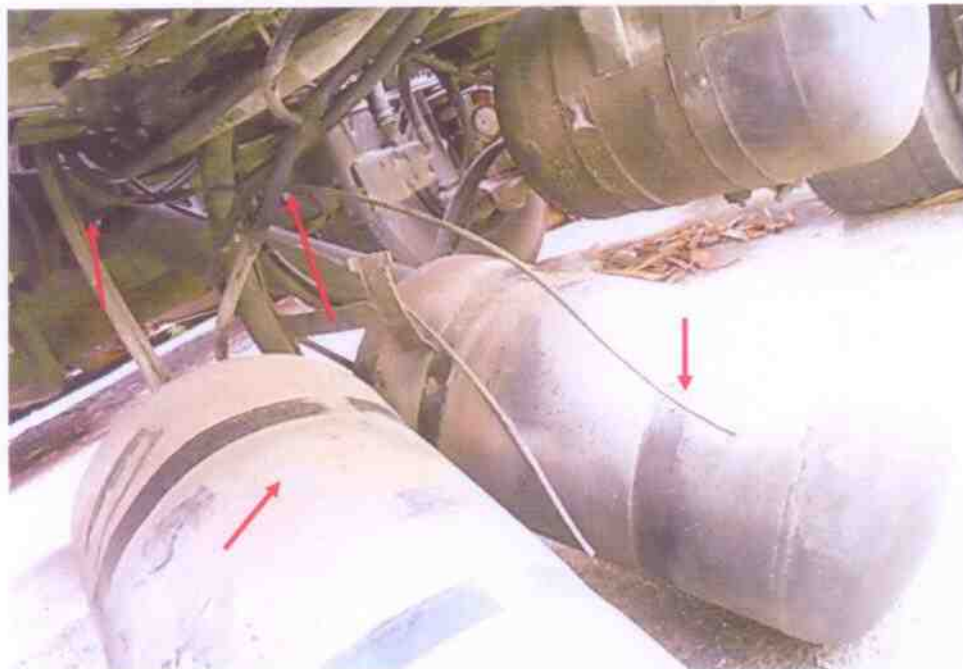
Photo 19 shows the hoses of the air pressure tanks, which are some of the components for the air-assisted braking system of the Tow Truck. These components were found to be cut & dislodged from the original installation. Hence, causing air leakage to the compressed air for the braking system.

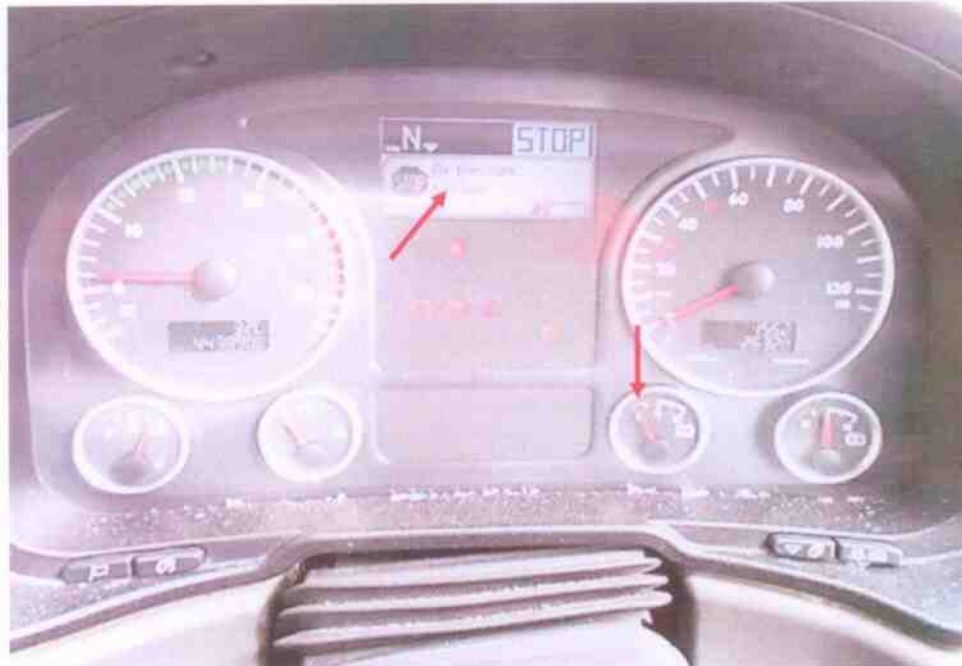
Photo 20 shows the air pressure meter on the dashboard, it indicates that there a low pressure on the air pressure while in idling mode.

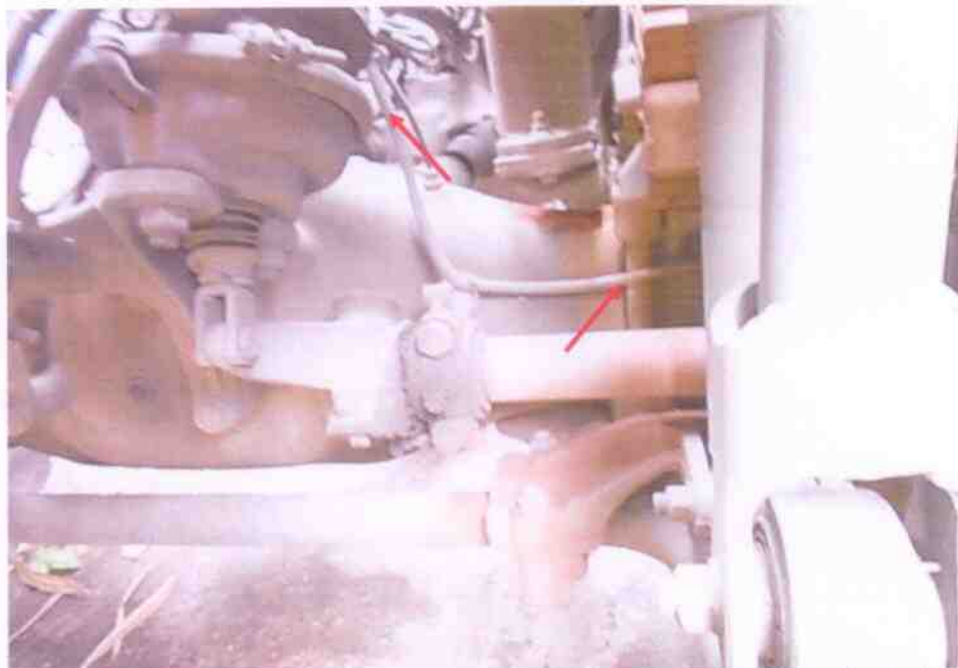
Photo 21 shows the brake hoses (arrowed) leading to the rear right wheel of the Tow Truck. At the time of our inspection, the various mechanical components of the air-assisted hydraulic braking system of the Tow Truck were all found to be in good general condition and securely fitted.

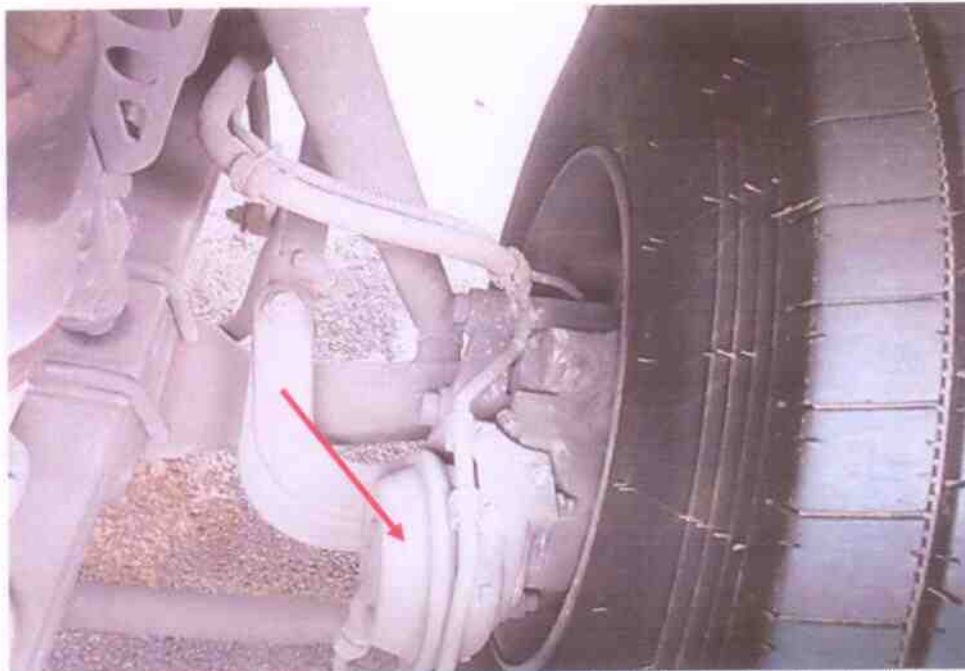
Photo 22 shows the brake air cylinder (arrowed) at the front right wheel of the Tow Truck. Such air cylinder, which is amongst the various components for the full air-assisted braking system, can be found attached to all the front wheels and all the wheels of the Tow Truck. Upon our checks, we had found all the brake air cylinders to be undamaged and securely fitted to all the wheels of the Tow Truck.
