#### INVESTIGATION REPORT:

Our Ref : CS/CTI18000550/N  
Policy No : DMHCSN1748561700  
Insured : SCR 8873P  
Date of Incident : 28 December 2017  
Location : Buangkok Drive towards Buangkok Green

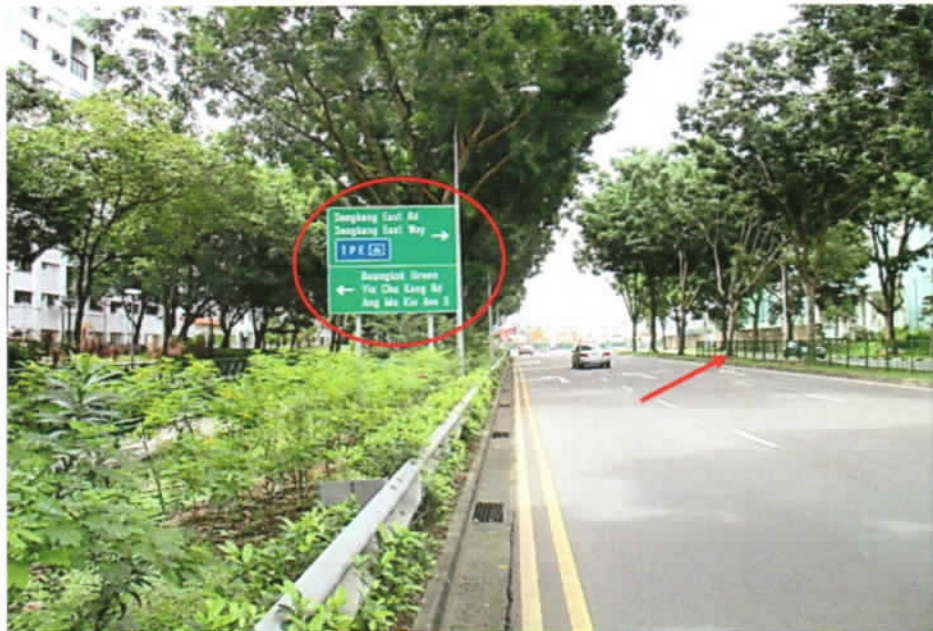
**Photo 1** shows the location where the incident had occurred, along the centre divider (arrowed) at Buangkok Drive towards Buangkok Green after the road direction signboard (circled). We noticed that the vicinity was not monitored by CCTV camera(s).

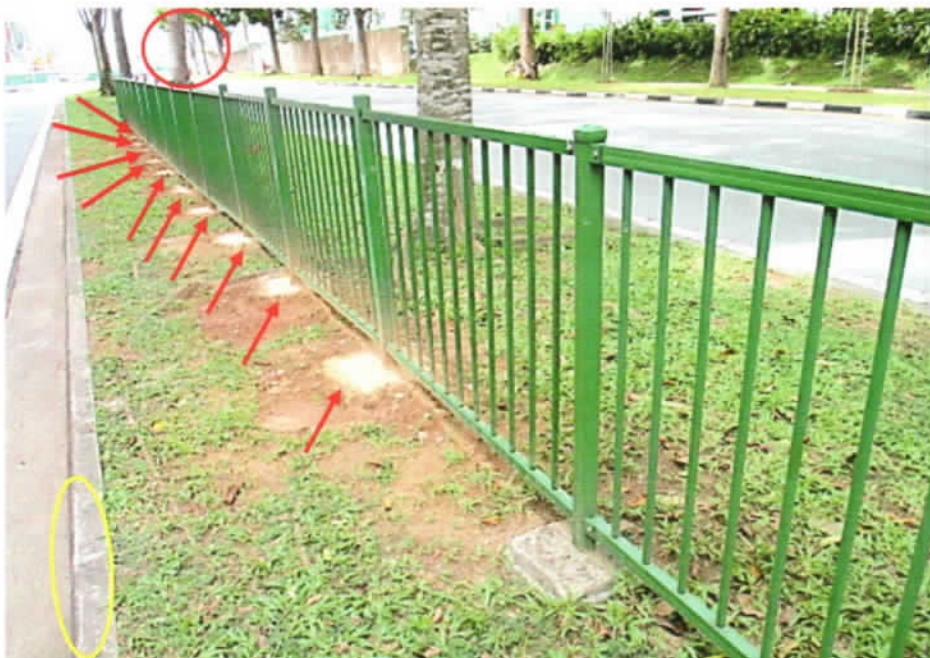
**Photo 2** shows the graze marks on a kerb (yellow circle) along the centre divider which Mr Chong had mounted. We observed that some of the greenish metal railings along the centre divider which were closest to the damaged tree Mr Chong collided into (red circle) had been replaced. The bases of these railings and the re-laid soil at the bottom of these railings are indications that these railings had been recently replaced (red arrows).

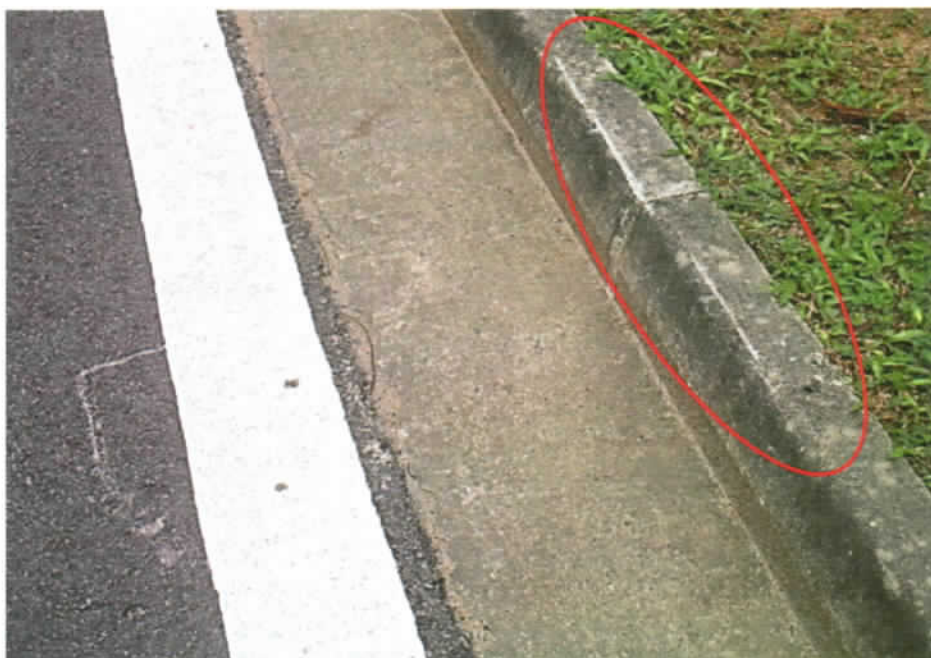
**Photo 3** shows a close up view of the graze marks found on a kerb which Mr Chong had mounted (circled).

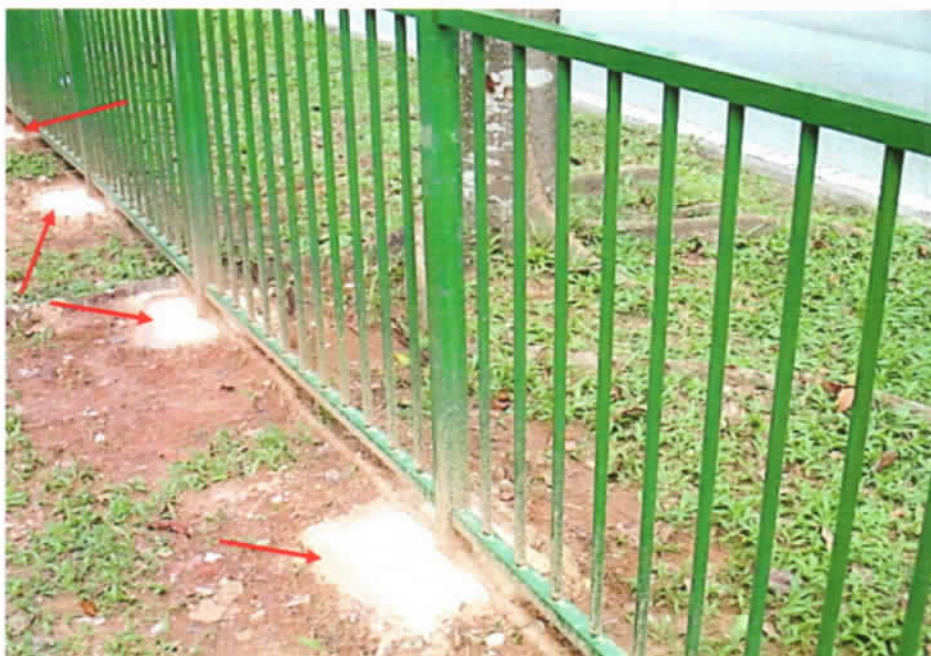
**Photo 4** shows a close up view of the bases (red arrows) and the re-laid soil at the bottom of the greenish metal railings which are indications that these railings had been recently replaced.

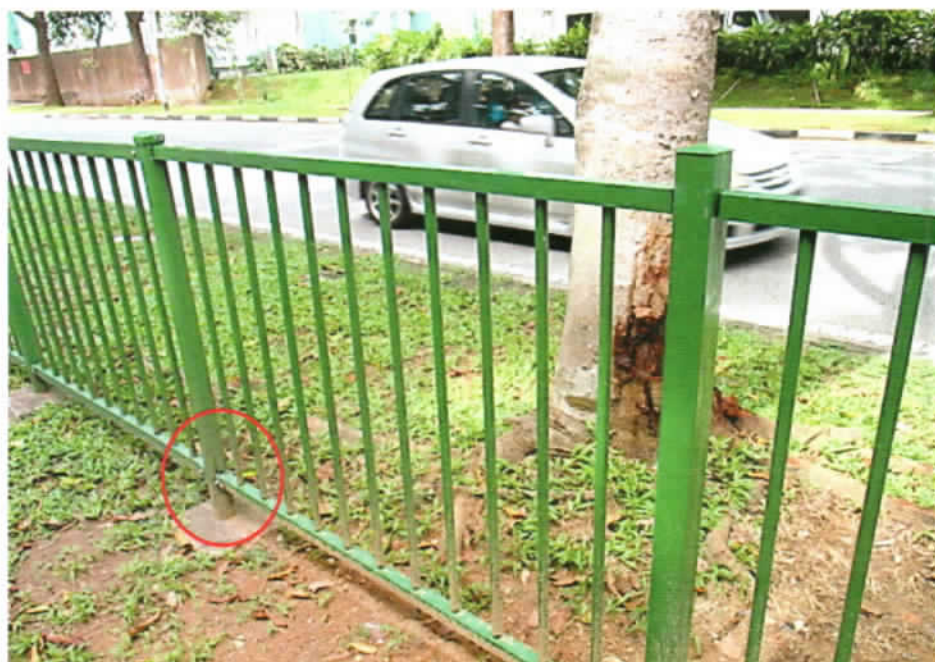
**Photo 5** shows minor damage to the base of a railing (circled) adjacent to the tree Mr Chong had collided into.

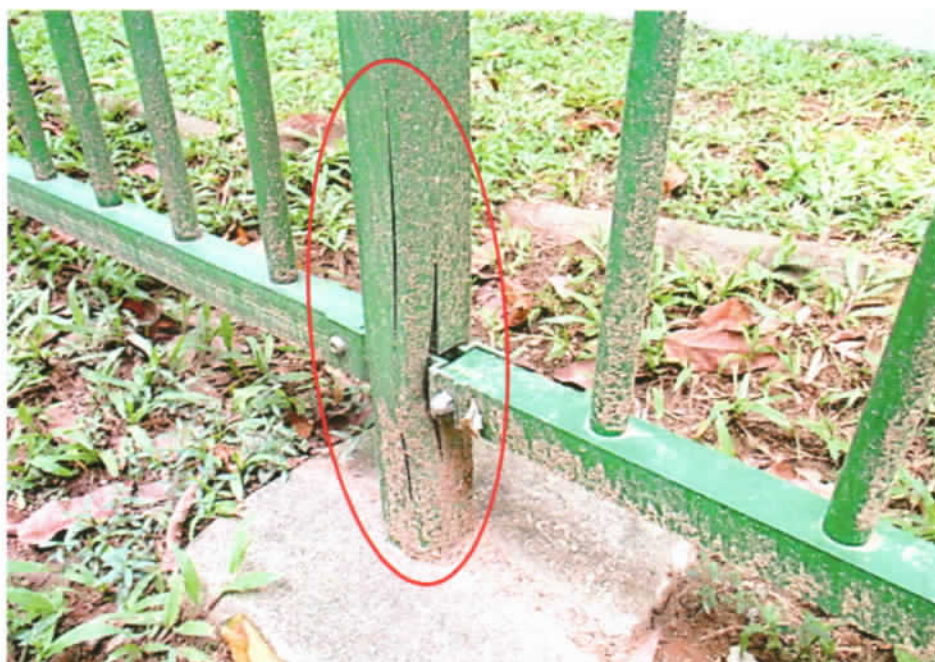
**Photo 6** shows a close up view of the minor damage to the base of a railing (circled) adjacent to the tree Mr Chong had collided into.

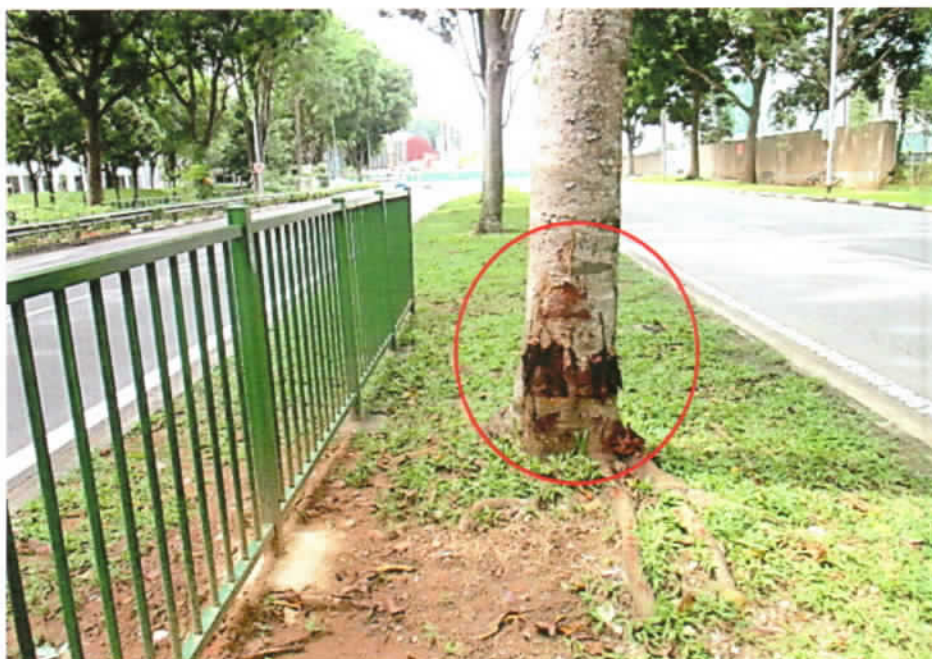
**Photo 7** shows the tree which Mr Chong collided into. The barks of the tree were observed to be torn (circled).

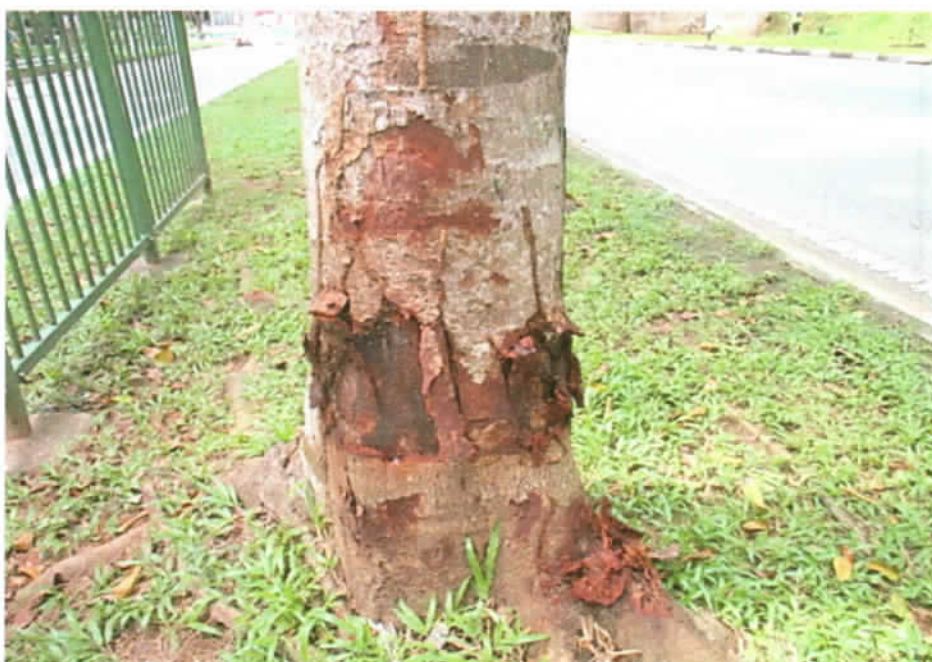
**Photo 8** shows a close up view of the torn barks of the tree which Mr Chong collided into.

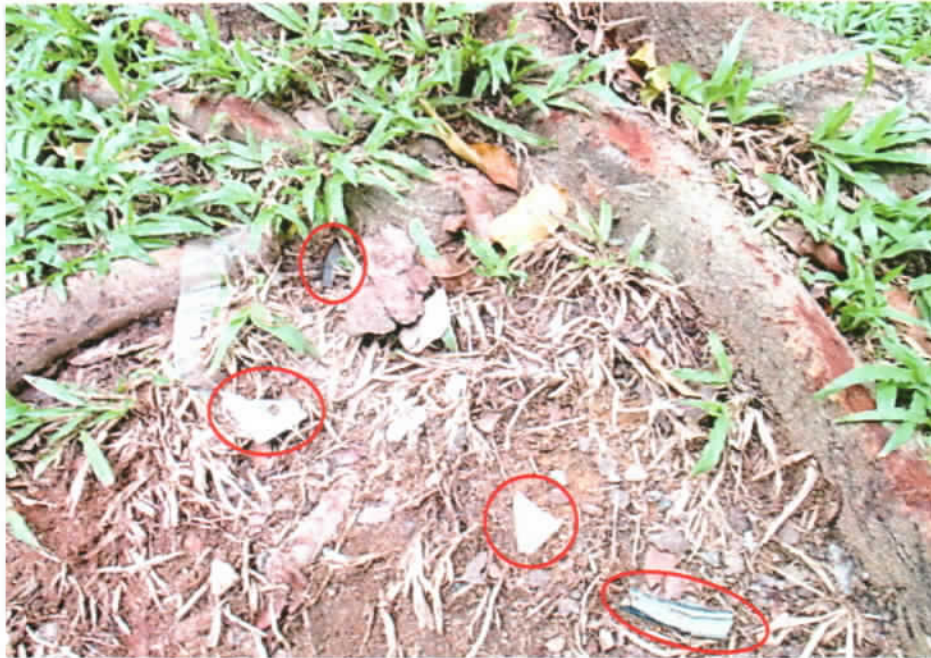
**Photo 9** shows a close up view of the broken plastic parts and vehicular debris (red circles) that were found on the grass patch surrounding the tree.

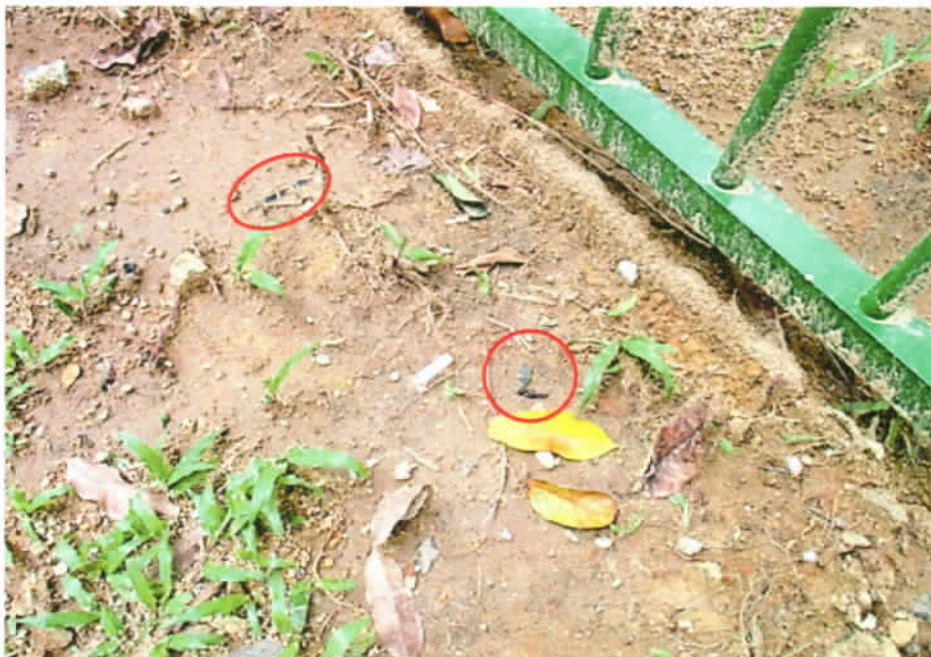
**Photo 10** shows a close up view of the broken plastic parts and vehicular debris (red circles) that were found on the ground near the replaced railings.

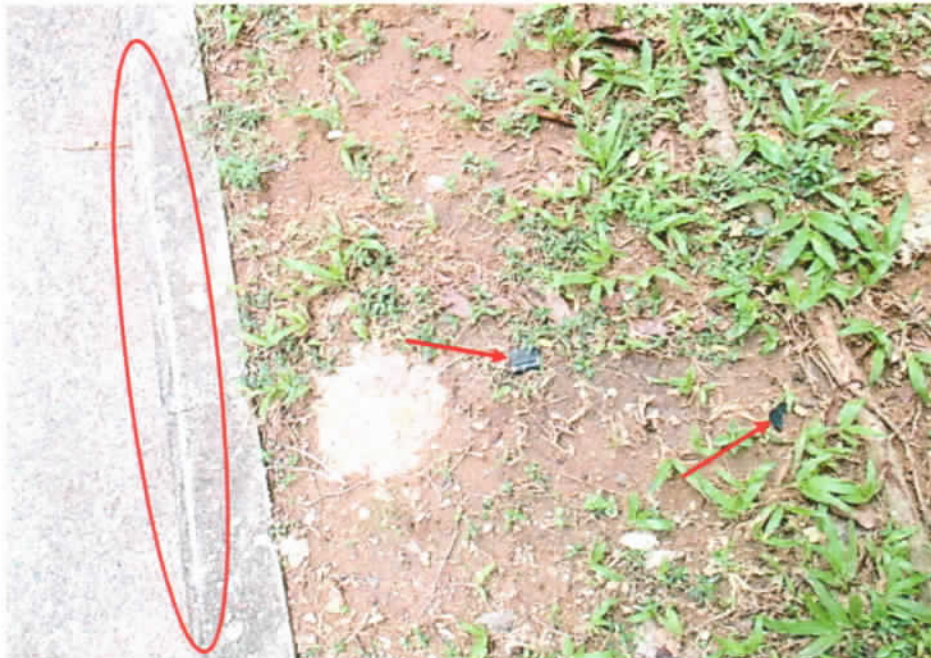
**Photo 11** shows a close up view of the broken plastic parts and vehicular debris (red arrows) that were found on the ground near the kerb which Mr Chong had mounted, causing the graze marks (circled).

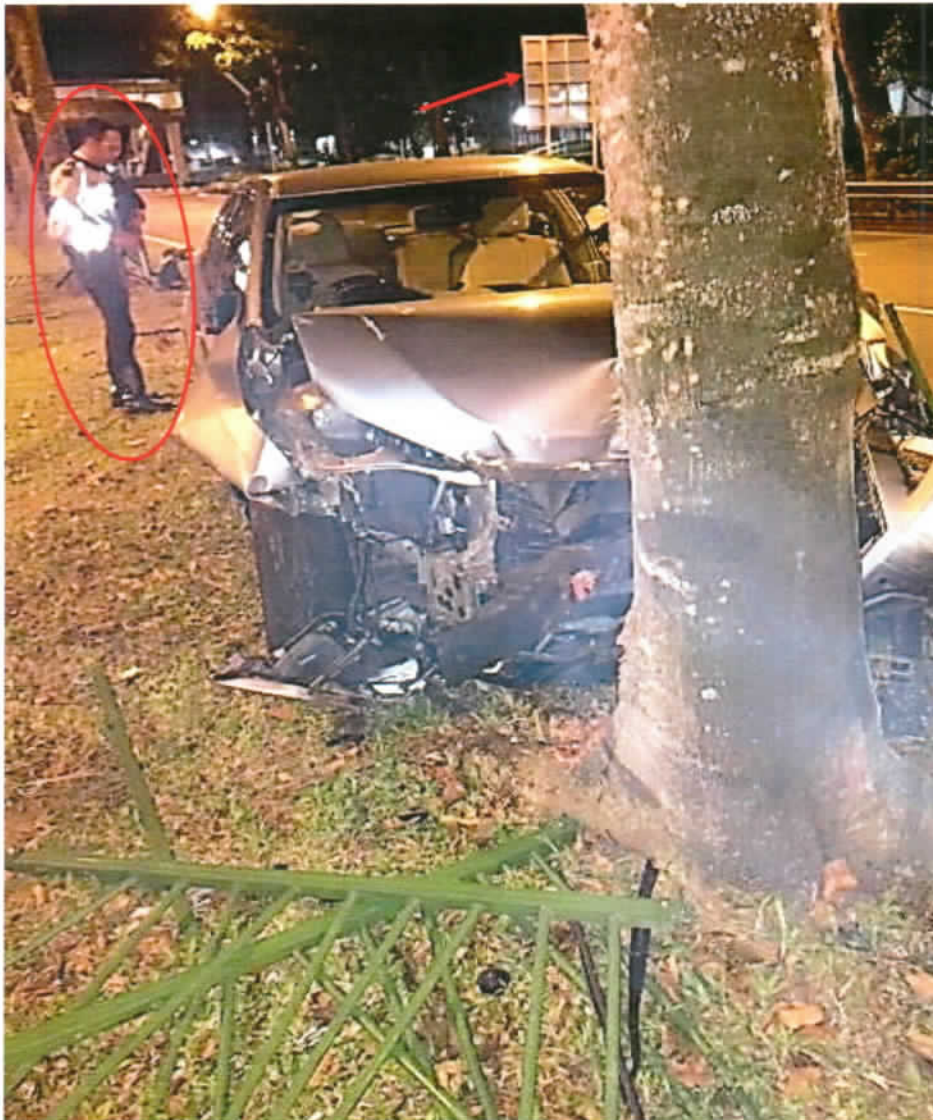
**Photo 12** shows the Insured Vehicle at its respective final rest position at the incident scene before it was towed away. It seems to correlate with Mr Chongs' account of the incident. The incident had occurred after the road direction signboard (arrowed). Mr Chong had mounted the kerb along the centre divider, ran over the greenish metal railings and collided into a tree. The photograph also showed the presence of Traffic Police officers at the scene (circled) after the incident.

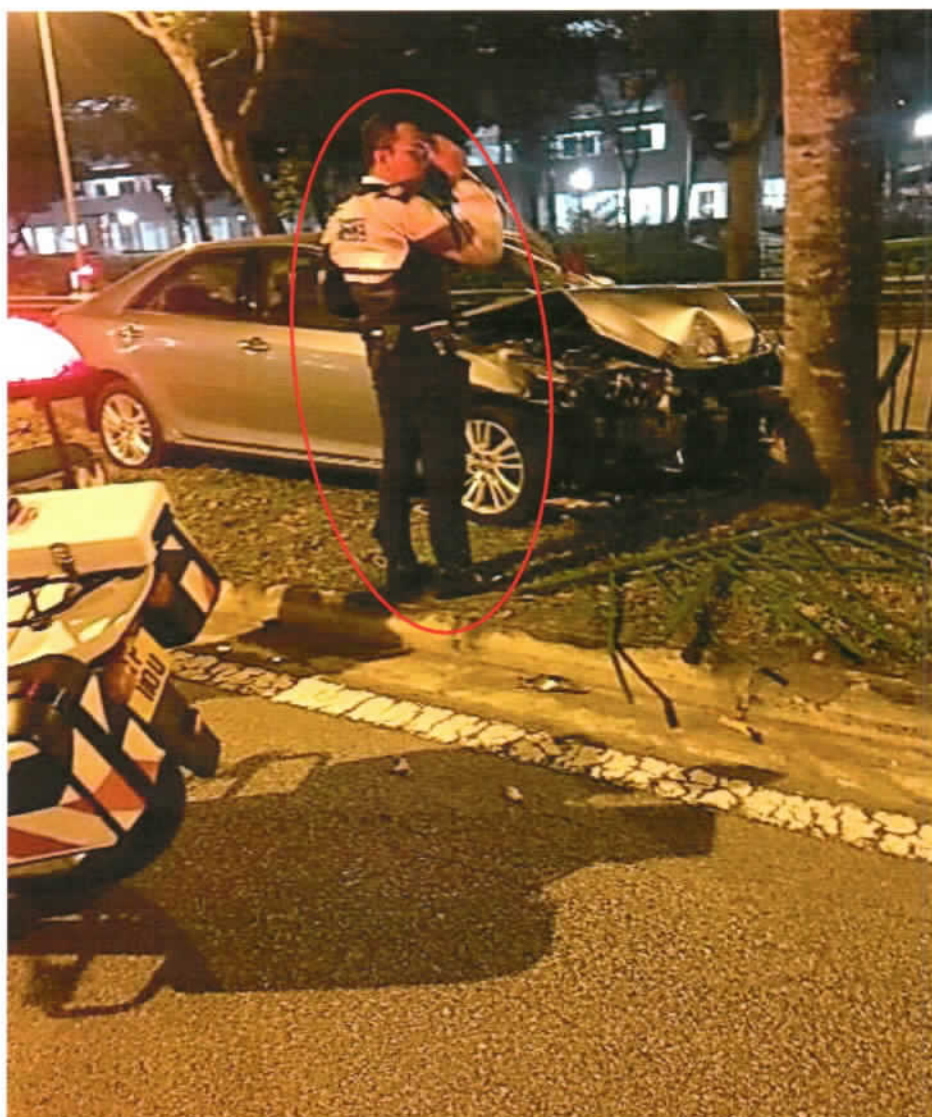
**Photo 13** shows the Insured Vehicle at its respective final rest position at the incident scene before it was towed away. It seems to correlate with Mr Chongs' account of the incident. In particular, the presence of Traffic Police officers (circled) together with the ability of Mr Chong to take clear photographs after the incident would suggest that there was no drink driving involved in this particular incident.

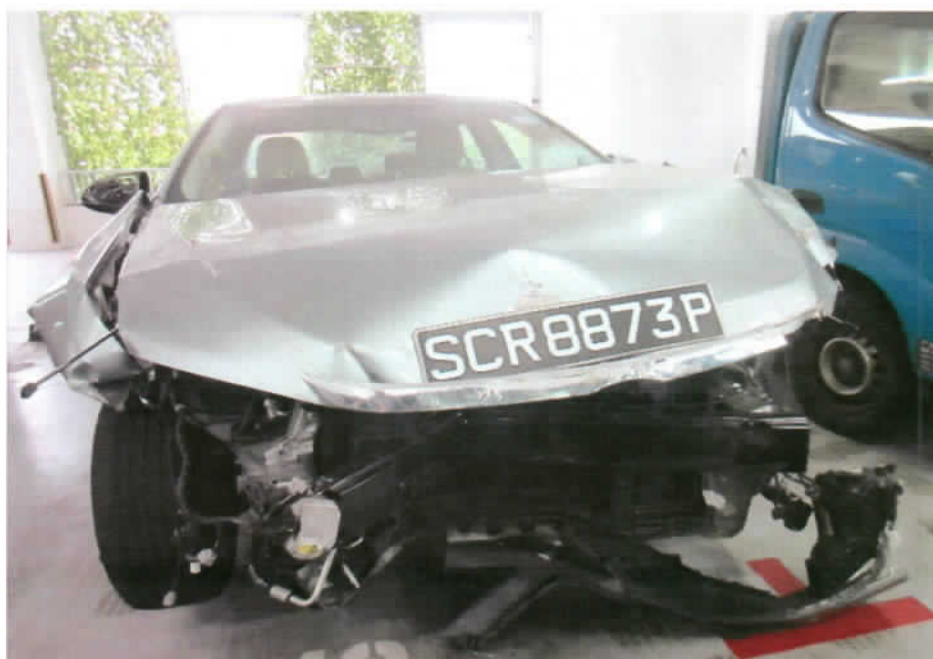
19. Our physical inspection of the Insured Vehicle at KKH revealed that the Insured Vehicle had sustained extensive damages to its entire front portion, particularly to its front windscreen, front bonnet, front bumper, front bumper reinforcement panel and side panels. There were also some relatively minor marks of grazing nature observed on the lower right portion as well as around the edges of the front right wheel rim of the Insured Vehicle as a result of mounting the kerb. There were no remains of both airbags in the interior compartment of the Insured Vehicle which corroborates with Mr Chong's statement that none of the airbags were deployed upon the Insured Vehicle's collision with the tree.

**Photo 14** shows the general front view of the Insured Vehicle during the physical inspection at KKH. The Insured Vehicle had sustained extensive damages to its entire front portion, particularly to its front windscreen, front bonnet, front bumper, front bumper reinforcement panel and side panels.

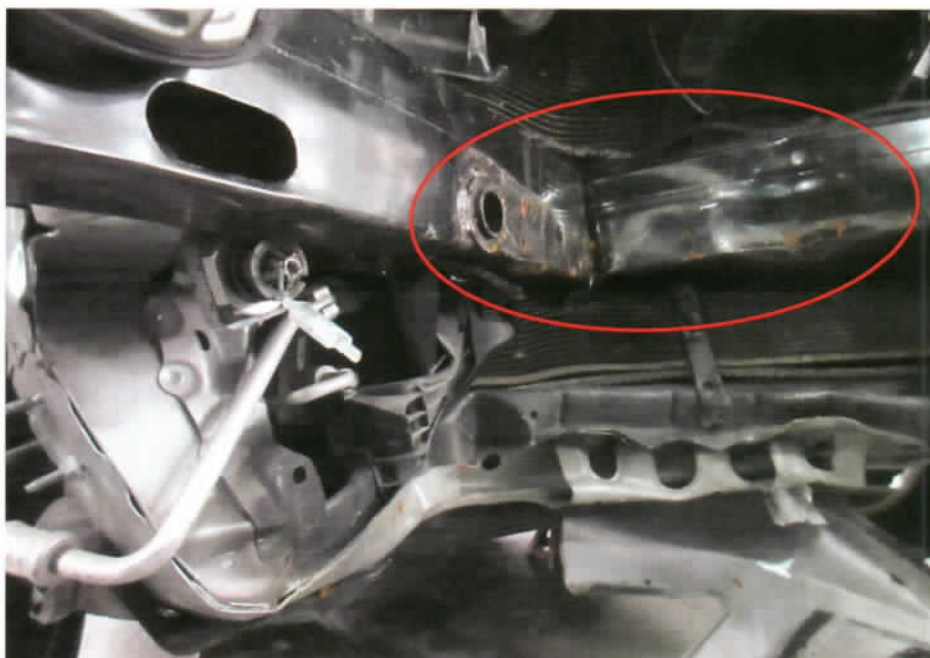
**Photo 15** shows a closer view of the broken pieces of tree bark and/or soil particles that were found stuck to the front bumper reinforcement panel (circled) of the Insured Vehicle.

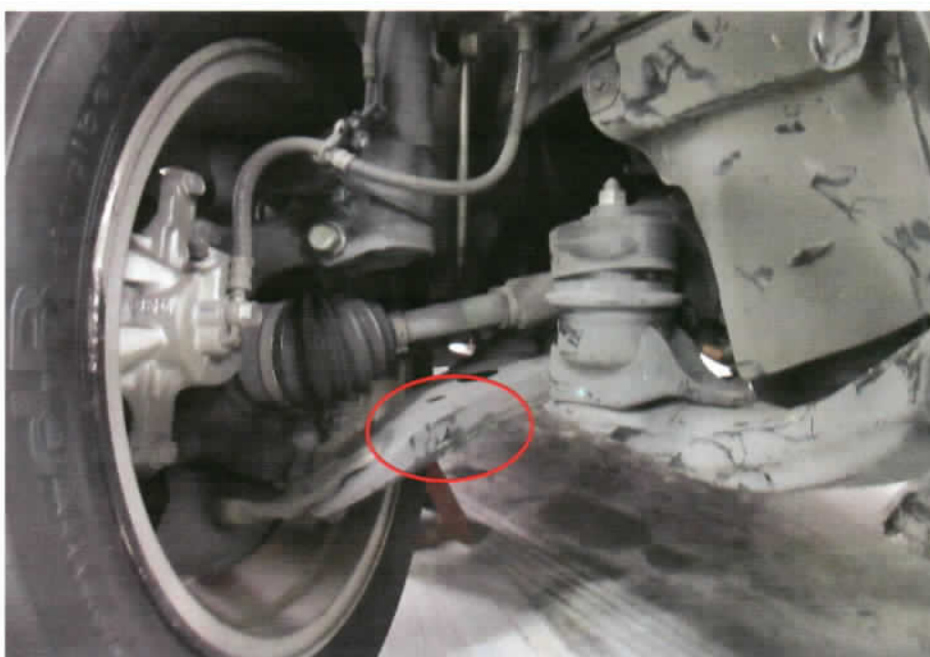
**Photo 16** shows the green paint transfer marks found on the right tie rod of the Insured Vehicle (circled), corresponding to the Insured Vehicle running over the greenish metal railings.

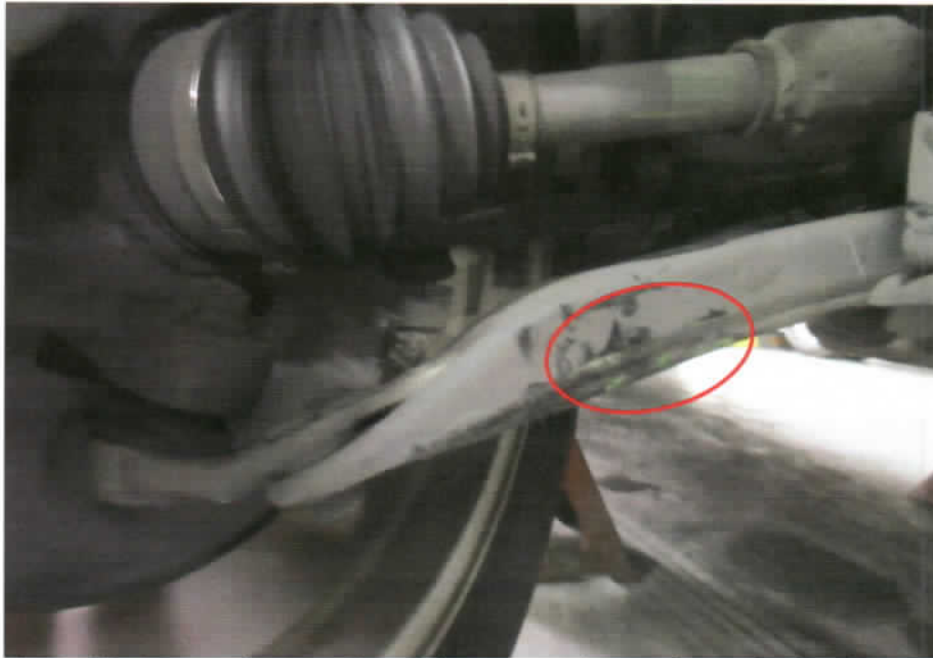
**Photo 17** shows a close up view of the green paint transfer marks found on the right tie rod of the Insured Vehicle (circled), corresponding to the Insured Vehicle running over the greenish metal railings.

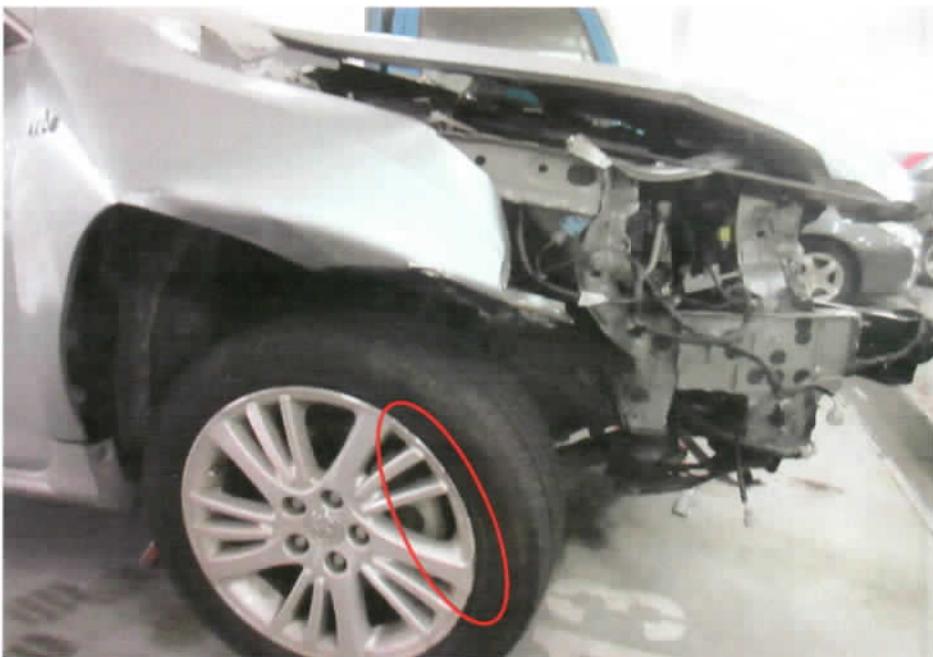
**Photo 18** shows some relatively minor marks of grazing nature observed around the edges of the front right wheel rim (circled) as a result of Mr Chong mounting the kerb.

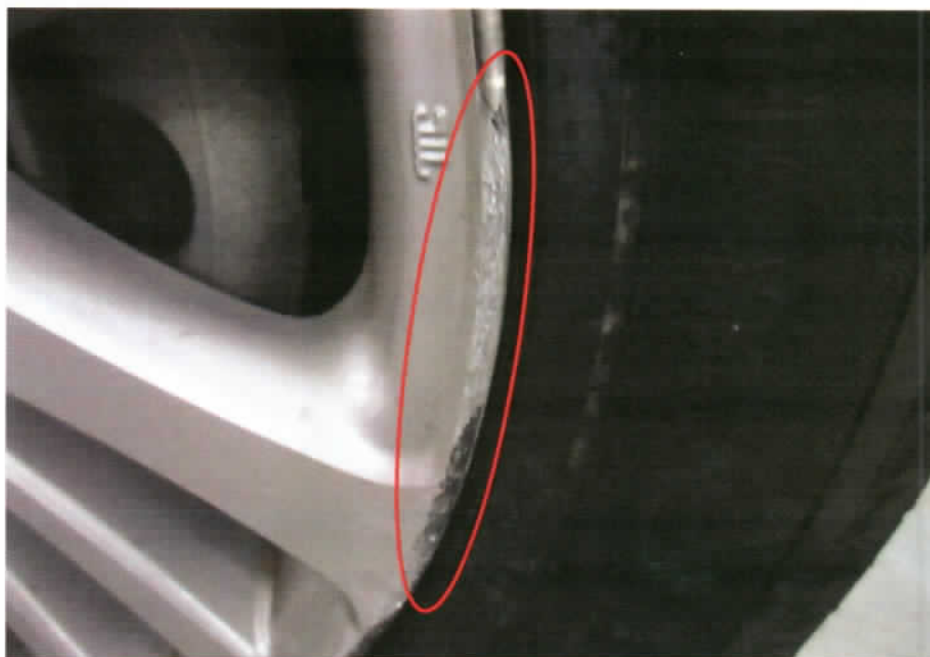
**Photo 19** shows a close up view of the relatively minor marks of grazing nature observed around the edges of the front right wheel rim (circled) as a result of Mr Chong mounting the kerb.

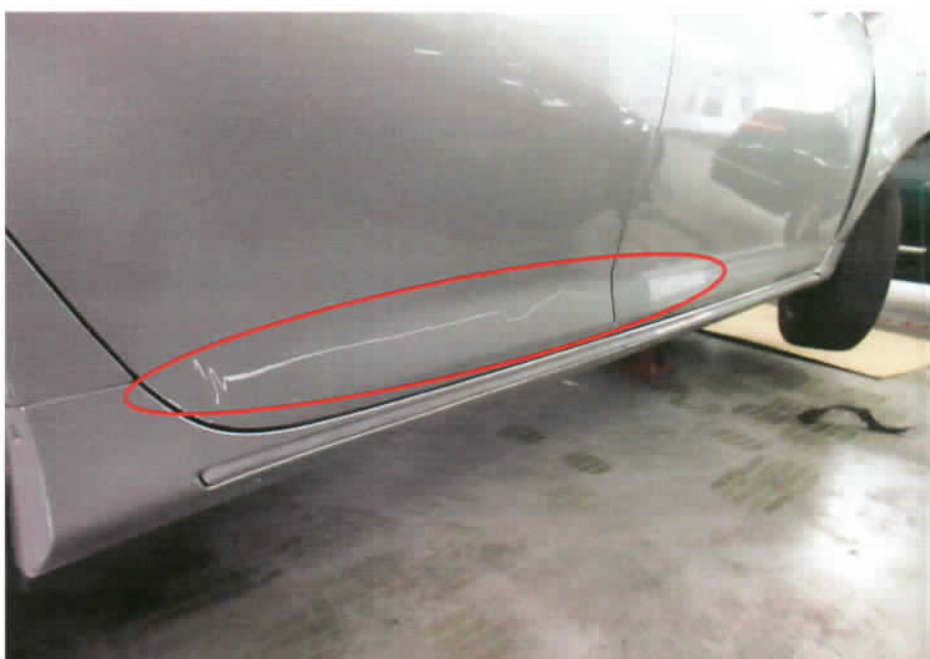
**Photo 20** shows a closer view of the graze marks observed on the lower right portion of the Insured Vehicle (circled), corresponding to Mr Chong mounting the kerb.

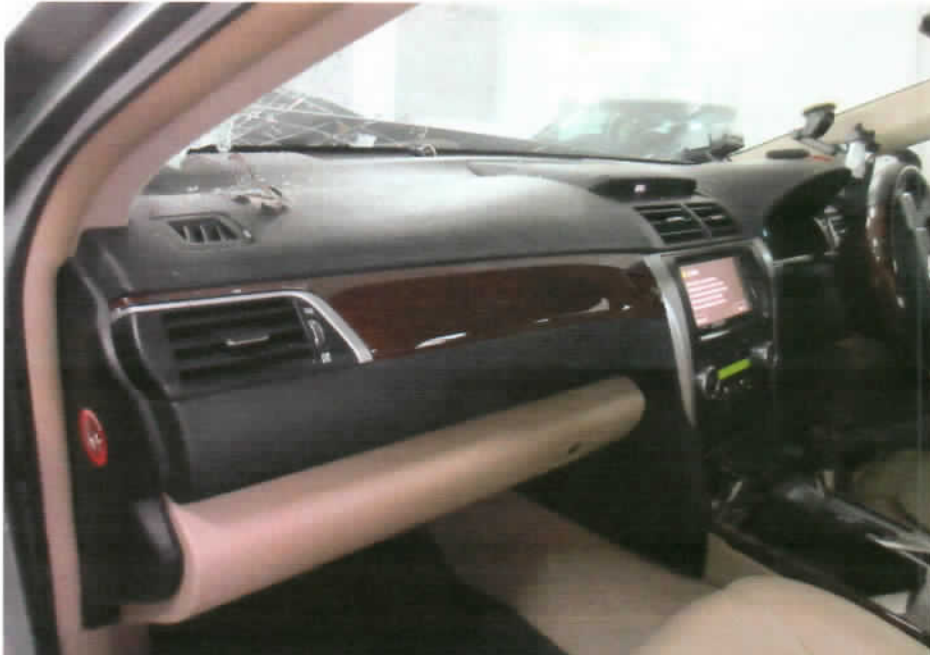
**Photo 21** shows the interior compartment of the Insured Vehicle. There were no remains of both airbags which corroborates with Mr Chong's statement that none of the airbags were deployed upon the Insured Vehicle's collision with the tree.
