**INVESTIGATION REPORT:**

Our Ref : CS/CTI18000550/N  
Policy No : DMHCSN1748561700  
Insured : SCR 8873P  
Date of Incident : 28 December 2017  
Location : Buangkok Drive towards Buangkok Green

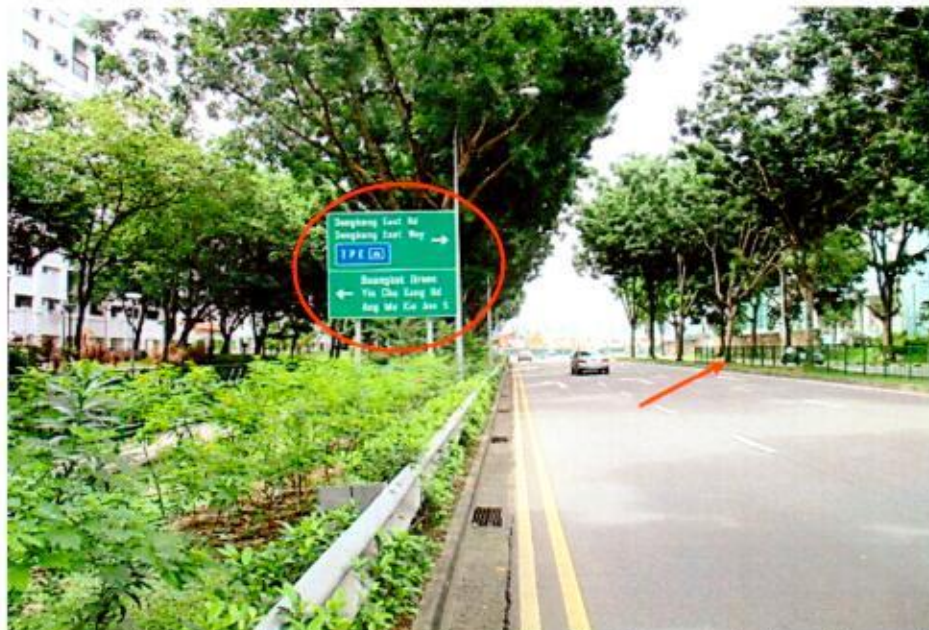
**Photo 1** shows the location where the incident had occurred, along the centre divider (arrowed) at Buangkok Drive towards Buangkok Green after the road direction signboard (circled). We noticed that the vicinity was not monitored by CCTV camera(s).

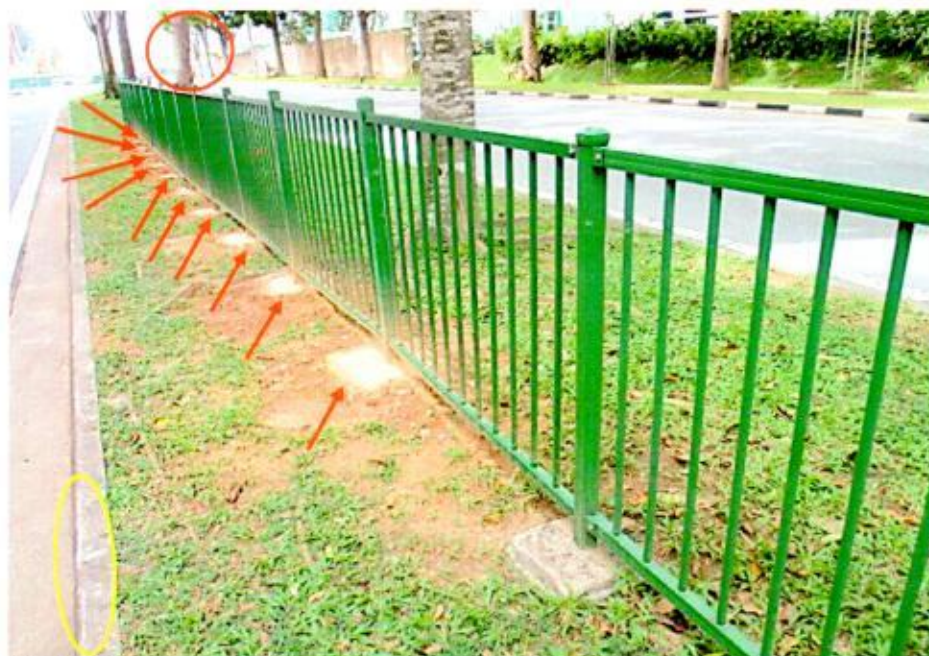
**Photo 2** shows the graze marks on a kerb (yellow circle) along the centre divider which Mr Chong had mounted. We observed that some of the greenish metal railings along the centre divider which were closest to the damaged tree Mr Chong collided into (red circle) had been replaced. The bases of these railings and the re-laid soil at the bottom of these railings are indications that these railings had been recently replaced (red arrows).

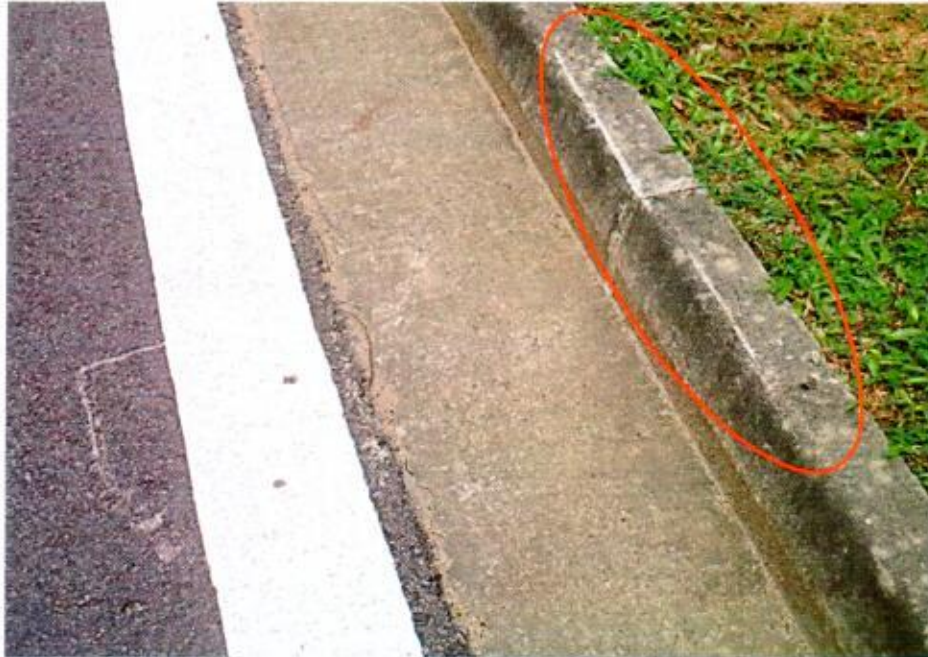
**Photo 3** shows a close up view of the graze marks found on a kerb which Mr Chong had mounted (circled).

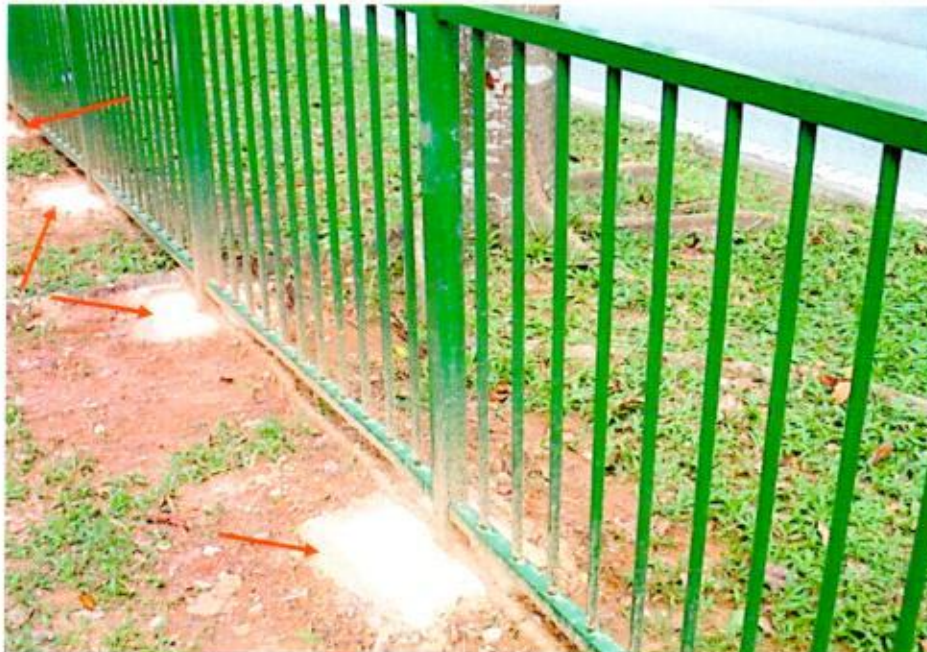
**Photo 4** shows a close up view of the bases (red arrows) and the re-laid soil at the bottom of the greenish metal railings which are indications that these railings had been recently replaced.

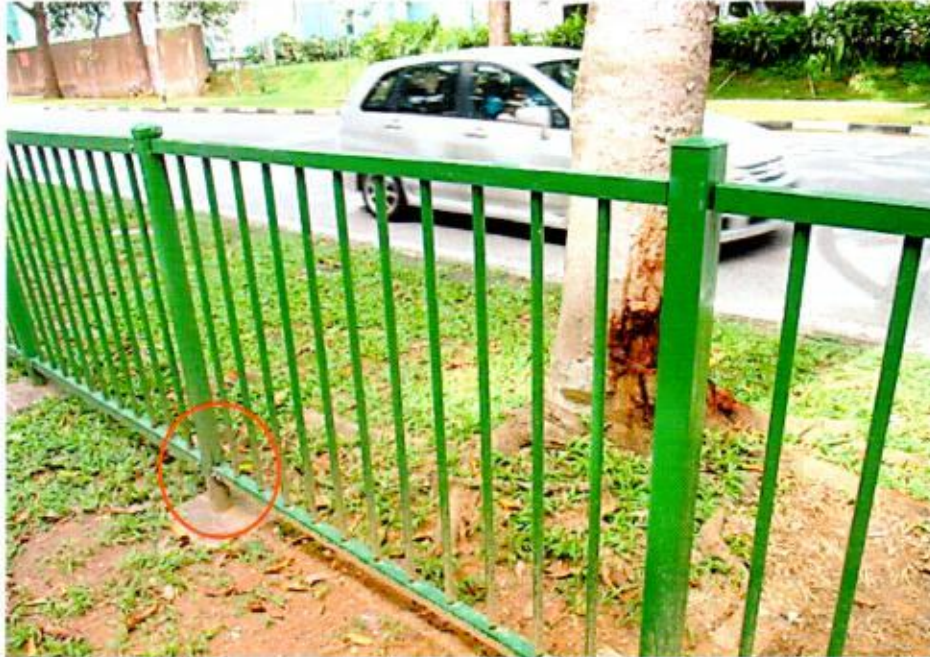
**Photo 5** shows minor damage to the base of a railing (circled) adjacent to the tree Mr Chong had collided into.

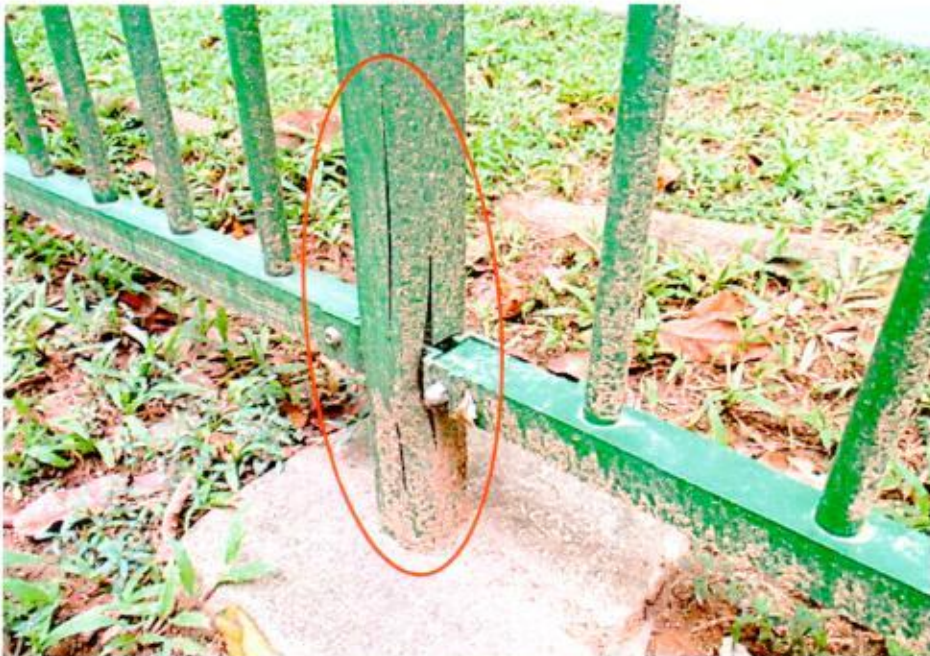
**Photo 6** shows a close up view of the minor damage to the base of a railing (circled) adjacent to the tree Mr Chong had collided into.

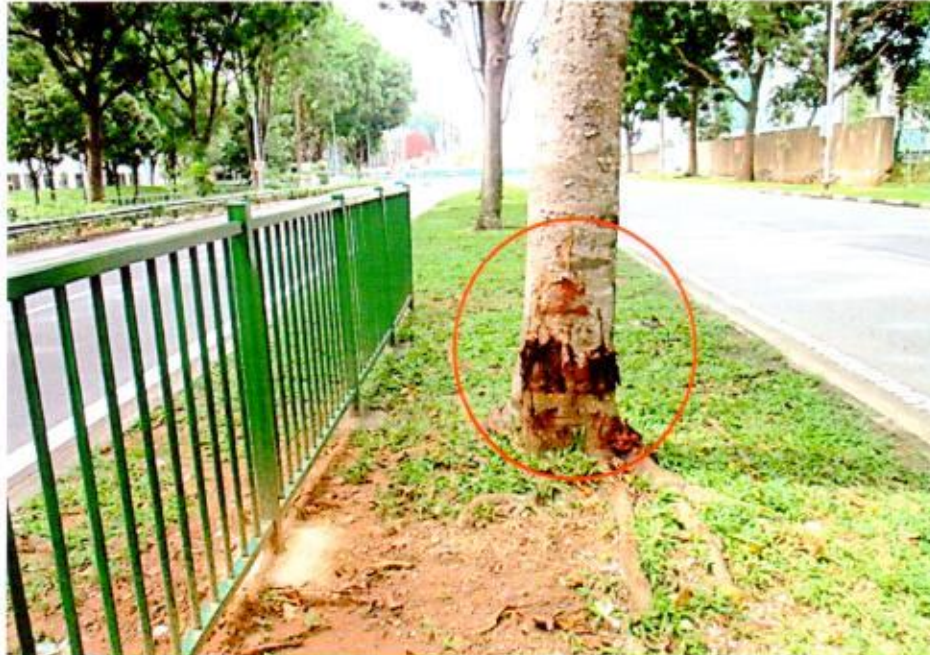
**Photo 7** shows the tree which Mr Chong collided into. The barks of the tree were observed to be torn (circled).

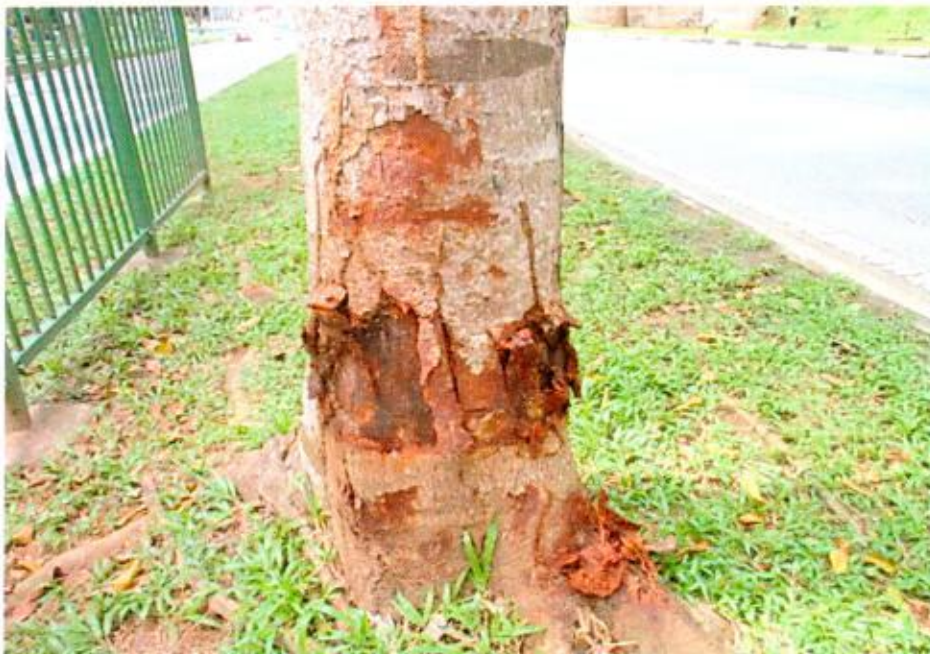
**Photo 8** shows a close up view of the torn barks of the tree which Mr Chong collided into.

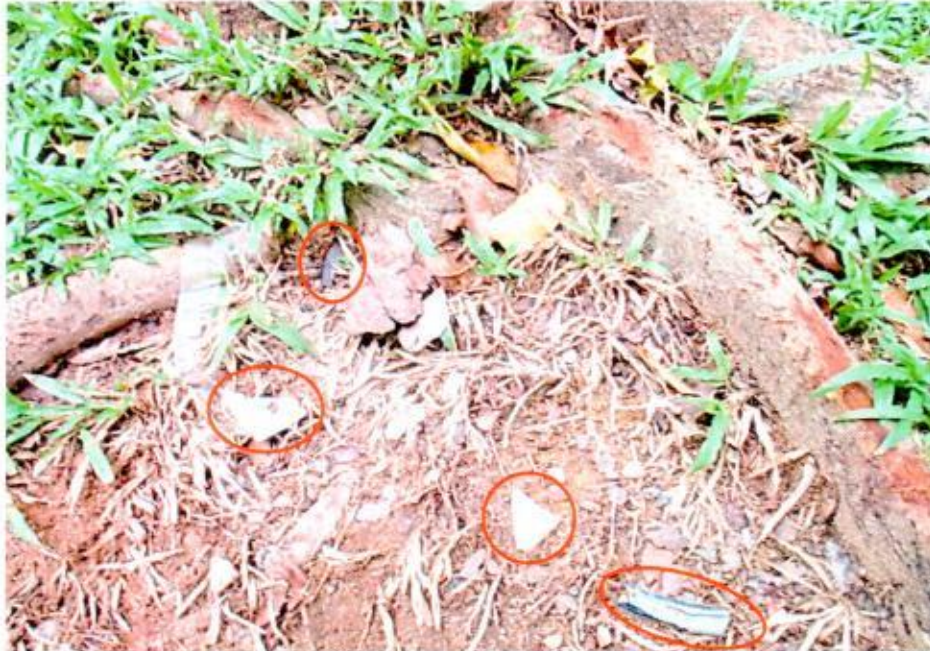
**Photo 9** shows a close up view of the broken plastic parts and vehicular debris (red circles) that were found on the grass patch surrounding the tree.

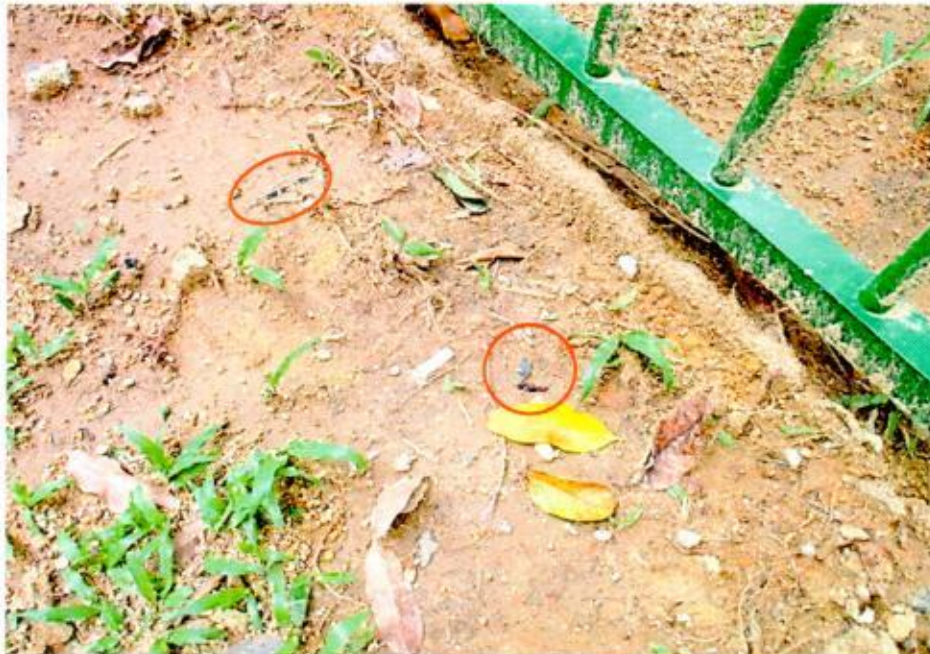
**Photo 10** shows a close up view of the broken plastic parts and vehicular debris (red circles) that were found on the ground near the replaced railings.

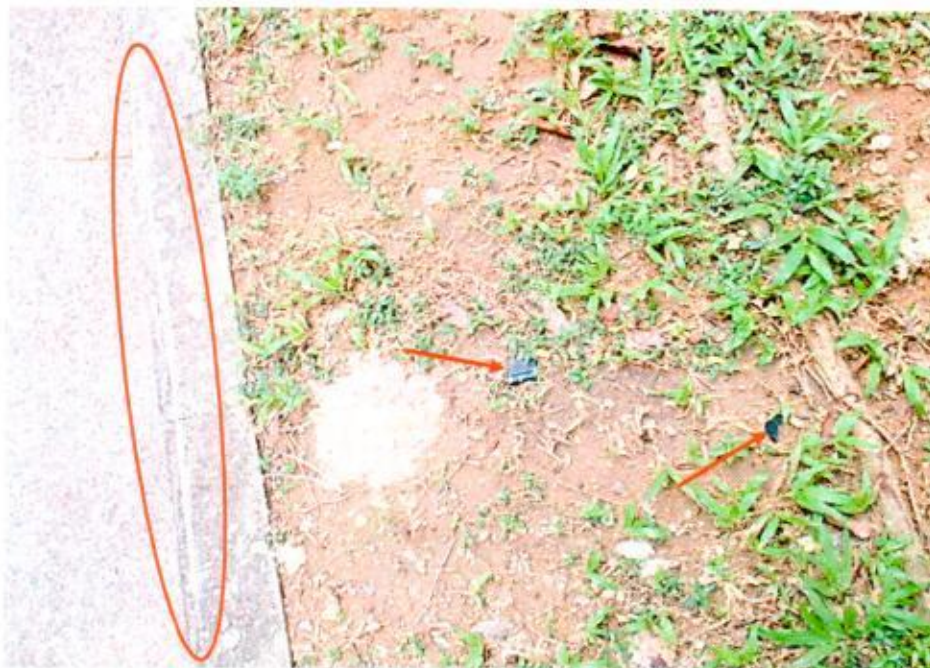
**Photo 11** shows a close up view of the broken plastic parts and vehicular debris (red arrows) that were found on the ground near the kerb which Mr Chong had mounted, causing the graze marks (circled).

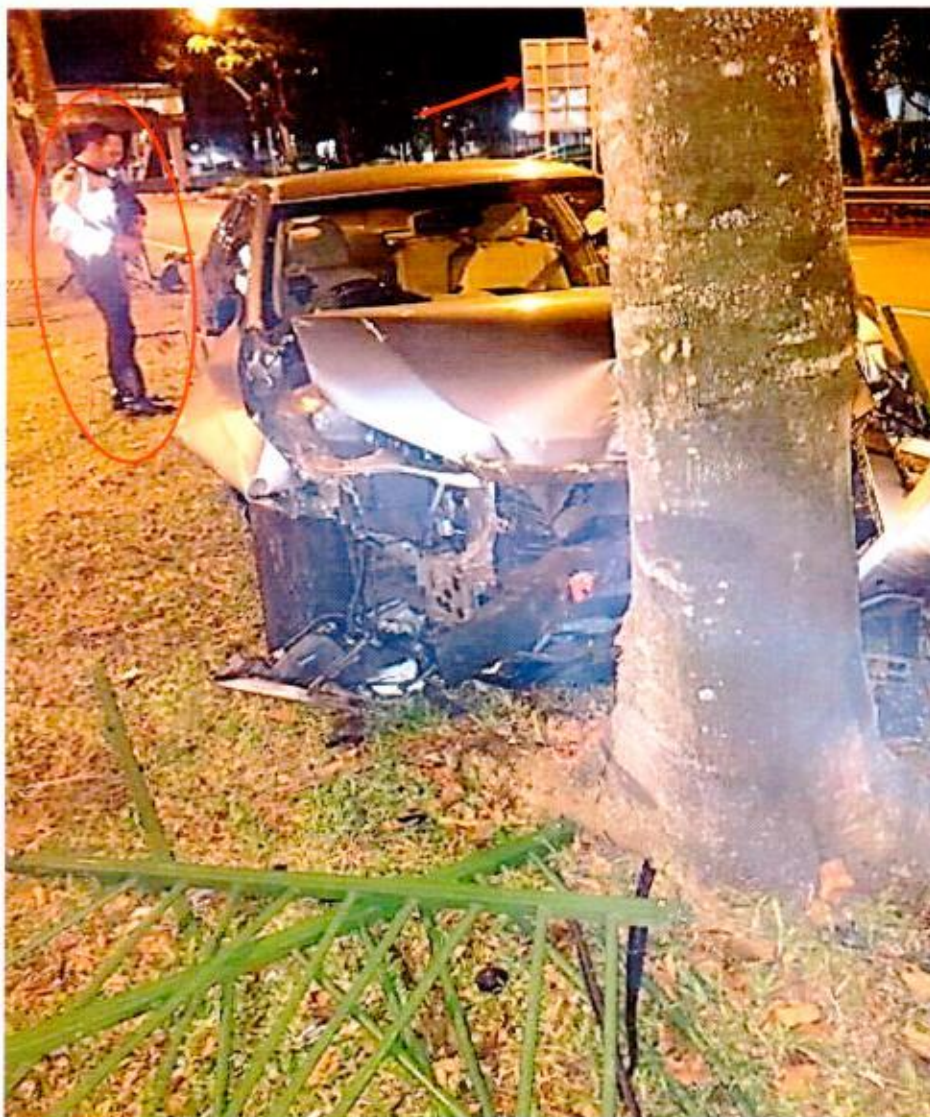
**Photo 12** shows the Insured Vehicle at its respective final rest position at the incident scene before it was towed away. It seems to correlate with Mr Chongs' account of the incident. The incident had occurred after the road direction signboard (arrowed). Mr Chong had mounted the kerb along the centre divider, ran over the greenish metal railings and collided into a tree. The photograph also showed the presence of Traffic Police officers at the scene (circled) after the incident.

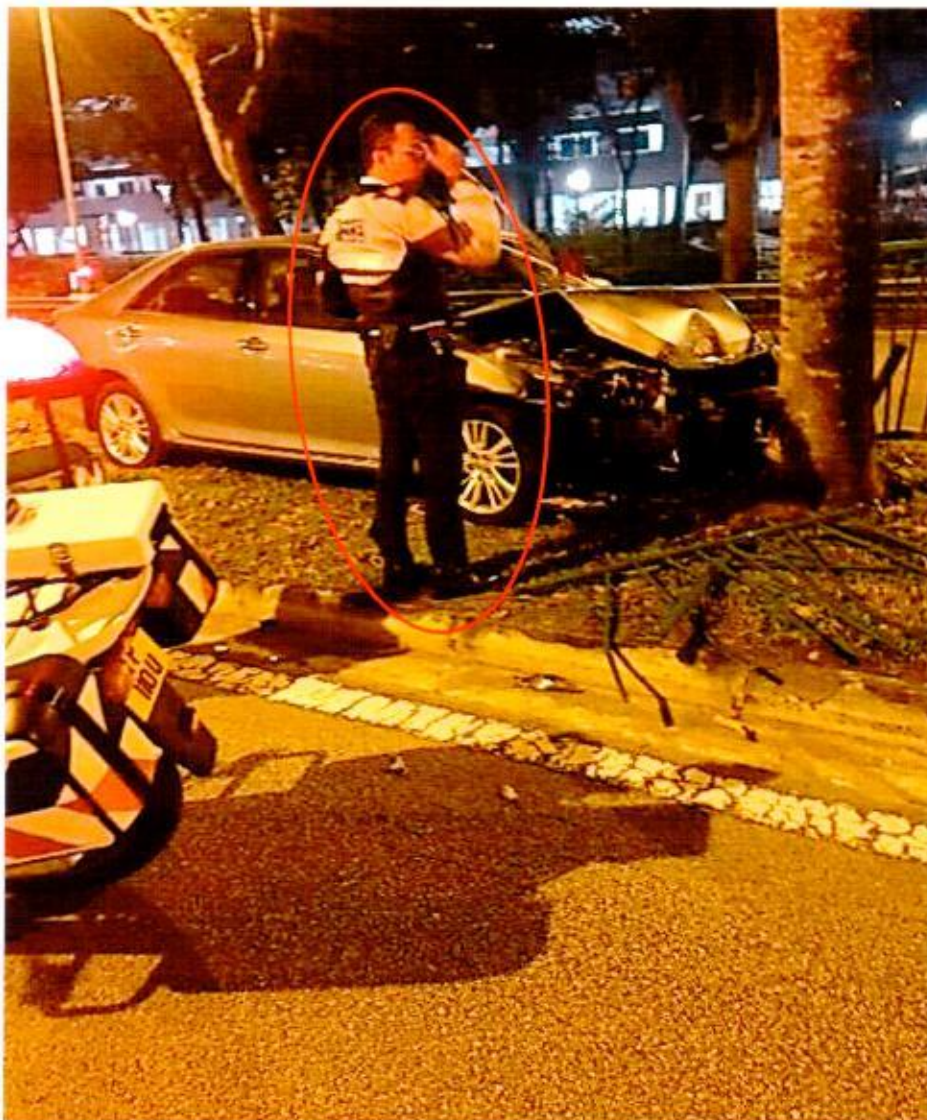
**Photo 13** shows the Insured Vehicle at its respective final rest position at the incident scene before it was towed away. It seems to correlate with Mr Chongs' account of the incident. In particular, the presence of Traffic Police officers (circled) together with the ability of Mr Chong to take clear photographs after the incident would suggest that there was no drink driving involved in this particular incident.

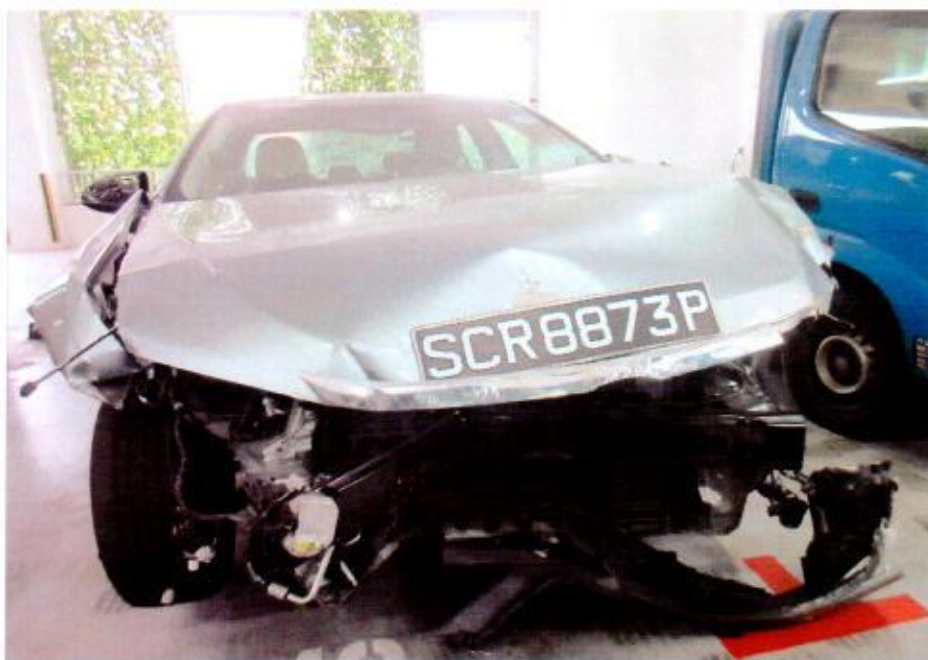
19. Our physical inspection of the Insured Vehicle at KKH revealed that the Insured Vehicle had sustained extensive damages to its entire front portion, particularly to its front windscreen, front bonnet, front bumper, front bumper reinforcement panel and side panels. There were also some relatively minor marks of grazing nature observed on the lower right portion as well as around the edges of the front right wheel rim of the Insured Vehicle as a result of mounting the kerb. There were no remains of both airbags in the interior compartment of the Insured Vehicle which corroborates with Mr Chong's statement that none of the airbags were deployed upon the Insured Vehicle's collision with the tree.

**Photo 14** shows the general front view of the Insured Vehicle during the physical inspection at KKH. The Insured Vehicle had sustained extensive damages to its entire front portion, particularly to its front windscreen, front bonnet, front bumper, front bumper reinforcement panel and side panels.

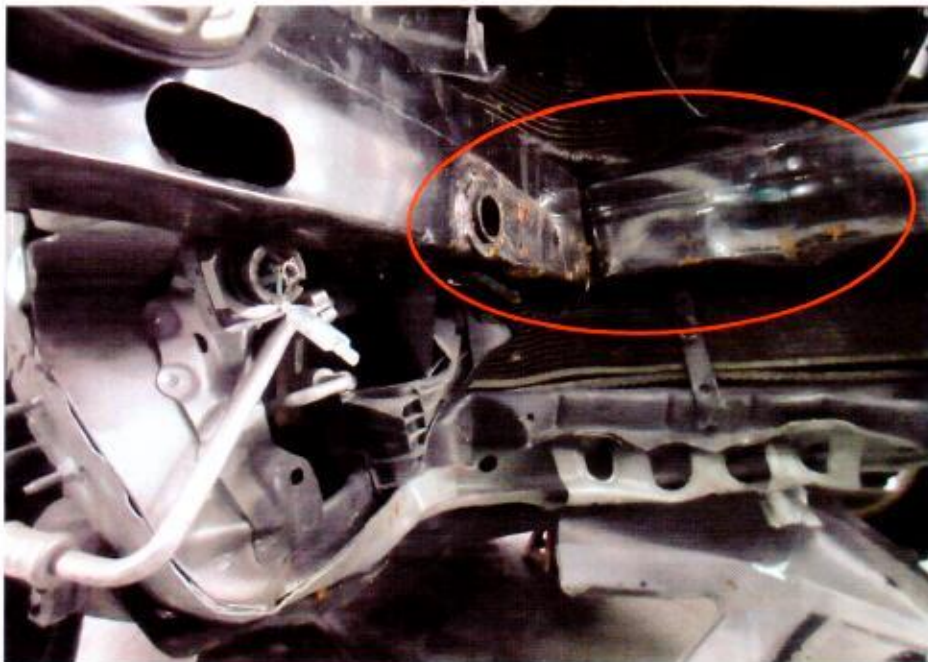
**Photo 15** shows a closer view of the broken pieces of tree bark and/or soil particles that were found stuck to the front bumper reinforcement panel (circled) of the Insured Vehicle.

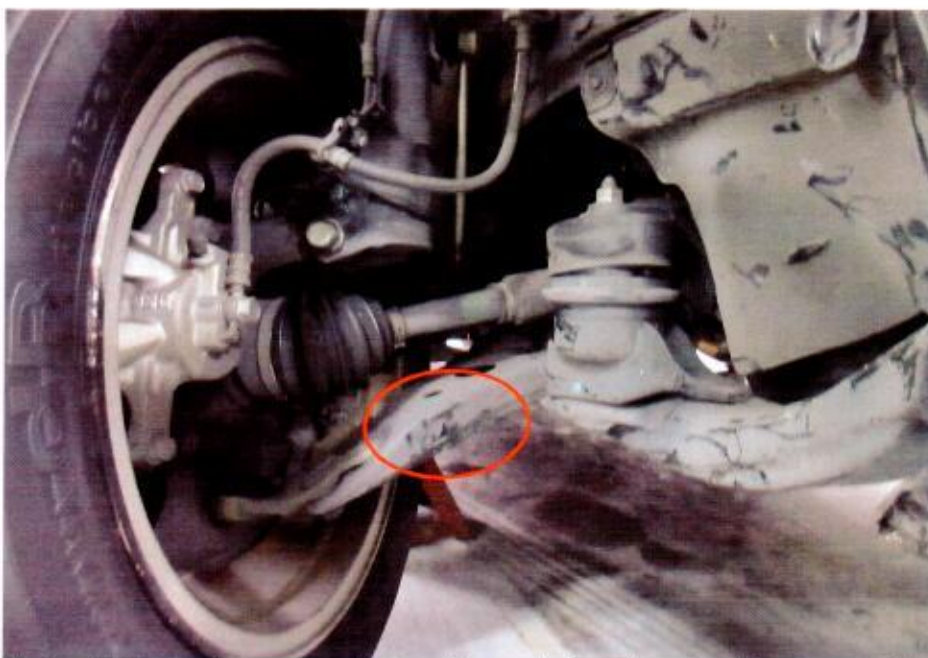
**Photo 16** shows the green paint transfer marks found on the right tie rod of the Insured Vehicle (circled), corresponding to the Insured Vehicle running over the greenish metal railings.

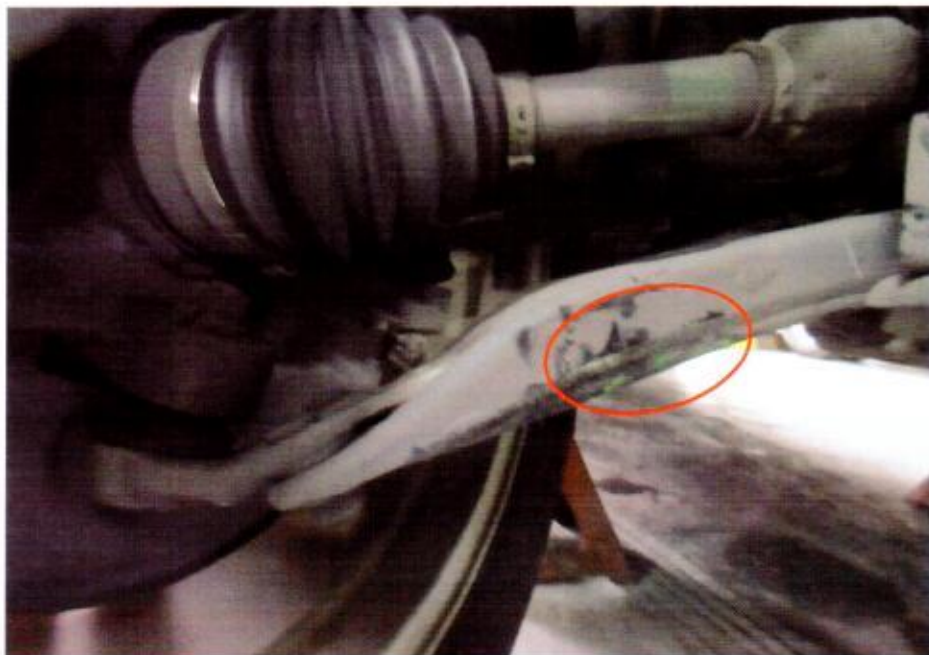
**Photo 17** shows a close up view of the green paint transfer marks found on the right tie rod of the Insured Vehicle (circled), corresponding to the Insured Vehicle running over the greenish metal railings.

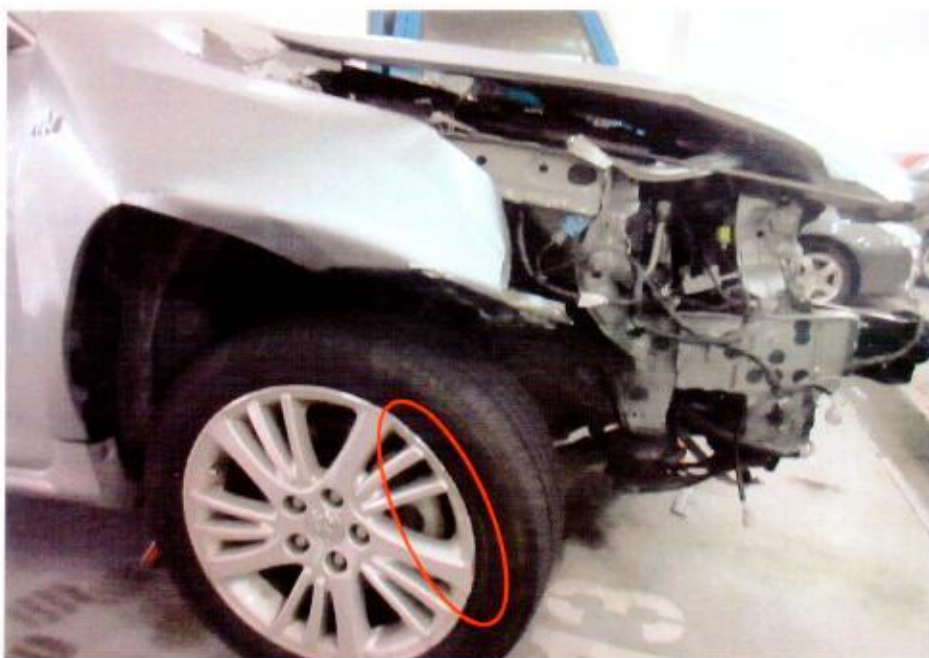
**Photo 18** shows some relatively minor marks of grazing nature observed around the edges of the front right wheel rim (circled) as a result of Mr Chong mounting the kerb.

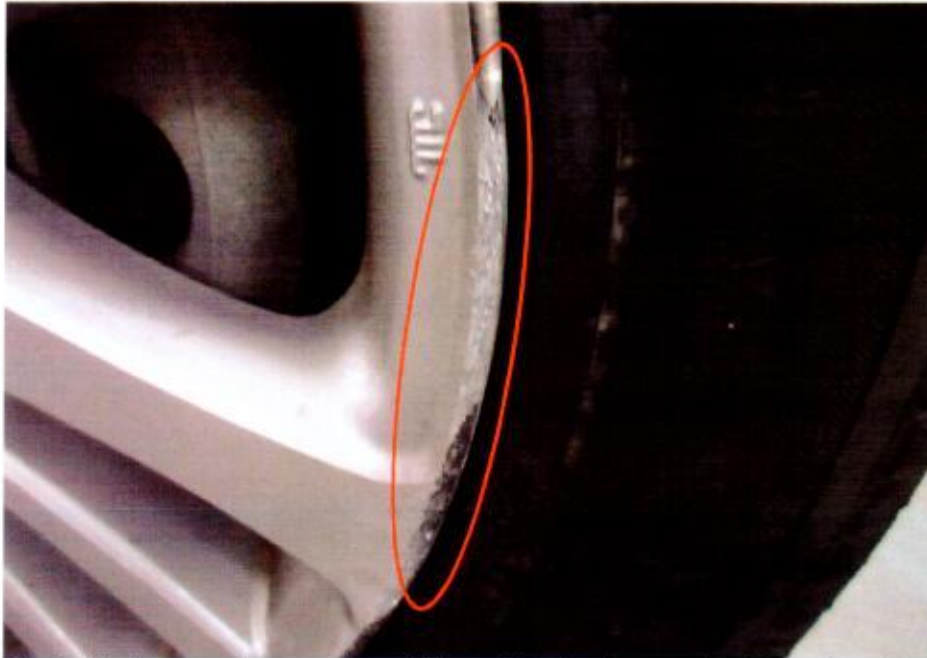
**Photo 19** shows a close up view of the relatively minor marks of grazing nature observed around the edges of the front right wheel rim (circled) as a result of Mr Chong mounting the kerb.

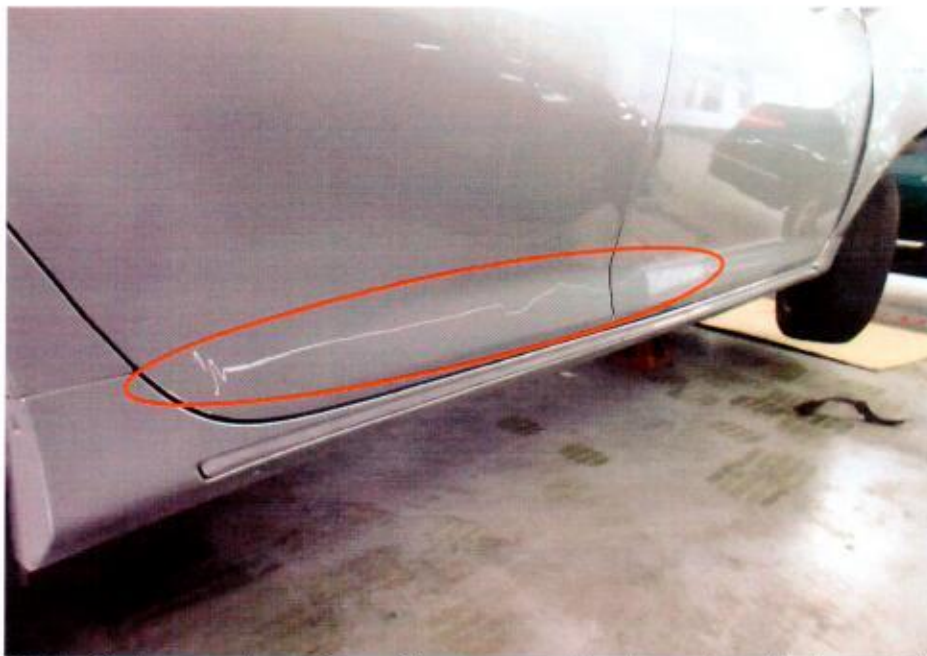
**Photo 20** shows a closer view of the graze marks observed on the lower right portion of the Insured Vehicle (circled), corresponding to Mr Chong mounting the kerb.

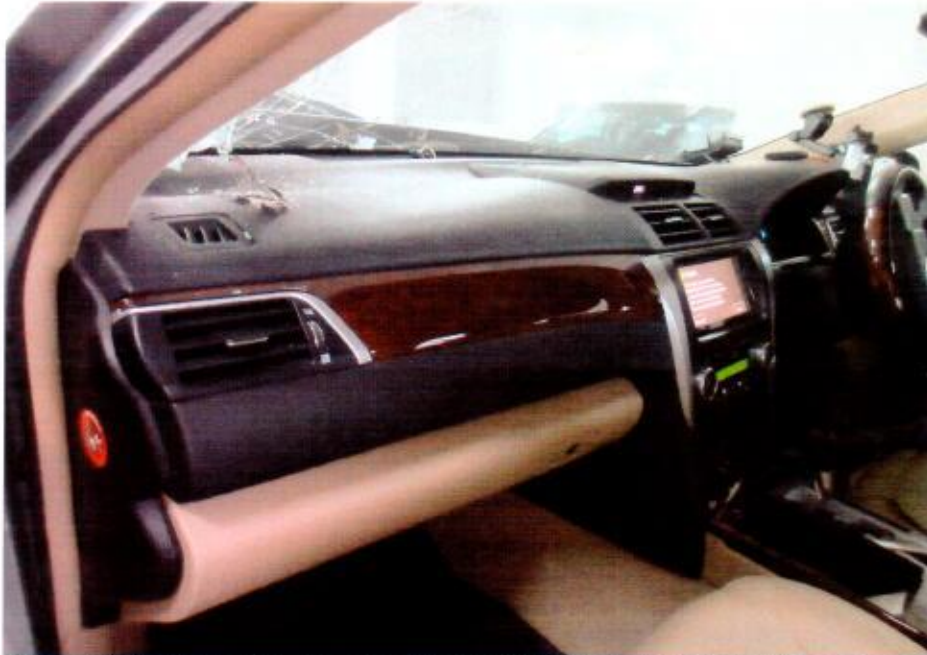
Photo 21 shows the interior compartment of the Insured Vehicle. There were no remains of both airbags which corroborates with Mr Chong's statement that none of the airbags were deployed upon the Insured Vehicle's collision with the tree.
