Your Ref : 6216126103SG (003)  
Our Ref : CC3/AIG18000691/N

2 June 2019

**AUTOMOBILE TECHNICAL INVESTIGATION REPORT OF ACCIDENT  
INVOLVING SHB 9981D AND SJX 3357G ON 7 JANUARY 2018**

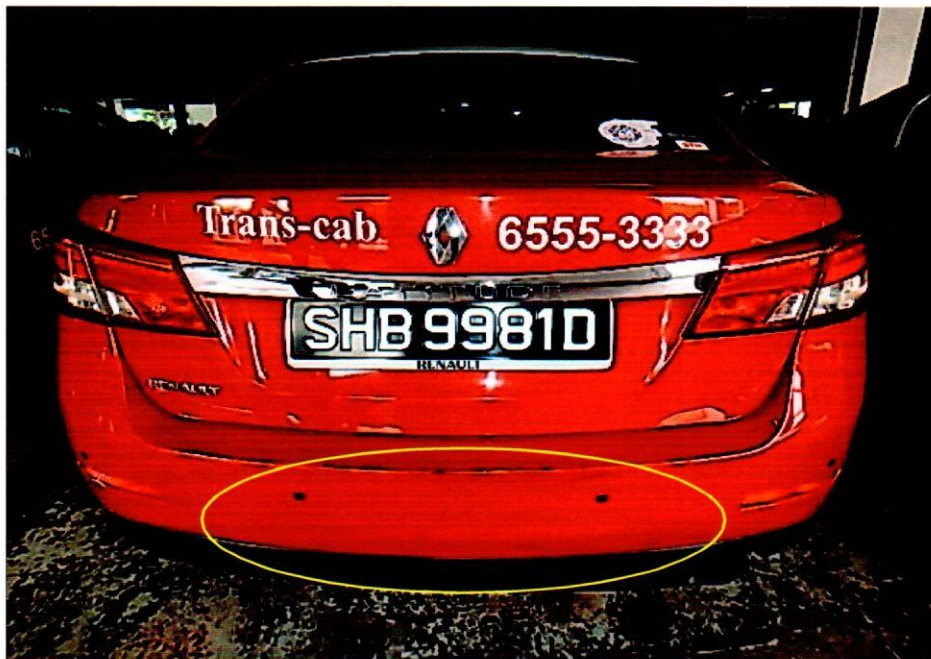
7. From our examination of the photographs taken during the Pre- Repair Survey conducted by LKK Auto Consultants Pte. Ltd. about 2 days after the accident, the damage to the Taxi was observed to be confined to its rear centre portion. We observed a dent as well as paint graze marks at the centre portion. We also noted vertical indentations on the lower rear bumper. The boot lid was also dented at the lower centre portion. See photos 1 - 5 below.

**Photo 1** shows the general view of the rear of the Taxi at the time of the Pre-Repair Survey conducted by LKK Auto Consultants Pte. Ltd. taken 2 days after the accident. The damage to the Taxi was observed to be confined to its rear centre portion (circled).

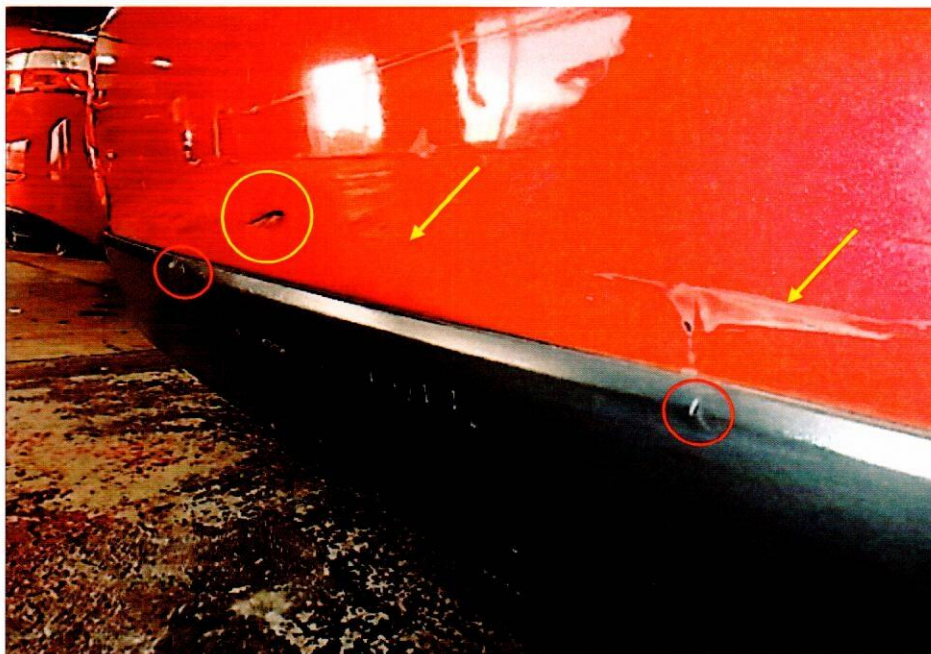
**Photo 2** shows upon closer examination of the centre portion of the rear bumper, we observed a dent (yellow circle), paint graze marks (yellow arrows) as well as vertical indentations on the lower rear bumper (red circles) of the Taxi.

11. Firstly, the vertical indentations on the Taxi's lower rear bumper were caused by an object that is of a similar shape, pressing onto the rear portion of the Taxi. If one was to consider the shape of the Mercedes's front number plate frame, it would then appear that these vertical indentations were caused by the top corners of the Mercedes's front number plate frame.

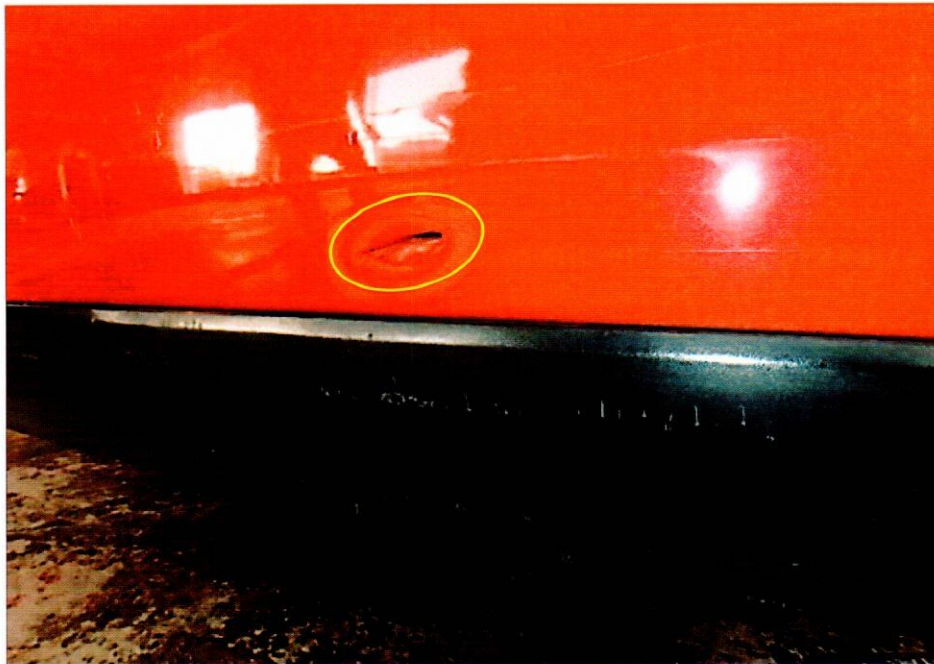
**Photo 3** shows a close up view of the dent (yellow circle) on the centre portion of the Taxi's rear bumper.

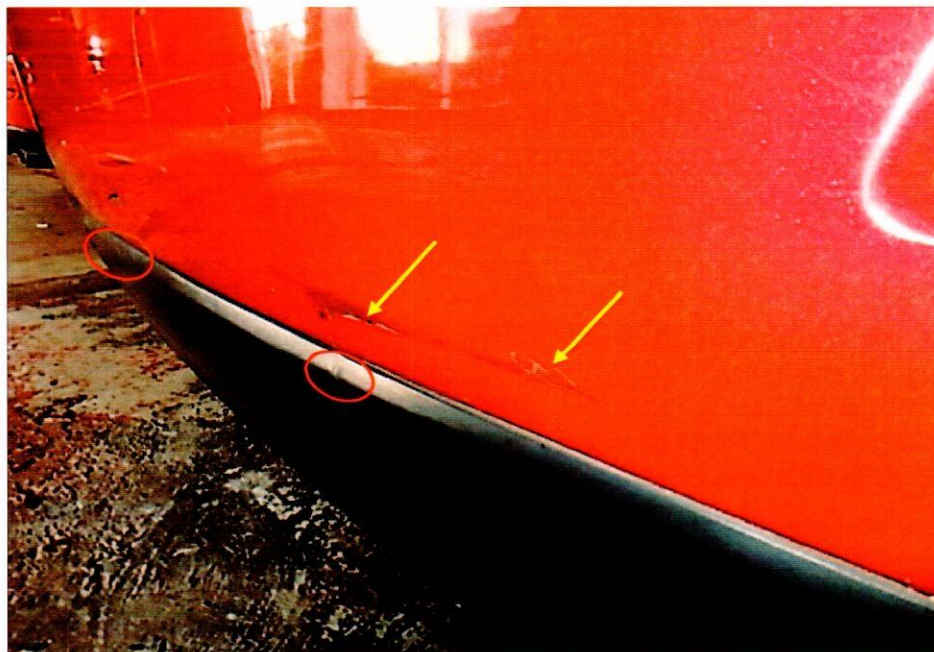
**Photo 4** shows a close up view of the paint graze marks (yellow arrows) on the centre portion of the Taxi's rear bumper as well as vertical indentations (red circles) on the lower rear bumper of the Taxi.

- 19. The damage to the lower rear bumper of the Taxi was caused by the front number plate frame of the Mercedes, specifically by the top corners of the Mercedes's number plate frame. This is supported by the following material/physical evidence:-

- a) the shape of the vertical indentations on the Taxi's lower rear bumper had corresponded to the shape of the top portion of the Mercedes's front number plate frame;

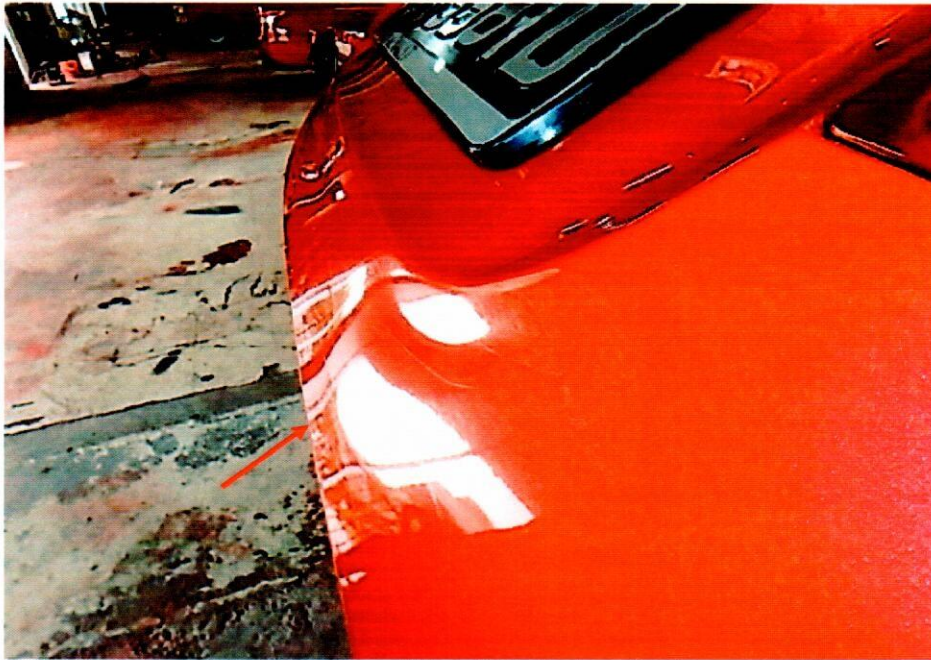
**Photo 5** shows a close up view of the slight dent on the lower centre portion of the Taxi's boot lid (arrowed).

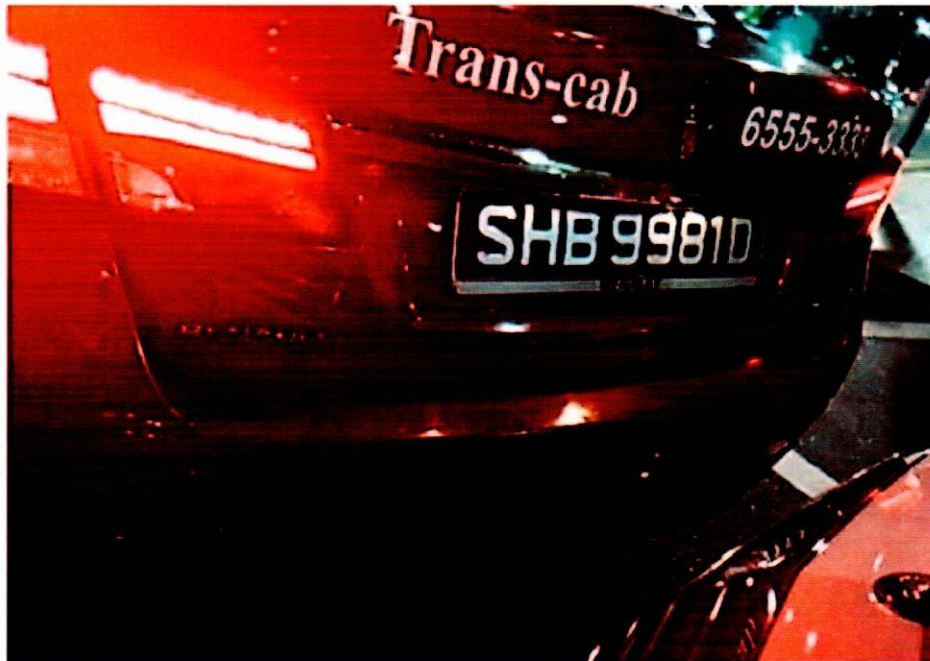
**Photo 6** shows the position of the Involved Motor Vehicles at the accident location. The position of the Mercedes appeared to be slightly towards the right from the rear of the Taxi.

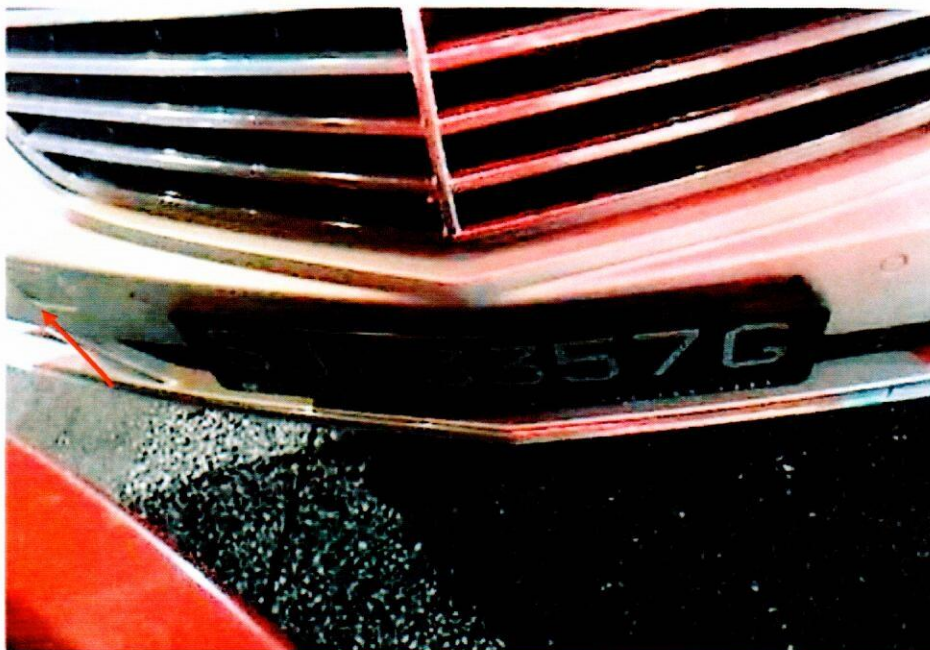
**Photo 7** shows the position of the Mercedes after the accident. Upon closer examination we observed that the front right tow cover of the Mercedes was pushed inwards (arrowed).

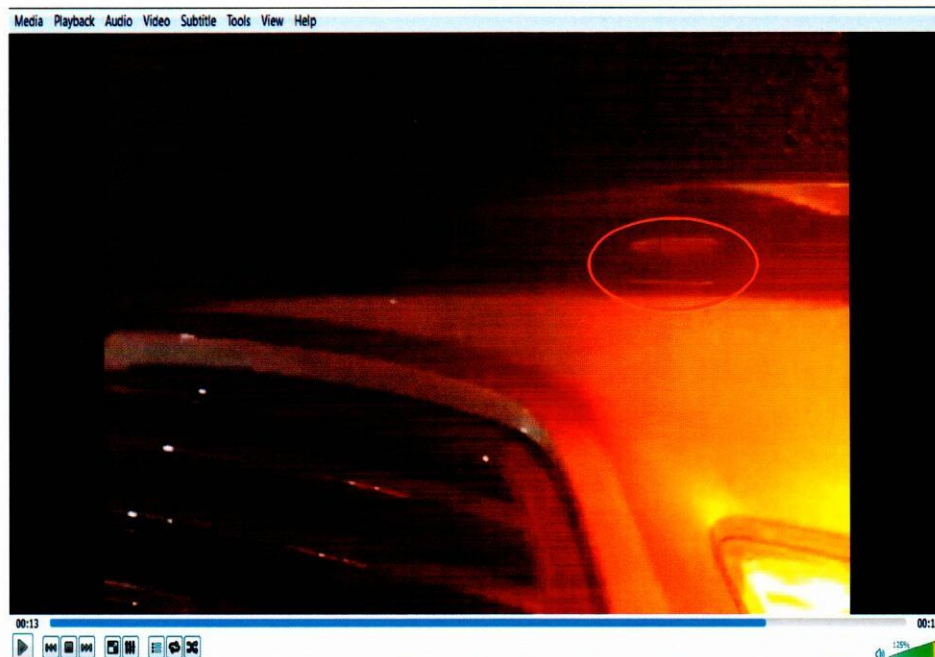
**Screenshot 1** of the video recording taken from the mobile phone of Ms Pandit shows the front right tow cover of the Mercedes which was observed to be pushed inwards (circled) at the 13 second mark.

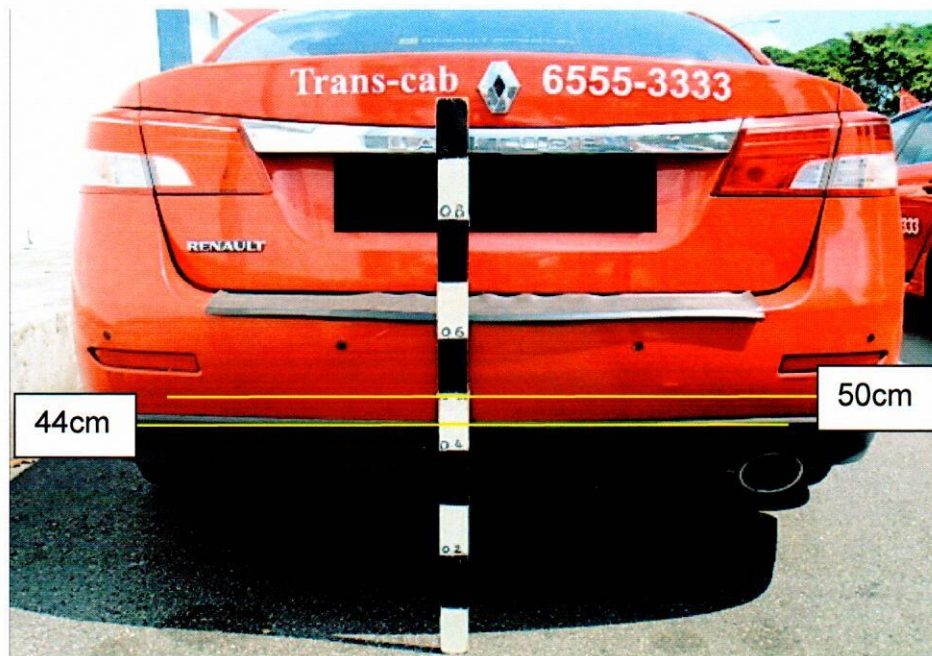
**Photo 8** shows the height measurement being conducted on the rear portion of the Taxi (using a similar make and model). The height above ground level of the Taxi's lower rear bumper where the vertical indentations were found was measured to be approximately 44cm. The height above ground level of the Taxi's rear bumper where the dent and paint graze marks were found was measured to be approximately 50cm.

- a) the height above ground level of the Taxi's lower rear bumper where the vertical indentations were found was measured to be approximately 44cm;
- b) the height above ground level of the Taxi's rear bumper where the dent and paint graze marks were found was measured to be approximately 50cm;
- c) the height above ground level of the bottom portion of the Mercedes's front right tow cover which was observed to be pushed inwards was measured to be approximately 44cm;
- d) the height above ground level of the top corners of the Mercedes's front number plate frame was also measured to be approximately 44cm;

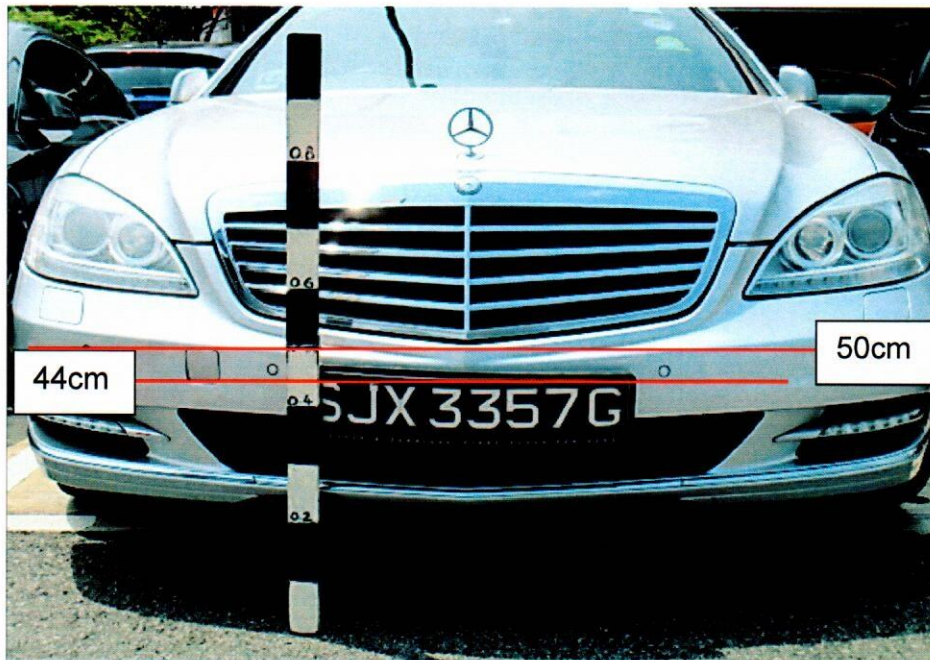
**Photo 9** shows the height measurement being conducted on the front portion of the Mercedes. The height above ground level of the bottom portion of the Mercedes's front right tow cover which was observed to be pushed inwards was measured to be approximately 44cm. The height above ground level of the top corners of the Mercedes's front number plate frame was also measured to be approximately 44cm. The height above ground level of the top portion of the Mercedes's front right tow cover was measured to be approximately 50cm.

- e) the height above ground level of the top portion of the Mercedes's front right tow cover was measured to be approximately 50cm;
- f) the height measurements appear to support the findings of possible contact between the rear portion of the Taxi and the front portion of the Mercedes. The damage observed on the rear portion of the Taxi was a result of this contact and corresponds to the damage observed on the front portion of the Mercedes.

- b) the height above ground level of the vertical indentations was of the corresponding height above ground of the top corners of the Mercedes's front number plate frame.
