Your Ref : 6216126103SG (003)  
Our Ref : CC3/AIG18000691/N

2 June 2019

**AUTOMOBILE TECHNICAL INVESTIGATION REPORT OF ACCIDENT  
INVOLVING SHB 9981D AND SJX 3357G ON 7 JANUARY 2018**

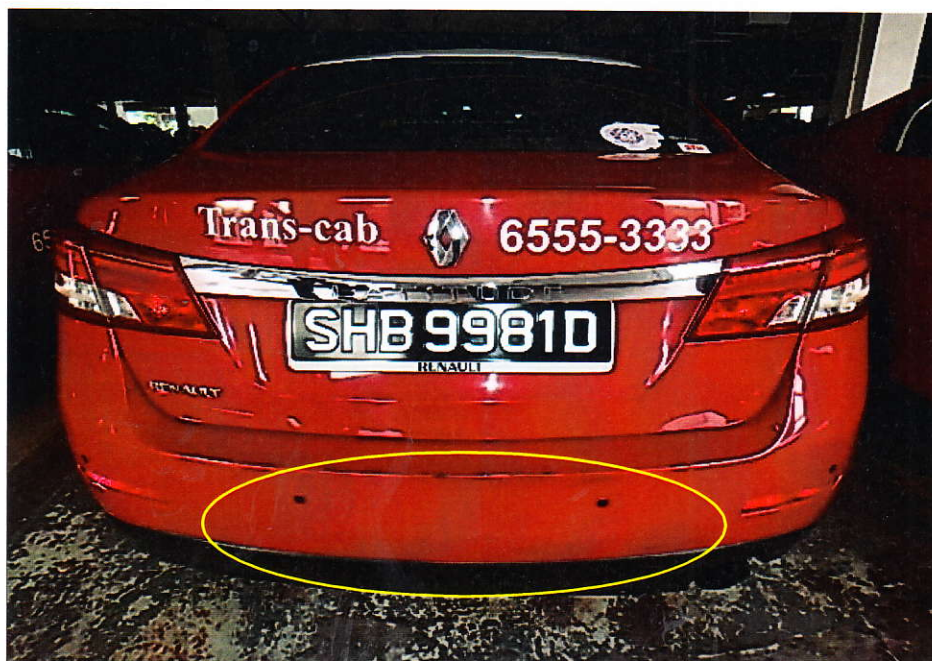
7. From our examination of the photographs taken during the Pre- Repair Survey conducted by LKK Auto Consultants Pte. Ltd. about 2 days after the accident, the damage to the Taxi was observed to be confined to its rear centre portion. We observed a dent as well as paint graze marks at the centre portion. We also noted vertical indentations on the lower rear bumper. The boot lid was also dented at the lower centre portion. See photos 1 - 5 below.

**Photo 1** shows the general view of the rear of the Taxi at the time of the Pre-Repair Survey conducted by LKK Auto Consultants Pte. Ltd. taken 2 days after the accident. The damage to the Taxi was observed to be confined to its rear centre portion (circled).

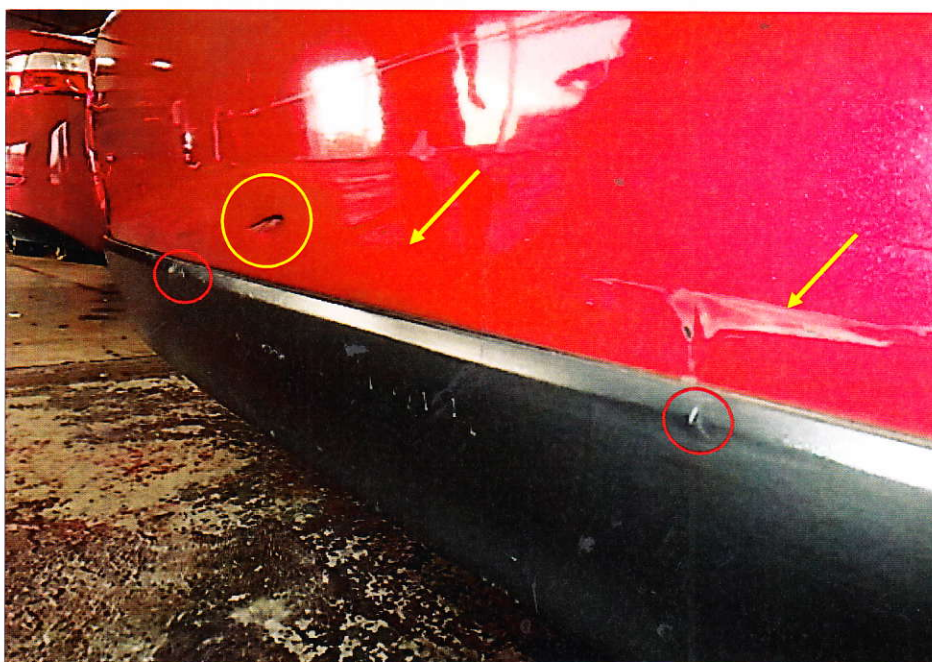
**Photo 2** shows upon closer examination of the centre portion of the rear bumper, we observed a dent (yellow circle), paint graze marks (yellow arrows) as well as vertical indentations on the lower rear bumper (red circles) of the Taxi.

11. Firstly, the vertical indentations on the Taxi's lower rear bumper were caused by an object that is of a similar shape, pressing onto the rear portion of the Taxi. If one was to consider the shape of the Mercedes's front number plate frame, it would then appear that these vertical indentations were caused by the top corners of the Mercedes's front number plate frame.

- 19. The damage to the lower rear bumper of the Taxi was caused by the front number plate frame of the Mercedes, specifically by the top corners of the Mercedes's number plate frame. This is supported by the following material/physical evidence:-

- a) the shape of the vertical indentations on the Taxi's lower rear bumper had corresponded to the shape of the top portion of the Mercedes's front number plate frame;

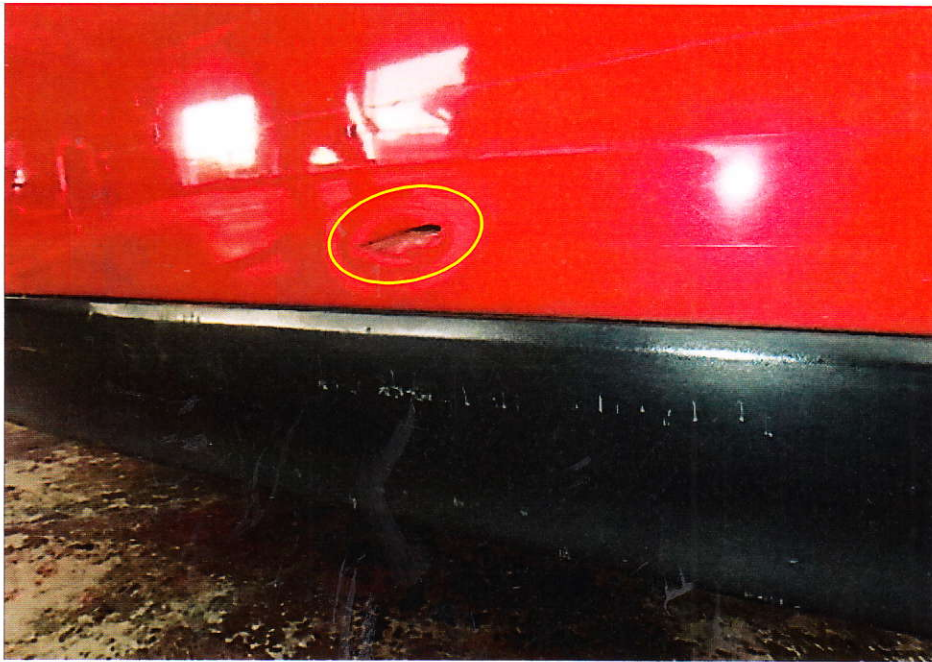
**Photo 3** shows a close up view of the dent (yellow circle) on the centre portion of the Taxi's rear bumper.

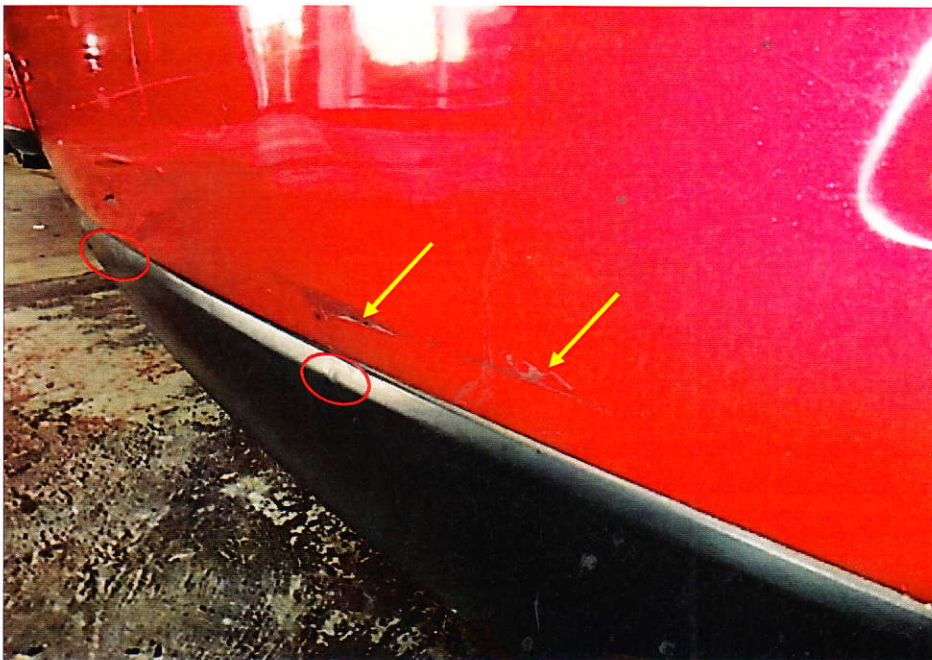
**Photo 4** shows a close up view of the paint graze marks (yellow arrows) on the centre portion of the Taxi's rear bumper as well as vertical indentations (red circles) on the lower rear bumper of the Taxi.

- 20. Upon contact, the front number plate frame of the Mercedes had compressed against the lower rear bumper of the Toyota, creating the permanent vertical indentations on the lower rear bumper as well as the dislodgement of the Mercedes's front number plate.

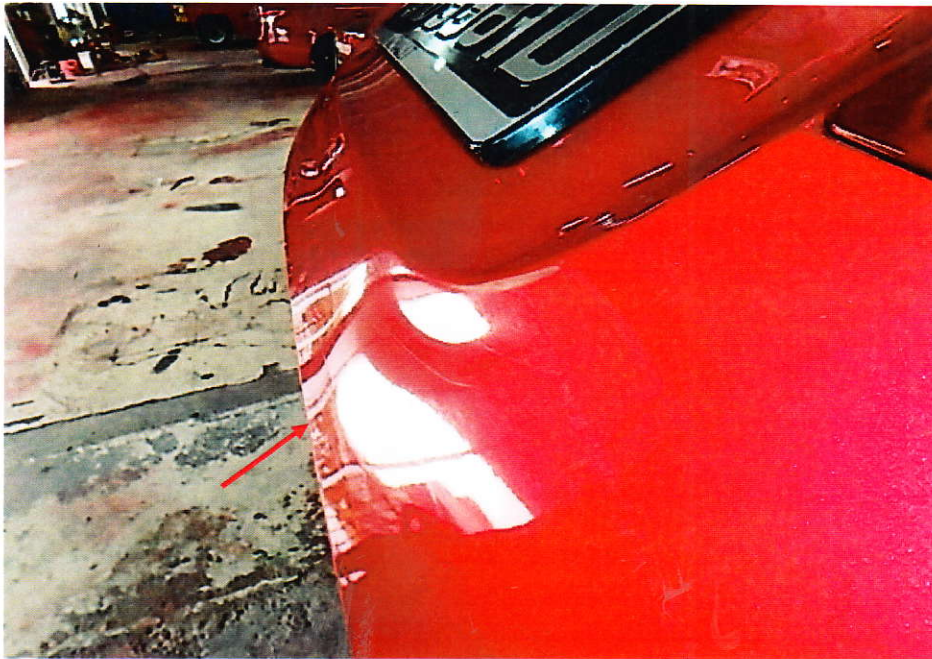
Photo 5 shows a close up view of the slight dent on the lower centre portion of the Taxi's boot lid (arrowed).

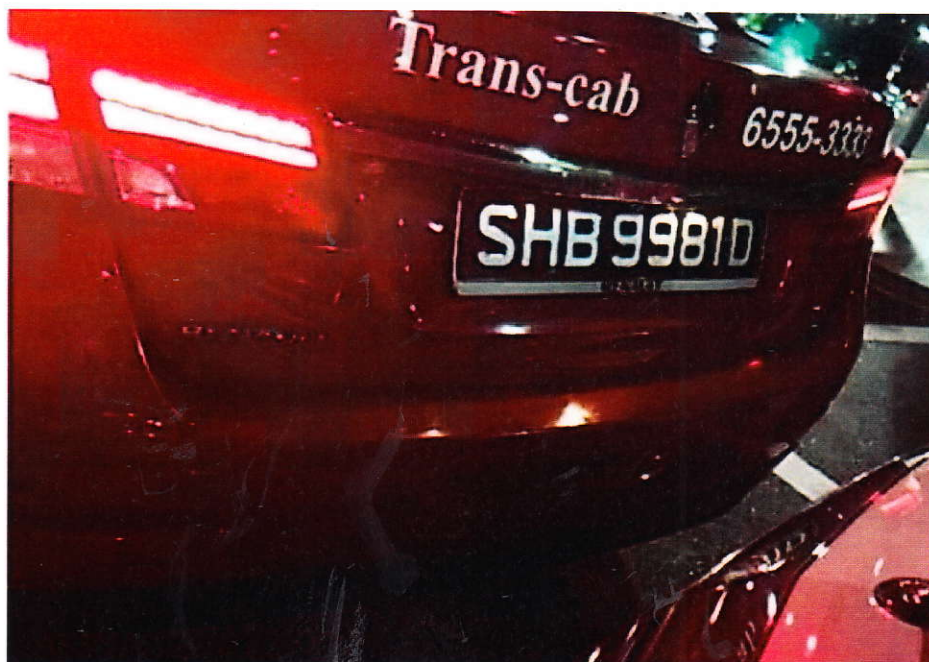
**Photo 6** shows the position of the Involved Motor Vehicles at the accident location. The position of the Mercedes appeared to be slightly towards the right from the rear of the Taxi.

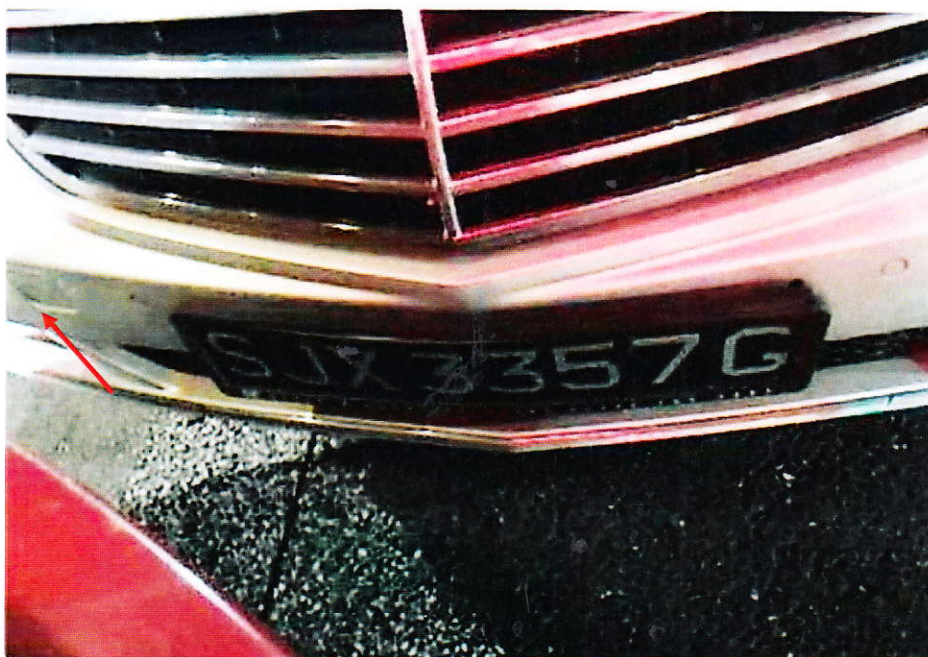
**Photo 7** shows the position of the Mercedes after the accident. Upon closer examination we observed that the front right tow cover of the Mercedes was pushed inwards (arrowed).

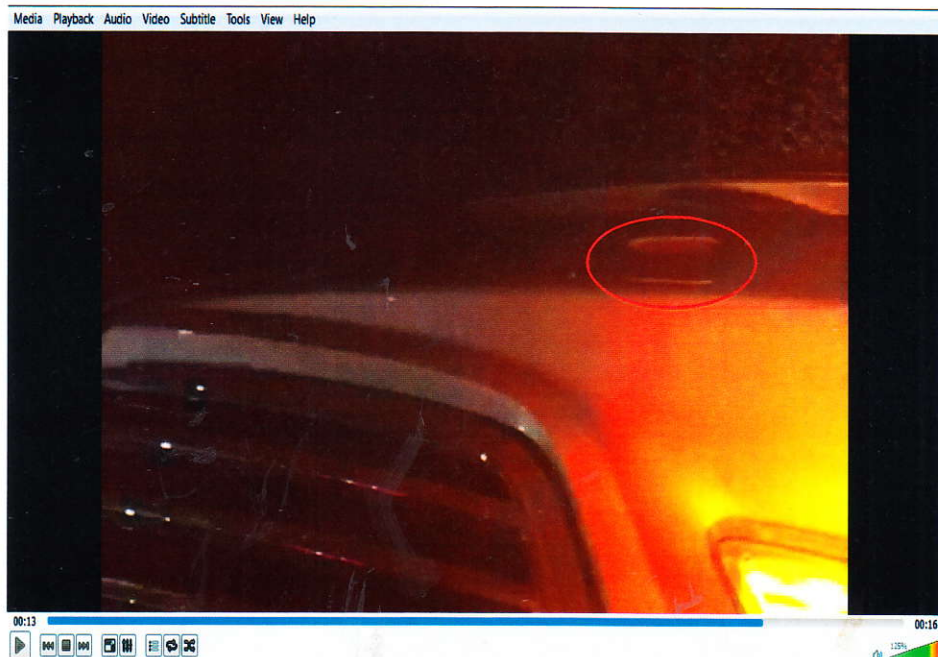
**Screenshot 1** of the video recording taken from the mobile phone of Ms Pandit shows the front right tow cover of the Mercedes which was observed to be pushed inwards (circled) at the 13 second mark.

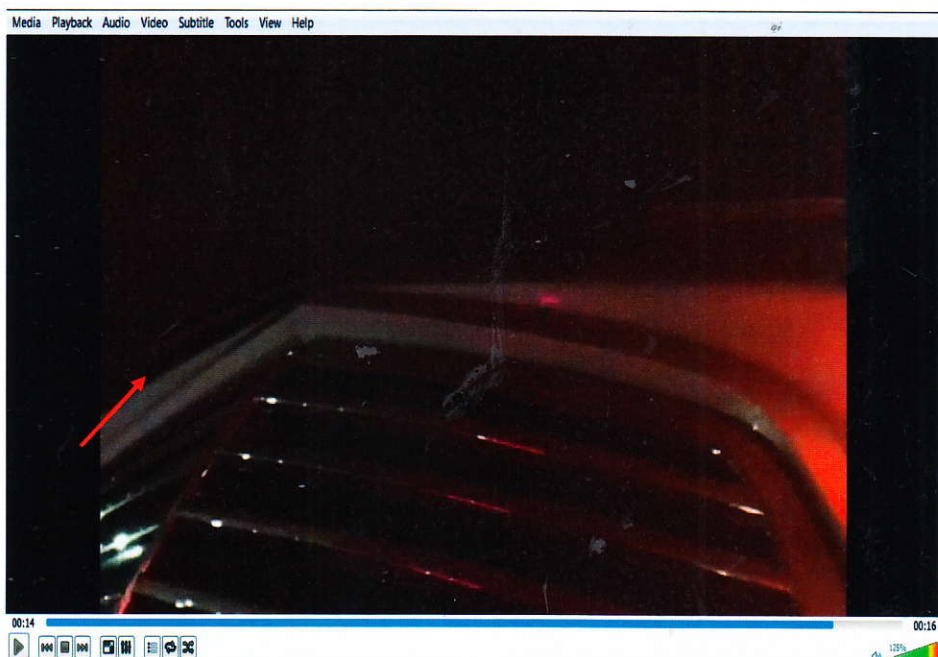
**Screenshot 2** of the video recording taken from the mobile phone of Ms Pandit shows the front number plate of the Mercedes which had appeared dislodged post- accident (arrowed) at the 14 second mark.

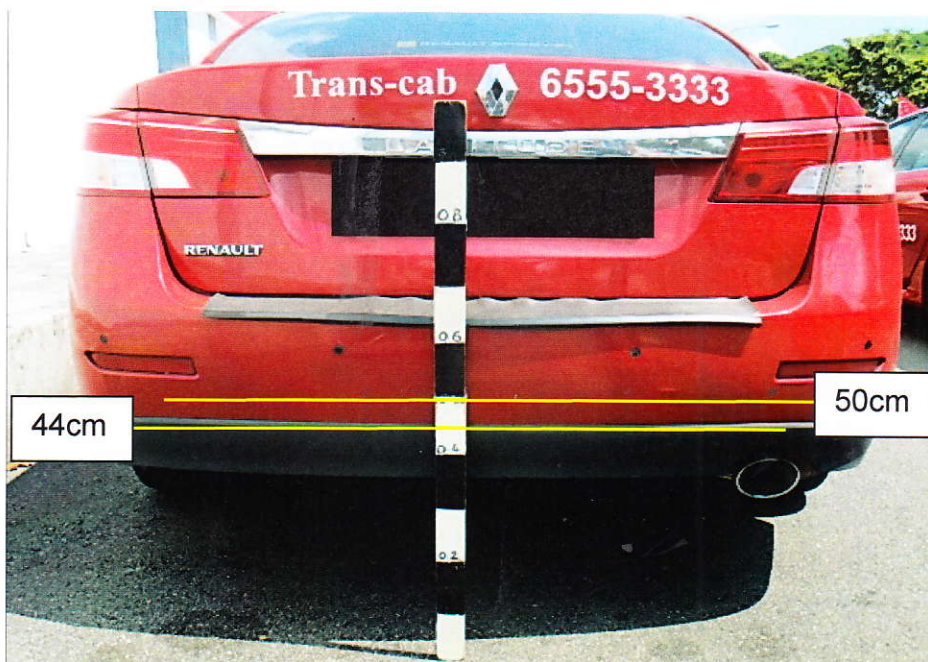
**Photo 8** shows the height measurement being conducted on the rear portion of the Taxi (using a similar make and model). The height above ground level of the Taxi's lower rear bumper where the vertical indentations were found was measured to be approximately 44cm. The height above ground level of the Taxi's rear bumper where the dent and paint graze marks were found was measured to be approximately 50cm.

- b) the height above ground level of the vertical indentations was of the corresponding height above ground of the top corners of the Mercedes's front number plate frame.

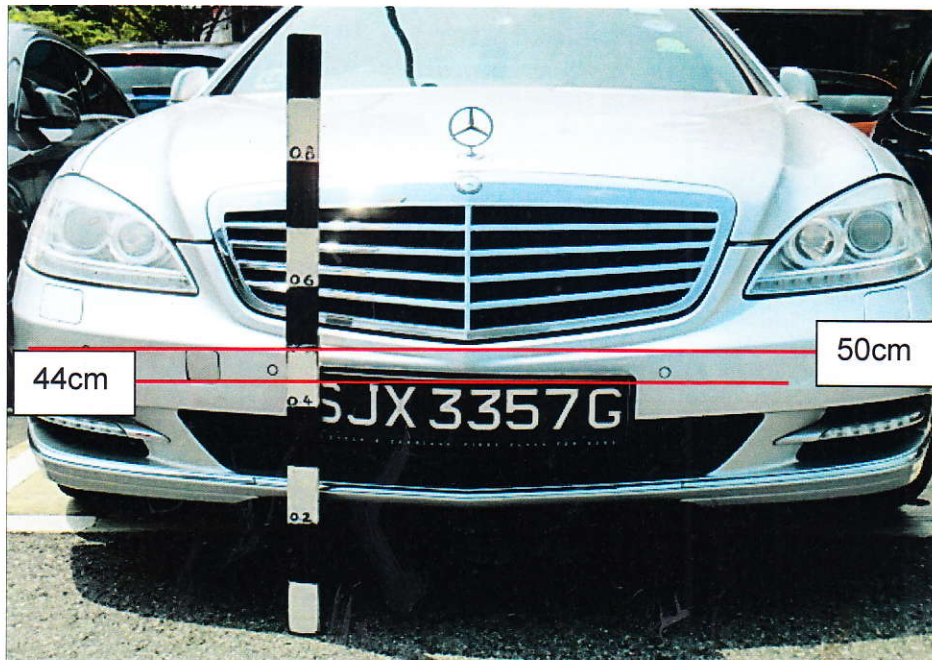
**Photo 9** shows the height measurement being conducted on the front portion of the Mercedes. The height above ground level of the bottom portion of the Mercedes's front right tow cover which was observed to be pushed inwards was measured to be approximately 44cm. The height above ground level of the top corners of the Mercedes's front number plate frame was also measured to be approximately 44cm. The height above ground level of the top portion of the Mercedes's front right tow cover was measured to be approximately 50cm.

- e) the height above ground level of the top portion of the Mercedes's front right tow cover was measured to be approximately 50cm;
- f) the height measurements appear to support the findings of possible contact between the rear portion of the Taxi and the front portion of the Mercedes. The damage observed on the rear portion of the Taxi was a result of this contact and corresponds to the damage observed on the front portion of the Mercedes.
