**Preliminary Advice**

Insured Vehicle No : SKD1348P  
TP Vehicle No : SGP1846C  
Make : TOYOTA SIENTA  
Date of Inspection : 17/01/2018  
Inspection At : SMRT

**Point of Impact / General Description of Damages**

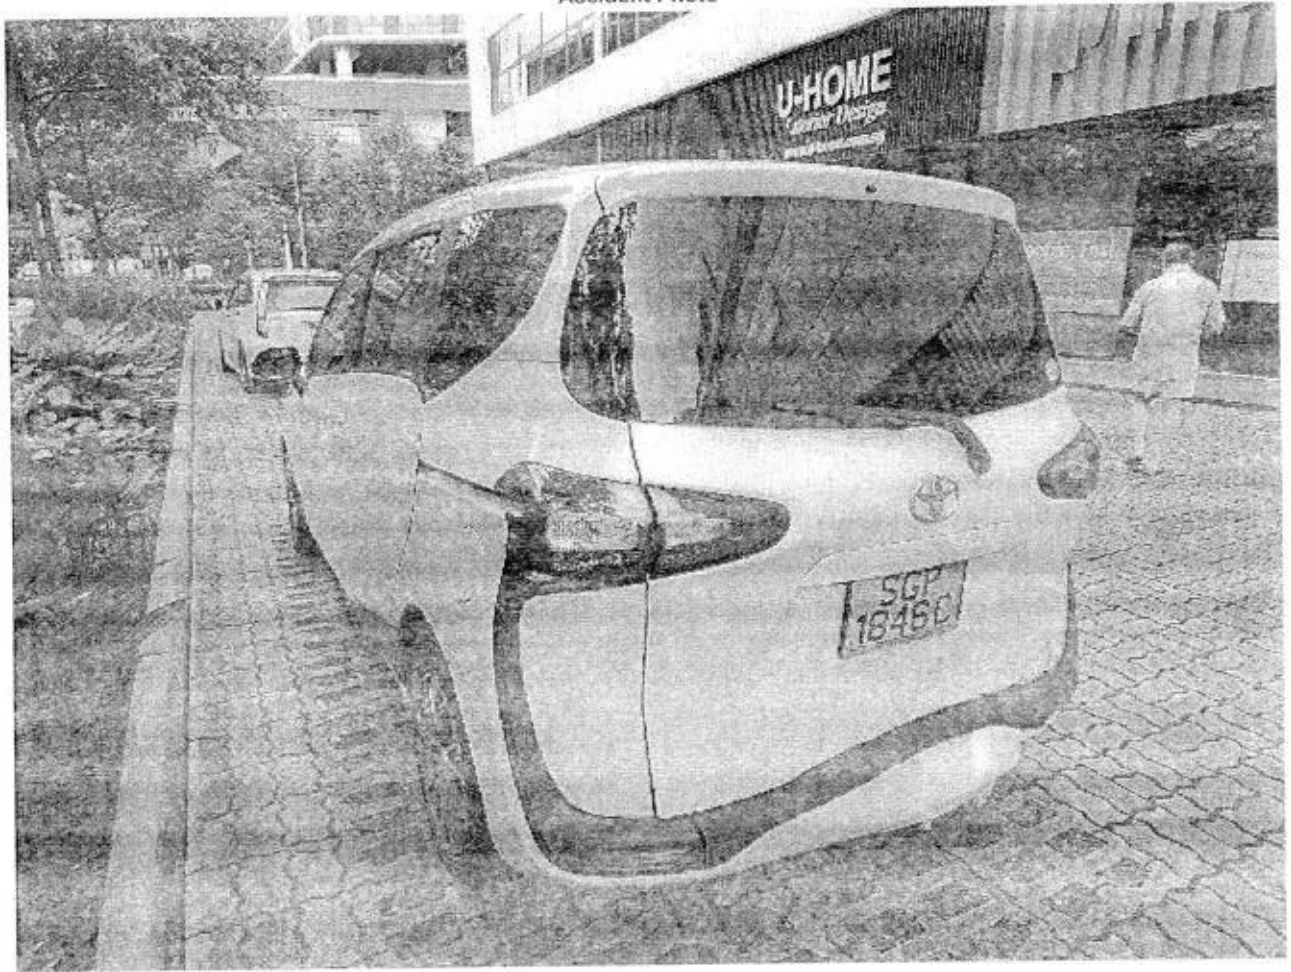
Accident Photo

The vehicle sustained impact / damages rear portion and parts claimed are consistent to the accident.
