Your Ref : 546370
Our Ref : CS/MSG18001104/D

16 March 2018

AUTOMOBILE TECHNICAL INVESTIGATION REPORT OF INCIDENT INVOLVING GY 1108C AND SGM 2628A ON 16 JANUARY 2018

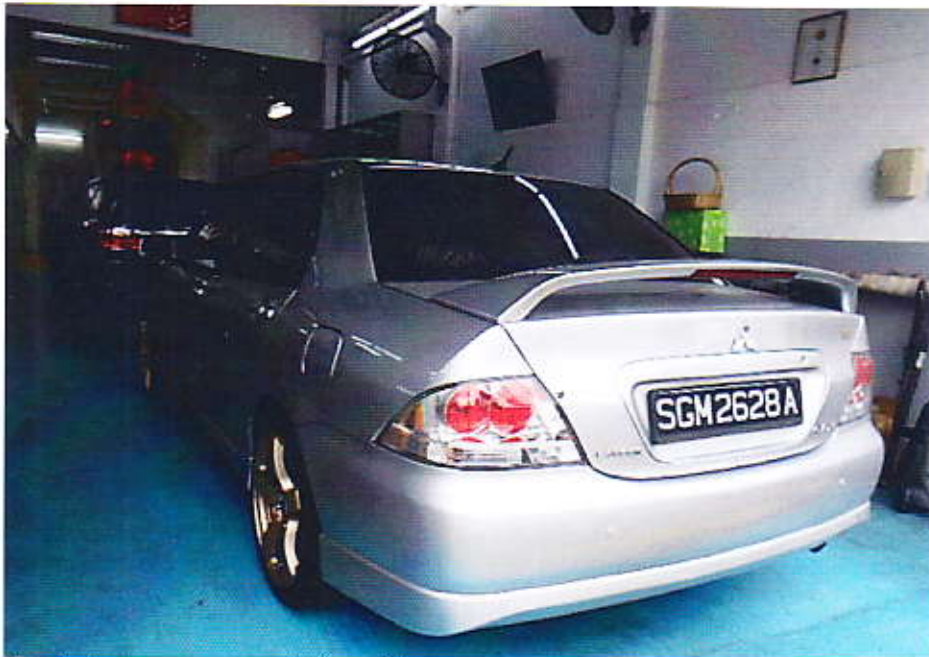
Photo 1 shows a general view of the rear left portion of the Third Party Vehicle at the time of my physical inspection on 02 February 2018. The mileage of the Third Party Vehicle at the time of my inspection was recorded to be 235,262km.

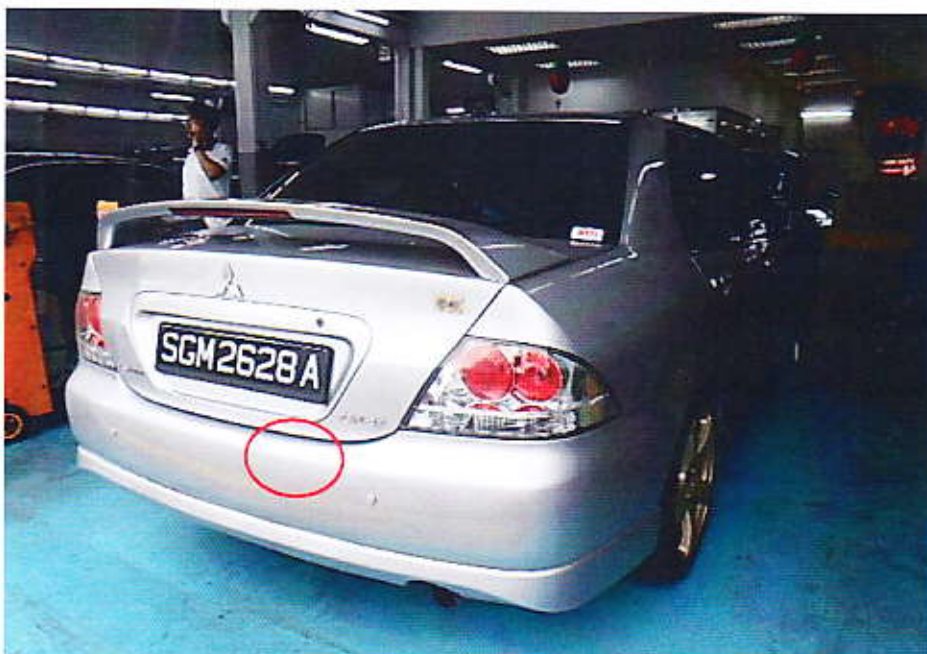
Photo 2 shows a general view of the rear right portion of the Third Party Vehicle at the time of my physical inspection on 02 February 2018. The owner/driver of the Third Party Vehicle who was present had pointed out some damages at the rear centre (circled) of the Third Party Vehicle. According to the owner/driver, the damage pointed out was caused by the contact from the Insured Vehicle.

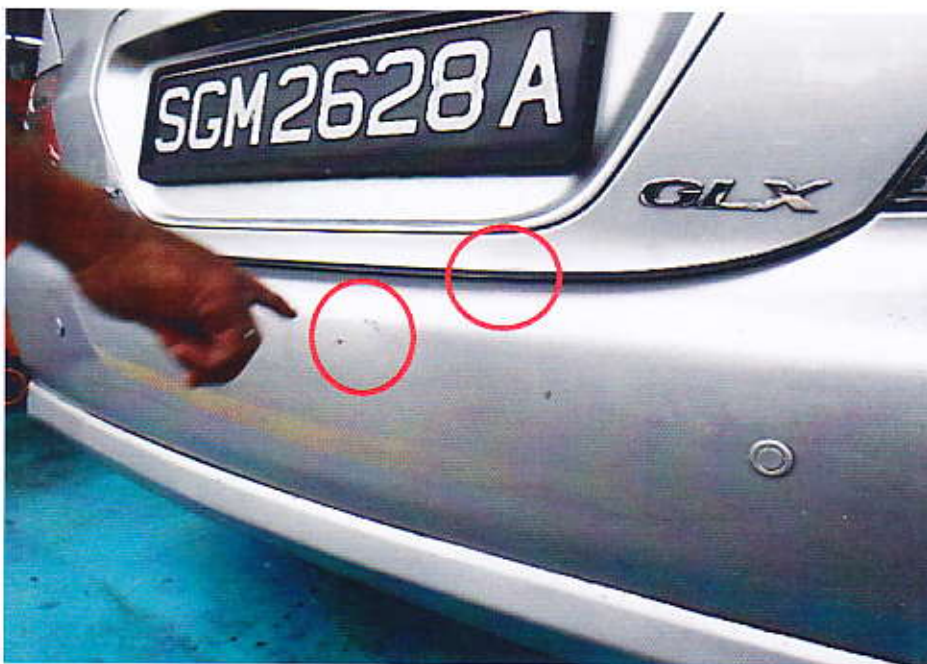
Photo 3 shows a closer view of the damage that was pointed out to me by the owner/driver of the Third Party Vehicle. According to the owner/driver, the damage (circled) pointed out was caused by contact from the Insured Vehicle.

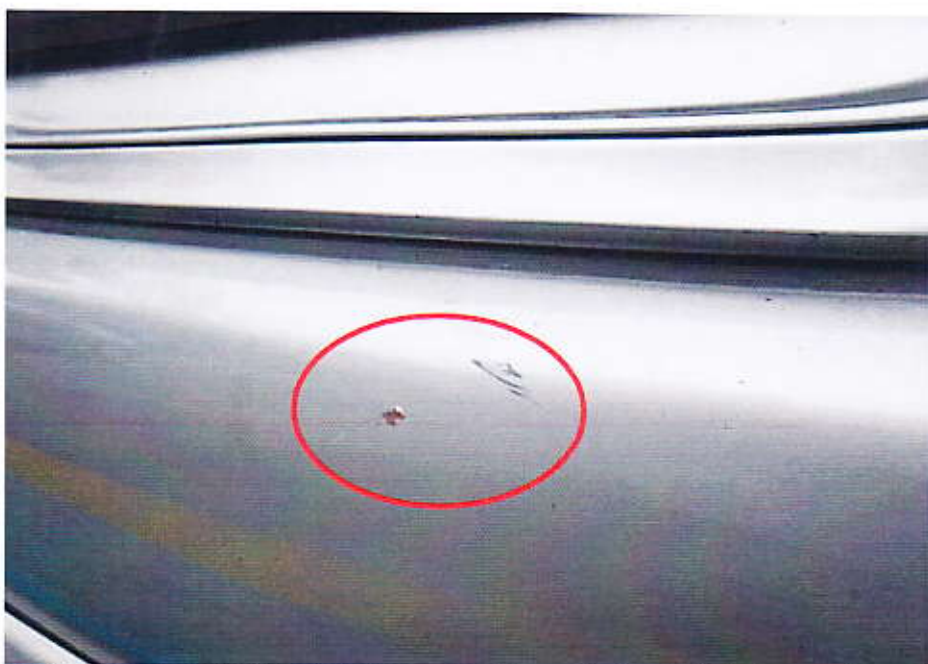
Photo 4 shows some relatively minor scratch marks (circled) that were observed on the rear bumper of the Third Party Vehicle. These scratches were pointed out to me by the owner/driver of the Third Party Vehicle as damage that was caused by the Insured Vehicle.

13. The scratch marks on the rear bumper can then be considered to be a damage that was caused by a direct contact from the object applying the force/load. The slight dent that was observed on its rear bootlid was an induced damage caused when the rear bumper was compressed inwards.

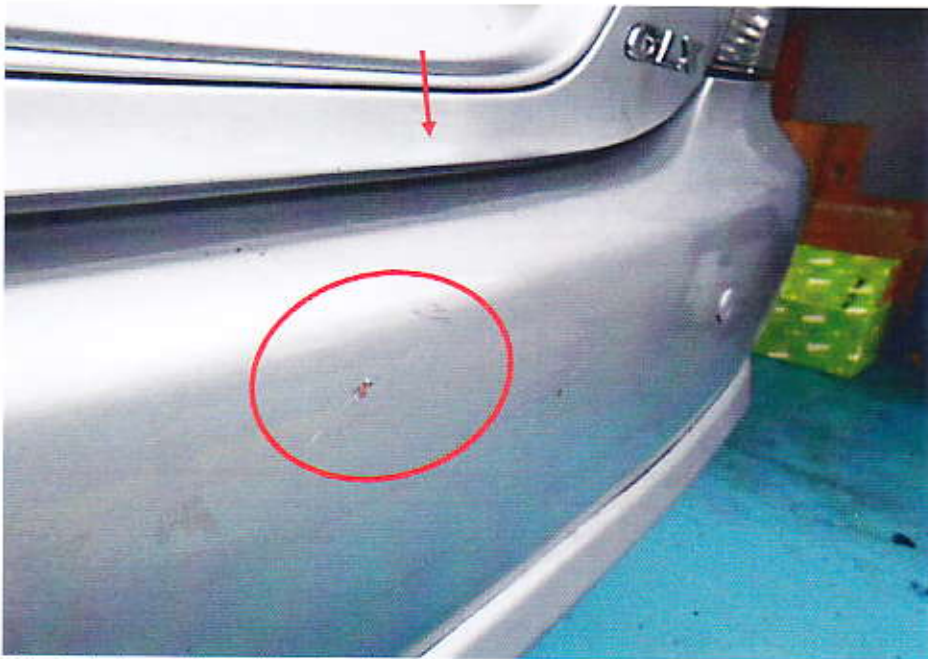
Photo 5 shows the relatively minor scratch marks (circled) that were observed on the rear bumper, and slight dent (arrowed) that was observed on the lower edge of the rear bootlid.

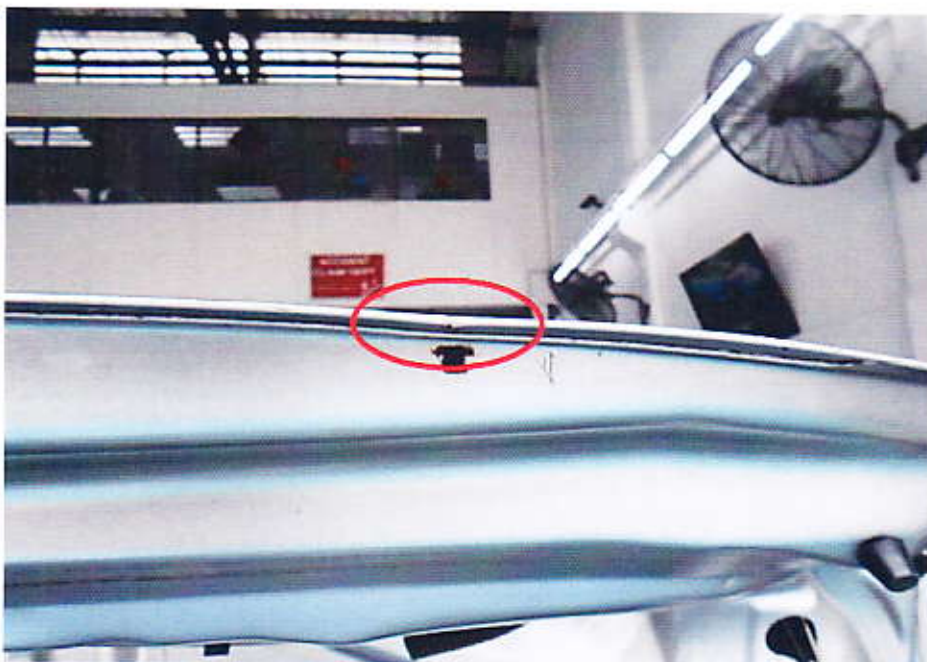
Photo 6 shows the slight dent (circled) that was observed on the lower edge of the bootlid of the Third Party Vehicle. This dent was pointed out to me by the owner/driver of the Third Party Vehicle as damage that was caused by the Insured Vehicle.

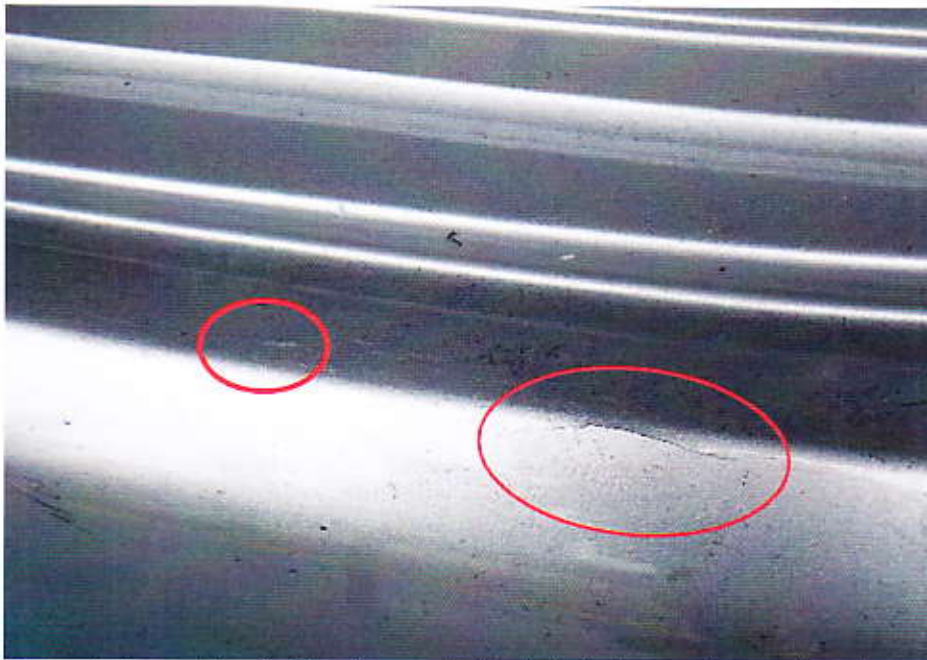
10. Upon closer examination of the damaged area of the Third Party Vehicle, I had observed slight paint cracks at the top surface area of its rear bumper. Such paint cracks are usually caused when a force/load is applied to the rear bumper, compressing the rear bumper inwards. Due to the elastic nature of the rear bumper, the paint at the top surface area of the rear bumper would tend to crack when the rear bumper returns back to shape after being compressed inwards. See photo 7 below.

Photo 7 shows the slight paint cracks (circled) that was observed on the top surface area of the Third Party Vehicle's rear bumper. Such paint cracks are usually caused when a force/load is applied to the rear bumper, causing the rear bumper to be compressed inwards. Due to the elastic nature of the rear bumper, the paint at the top surface area of the rear bumper would tend to crack when the rear bumper returns back to shape after being compressed inwards.

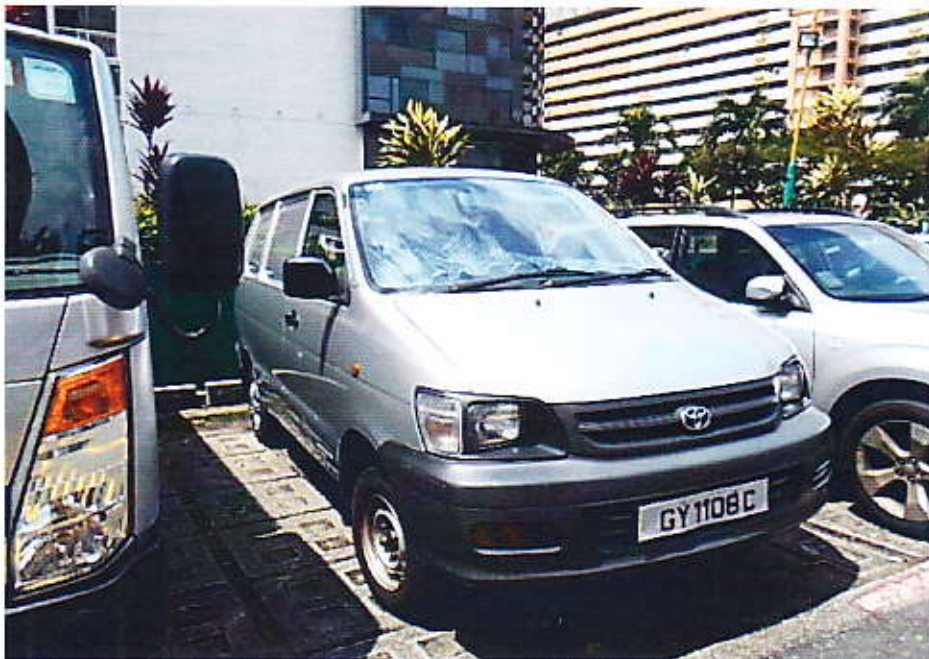
Photo 8 shows a general view of the front right portion of the Insured Vehicle at the time of my inspection. The mileage of the Insured Vehicle at the time of my inspection was recorded to be 95,985km. The front bumper of the Insured Vehicle was observed to be with damages at multiple areas.

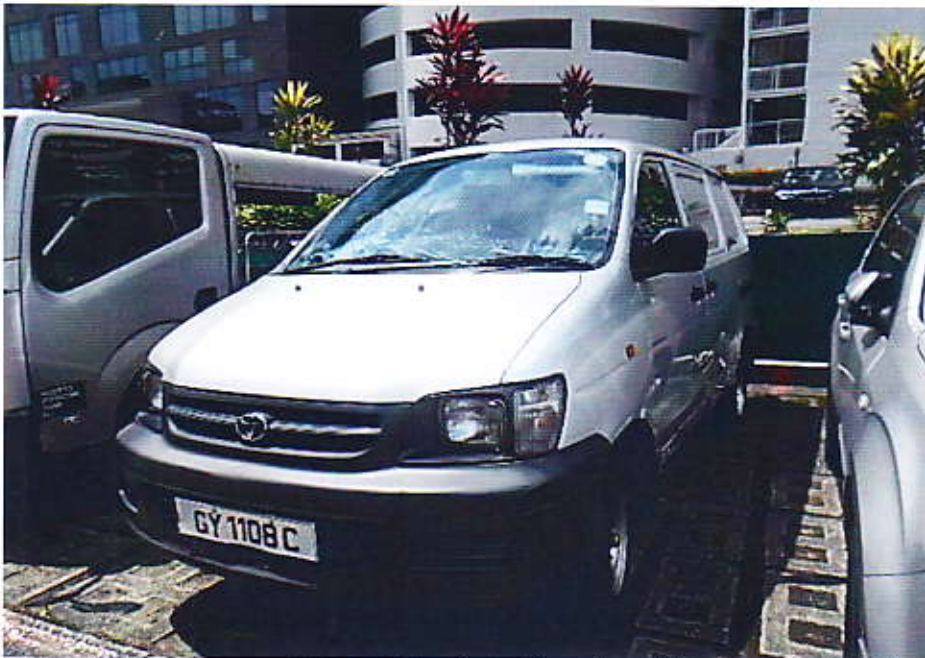
Photo 9 shows a general view of the front left portion of the Insured Vehicle at the time of my inspection. The mileage of the Insured Vehicle at the time of my inspection was recorded to be 95,985km. The front bumper of the Insured Vehicle was observed to be with damages at multiple areas.

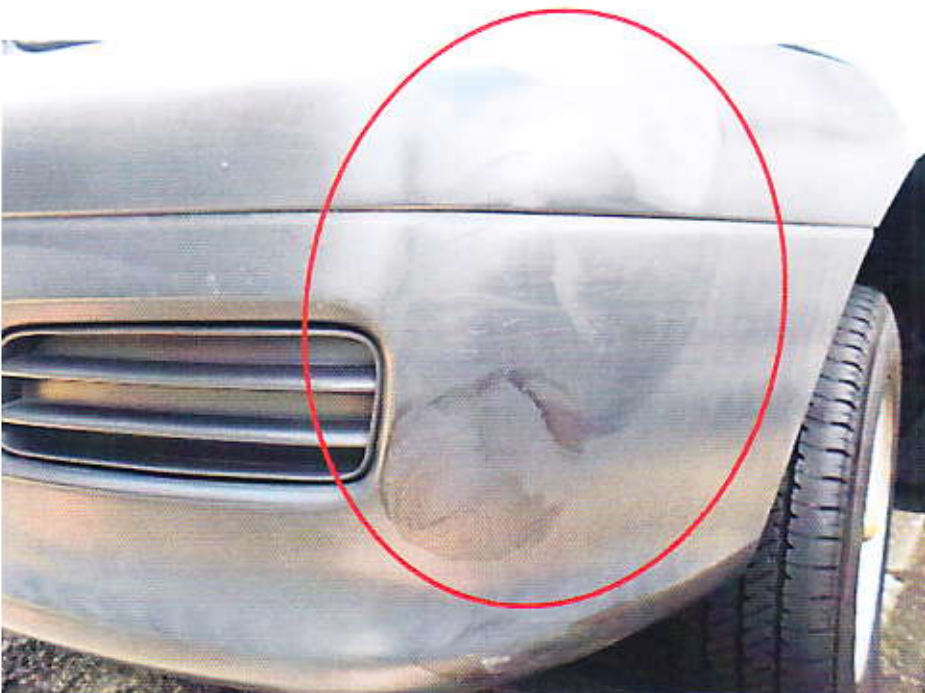
Photo 10 shows the grazed marks (circled) that were found on the left corner area of the Insured Vehicle's front bumper. These grazed marks were amongst the multiple damages that were found on the front bumper of the Insured Vehicle.

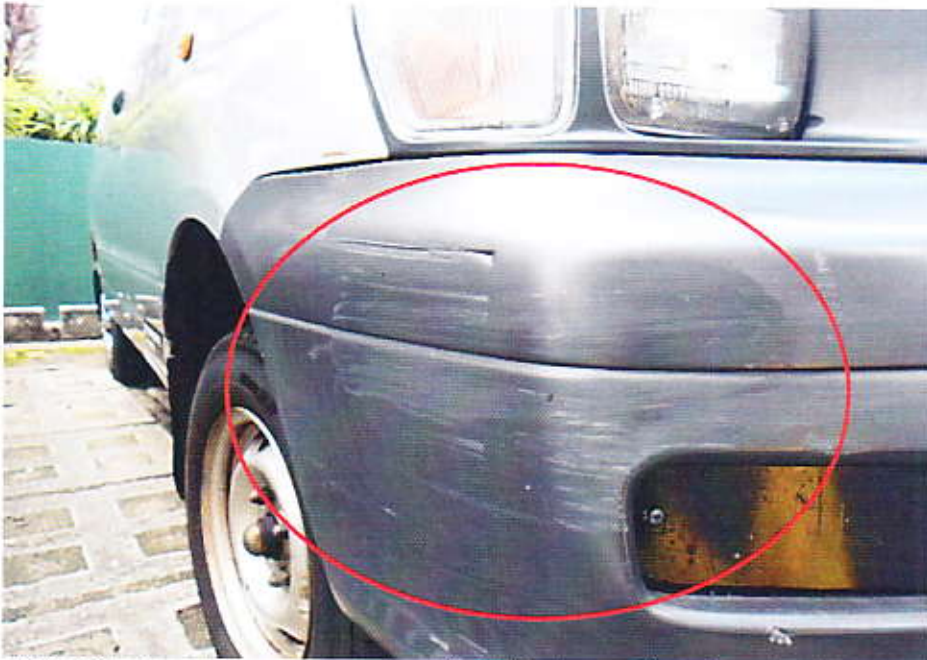
Photo 11 shows the grazed marks (circled) that were found on the right corner area of the Insured Vehicle's front bumper. These grazed marks were amongst the multiple damages that were found on the front bumper of the Insured Vehicle.

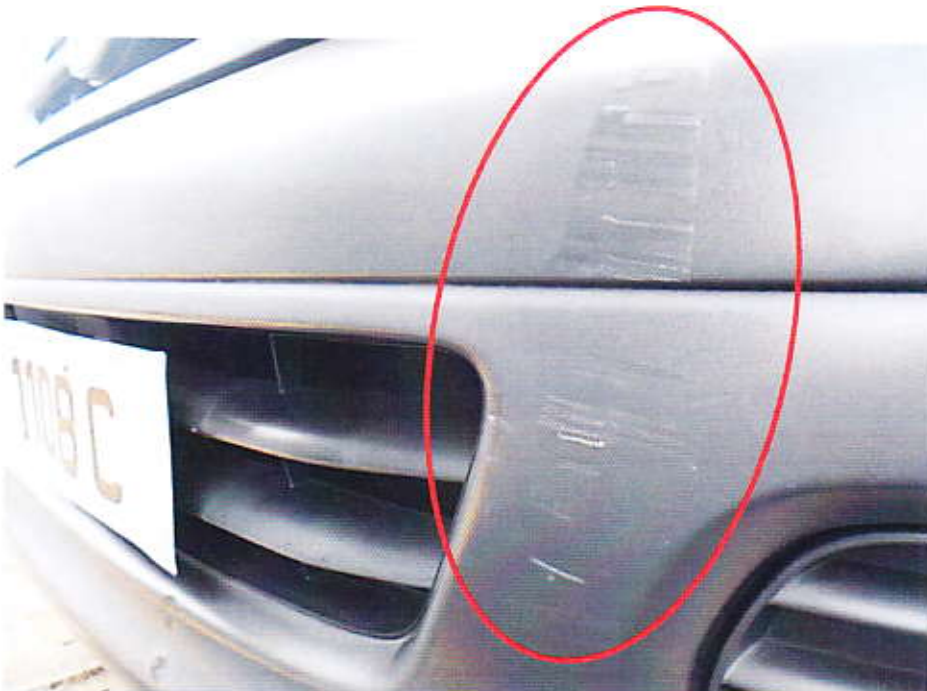
Photo 12 shows the grazed marks (circled) that were found on the centre area of the Insured Vehicle's front bumper. These grazed marks were amongst the multiple damages that were found on the front bumper of the Insured Vehicle.

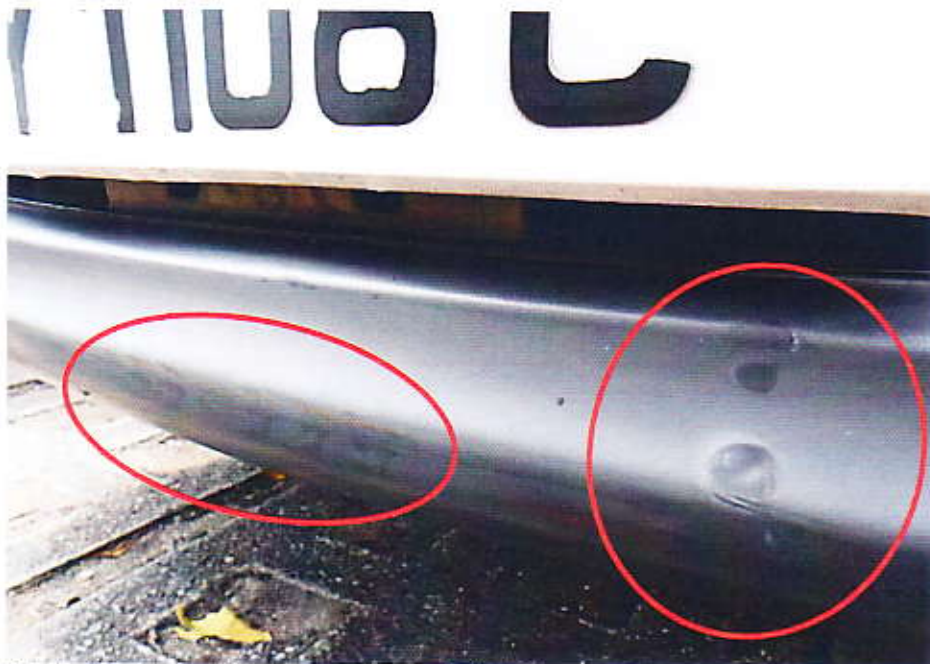
Photo 13 shows the damage (circled) that was found on the lower part of the Insured Vehicle's front bumper, at the centre area of the front bumper. These damages were amongst the multiple damages that were found on the front bumper of the Insured Vehicle.

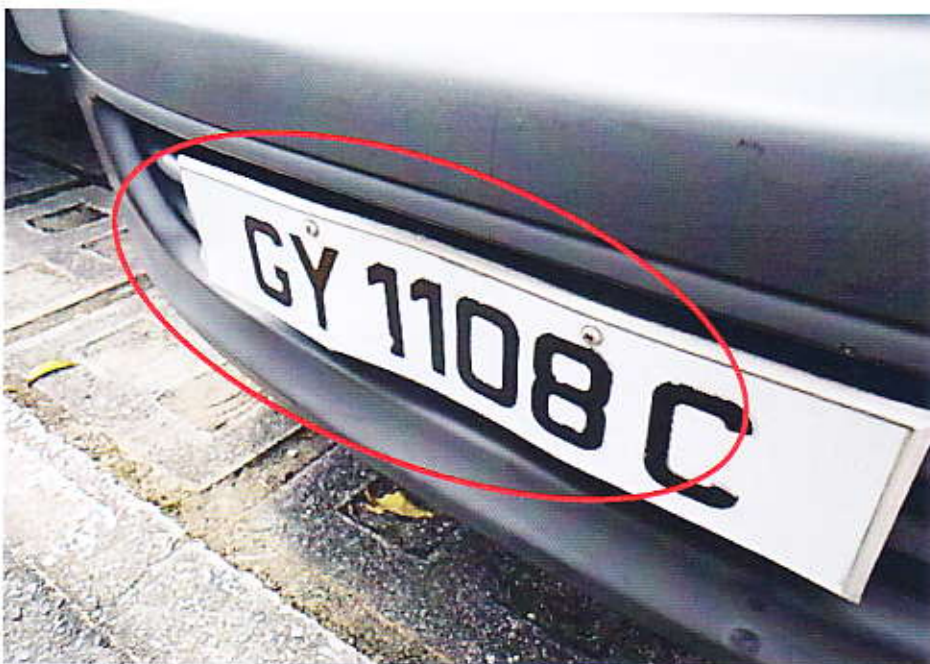
Photo 14 shows the front number plate of the Insured Vehicle bent (circled). Apart from the damages to the Insured Vehicle's front bumper and this damage to its front number plate, I did not observe any other visible damage at the frontal portion of the Insured Vehicle.

22. The front number plate of the Insured Vehicle was of mild steel/metal type of material and not covered with any hard plastic frame. Hence upon contact, had possibly caused the scratch marks seen on the rear bumper of the Third Party Vehicle. The front bumper of the Insured Vehicle and the rear bumper of the Third Party Vehicle were both made of thermoplastic type of material. Contact between body parts of such material, would normally cause distortion to the body parts instead of leaving scratch marks. The damage to the rear bumper of the Third Party Vehicle being possibly caused by the front number plate of the Insured Vehicle, is therefore supported by the height above ground level of these body parts, and the materials that these body parts are made of.

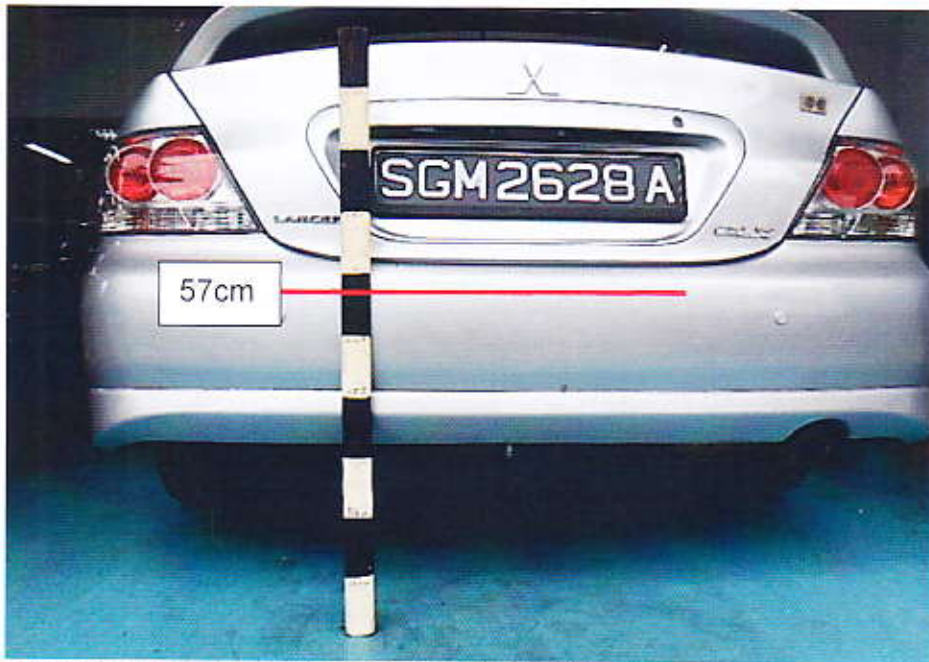
Photo 15 shows the height measurement that was conducted on the rear portion of the Third Party Vehicle. The height above ground level of the minor scratches on the centre area of the rear bumper was approximately 57cm.

21. Basing on the height measurements, the height above ground level of the Third Party Vehicle's rear bumper, where the minor scratch marks were found was measured to be approximately 57cm above ground level. The body part at the frontal portion of the Insured Vehicle at this 57cm height above ground level was the top end of its front number plate. In general, the height measurements carried out appear to indicate that the minor scratch marks were possibly caused by contact from the front number plate of the Insured Vehicle.

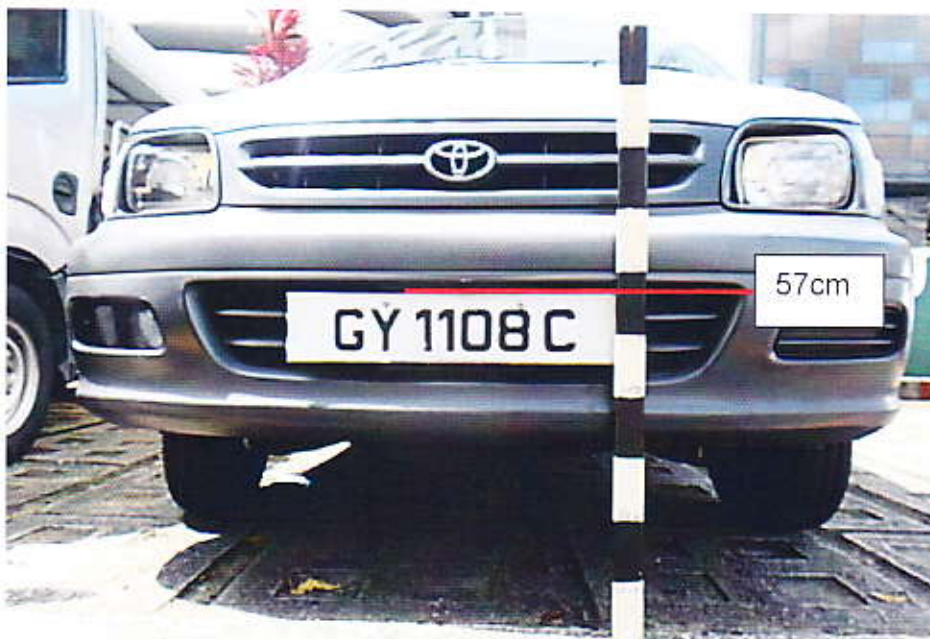
Photo 16 shows the height measurement that was conducted on the frontal portion of the Insured Vehicle. The top end of the front number plate was found to be 57cm above ground level.
