Your Ref : 546370  
Our Ref : CS/MSG18001104/D

**M/s MSIG Insurance (Singapore) Pte Ltd**

**AUTOMOBILE TECHNICAL INVESTIGATION REPORT OF INCIDENT  
INVOLVING GY 1108C AND SGM 2628A ON 16 JANUARY 2018**

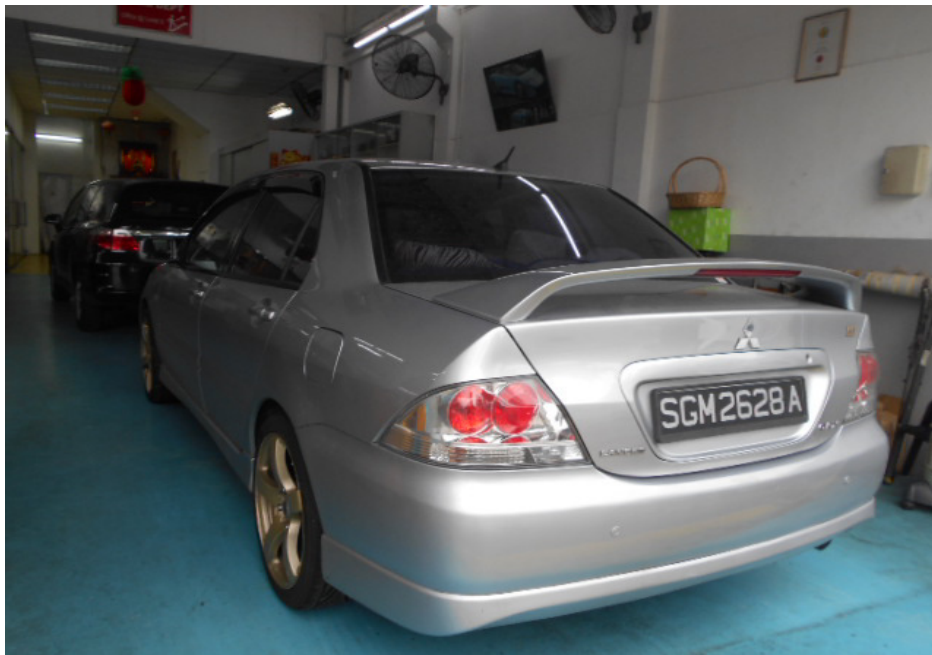
**Photo 1** shows a general view of the rear left portion of the Third Party Vehicle at the time of my physical inspection on 02 February 2018. The mileage of the Third Party Vehicle at the time of my inspection was recorded to be 235,262km.

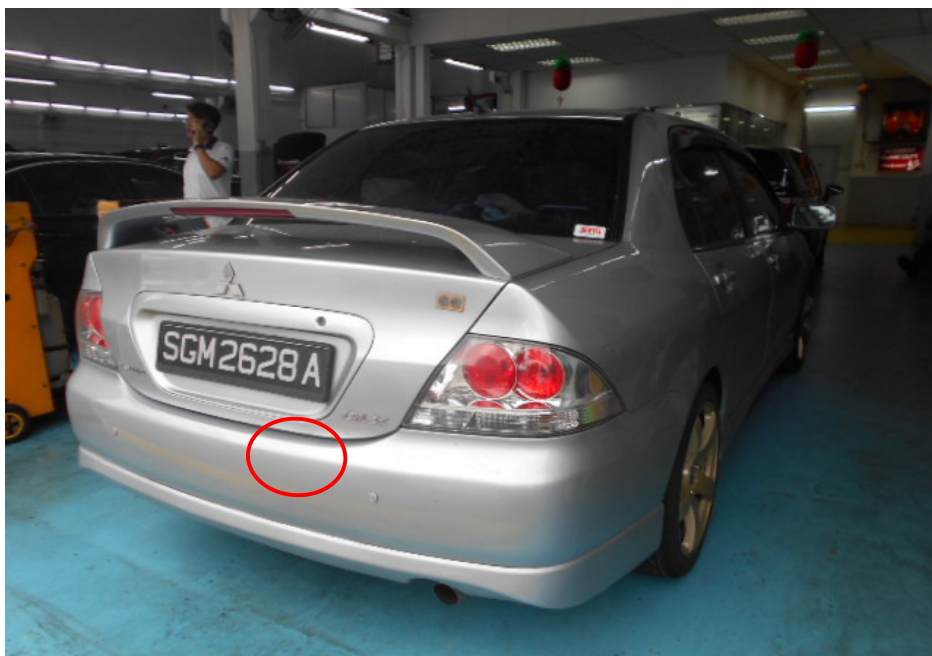
**Photo 2** shows a general view of the rear right portion of the Third Party Vehicle at the time of my physical inspection on 02 February 2018. The owner/driver of the Third Party Vehicle who was present had pointed out some damages at the rear centre (circled) of the Third Party Vehicle. According to the owner/driver, the damage pointed out was caused by the contact from the Insured Vehicle.

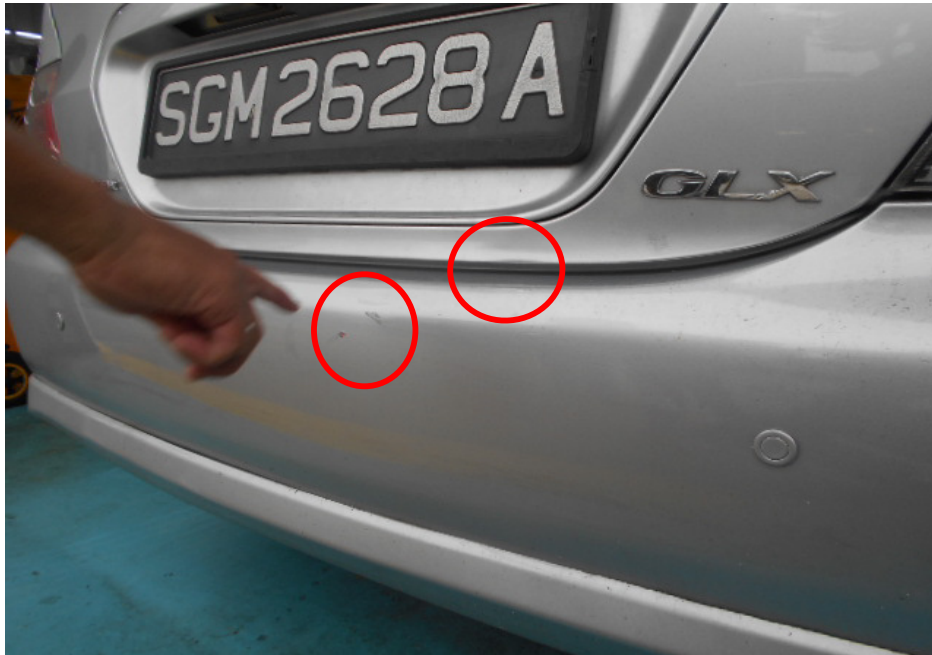
**Photo 3** shows a closer view of the damage that was pointed out to me by the owner/driver of the Third Party Vehicle. According to the owner/driver, the damage (circled) pointed out was caused by contact from the Insured Vehicle.

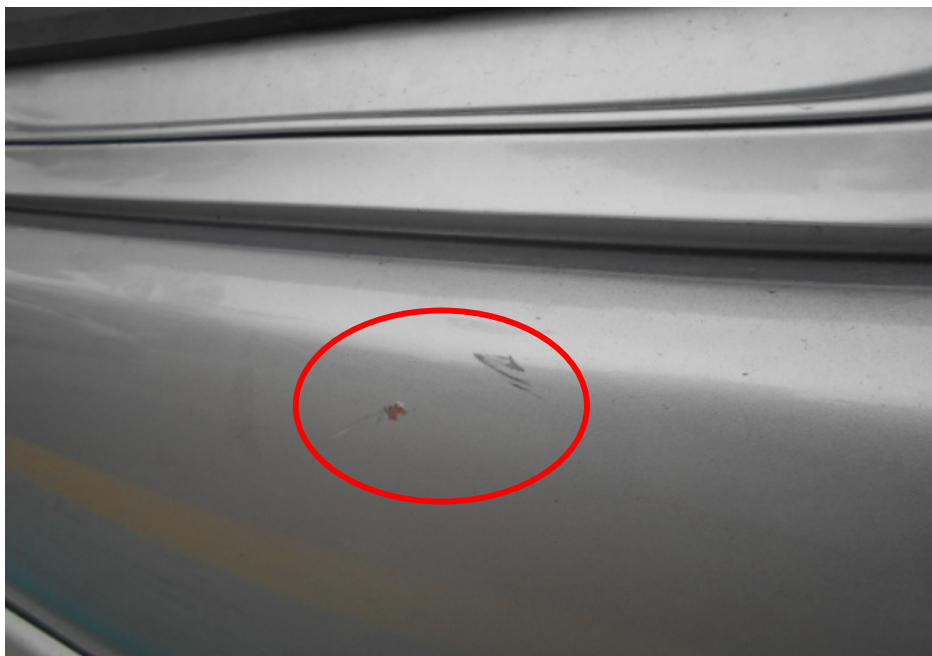
**Photo 4** shows some relatively minor scratch marks (circled) that were observed on the rear bumper of the Third Party Vehicle. These scratches were pointed out to me by the owner/driver of the Third Party Vehicle as damage that was caused by the Insured Vehicle.

13. The scratch marks on the rear bumper can then be considered to be a damage that was caused by a direct contact from the object applying the force/load. The slight dent that was observed on its rear bootlid was an induced damage caused when the rear bumper was compressed inwards.

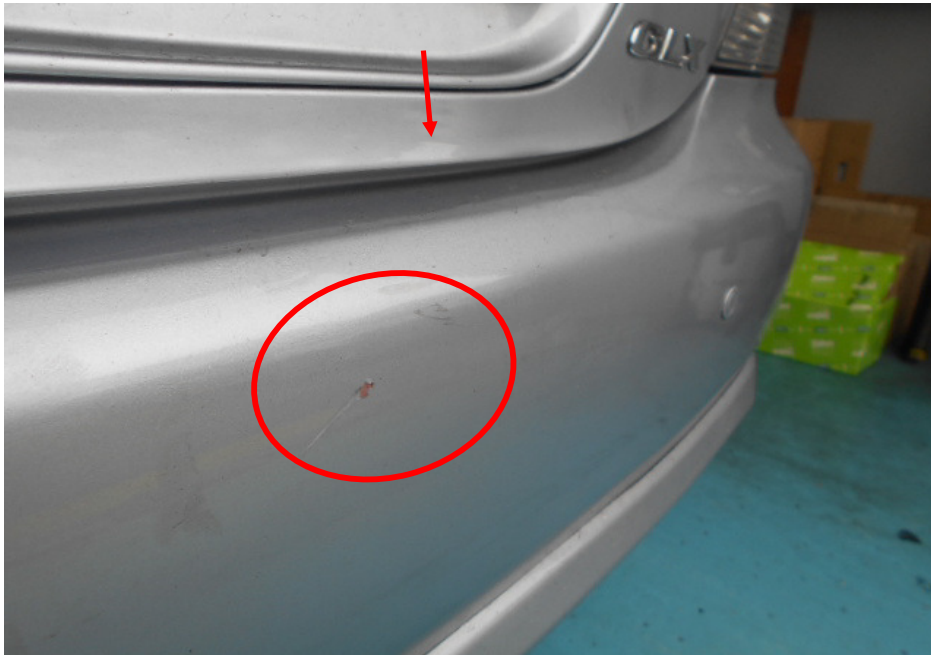
**Photo 5** shows the relatively minor scratch marks (circled) that were observed on the rear bumper, and slight dent (arrowed) that was observed on the lower edge of the rear bootlid.

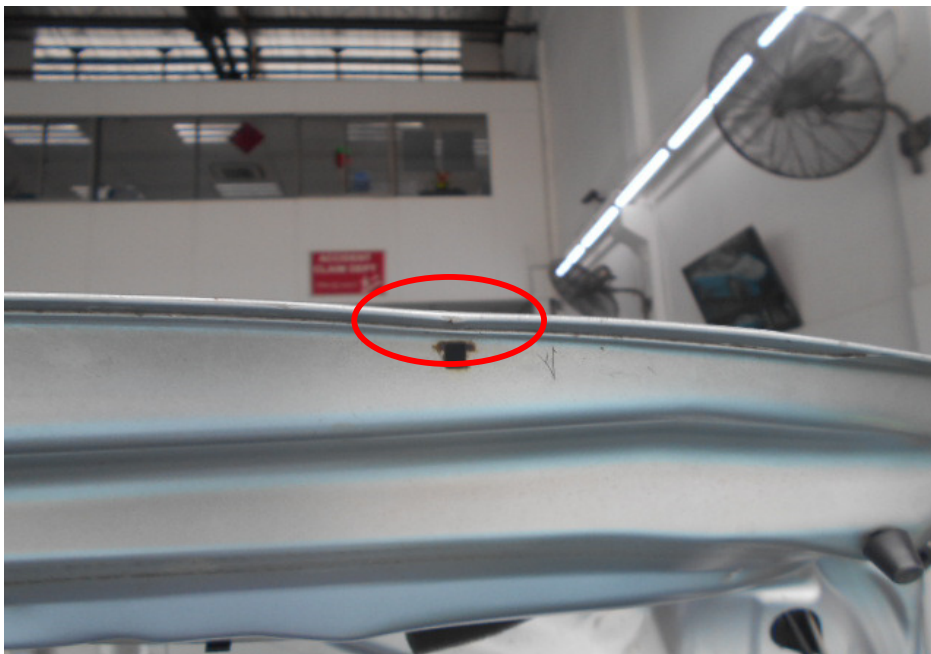
**Photo 6** shows the slight dent (circled) that was observed on the lower edge of the bootlid of the Third Party Vehicle. This dent was pointed out to me by the owner/driver of the Third Party Vehicle as damage that was caused by the Insured Vehicle.

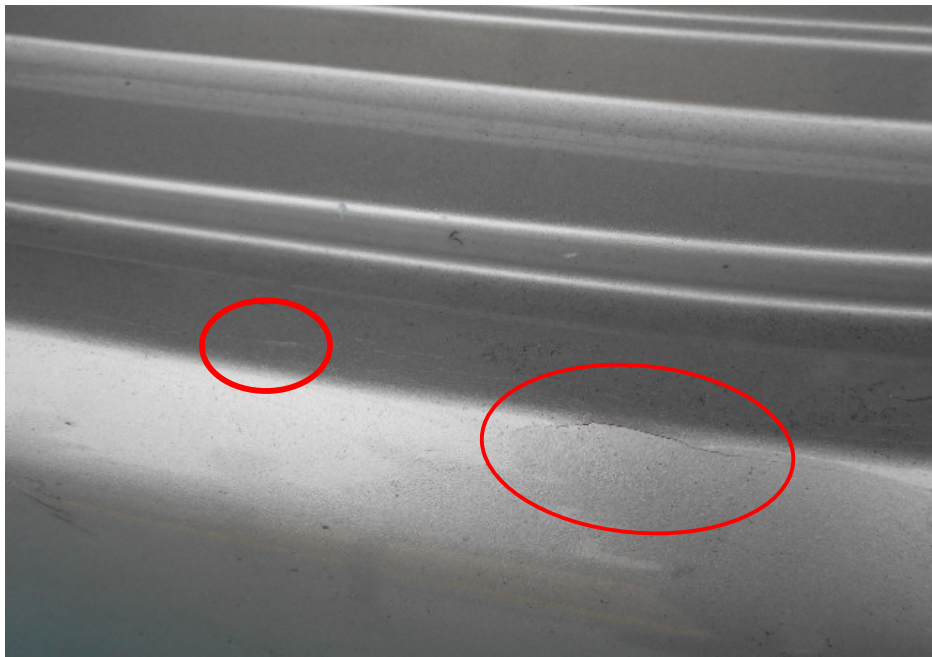
10. Upon closer examination of the damaged area of the Third Party Vehicle, I had observed slight paint cracks at the top surface area of its rear bumper. Such paint cracks are usually caused when a force/load is applied to the rear bumper, compressing the rear bumper inwards. Due to the elastic nature of the rear bumper, the paint at the top surface area of the rear bumper would tend to crack when the rear bumper returns back to shape after being compressed inwards. See photo 7 below.

**Photo 7** shows the slight paint cracks (circled) that was observed on the top surface area of the Third Party Vehicle's rear bumper. Such paint cracks are usually caused when a force/load is applied to the rear bumper, causing the rear bumper to be compressed inwards. Due to the elastic nature of the rear bumper, the paint at the top surface area of the rear bumper would tend to crack when the rear bumper returns back to shape after being compressed inwards.

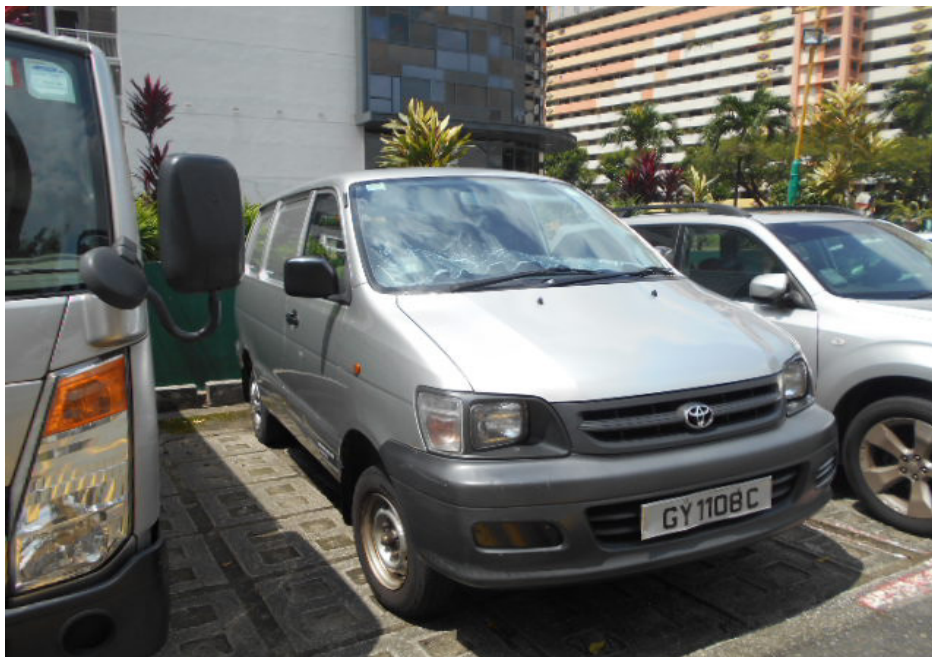
**Photo 8** shows a general view of the front right portion of the Insured Vehicle at the time of my inspection. The mileage of the Insured Vehicle at the time of my inspection was recorded to be 95,985km. The front bumper of the Insured Vehicle was observed to be with damages at multiple areas.

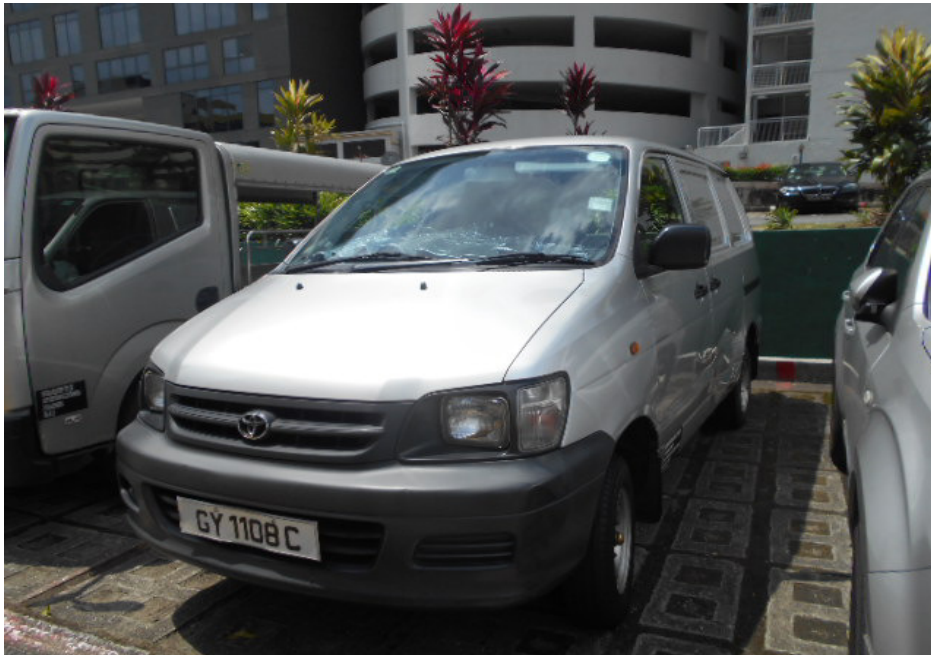
**Photo 9** shows a general view of the front left portion of the Insured Vehicle at the time of my inspection. The mileage of the Insured Vehicle at the time of my inspection was recorded to be 95,985km. The front bumper of the Insured Vehicle was observed to be with damages at multiple areas.

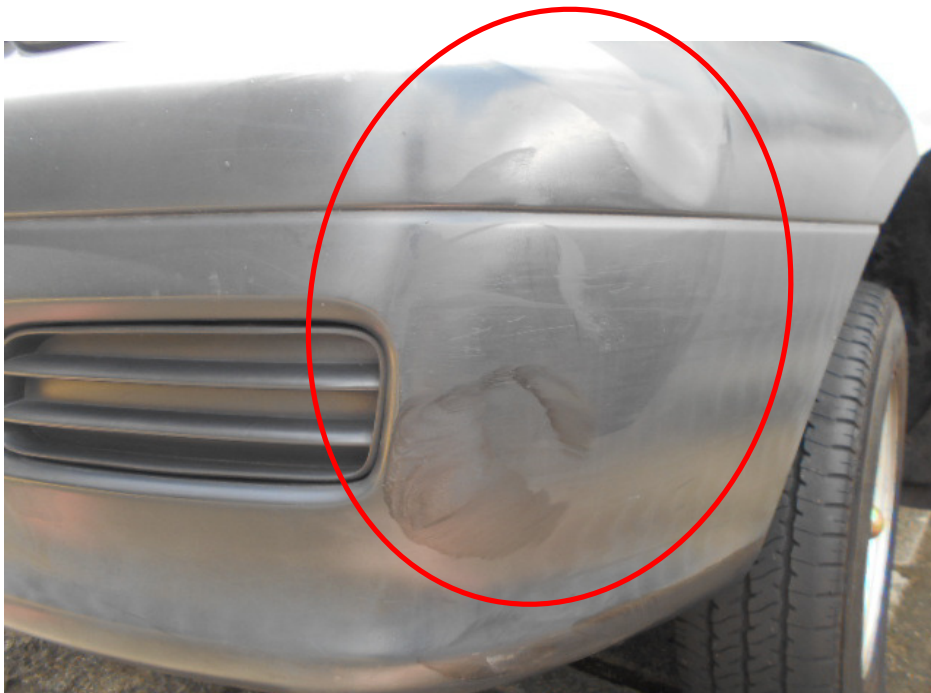
**Photo 10** shows the grazed marks (circled) that were found on the left corner area of the Insured Vehicle's front bumper. These grazed marks were amongst the multiple damages that were found on the front bumper of the Insured Vehicle.

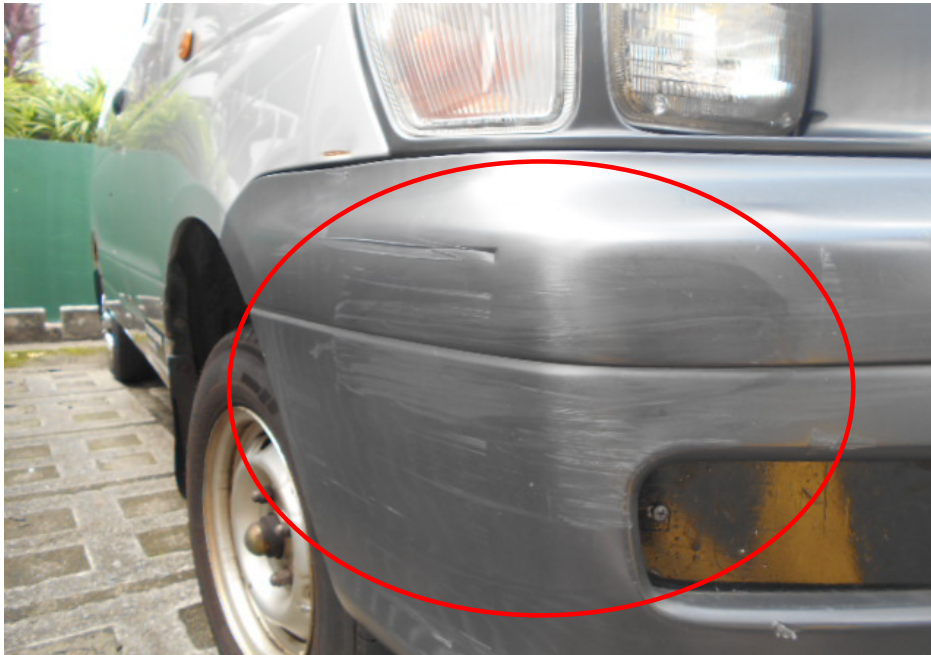
**Photo 11** shows the grazed marks (circled) that were found on the right corner area of the Insured Vehicle's front bumper. These grazed marks were amongst the multiple damages that were found on the front bumper of the Insured Vehicle.

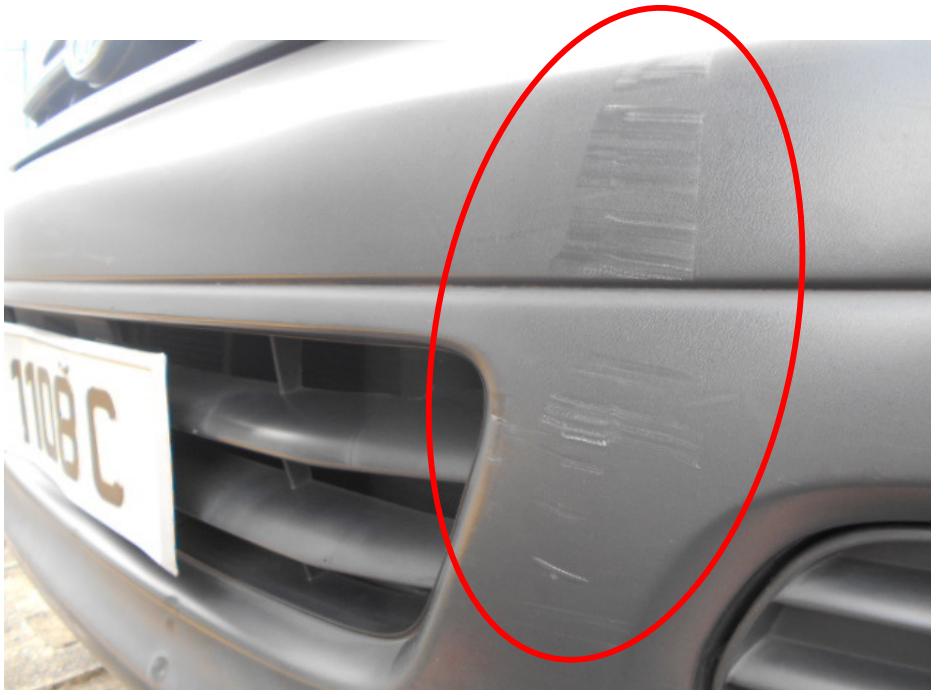
**Photo 12** shows the grazed marks (circled) that were found on the centre area of the Insured Vehicle's front bumper. These grazed marks were amongst the multiple damages that were found on the front bumper of the Insured Vehicle.

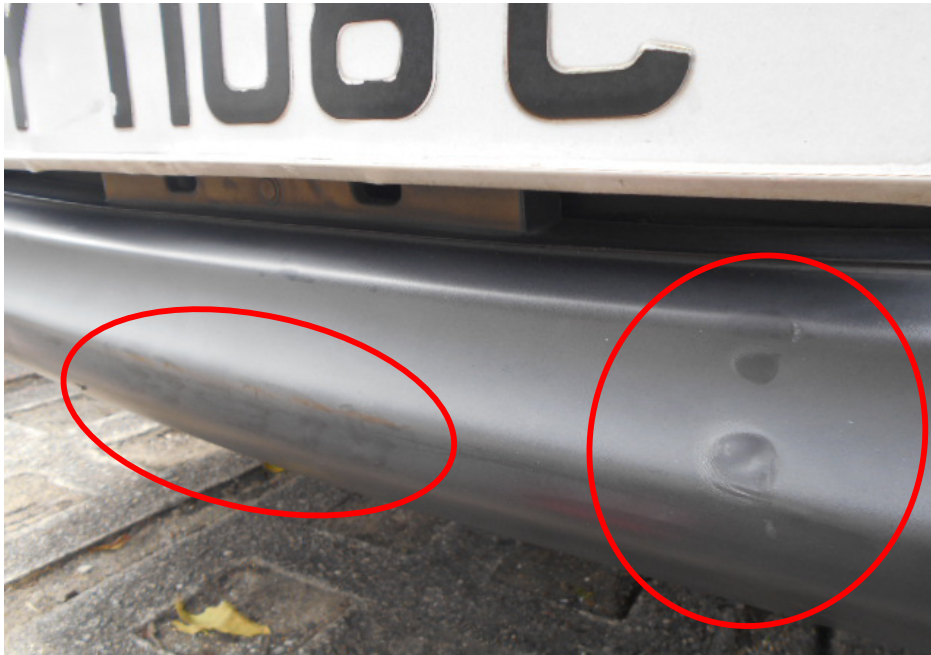
**Photo 13** shows the damage (circled) that was found on the lower part of the Insured Vehicle's front bumper, at the centre area of the front bumper. These damages were amongst the multiple damages that were found on the front bumper of the Insured Vehicle.

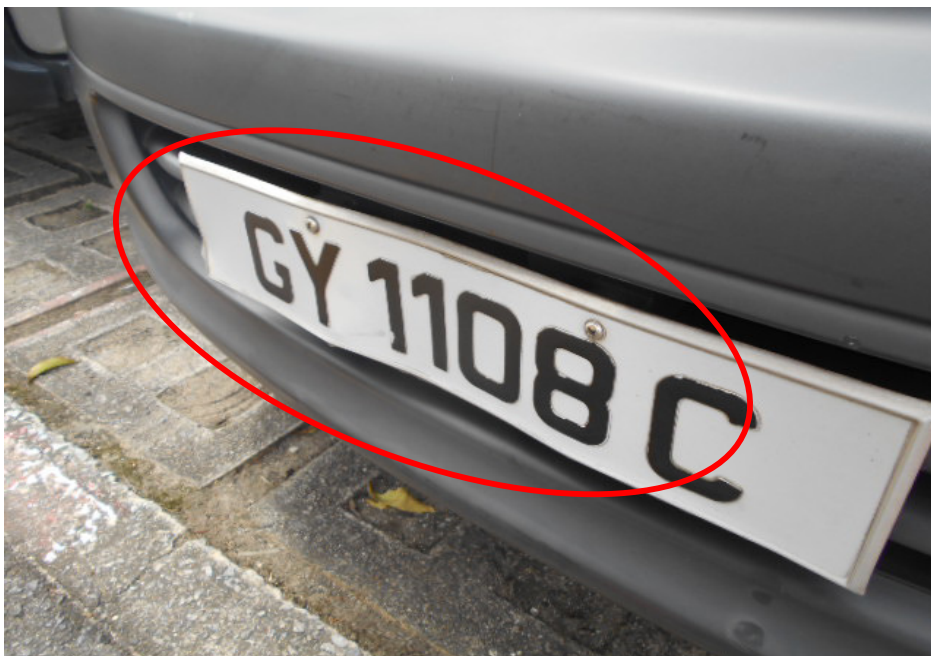
**Photo 14** shows the front number plate of the Insured Vehicle bent (circled). Apart from the damages to the Insured Vehicle's front bumper and this damage to its front number plate, I did not observe any other visible damage at the frontal portion of the Insured Vehicle.

22. The front number plate of the Insured Vehicle was of mild steel/metal type of material and not covered with any hard plastic frame. Hence upon contact, had possibly caused the scratch marks seen on the rear bumper of the Third Party Vehicle. The front bumper of the Insured Vehicle and the rear bumper of the Third Party Vehicle were both made of thermoplastic type of material. Contact between body parts of such material, would normally cause distortion to the body parts instead of leaving scratch marks. The damage to the rear bumper of the Third Party Vehicle being possibly caused by the front number plate of the Insured Vehicle, is therefore supported by the height above ground level of these body parts, and the materials that these body parts are made of.

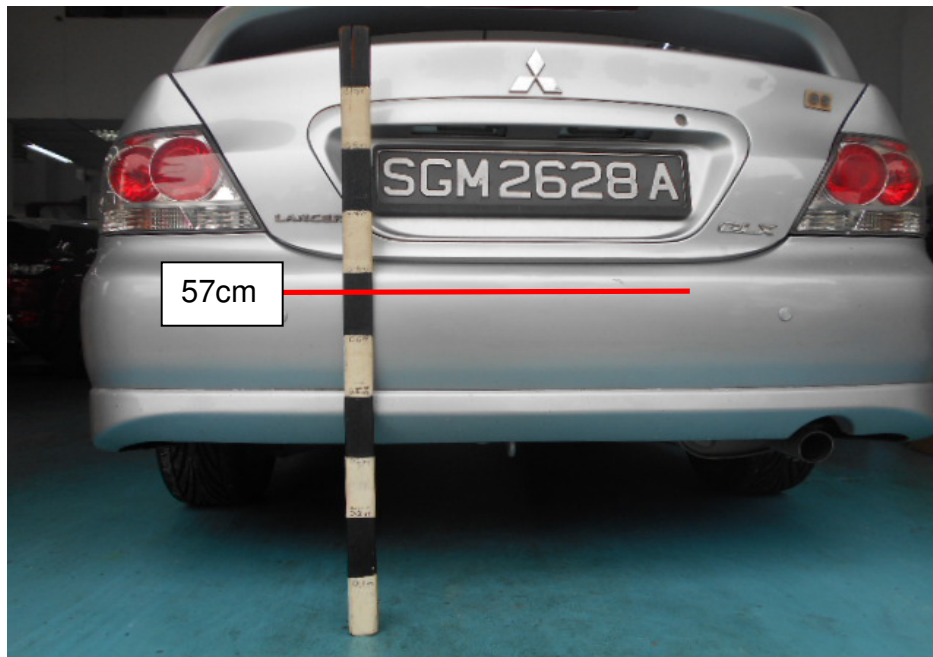
**Photo 15** shows the height measurement that was conducted on the rear portion of the Third Party Vehicle. The height above ground level of the minor scratches on the centre area of the rear bumper was approximately 57cm.

21. Basing on the height measurements, the height above ground level of the Third Party Vehicle's rear bumper, where the minor scratch marks were found was measured to be approximately 57cm above ground level. The body part at the frontal portion of the Insured Vehicle at this 57cm height above ground level was the top end of its front number plate. In general, the height measurements carried out appear to indicate that the minor scratch marks were possibly caused by contact from the front number plate of the Insured Vehicle.

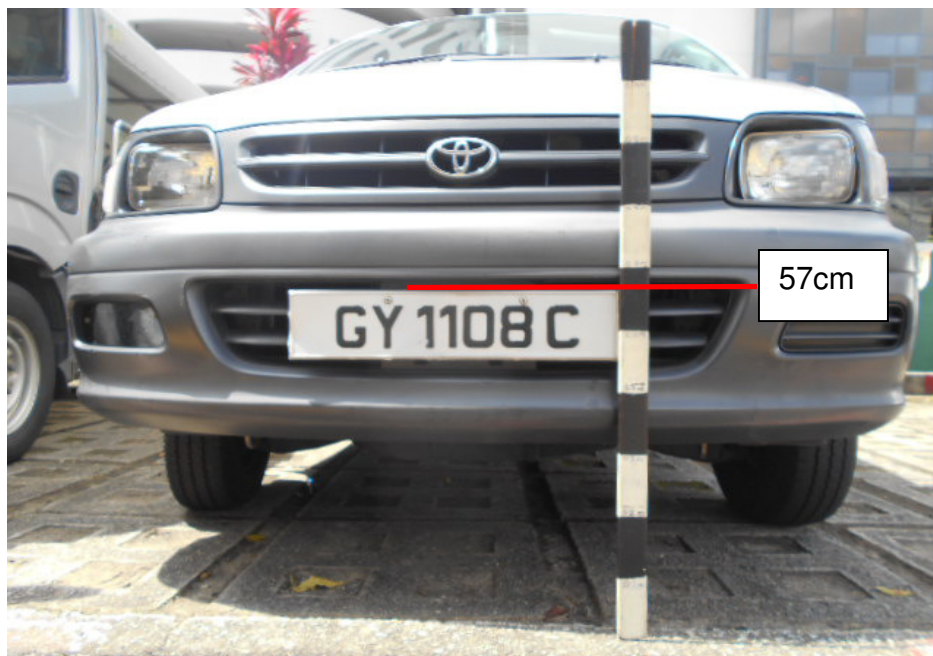
**Photo 16** shows the height measurement that was conducted on the frontal portion of the Insured Vehicle. The top end of the front number plate was found to be 57cm above ground level.
