## SMRT Accident Vehicle Repair Estimates

Reg. No : SMB88H  
Ref. No : BUS/01/18/5019  
Reg. Date : 17/07/2009  
Vehicle Type : BUS -12M  
Make : MBOC500 (MERCEDES)  
Model : MERCEDES MBOC500  
Name of Driver : Prabu Kannappan  
Type of Accident : HEAD TO REAR  
Date / Time of Accident : 10/01/2018 08:18:00 PM  
Accident Reported Date / Time : 15/01/2018 12:00:00 AM  
Surveyor is Required? : Yes  
Survey by : IDAC  
Vehicle is Towed Back? : No  
Towed Back Date/Time : 01/01/2000  
Replacement Vehicle issued? : No  
Accident Repair Job Card No : 000024094174  
Special Instruction to ARC,if any :

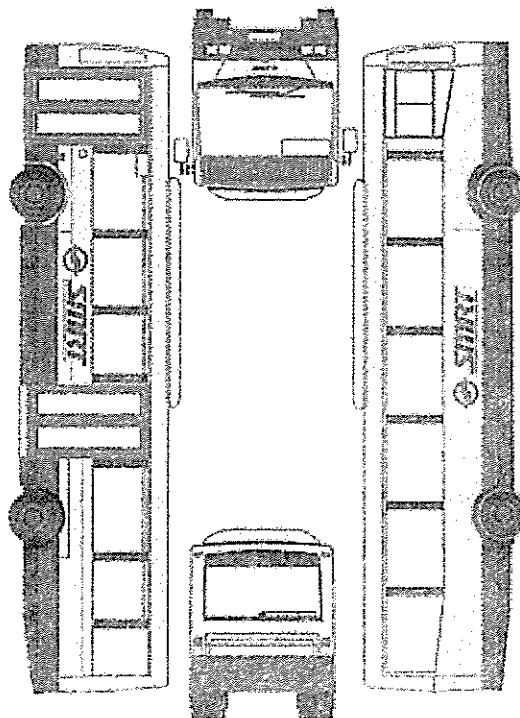
SMB88H - rear right bumper cracked  
FW1364B - (TP) Insured with NTUC  
Before paint photo  
after paint photo.

Job Scope	Quotation from ARC	Adjusted by Surveyor, if applicable
TO REPAIR RH REAR PORTION	2,120.00	1,590.00
<b>Total Labour</b>	<b>2,120.00</b>	<b>1,590.00</b>

Job Scope	Quotation from ARC	Adjusted by Surveyor, if applicable
PROVIDE LABOUR AND MATERIAL TO PUTTY AND RESPRAY ABOVE REPAIR ITEMS	860.00	760.00
<b>Total Spray Painting &amp; Panel Beating</b>	<b>860.00</b>	<b>760.00</b>

Part Number	Portion	Stock No	Part Name	Qty	List Price (\$)	Discount (%)	Final Price (\$)	ARC Recommendation	Surveyor Approved	Photos Attached
	VE	6008191	REAR REFLECTOR LIGHT L/H	0	5.14	10.00	0.00	Replace	Not given	No
	REAR	6009369	REAR BUMPER RH	1	1,242.00	10.00	1,117.80	Replace	Replace	No
5027		6010235	RH SKIRT PANEL R12	1	2,430.20	100.00	0.00	Replace	Repair	No
	REAR	6009365	PANEL, REAR: FIBREGLASS, FOR MB OC500 BUS	1	2,173.50	100.00	0.00	Replace	Repair	No
TOTAL MATERIALS							1,117.80	1,117.80		
TOTAL MATERIALS(Discounted)							894.24	894.24
