Your Ref: 1396297935SG-001
Our Ref :CI/AIG18001166/Z

19th January 2018

**TECHNICAL INVESTIGATION REPORT OF FIRE INCIDENT INVOLVING THE
INSURED VEHICLE SJZ 8084A ON 30th DECEMBER 2017**

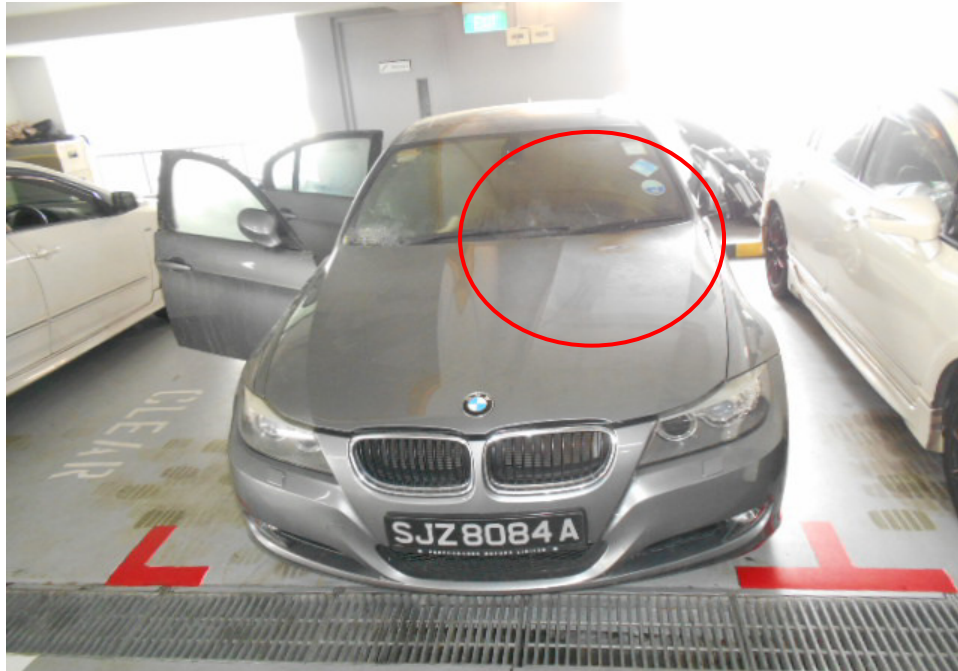
Photo 1 shows the general view of the front portion of the Insured Vehicle at the time of our inspection. The fire damage to the Insured Vehicle was confined to its front bonnet, at the left top area; wiper panel garnish; front windshield; front dashboard and left front door (interior) amongst the body parts that were found to have been affected as a result of the fire.

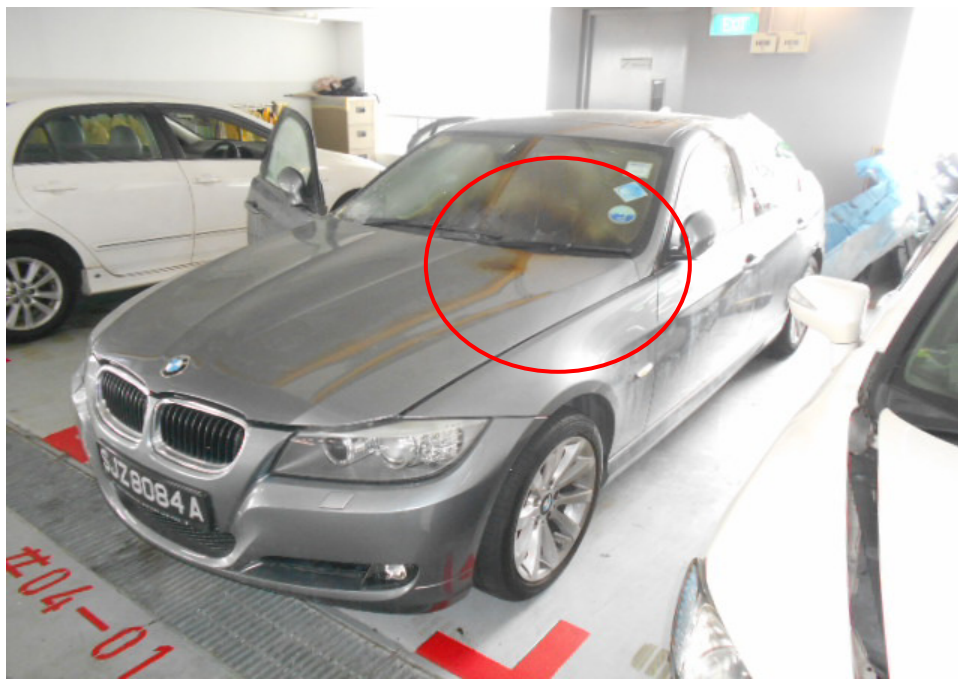
Photo 2 shows the general view of the front left portion of the Insured Vehicle at the time of our inspection. The fire damage to the Insured Vehicle was confined to its front bonnet, at the left top area; wiper panel garnish; front windshield; front dashboard and left front door (interior) amongst the body parts that were found to have been affected as a result of the fire.

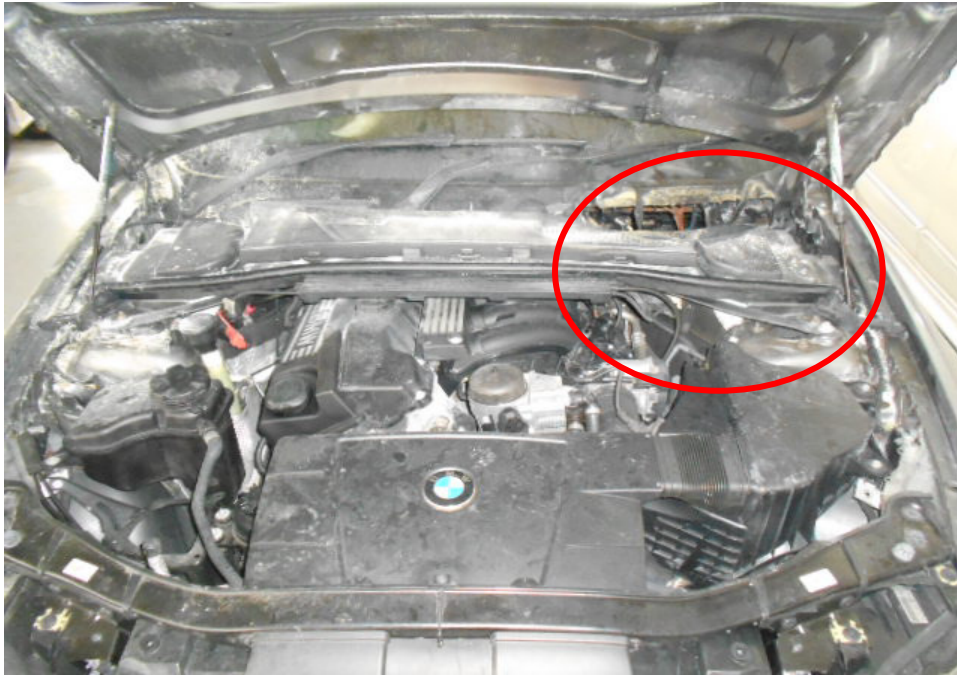
Photo 3 shows the engine compartment of the Insured Vehicle at the time of our inspection. The engine compartment of the Insured Vehicle was observed to be partially burnt. Some parts inside the engine compartment, at the rear left area (circled), were found to be burnt and/or melted as a result of the fire.

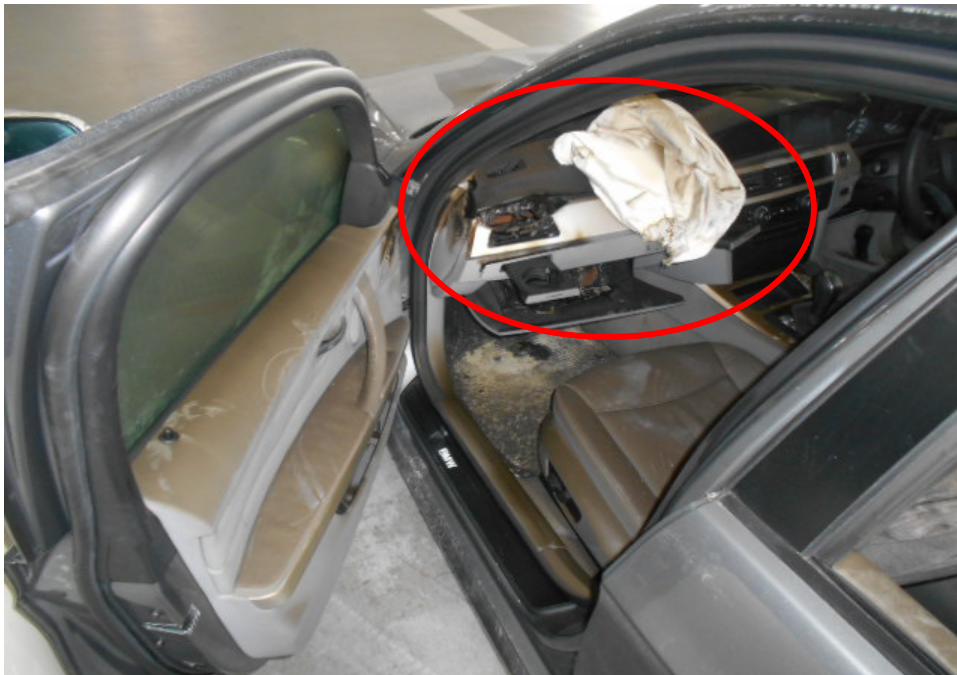
Photo 4 shows the interior compartment of the Insured Vehicle, which was observed to be partially burnt and/or melted. The front dashboard & front windscreen were amongst the parts that were found to have been burnt and/or melted as a result of the fire. The front left air bag was also found to be activated due to the incident.

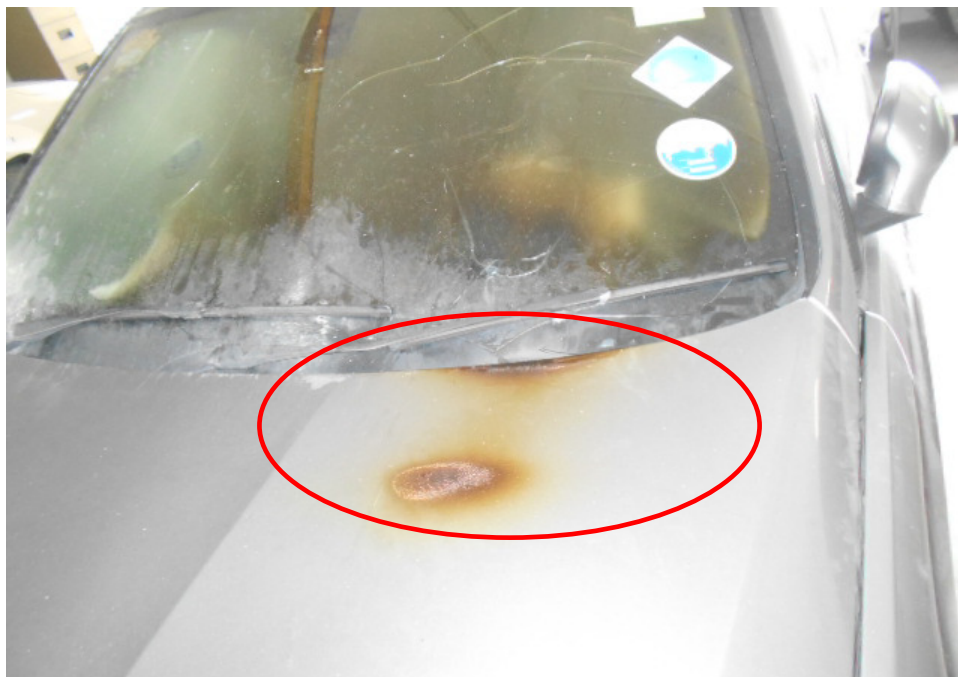
8. For this particular case, the fire appears to have originated within the engine compartment of the Insured Vehicle, somewhere around its front portion in between the engine & interior portion. This can be determined from the burn pattern and the high heat intensity burn marks (whitish burn marks) found on the front bonnet of the Insured Vehicle, at both its top and under side, and also given that there was no other areas of the Insured Vehicle that were found with damage of burnt nature.
9. These whitish burn marks are a result of exposure to prolong heat intensity. Rust would normally start to develop around these areas soon after a fire as prolonged exposure to high heat intensity usually causes steel/metal material body parts to be exposed to natural environmental condition. See photo 5 & 6 below.

Photo 5 shows the burn pattern and whitish burn marks (circled) that were found on the top side of the front bonnet of the Insured Vehicle. Such whitish burn marks are a result of exposure to prolong heat intensity, which may indicate where the fire had started. Rust would also begin to develop on these areas soon after the fire.

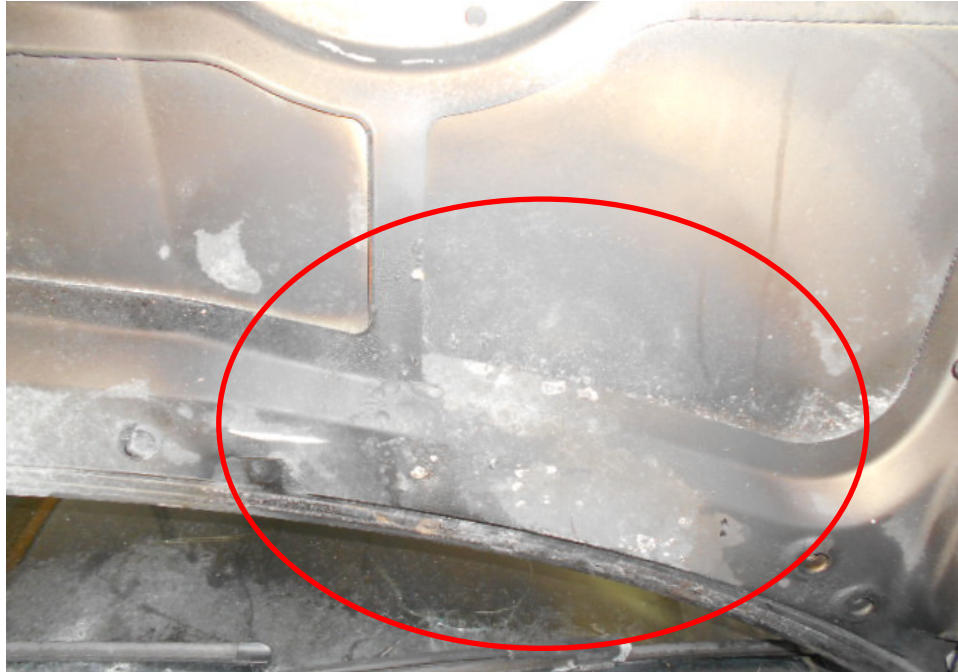
Photo 6 shows the whitish burn marks that were found on the underside of the front bonnet, directly under the area where the same whitish burn marks were found on the top side of the front bonnet. The rust (circled) that had developed around this area was a result of prolong exposure to high heat intensity, which had caused the steel/metal material of the front bonnet to be exposed to natural environmental condition.

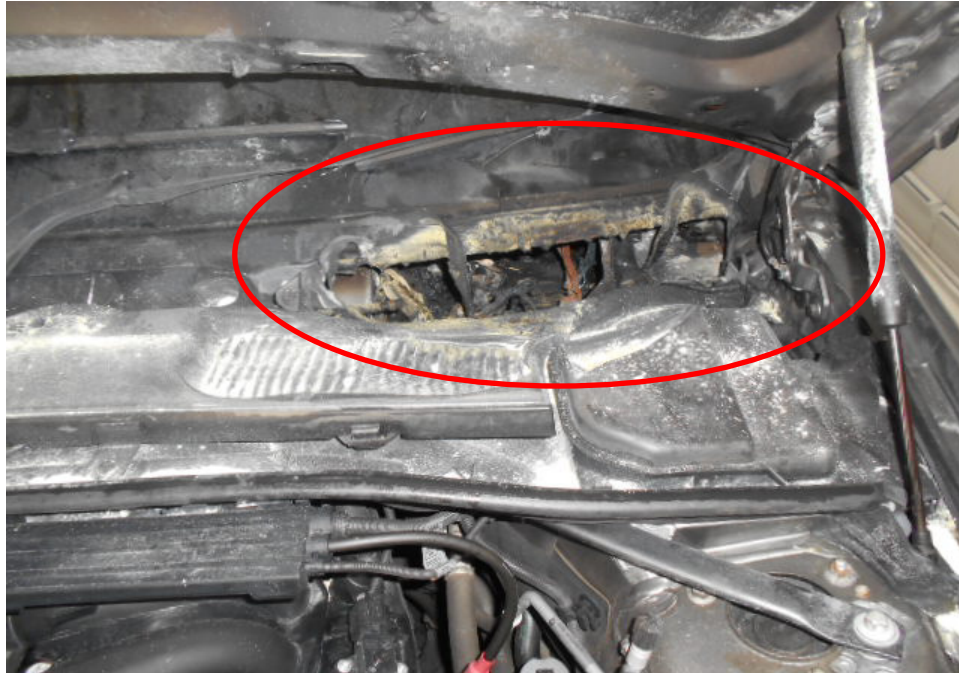
10. Upon closer examination of the area around the left rear of the engine compartment, which was in the immediate vicinity of where the fire to the Insured Vehicle had likely started, we had found several stretches of wiring burnt internally to its bare copper state. The wirings were likely to be the original engine wire harness. Such condition normally indicate internal heating of copper wires which is a sign of an electrical short circuit occurring. This would then appear to suggest that the cause of fire to the Insured Vehicle could have possibly been due to electrical in nature. See photo 7 & 8 below.

Photo 7 shows a closer view of the wirings around the left rear of the engine compartment, which was in the immediate vicinity where the fire to the Insured Vehicle had likely started.

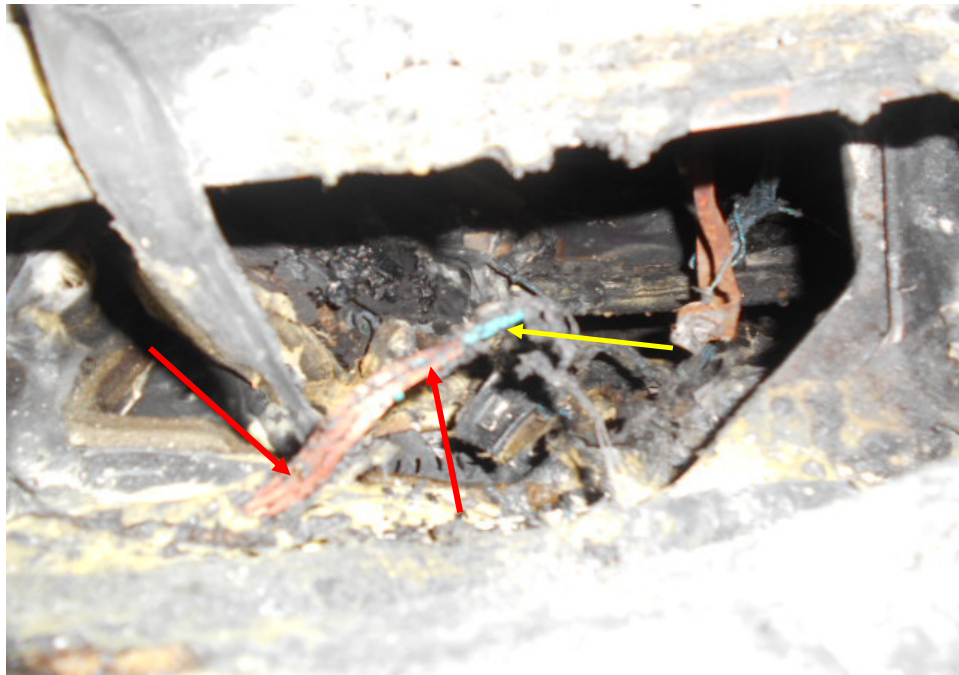
Photo 8 shows a closer view of the wirings (red arrow) which were found to have been burnt internally to its bare copper state, suggesting occurrence of an electrical short circuit. These wirings were observed to be greenish (yellow arrow) believe to be the focal point of the fire ignition.

32. Having investigated and technically analysed the damages of burnt nature to the Insured Vehicle, We are of the view that the cause of fire to the Insured Vehicle was of electrical in nature. For this particular case, the fire had originated along the wiring inside the engine compartment, somewhere around its front portion in between the engine & interior portion. The wirings were likely to be the original engine wire harness.

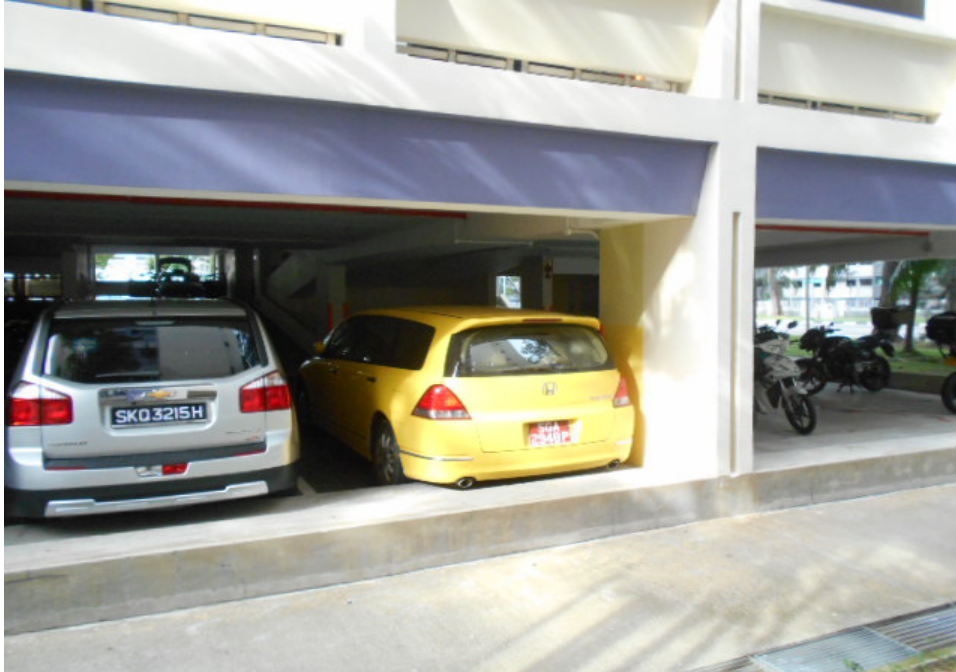
Photo 13 shows the general view of where the Insured Vehicle was parked (arrowed) at the time of incident. This was inside parking lot 3, which is the first of 3 parking lots in between the motorcycle lot and the handicapped lot. The ceiling and water pipe directly above the parking lot, were not affected by the fire incident.

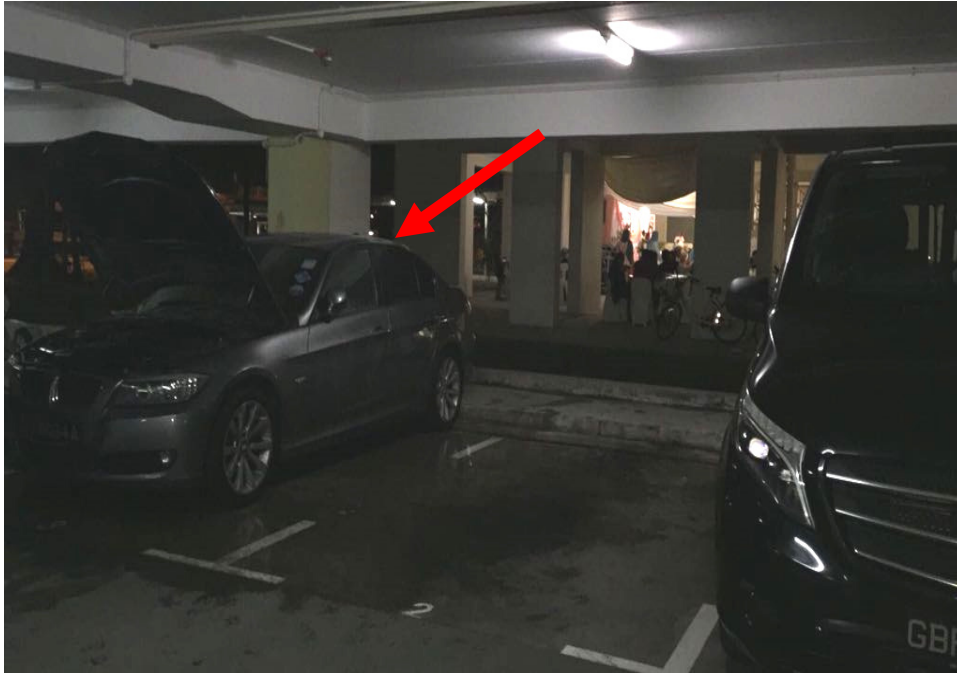
Photo 14 shows the Insured Vehicle at the incident scene after the fire was extinguished (arrowed). There appears to be no abnormal foreign material(s) and/or object(s) found on the ground in the immediate area where the Insured Vehicle was parked. In general, the information that could be gathered from these photographs had corresponded to the events that were related to us by Mr Lee.

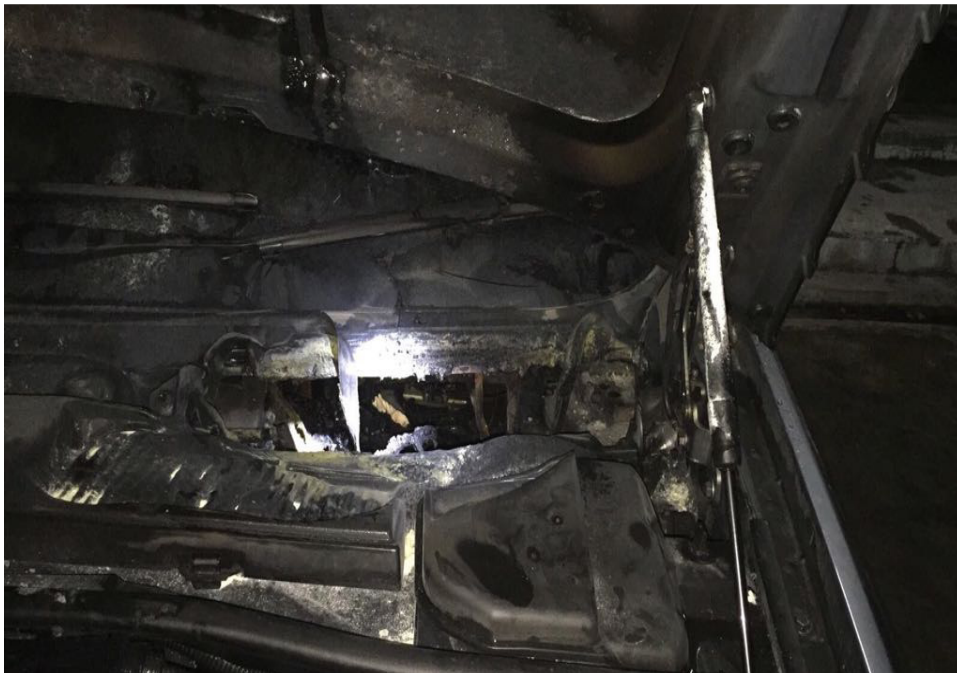
Photo 15 shows the Insured Vehicle at the incident scene after the fire was extinguished. The engine sustained partial burnt due to the incident.

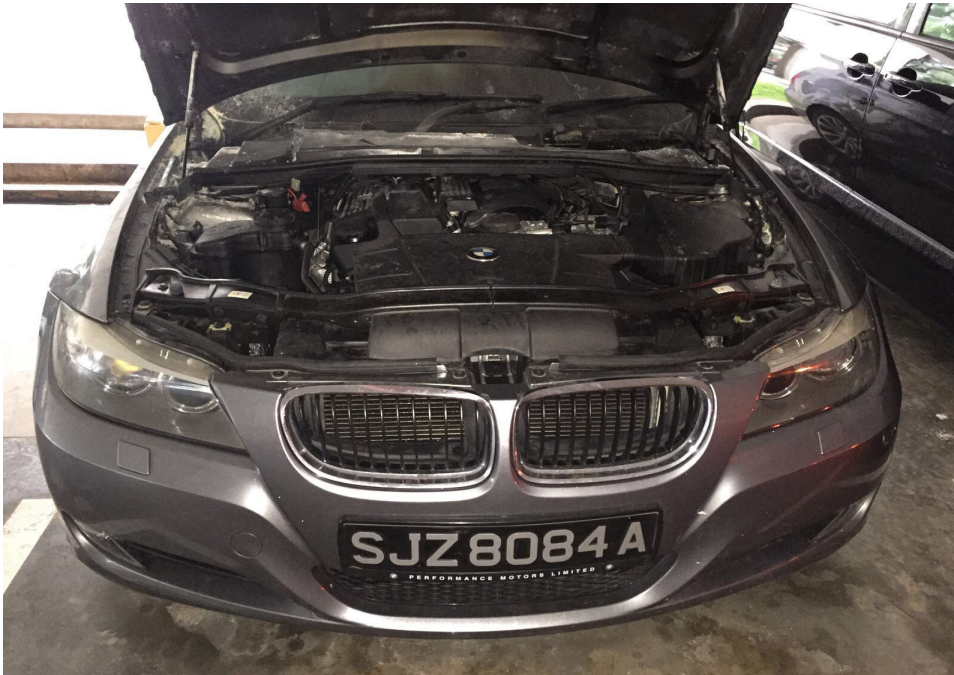
Photo 16 shows the Insured Vehicle at the incident scene on the next day. There appears to be no abnormal foreign material(s) and/or object(s) found on the ground in the immediate area where the Insured Vehicle was parked.
