Your Ref: 1396297935SG-001  
Our Ref :CI/AIG18001166/Z

**M/s AIG Asia Pacific Insurance Pte. Ltd.**

**TECHNICAL INVESTIGATION REPORT OF FIRE INCIDENT INVOLVING THE INSURED VEHICLE SJZ 8084A ON 30<sup>th</sup> DECEMBER 2017**

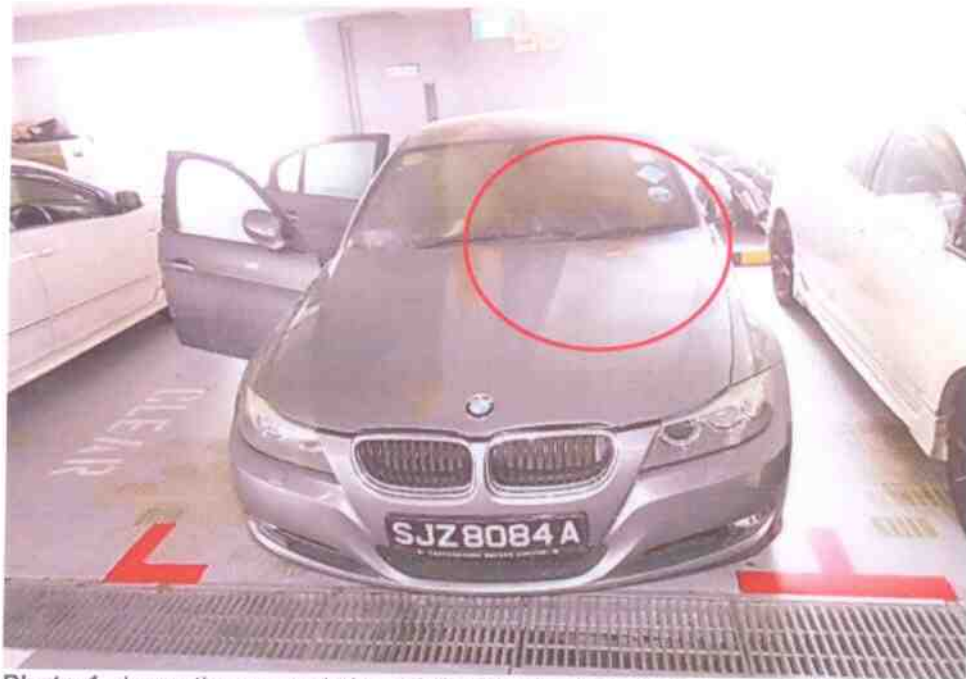
**Photo 1** shows the general view of the front portion of the Insured Vehicle at the time of our inspection. The fire damage to the Insured Vehicle was confined to its front bonnet, at the left top area; wiper panel garnish; front windshield; front dashboard and left front door (interior) amongst the body parts that were found to have been affected as a result of the fire.

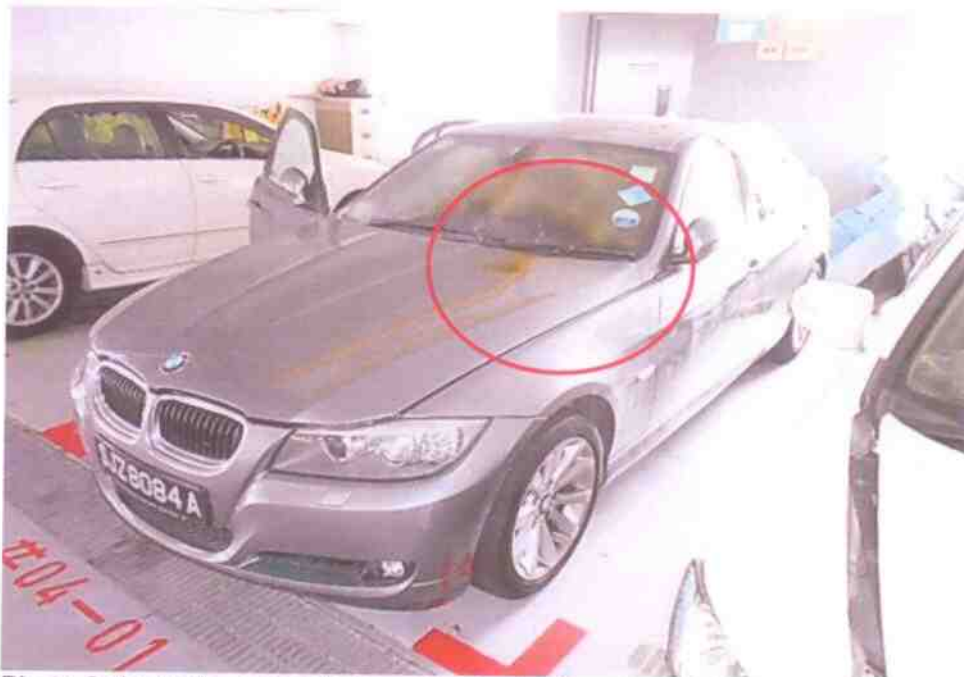
**Photo 2** shows the general view of the front left portion of the Insured Vehicle at the time of our inspection. The fire damage to the Insured Vehicle was confined to its front bonnet, at the left top area; wiper panel garnish; front windshield; front dashboard and left front door (interior) amongst the body parts that were found to have been affected as a result of the fire.

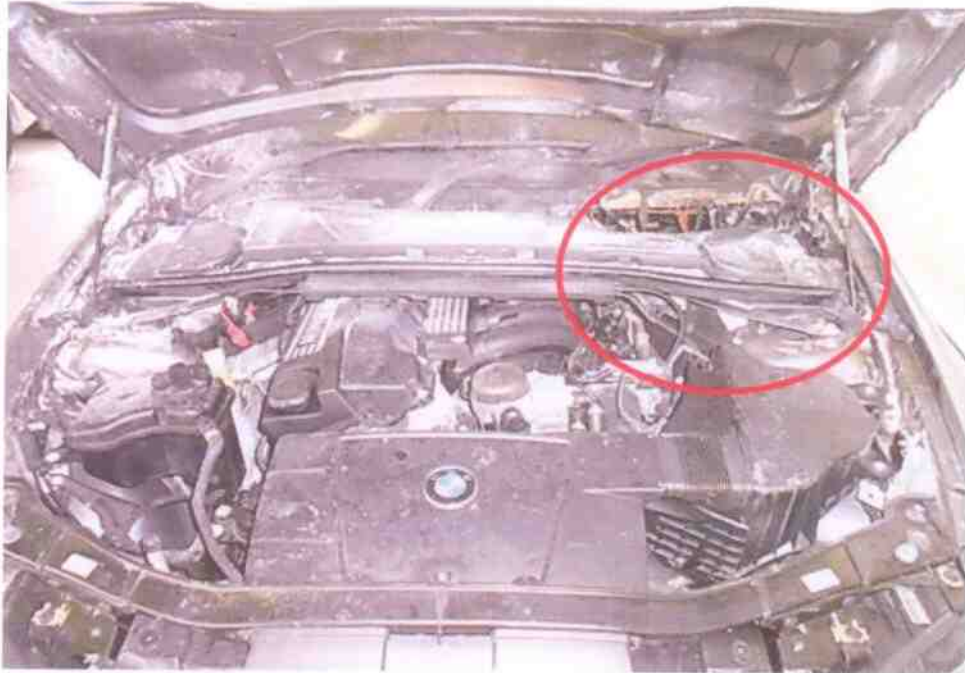
**Photo 3** shows the engine compartment of the Insured Vehicle at the time of our inspection. The engine compartment of the Insured Vehicle was observed to be partially burnt. Some parts inside the engine compartment, at the rear left area (circled), were found to be burnt and/or melted as a result of the fire.

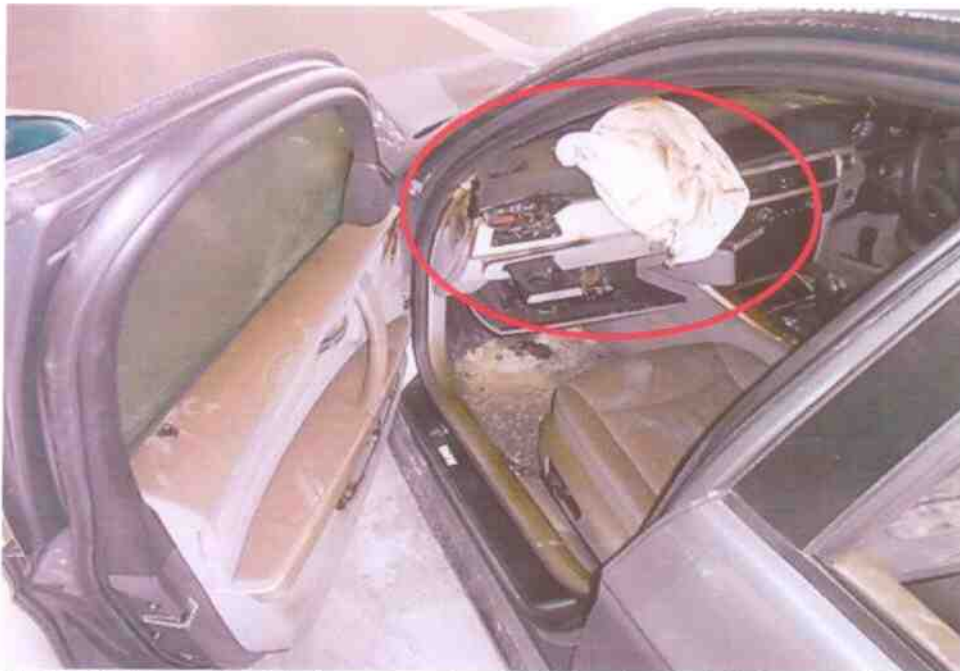
**Photo 4** shows the interior compartment of the Insured Vehicle, which was observed to be partially burnt and/or melted. The front dashboard & front windscreen were amongst the parts that were found to have been burnt and/or melted as a result of the fire. The front left air bag was also found to be activated due to the incident.

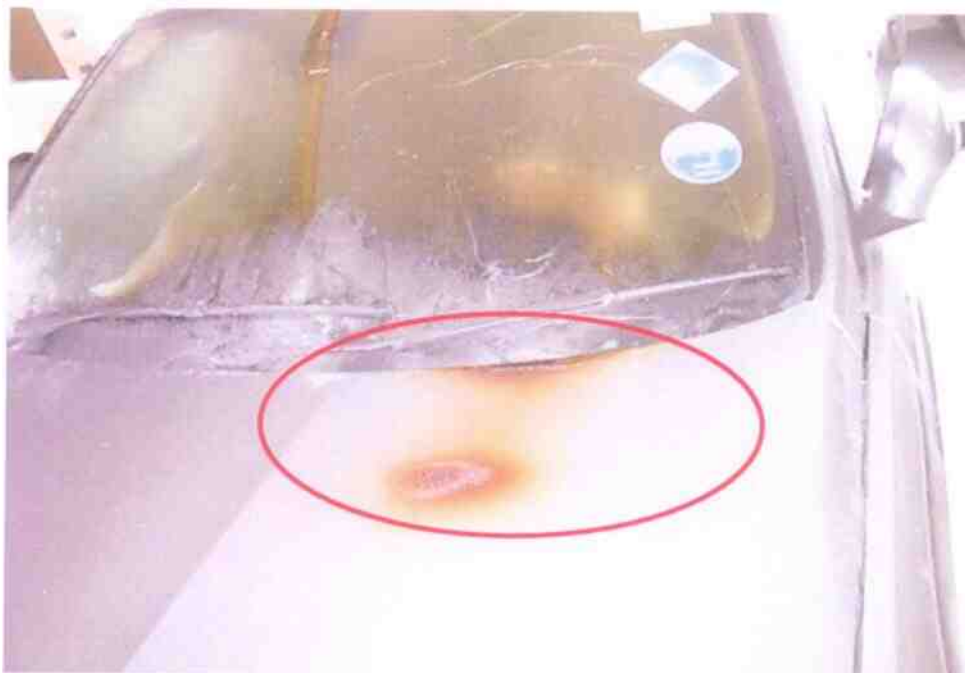
8. For this particular case, the fire appears to have originated within the engine compartment of the Insured Vehicle, somewhere around its front portion in between the engine & interior portion. This can be determined from the burn pattern and the high heat intensity burn marks (whitish burn marks) found on the front bonnet of the Insured Vehicle, at both its top and under side, and also given that there was no other areas of the Insured Vehicle that were found with damage of burnt nature.
9. These whitish burn marks are a result of exposure to prolong heat intensity. Rust would normally start to develop around these areas soon after a fire as prolonged exposure to high heat intensity usually causes steel/metal material body parts to be exposed to natural environmental condition. See photo 5 & 6 below.

**Photo 5** shows the burn pattern and whitish burn marks (circled) that were found on the top side of the front bonnet of the Insured Vehicle. Such whitish burn marks are a result of exposure to prolong heat intensity, which may indicate where the fire had started. Rust would also begin to develop on these areas soon after the fire.

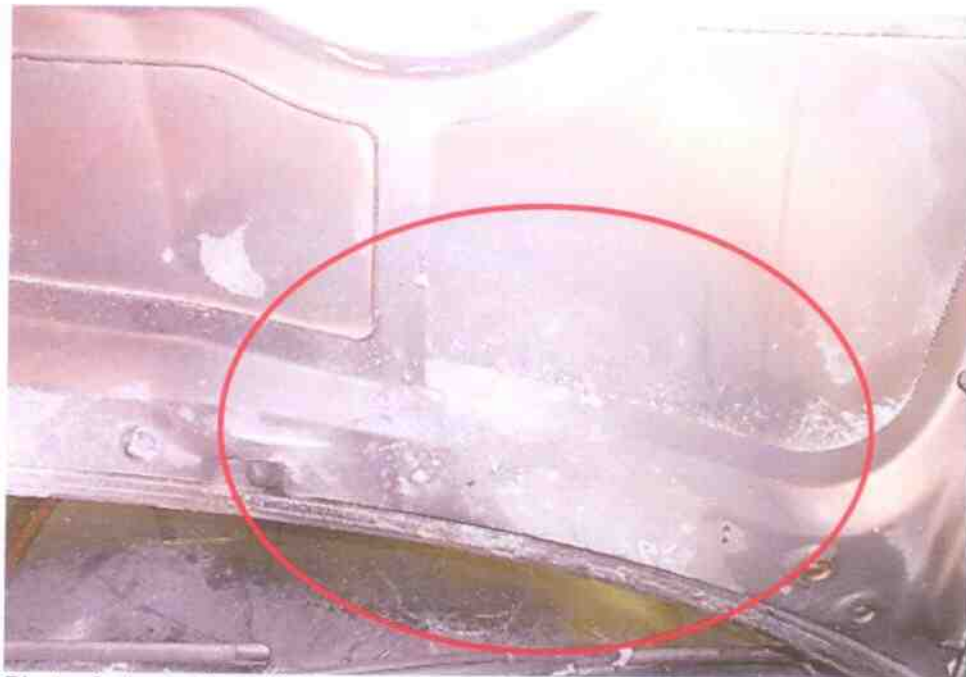
**Photo 6** shows the whitish burn marks that were found on the underside of the front bonnet, directly under the area where the same whitish burn marks were found on the top side of the front bonnet. The rust (circled) that had developed around this area was a result of prolong exposure to high heat intensity, which had caused the steel/metal material of the front bonnet to be exposed to natural environmental condition.

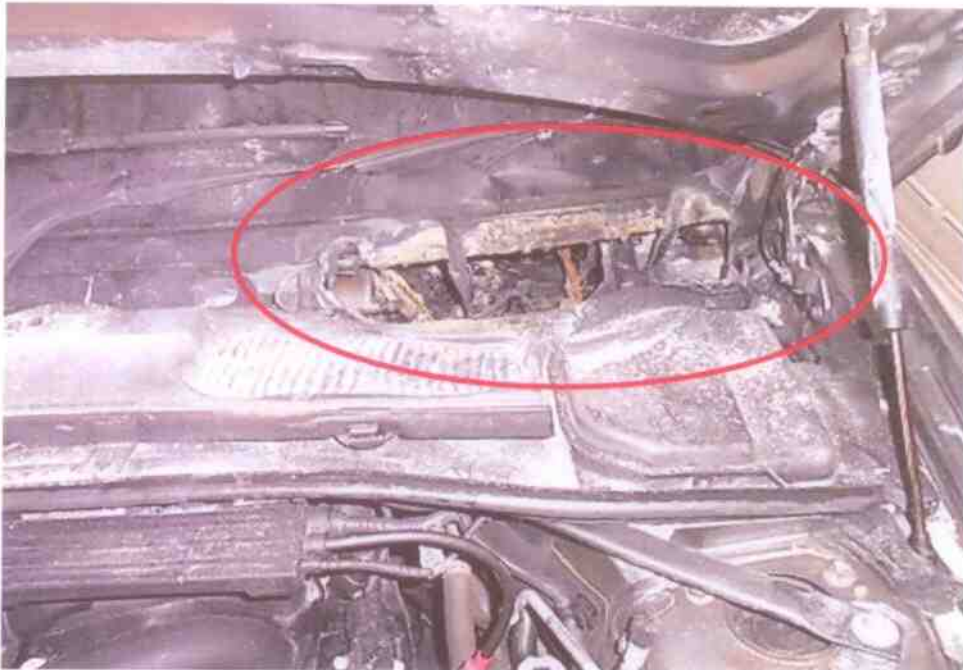
10. Upon closer examination of the area around the left rear of the engine compartment, which was in the immediate vicinity of where the fire to the Insured Vehicle had likely started, we had found several stretches of wiring burnt internally to its bare copper state. The wirings were likely to be the original engine wire harness. Such condition normally indicate internal heating of copper wires which is a sign of an electrical short circuit occurring. This would then appear to suggest that the cause of fire to the Insured Vehicle could have possibly been due to electrical in nature. See photo 7 & 8 below.

**Photo 7** shows a closer view of the wirings around the left rear of the engine compartment, which was in the immediate vicinity where the fire to the Insured Vehicle had likely started.

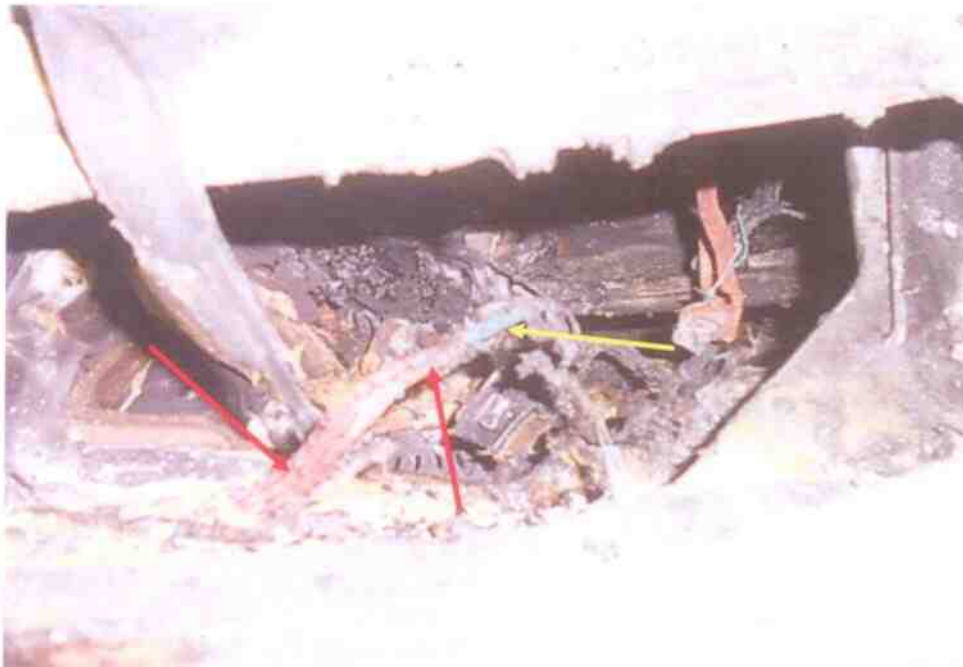
**Photo 8** shows a closer view of the wirings (red arrow) which were found to have been burnt internally to its bare copper state, suggesting occurrence of an electrical short circuit. These wirings were observed to be greenish (yellow arrow) believe to be the focal point of the fire ignition.

32. Having investigated and technically analysed the damages of burnt nature to the Insured Vehicle, We are of the view that the cause of fire to the Insured Vehicle was of electrical in nature. For this particular case, the fire had originated along the wiring inside the engine compartment, somewhere around its front portion in between the engine & interior portion. The wirings were likely to be the original engine wire harness.

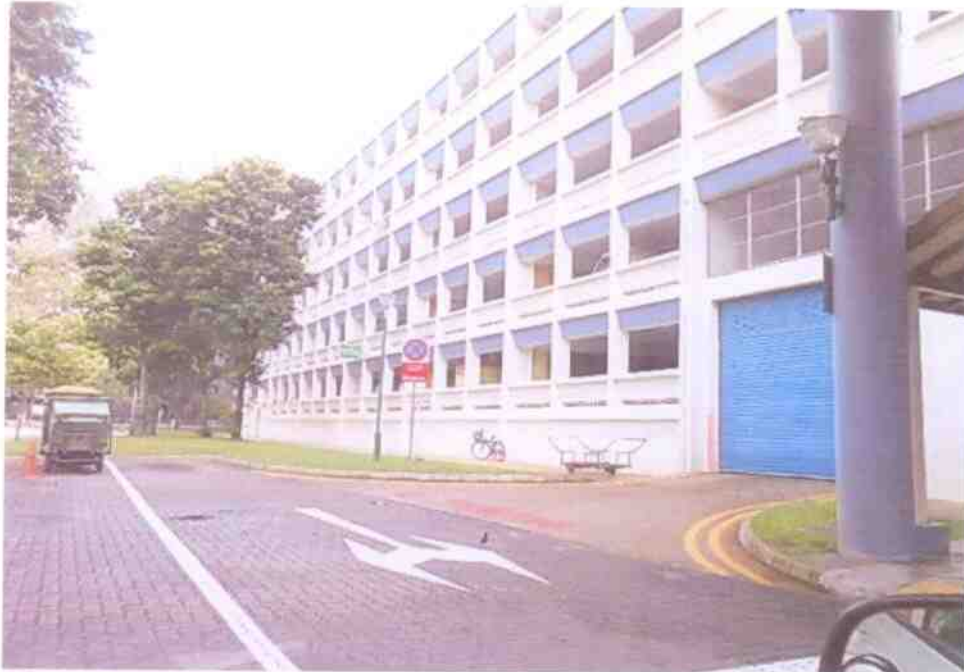
**Photo 9** shows the general view of the multi-storey carpark where the Insured Vehicle was parked at the time of incident. This was inside the premises of blk 115A Ho Ching Road. The Insured Vehicle was parked at the 1<sup>st</sup> floor of this carpark at the material time of incident.

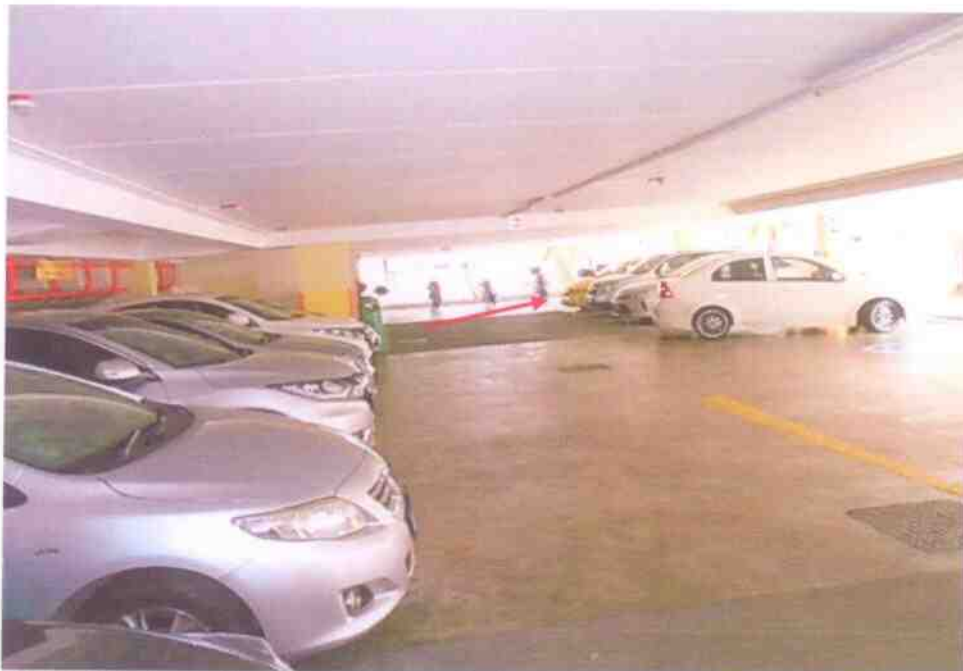
**Photo 10** shows the general view of where the Insured Vehicle was parked (arrowed) at the time of incident. This was inside parking lot 3, which is on the left side of the carpark driveway, at the 1<sup>st</sup> floor of the multi-storey carpark.

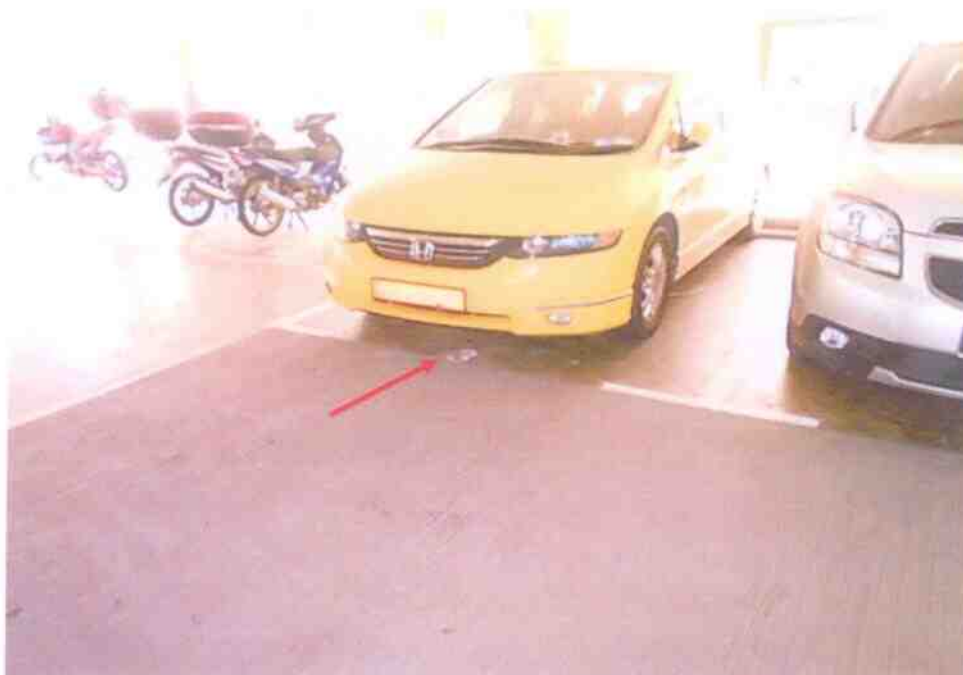
**Photo 11** shows the general view of where the Insured Vehicle was parked (arrowed) at the time of incident. This was inside parking lot 3, which is the first of 3 parking lots in between the motorcycle lot and the handicapped lot.

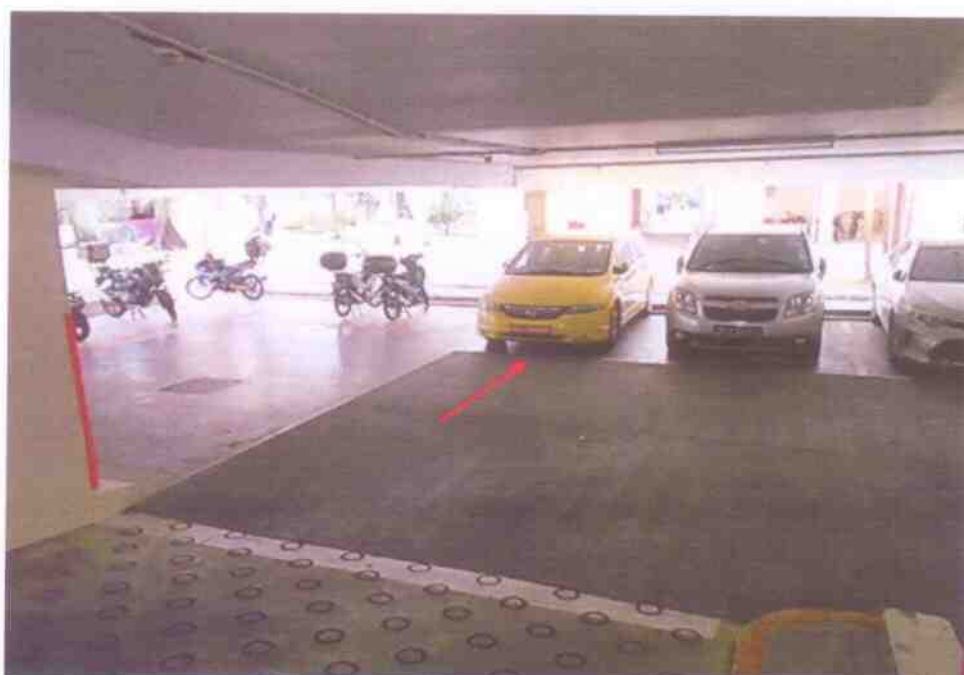
**Photo 12** shows the general view of where the Insured Vehicle was parked (arrowed) at the time of incident. This was inside parking lot 3, which is the first of 3 parking lots in between the motorcycle lot and the handicapped lot. The ceiling and water pipe directly above the parking lot, were not affected by the fire incident.

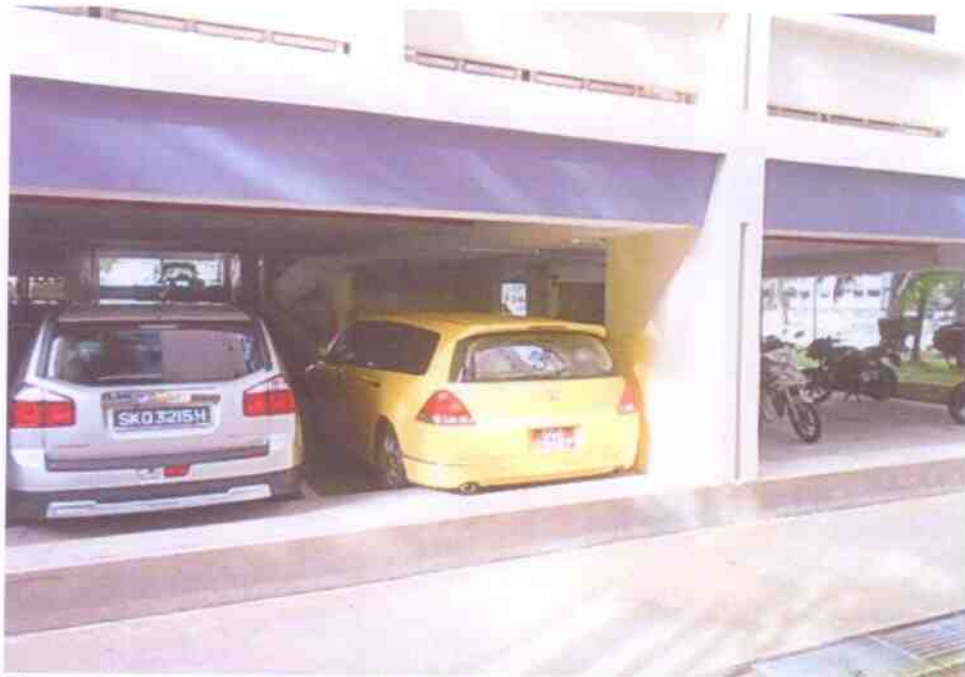
**Photo 13** shows the general view of where the Insured Vehicle was parked (arrowed) at the time of incident. This was inside parking lot 3, which is the first of 3 parking lots in between the motorcycle lot and the handicapped lot. The ceiling and water pipe directly above the parking lot, were not affected by the fire incident.

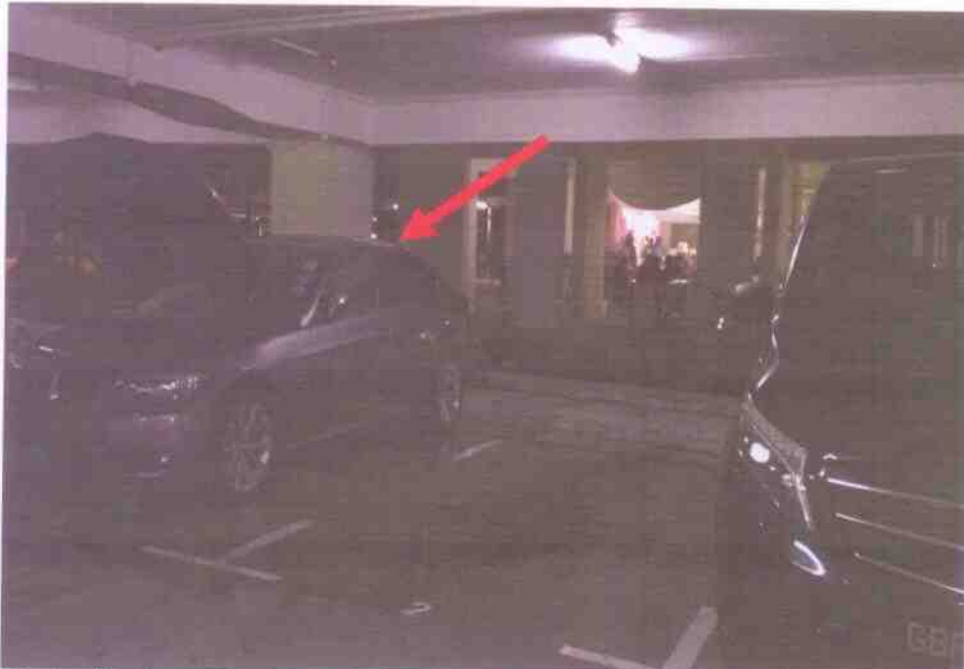
**Photo 14** shows the Insured Vehicle at the incident scene after the fire was extinguished (arrowed). There appears to be no abnormal foreign material(s) and/or object(s) found on the ground in the immediate area where the Insured Vehicle was parked. In general, the information that could be gathered from these photographs had corresponded to the events that were related to us by Mr Lee.

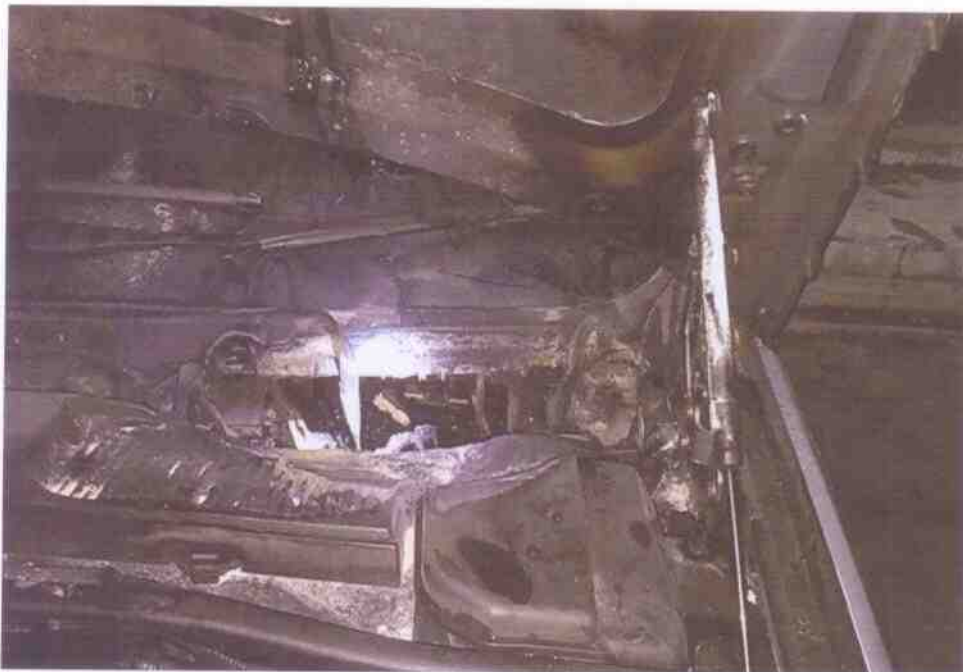
**Photo 15** shows the Insured Vehicle at the incident scene after the fire was extinguished. The engine sustained partial burnt due to the incident.

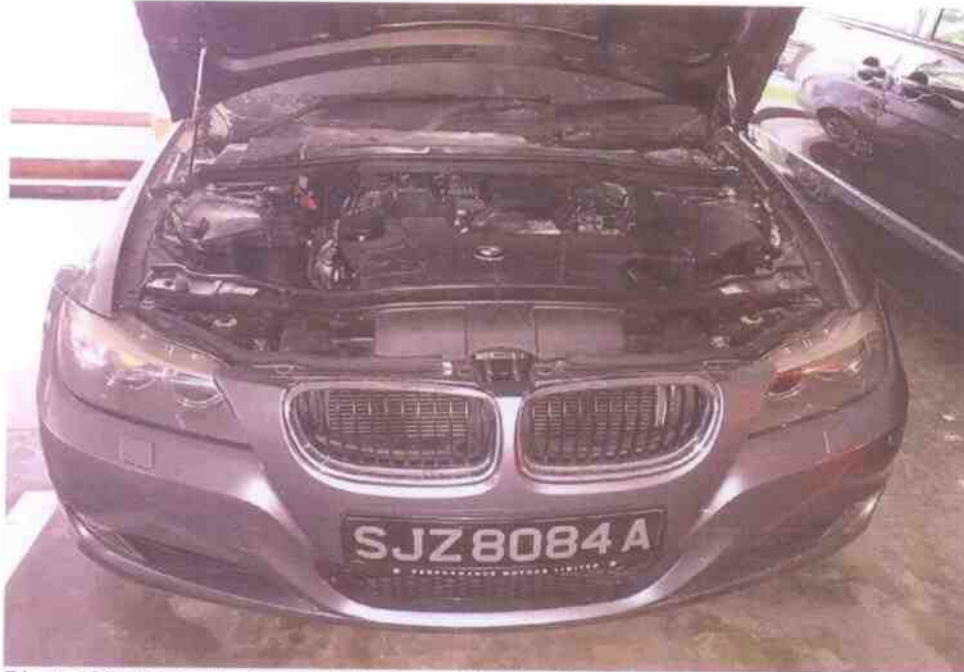
**Photo 16** shows the Insured Vehicle at the incident scene on the next day. There appears to be no abnormal foreign material(s) and/or object(s) found on the ground in the immediate area where the Insured Vehicle was parked.
